Centre for Archaeology Report 48/2004

Tree-Ring Analysis of Timbers from Dacre Hall,
Lanercost Priory, Brampton, Near Carlisle, Cumbria

A J Arnold, R E Howard and Dr C D Litton

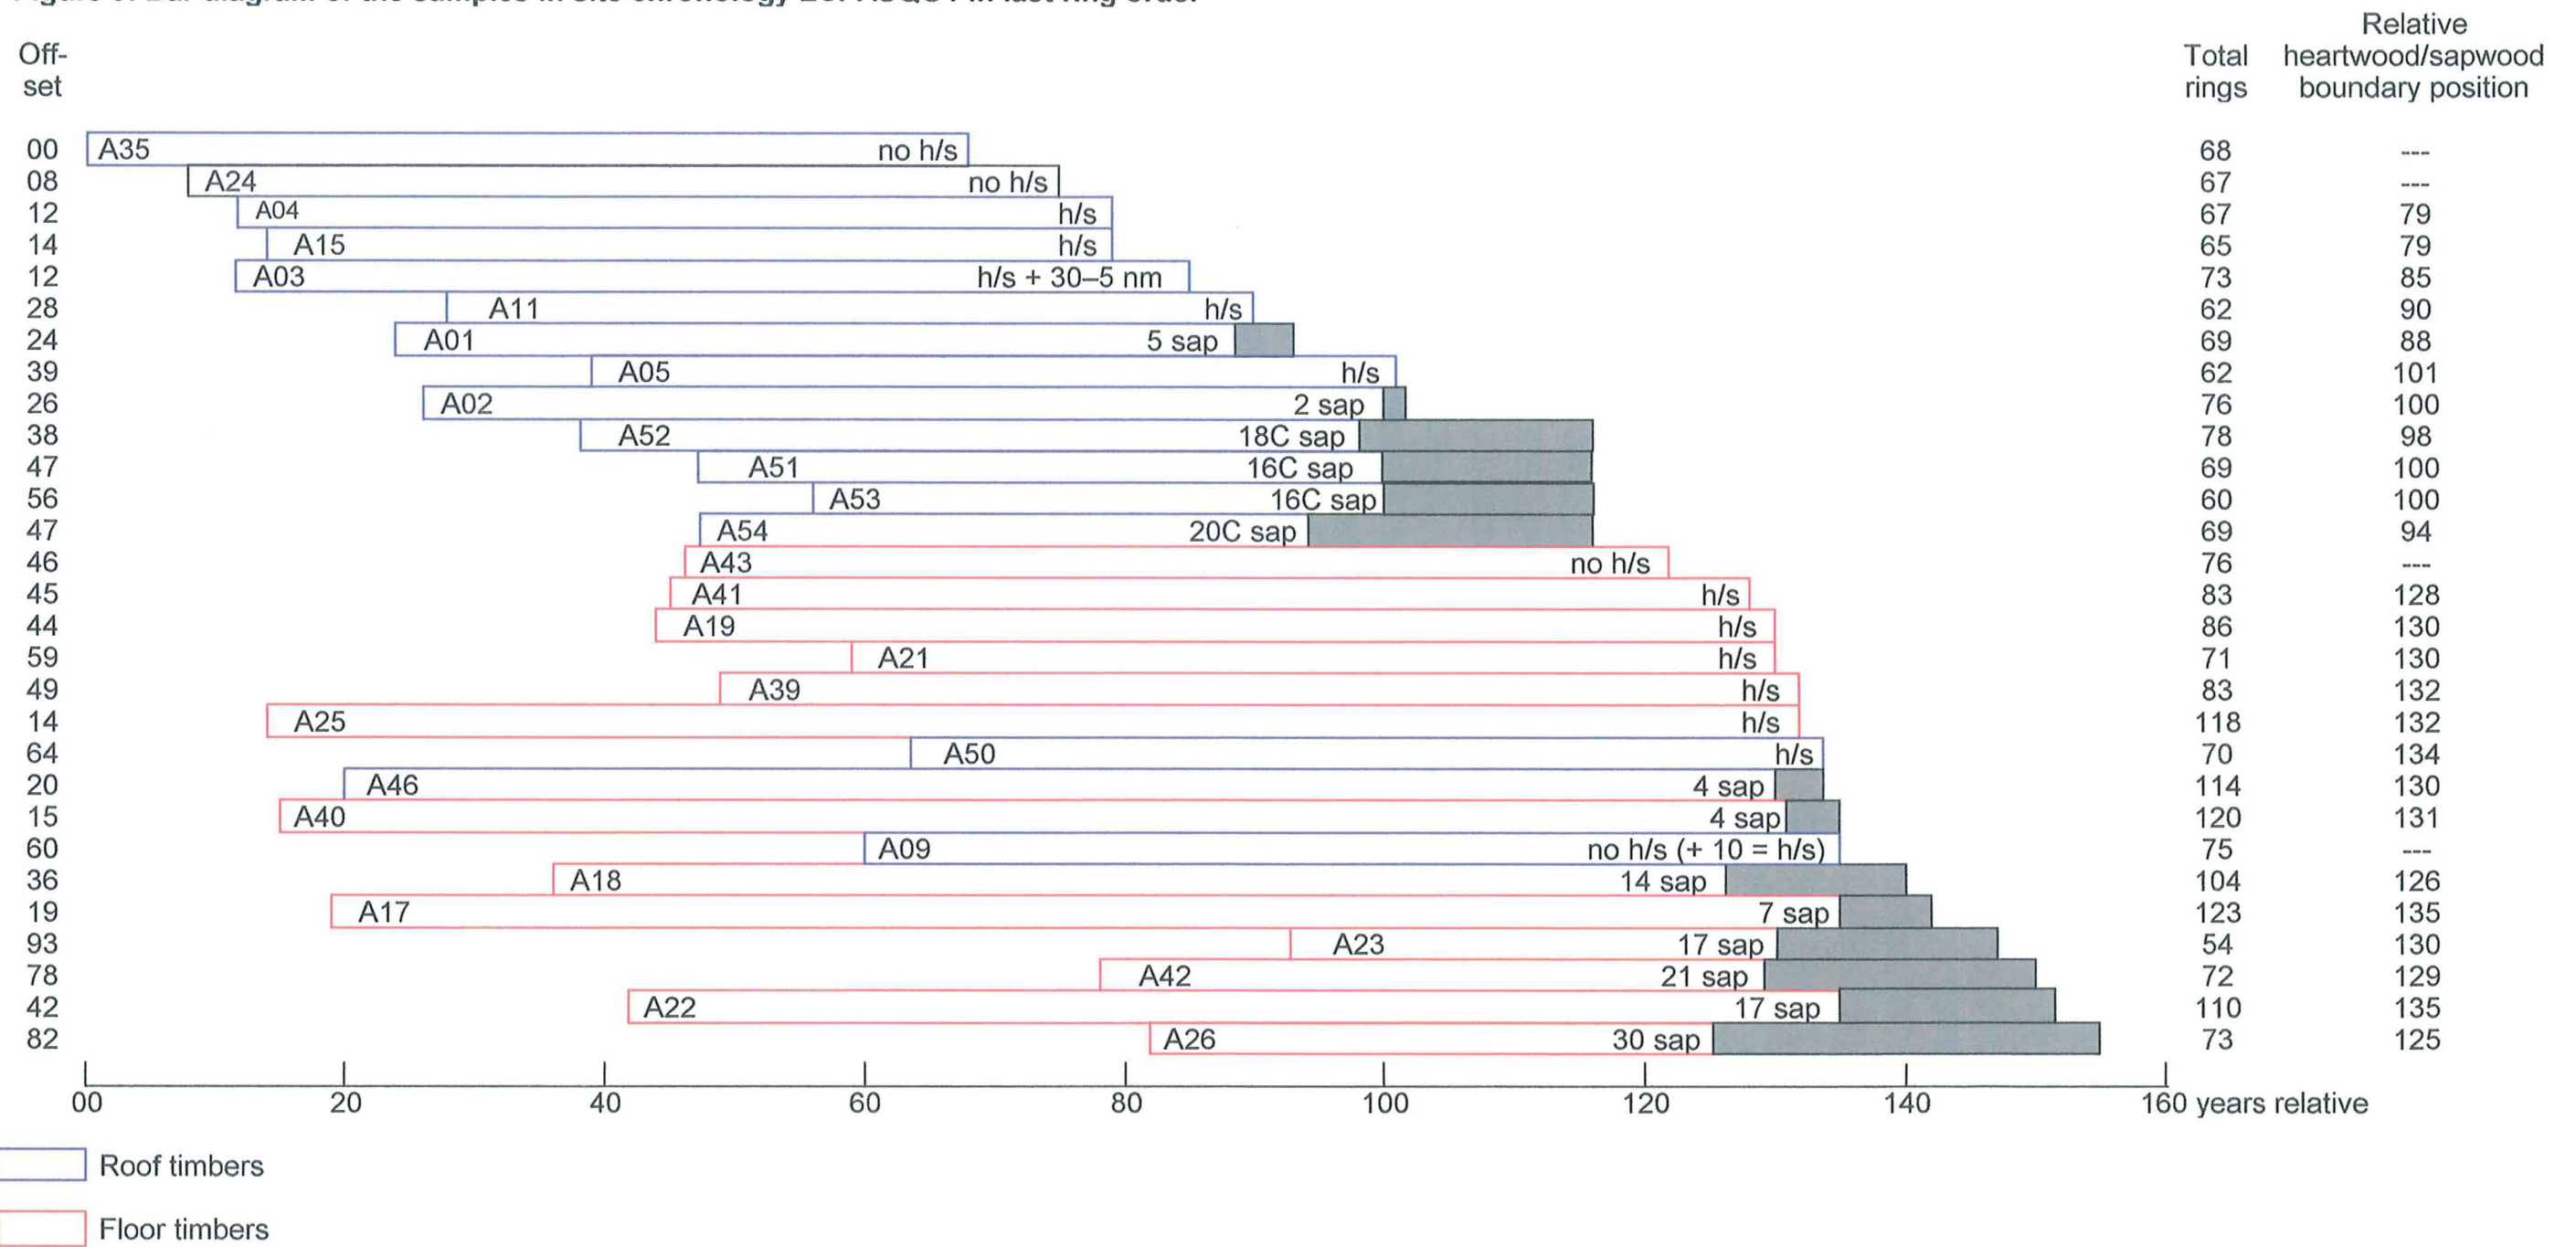
Figure 9: Bar diagram of the samples in site chronology LCPASQ01 in last ring order

white bars = heartwood rings, shaded area = sapwood rings
 h/s = heartwood/sapwood boundary is last ring on sample
 C = complete sapwood retained on sample, the last measured ring date is the felling date of the timber
 c = complete sapwood on sample, all or part lost during sampling

These data were then compared with each other by the Litton/Zainodin grouping procedure (see appendix). At a minimum t -value of 4.5 five site chronologies could be formed. The first site chronology, LCPASQ01, consists of 29 samples and has a combined overall length of 155 rings. The relative positions of the cross-matching samples are shown in the bar diagram, Figure 9.

The next latest material is represented in site chronology, LCPASQ01 (Fig 9), which comprises 29 samples with a combined overall length of 155 rings. These rings are dated as spanning the period AD 1350 to AD 1504. At least two phases of felling are represented by this material. An attempt to illustrate this is given in the bar diagram Figure 14, where the samples are sorted into roof or floor timbers, and in Figure 15 where the samples from the roof are sorted according to truss.

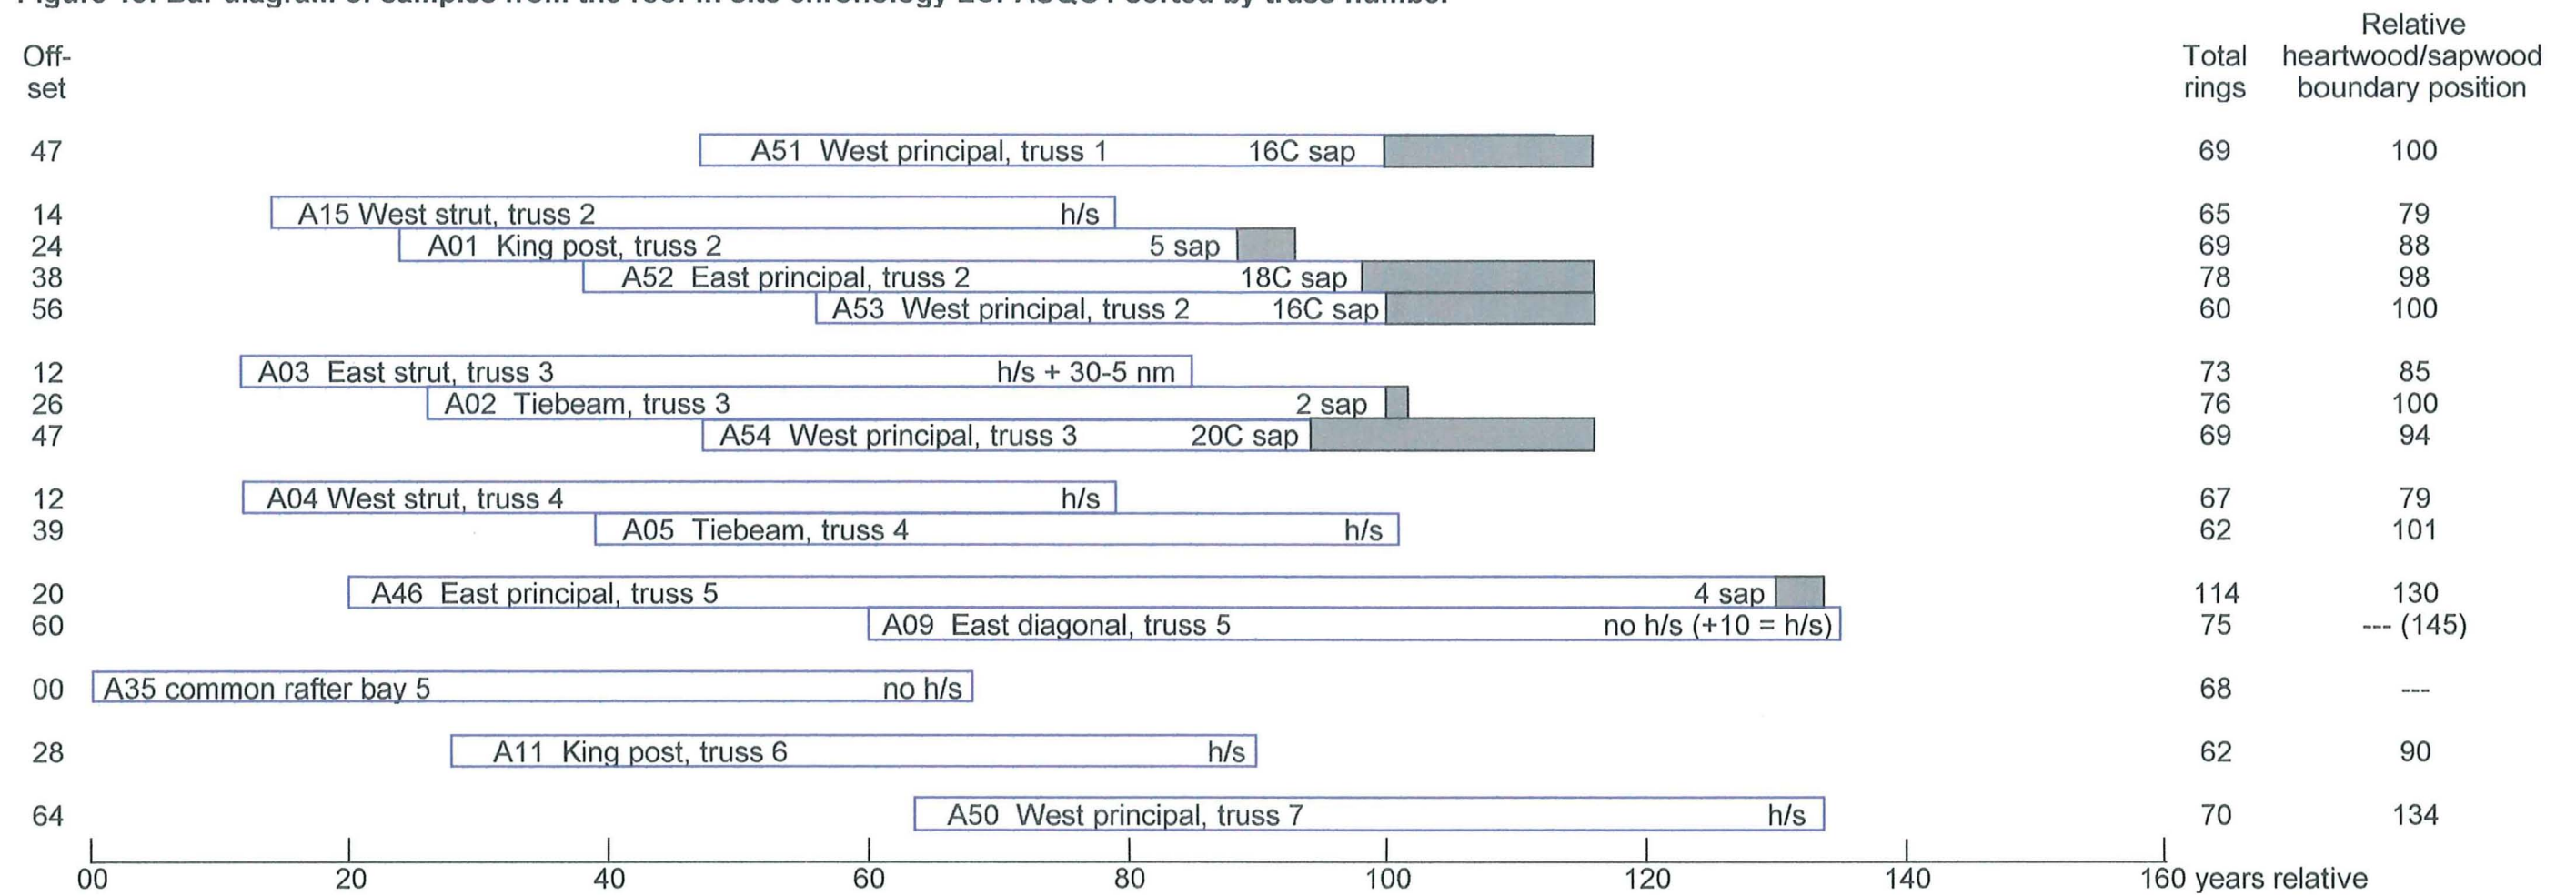
Figure 15: Bar diagram of samples from the roof in site chronology LCPASQO1 sorted by truss number

white bars = heartwood rings, shaded area = sapwood rings
 h/s = heartwood/sapwood boundary is last ring on sample
 C = complete sapwood retained on sample, the last measured ring date is the felling date of the timber
 c = complete sapwood on sample, all or part lost during sampling

The relative positions of the heartwood/sapwood boundaries on a number of other samples from these trusses in site chronology LCPASQ01, and also on a sample from truss 6, LCP-A11, all lie relatively close to each other. Such a relative closeness is consistent with the trees they represent being felled in AD 1465 too. This point is illustrated in Figure 15, where the dated samples from the roof in site chronology LCPASQ01 are shown sorted by truss number.

Figure 15 will also illustrate, however, that other timbers from the hall roof, particularly timbers from trusses 5 and 7, samples LCP-A09, A46, and A50, were certainly felled later. Two of these samples, LCP-A46 and A50, retain some sapwood or the heartwood sapwood boundary, the average last heartwood ring date of these being AD 1481. A further sample, LCP-A09, has last measured heartwood rings which approach the heartwood/sapwood boundary (the last 8 - 10 rings being unmeasurable due to compaction). Given that this sample's last heartwood ring date is AD 1484, this would give the sample a heartwood/sapwood boundary date of no later than AD 1494. Taken together is estimated that these sample represent trees with an estimated felling date in the range AD 1502 to AD 1527.

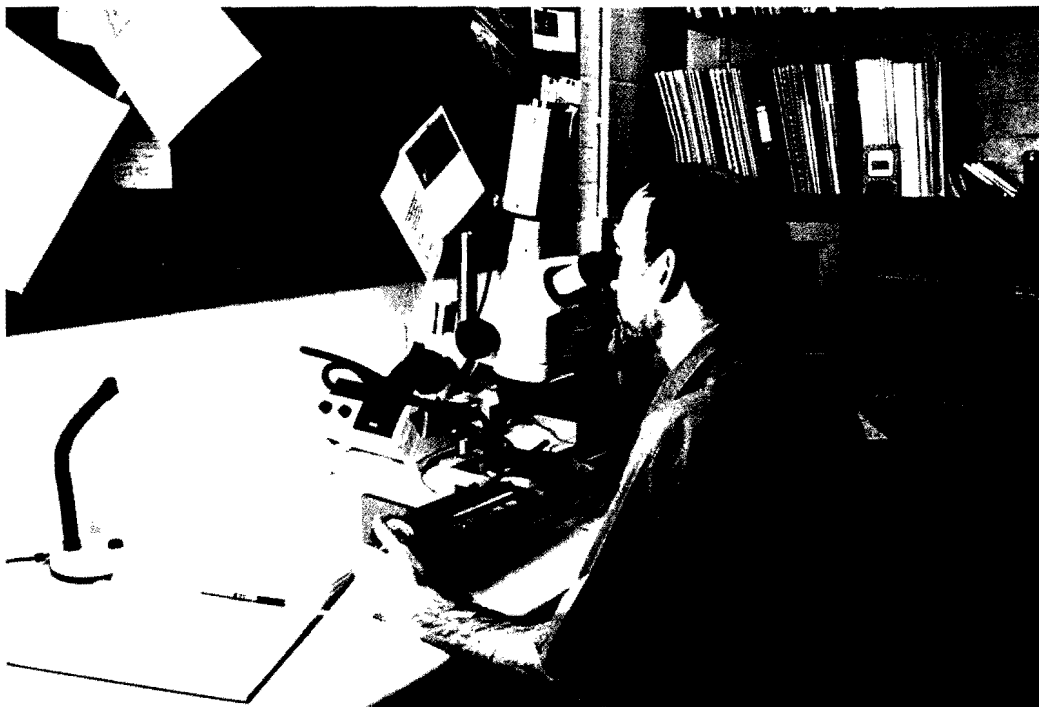
Fig. 3 Measuring ring widths under a microscope. The microscope is fixed while the sample is on a moving platform. The total sequence of widths is measure twice to ensure that an error has not been made. This type of apparatus is needed to process a large number of samples on a regular basis.
