Centre for Archaeology Report 4/2005

**Tree-Ring Analysis of Timbers from Southall Manor House,
The Green, Southall, Ealing, Greater London**

A J Arnold, R E Howard and Dr C D Litton

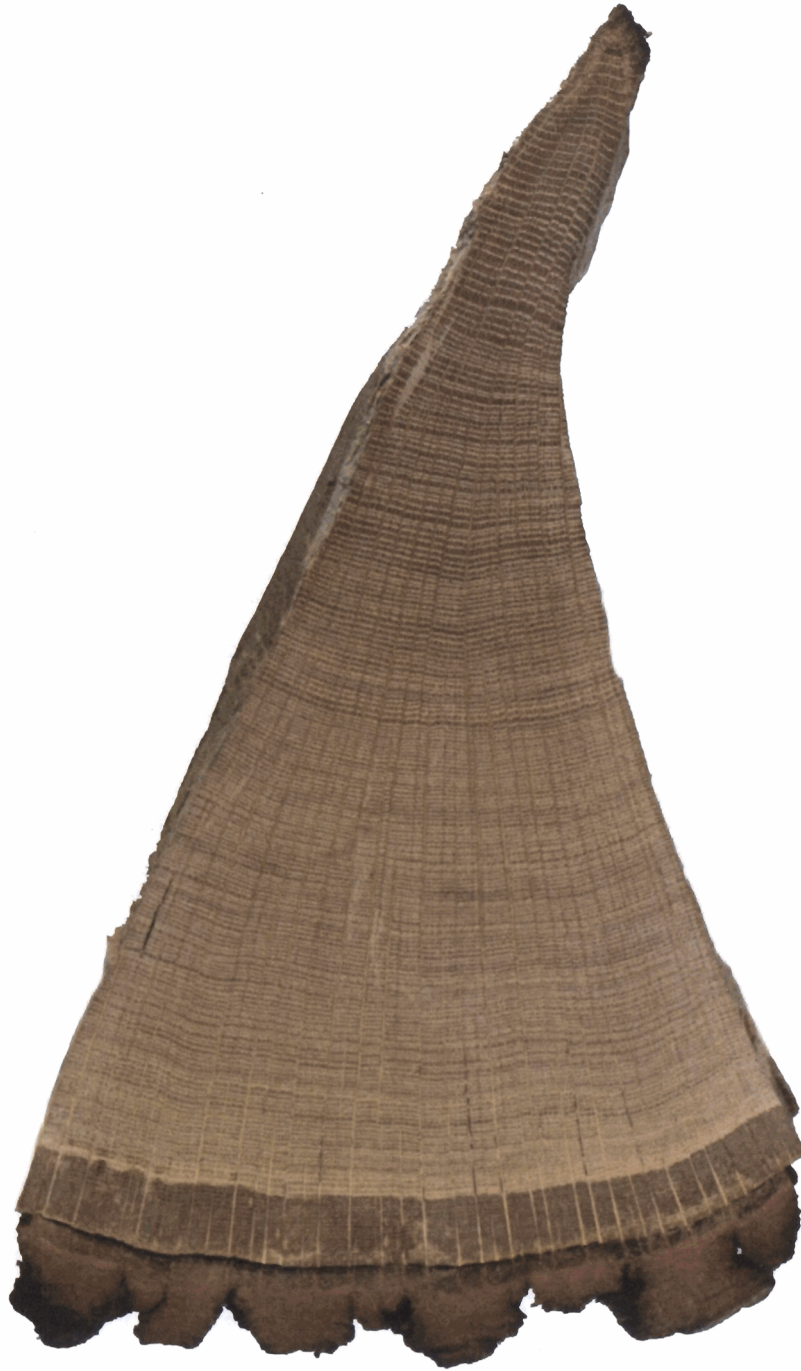
Fig 1. A wedge of oak from a tree felled in 1976. It shows the annual growth rings, one for each year from the innermost ring to the last ring on the outside just inside the bark. The year of each ring can be determined by counting back from the outside ring, which grew in 1976.

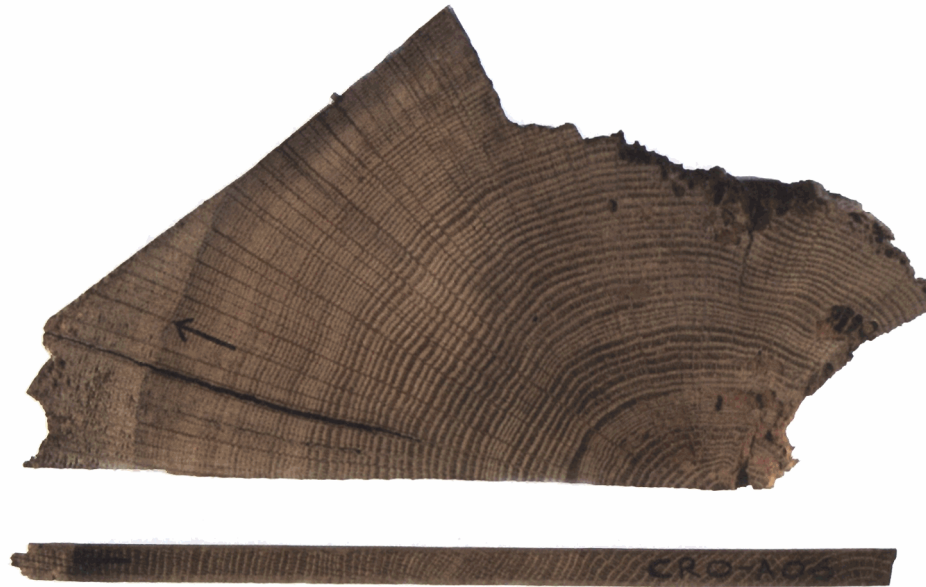
Fig 2. Cross-section of a rafter showing the presence of sapwood rings in the left hand corner, the arrow is pointing to the heartwood/sapwood boundary (H/S). Also a core with sapwood; again the arrow is pointing to the H/S. The core is about the size of a pencil.

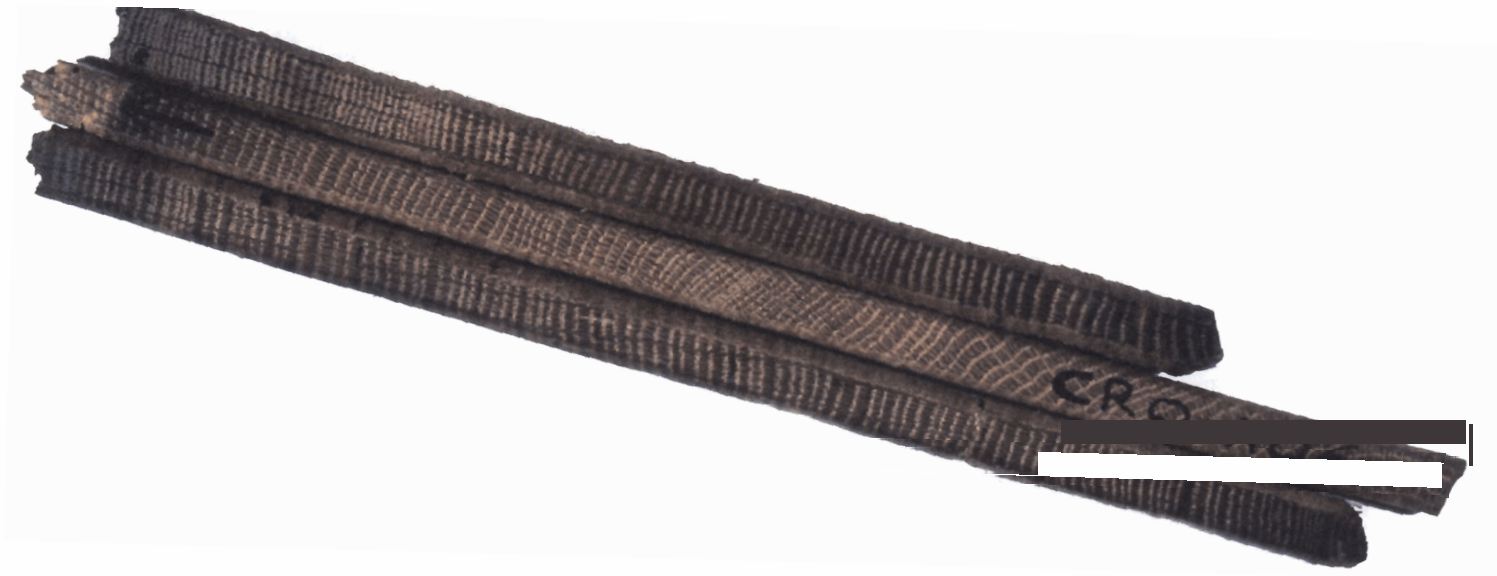
Fig 4. Three cores from timbers in a building. They come from trees growing at the same time. Notice that, although the sequences of widths look similar, they are not identical. This is typical.
