Centre for Archaeology Report 55/2005

**Tree-Ring Analysis of Timbers from Wolfeton Riding  
House, Wolfeton House, Charminster, Dorset**

### **Summary**

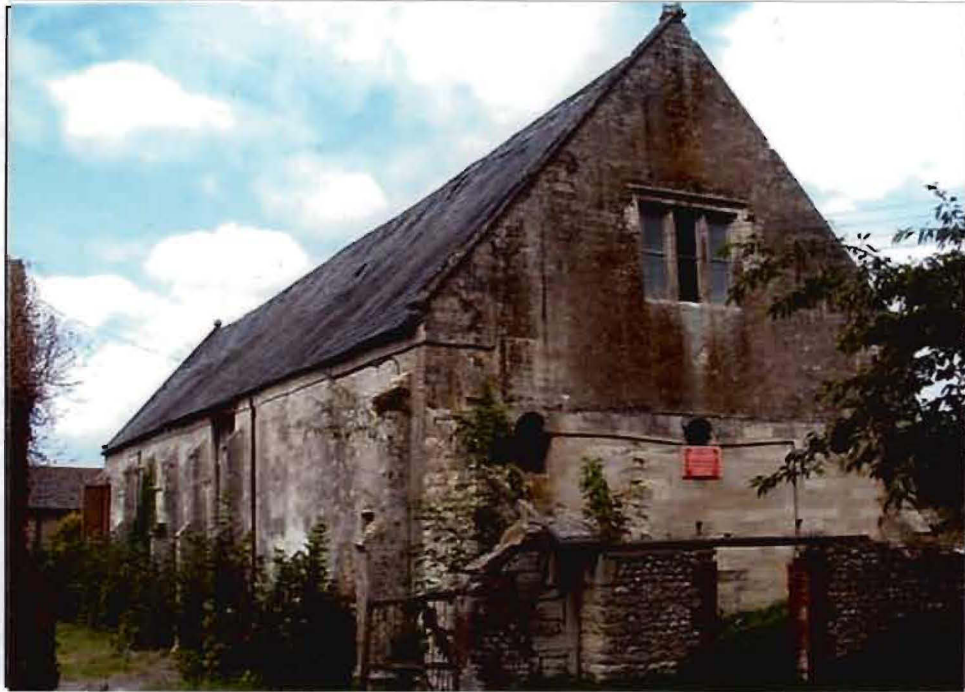
**Figure 2:** Exterior view of the Riding House from the south east, looking north west

The Riding House (NGR SY 6785 9225; Fig 1) is situated a little more than 100 metres north of Wolfeton House, near the village of Charminster. It is described in detail in a report by Rodwell (1986) from which the following brief notes have been taken. The rectangular stone-built property (Fig 2) is approximately 33.5m by 9.1m, and originally had two ranges projecting at right angles to the north wall. Although latterly used as a barn, the Royal Commission on the Historical Monuments of England (1970) recognised it as having been built as a riding house. The first documented purpose-built riding house in England was erected for Prince Henry at St James' Palace in AD 1607–9, and other examples followed in the early seventeenth century. Wolfeton Riding House is rather narrower than most known examples, and it had a ceiling, where most examples were open to the roof. As a building, Rodwell suggests that its closest parallel is with the 'hospice' at Ansty, Wiltshire, on the Wardour Castle Estate, which is almost identical in size, and very similar in layout. That building is thought to have been built shortly after AD 1594. Other similarities with a riding house at Lulworth Castle, Dorset, built between c AD 1588 and c AD 1610, suggest a date for the Wolfeton riding house around AD 1600, but Rodwell (1991) thought it unlikely to predate the example at St James' Palace.

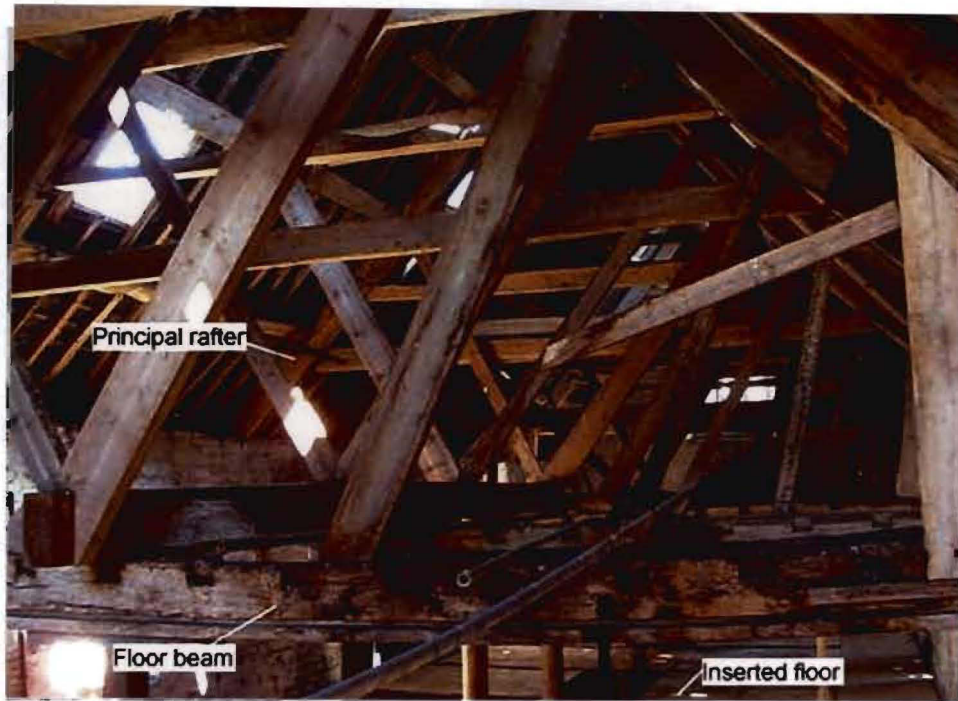
The interior (Fig 3) has an extant inserted floor of coniferous wood construction, now somewhat unsafe in some areas, but providing a good platform for access to the older timbers in many areas. Eight large floor beams, 0.3m square, of which the second from the west end now remains only as a stump in the north wall, are set nearly 1m below wallplate level. Each of these supported 21 ceiling joists, represented by mortices in the east underside of each beam. On the west side a continuous pulley mortice enabled the joists to be inserted after the beams had been set in position. The upper edges of these beams bear mortices for 17 attic floor joists. Holes for the joists in the south wall indicate that at least some of the joists were inserted before the wall was built around them.

**Figure 3:** Internal view of the Riding House, looking towards the east end
