Centre for Archaeology Report 56/2005

Dendrochronological Research in Devon: Phase 1

Cathy Groves
(with contributions from John Thorp)

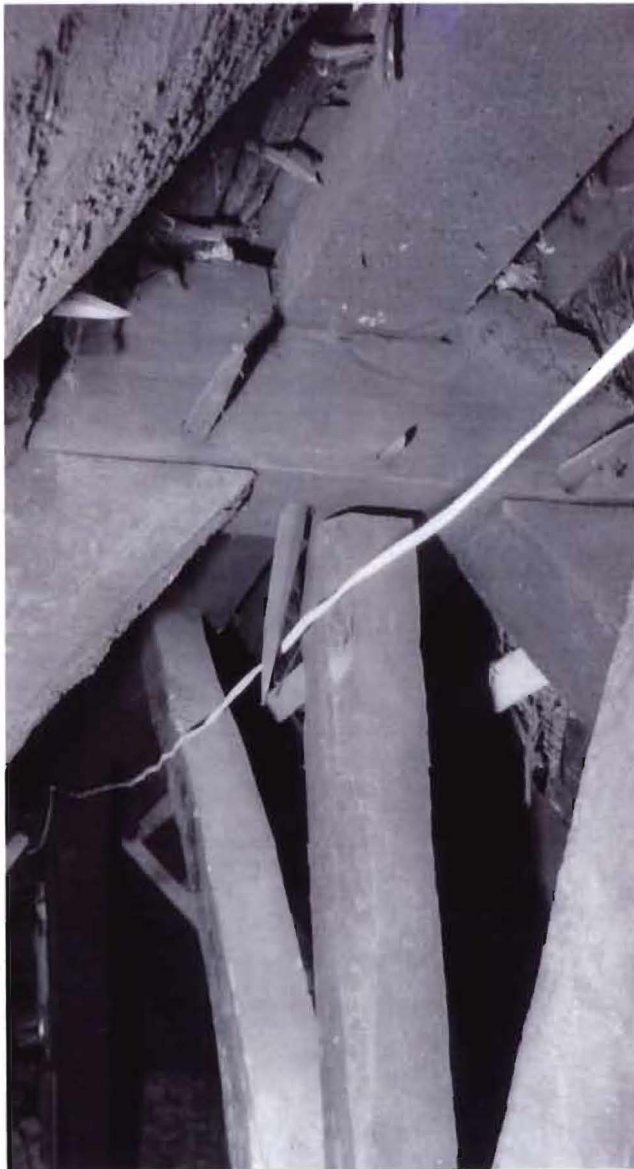
Figure 3c Old Rectory, Cheriton Bishop: truss 3 from the west (photograph J R L Thorp)

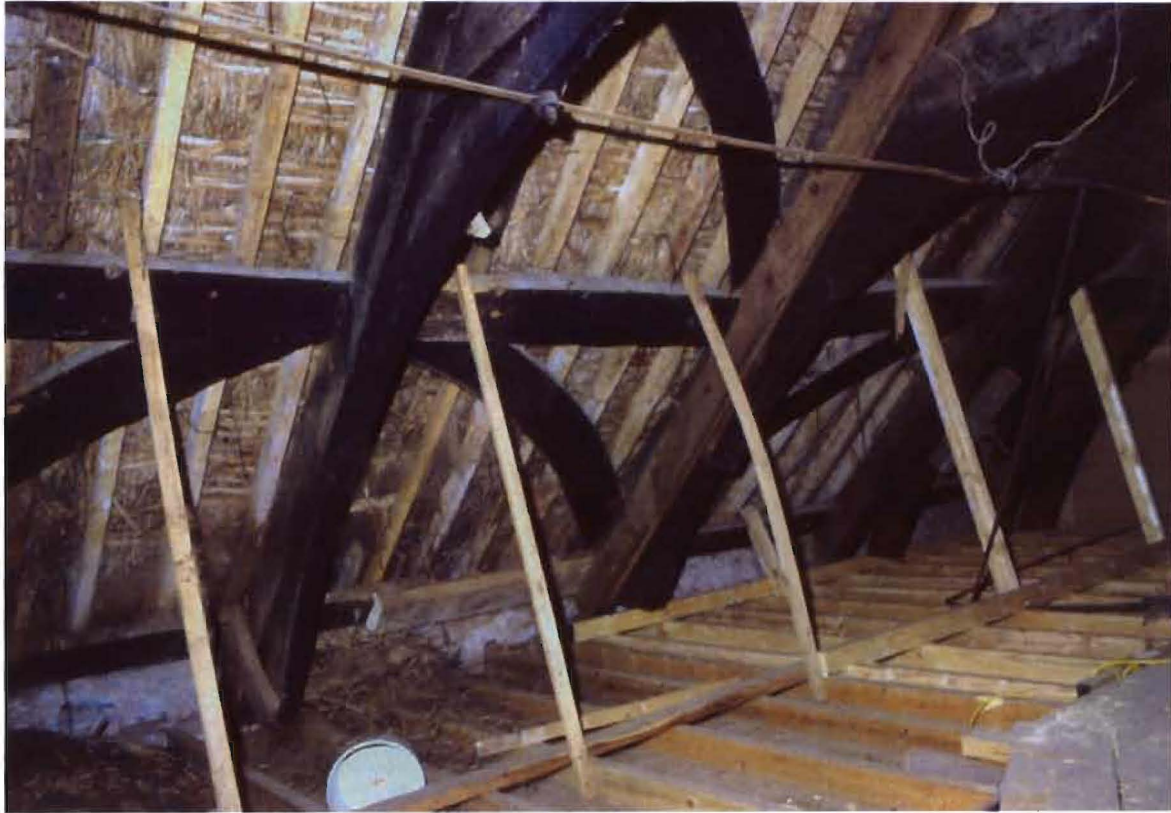
Figure 3s Traymill, Thorverton: south side, trusses 4 to 7 (photograph J R L Thorp)

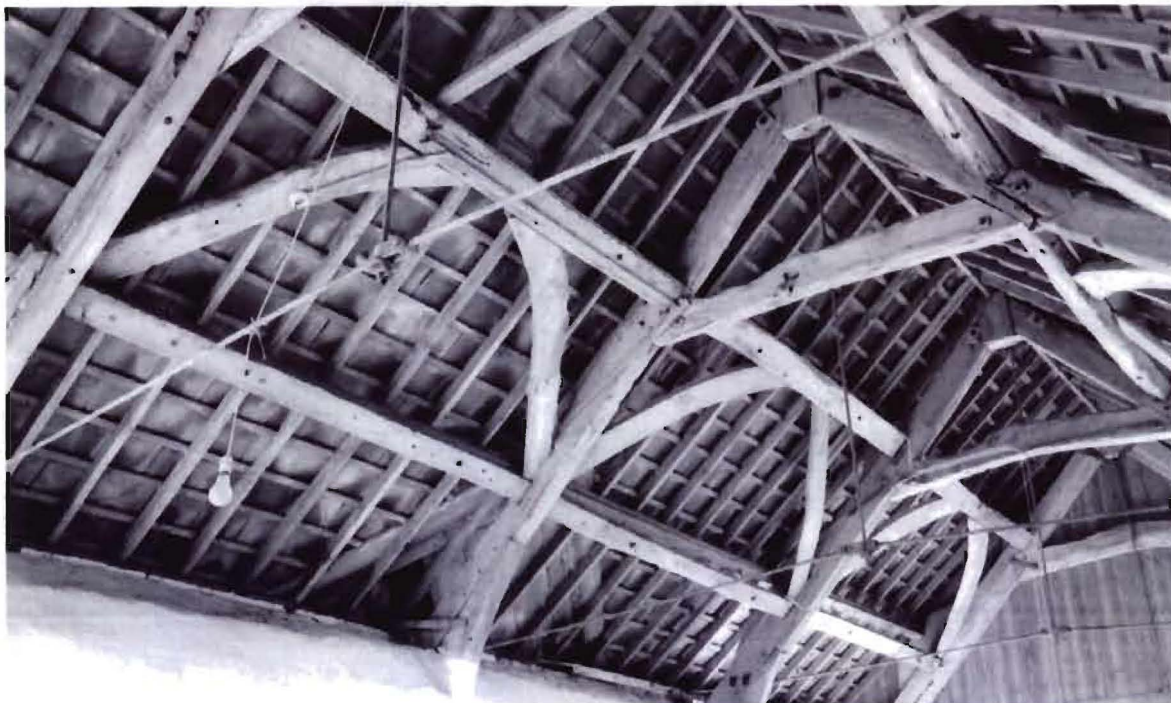
Figure 3t Glebe House barn, Whitestone: trusses 2 to 5 from the north-west (photograph J R L Thorp)

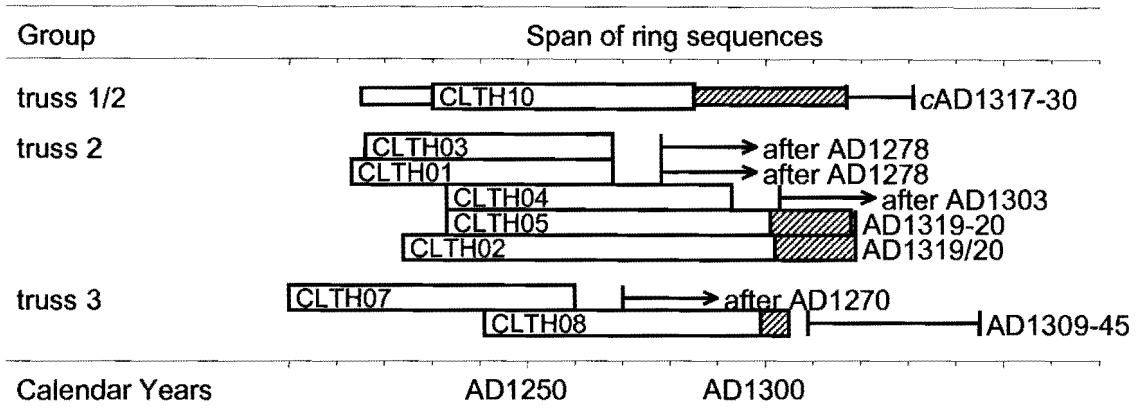
Figure 5d Bar diagram showing the relative positions of the dated ring sequences and their felling dates from Thorne, Clannaborough
