**Tree-Ring Analysis of Timbers from Howbury Barn,
Moat Lane, Slade Green, London Borough of Bexley**

Dr Martin Bridge

Summary

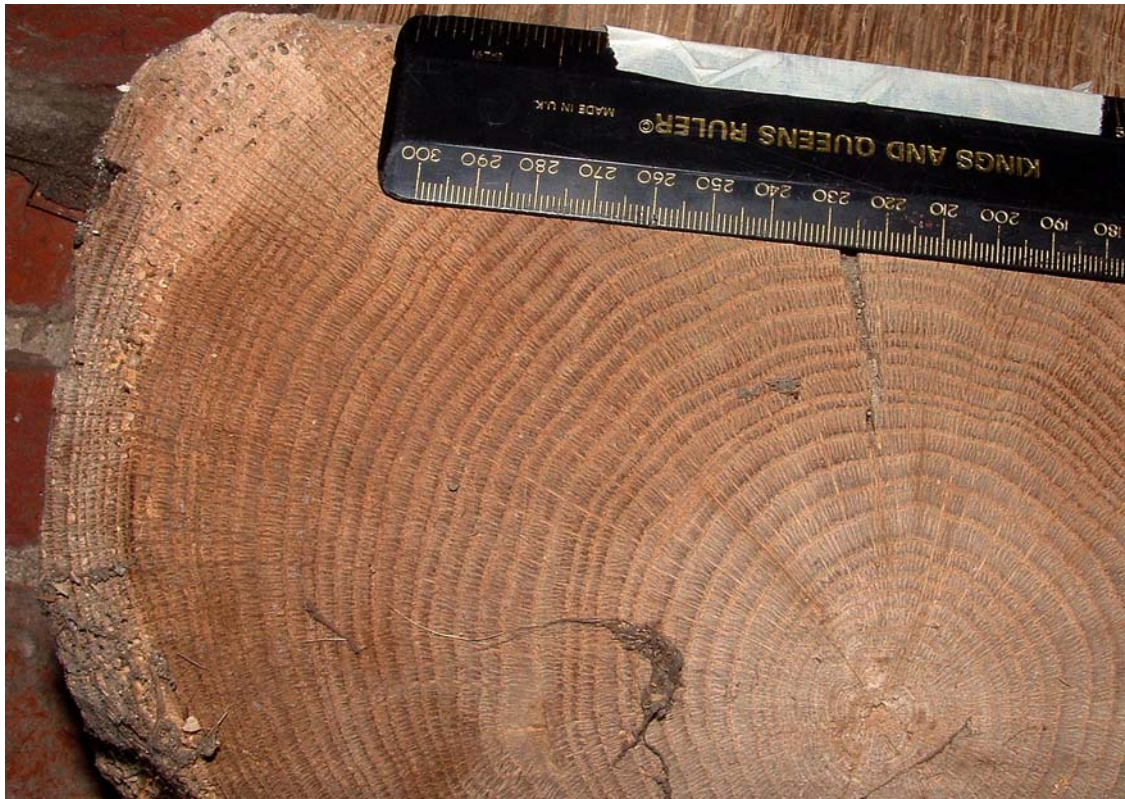
Figure 3: Photograph of **HOW06**, the corbel to truss 7 on the south side

The site was visited in May 2005. In the initial assessment, accessible oak timbers with more than 50 rings and traces of sapwood were sought. Those building timbers judged to be potentially useful were cored using a 15mm auger attached to an electric drill. The cores were glued to wooden laths, labelled, and stored for subsequent analysis. One timber had a clean cut end, and this was photographed along with a crude scale (Fig 3). Subsequent analysis of this sample was by measuring direct from the photograph.

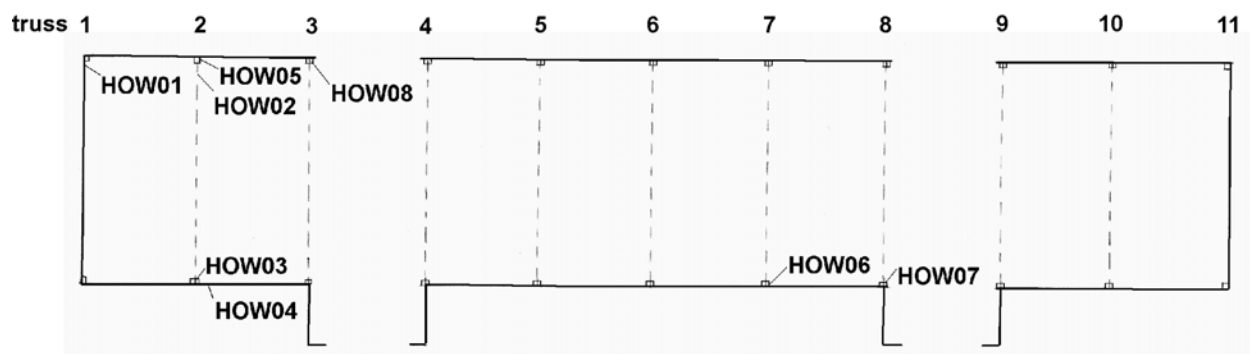
Figure 4: Sketch plan showing the approximate locations of the timbers sampled for dendrochronology. The trusses are numbered from the west (left) end

Eight oak (*Quercus* spp.) timbers were cored, the details being recorded in Table 1, and illustrated in Figure 4. In two cases the cores broke up and were not examined further, other than to assess the approximate number of rings in each. There were too few rings to justify taking a second core from these two timbers. Timbers in the porches were also assessed. These looked to be contemporaneous with the main roof timbers, and none were judged to have sufficient rings to make them worthwhile sampling.
