TREE-RING ANALYSIS OF TIMBERS FROM LEIGH BARTON, CHURCHSTOW, DEVON

**Cathy Groves
January 2006**

SUMMARY

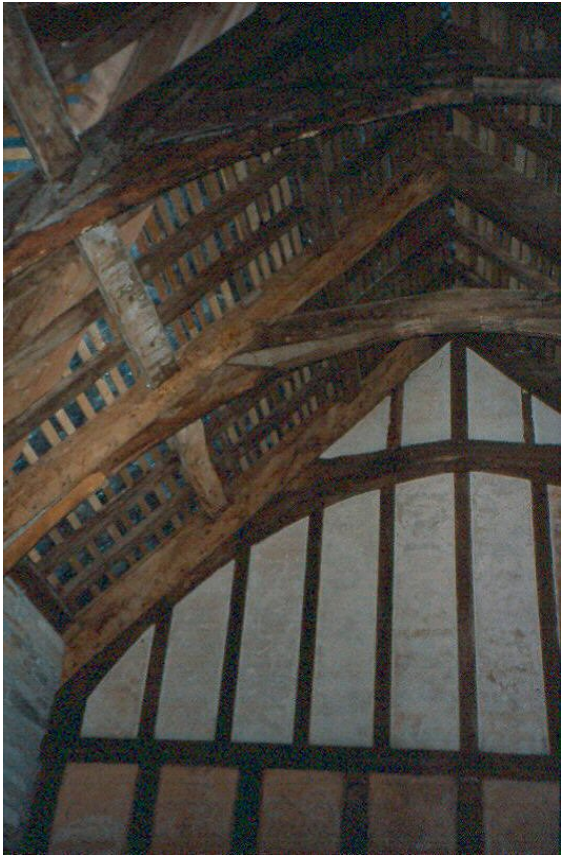
Figure 4 West face of truss T105 in the south range (photograph C Groves)

The nine trusses in the south range roof were labelled T101–T109 from east to west (Fig 10). It was noted that carpenters marks of IIII, III, and II were present on trusses T101 to T103 respectively, whilst truss T105 which divides the two chambers was

marked with a V. This could potentially suggest that the two sets of trusses for the chambers were marked up separately. The timbers appear to have been trestle sawn with saw marks and a triangular snap off point being particularly obvious on the north principal of truss T105. The lack of a deliberate retention policy during the renovation in the 1980s meant that sampling would have to rely on the removal of core samples from the extant historic elements. The presence of so much modern material clearly restricted sampling of the roof structure. Sampling was further restricted by the observation that the extant historic elements in the more highly decorative roof over the west chamber appeared to be generally derived from slightly faster-grown younger trees, hence less suitable for dendrochronological analysis, than those used in the roof structure over the east chamber. The extant historic wall-plates were all rejected as unsuitable but a series of 11 samples was taken from this roof structure. The ceiling beams were labelled B101–B106 from east to west (Fig 11) but only one was considered suitable for sampling. However a cross-sectional slice was obtained from an offcut present on-site that was thought to be part of a ceiling beam originally from the south range or possibly the west range. Six other cores were taken from lintels and door frames.

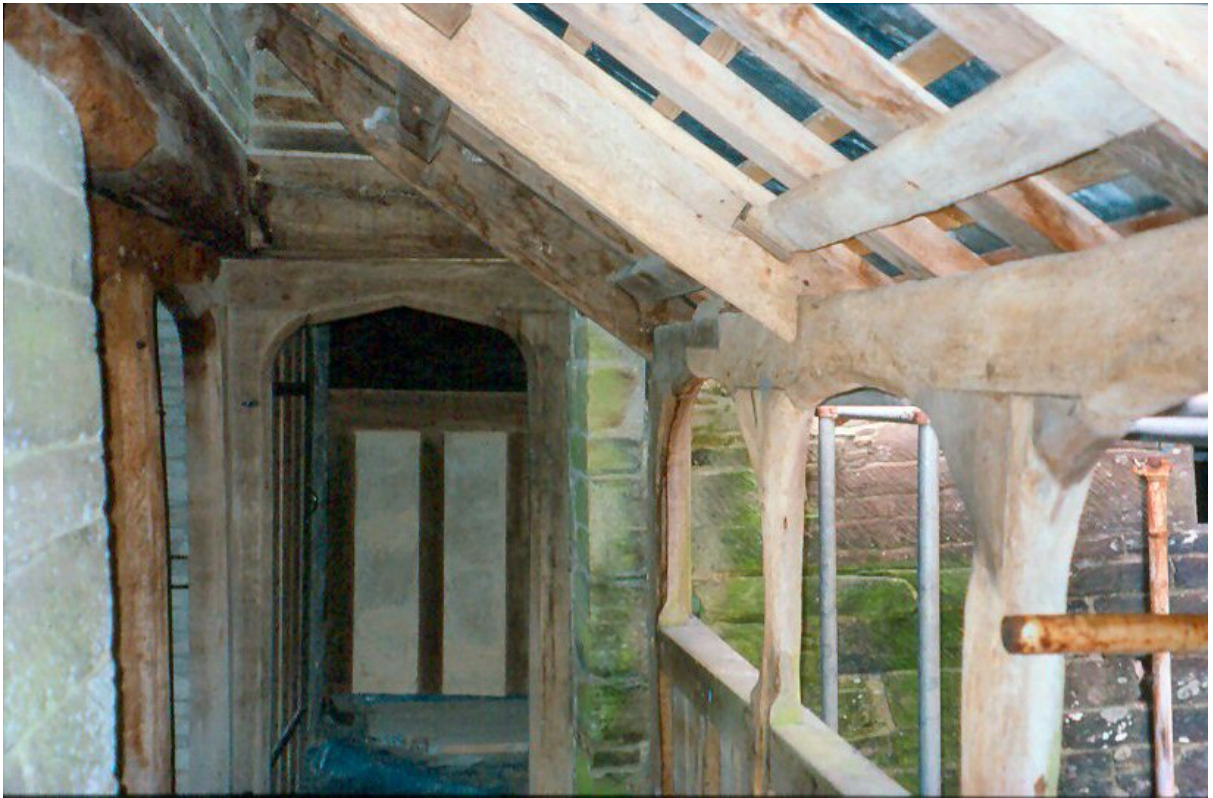
Figure 7 The gallery roof looking to the entrance to the west range (photograph C Groves)

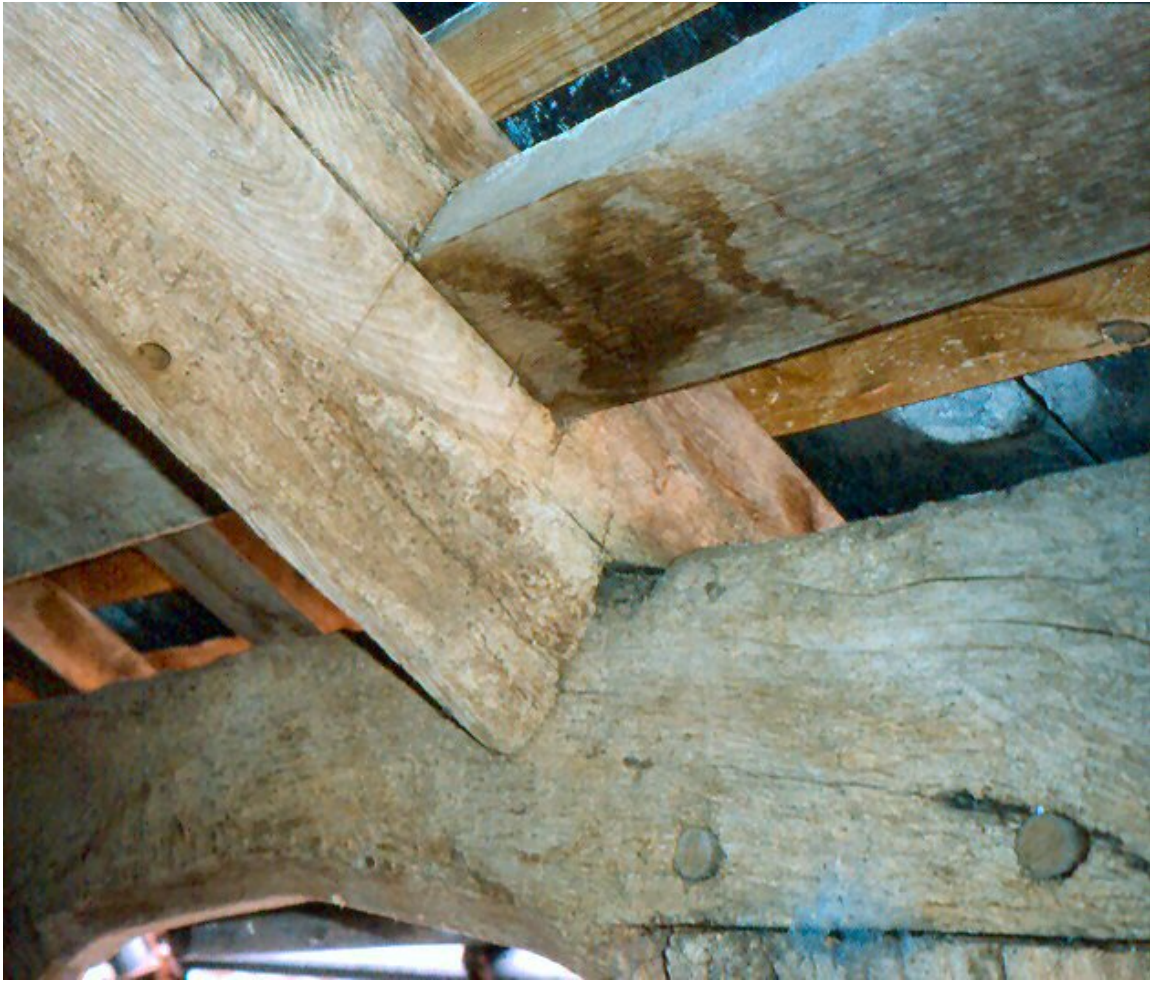
Figure 8 Detail of a shore-type truss in the gallery (photograph C Groves)

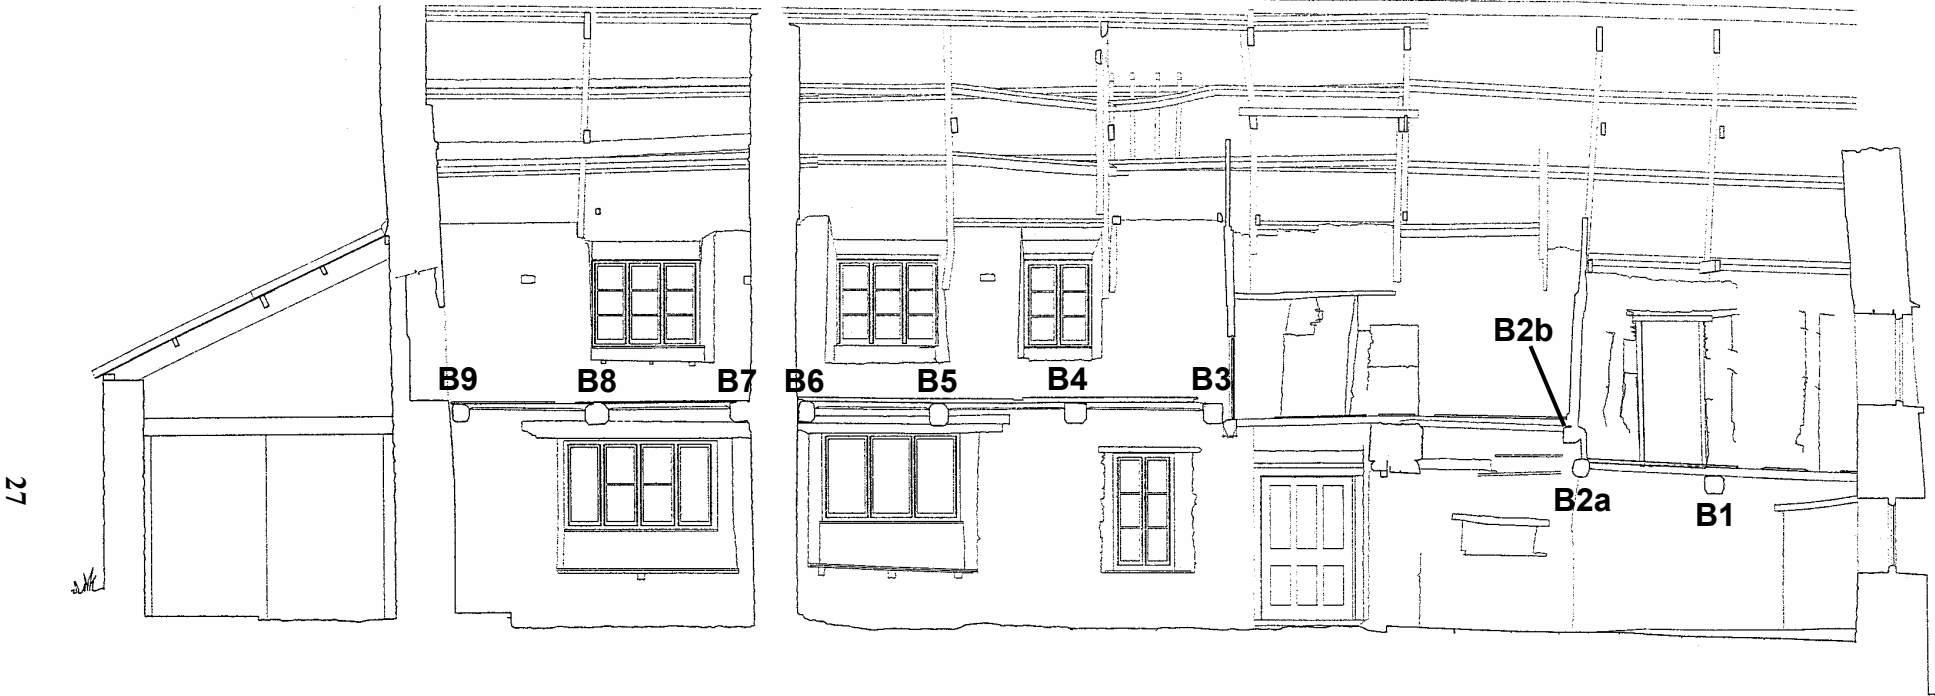
Figure 15 Section through the north range, north face of the south wall, showing the ceiling beam numbering scheme including B2a and B2b (after English Heritage drawing AS8/004 by Selwood 1995)

The ceiling beams in the parlour, ceiled-over hall and service end were labelled B1–B9 from west to east but included a B2a and a B2b (Figs 11 and 15). All were sampled. They were expected to be contemporary with the reroofing with the exception of B1, the westernmost ceiling beam, thought to be potentially associated with the initial building of the farmhouse.

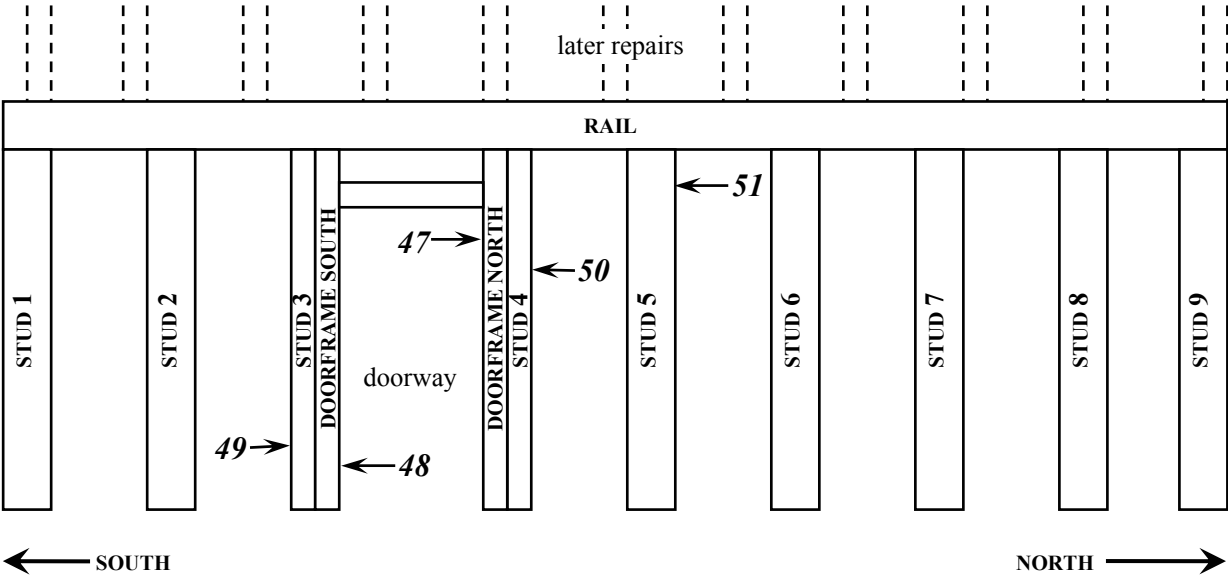
Figure 16 Sketch showing the numbering scheme for the western partition in the north range and the approximate location of samples 47–51

Eight samples were obtained from door posts: one from the doorway from the hall to the stairs, four from the doorways from the stairs into the chambers above the hall and parlour, two from the doorway in the western partition between the two chambers at the west end of the farmhouse over the service end and passage, and one from the doorway leading from the south-west corner of the service end into the west range (Figs 12, 13 and 16). The latter doorway is thought to have been inserted when the west and south ranges were constructed. In addition to the two samples from the doorframe, three studs in the western partition were also sampled (Fig 16).

The approximate location of all of the samples taken from the north range are, where known, indicated in Figures 12, 13, 16, and 17. This excludes the individual parlour

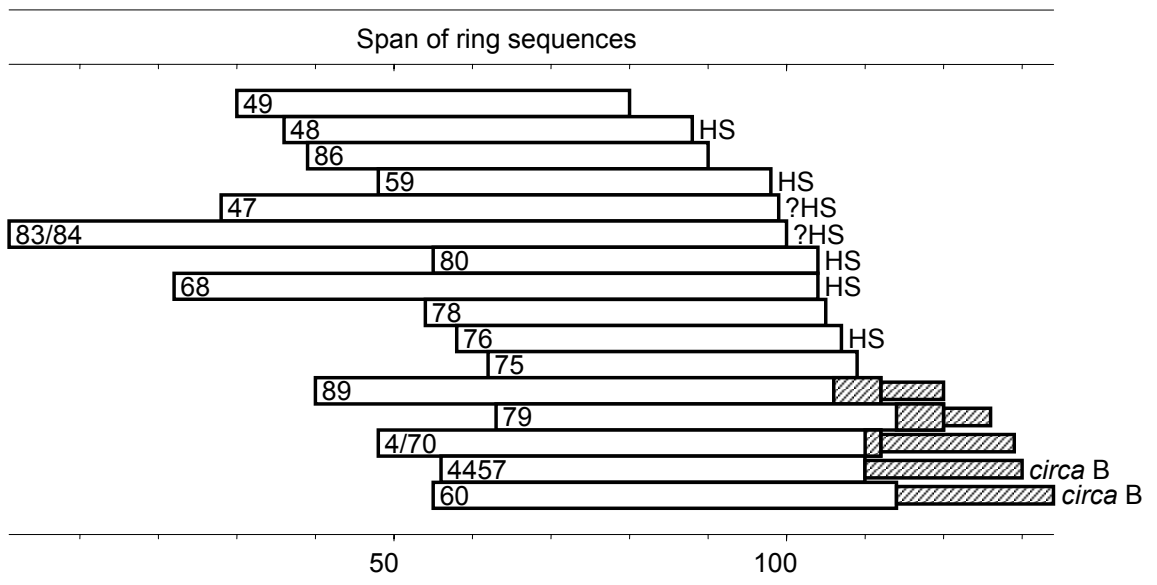
Figure 21 Bar diagram showing the relative positions of the matched ring sequences incorporated into site master chronology *LBC-D*

- six series crossmatched to form a 79-year site master chronology, *LBC-C* (Fig 20; Table 6);
- 16 series crossmatched to form a 120-year site master chronology, *LBC-D* (Fig 21; Table 7). Two of these series, 4270 and 4457, from principals, are likely to have been derived from the same tree and were therefore combined to produce a single tree sequence before being combined into the site master chronology;

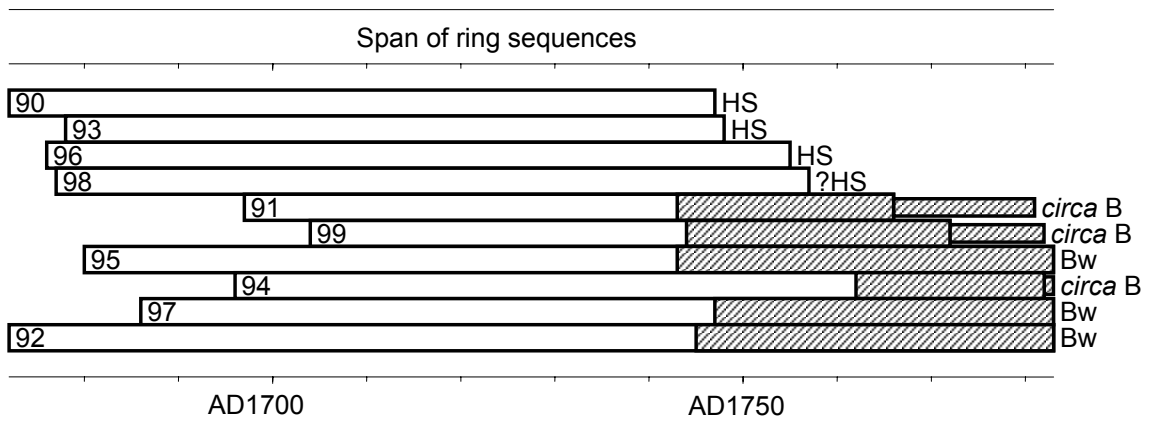
Figure 22 Bar diagram showing the relative positions of the dated ring sequences incorporated into site master chronology *LBC-E*

- 10 series crossmatched to form a 112-year site master chronology, *LBC-E* (Fig 22; Table 8). Three of these series, *94*, *96*, and *98*, are likely to have been derived from the same tree and were therefore combined to produce a single tree sequence before being combined into the site master chronology
- three series crossmatched to form a 110-year site master chronology, *LBC-F* (Fig 23; Table 9);
- two series, probably derived from the same tree, crossmatched to form a 85-year site master chronology, *LBC-G* (Fig 24; Table 10).

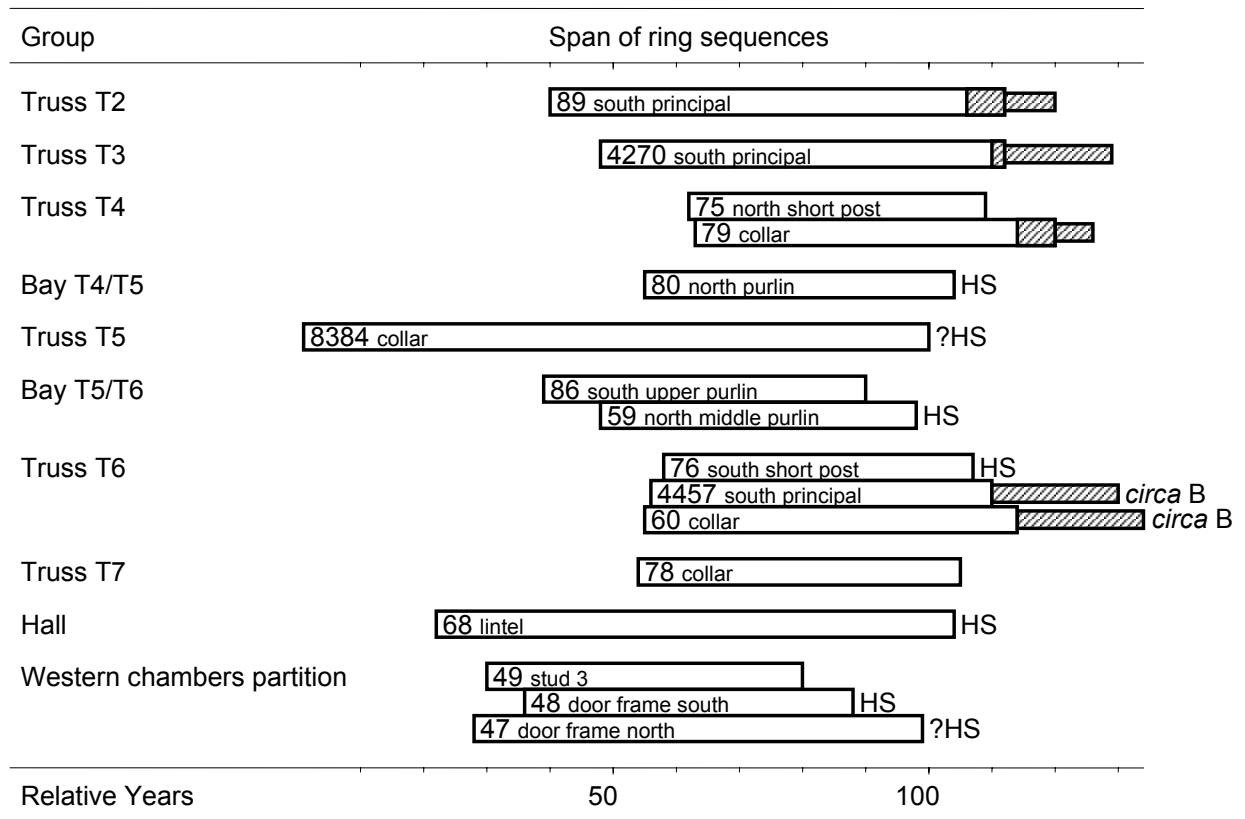
Figure 26 Bar diagram showing the relative positions of the matched ring sequences incorporated into site master chronology *LBC-D*, all from the north range, arranged by location and function

The second group of undated material is the 16 timbers that formed the site master chronology *LBC-D* (Fig 26). This material is dominated by timbers associated with

the roof structure but also includes a lintel from the hall and three timbers associated with the partition between the two west chambers. The results indicate that all of these timbers appear likely to be coeval showing that the bulk of the material from the roof, a hall lintel, and the western partition are the product of a single period of felling. Structural evidence indicates that the roof and the western partition should be contemporary and are associated with Phase 5 of the development of the north range. However the dendrochronological analysis cannot produce statistical evidence to conclusively link this group of timbers with the dated timbers from roof trusses T5, T6, and T7, nor can it independently date this group of material, even though it includes timbers from all six extant trusses and purlins from bays T4/5 and T5/6. Thus the analysis can neither confirm nor refute whether this group of timbers are part of the Phase 5 alterations. If they are, as the structural evidence strongly suggests, then they appear likely to come from a different woodland source to the dated timbers from the roof. The growth conditions in this woodland may be dominated by more localised environmental factors, natural or anthropogenic, that are masking the more general climatic signal required for successful dating, a problem which is relatively common in parts of Devon (Groves 2004; Groves 2005). Another possible explanation of the presence of two distinct groups of timber in the roof could be through reuse of timber. However there were no obvious signs of reuse or resetting so this seems unlikely.
