Research Department Report Series 31/2006

**Church of St Peter and St Paul, Hambledon, Hampshire.
Tree-Ring Analysis of Timbers.**

**Tree-Ring Analysis of Timbers from the Church of St Peter
and St Paul, Hambledon, Hampshire**

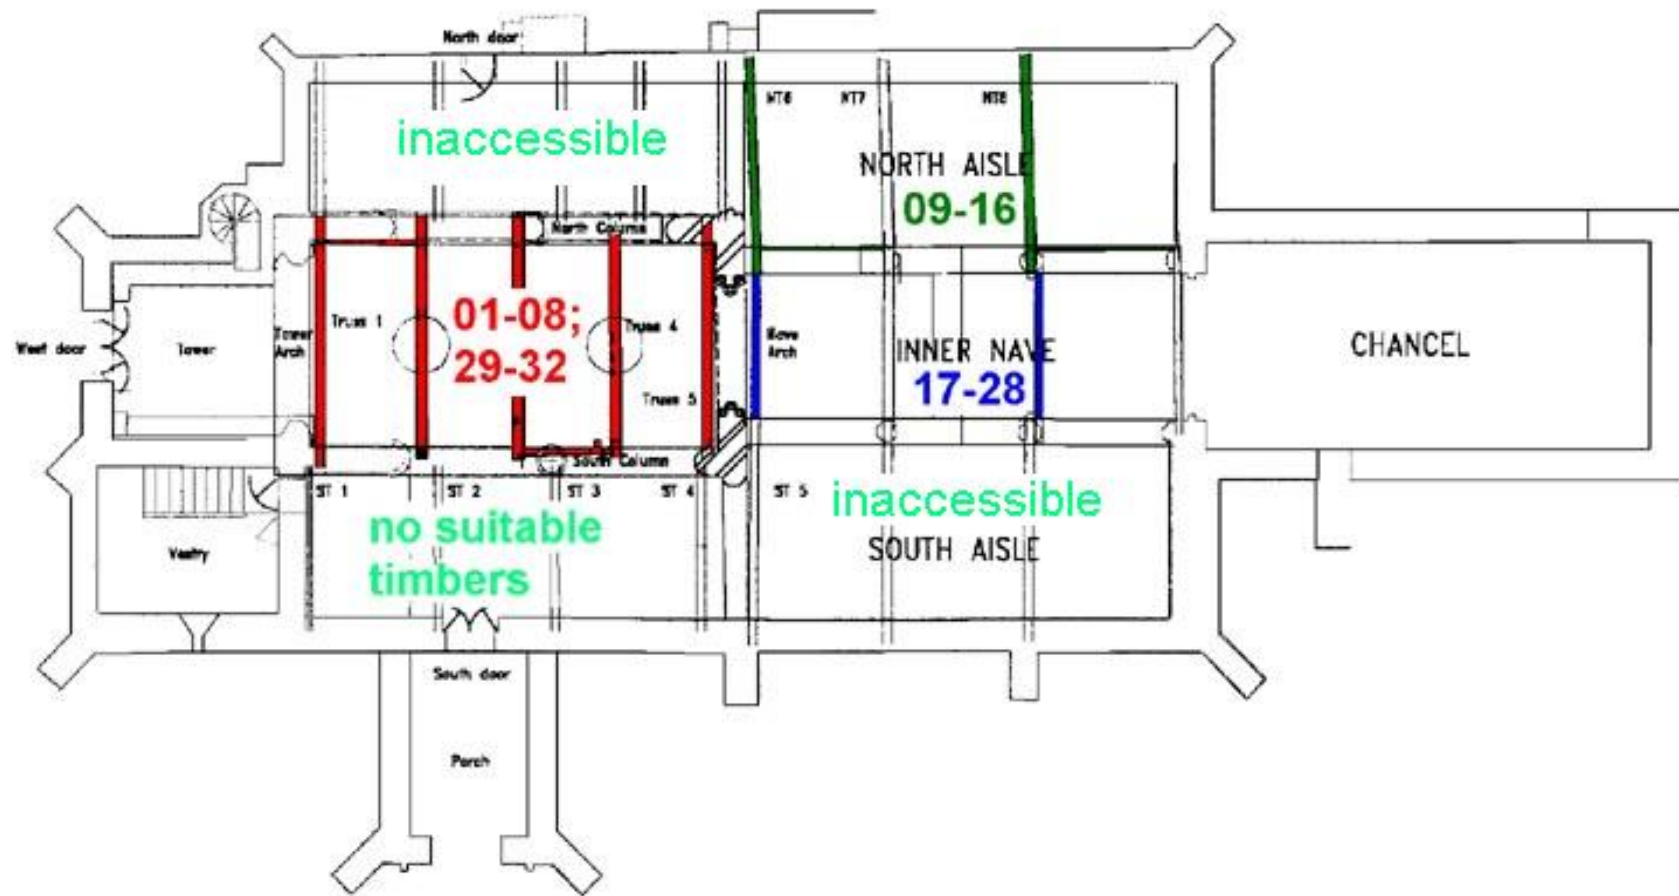
Figure 2: Plan of the church, showing the areas investigated and the sample numbers relevant to each roof

The basic plan of the church (Fig 2) is based around a Saxon church of aisle-less nave and chancel which has had the addition of a two-bay north aisle in the late twelfth century, and a south aisle at around the same time. There have been several eastward extensions, notably to the chancel and both the north and south aisles, thought to be of thirteenth-century origin. This has created an 'inner nave' from the original chancel.

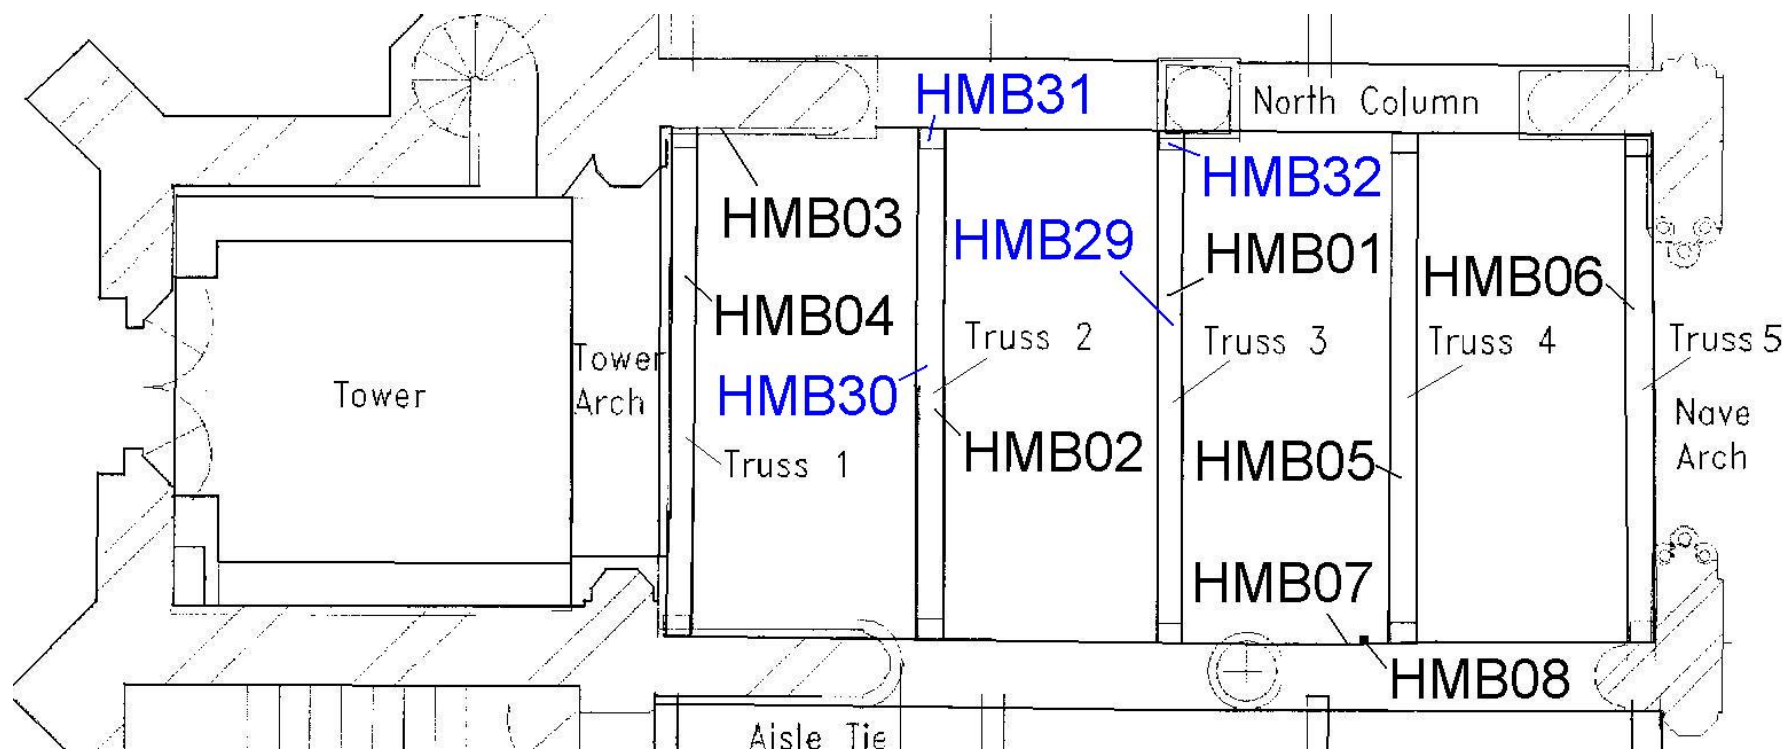
Figure 3: Plan of the outer (west) nave roof showing the locations of timbers sampled for dendrochronology. Those numbered in black are at tiebeam level, whilst those in blue are above tiebeam height. Adapted from an original drawing by G E Robertson

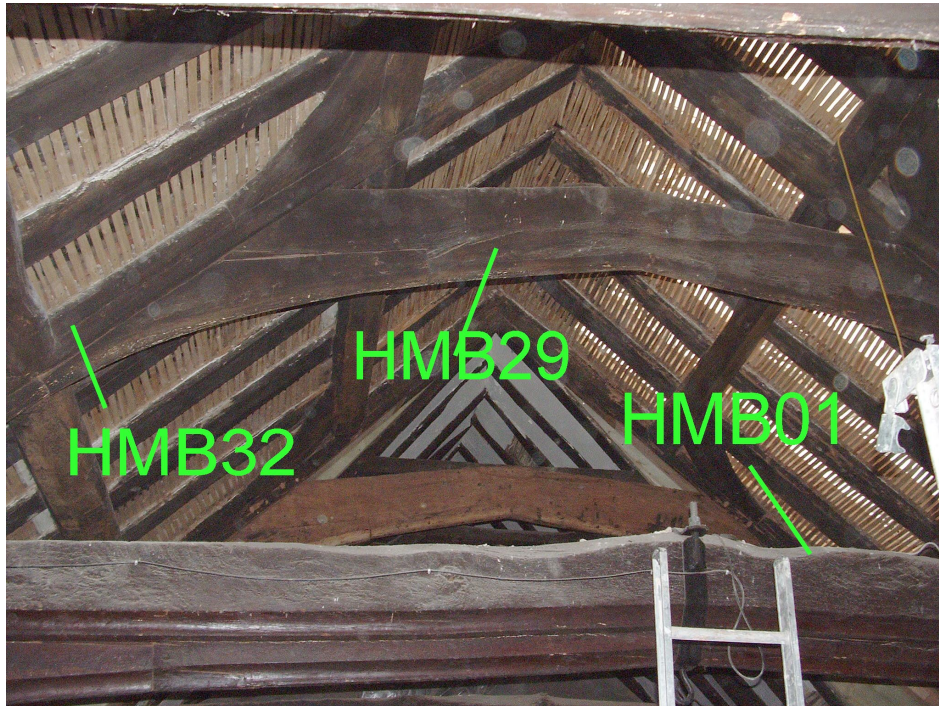
Figure 4: Outer nave roof, looking east, showing the timbers sampled from the middle truss

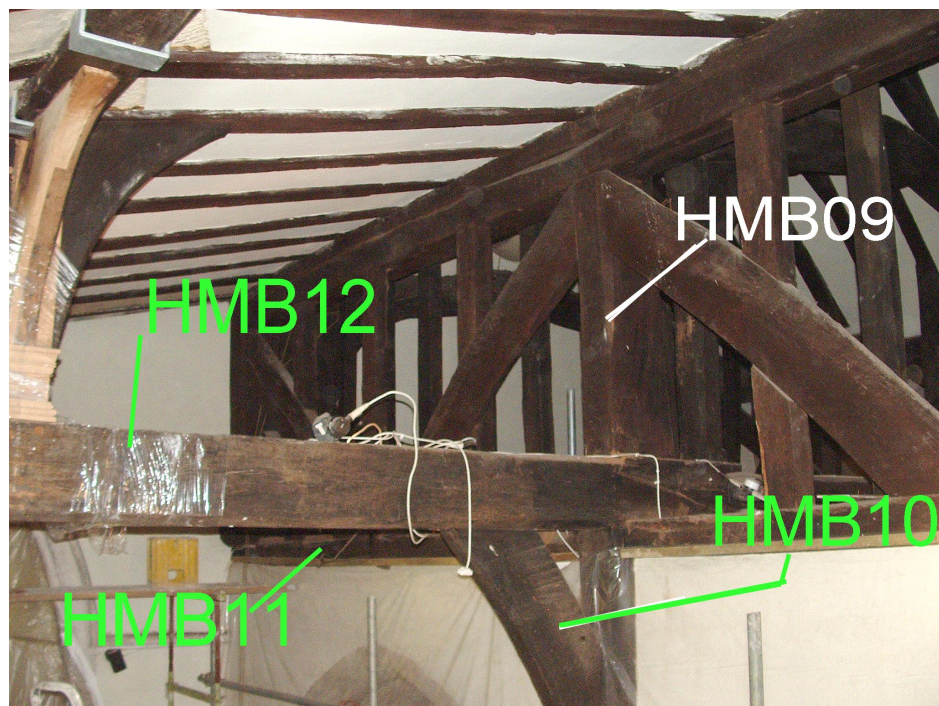
Figure 5: Inner north aisle roof, looking south-east towards the inner nave, showing timbers sampled

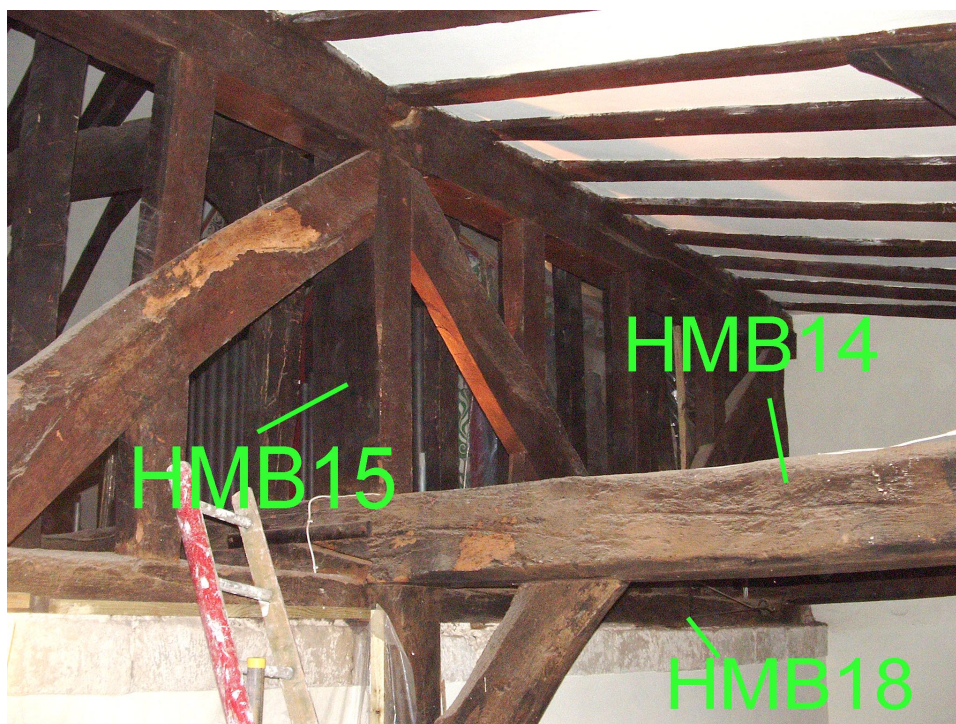
Figure 6: Inner north aisle roof, looking south-west towards the inner nave and organ, showing the timbers sampled

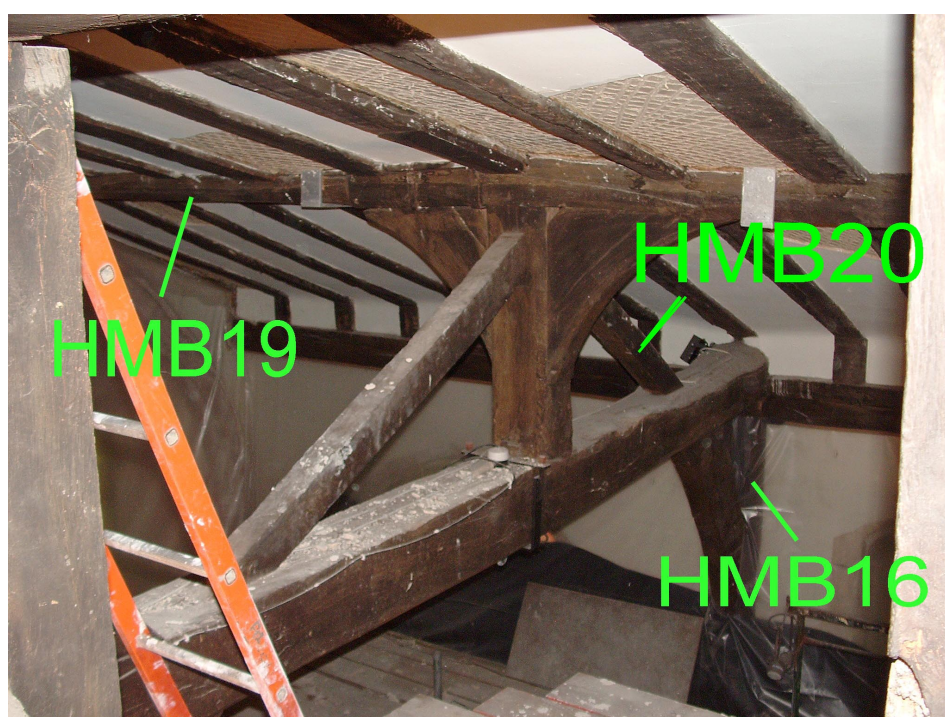
Figure 7: Inner north aisle roof looking north-west from the inner nave, showing timbers sampled

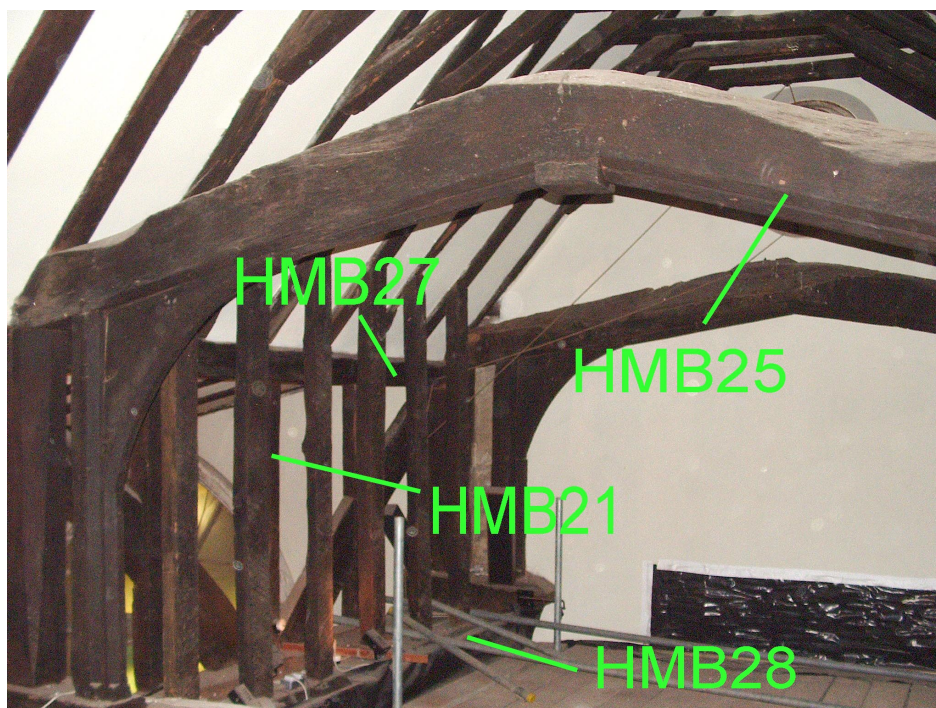
Figure 8: Inner nave, looking north-east, showing timbers sampled

The outer (west) south aisle roof was investigated, but no timbers were assessed as having sufficient rings for dendrochronological dating, and therefore no sampling was undertaken in this roof. No access was available to the outer (west) north aisle roof. For the sampled areas of the outer (west) nave, the inner (east) north aisle and the inner (east) nave, roof areas, details of the samples are given in Table 1, and the locations of timbers sampled are illustrated, where possible, in Figures 2–9. Those timbers not illustrated are relatively easy to place: HMB13 is the equivalent brace to HMB10 at the other end of the tie; HMB17 is the tie against the west wall, just visible in the background in Figure 6; HMB23 and HMB24 are equivalent to HMB22 and HMB25, only on the truss to the west; and HMB26 is the equivalent post to the north post seen in Figure 8, only on the south side.

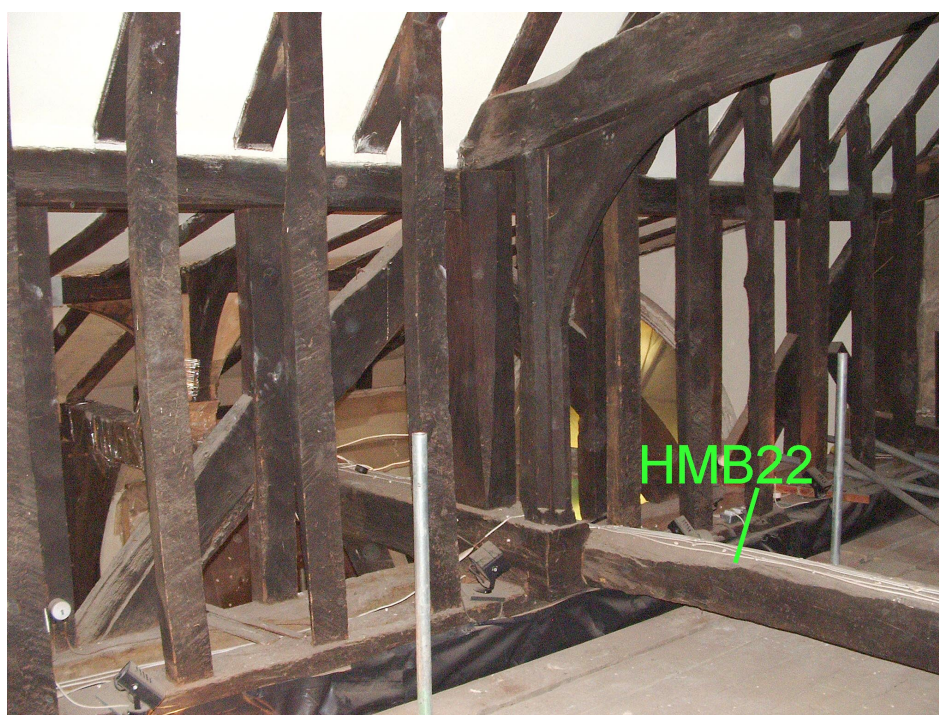
Figure 9: Inner nave, looking north-east, showing the tiebeam sampled

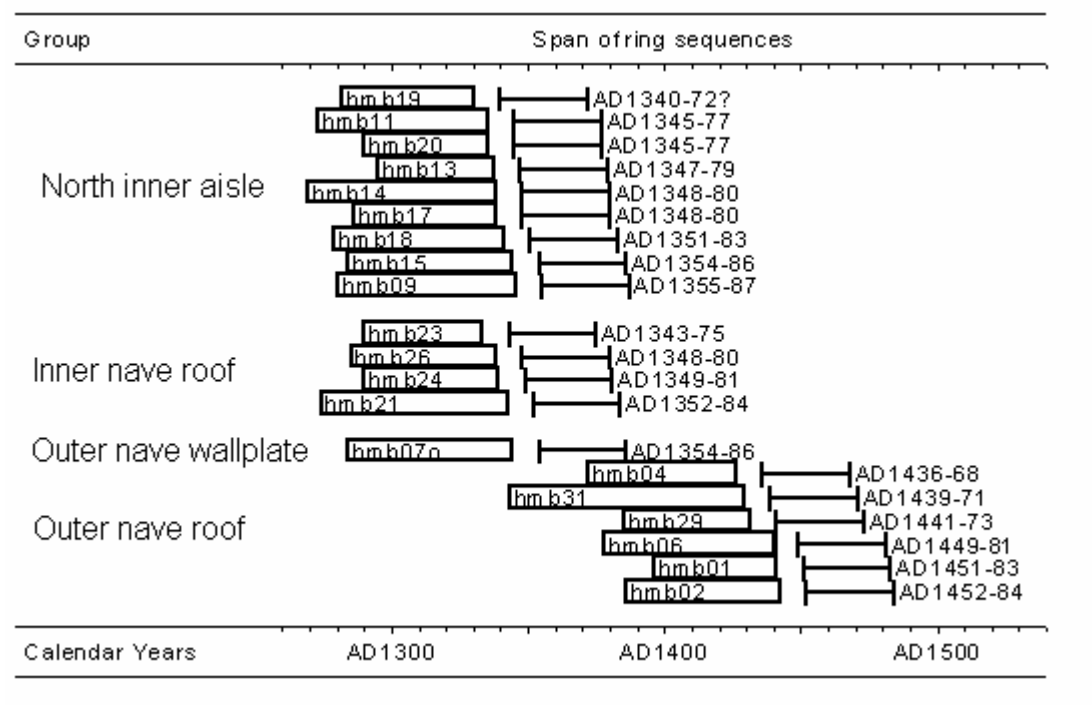
Figure 10: Bar diagram showing the relative positions of overlap of the dated timbers, along with their interpreted likely felling dates

The first site master was dated to the period AD 1269–1346, the dating evidence being presented in Table 4. The second site master was dated to the period AD 1343–1443, its dating evidence being shown in Table 5. The data for both series are shown in Table 6. The cross-matching positions of the dated timbers are shown in Figure 10, along with their interpreted likely felling date ranges.

It would appear that all the dated timbers from the inner north aisle and the inner nave roof, along with a wallplate in the outer nave roof, form a single group of timbers felled at the same time, and represent a single phase of construction. The mean heartwood-sapwood boundary date for this group of thirteen series is AD 1339 (including the possible heartwood-sapwood boundary on HMB19), giving a most likely felling date range of AD 1348–80. With no complete sapwood on the timbers, it is not possible to say whether the north inner aisle roof and the inner nave roof are exactly coeval, or whether one is a few years later than the other, but the fourteenth-century dates for them are a little later than had been suggested as their possible construction date in the thirteenth-century.
