TREE-RING ANALYSIS OF TIMBERS FROM THE GUILDHALL COMPLEX AND THE PEDAGOGUE'S HOUSE, STRATFORD-UPON-AVON, WARWICKSHIRE

### **Summary**

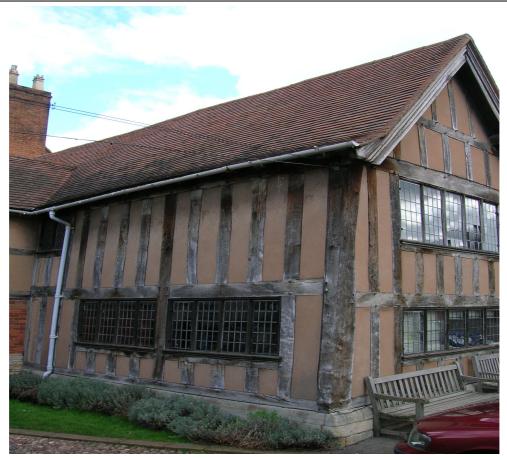
**Figure 4a/b:** View of the main and south ranges of the Guildhall (top, viewed from the southeast) and the south end of the Pedagogue's House (bottom, viewed from the south-west)

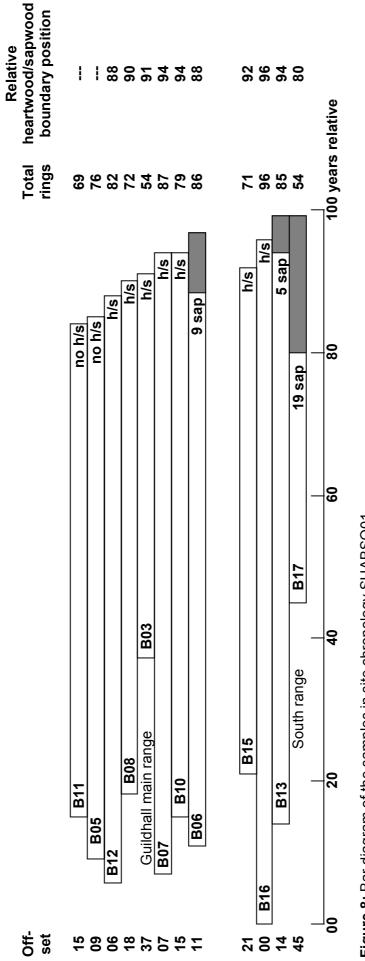
white bars = heartwood rings, shaded area = sapwood rings h/s = heartwood/sapwood boundary

Each of the 33 samples obtained was prepared by sanding and polishing. It was seen at this point that eight samples had too few rings for reliable dating (ie less than 54) and these samples were rejected from this programme of analysis. The ring-widths of the remaining 25 samples were, however, measured, the data of these measurements being given at the end of this report. The data of these measurements were then compared with each other by the Litton/Zainodin grouping procedure (see appendix) allowing two groups of cross-matching samples to be formed, as shown in the bar diagrams, Figures 8 and 9.

The first site chronology, SUABSQ01, comprises 12 samples with an overall length of 99 rings. This site chronology was compared to a number of relevant reference chronologies for oak, this indicating a cross-match when the date of the first ring is AD 1305 and the date of the last ring is AD 1403. Evidence for this dating is given in the *t*-values of Table 2. The second site chronology, SUABSQ02, comprises 7 samples with an overall length of 126 rings. Site chronology SUABSQ02 was also compared to a number of relevant reference chronologies for oak. This indicated a cross-match when the date of the first ring is AD 1377 and the date of the last ring is AD 1502. Evidence for this dating is given in the *t*-values of Table 3.

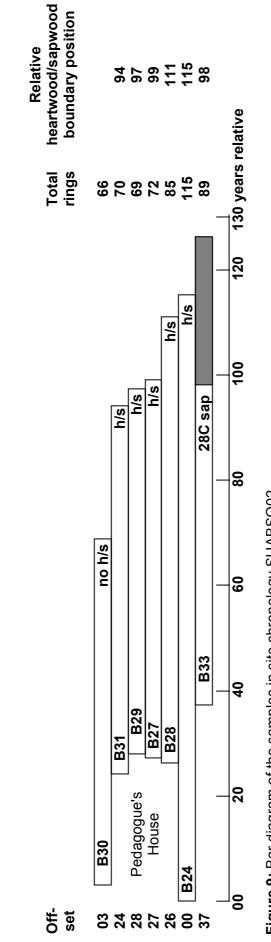
Figure 9: Bar diagram of the samples in site chronology SUABSQ02

white bars = heartwood rings, shaded area = sapwood rings

h/s = heartwood/sapwood boundary

C = complete sapwood is retained on the sample, the last measured ring date is the felling date of the timber

Seven samples from the Pedagogue's House have been dated. One sample, SUA-B33, retains complete sapwood, with a last ring date of AD 1502. This is thus the felling date of the timber represented. The relative position of the heartwood/sapwood boundary on the other six dated samples from this building is generally consistent with a single felling date and it is likely that they represent timbers which were all felled in AD 1502 as well.

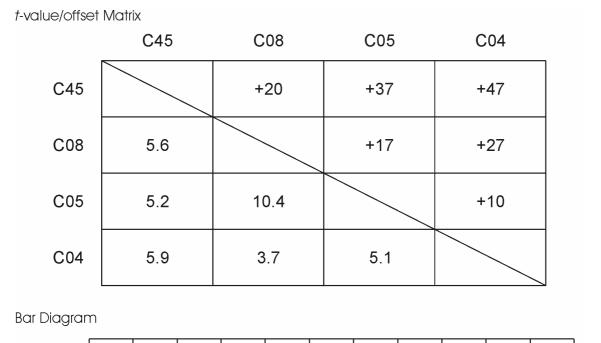
**Figure 5:** Cross-matching of four sequences from a Lincoln Cathedral roof and the formation of a site sequence from them.

The *bar diagram* represents these sequences without the rings themselves. The length of the bar is proportional to the number of rings in the sequence. Here the four sequences are set at relative positions (*offsets*) to each other at which they have maximum correlation as measured by the *t*-values.

The *t*-value/offset matrix contains the maximum *t*-values below the diagonal and the offsets above it. Thus, the maximum *t*-value between C08 and C45 occurs at the offset of +20 rings and the *t*-value is then 5.6.

The *site sequence* is composed of the average of the corresponding widths, as illustrated with one width.

This is illustrated in Figure 5 with timbers from one of the roofs of Lincoln Cathedral. Here four sequences of ring widths, LIN-CO4, 05, 08, and 45, have been cross-matched with each other. The ring widths themselves have been omitted in the *bar-diagram*, as is usual, but the offsets at which they best cross-match each other are shown; eg the sequence of ring widths of C08 matches the sequence of ring widths of C45 best when it is at a position starting 20 rings after the first ring of C45, and similarly for the others. The actual *t*-values between the four at these offsets of best correlations are in the matrix. Thus at the offset of +20 rings, the *t*-value between C45 and C08 is 5.6 and is the maximum found between these two among all the positions of one sequence relative to the other.

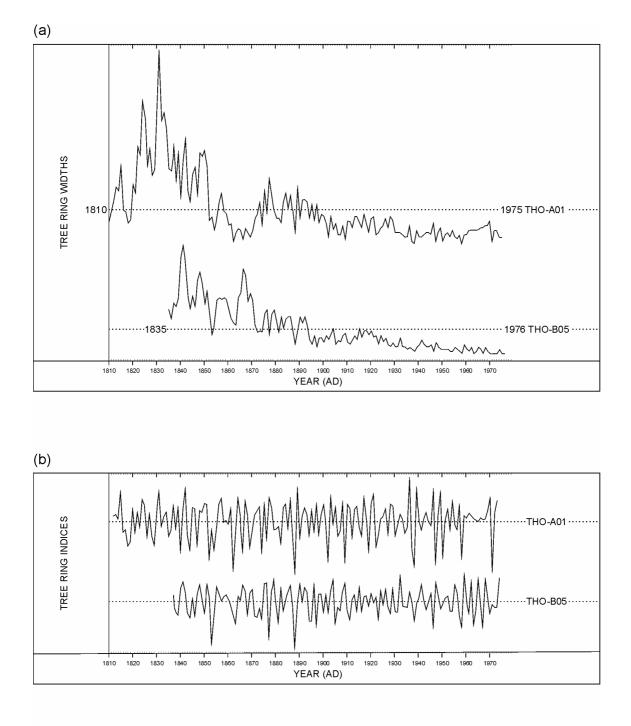
**Figure 7 (a):** The raw ring-widths of two samples, THO-A01 and THO-B05, whose felling dates are known. Here the ring widths are plotted vertically, one for each year, so that peaks represent wide rings and troughs narrow ones. Notice the growth-trends in each; on average the earlier rings of the young tree are wider than the later ones of the older tree in both sequences.

Figure 7 (b): The *Baillie-Pilcher* indices of the above widths. The growth-trends have been removed completely.

**Ring-width Indices.** Tree-ring dating can be done by cross-matching the ring widths 7. themselves, as described above. However, it is advantageous to modify the widths first. Because different trees grow at different rates and because a young oak grows in a different way from an older oak, irrespective of the climate, the widths are first standardized before any matching between them is attempted. These standard widths are known as ring-width indices and were first used in dendrochronology by Baillie and Pilcher (1973). The exact form they take is explained in this paper and in the appendix of Laxton and Litton (1988) and is illustrated in the graphs in Fig 7. Here ring-widths are plotted vertically, one for each year of growth. In the upper sequence of (a), the generally large early growth after 1810 is very apparent as is the smaller later growth from about 1900 onwards when the tree is maturing. A similar phenomenon can be observed in the lower sequence of (a) starting in 1835. In both the widths are also changing rapidly from year to year. The peaks are the wide rings and the troughs are the narrow rings corresponding to good and poor growing seasons, respectively. The two corresponding sequence of Baillie-Pilcher indices are plotted in (b) where the differences in the immature and mature growths have been removed and only the
