BENINGBROUGH HALL,
NORTH YORKSHIRE
AN ARCHAEOLOGICAL SURVEY AND
INVESTIGATION OF THE POST-MEDIEVAL
PARK AND GARDENS

Research Department Report 079-2006

Beningbrough Hall, North Yorkshire: an archaeological survey and investigation of the post-medieval park and gardens

NGR: SE 5162 5841

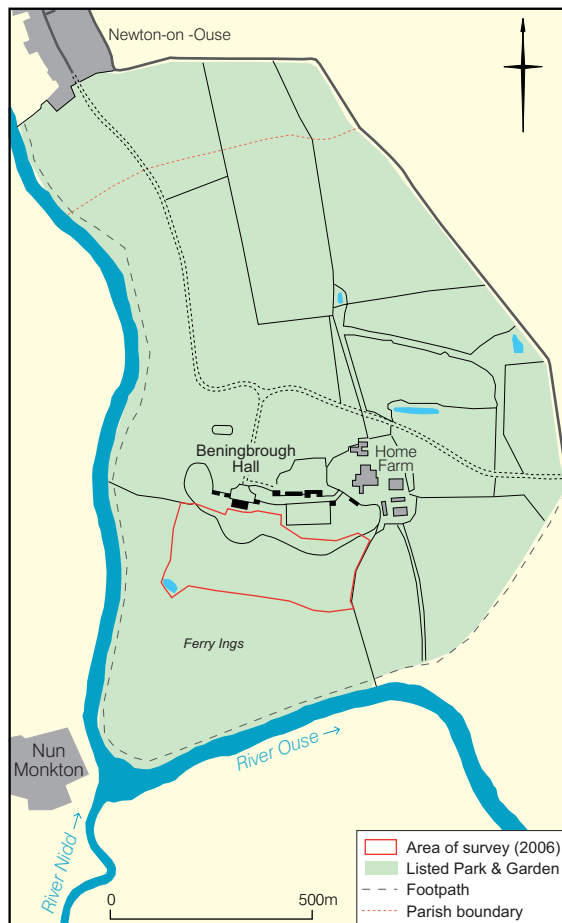
Figure 2
Map of the
Beningbrough Hall
environs showing the
area of the English
Heritage survey

undertaken by English Heritage beyond the reappraisal of historic maps and plans. The 2006 field investigation, which covered an area of c10 hectares (25 acres) at the north end of Ferry Ings and to the south of Beningbrough Hall (Figure 2), was carried out in detail to Level 3 standard (as defined in RCHME 1999, 3-4). To support the field survey, aerial photographic coverage for the area was also consulted.

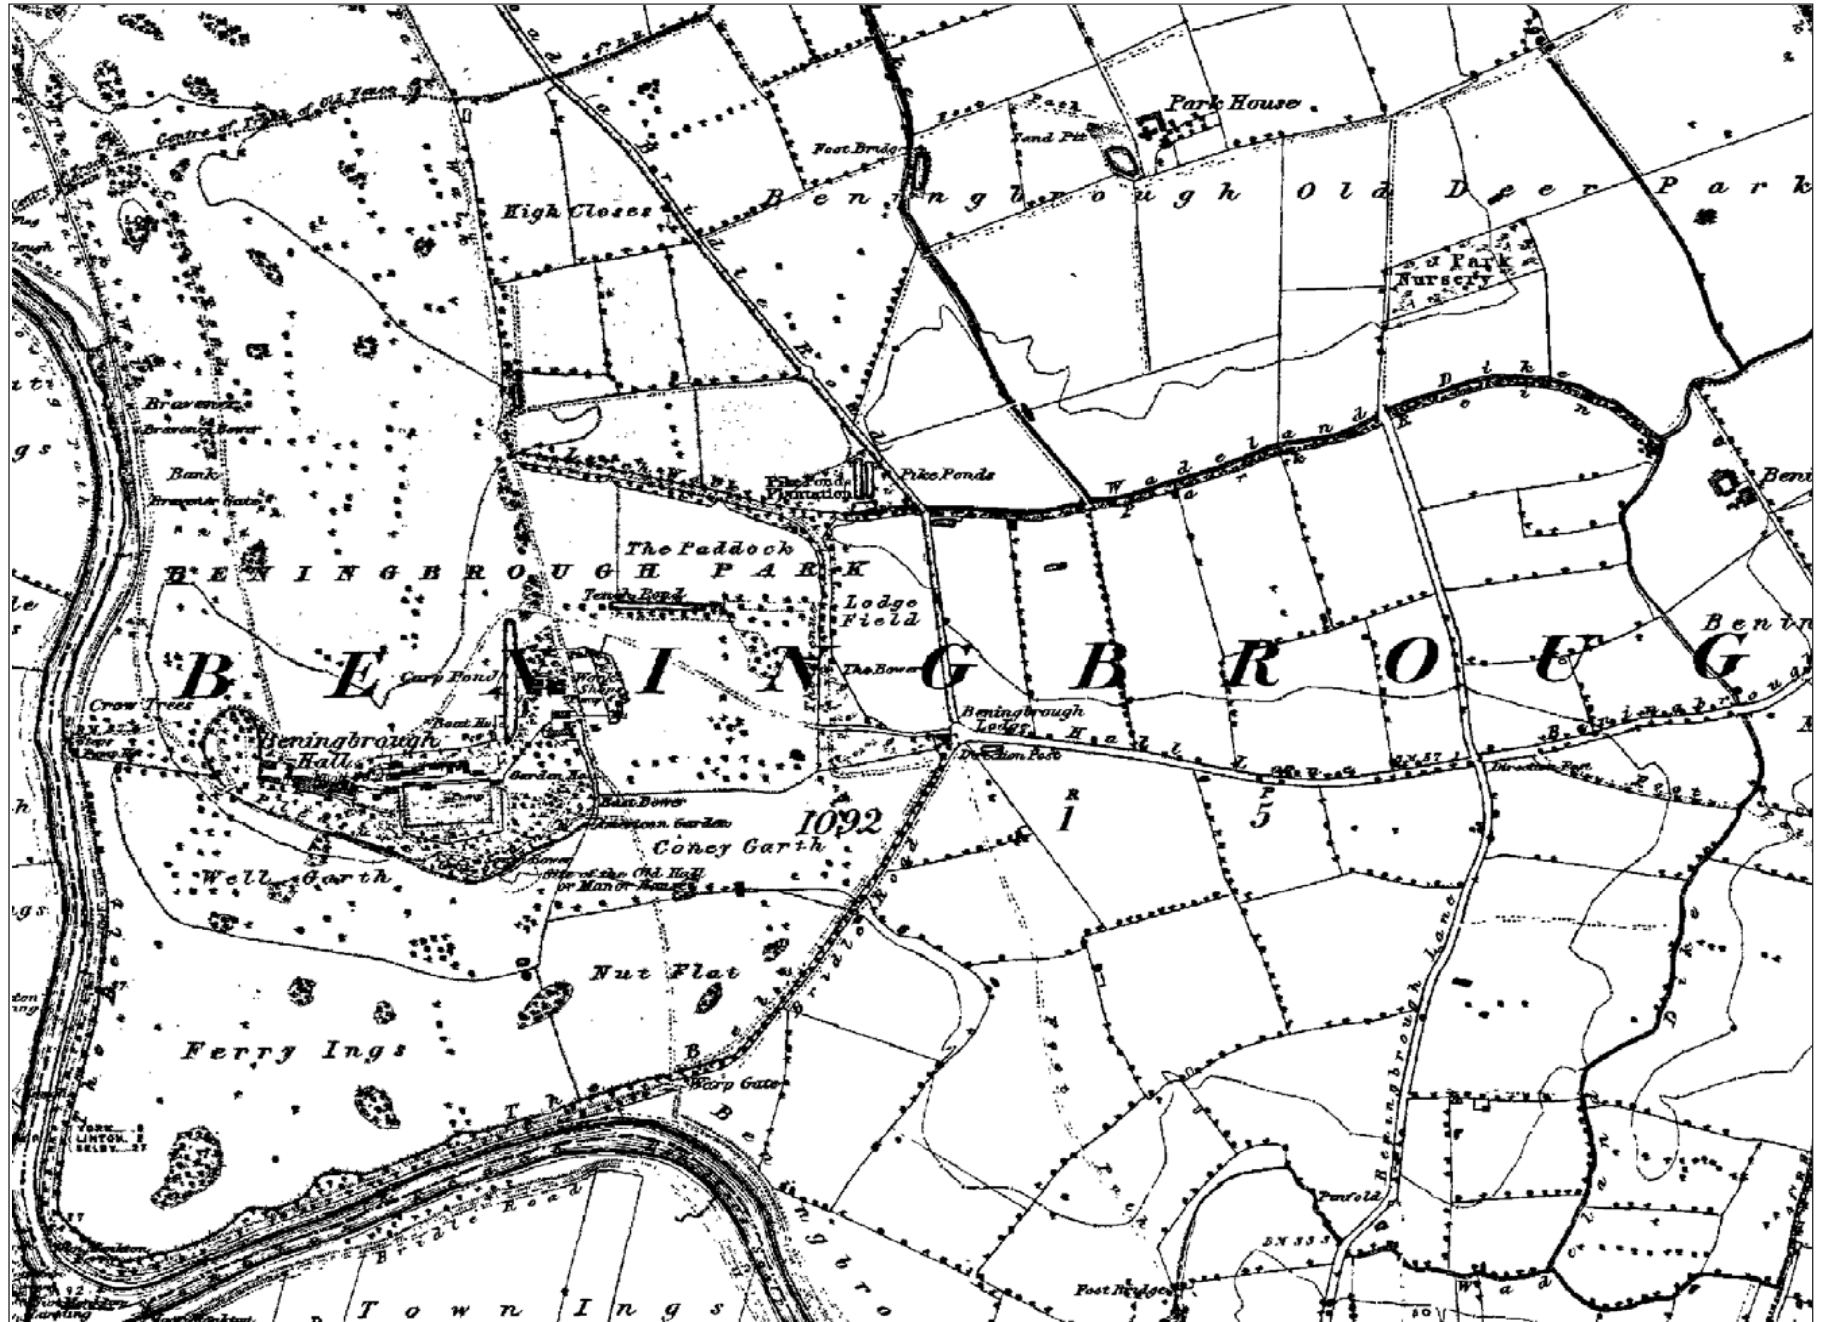
Figure 3 Extract from the 1852 Ordnance Survey First Edition 6-inch map (surveyed in 1848)

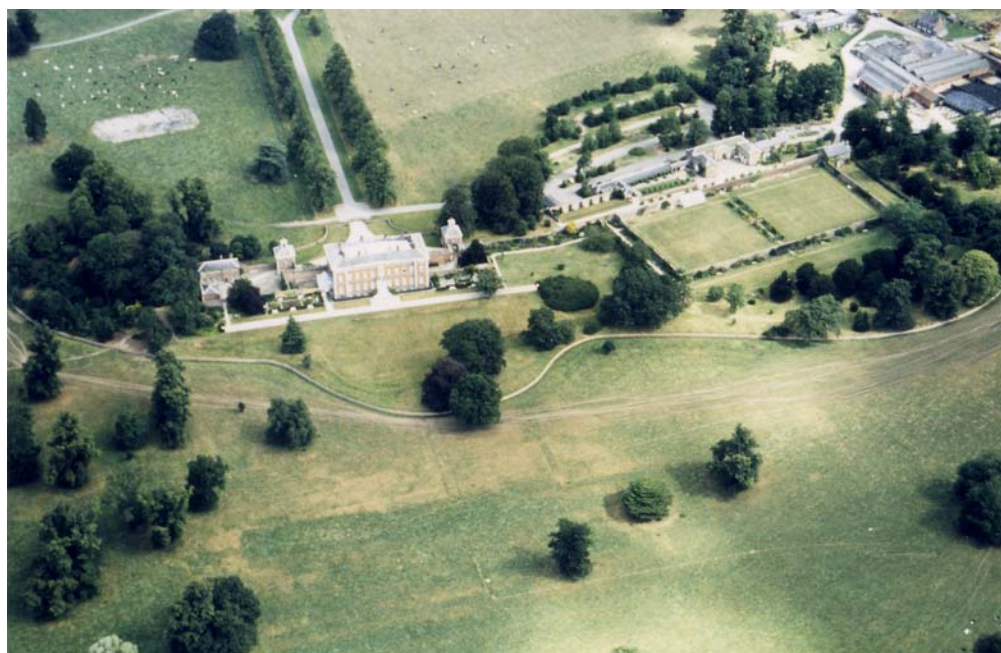
Figure 7
Aerial photograph of
Beningbrough Hall
with remains of the
1716 formal garden
showing as
cropmarks. ©
English Heritage.
NMR 12018/19 SE
5158/20 05-Aug-1990.

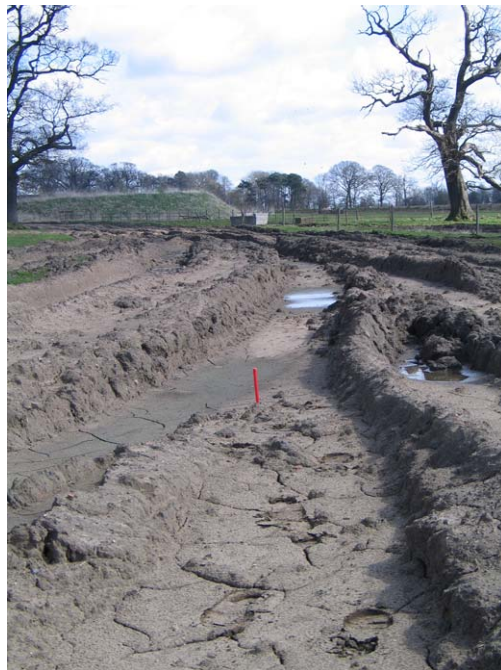
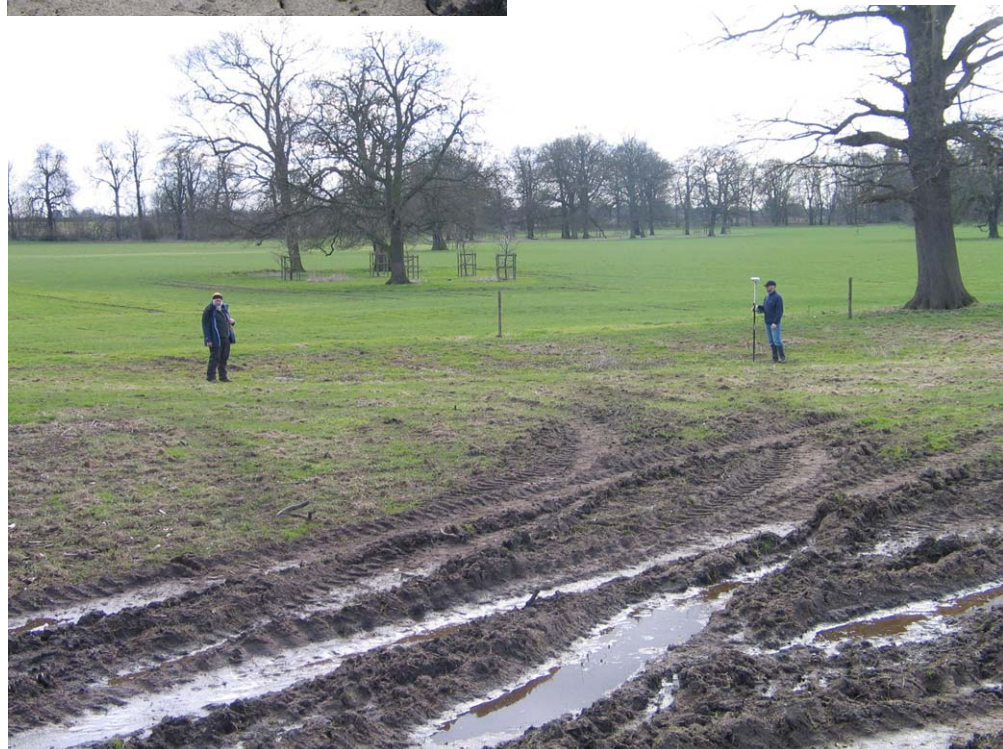
Undoubtedly, the ongoing wear and tear caused by agricultural vehicles is adversely affecting the surviving earthworks and in places is likely to be damaging archaeological remains buried relatively deeply beneath the surface (Figures 9a & b). The platform believed to be the site of the old hall or manor house, thought to be that built by the Bouchier family either in the later 16th century or between 1662 and 1665, is being particularly severely damaged. In addition to the churning-up of the surface, compaction may also threaten more deeply buried remains, while changes in the drainage could lead to the loss or deterioration of any

*Figures 9a & b
Examples of damage
to the ground surface
to the south of
Beningbrough Hall
caused by large
agricultural vehicles
regularly traversing
this area*

organic deposits preserved in waterlogged lower levels. While the earthwork survey indicates the likely general location and orientation of the building, geophysical survey could potentially reveal more about its extent and level of preservation below ground.
