# H M TOWER OF LONDON (TOL99 & TOL100) LONDON BOROUGH OF TOWER HAMLETS THE TREE-RING DATING OF THE WHITE TOWER

## SCIENTIFIC DATING REPORT

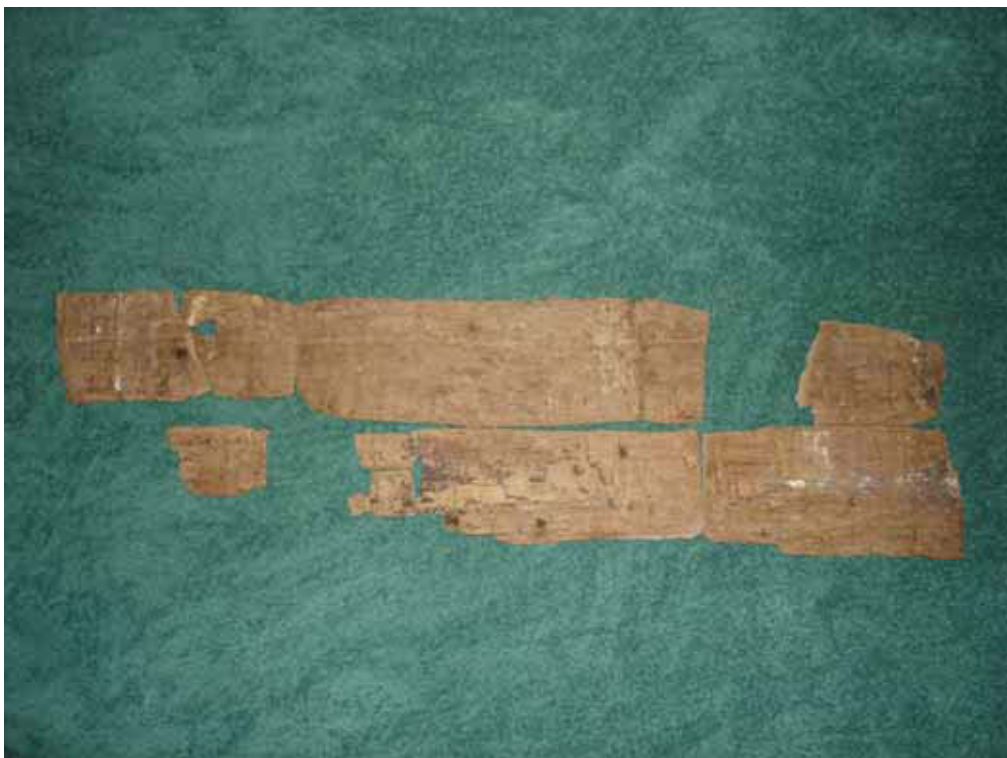
**Figure 15:** Photograph of board found in drain at second-floor level, east side (**wt22**)
