CHURCH OF ST HELEN AND ST GILES,
THE BROADWAY, RAINHAM,
LONDON BOROUGH OF HAVERING
TREE-RING ANALYSIS OF TIMBERS
FROM THE SOUTH CHANCEL DOOR

SCIENTIFIC DATING REPORT

Martin Bridge and Dan Miles

TREE-RING ANALYSIS OF TIMBERS
FROM THE SOUTH CHANCEL DOOR

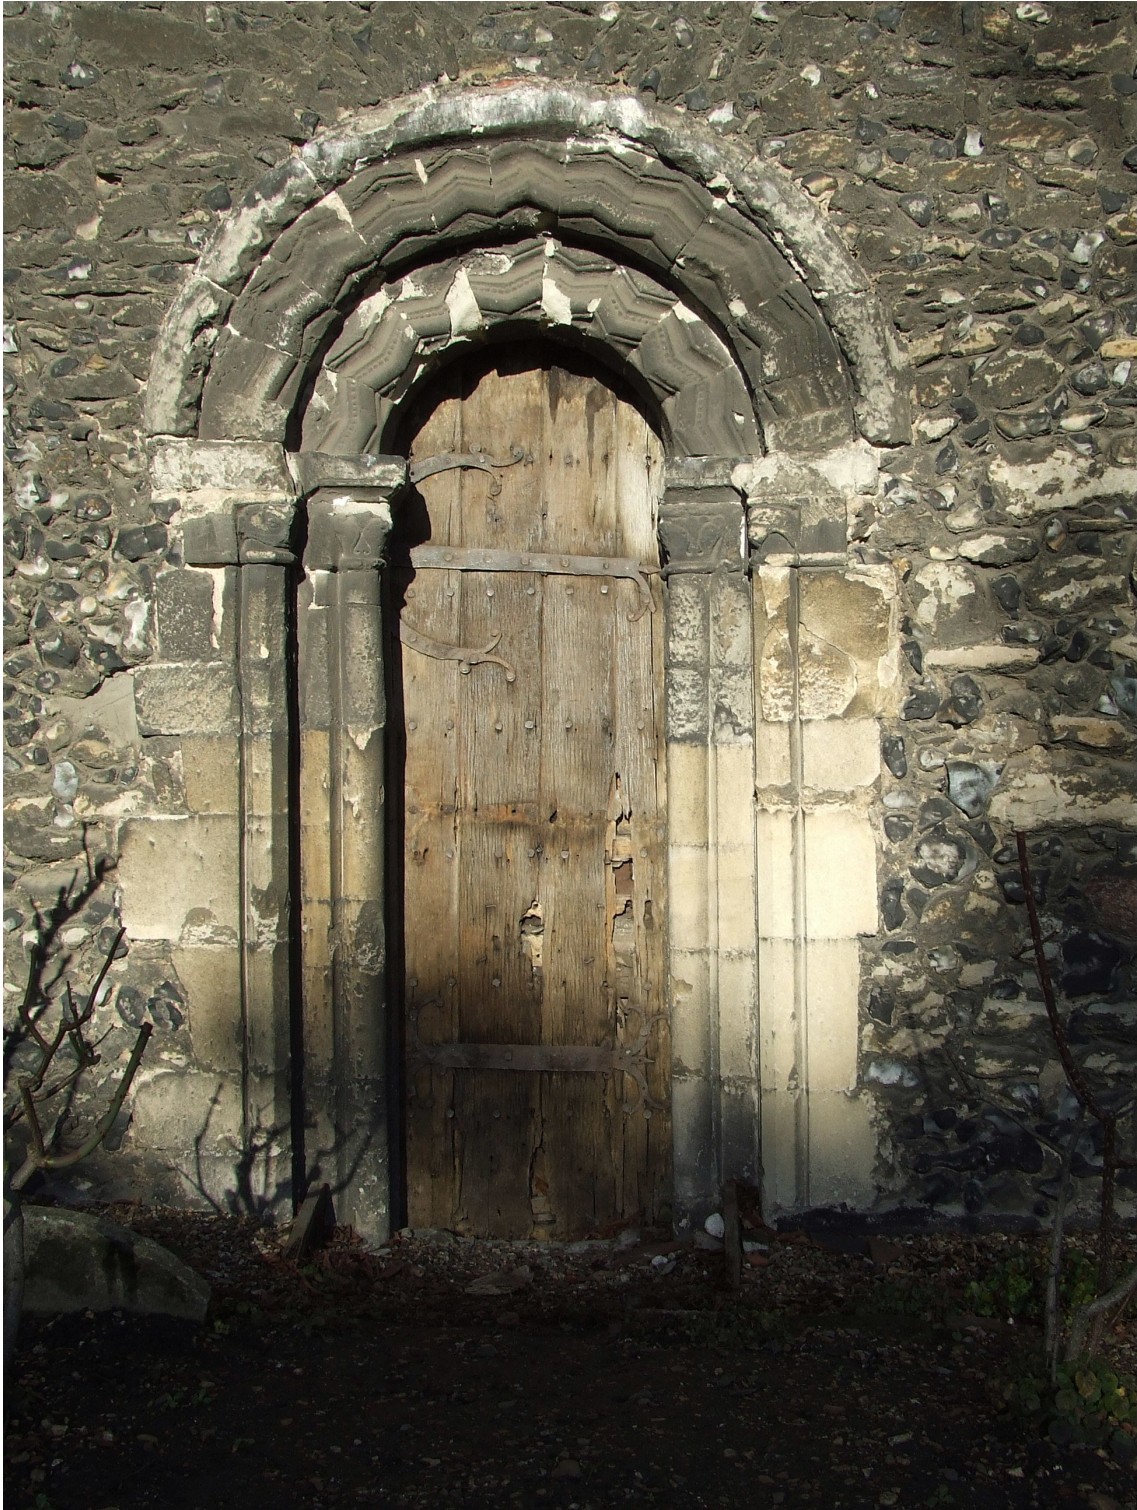
Figure 2. Photograph of the twelfth-century doorway and the front of the recently uncovered door

This Grade-I listed church, situated in the centre of the town (Fig 1), is a remarkably complete and unaltered Norman church, thought to date to c. AD 1170. When the RCHME visited in the early part of the last century (RCHME 1923), they noted a twelfth-century doorway in the north aisle of the church and one in the south wall of the chancel (Fig 2), which they described thus:

'between the two western windows is a late 12th-century doorway with a semi-circular arch of two orders enriched with chevron ornament and with a label carved with nail-head ornament; the jambs have each an attached shaft with the capital carved with water-leaf and grotesque face; the lower parts of the jambs have been restored.'

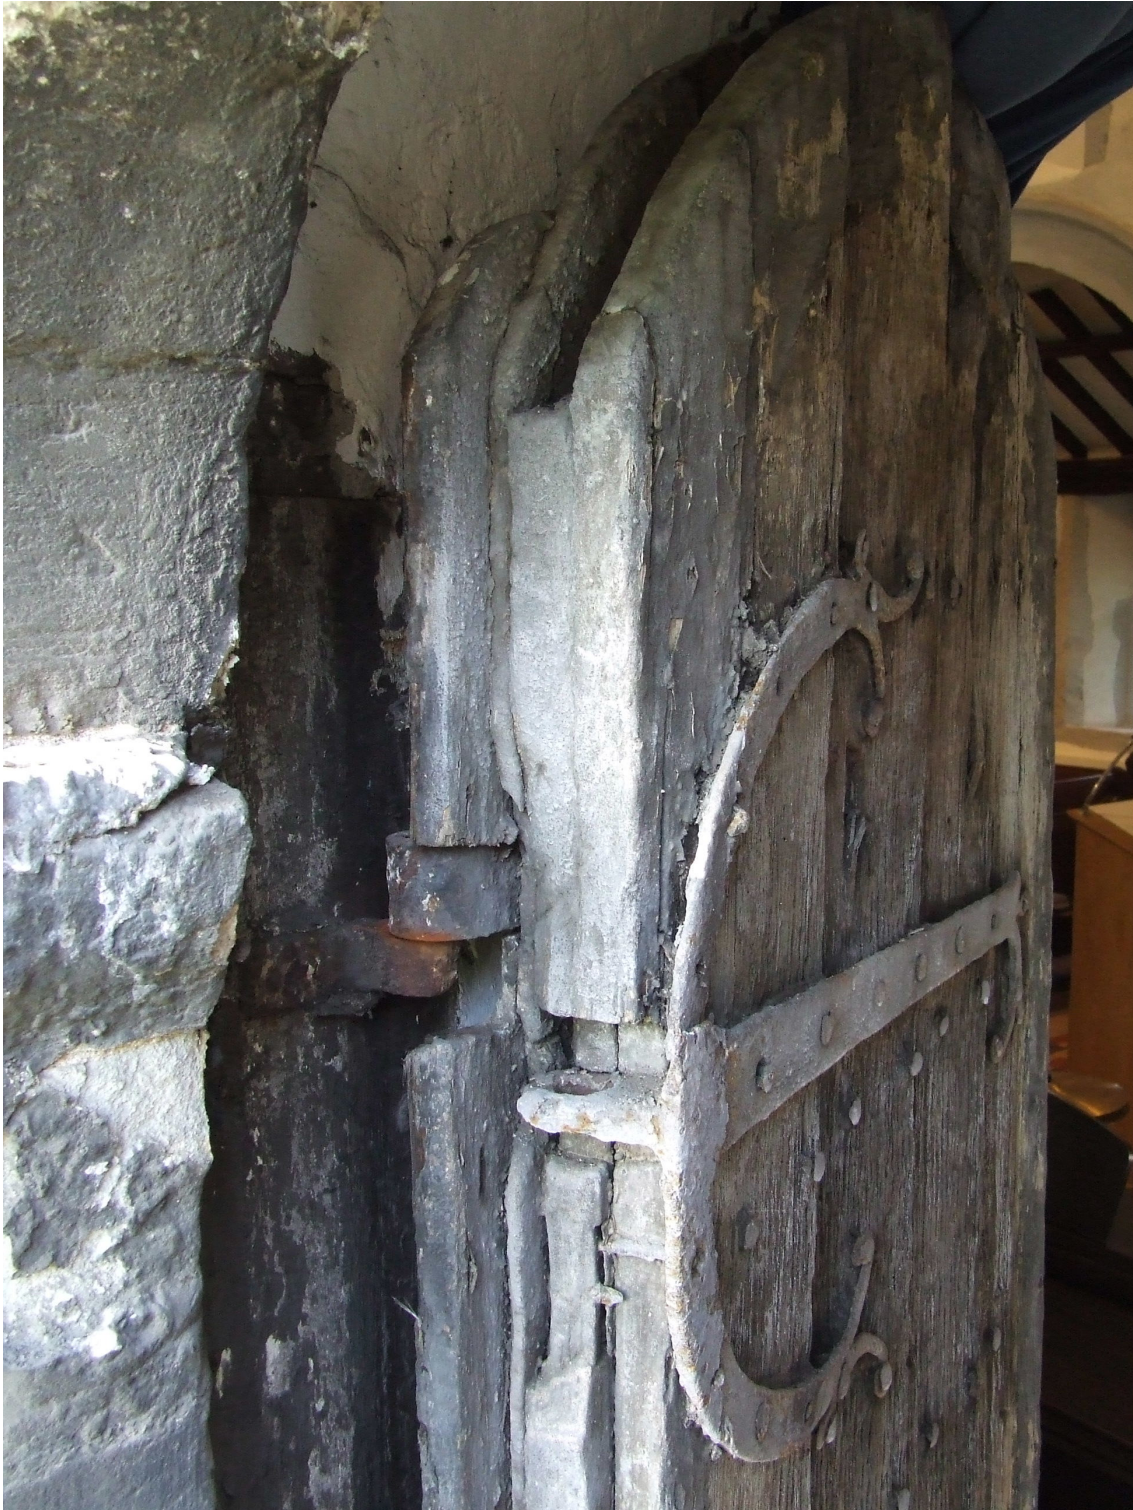
Figure 4. View of the door showing the front boards, the ironwork, the original pintle, the very thin rear boards, and the thicker rear cladding and present pintle

grooves on the adjacent board, and these have again been covered in much thicker boards (Fig 4). The outer boards have been heavily weathered, and the position of now moved or missing ironwork can be seen as ridges of less weathered material (Fig 5).

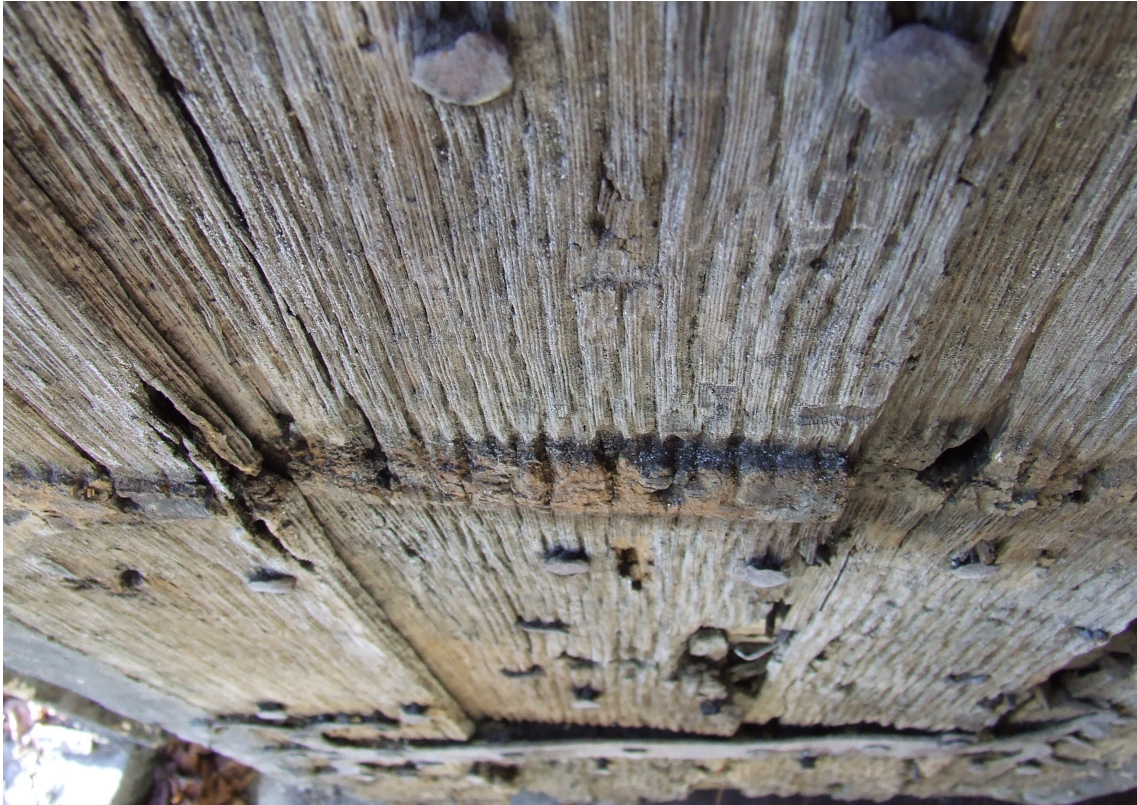
Figure 5. View looking down the outer face of the door from an elevated position, showing the degree of weathering and a raised section where ironwork once sat, protecting the wood surface
