Centre for Archaeology Report 1/2003

**Fieldwork Report: Evaluation of Service Trench
Excavations within the Kenwood House Estate**

Dave Fellows

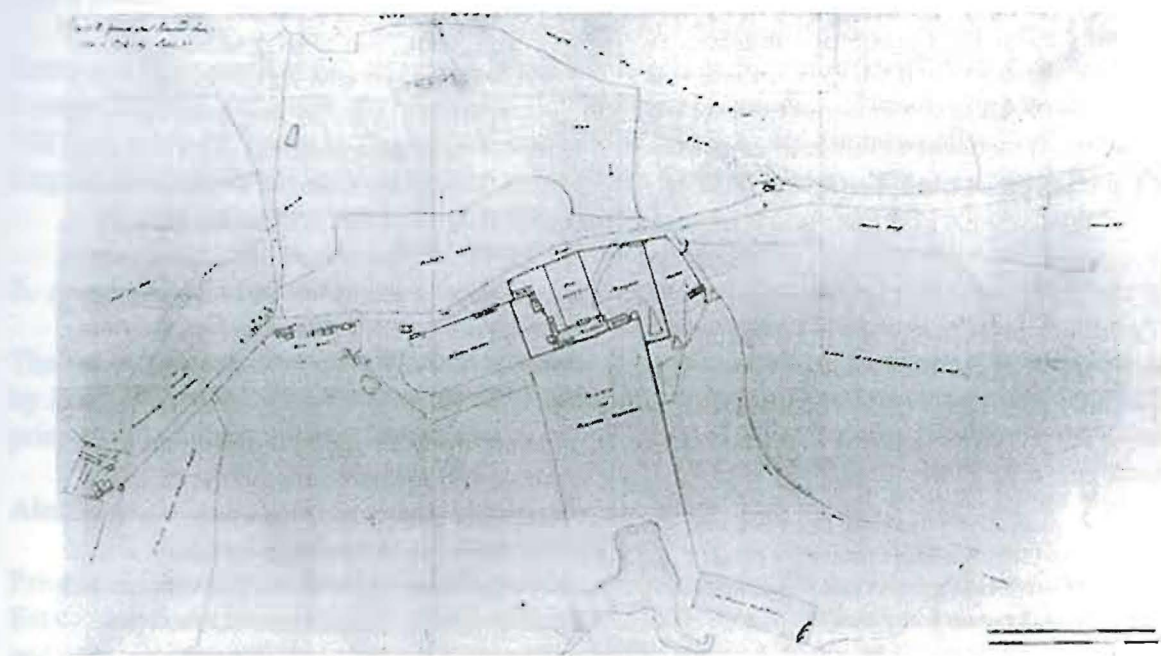
Figure 2. Plan of the Grounds at Kenwood by Pritchard, 1793 (taken from Bryant and Colson, 1990)

The 1793 Pritchard survey of the estate (see *figure 2*) shows a range of kitchen offices located to the north-west of the house, between the Orangery and the previously mentioned 18th-century stable block. These were demolished by George Saunders in the late 18th century to enable the addition of the north-west wing to the house. Fortunately the kitchen complex remained undisturbed by the service trench excavations to the north and west, and it seems likely that the wall foundations of the complex will have survived below ground (*figure 4*).

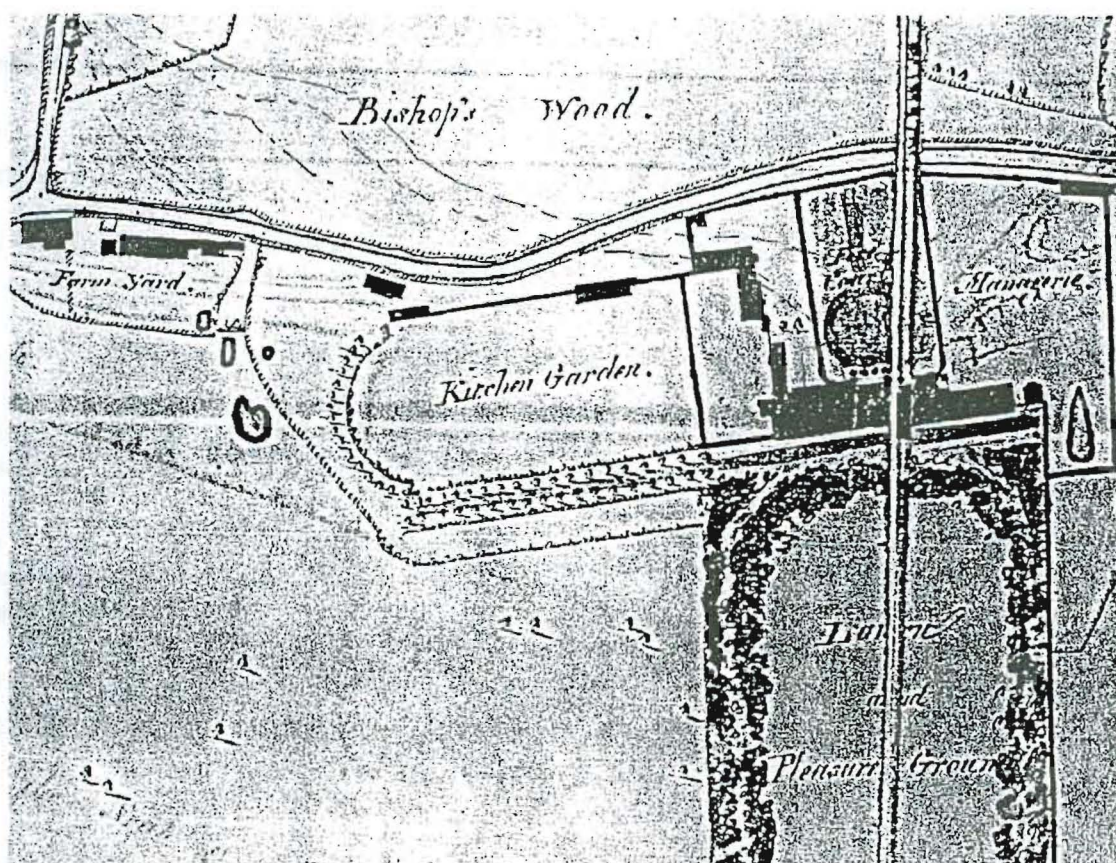
Figure 3. Plan of estate and house prior to remodelling to Humphry Repton's designs (taken from Repton's Red Book of Kenwood, 1793)

The layout of the estate prior to the 2nd Earl's remodelling works can be seen on *figures 2 and 3*, reproduced plans of the estate dating from 1793. To the north of the house there were three walled courtyards – the central court or Fore Court at the front of the house, a service courtyard with stables to the north west of the house, and a courtyard containing a menagerie to the north east of the house. Each of these opened onto Hampstead Lane. Repton's proposals lead to Hampstead Lane being diverted to the north, allowing the house to open onto a lawned area following the demolition of the walled courtyards (the Half Moon Lawn). New sweeping carriageways were constructed leading from Hampstead Lane to the front of

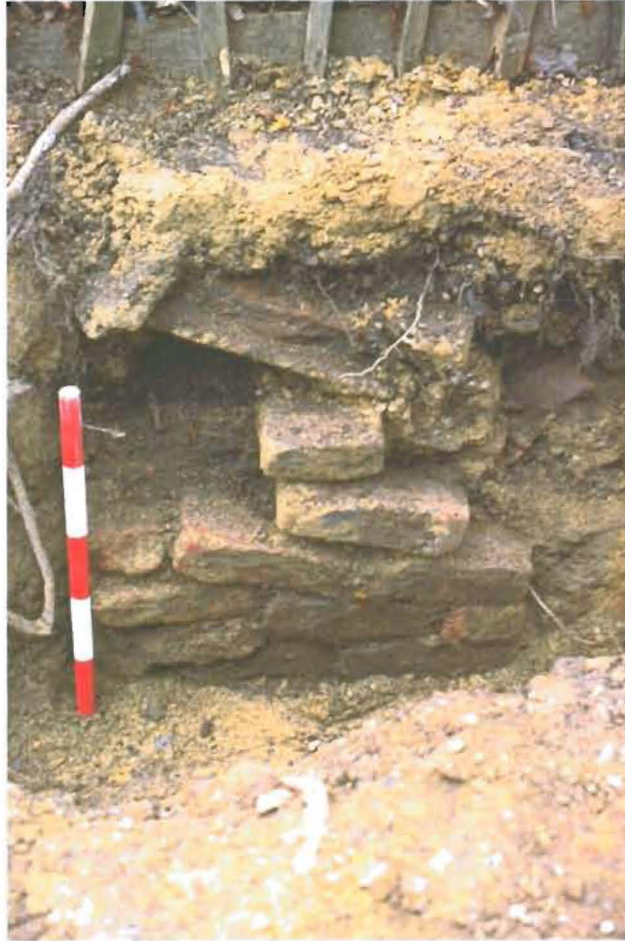
Figure 6. Photograph of context 101 - one of the three brick structures seen in the excavations along the side of the road in trench 1 to the north-west of the house

Three brick built structures of similar form were seen in the southern section of the trench. Each of the structures were 0.60m wide and were constructed of handmade red bricks measuring 0.22 x 0.11 x 0.06m (8¾ x 4½ x 2½ inches), with the easternmost capped by an iron plate. The faces exposed by the excavation were finished faces and the foundation trench cuts through the sandy clay were recorded (see *figures 6 and 7*).

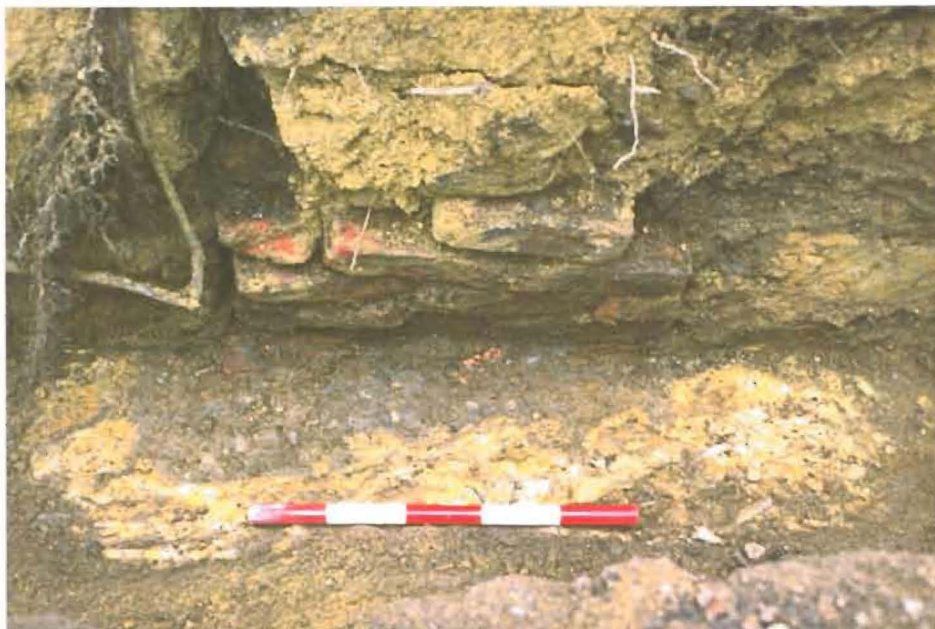
Figure 7. Photograph showing brick structure (context 101) highlighting insertion cut (context 102) in the base of the trench

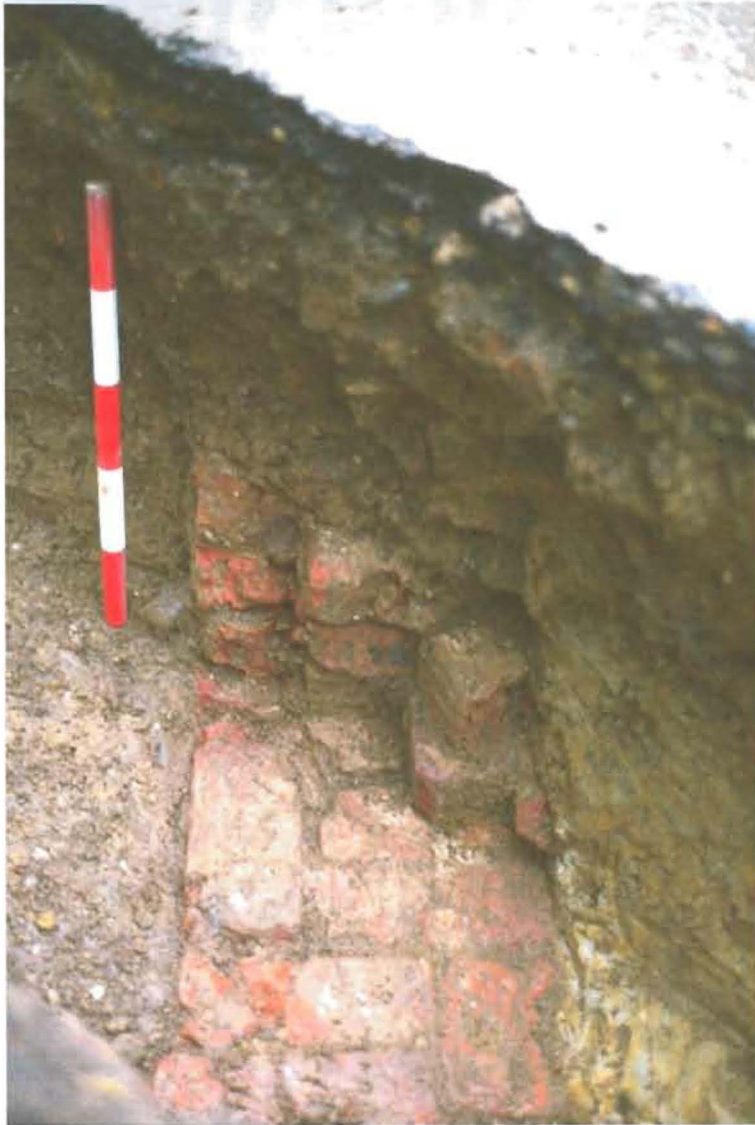
Figure 8. Trench 1, remains of 18th century stable block wall looking northwest

As the trench neared the house the deposits became more disturbed. This was partly due to the installation of services (cables and drain pipes) along the side of the driveway, but was also due to the presence of the buried remains of a demolished building. Two parallel brick walls, contexts 116 & 117, were revealed running north-south across the trench. They were 0.33m wide, constructed of soft red hand-made bricks laid in English Bond, and were positioned 1.95m apart (see *figures 5 and 8*).

The walls had been demolished prior to the construction of the driveway in the late 18th century, and they occupy the position of the 18th-century stable block. The location is shown

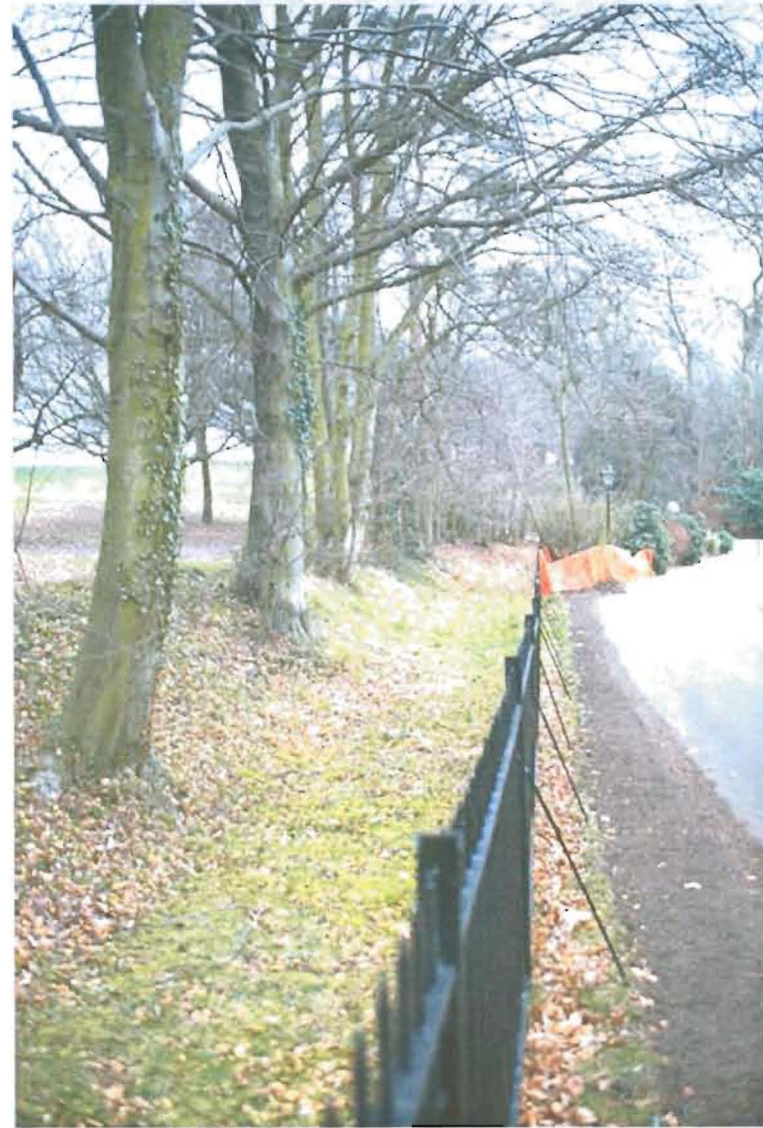
Figure 9. Trench 3, view of ancient boundary bank and ditch to the east of the house looking southeast

Excavations into the fills of the ancient boundary ditch (*figure 9*) revealed up to 0.45m of root-disturbed topsoil overlying at least 0.25m of a mixed dark yellowish brown loose silty sand layer with gravel inclusions that contained fragments of brick and tile. The presence of these ceramic building materials suggests that if any medieval deposits survive, they are below the level of the service trench excavations.

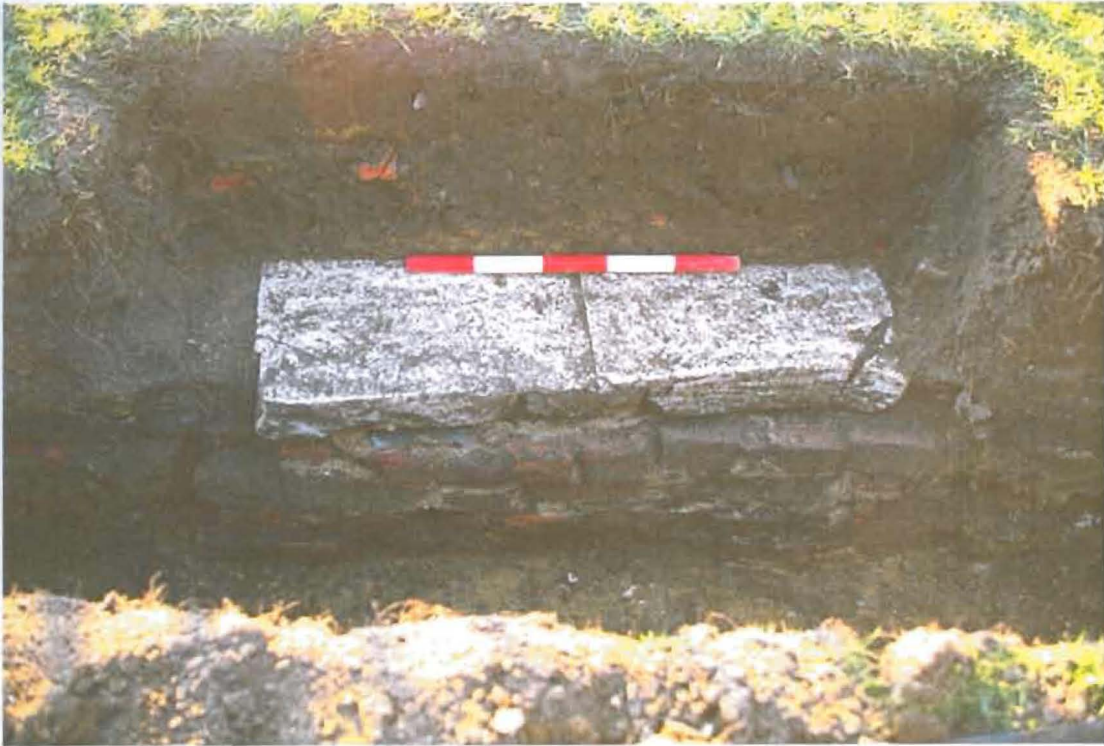
Figure 12. Photograph showing one of the three brick manholes/inspection shafts capped with Portland limestone slabs (context 127 - see figure 5)

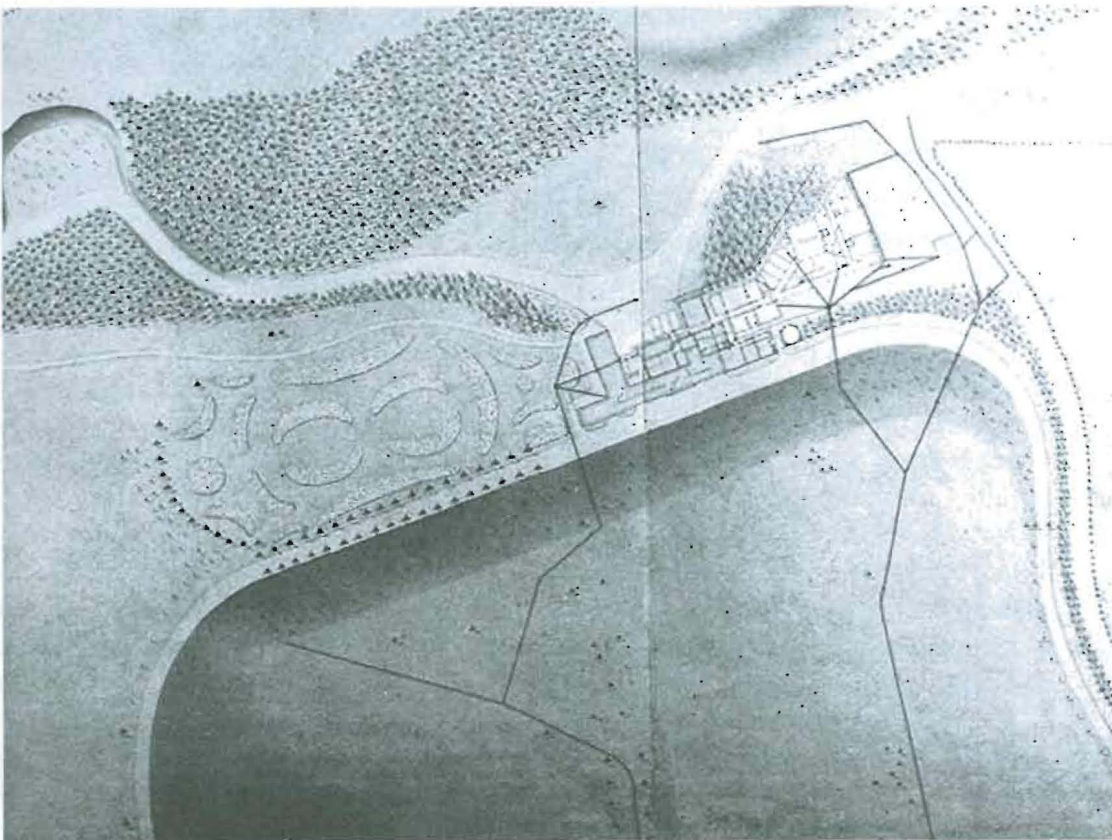
Figure 13. Plan of Kenwood House, Offices and adjoining Grounds with drainage lines marked, attributed to Pritchard, 1797 (taken from Bryant and Colson, 1990)

Three of the arched brick drains known to exist were encountered during the service trenching work, (Objective 3.4), and these may date from the period of reorganisation of the grounds by Humphry Repton in the late 18th century. Two further drains retaining just their tile bases were also located. Other drainage features that were encountered included three large limestone capped brick inspection shafts to the west of the house and in the trench part way down the terrace. A land drain filled with gravel, brick and ceramic fragments and broken glass was excavated in the Half-Moon Lawn trench, and a ceramic drain was located in the garden to the north-east of the house. Evidence for the location of these early drainage structures can be seen on a plan attributed to Pritchard from 1797 (Bryant & Colson, 1990).

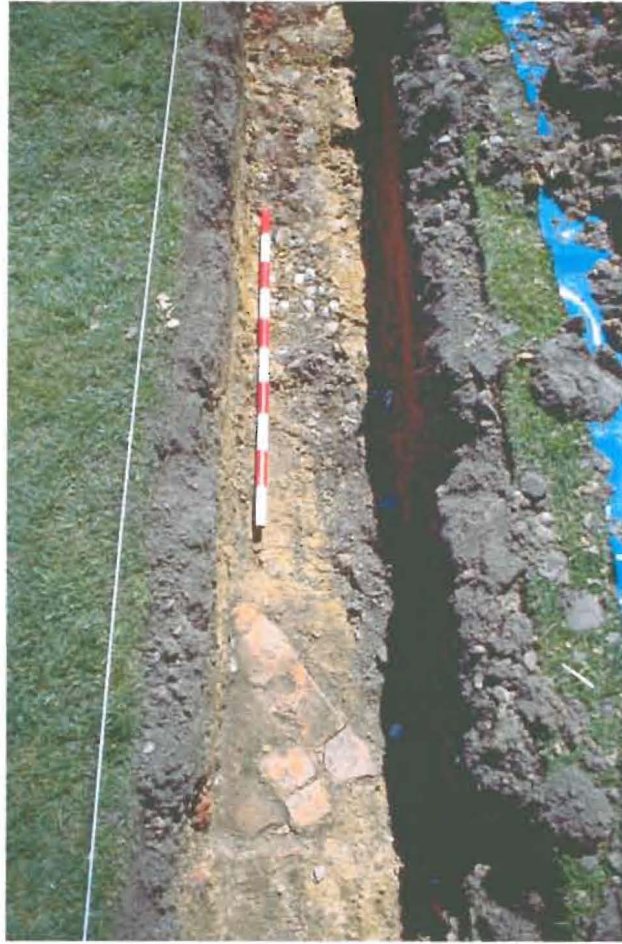
Figure 14. Trench 5, remains of tile drain base and land drain across Half-Moon Lawn looking north (1m scale)

During the excavations across the Half-Moon Lawn, two of the different types of drain used were encountered. Towards the southern end of the trench, the remains of the tile base of a north-south aligned drain was excavated and recorded (context 143). Running alongside this

and extending to the south-west for a length of c.4.5m was a crude land drain. This consisted of a sinuous linear cut 0.30m wide (context 141) that had vertical sides, and had a shallower secondary cut entering from the west. From the length of cut seen in the excavation, the drain appeared to be zig-zagging down the slope towards the driveway. The drain was filled predominantly with rounded gravel fragments up to 0.05m in size, but also contained brick and brick paviour fragments, along with pieces of broken bottle glass and clay flower pots (context 142). The drain was functioning very effectively at the time of excavation, with the drainage material being saturated although the surrounding deposits were relatively dry. This land drain appeared to post-date the brick culvert, possibly replacing it when it fell into disrepair or disuse (see photograph – *figure 14*).

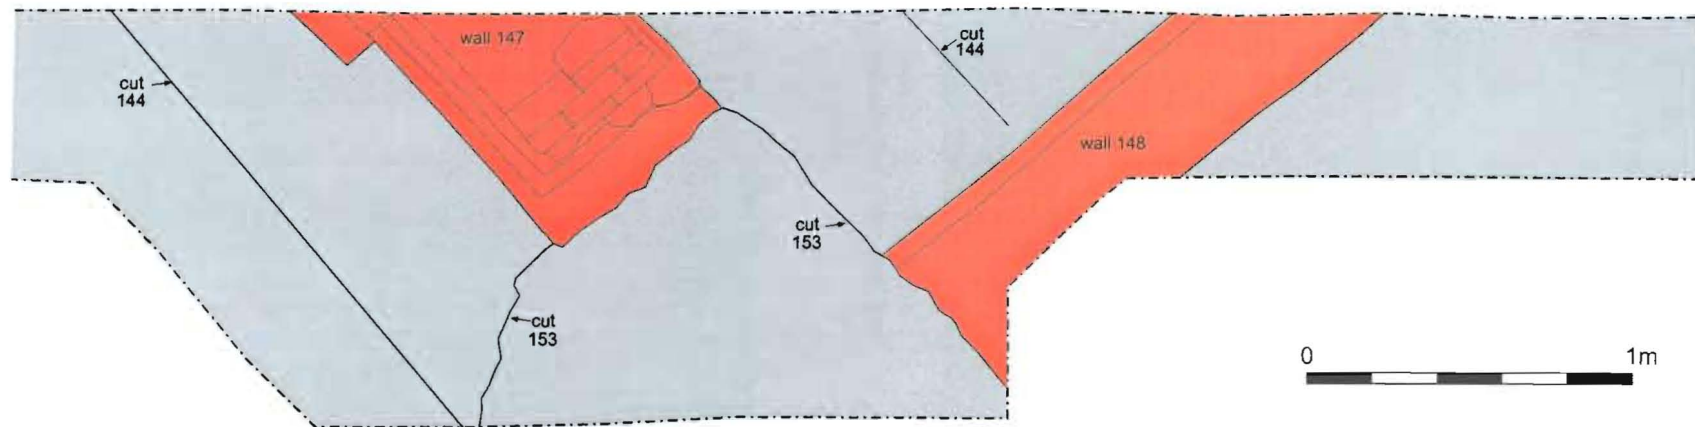
Figure 17. Plan of Half-Moon lawn trench

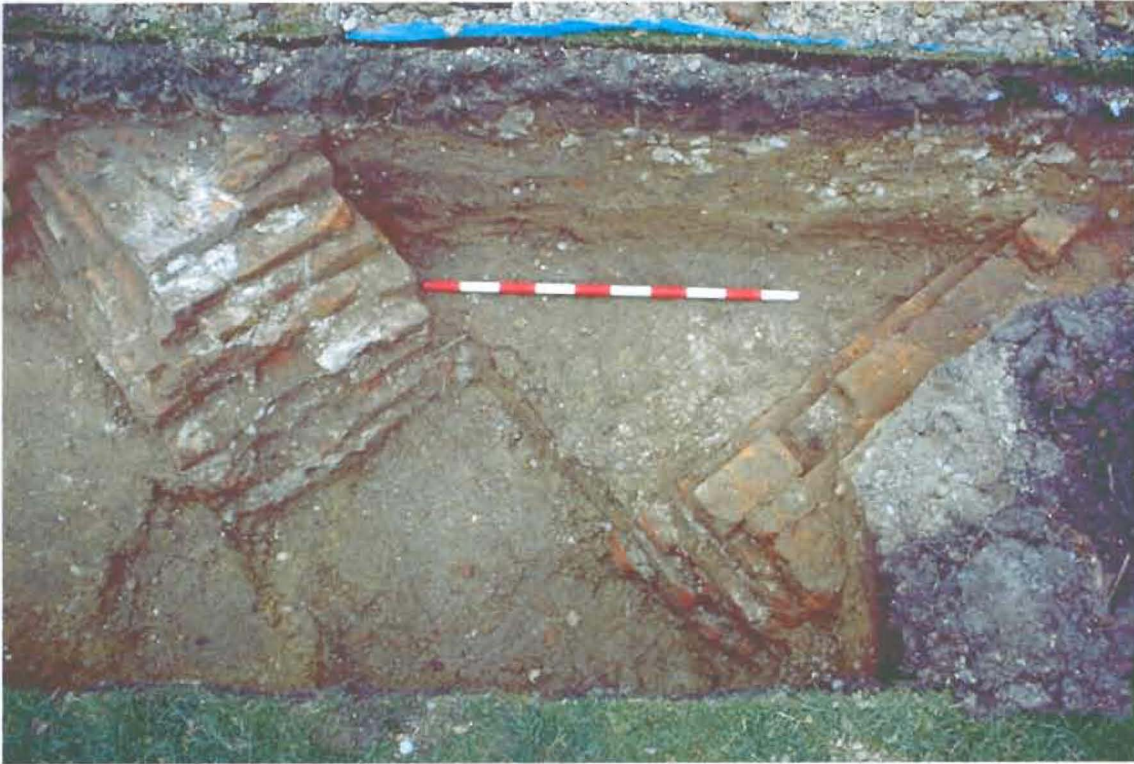
Figure 18. Trench 5, estate boundary wall (early 18th century) with earlier truncated wall, looking west (1m scale)

The Estate boundary wall was of early 18th-century date. The re-alignment of Hampstead Lane, and the creation of sweeping carriageways as access routes from the newly constructed lodges during the landscaping alterations undertaken by Humphry Repton and George Saunders for the 2nd Earl of Mansfield between 1793 and 1796 caused the removal of the boundary wall.

To the north of the 18th-century boundary wall (wall 147) the excavation showed no evidence of the road, although above the dismantled early brick wall (wall 148) levelling layers of clay silt (layer 159) and loose gravel (layer 158) may have been bedding for the road surface. It seems equally likely that these were layers resulting from the contouring and landscaping of this area to the north of the house when the new carriageways were constructed in the late 18th century.

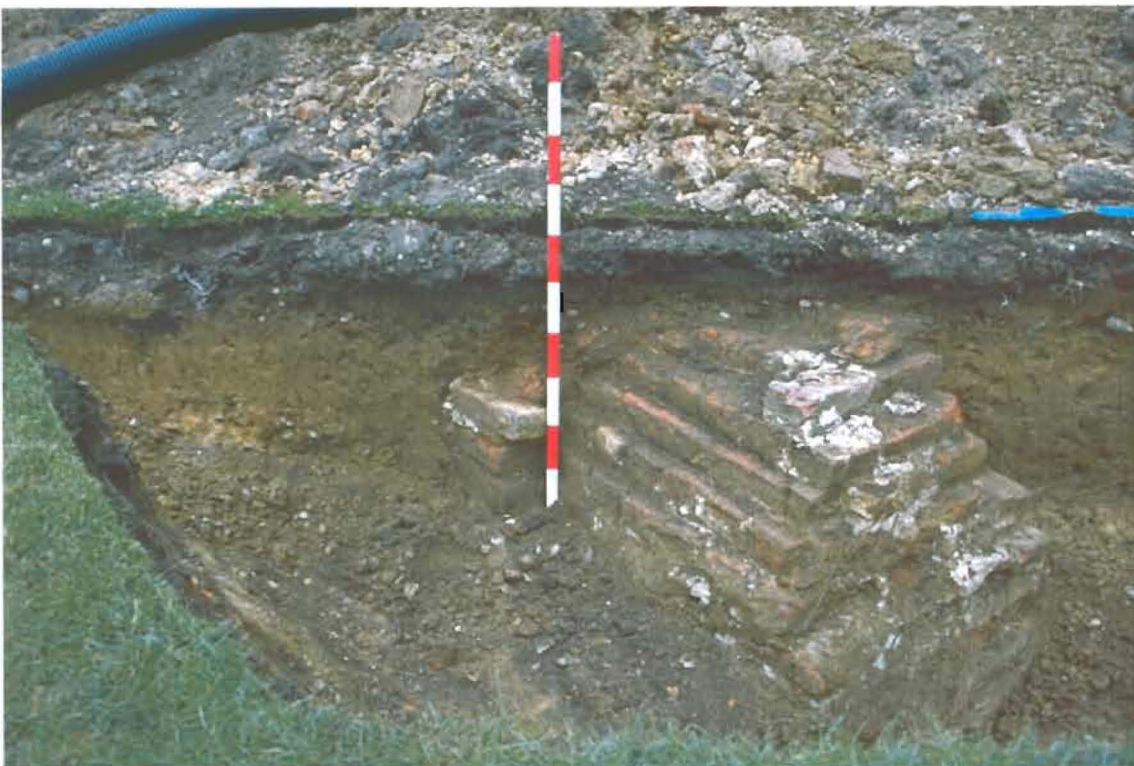
Figure 19. Trench 5, 18th century estate boundary wall with brickwork of gatepost, looking west (1m scale)

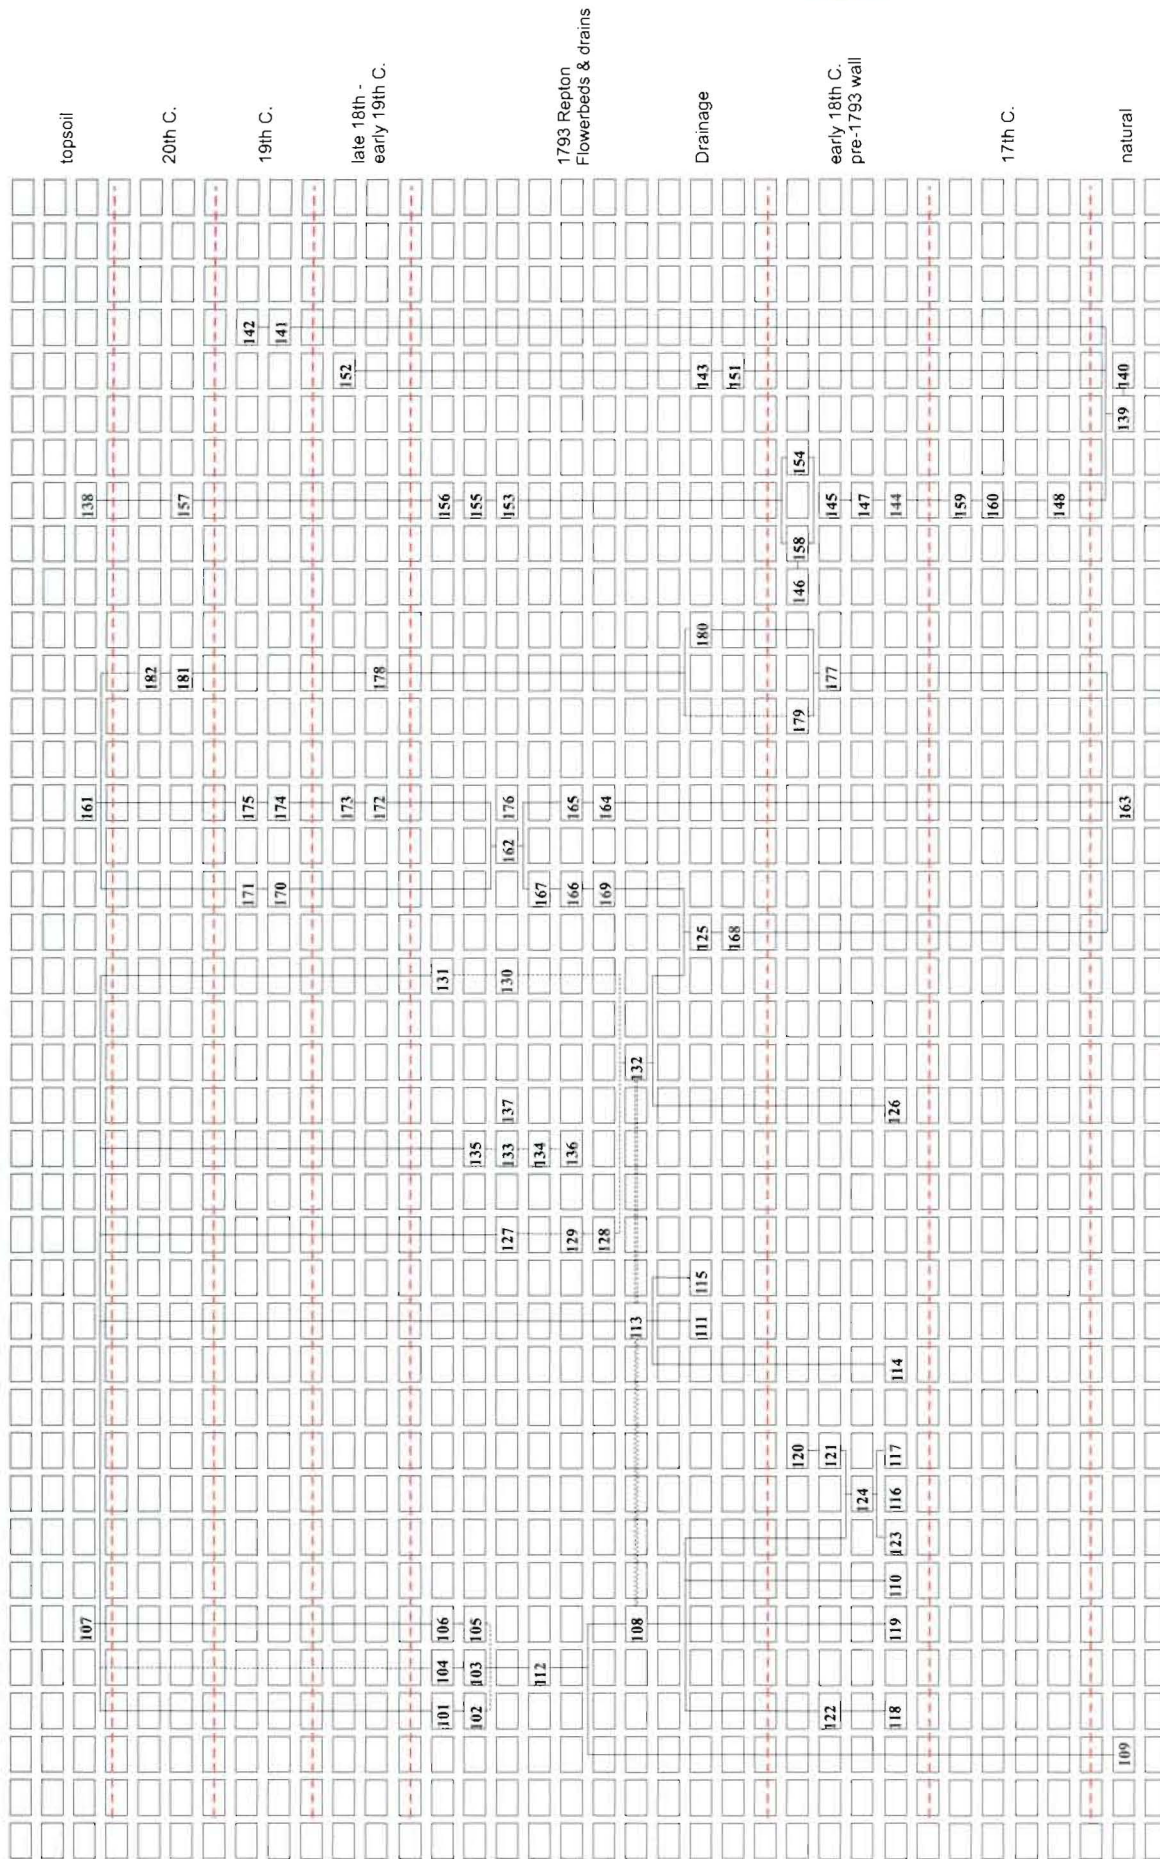
Figure 20. Stratigraphic matrix for the site excavations
