Centre for Archaeology Report 75/2003

**Tree-Ring Analysis of Oak Timbers from a Building on the Lea
Road Foundry Site, Church Street, Dronfield, Derbyshire**

Ian Tyers

A tree-ring dating programme was commissioned on timbers in a newly identified timber-framed building on a site in Church Street, Dronfield, Derbyshire, by English Heritage in AD 2003. The tree-ring results indicate that timbers felled in the winter of AD 1526/7 are present in the structure.

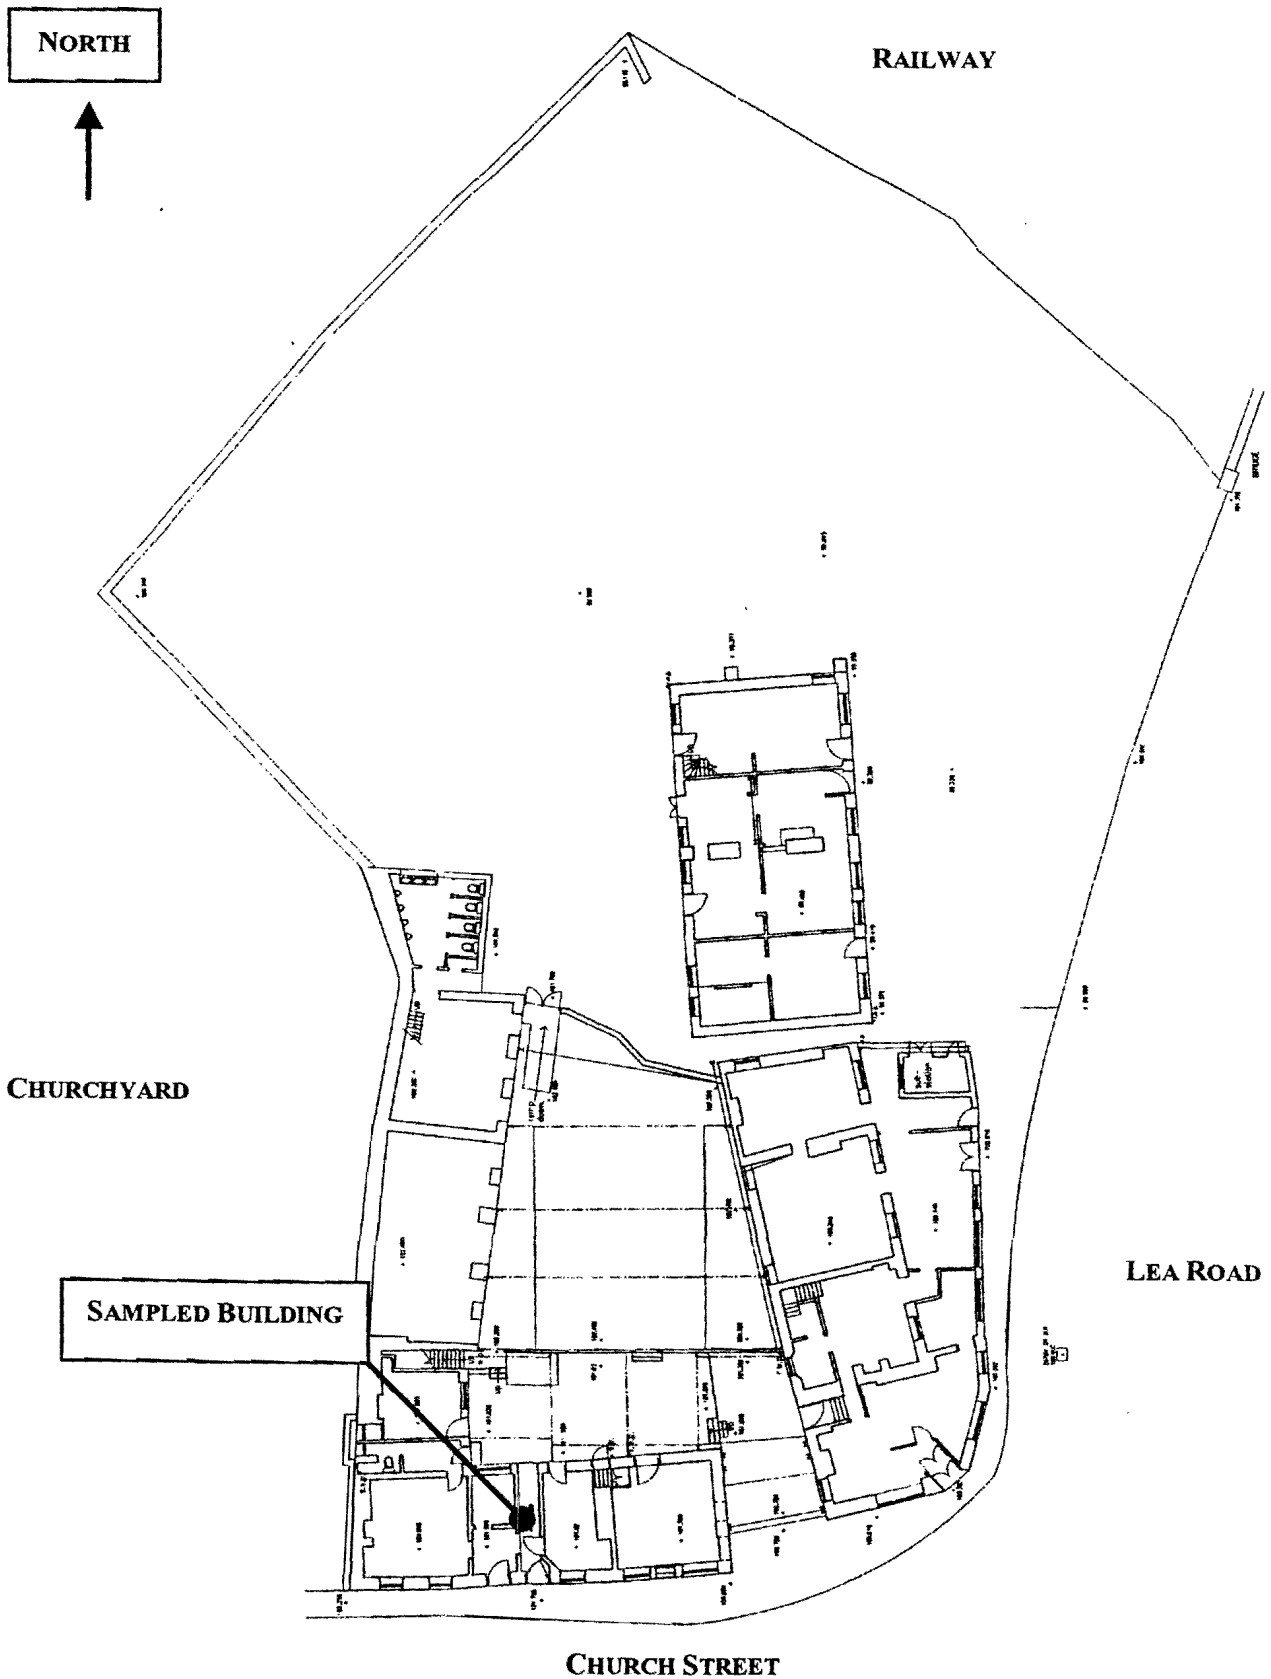
Figure 3 Location of the sampled building within the Lea Road Foundry site, Church Street, Dronfield, Derbyshire (based upon Barlow Building Design Plan 2111/01, supplied by English Heritage). The sampled building is along the south edge of the site

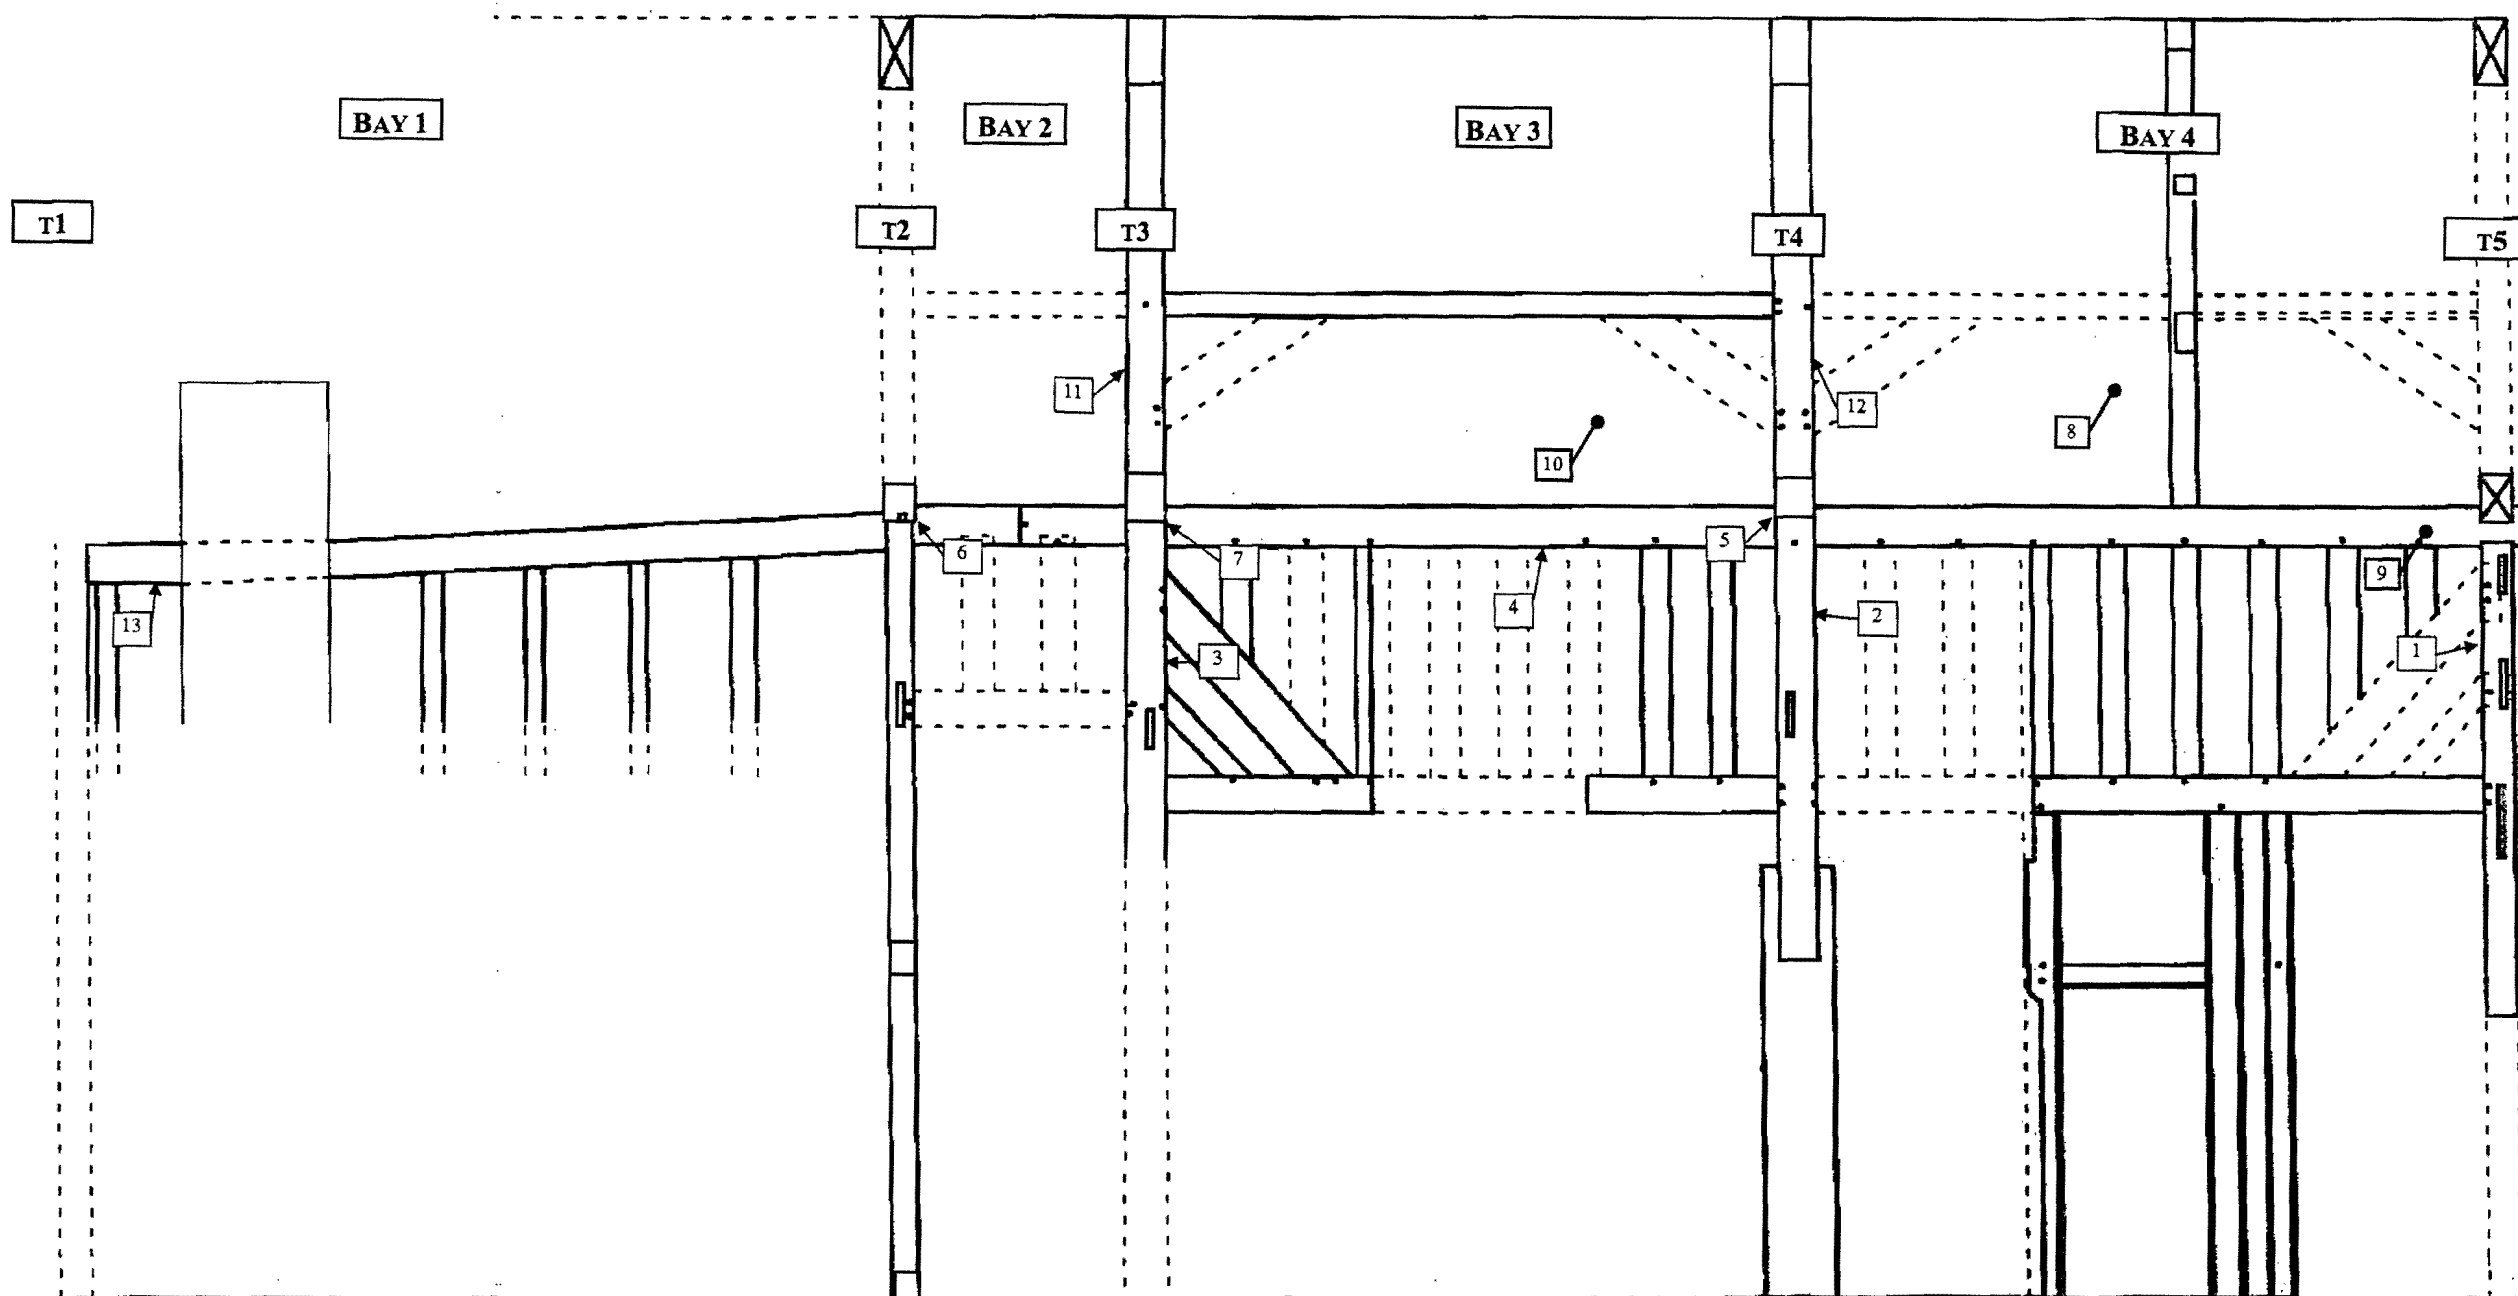
Figure 4 Elevation of the original part of the sampled building at the Lea Road Foundry Site, Church Street, Dronfield, Derbyshire. From the inside looking north showing the truss and bay numbering scheme adopted for this report (based on a figure supplied by English Heritage). The labelled arrows indicate the approximate locations of the sampled timbers visible on this elevation, labels 8, 9, and 10 indicate the approximate equivalent location of sampled timbers on the southern elevation. The timber from which sample 14 was derived is not visible on this section

Thirteen timbers were selected for sampling from the apparently original structure. Following discussion with Adam Menuge, and with the agreement of Peter Marshall, a further sample from the inserted floor was also obtained. The samples were numbered 1-14 (Table 1). Adam Menuge had assigned Truss 1 to be the missing truss at the west end with Truss 5 at the eastern end (Fig 4), the sample locations throughout the structure were recorded using this scheme (Figs 4-5).

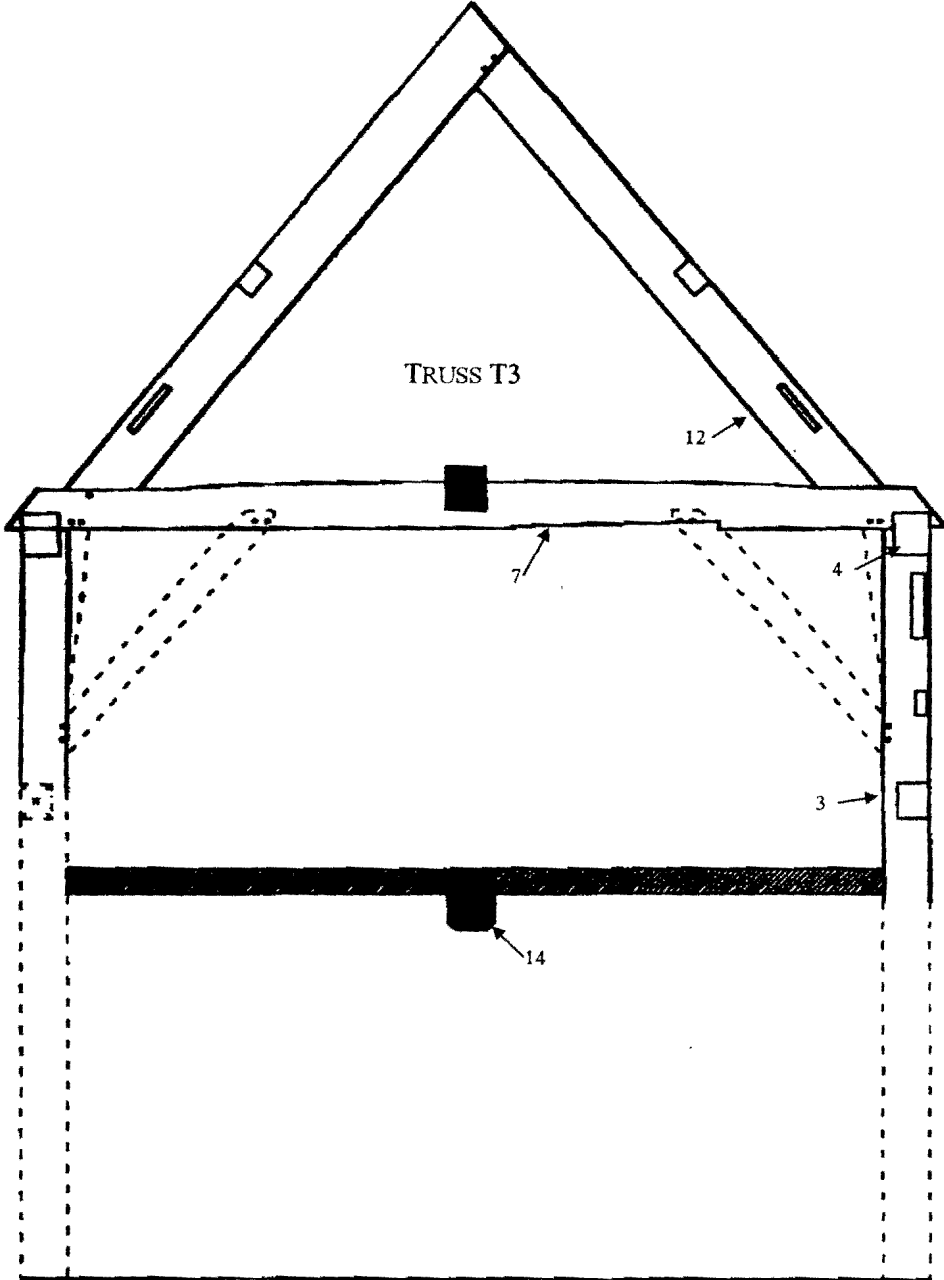
Figure 5 Elevation of Truss 3 looking west at the Lea Road Foundry Site, Church Street, Dronfield, Derbyshire. The labelled arrows indicate the approximate locations of the sampled timbers visible on this elevation, this section shows the location of the inserted floor and the timber from which sample 14 was derived. Based on a figure supplied by English Heritage

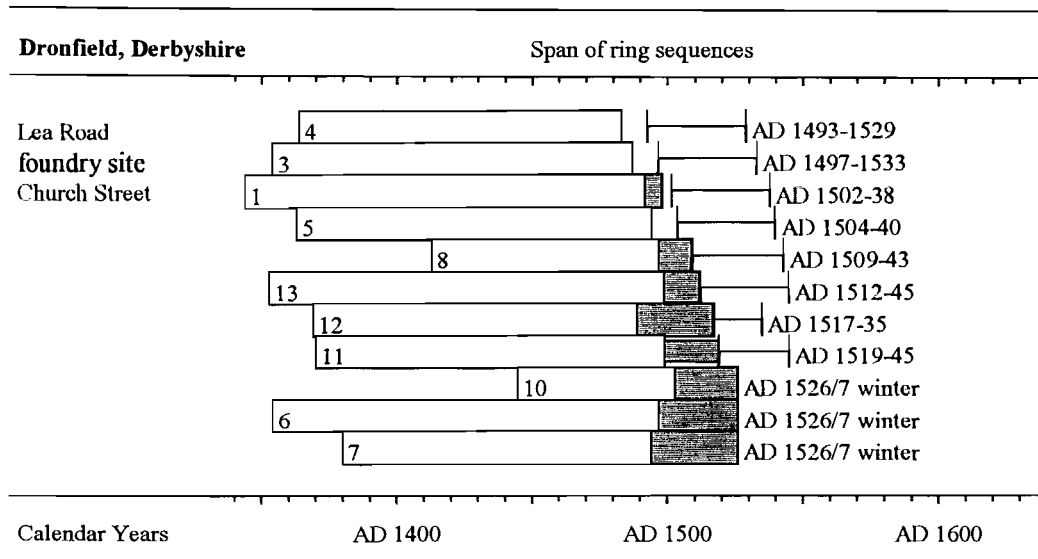
Figure 6 Bar diagram showing the chronological positions of the dated timbers from the building at the Lea Road Foundry Site, Church Street, Dronfield, Derbyshire. The estimated felling period for each sequence is also shown

The 183-year chronology DRONFIELD is dated AD 1344 to AD 1526 inclusive. It was created from eleven timbers. Three of the dated timbers are complete to the original bark surface. These timbers still retained their bark. There is therefore no interpretative problem with the site since all three are timbers felled within the non-growing period between autumn AD 1526 and spring AD 1527. All of the eight other dated samples retain some sapwood, or are complete to the heartwood/sapwood boundary, and all appear to be contemporaneous (Fig 6; Table 1).
