KITCHENER'S CAMPS AT SEAFORD A FIRST WORLD WAR LANDSCAPE ON AERIAL PHOTOGRAPHS

ARCHAEOLOGICAL REPORT

Kitchener's Camps at Seaford: A First World War Landscape on aerial photographs

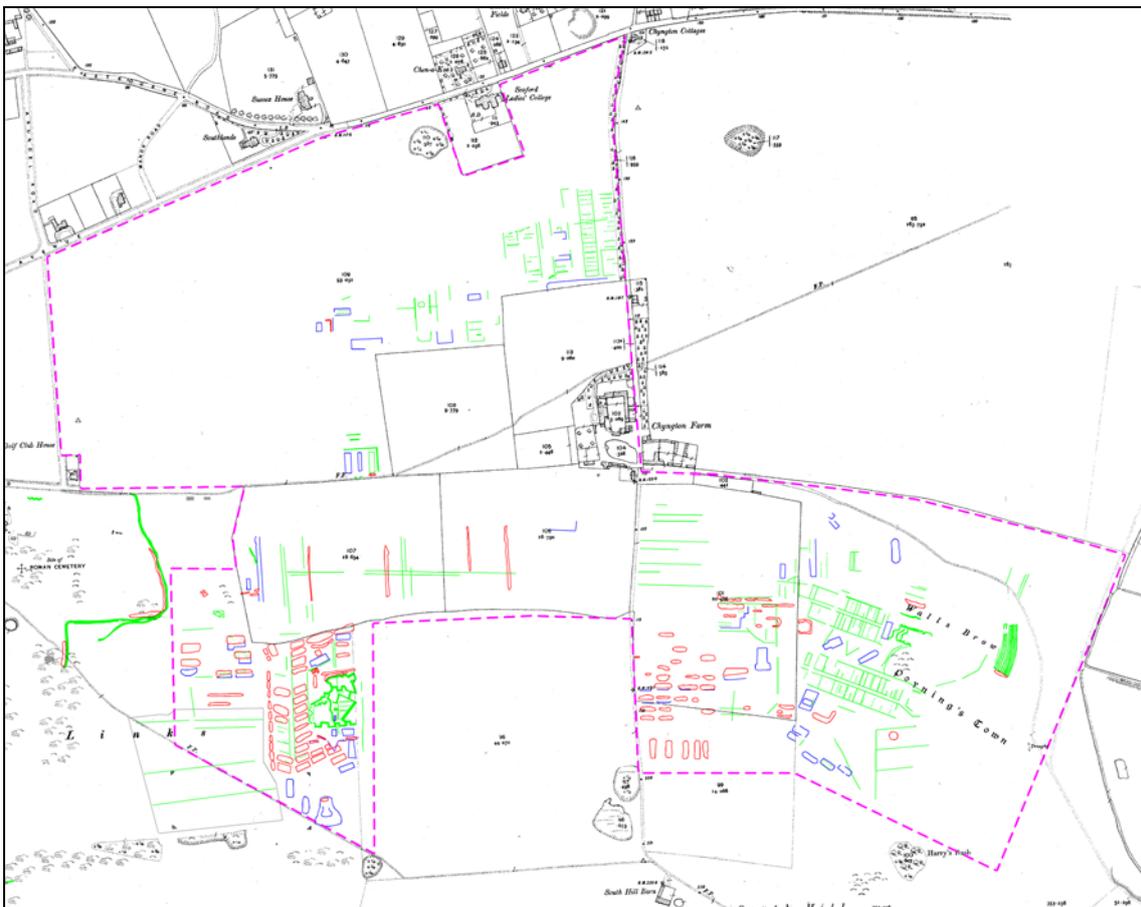
Fig 4: Extents of South Camp, based on the 1916 Royal Engineer's plan, outlined in pink. Aerial photo mapping is in colour, the background is an Ordnance Survey 6" map from 1911. © and database right Crown Copyright and Landmark Information Group Ltd (All rights reserved 2010). Licence numbers 000394 and TP0024.

The extent of South Camp (the larger of the two camps, also known as Chyngton Camp) is depicted on the military blueprint drawn up in 1916 (Q4-54887, Series E-17, Vol 21, File '21' (21-27) 1916-C 'Plans de camps'). Comparing the plan with the aerial photograph mapping it is clear that although there were internal changes, the extent of

the camp was never greater than that shown on the 1916 plan (Fig 4). South Camp stretched from the east end of Seaford Head Golf Course to the edge of the steep decent into the Cuckmere Valley and was roughly 1.5 km long. To the north, the camp extended almost as far as Eastbourne Road and to the south ended at the steep slope up onto Seaford Head. The camp enveloped Chyngton Farm consuming the fields to its south and west but avoiding the land to the north and east, possibly leaving this land for the farm.

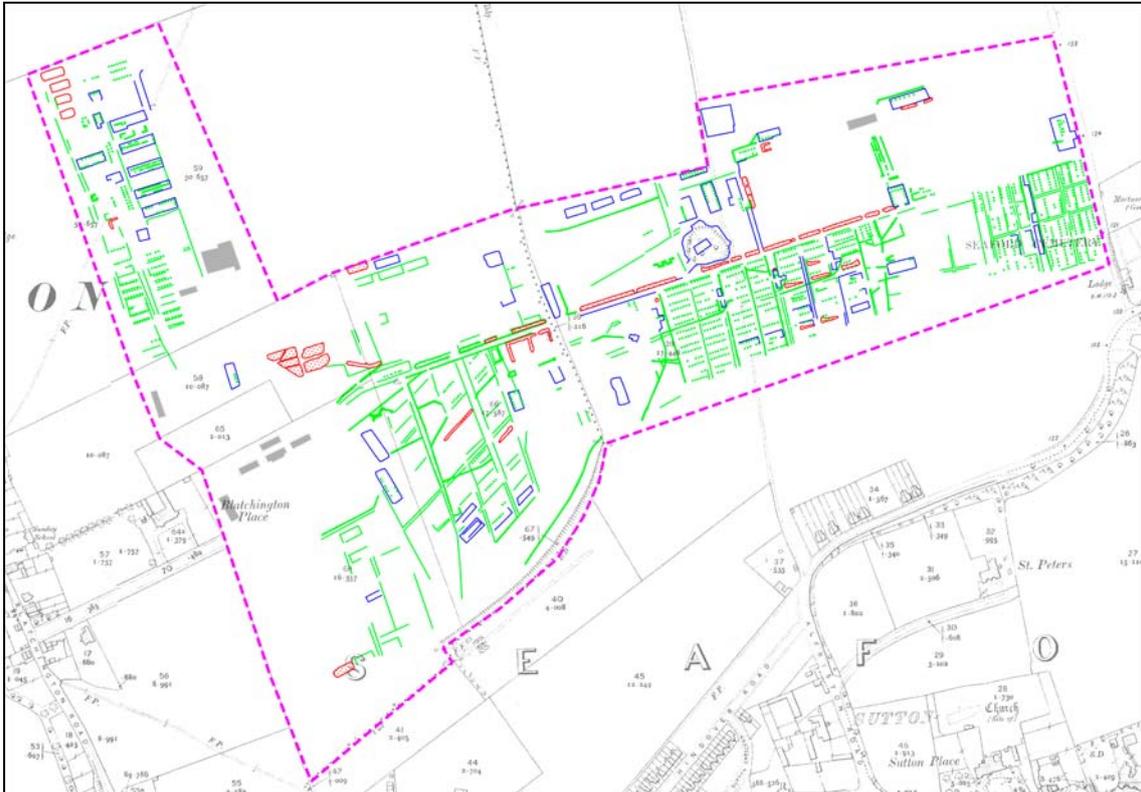
Fig 5: North Camp extents based on the aerial photo mapping outlined in pink. The camp sits within an area of fields and does not encroach on any buildings. Aerial photo mapping is in colour, the background is an Ordnance Survey 6" map from 1911 © and database right Crown Copyright and Landmark Information Group Ltd (All rights reserved 2010). Licence numbers 000394 and TP0024.

North Camp was smaller than south camp and occupied an area of farmland to the immediate east of East Blatchington, a village suburb of the town (Fig 5). There is no known blueprint plan of North Camp. However, the archaeological features seen in aerial photographs from the 1940s and 1950s repeat elements of the layout seen in South Camp.

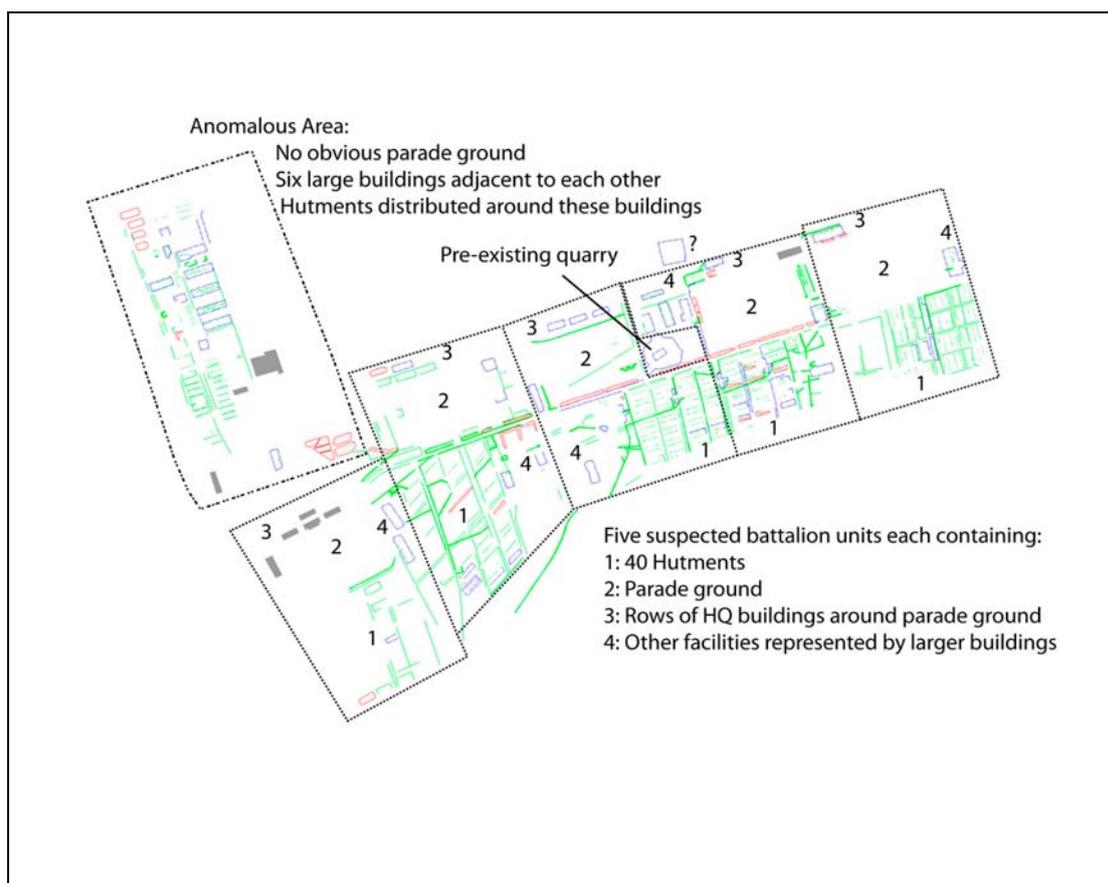
Fig 6: Suggested layout of North Camp. Air photo mapping in colour, information from the 1916 plan in black.

South Camp is depicted on a 1916 plan subdivided into numbered areas. Each area comprised a parade ground around which were arranged a group of buildings including 40 huts. The areas of South Camp are numbered 6-15. That areas 1-5 are in North Camp is suggested by the aerial photographs which show five parade grounds each surrounded by the remains of the same pattern of buildings (Fig 6).

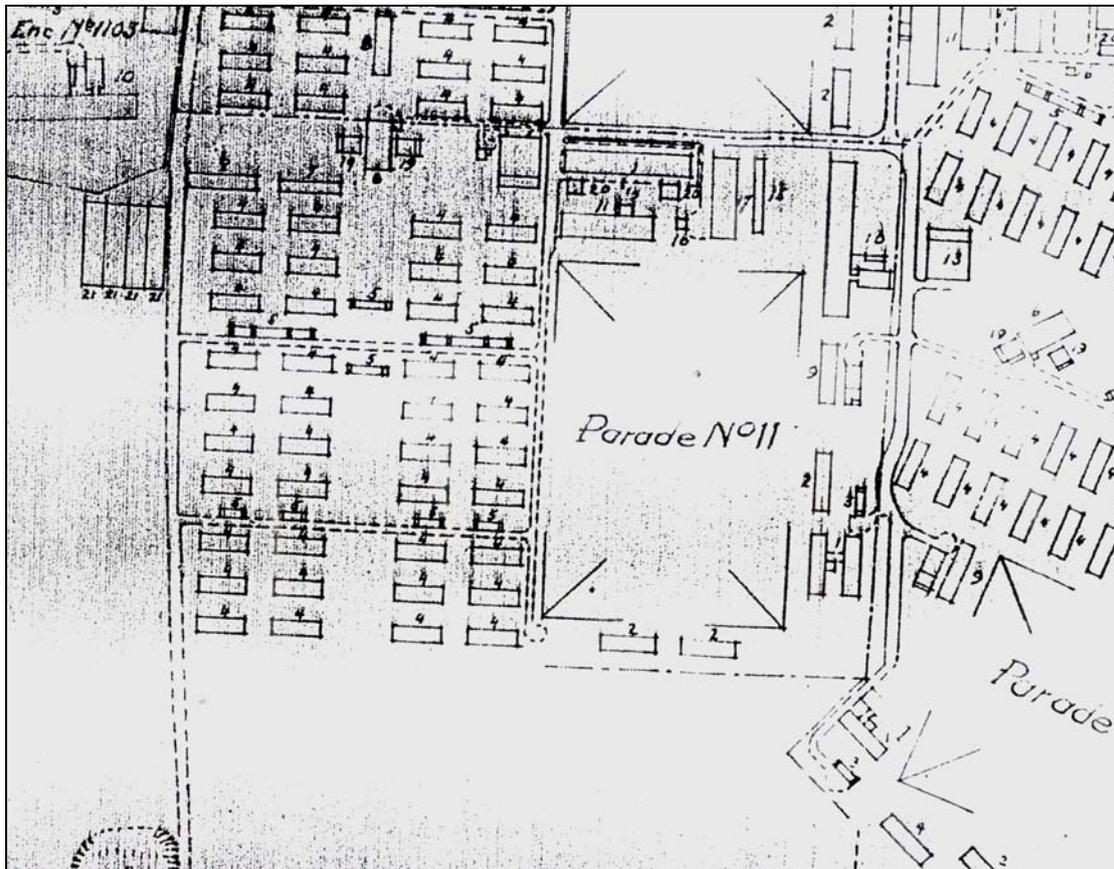
Fig 7: A typical battalion unit at South Camp. The barracks, and washing and cooking amenities are to the west of the parade ground, the HQ buildings are located to the south and east, and the storage and transport facilities such as stables are to the north. Canadian National Archives Reference: Q4-54887, Series E-17, Vol 21, File '21' (21-27) 1916-C 'Plans de camps' Crown Copyright, The National Archives, UK.

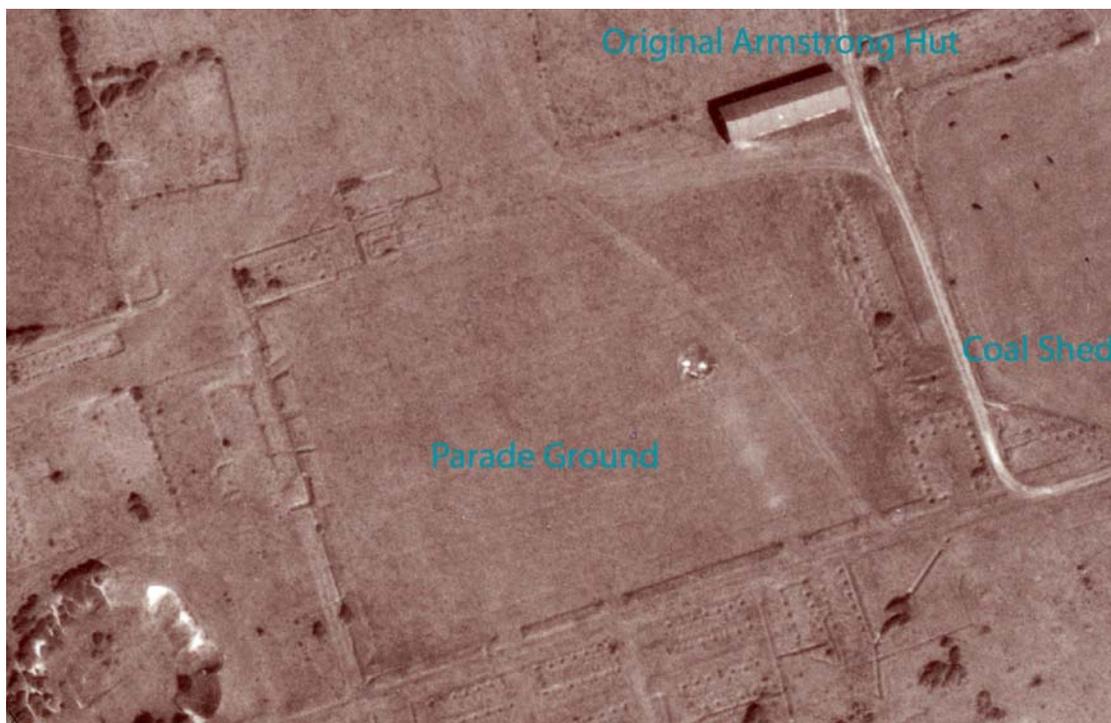
Fig 8: 1951 Aerial photograph showing the buildings beside a parade ground. NMR RAF/58/613 4237 05-APR-1951 English Heritage (NMR) RAF Photography.

Figure 8 shows one of a few Armstrong Huts surviving in 1951, possibly maintained as an agricultural building. Building foundations can be seen including the holes for the supporting piers. The foundations of a coal shed can be identified at the bottom right of the parade ground. The shed appears to have posts for a walls and roof but with a central open space and a wide entrance onto a camp road presumably for vehicle access.

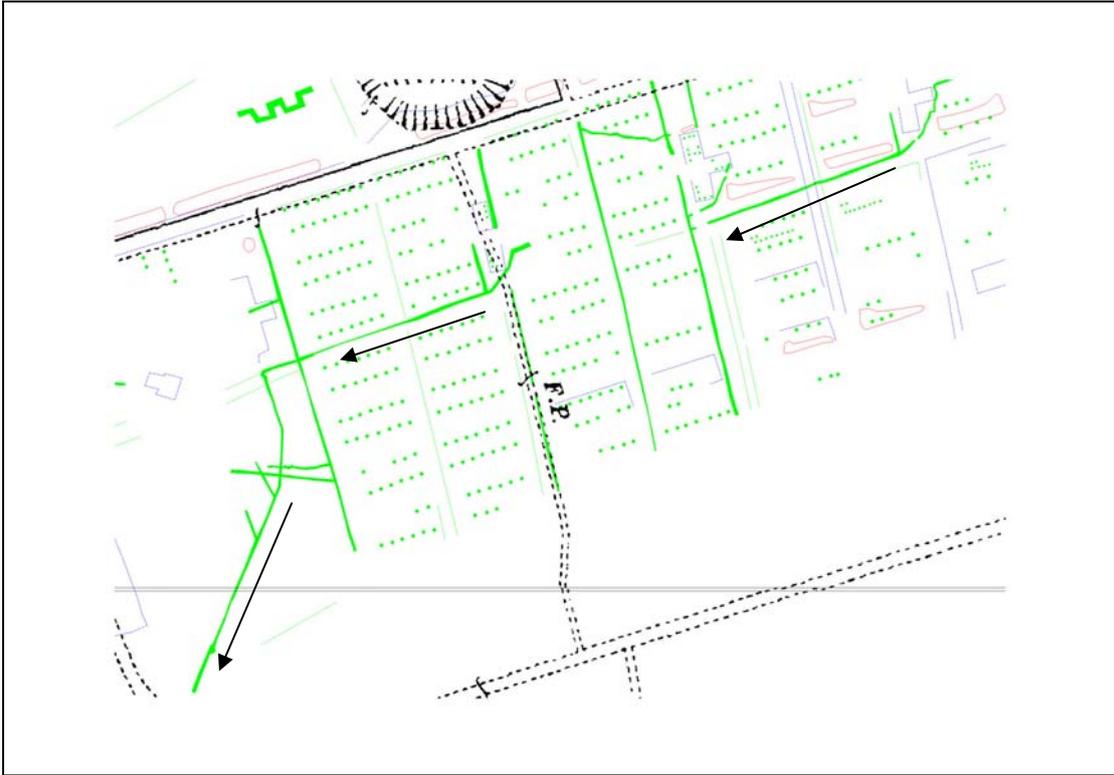
Fig 9: Plan of probable drainage ditches at North Camp. The arrows indicate the direction in which water would have flowed. Background is an Ordnance Survey 6" map from 1911 © and database right Crown Copyright and Landmark Information Group Ltd (All rights reserved 2010). Licence numbers 000394 and TP0024.

Figure 9 shows drainage ditches extending away from the three building clusters that resemble the cookhouse/wash-up combinations seen in South Camp. This seems a logical pattern for drainage ditches to follow. The ditches are not so obvious on aerial photographs from 1948 and it is possible to speculate that by 1951, the drains had been opened and the pipes salvaged, possibly because of post-Second World War shortages.

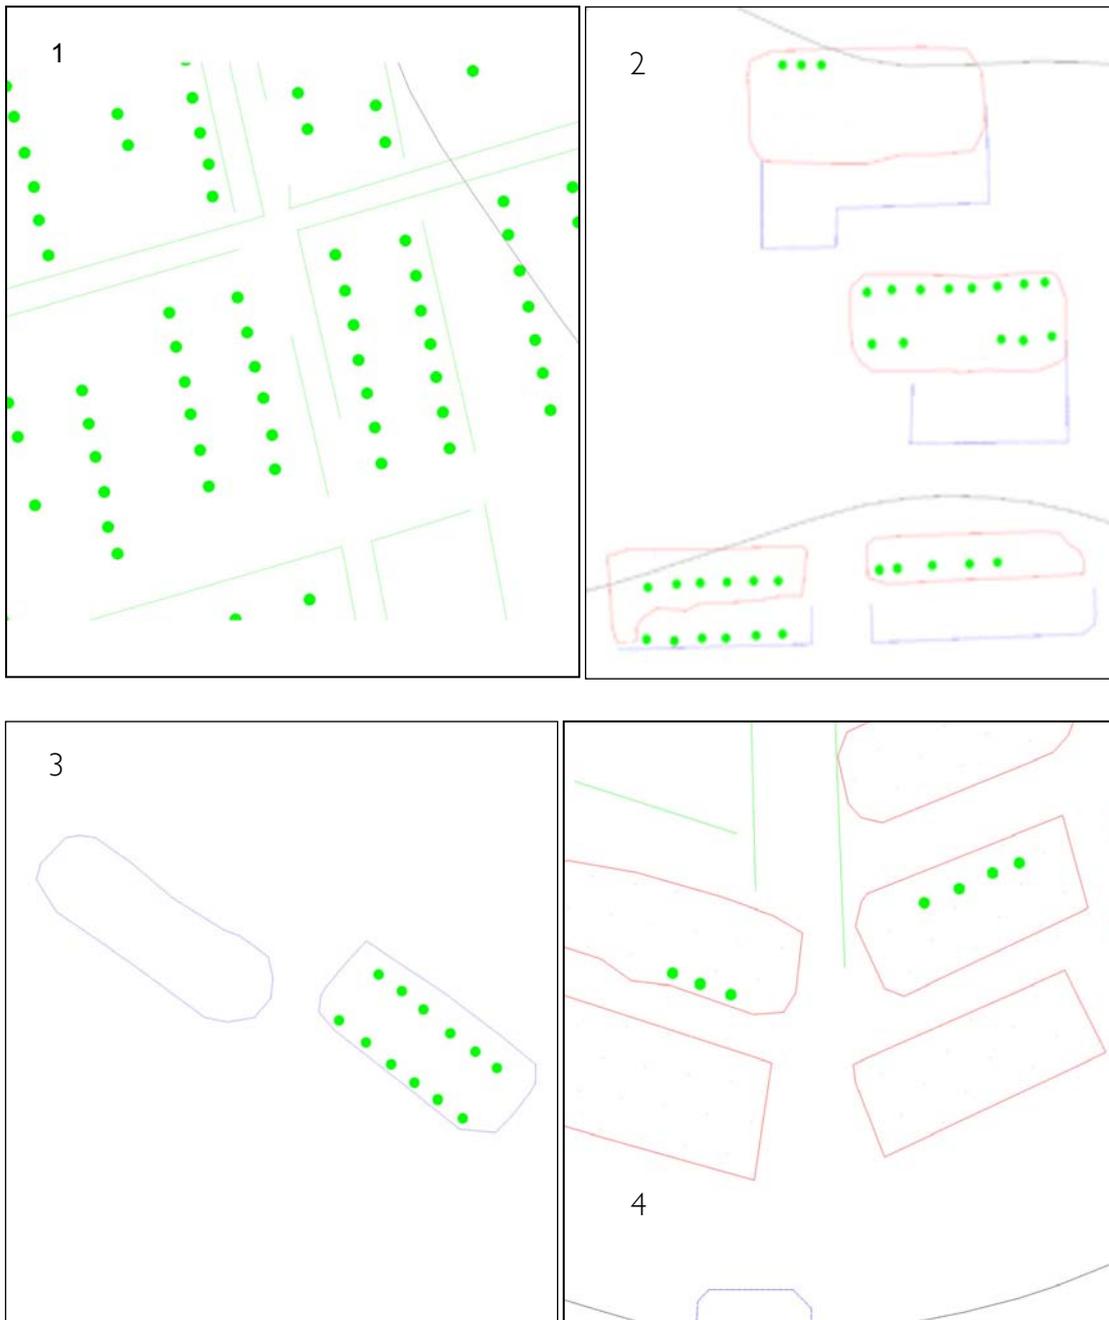
Fig 10: Different styles of building foundation as shown on the aerial photograph mapping.

Figure 10 shows the various layouts of the buildings. Figure 10.1 shows barrack huts constructed on a level surface with drainage ditches. Figure 10.2 shows barrack huts cut into the slope of the hillside with a raised earthwork to create a level platform. Figure 10.3 shows barrack huts constructed within a cut area. Figure 10.4 shows: barrack huts constructed on a raised earthwork platform in a herringbone pattern that follows the contours of the slope. The huts are all approximately 20m long.

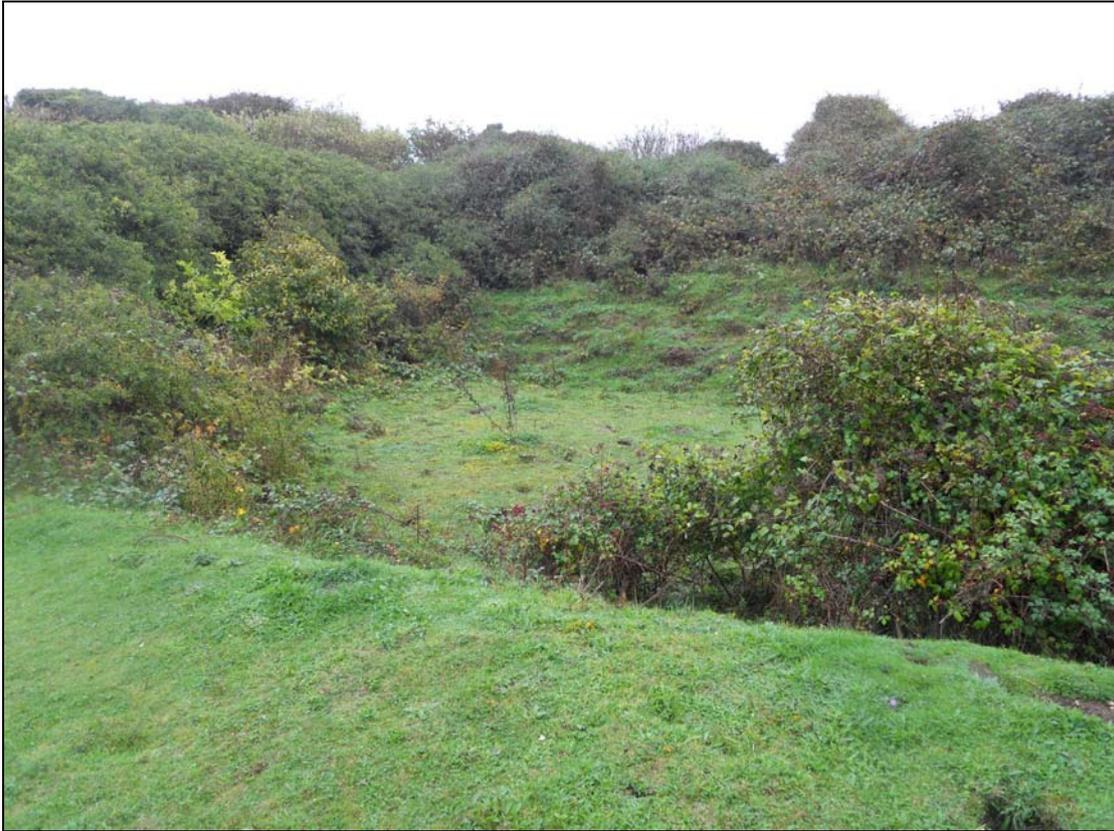
Fig 11: The deep building cut for the drying room associated with the battalion unit based around parade ground 10. Author's photograph.

The cut for a drying room is preserved in scrubland to the east of Seaford Head Golf Course (Fig 11). It is likely that this was designed to improve air circulation through the building.

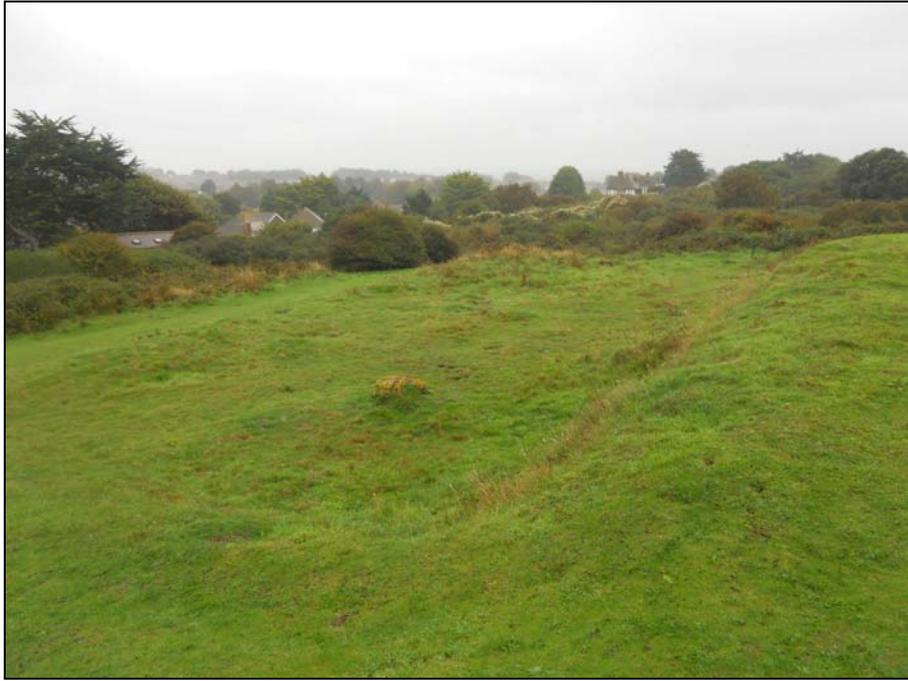
Fig 12: Image showing an extant hut platform with brick pier. Author's Photograph.

Schofield describes the standard design and materials used for the Armstrong hutments. Brick piers were initially used but were replaced by woodpiles, as bricks became scarce (Schofield, 2006, 5). A hut platform still visible at Seaford has a brick pier in situ (Fig 12). However, it is possible that other camp buildings used wood. Schofield describes the standard hut building material as red fir scantlings (ibid). This material was likely to have been used at Seaford as the huts depicted in the postcards are mostly of a light wood, which in colour images has a reddish tint (E.g. in Figs 13 & 18). Figure 13 shows some of the huts under construction with piles of planks and huts with no windows, the dark roofs are likely to be tar covered. Several huts survived post war many being sold off and used as private dwellings, this process is described in a later section of this report.

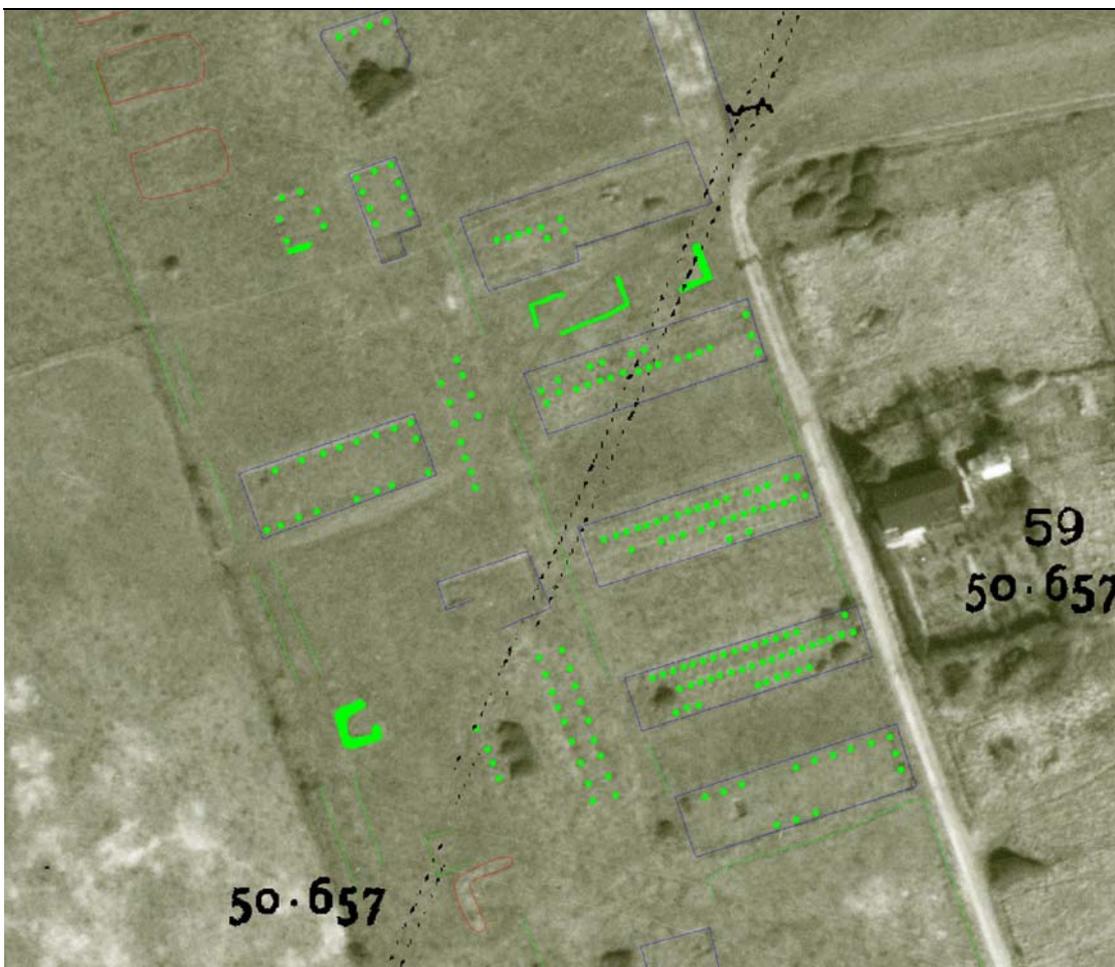
Fig 14: Image showing a 1951 aerial photograph overlaid with the mapping depicting the unusual northwestern part of North Camp. NMR RAF_58_613 4235 5-APR-1951. English Heritage (NMR) RAF Photography.

The area illustrated in Figure 14 presents more of a challenge to interpretation. The building's foundations seen here deviate from the pattern in the rest of the camp. The area contains a row of five large rectangular buildings, supported on many posts. The buildings share the dimensions of the large standardised storage buildings (e.g. vehicle stores, stables) from elsewhere in the camps at approximately 120' x 30' (37 x 9 meters). It is unusual in that these large buildings are clustered together in a pattern that has no comparison in South Camp where, according to the plan, each battalion would have a couple of large buildings for specific purposes. As it is unique, it is possible that this area had a specific function at a divisional level. There is evidence of a detachment of Canadian Engineers, a motorised machine gun depot and a recycling depot at the camp (Luke Barber pers. comm.) all of which have undisclosed locations. This northwest area of North Camp is a strong candidate for the location of this distinctive activity or may have been the location of the divisional HQ (See Figs 6 & 14).

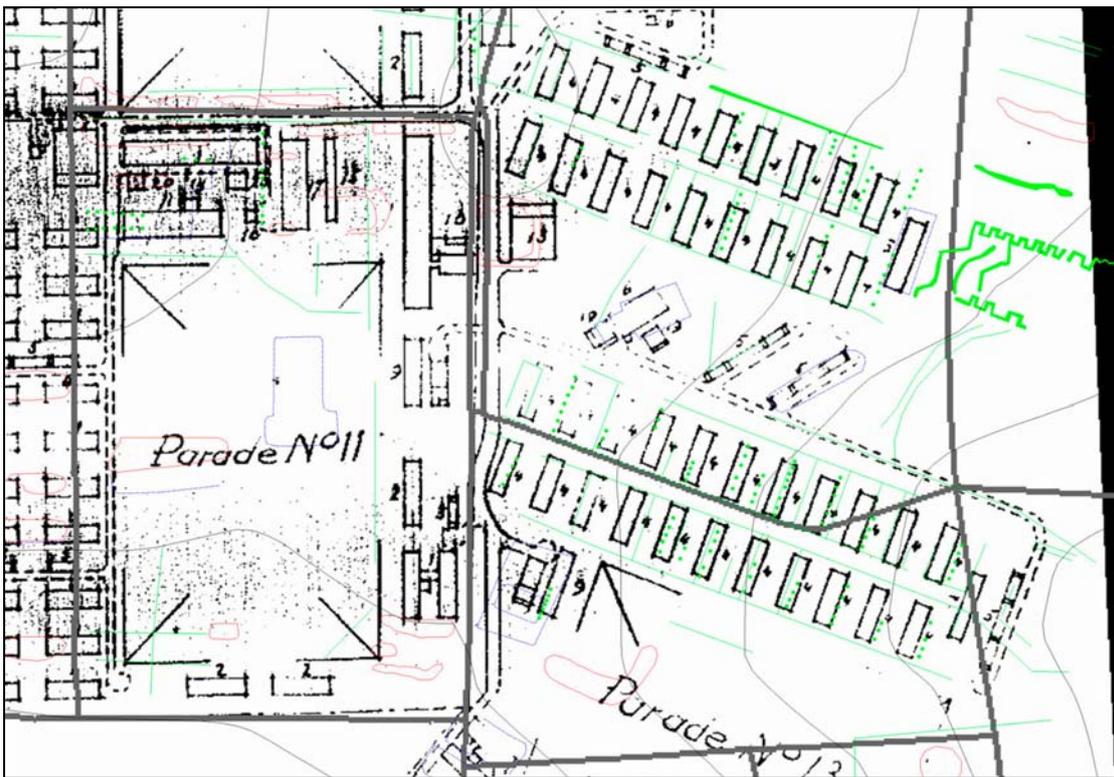
Fig 15: Diagram comparing part of the 1916 plan with the mapping for the east end of South Camp. Note the hut foundations located on parade ground 11 and the L-shaped earthwork on parade ground 13 (bottom right). Canadian National Archives Reference: Q4-54887, Series E-17, Vol 21, File '21' (21-27) 1916-C 'Plans de camps' Crown Copyright, The National Archives, UK.

Another area of the camp with aerial photographic evidence for variation from the original design is the far eastern end of South Camp. The area appears to have witnessed physical changes that deviated from the 1916 plan. On the aerial photographs several hut bases appear in the area defined as Parade 11 as does an earthwork feature on the edge of Parade 13 (Fig 15). Rows of possible hut foundations, or training features, extend to the northeast. These are not depicted on the 1916 plan and their function is unknown. It is possible that as the war progressed more accommodation was needed and parade grounds became less important. It is possible that parade and ceremony become secondary to the other functions of the camp as reinforcements were being rushed through their training in the face of mounting casualties.

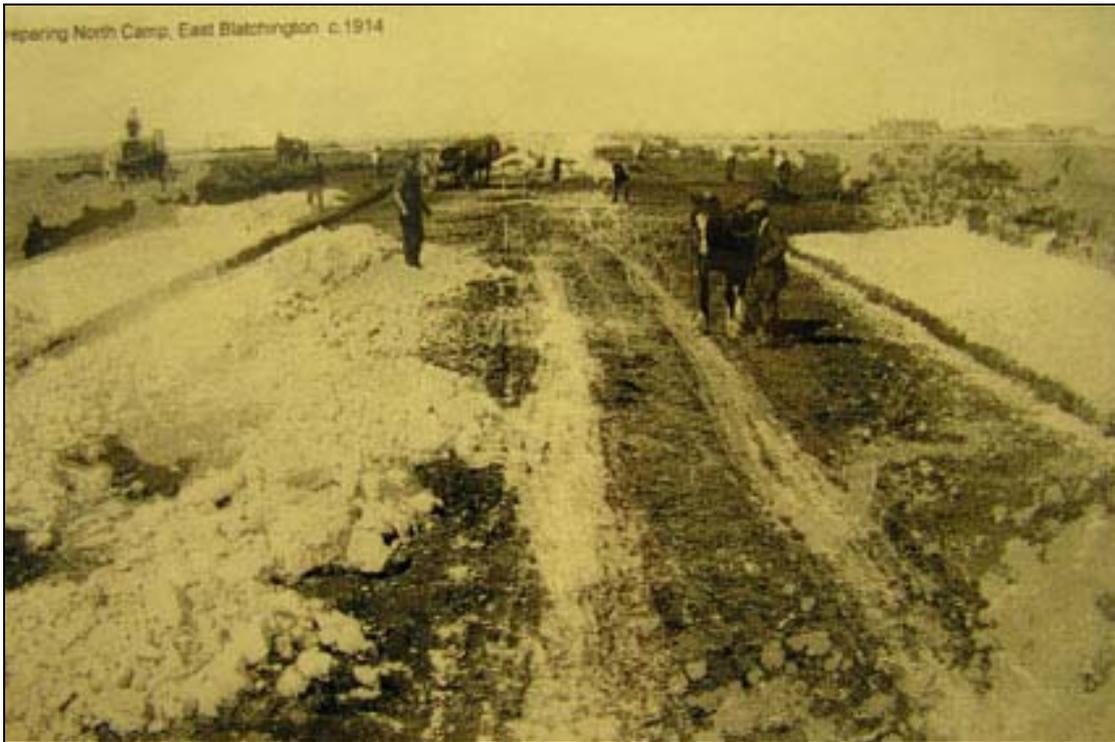
Fig 16: Postcard showing the laying down of a chalk road surface. Reproduced by courtesy of Luke Barber.

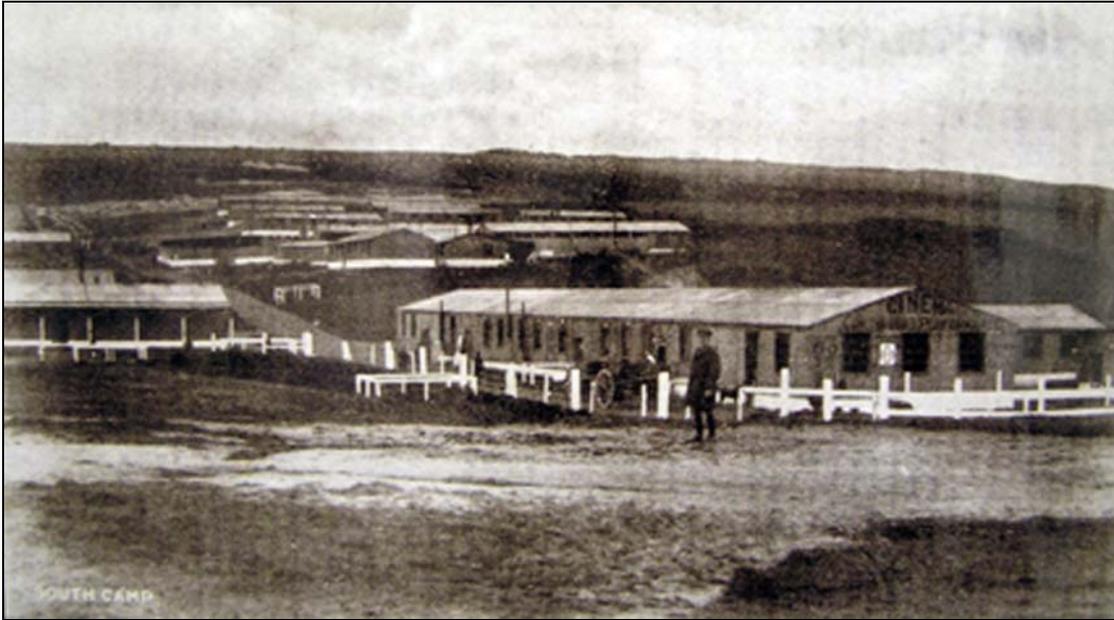
Fig 18: Postcard of the South Camp cinema. Reproduced courtesy of Seaford Museum and Heritage Society.

Provision for new forms of recreational activity is also evident at the camps and a postcard image shows a cinema at South Camp (Fig 18). The cinema building resembles a standard Armstrong Hut. Judging by the layout of nearby buildings and the topography it is likely that the Cinema was located in the south west of the camp probably within a Regimental Institute building (Fig 19). Cinema could have suited the sober, educational recreation promoted by the institute. The sign on the building's wall states 'Spontaneous Performance' suggesting that the facility was probably quite informal. First World War cinema offered an evening's entertainment and news information about the war including patriotic 'Rolls of Honour' detailing the wounded or dead. Propaganda films were frequently shown such as the 1915 'Britain Prepared' and the 1917 'Women's Land Army' and films that, although patriotic, began to depict the true nature of the conflict such as the highly acclaimed 'Battle of the Somme' released in 1916 (<http://www.filmreference.com/encyclopedia>).

Fig 19: Diagram showing the location of the cinema in the camp (middle top). The view in Fig 18 would be from about the mid-left of the plan. Canadian National Archives Reference: Q4-54887, Series E-17, Vol 21, File '21' (21-27) 1916-C 'Plans de camps' Crown Copyright, The National Archives, UK.

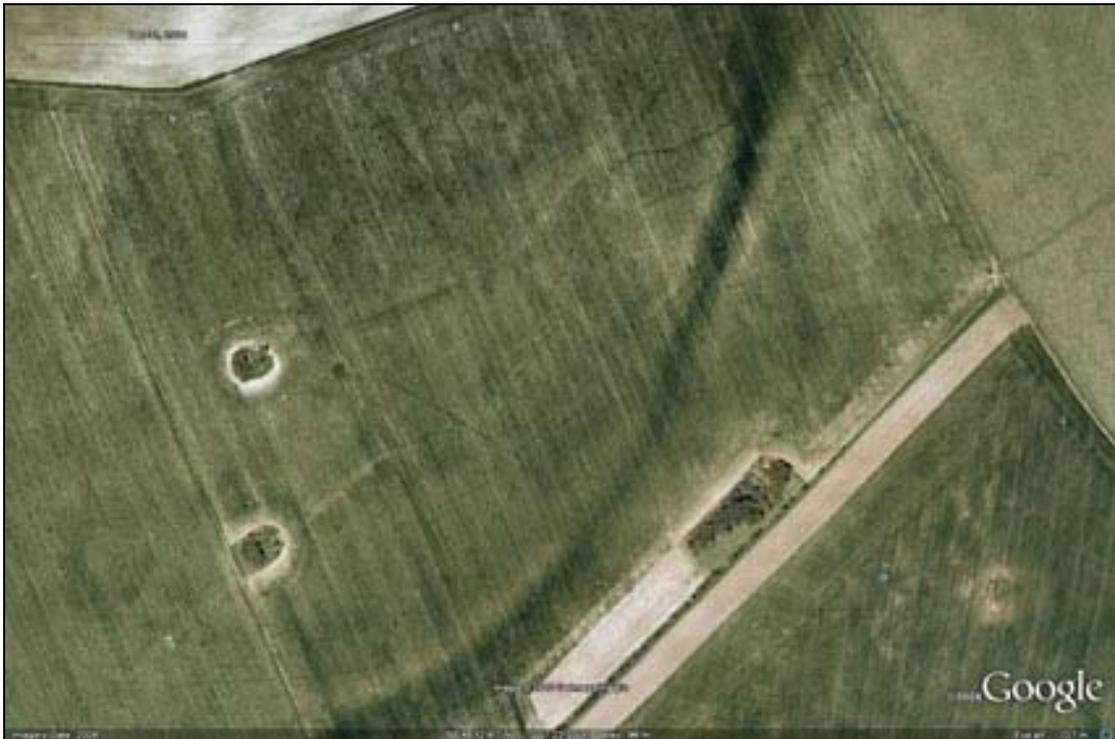
Fig 21: Aerial photograph showing practice trenches visible as cropmarks on the downs 2km to the north of Seaford North Camp. © 2009 Google, Image © 2011 Getmapping plc.

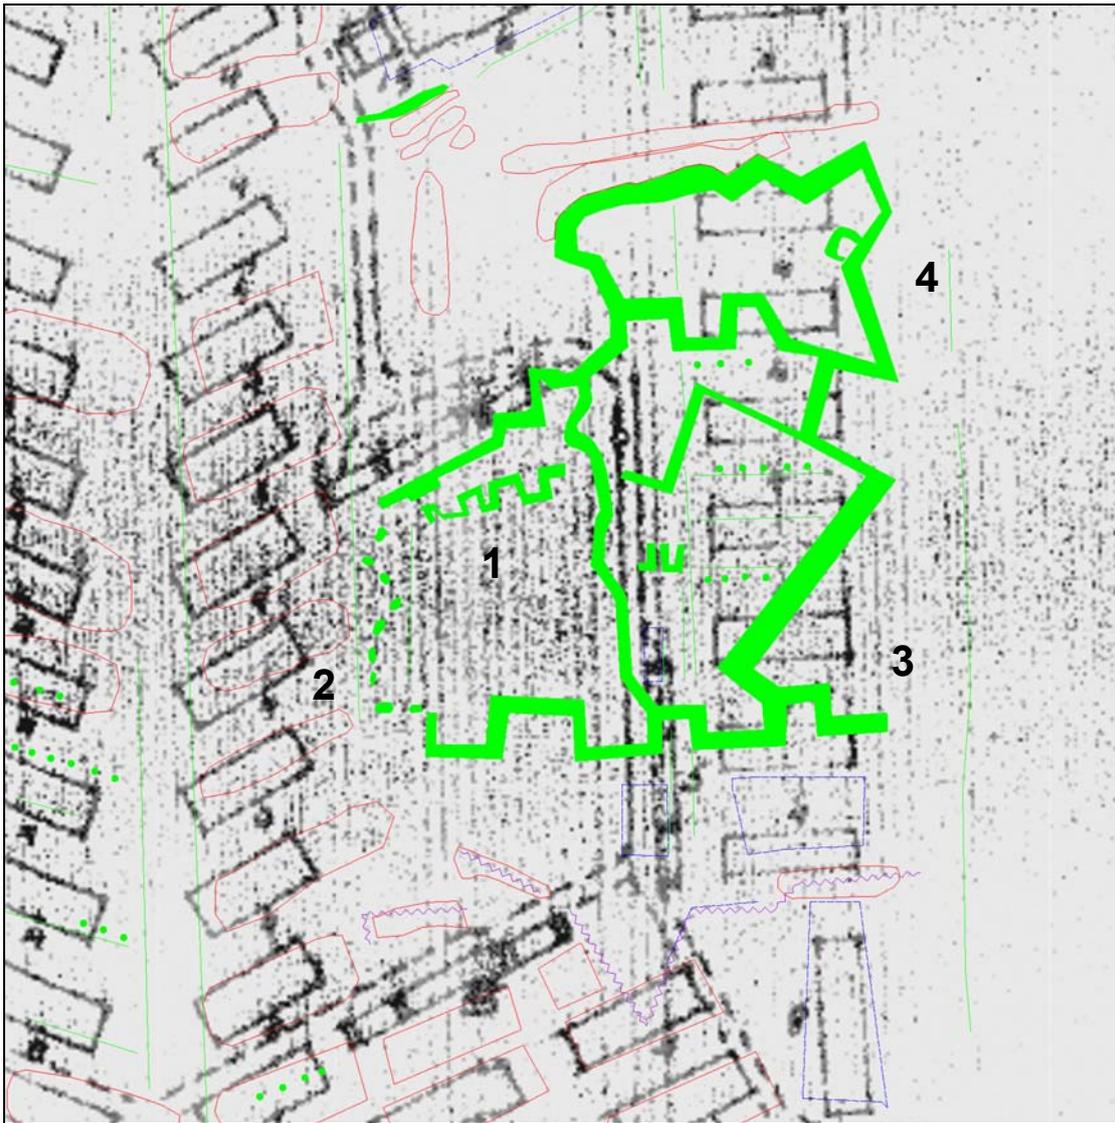
Fig 22: The trench works seen on aerial photographs on the south side of the camp overlaid onto the 1916 plan of South Camp (Canadian National Archives Reference: Q4-54887, Series E-17, Vol 21, File '21' (21-27) 1916-C 'Plans de camps' Crown Copyright, The National Archives, UK).

The trenching, which may be of a First World War date (Fig 22 area 1), could be a model demonstration trench. There is, however, a problem with this interpretation as a post card image dated January 1915 clearly shows the open area from a vantage point on the slopes of Seaford Head and it contains no sign of a trench. This does not rule out the notion that the trench could have been dug later during the conflict just that it was not a part of the initial camp construction. Alternatively, the earliest phase of trenching may date from between the wars; newspaper reports show that military training activity continued in the area (see below, page 34). Further unravelling of the sequence of trenches at Seaford South Camp could be achieved by analytical field survey and targeted excavation.

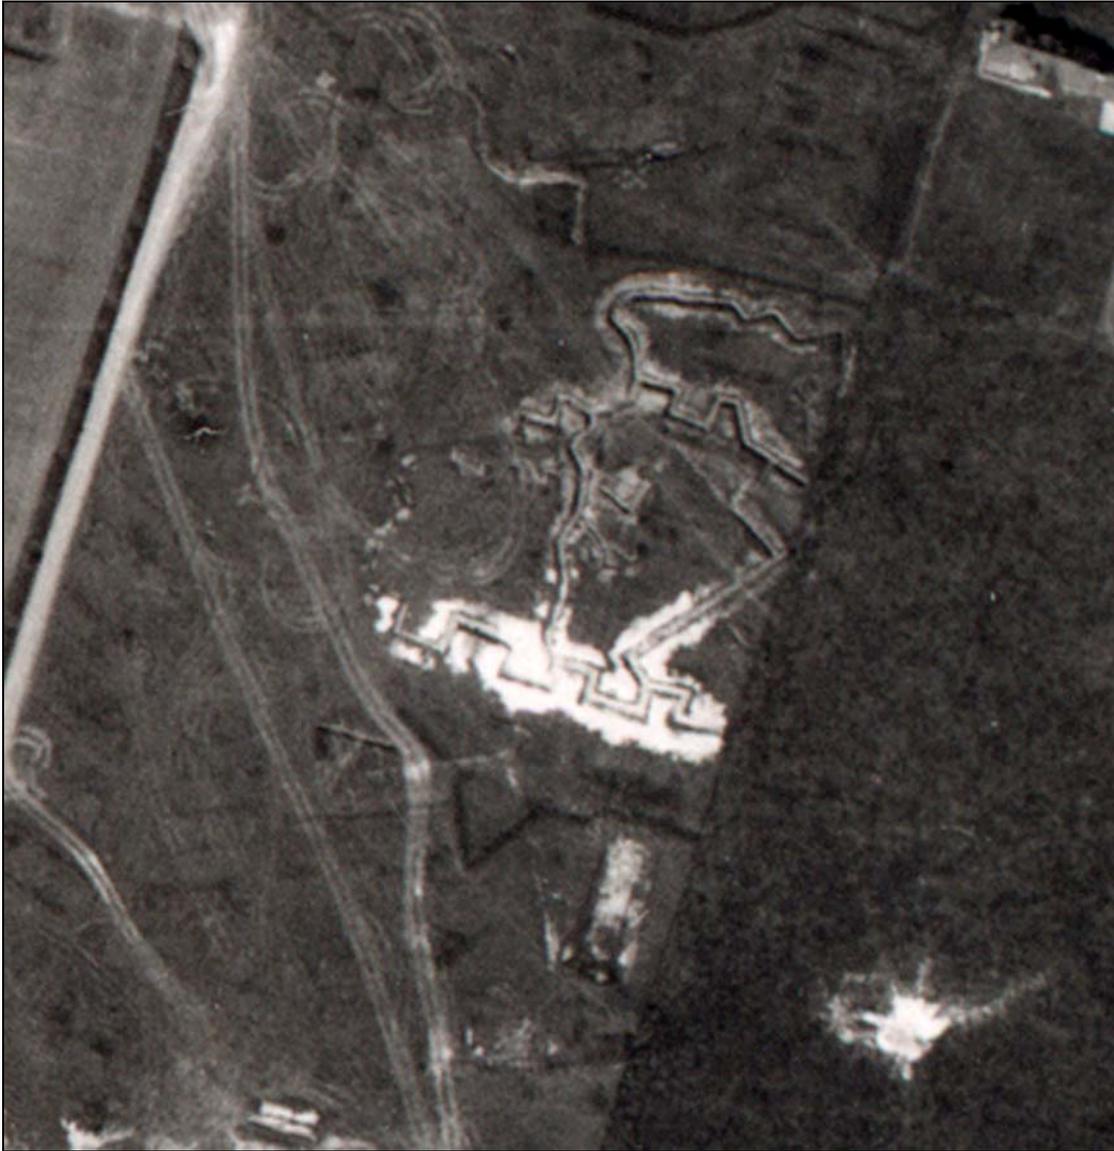
Fig 23: Aerial photograph from 1942 showing the trenches looking freshly dug out of the chalk. Note the vehicle tracks and the V-shaped arrangement of barbed wire (lower centre of photo) all suggestive of Second World War military activity at the trenches. NMR RAF/HLA/538 6 11 08-MAY-1942 English Heritage (NMR) RAF Photography).

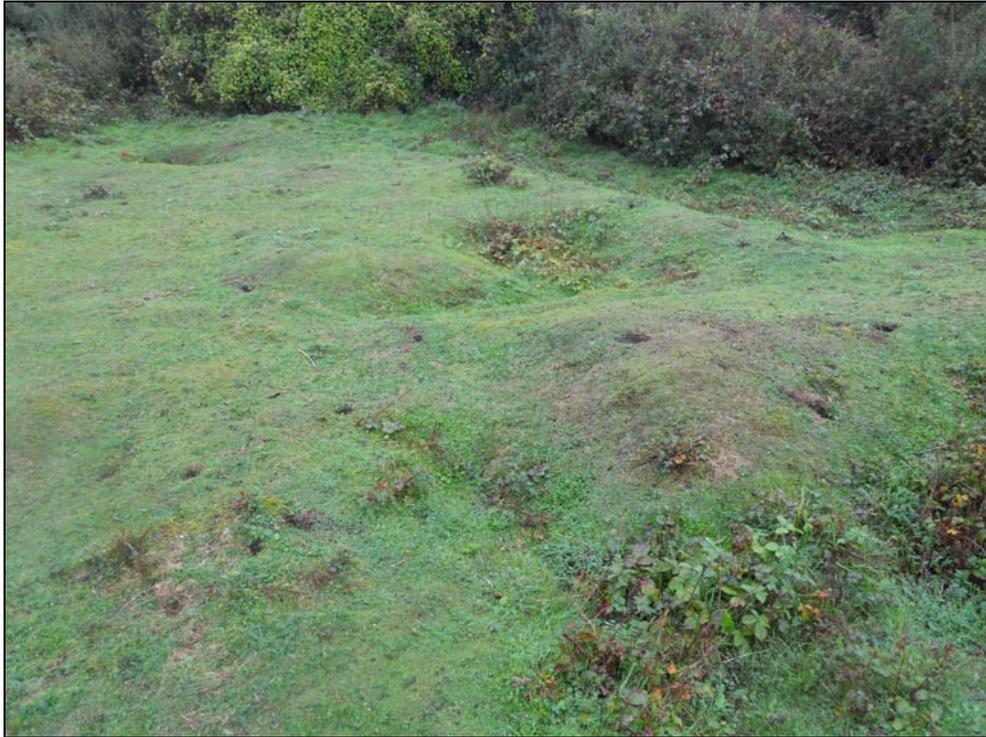
Fig 24: Extant trenches. These partially filled in features are probably from the earliest phase of activity (see Fig 22 1). Author's photograph.

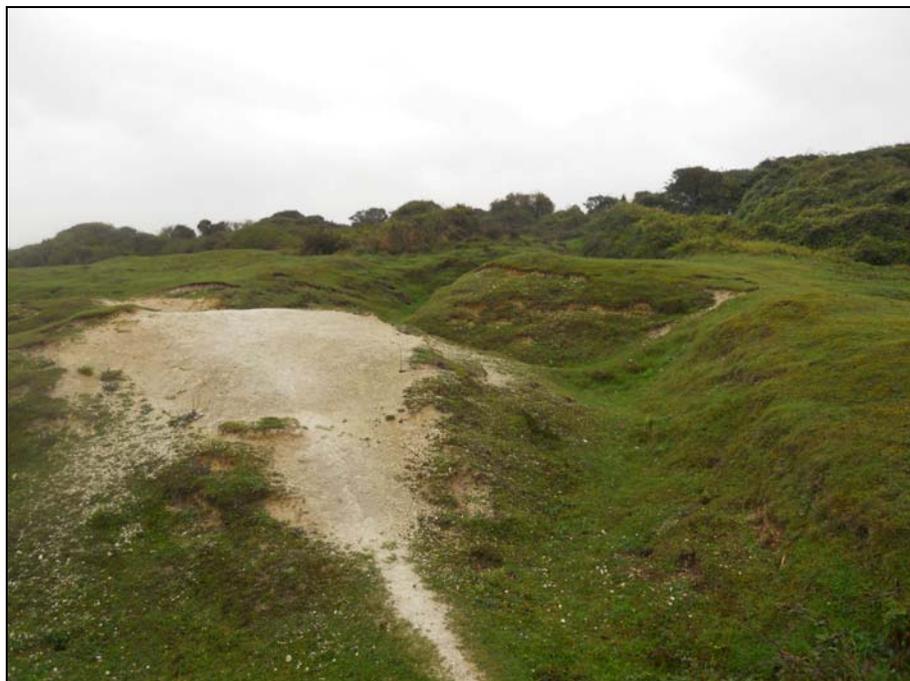
Fig 25: *The larger, probably later, trenches. Note the damage from motorbikes.* Author's photograph.

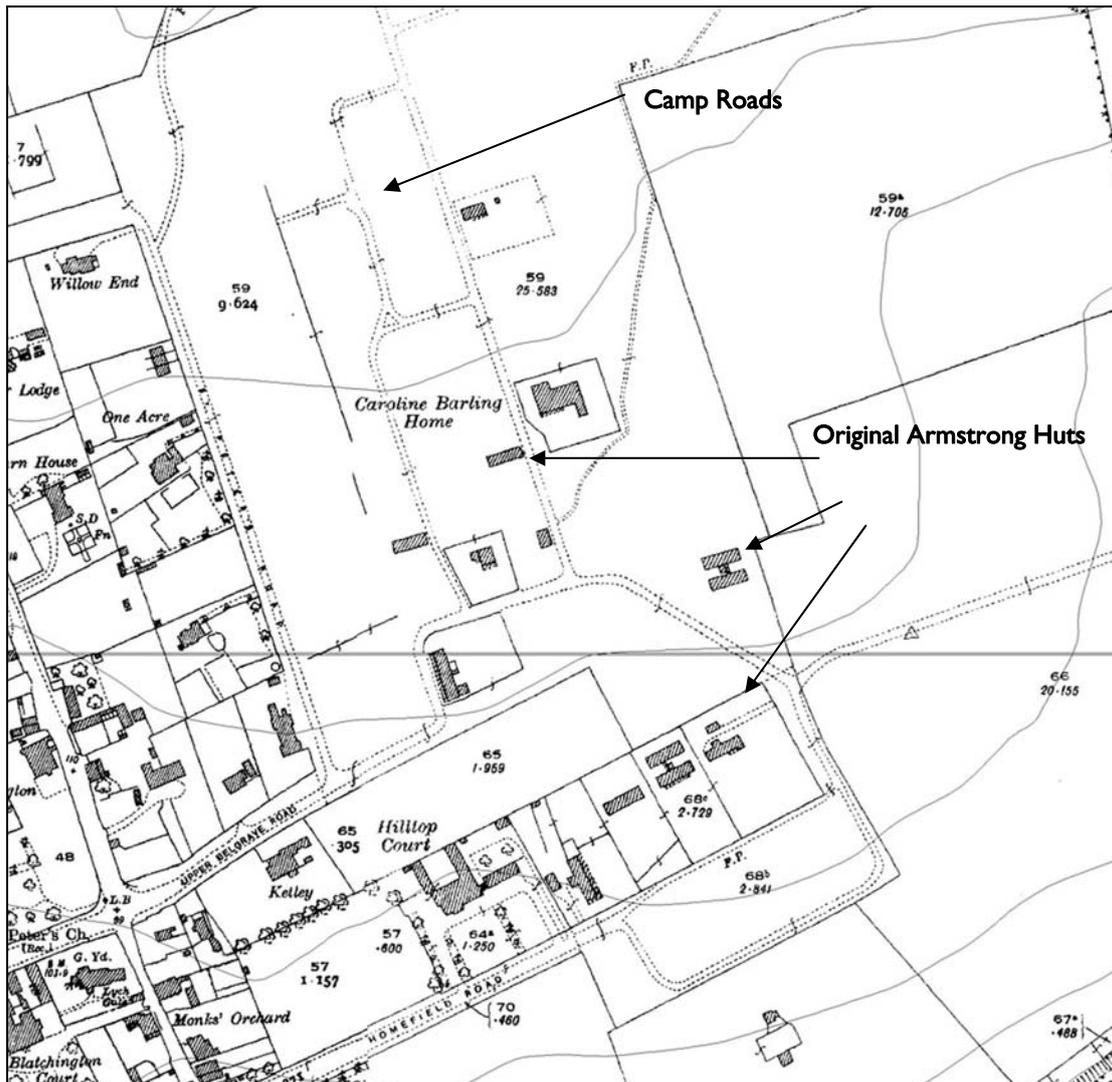
Fig 26: The 1927 1:10,560 Ordnance Survey map shows part of the road layout of North Camp preserved in East Blatchington. Original Armstrong Huts have been reused as dwellings and as the Caroline Barling Home (© and database right Crown Copyright and Landmark Information Group Ltd (All rights reserved 2010). Licence numbers 000394 and TP0024).

In the same manner in which local field boundaries and roads became part of the camps some of the camp roads were incorporated into the future layout of the new housing estates. Roads were hard to remove and useful assets in their own right therefore it was quite common for the roadways of military camps to be preserved in town layouts (Foot, 2005, 9). For example, North Way follows a North Camp route as does the appropriately named North Camp Lane and Northfield Drive. South Camp's layout was partially preserved in Chyngton Road, Fairways Road and Rodmel Road.

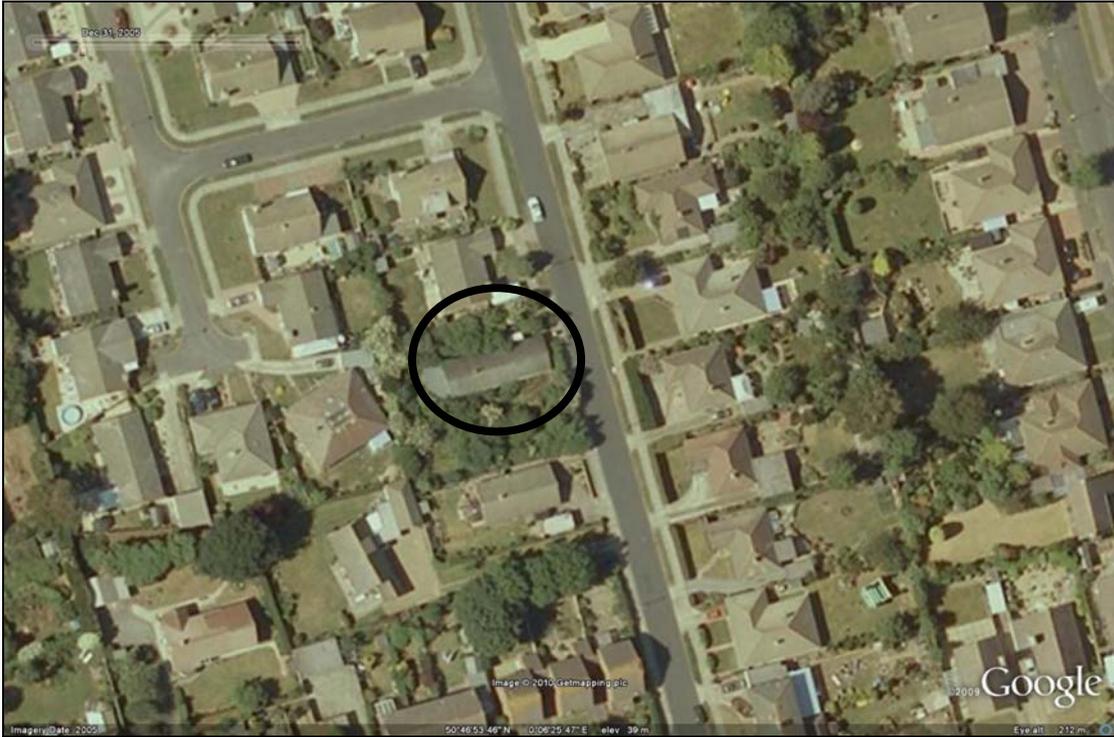
Fig 27: A 2005 aerial photograph showing the last surviving hut, now demolished, of North Camp. © 2009 Google, Image © 2011 Getmapping plc.

The addition of gardens also suggests that some of the huts were sold as private dwellings creating a sparsely occupied district of homes amidst the remains of North Camp. This area was developed in the 1960s but one such dwelling survived on North Way up until at least 2005 where it is visible on Google Earth (Fig 26). Unfortunately, the hut was demolished between 2005 and 2009, replaced by a modern suburban building.
