WESTACOTT BARTON, NORTH TAWTON, DEVON ANALYSIS AND INTERPRETATION OF A DEVON HALL HOUSE

Olivia Horsfall Turner and Barry V Jones

Research Department Report Series 57-2011

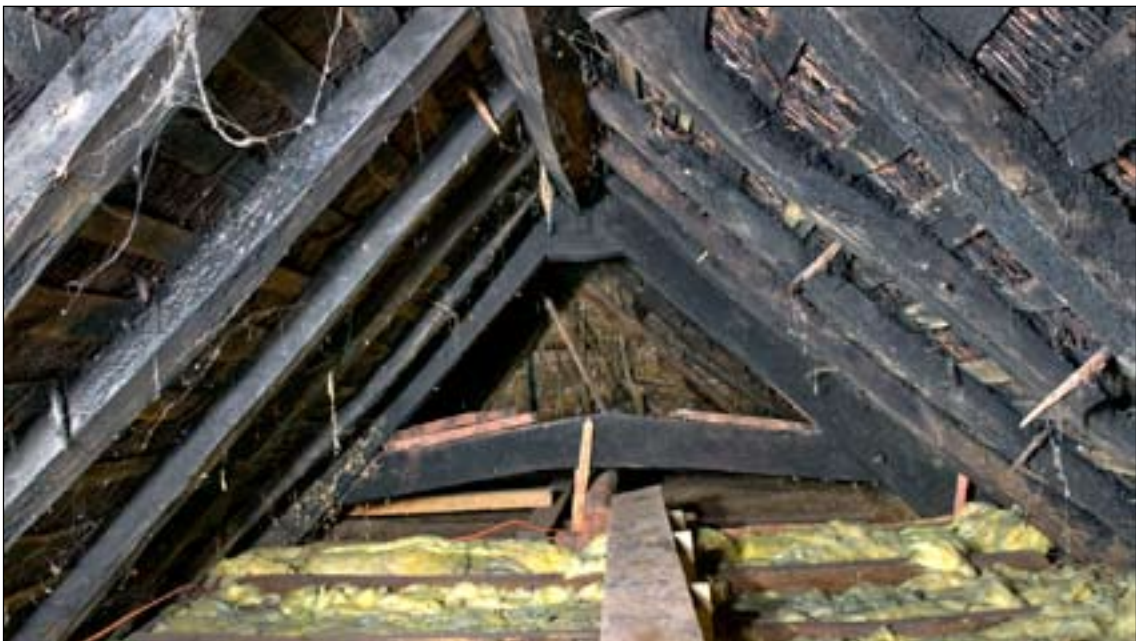
Figure 2. Roof space looking east towards cruck D-D1 showing smoke-blackened timbers and thatch (DPI13795).

Truss D-D1 is collared with a single-pegged cranked collar, and has a single-pegged yoke with tenons fitting into mortices in the cruck blades (see Fig 2). Rectangular stave holes on the upper side of the collar and circular stave holes on the soffit of the collar indicate that truss D-D1 was once closed. In addition, staves, which are probably part of the original closure, were noted resting on the collar at the time of the 2010 inspection.

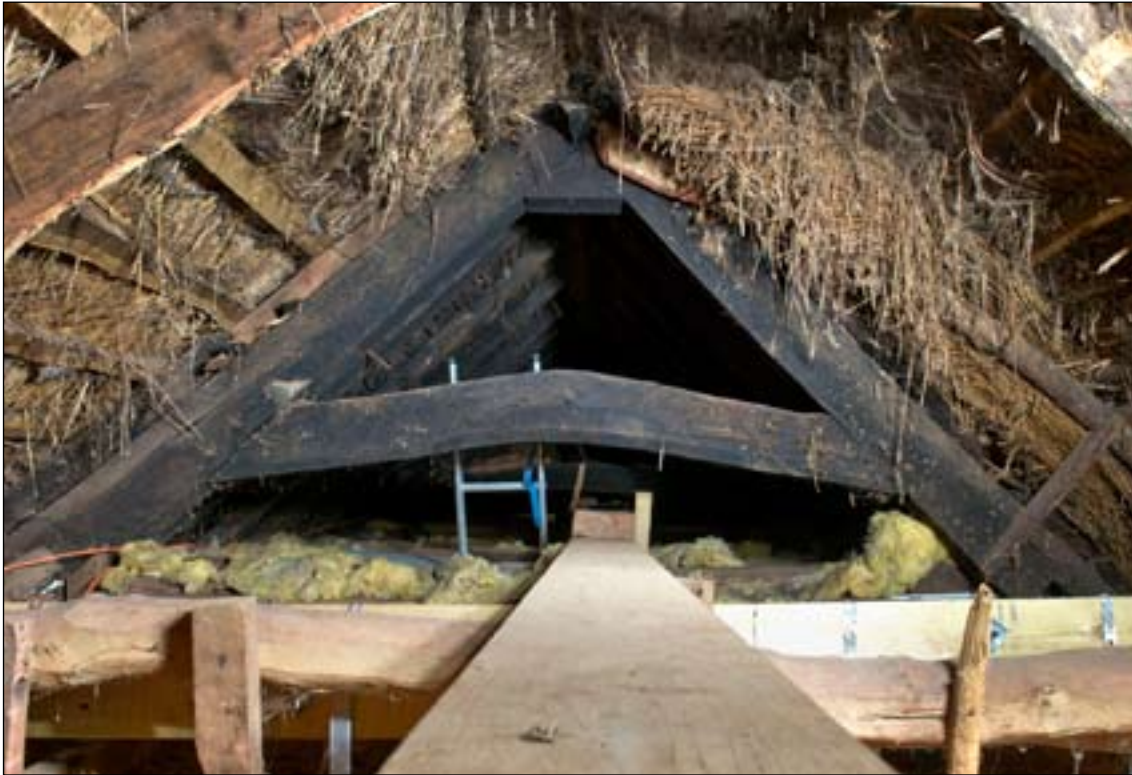
Figure 3. West face of cruck truss C-CI, also showing replaced timbers in Bay B-C (DPI13794).

blackened, but the rest of the timbers and thatch in this bay have been replaced (Fig 3). All four bays of the main range were therefore open to a heat source, or sources, at some point.

The fact that the west face of truss C is smoke blackened confirms the implication of the chamfered collar that the hall originally also included bay B-C (see Fig 3). The medieval thatch and lathes have, however, been removed, and a later roof structure has been formed at a slightly higher level. On the west face of the southern end of truss C-C1 an

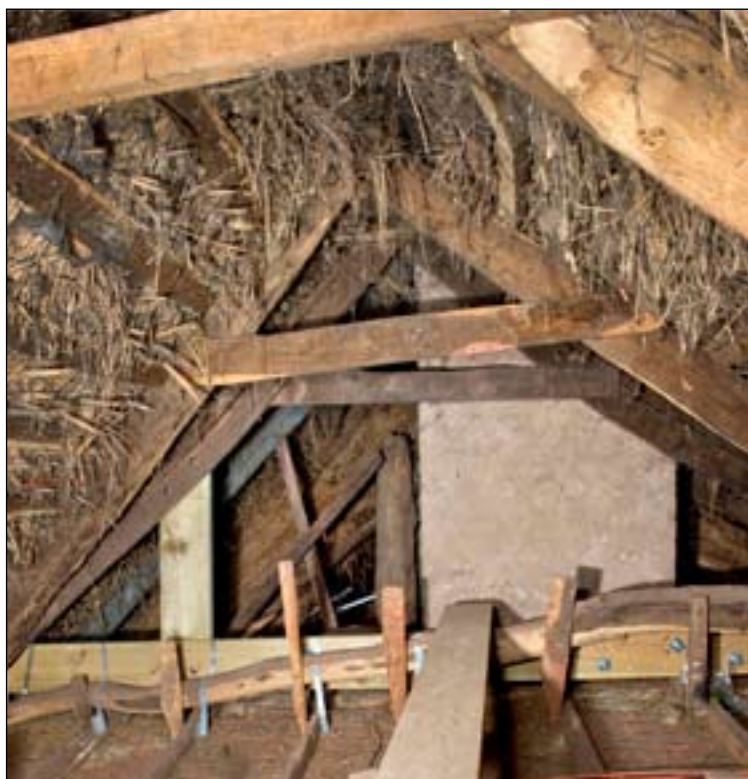
Figure 4. Roof space looking west to former position of cruck truss B-B1, showing inserted chimney stack (DPI13792).

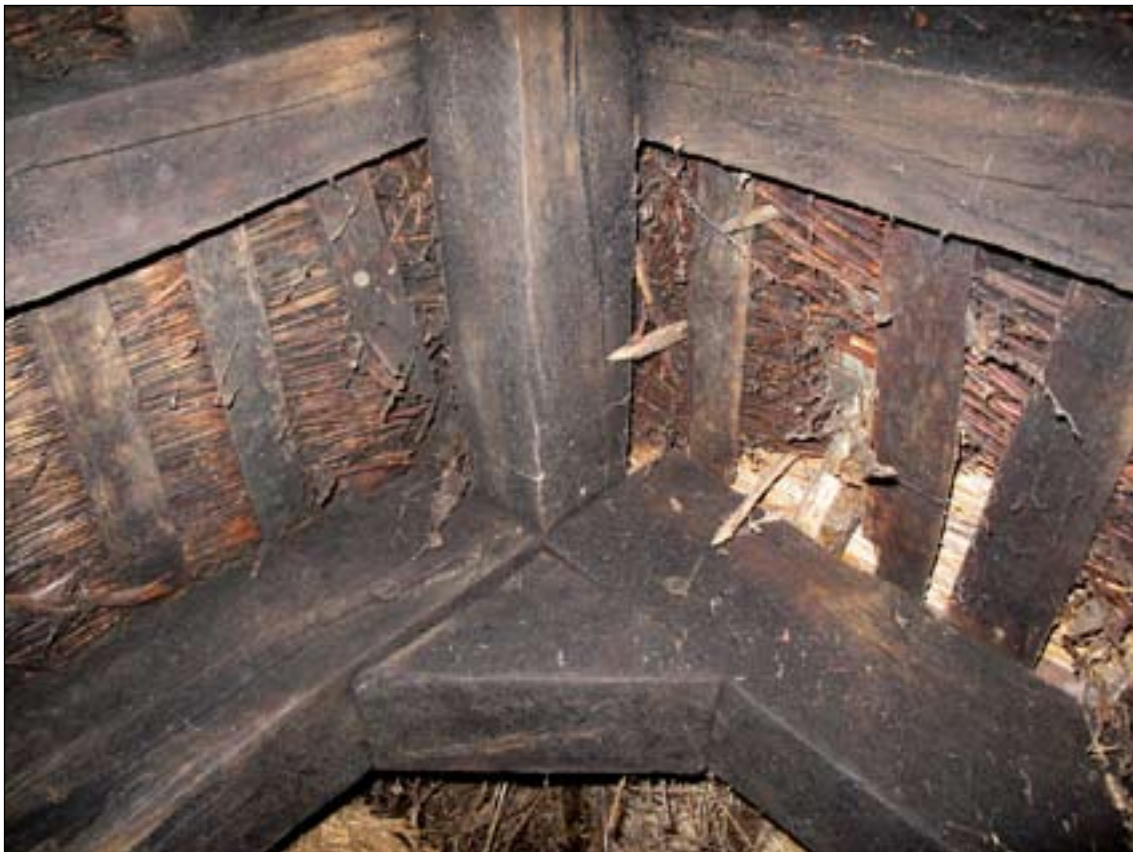
Figure 5. Diamond-set ridge piece, showing cruck blades abutting ridge purlin and joined by yoke (DPI13783).

The heavy ridge piece is diamond-set and runs from the east end of the roof, across truss D-DI, to truss C-CI. At truss D-DI and truss C-CI the cruck blades simply abut the ridge purlin and are joined by a yoke which supports the ridge piece and is single-pegged into each cruck blade (Fig 5). This is a notably minimal arrangement in a roof of this scale. To the west of truss C-CI, the apex of the roof space is located further to the south side of the building. The ridge piece is truncated at C-CI and is missing in bay B-C. It then reappears again in bay A-B, where it has collapsed. This disturbance to the original roof structure is probably a consequence of the insertion of a chimney stack along the line of

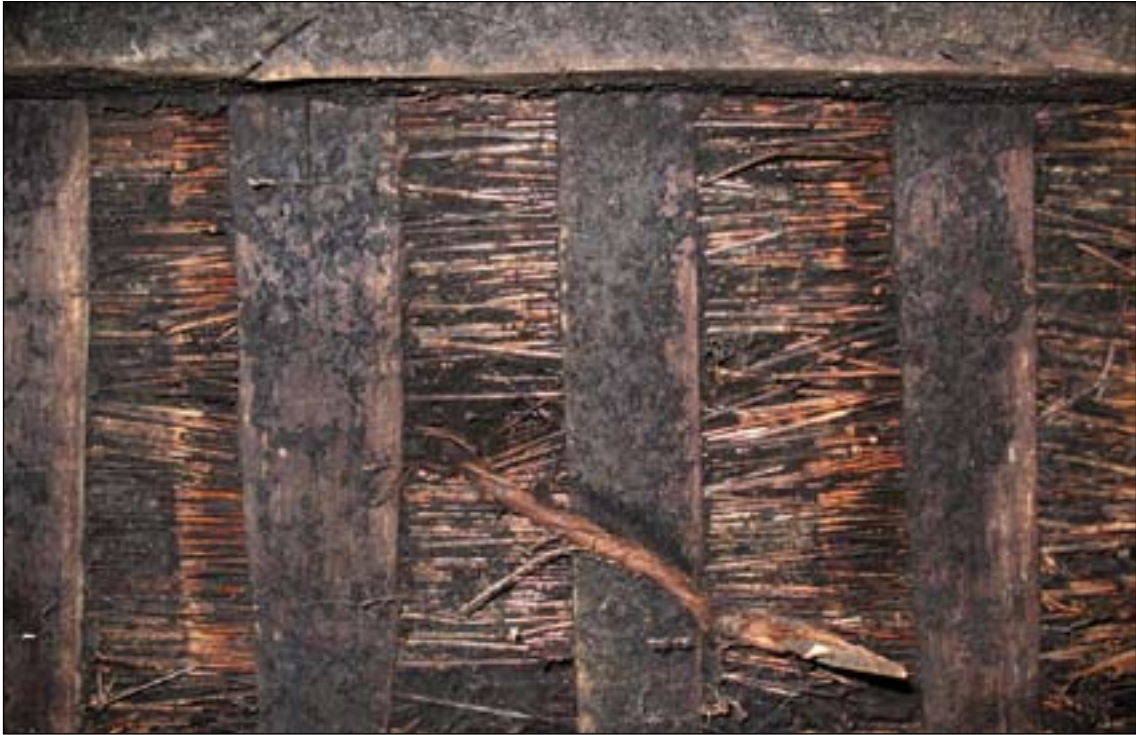
Figure 6. Detail of bay C-D, showing smoke-encrusted common rafters, laths, thatch and thatch ties (DPI13782).

Bay C-D remains in its entirety, featuring smoke-encrusted common rafters, laths, thatch, and thatch ties, indicating that this bay formed part of the original open hall (Fig 6). The encrustation is heavy throughout, but most densely deposited around cruck blade C-CI, suggesting that the open fire was located in that area of the hall. Truss C-CI is an open truss with a double-pegged, cranked collar that is chamfered on its soffit and stopped, and has a single-pegged yoke (Figs 7 and 8). A mortice and tenon construction for the yoke is not visible, as it is on truss D-DI. The even distribution of smoke blackening on both faces of truss C-CI as well as the chamfering and stops of the collar indicate that the truss has always been open.

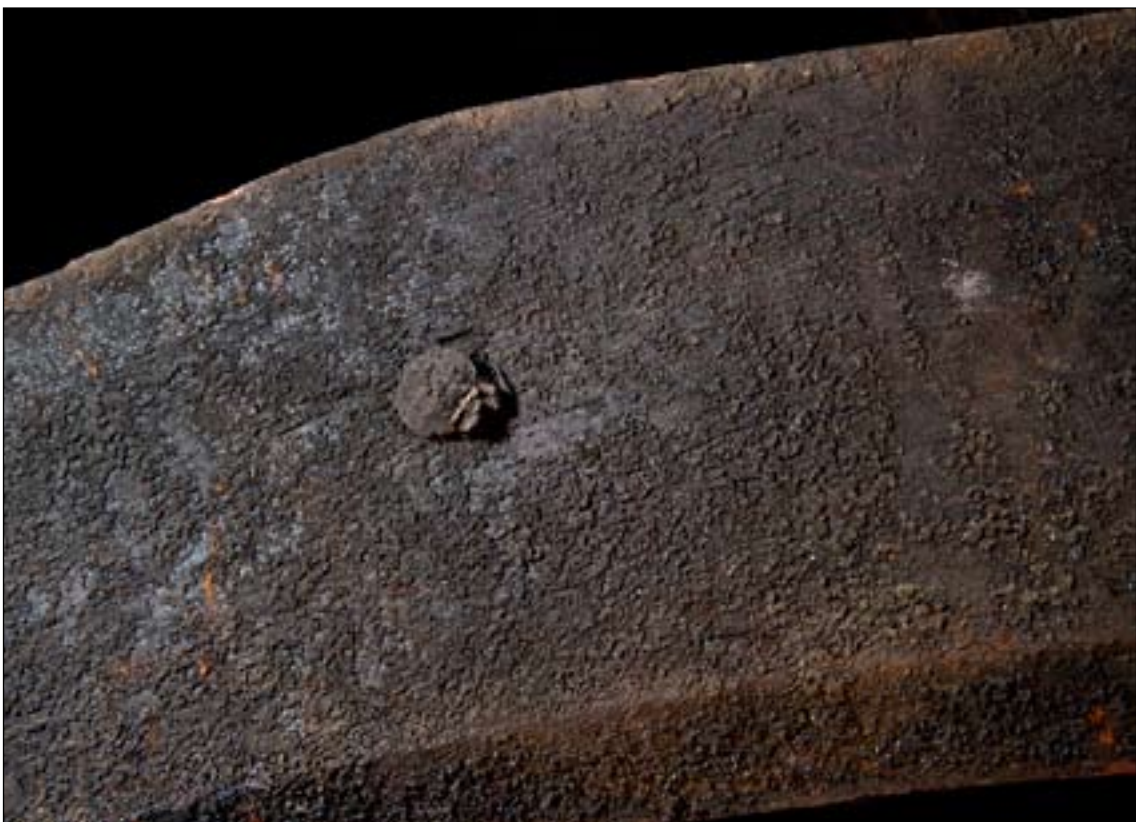
Figure 7. Detail of collar truss C-CI, showing chamfer, pegging and smoke encrustation (DPI13796).

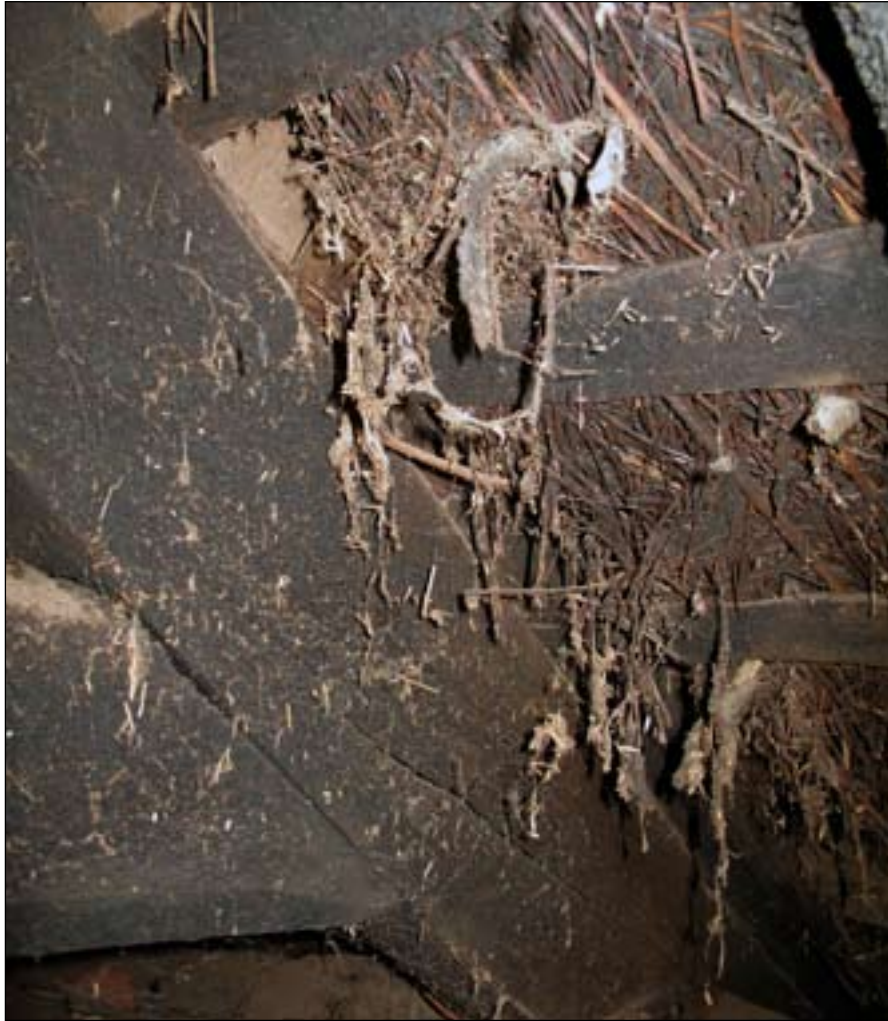
Figure 8. Detail of cruck C-CI, showing smoke encrustation and run-out stop on soffit of collar (DPI13781).

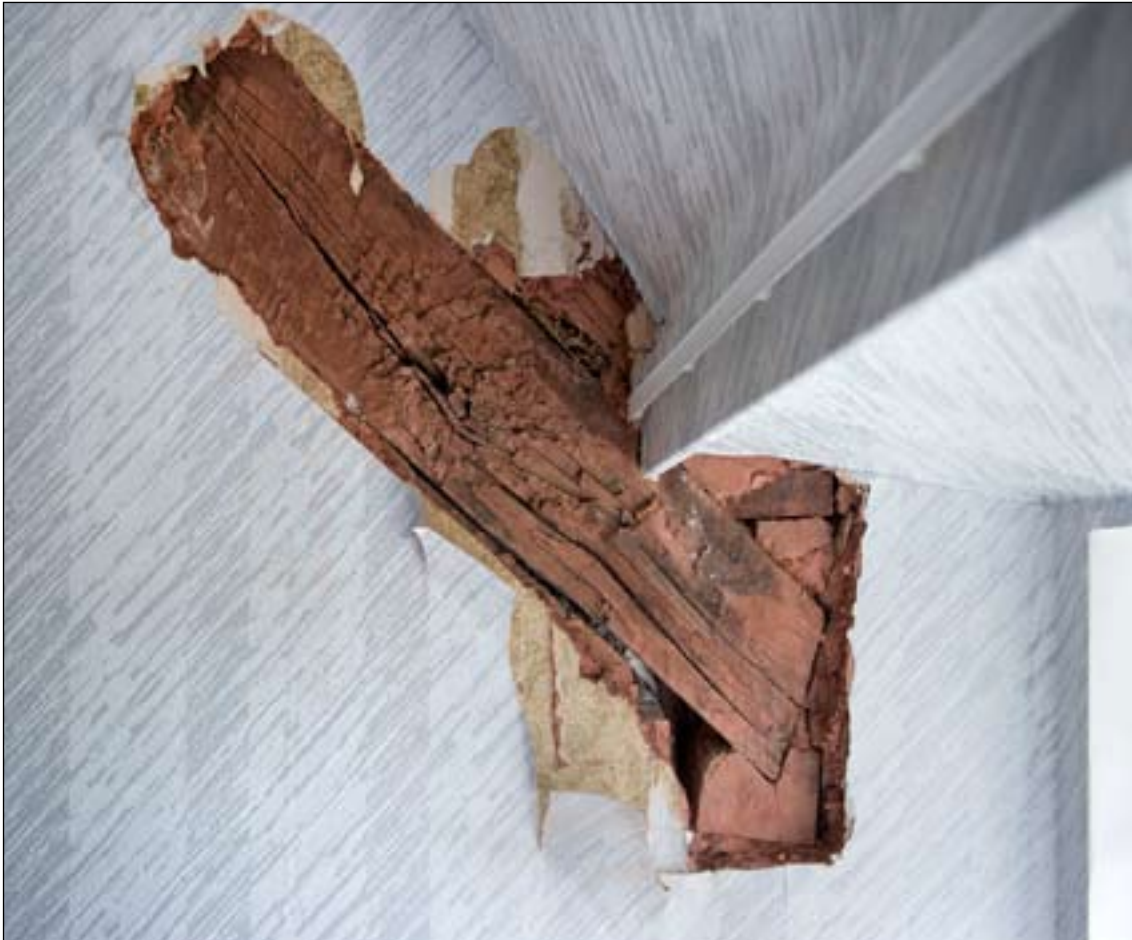
Figure 9. Southern foot of cruck C-C1, exposed at time of 2010 investigation (DPI13791).

The southern foot of cruck C-CI was exposed in early 2010, on account of concern that the cruck might be failing (Fig 9). Indeed, apparent inconsistencies in the construction of cruck C-CI in part prompted the Research Department's visit of 2010. The southern end of cruck C-CI no longer has the lower vertical timber of the jointed cruck construction, though what appears to be an empty mortice on the soffit of the principal rafter suggests its original existence. The missing lower vertical timber was presumably removed in connection with later alterations to the south wall, in particular the insertion of the dormer window located immediately to the west of the cruck.

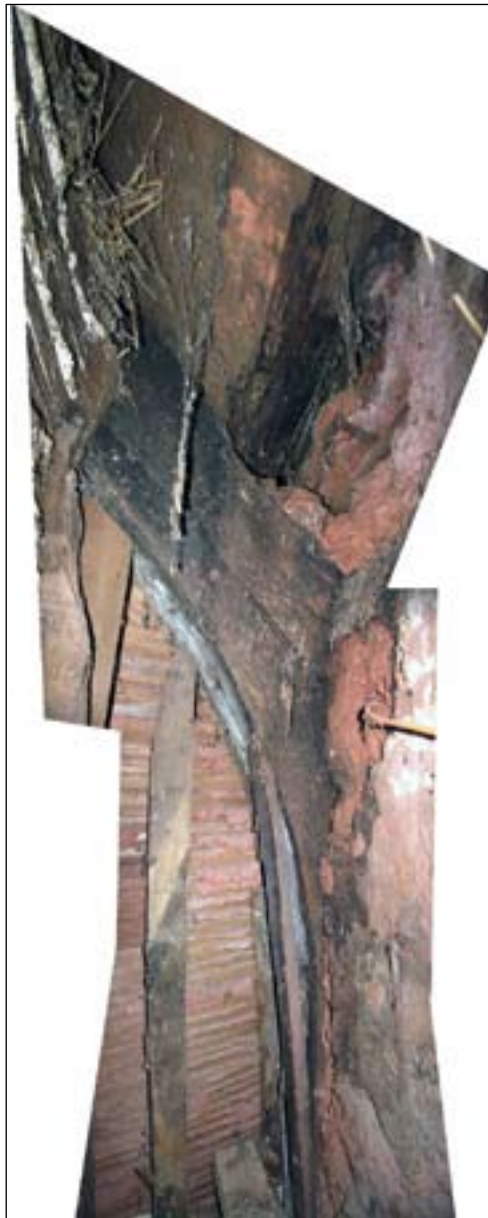
Figure 10. Northern foot of cruck C-CI, showing jointed-cruck construction (composite photograph) (DPI13802).

Another peculiarity of truss C-C1's construction is that there is no visible pegging for the lower timber into the cruck blade. Comparison of the two ends of the truss sheds light on this. The northern foot of cruck C-C1 is exposed within the wall space, and in 1996 could only be viewed from inside the wall. Now, where a cupboard has recently been inserted into the corridor, a piece of plasterboard has been cut out to allow sight of the cruck joint. At the northern foot of cruck C-C1, the main part of the blade (forming the roof pitch) is straight and extends down to the top of the cob wall, but its foot is of jointed-cruck construction, a curved timber being jointed to the soffit of the main blade (Figs 10 and 11). The curved timber forms an elbow extending down through the cob wall and projecting slightly from the wall's inner face. The joint between the two parts of the blade has a massive single peg driven through from the soffit of the curved timber; that is, face-pegged (see Fig 11). It is reasonable to infer, therefore, that this was also the method employed on the south end of the cruck, explaining the absence of pegging on the sides of the cruck. This method of pegging is found at other sites in Devon and forms part of the local carpentry tradition.

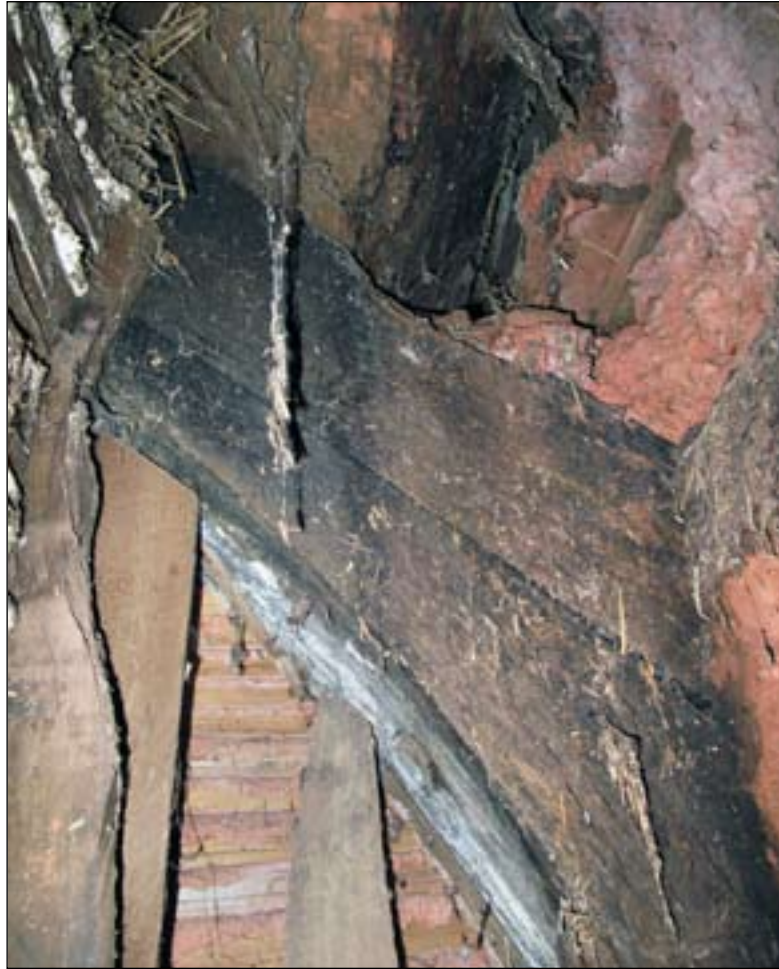
Figure 11. Detail of northern foot of cruck C-CI showing jointed-cruck construction and face-pegging (DP113780).

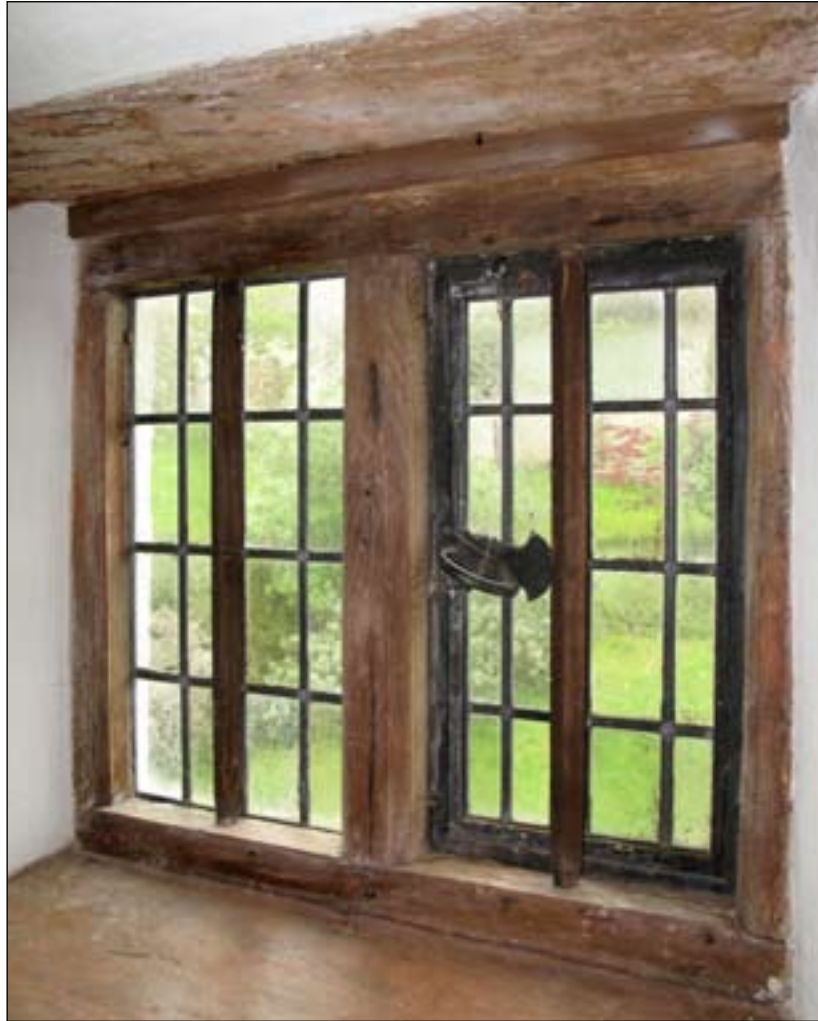
Figure 12. Two-light window in eastern wall of bay D-E, with chamfered mullions and jambs, probably dating to the late 16th or early 17th century (DPI13788).

Typologically, the eastern bay D-E probably contained the best chamber, with a service bay below. There is a window in the eastern wall of bay D-E (a two-light window with chamfered mullion and jambs) which probably dates to the late 16th or early 17th century but which may well have replaced an earlier window in the same position that gave light to the upper chamber (Fig 12).

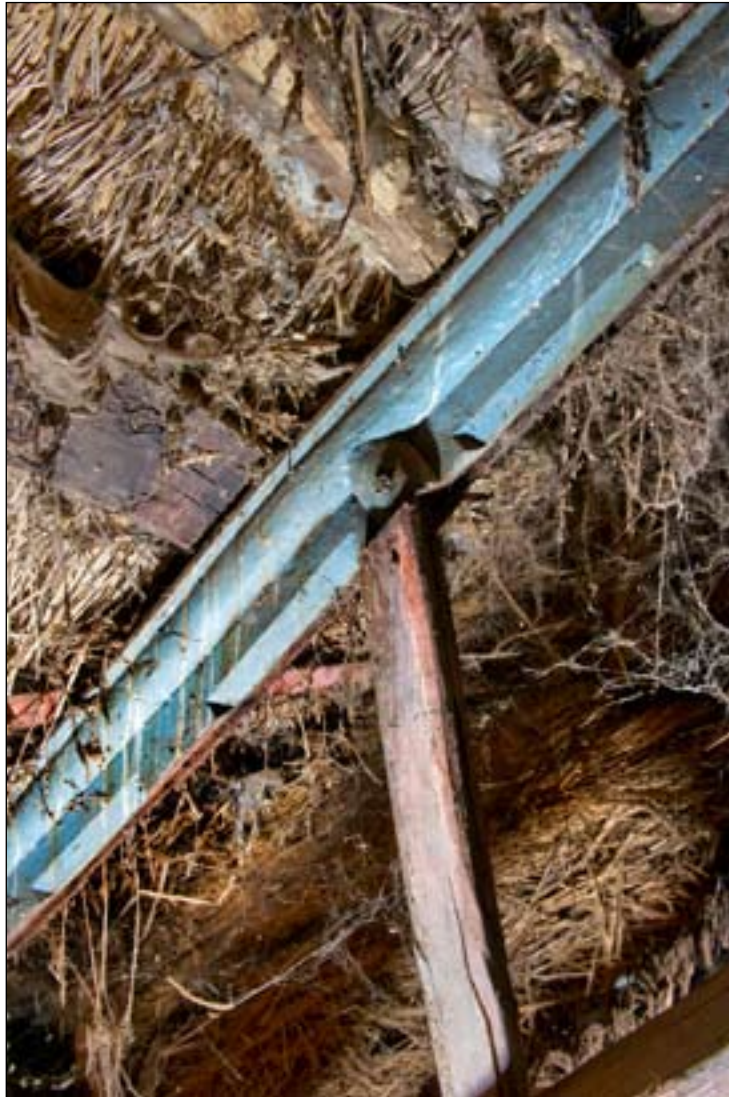
Figure 13. Section of medieval screen bressumer re-used as a rafter (DPI13793).

Part of a medieval screen bressumer survives in the roof of the main range, located just to the south of the inserted brick chimney, where it has been re-employed as a rafter (Fig 13 and Fig 14).

As noted in the 1996 report, the likelihood that this screen bressumer came from Westacott Barton itself rather than having been imported from elsewhere is strengthened by the presence of a corresponding length of panelled screen re-used in the linhay adjoining the south elevation (Fig 15 and see Fig 14). The bressumer is chamfered and has carpenter's mitres for the screen studs and panel heads, which are also marked by a series of mortices and grooves in the soffit. The upper part of the

bressumer has a quarter-round moulding extending along its length which is returned at regular intervals towards the bottom of the bressumer to form the beginning of what would have been vertical moulded bands. The timber has been painted at a later date but where it has no painted surfaces the timber is smoke blackened. Both faces of the bressumer are of matching quality and the top face has no mortices, indicating that the beam was positioned at the top of a screen which was open above.

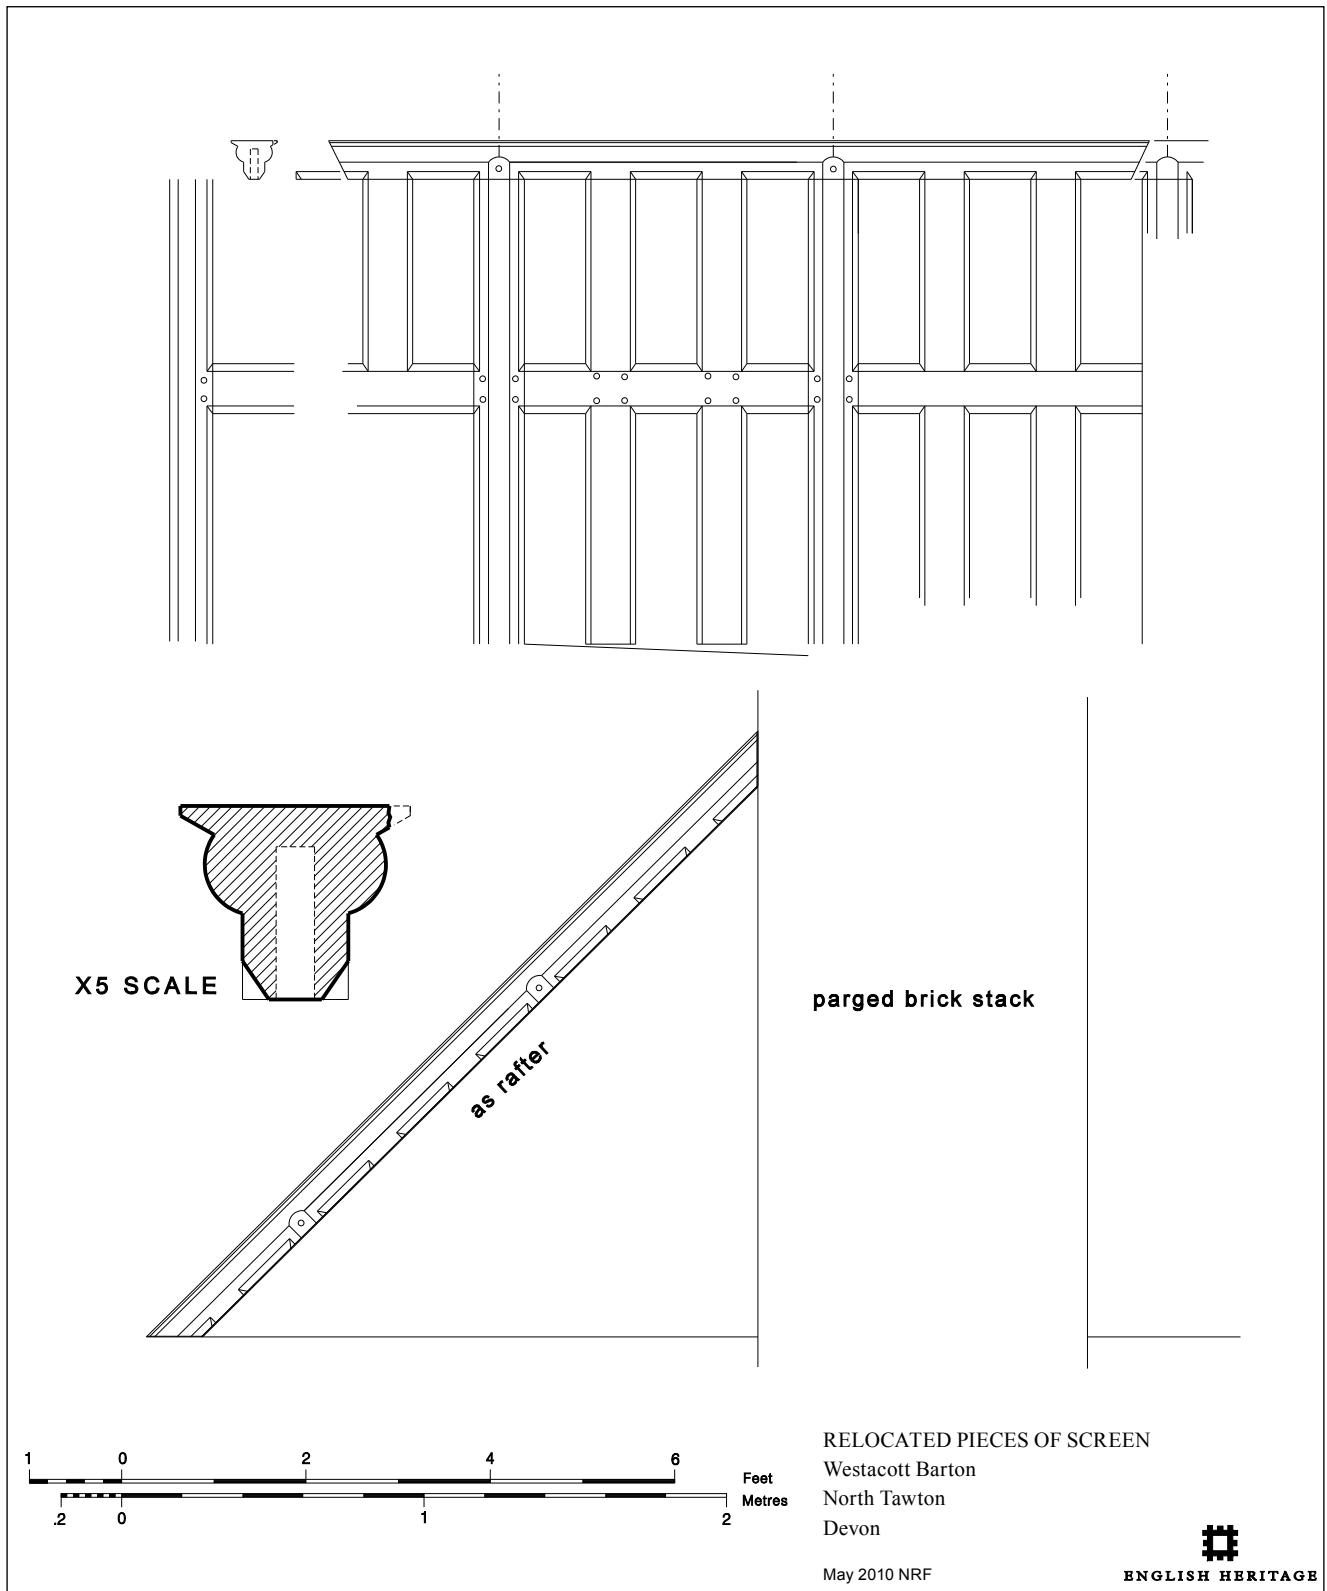
Figure 14. Pieces of screen relocated in linhay and screen bressumer re-used as a rafter (NBR BF 29994).

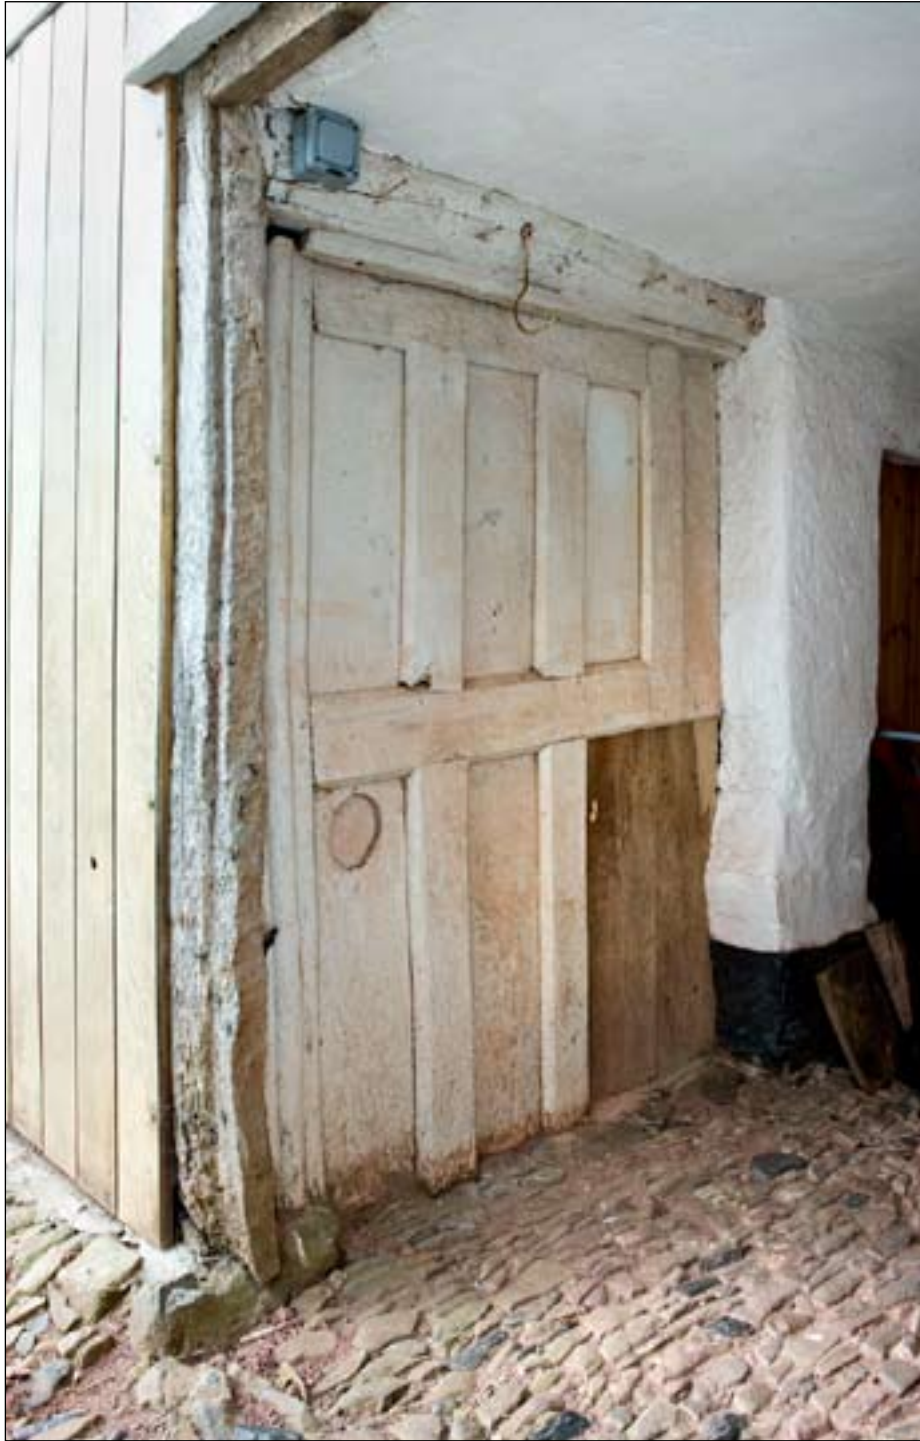
Figure 15. Panelled screen, probably part of the former screens passage, re-used in the linhay (DP113800).

In 1996 it was possible to examine both sides of the remaining part of the panelled screen that has been re-used in the linhay (see Fig 15). This showed them to be of matching quality, therefore proving that it is not a section of reused wall panelling. The screen has a quarter-round moulding, 6 centimetres wide, which matches that on the bressumer (see Fig 14). The surviving upper and lower panels are 61 and 81 centimetres tall respectively, and there are pegs in one of the rails for a third level of panels which have not survived. The rails and styles are chamfered.

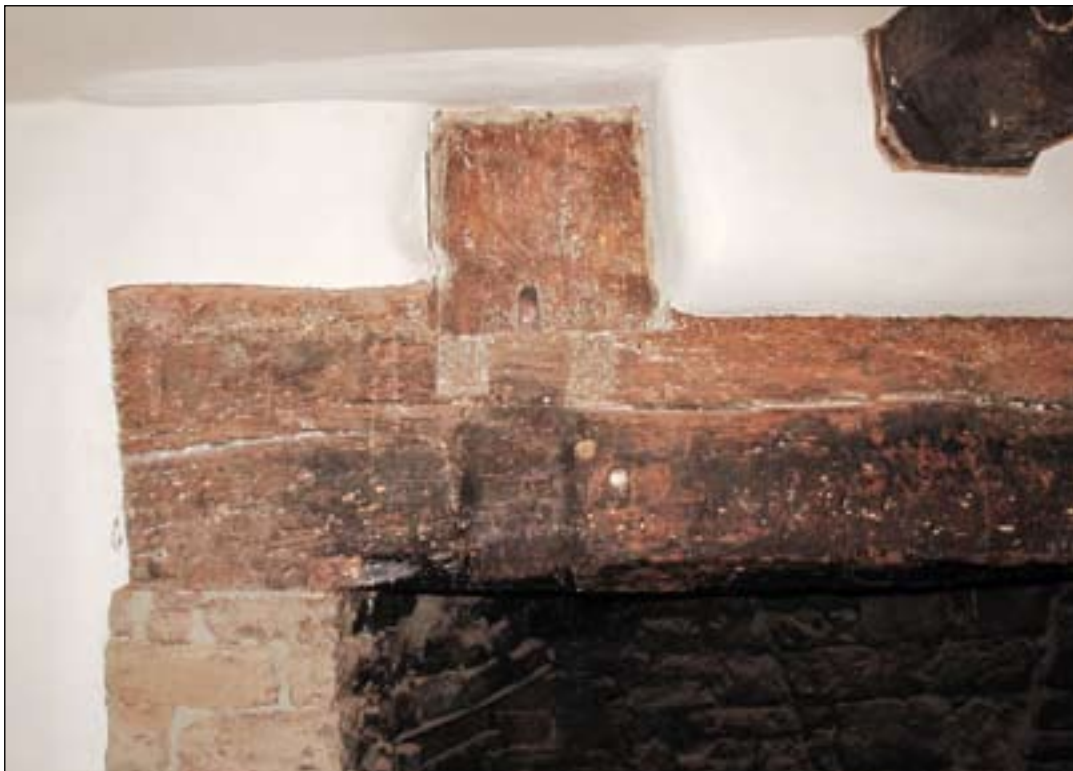
Figure 16. Chimney breast along A-A1, showing timber bressumer with chamfer and broach stops (DPI13785).

The beam running to the middle of the chimney breast ends in a carved stop with a step and a run-out (see Fig 16). The beam positioned to the south front runs into the wall without a carved stop, suggesting that, in fact, it continues behind the wall, and that the curved area now built out to accommodate the bread oven was a later addition to the fireplace area. The bread oven, which is built of brick, appears to date to the 18th or early 19th century and has a cast-iron door.

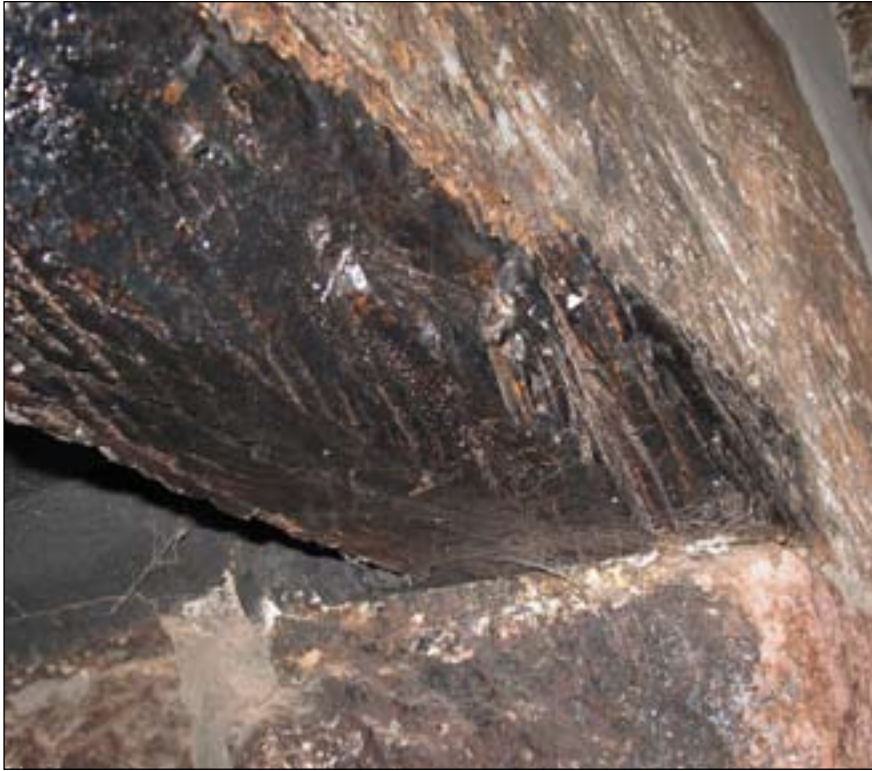
Figure 17. Detail of broach stop on bressumer of chimney breast at A-A1 (DPI13784).

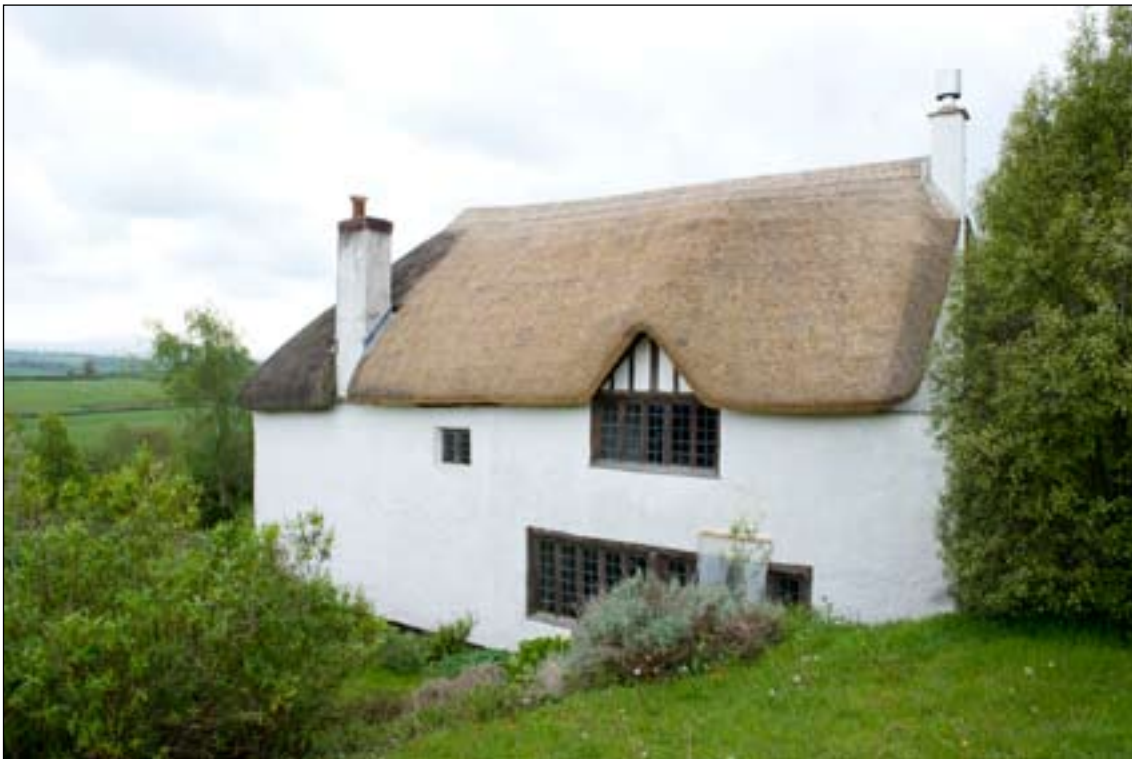
Figure 18. Exterior view from north-east showing small timber-framed gable (reconstructed in 1980s) above mullioned timber windows of north wing (DPI13772).

The north wing is a single-bay, two-storey parlour wing adjoining the north wall of the main range's easternmost bay, thereby forming an L-plan in conjunction with the original range. The addition probably included a staircase block located in the angle of the two ranges, though its original form has been subjected to later alterations. Both the north wing and the staircase block have cob walls and thatched roofs. That this was originally a parlour wing is indicated by the scale and quality of the windows on the east elevation (Fig 18). Both floors have large mullioned windows with moulded oak frames (Fig 19). The window on the ground floor has ten lights with a massive king mullion supporting most of the first-floor east wall (Fig 20). The window on the first floor has five lights. The frames feature ovolo mouldings (Fig 21) which, in association with a long-mullioned window form suggest a date of the late 16th or early 17th century. A modern timber post has been inserted in front of the ground-floor window to give additional support to the lintel, and a plan of the house in 1956 shows that this arrangement was preceded by a pillar which blocked the window's two central lights.¹ On the exterior, the windows are surmounted by a small timber-framed gable which was reconstructed in the 1980s (after having been removed for many years) on the basis of evidence exposed at the eaves (see Fig 18).²

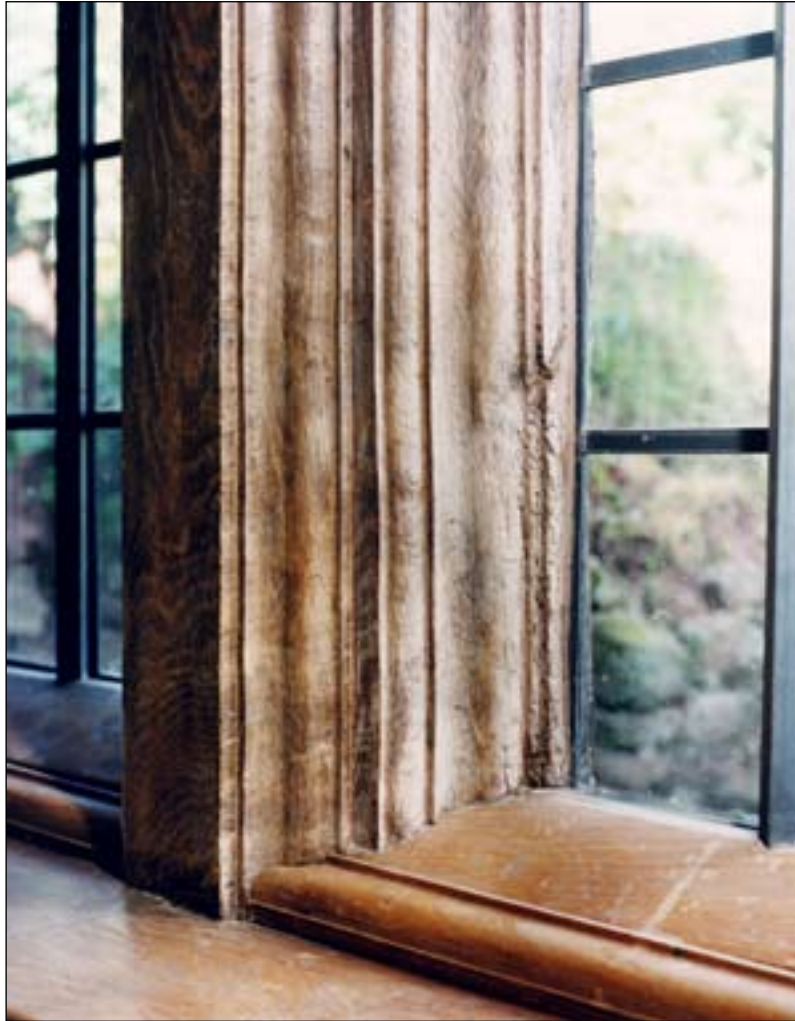
Figure 19. Detail of window-frame moulding of king mullion in window of north wing, ground floor (AA97101518).

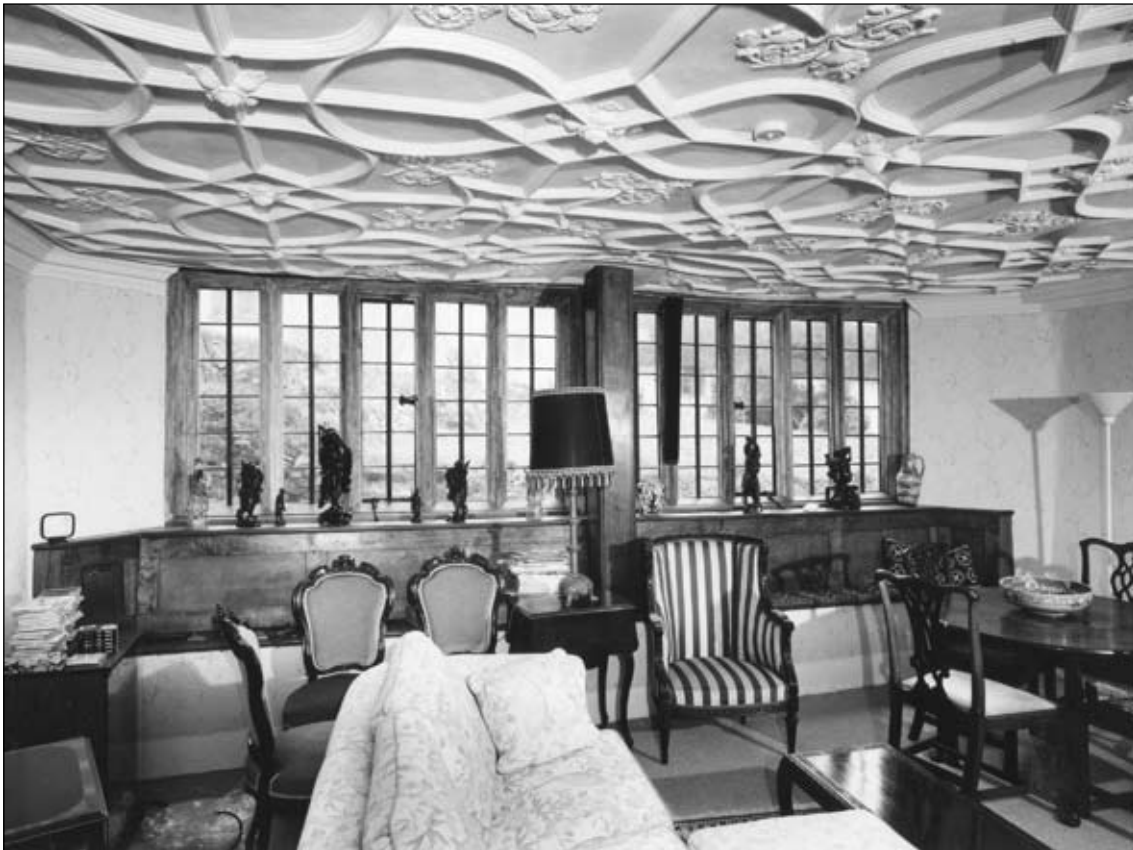
Figure 20. Ground-floor room of north wing showing ten-light mullioned window and plasterwork ceiling (BB96/03907).

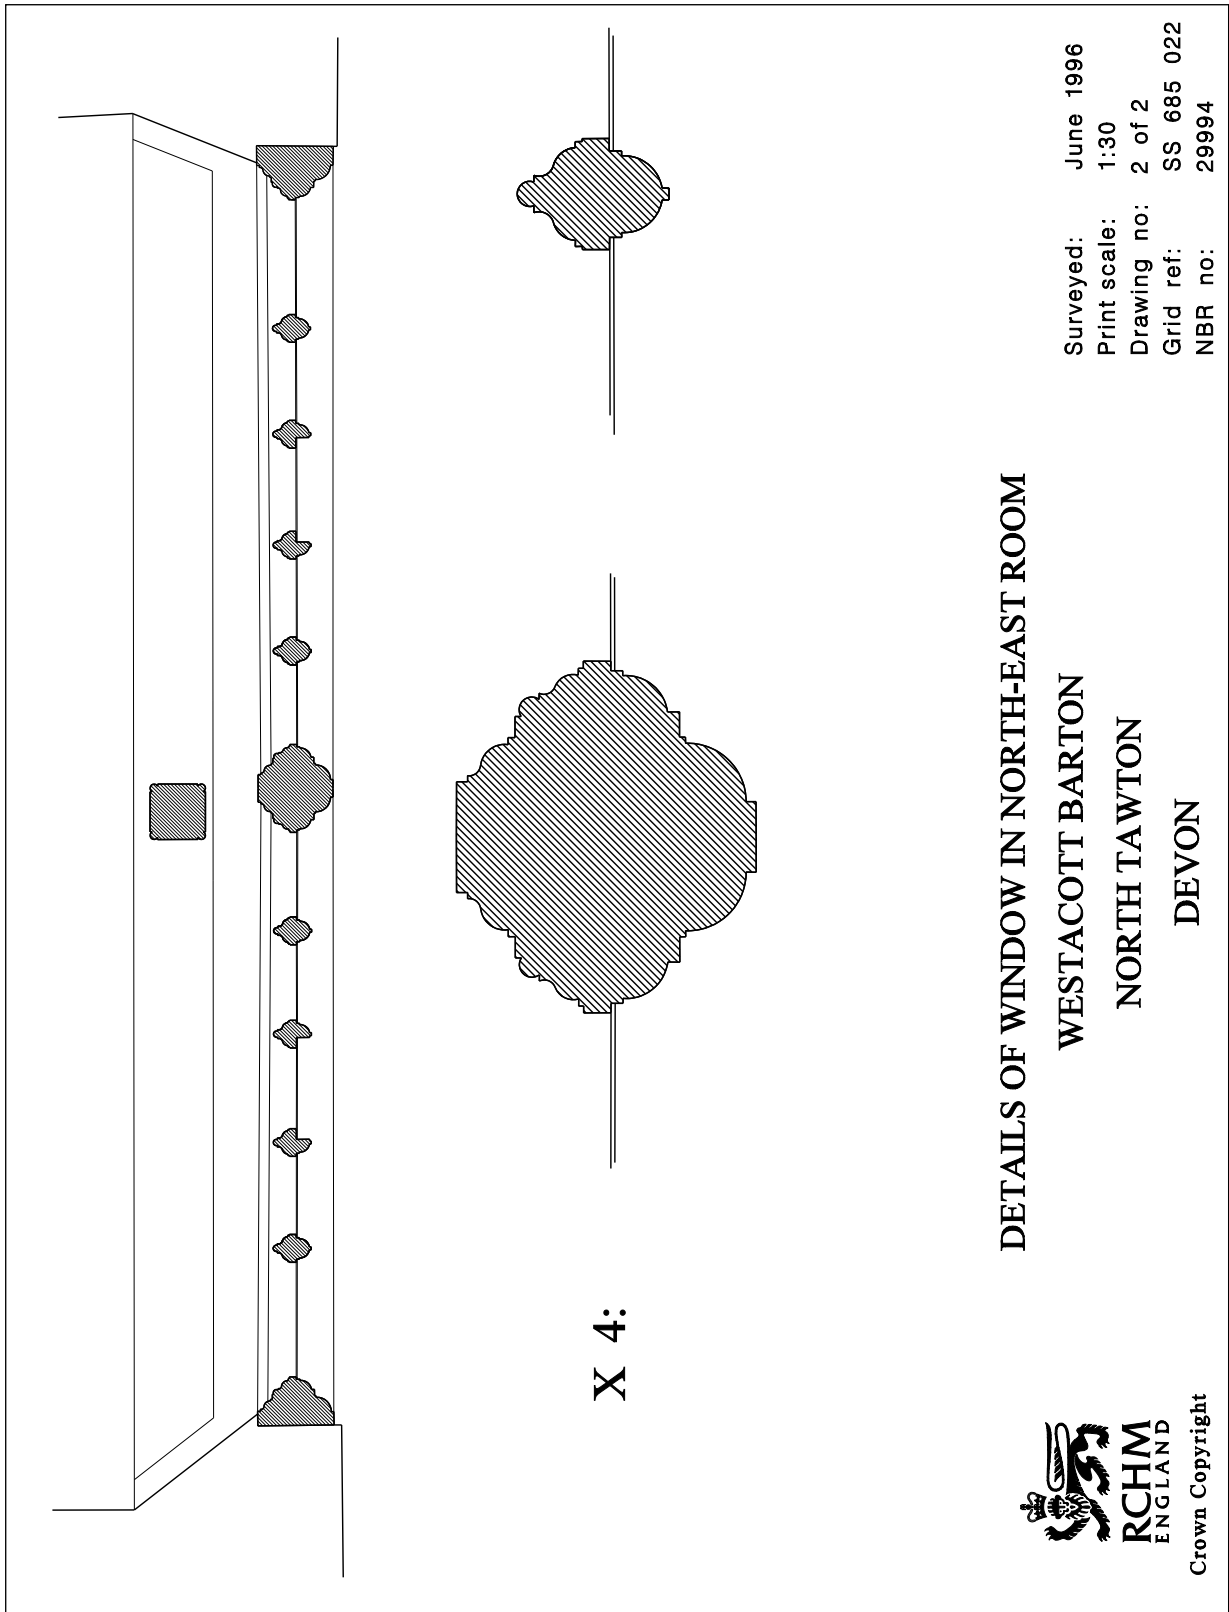
Figure 21. Details of window mouldings of oak-framed, ten-light window in ground-floor room of the north wing, from the 1996 RCHME report (NBR BF 29994).
