WESTACOTT BARTON, NORTH TAWTON, DEVON ANALYSIS AND INTERPRETATION OF A DEVON HALL HOUSE

Olivia Horsfall Turner and Barry V Jones

Research Department Report Series 57-2011

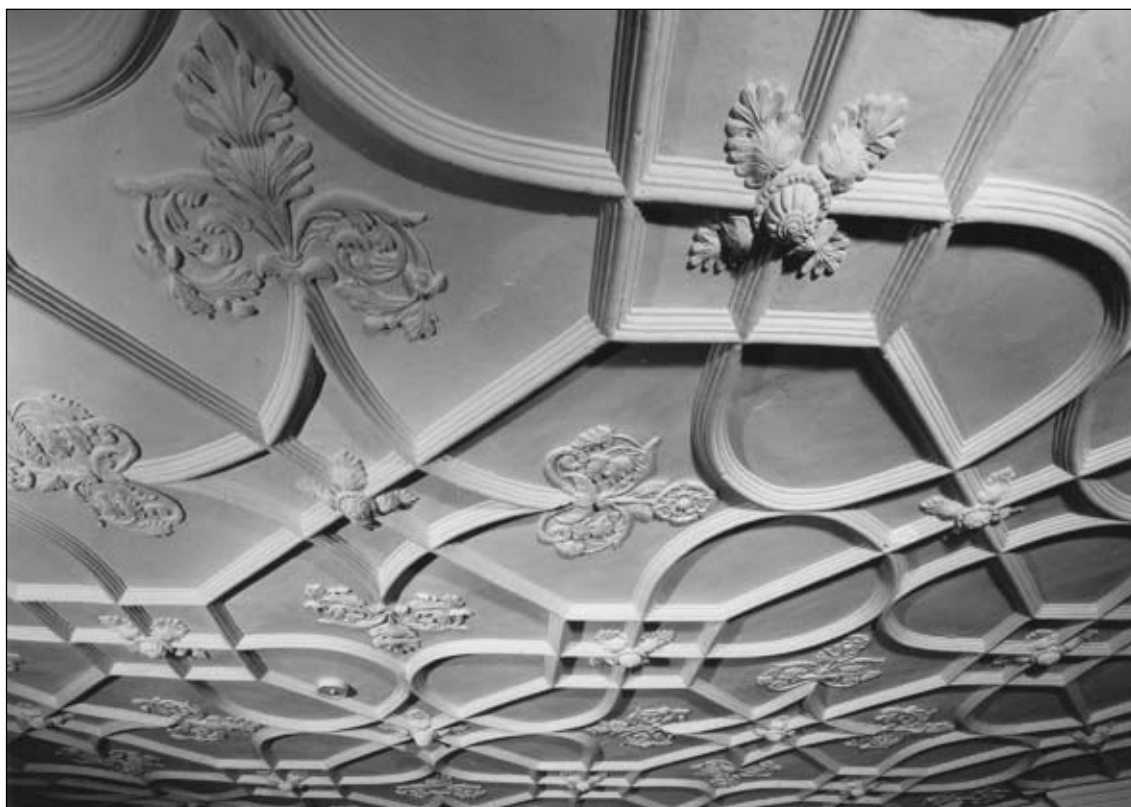
Figure 22. Plasterwork ceiling in ground-floor room of north wing (BB96/03908).

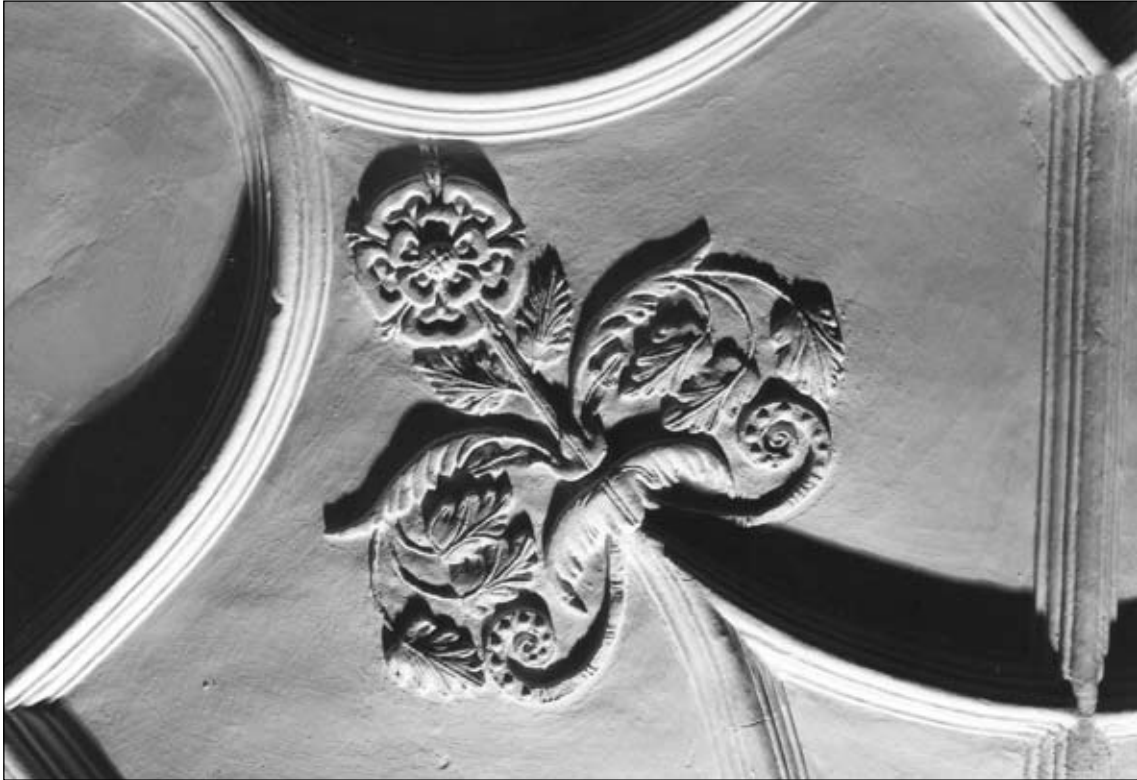
Figure 23. Detail of plasterwork ceiling in ground-floor room of north wing (BB96/03909).

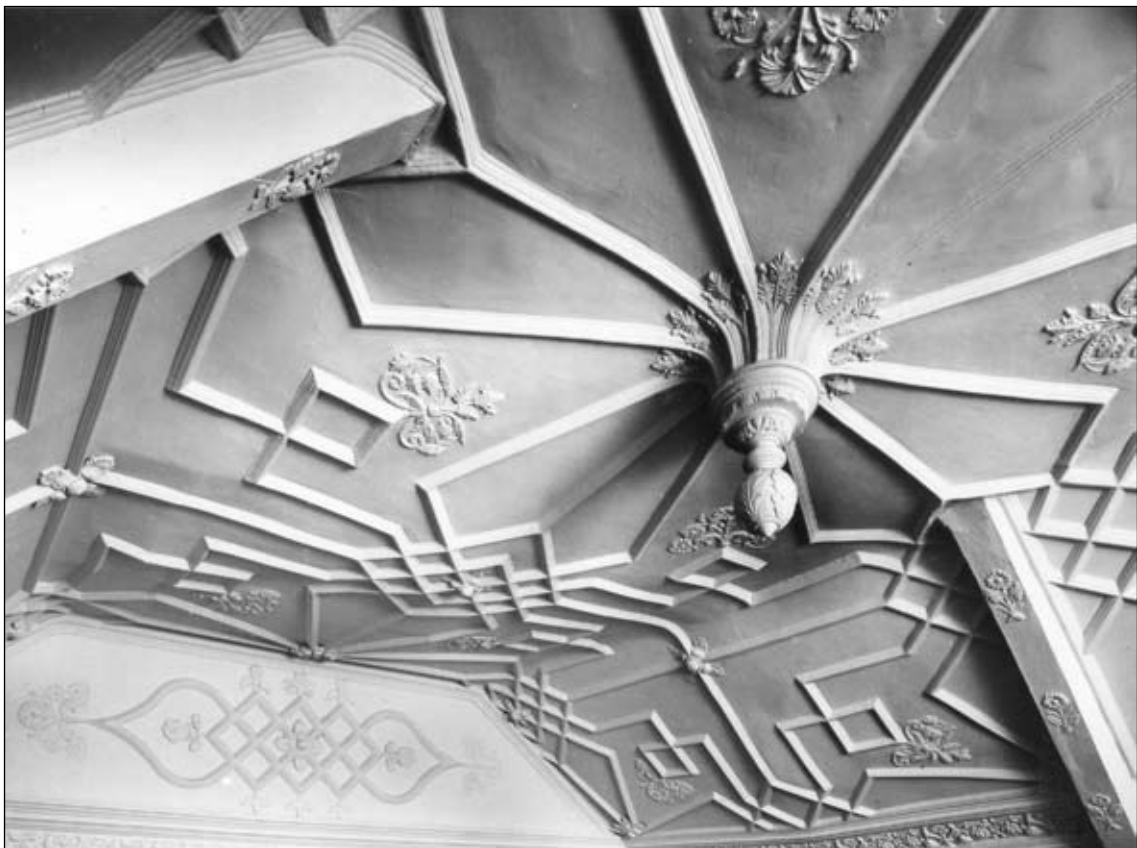
Figure 24. Plasterwork ceiling in first-floor room of north wing (BB96/03913).

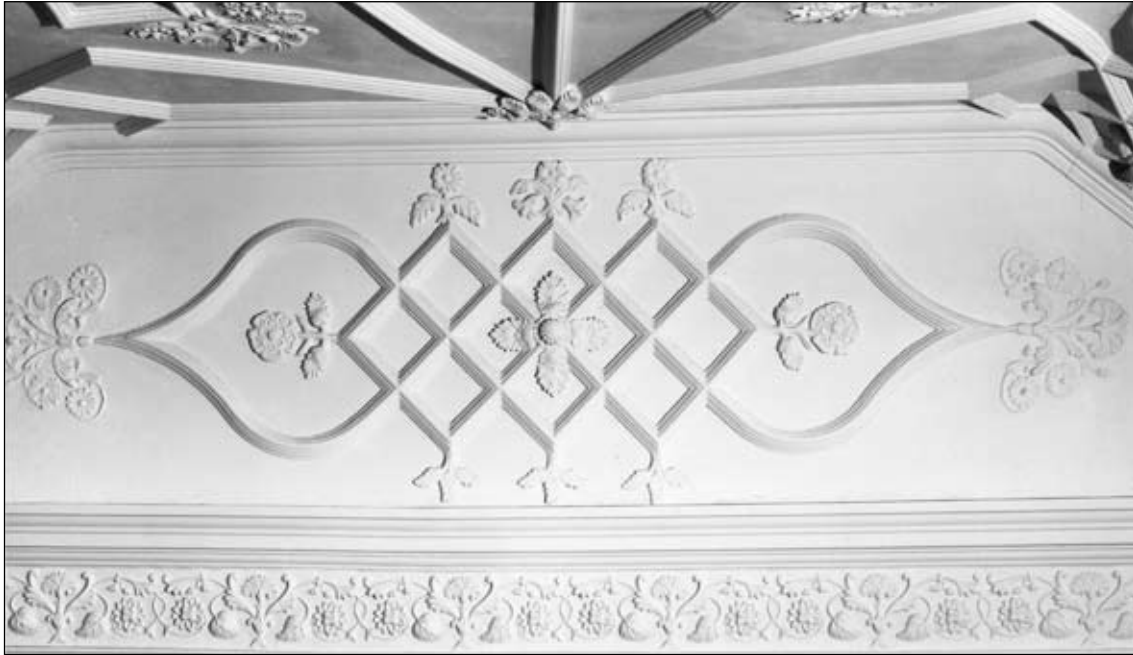
Figure 25. Detail of plasterwork on north wall of first-floor room of north wing (BB96/3912).

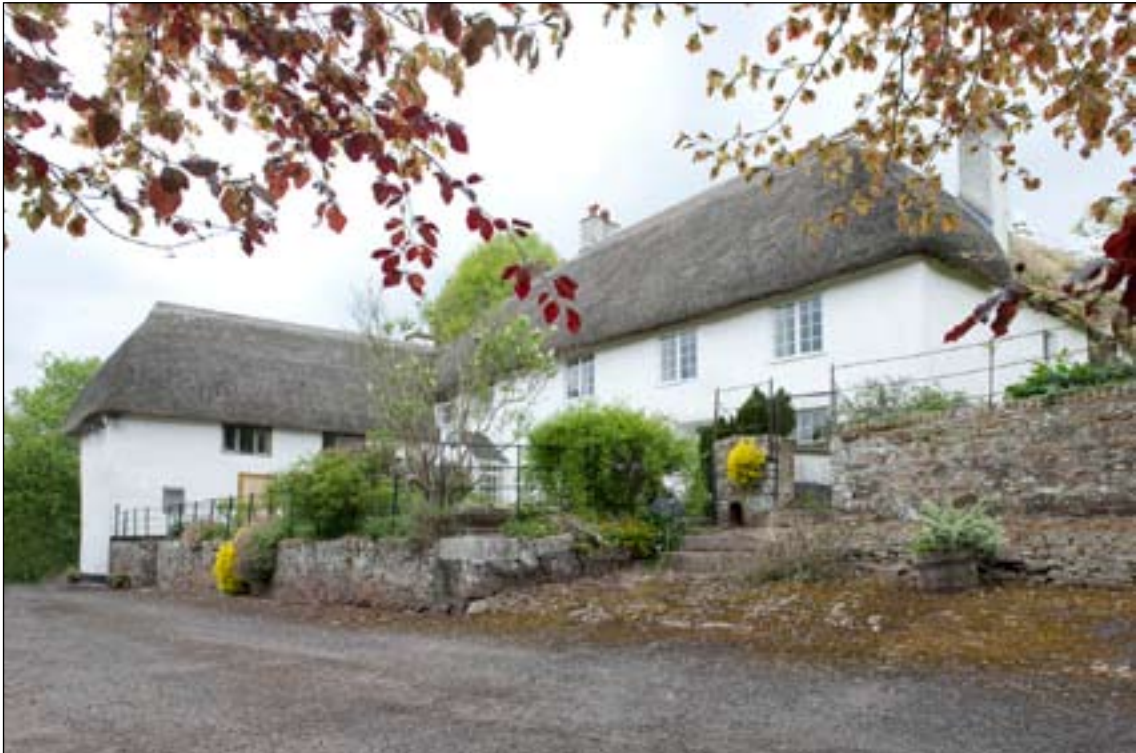
Figure 26. View of south elevation, with lincay projecting to south, and north wing visible projecting to rear (DPI13768).

In this period a projecting lincay was added to the front (south) elevation (Fig 26). The lincay is built of cob on a sandstone rubble base and has a thatch roof. It has three cart bays on the east elevation which have wooden posts and lintels. The cart bays were originally open but have been blocked with brick at a later date. Each of the posts supports a transverse waney-edged beam. Internally, on the ground floor a passage was provided through the lincay across the front of the main range. The first floor is now reached by an inserted wooden stair in the north-east corner of the range, adjoining the passage, and adjacent to the section of medieval screen (as described above).

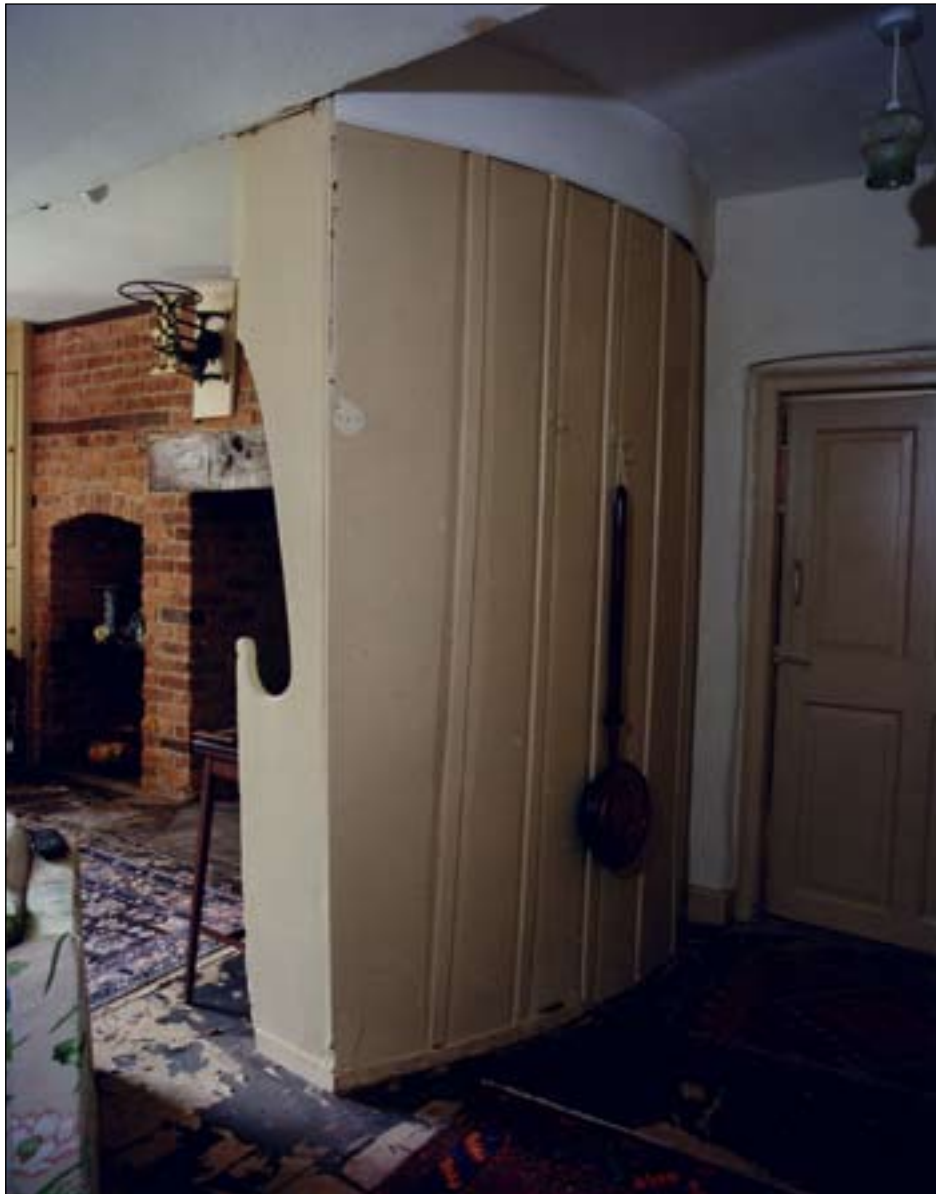
Figure 27. Interior of ground floor showing inserted brick chimney stack opening onto hall along B-B1, and settle (AA97/01519).

In the same period, and possibly introduced as part of the same phase, a new brick chimney stack was inserted into the east end of the kitchen (bay A-B), opening onto the hall (at B-B1 on plan). This replaced the cross-passage and the putative 16th fireplace or smoke-hood (discussed above). The chimney stack is built of brick (brick size: 23cms x 11cms x 7cms) and provides a fireplace on the ground floor in the east part of the original hall. There is a change in the ceiling height between the end of bay B-C and the end of the window embrasure: this is probably on account of cutting away the medieval floor joists in order to clear the space to drop in the stack. The moulding that runs north-south across bay B-C probably dates from this phase. It does not appear to be medieval, and was probably attached in order to provide some sort of finish after the works on the chimney stack area. The new fireplace has brick jambs, a squared wooden lintel and what is possibly a contemporary wooden settle against its north-east jamb (Fig 27).

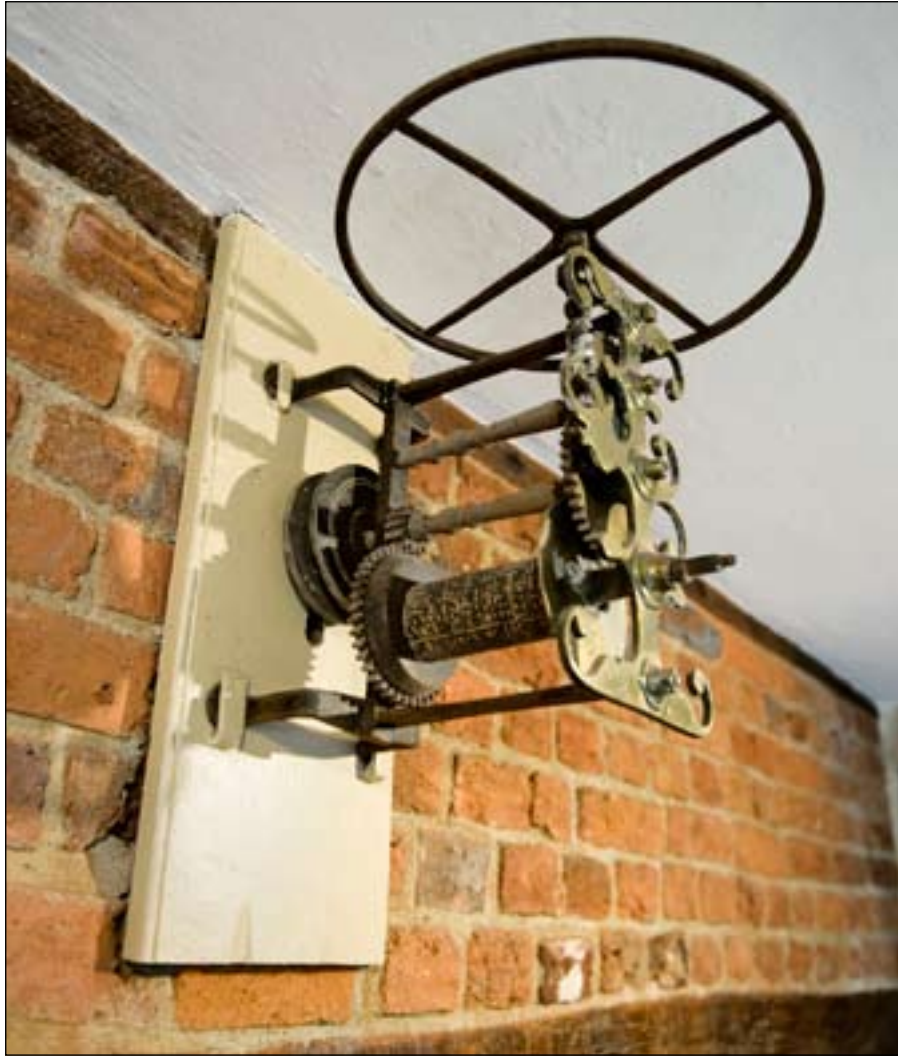
Figure 28. Turn-spit mechanism re-set above inserted fireplace at B-B1 (DP113776).

On the front of the chimney breast, above the lintel, there is a weight-operated mechanism for turning a spit (Fig 28). This may be of an earlier date than the fireplace and therefore re-set when the chimney stack was inserted. In the kitchen bay A-B, grooves in the bressumer above the fireplace suggest that it may have been the original location for the spit mechanism and imply that it may have been used there for a considerable number of years (see Fig 16).

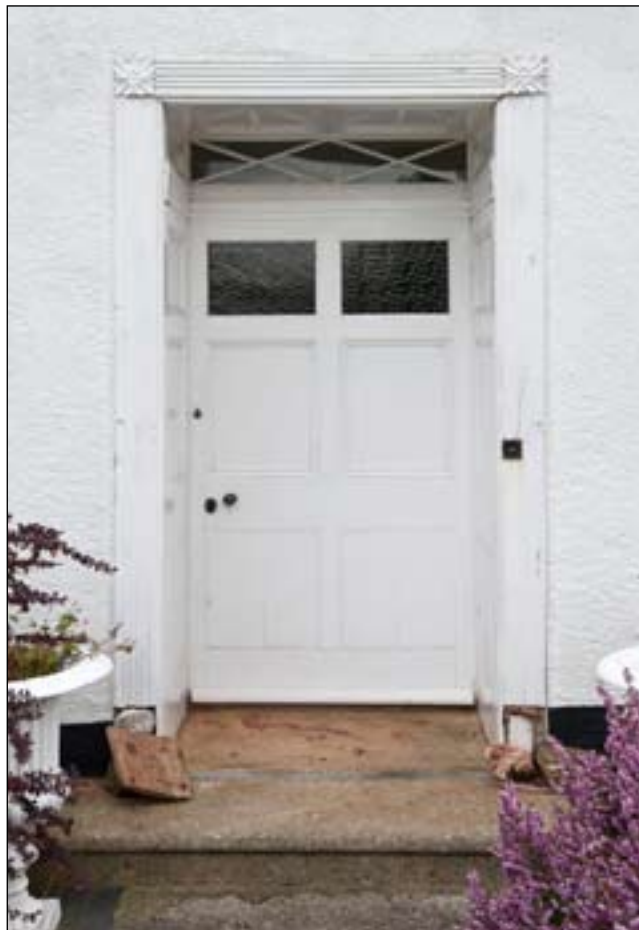
Figure 29. Regency-style doorcase inserted into facade at east end of main range (DPI13775).

It was probably also at this time that a passageway at the east end of the house was created in bay C-D, and an entrance with a Regency-style doorcase inserted in the façade at the east end of the main range. The doorcase has a fluted wooden surround with a flat head, a rectangular fanlight, six-panel door and panelled reveals (Fig 29). The passageway is positioned on axis with the doorway to the ground-floor room of the northern wing, suggesting a formal entrance which was presumably added in order to afford access directly into the north wing.
