Ancient Monuments Laboratory
Report 55/1999

TREE RING ANALYSIS OF TIMBERS
FROM HILL HALL, THEYDON MOUNT,
ESSEX

M C Bridge

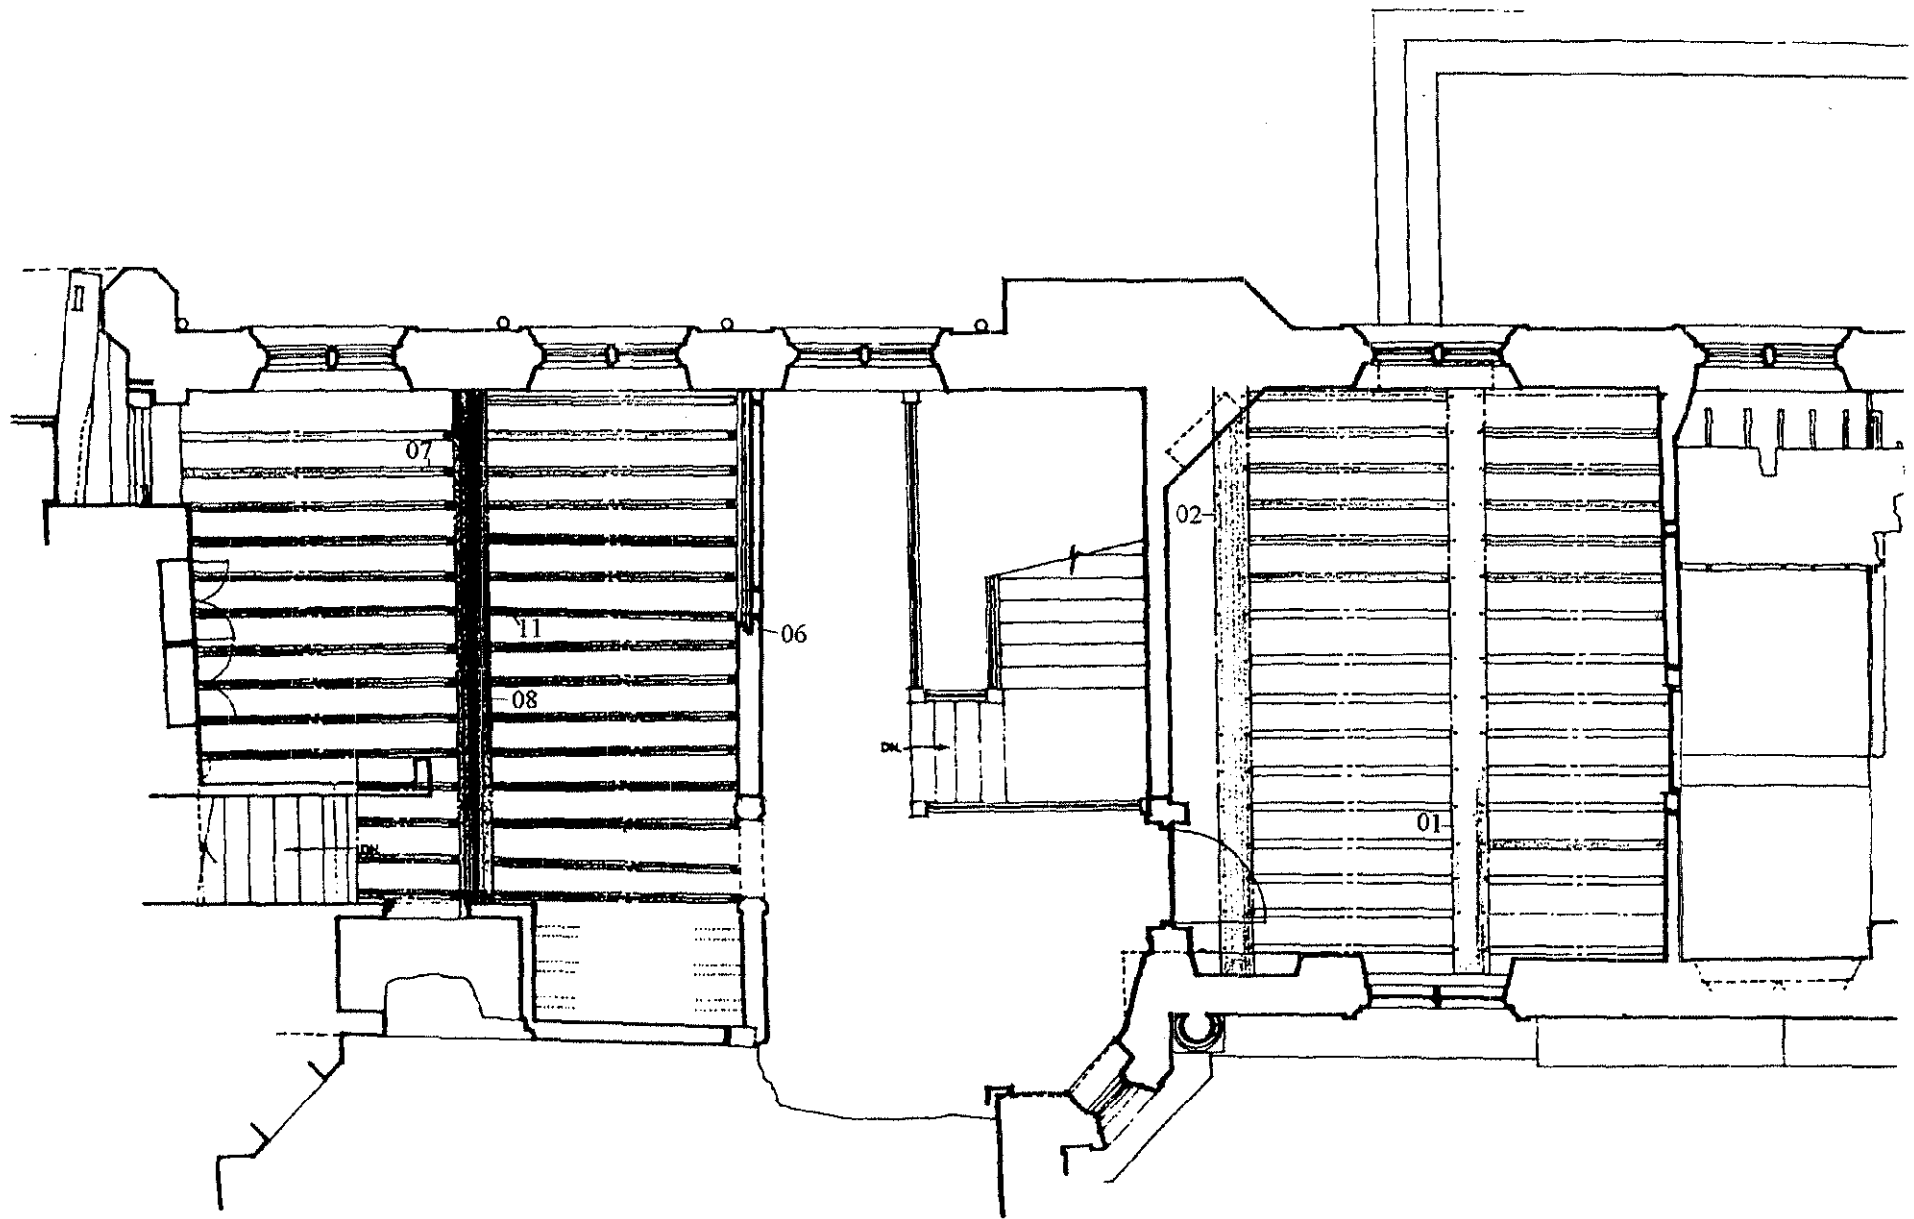
Figure 1: Plan of the north range, Hill Hall, Essex, showing locations of samples taken for dendrochronology

Timbers in both the north range and the north-west wing were sampled, the locations of those timbers sampled, are shown Figures 1-5, and described in Tables 1 and 2. Although not many timbers in either the north or north-west ranges had extensive sapwood surviving, enough timbers had some traces of sapwood that it was felt that the information they might yield justified the sampling done.

The oak ring series from the north range, samples HHT01 - HHT11 (Table 1, Figs 1 - 3) did not match each other, and therefore individual series were matched against a range of regional and site chronologies. Consistent significant matches were found for six of the timbers and the dates subsequently allotted to them are shown in Table 1, with the evidence for their dating in Table 3. The six series were combined into a site chronology Hill Hall 1 (Fig 6), which gave very good matches against a number of chronologies (see Table 4).

The first point of interest is that many of the timbers which survive in the north range (Figs 1 - 3) are of relatively poor quality, being full of knots, and are not finished to a high degree. The main beam from which sample HHT08 was taken for example, has no chamfers and a rough exterior. Many of the joists have rough rounded edges where the outside of the tree has been left. This seems like rather poor workmanship when compared to nearby properties such as the earlier Gosfield Hall (Bridge 1998c). The nature of the knotty timbers, coupled with the lack of internal matching between the components of this range, suggests that the timber may have come from hedgerow-like environments, possibly from scattered sites, although probably from the local region, given the nature of the crossmatching with reference material. The number of timbers with bands of varying width annual rings, showing sudden changes in the rate of growth, suggests that some lopping of the trees had taken place during their lifetime, though other causes, such as disease, cannot be entirely ruled out. Nevertheless, it was felt that these trees may represent typical growth over a wide area and although they did not crossmatch well statistically, the site master derived from them has been demonstrated to give strong matches against a range of reference chronologies (Table 4). The much earlier date derived for the outermost ring of HHT08 (AD 1546), which had no obvious signs of reuse, suggests that the tree had either been standing dead for many years prior to felling, or that this timber had been stored for many years before being used.

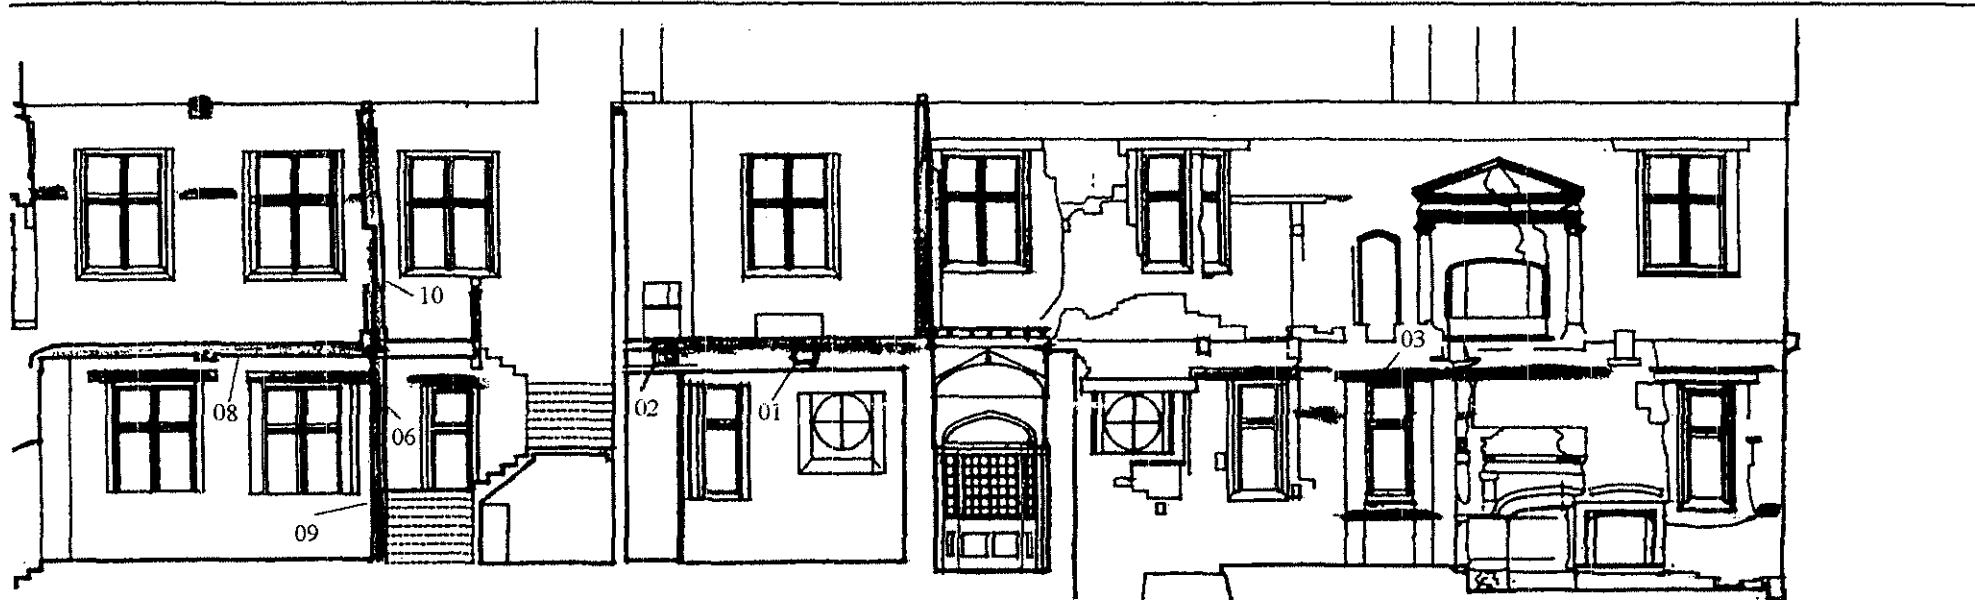
Figure 2: Drawing of the north wall of the north range, Hill Hall, Essex, showing locations of samples taken for dendrochronology

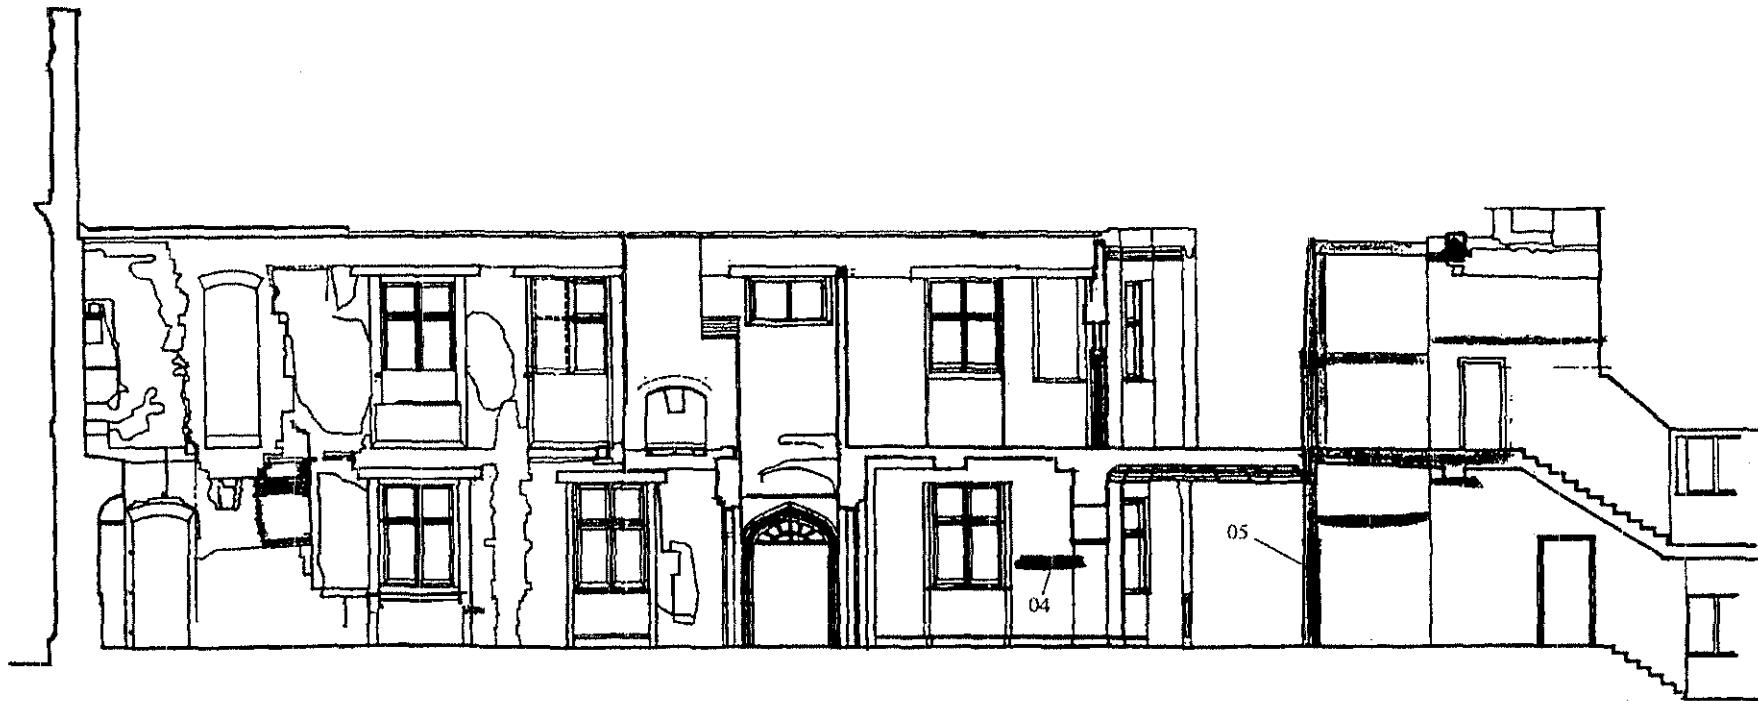
Figure 3: Drawing of the south wall of the north range, Hill Hall, Essex, showing locations of samples taken for dendrochronology

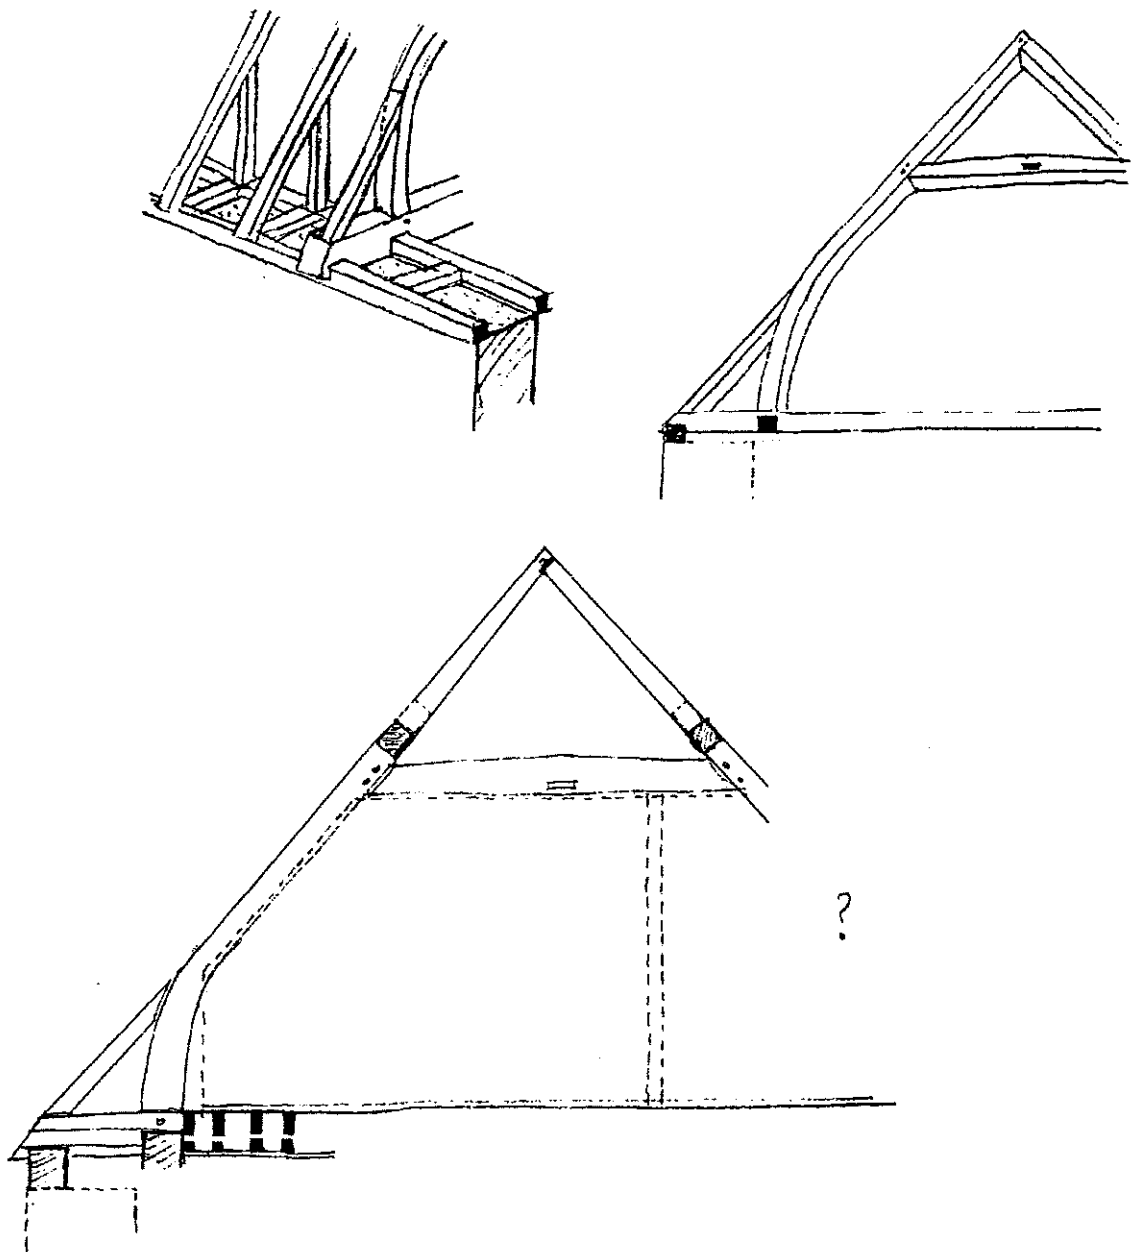
Figure 4: Sketches of the roof of the north west wing, Hill Hall, Essex, showing the general form of the trusses. Based on originals by Andy Wittrick (English Heritage)

The timbers in the north-west range (samples HHT12-HHT28, Table 2, Figs 4 and 5) had had their sapwood crudely removed, making it more difficult to find useful timbers with extensive

By contrast, the roof of the north-west wing (Figs 4 and 5), thought to have been built as servants' quarters, at least on the ground floor, has well-finished, refined carpentry. The sapwood appears to have been hacked off rather crudely, though this may well have been done many years later, probably when the wing was remodelled by Blomfield in the early-twentieth century (Drury pers comm). However, the presence of pit saw marks on many of the timbers, indicated that they were likely to be older than Blomfield's time. Many of the principal rafter pairs have made use of very fast-grown oak, and these may have been selected for strength. Many of the floor timbers (Fig 5), including joists and tie beams were cored. Several were found to have a high moisture content and the cores were difficult to extract.

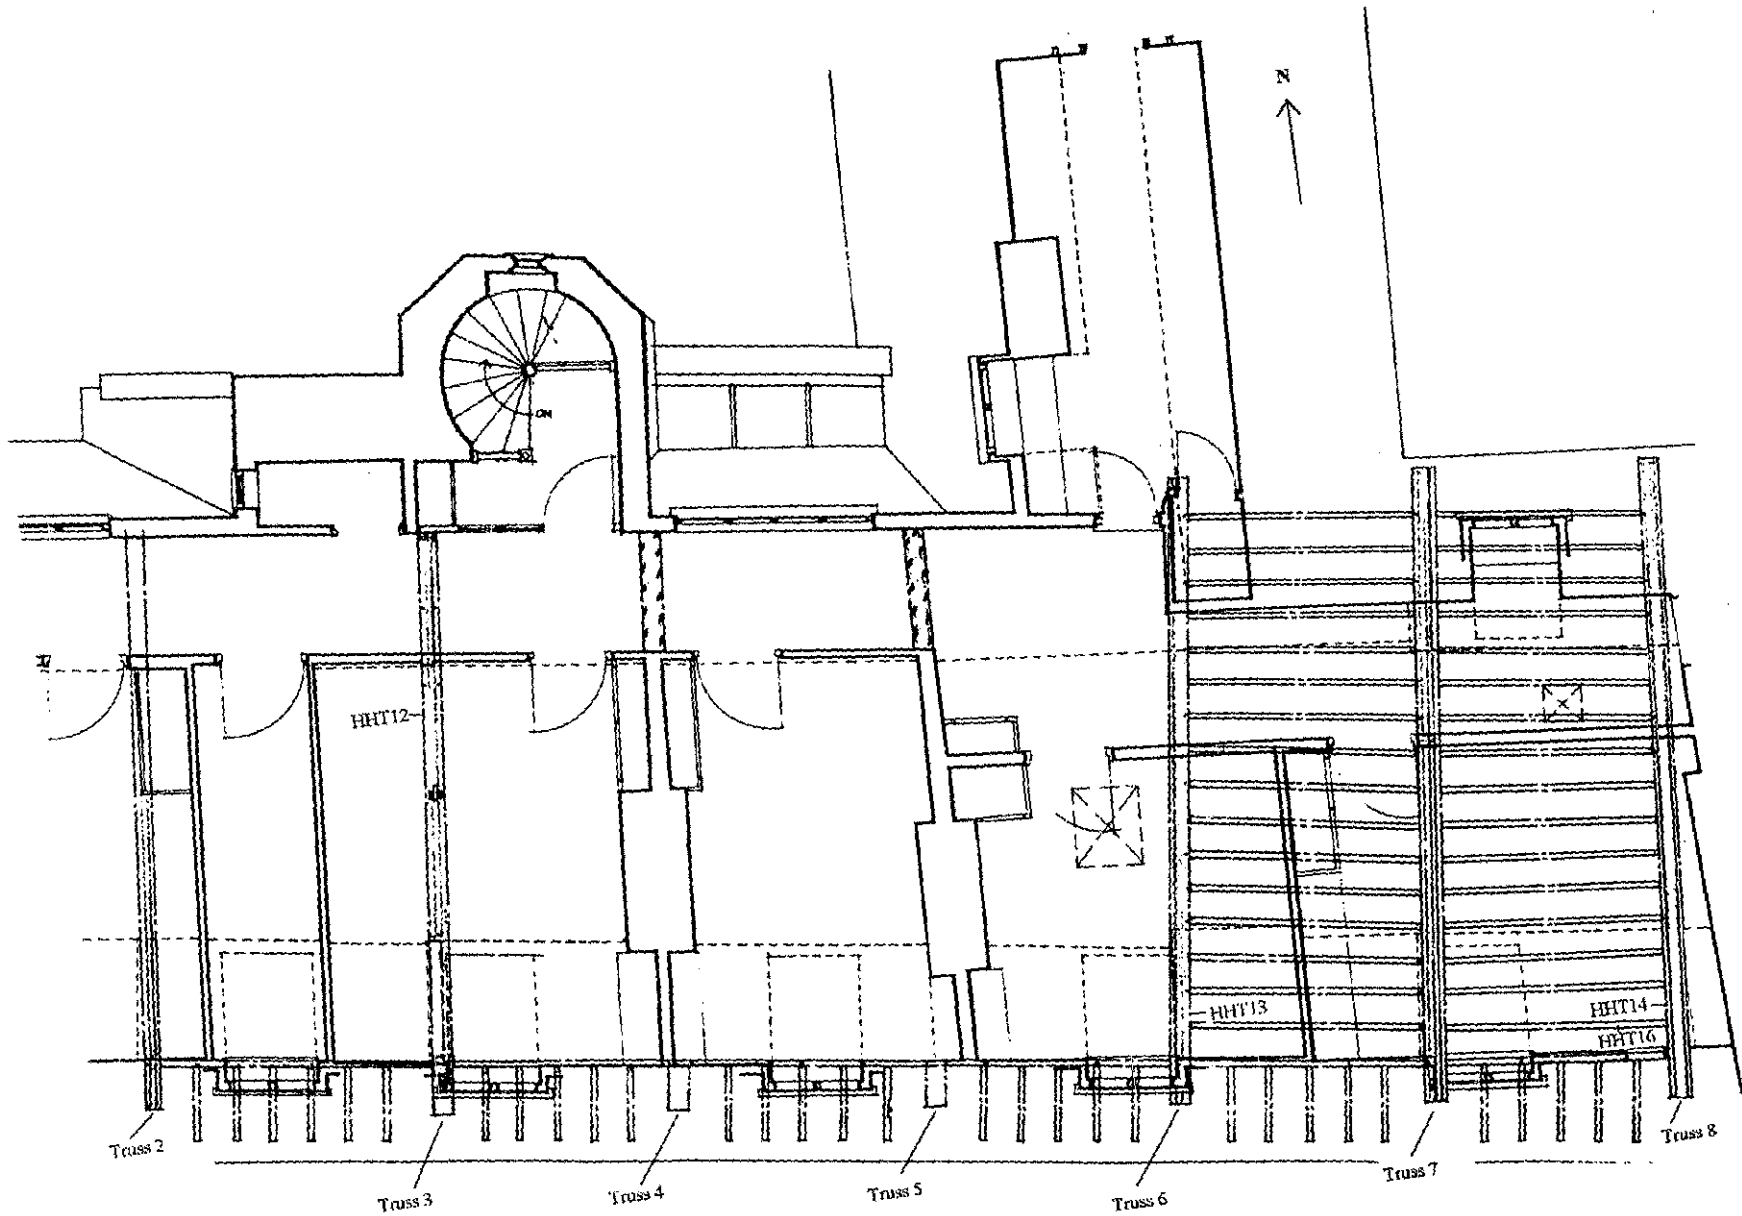
Figure 5: Plan of the first floor of the north west wing, Hill Hall, Essex, showing the truss numbering, and locations of samples taken for dendrochronology

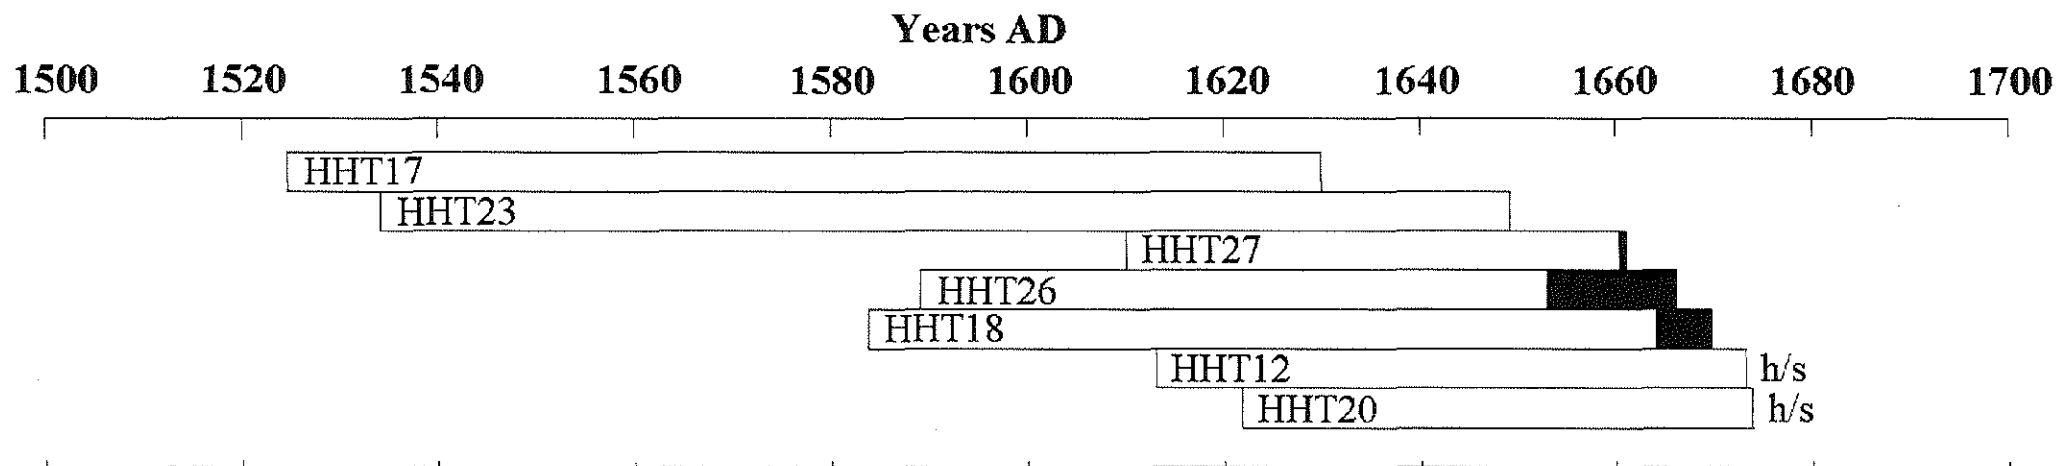
Figure 7: Bar diagram showing the relative positions of overlap of the dated timbers from the north-west range used in the site chronology HillHall 2. The shaded areas represent sapwood, h/s = heartwood-sapwood boundary

sapwood for dating. Individual truss drawings were not available and exact locations above tie beam level are not therefore indicated. Good crossmatching was found between seven of these timbers (Table 5) and their series were combined to form a second site chronology Hill Hall 2 (Fig 7), which was subsequently dated (see Table 6).
