ST OSYTH,
ESSEX
ST OSYTH'S PRIORY
HISTORIC BUILDINGS REPORT

Research Department Report Series 074-2011

**ST OSYTH'S PRIORY
ST OSYTH
ESSEX
HISTORIC BUILDINGS REPORT**

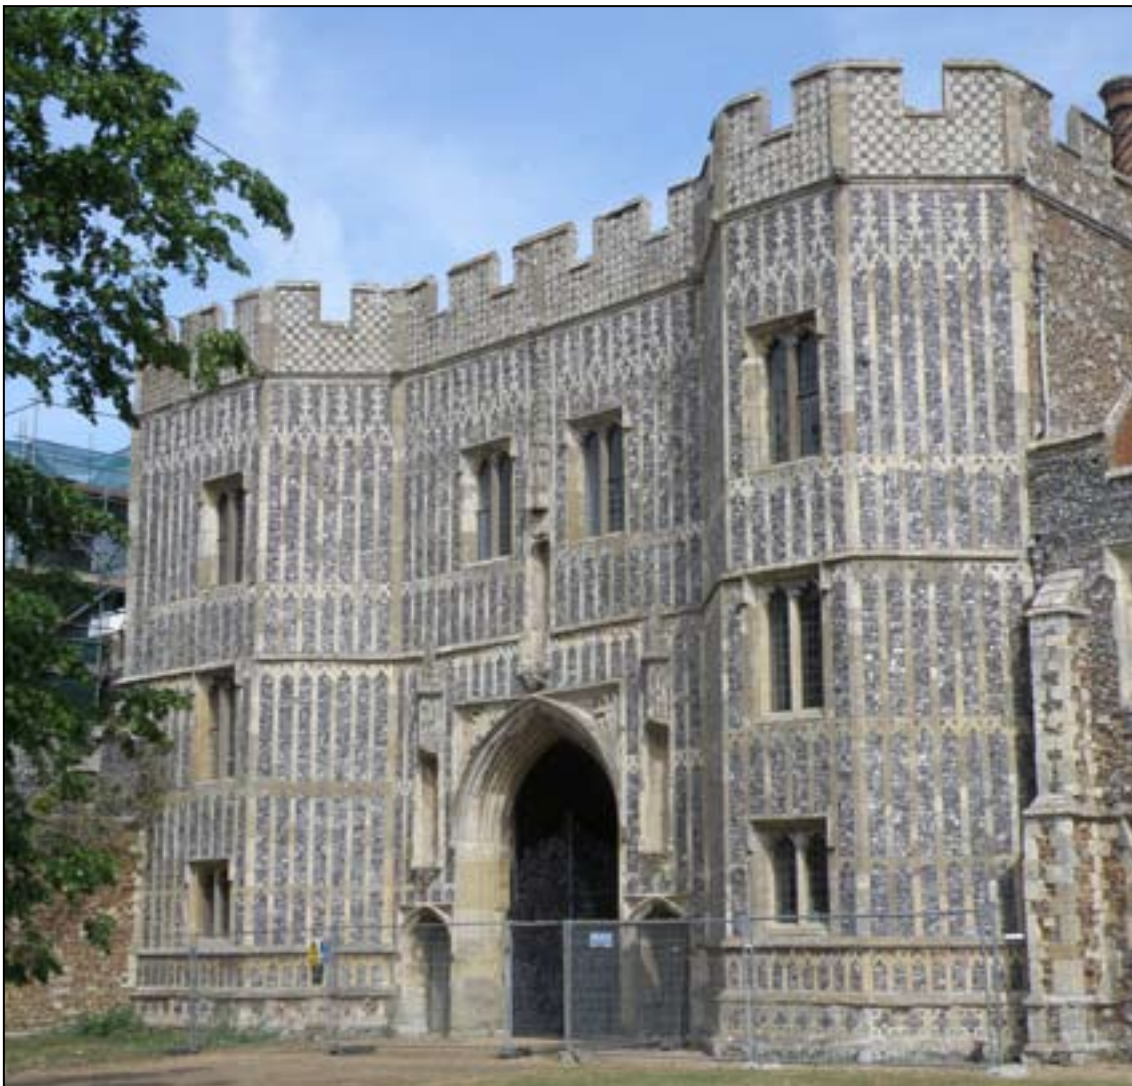
Fig. 2. The late 15th century Gatehouse.

Undoubtedly the most important building to survive on the site, the Gatehouse is, to quote Mark Girouard 'among the finest monastic buildings surviving in England'.¹⁰ It was built as the new main entrance to the monastic complex in the late 15th century (fig. 2). The Gatehouse survives today largely intact externally, though it had been allowed to fall into disrepair by the early 18th century and it was restored for the 3rd Earl of Rochford after 1721. The main façade with its knapped flint and stone flushwork is one of the best preserved examples of this type of late-medieval decoration to be found in East Anglia. The façade has three ornate canopied niches, now empty, and the central entrance archway contains fine quality sculptured reliefs of St Michael and the Dragon in the spandrels (fig. 3). Within this archway is an elaborate two-bay lierne vault with carved bosses. Internally the building retains a number of original features, such as chimney pieces, pointed-arched doorways and fragments of wall painting, plus a number of features from its early 18th-century restoration. There are lower two-storey lodging ranges flanking the gatehouse to the east and west. The final bay of the east range retains evidence that it was built as the original gatehouse in the late 13th century. The Gatehouse and its wings were converted into a separate dwelling in the 1950s by de Chair. The late 17th century staircase, with its barley-sugar balusters, was inserted at this time; it came originally from Costessey Hall in Norfolk. These alterations were designed by the architect, Darcy Braddell, and carried out by Henry Everett & Sons of Colchester.

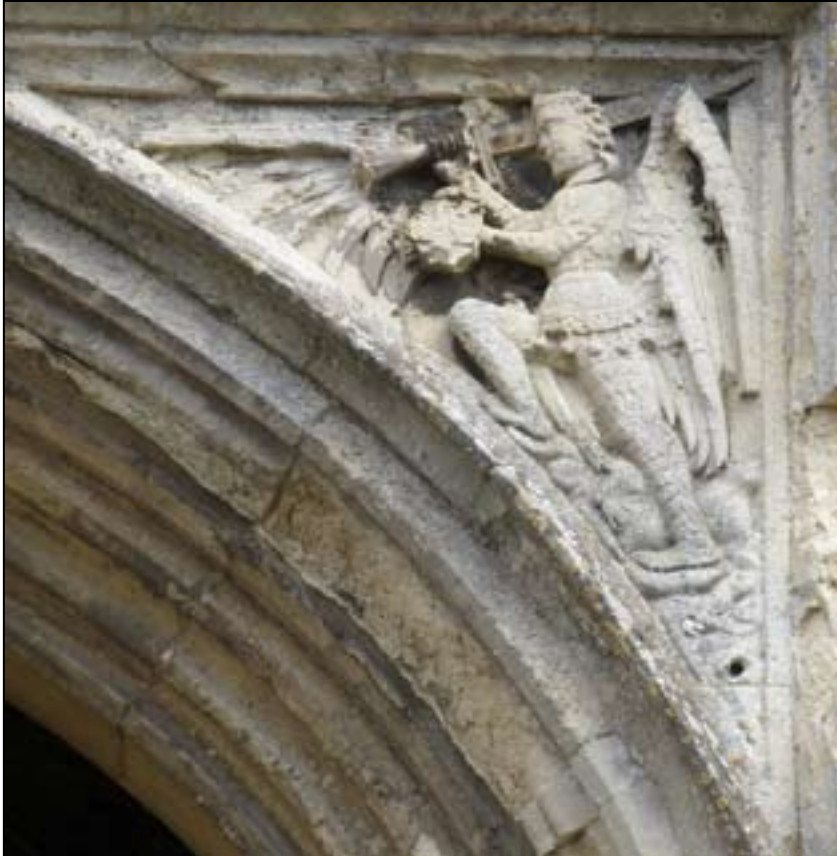
Fig. 3. A sculpted relief of St Michael in one of the spandrels of the entrance arch to the Gatehouse.

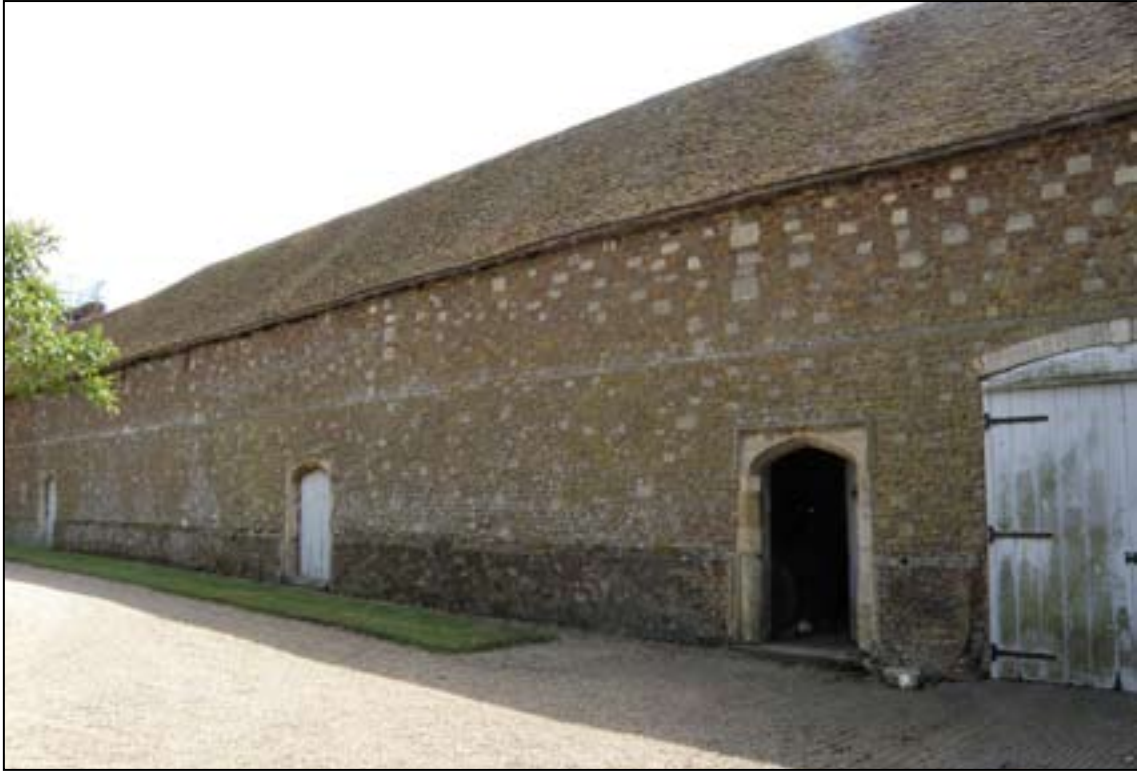
Fig. 4. The north stone wall of the Tithe Barn.

The mid-16th century Tithe Barn is a large timber-framed structure which adjoins the Gatehouse to the east. Its north and east walls are rubble stone (fig. 4) and its south and west walls are clad with horizontal timber boarding (fig. 5). The south front has three porches and the north wall has a deep moulded plinth, an upper chamfered band and three four-centred arched doorways (fig. 4). The roof has plain tie-beams with curved braces and plain collar-beams. The posts on the south side are more substantial than those on the north, indicating that this barn was built against the existing stone wall. A number of the posts on the north side have been cut away or removed completely (fig. 6). Part of the eastern end of the building has been converted to domestic accommodation.

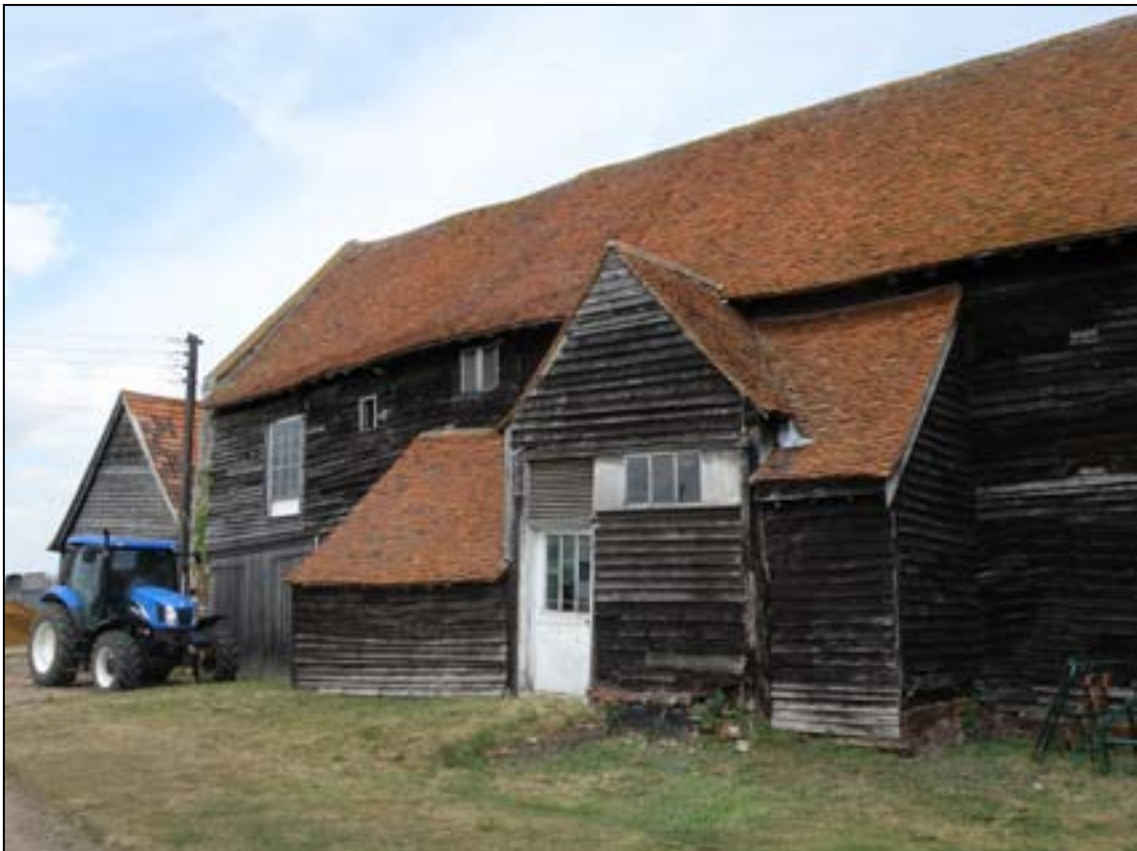
Fig. 5. The south front of the Tithe Barn.

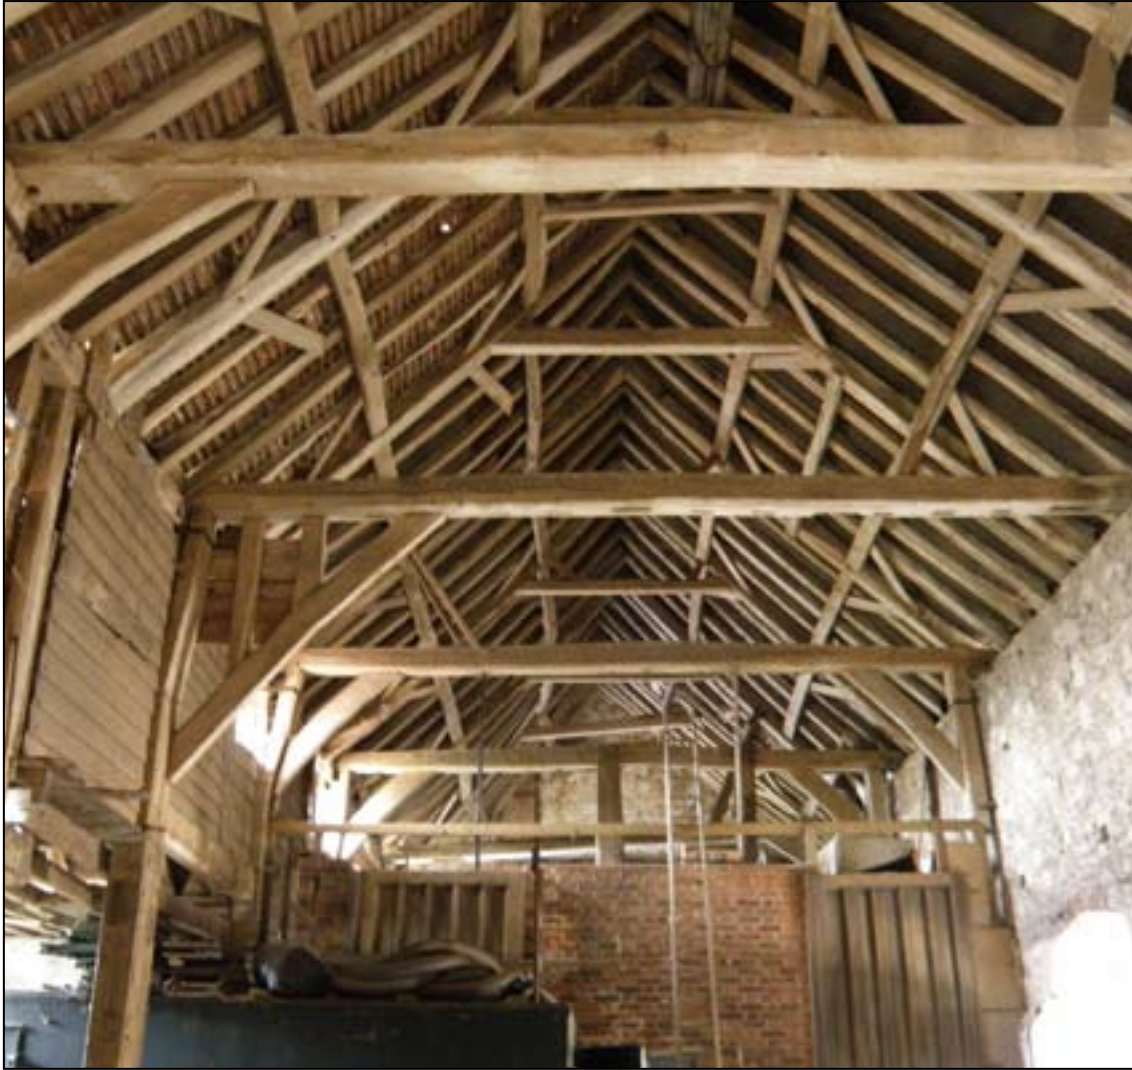
Fig. 6. The interior of the mid-16th century timber-framed Tithe Barn looking west.
© Pete Smith P5132878.JPG

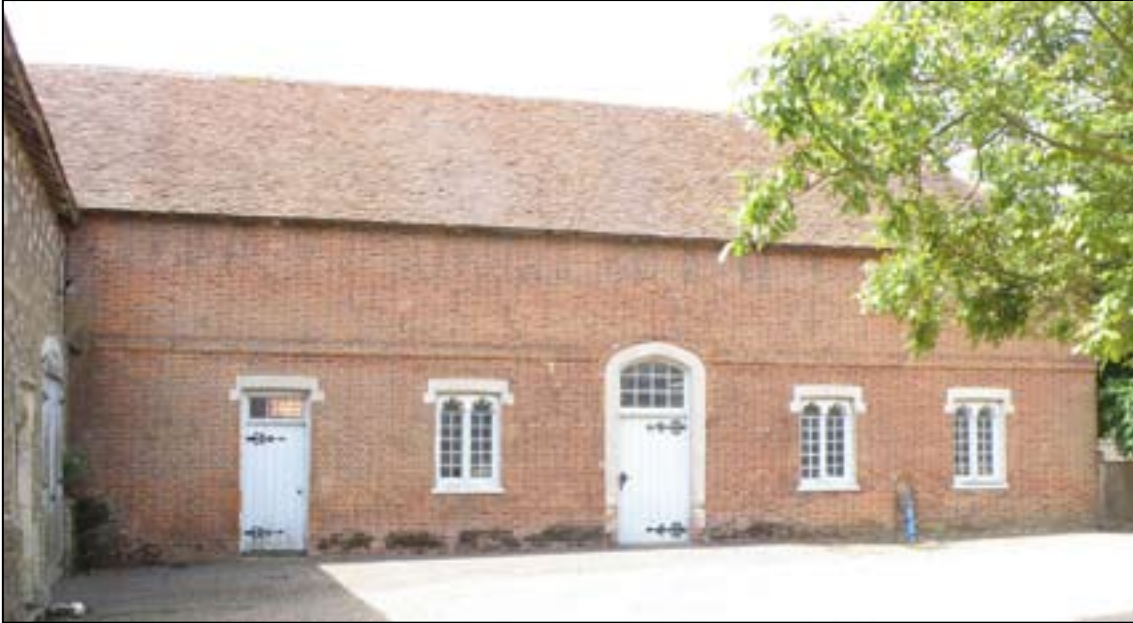
Fig. 7. The east facade of the late 18th century Stable, altered in the late 19th century
© Pete Smith P5132905A.JPG

The Stable occupies the southern section of the west side of the main court, adjoining the west end of the Tithe Barn. This late 18th century stable building (fig. 7) with hay lofts above was remodelled in the later 19th century for Sir John Johnson when it was given its distinctive two-light mullion windows with cusped heads, its four-centred arched doorway and its ornate iron hinges. The interior retains its late 19th century stalls and other equestrian fittings.

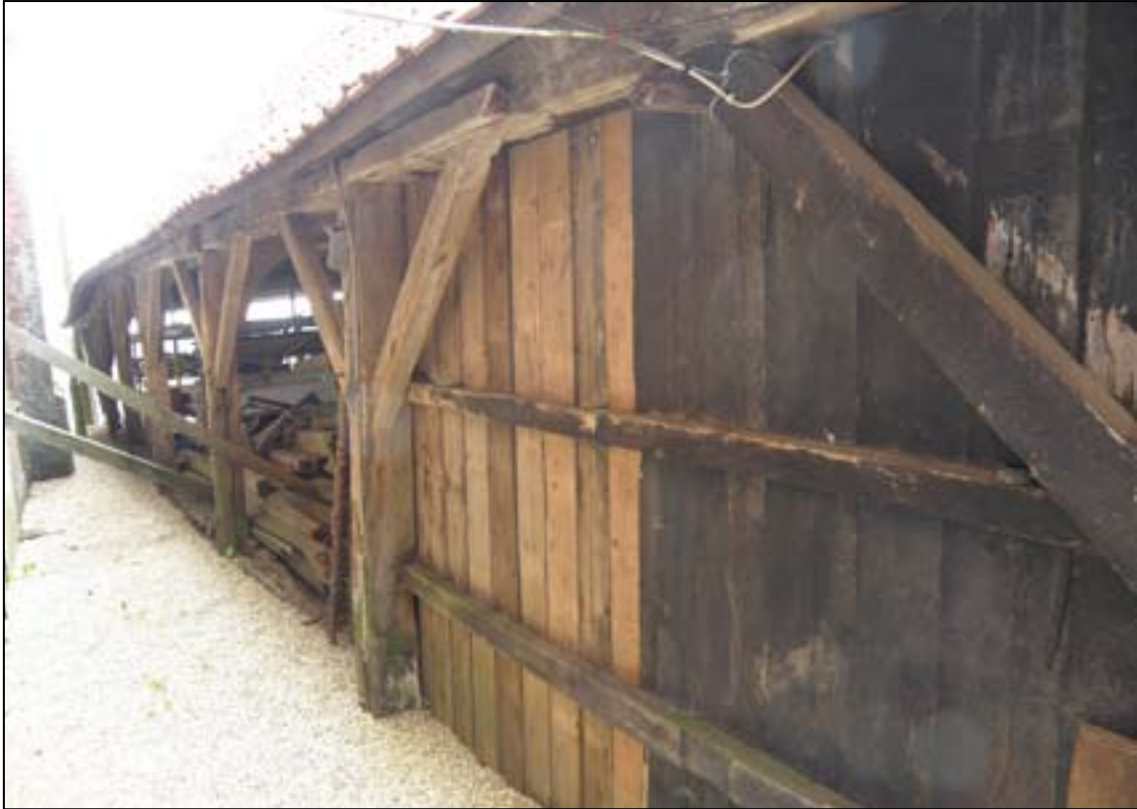
Fig. 8. The late 18th century timber-framed Cartshed, probably moved to its present site in the late 19th century. © Pete Smith P5132882.JPG

This long low timber-framed cart-shed dates from the late 18th century (fig. 8). It is partially clad in horizontal timber boarding and has a red tile roof. This roof has staggered side purlins and a ridge-piece with bracing to the posts. This building does not appear on either the 1762 survey (fig. 41) or the 1814 survey (fig. 44), but it does appear on the 1874 OS map (fig. 45). This building is therefore either an extremely late example of this type of timber-framed structure, or more likely it was dismantled and moved to its present site sometime between 1814 and 1874.

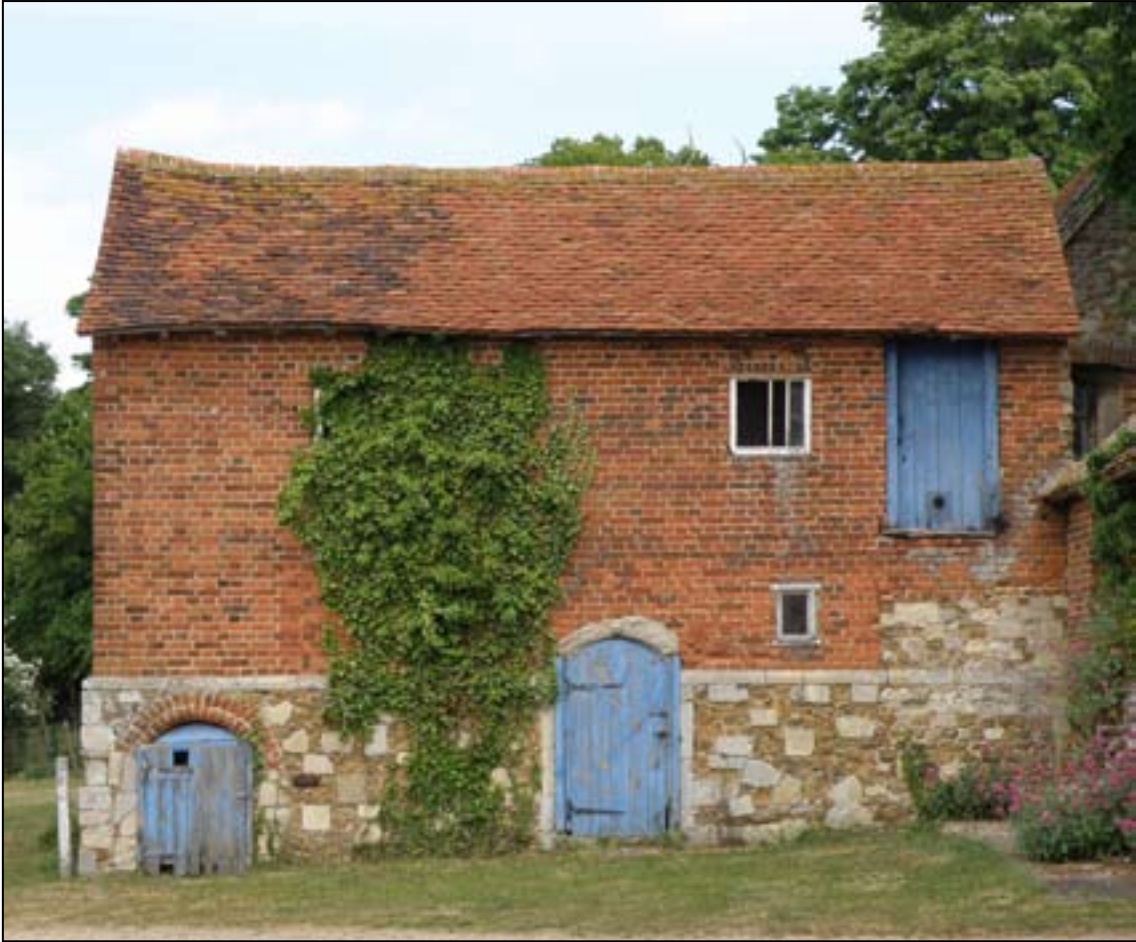
Fig. 9. The Brewhouse.

This small rectangular Brewhouse has a deep rubble stone plinth which appears to be much earlier in origin than the brick superstructure, which is overtly late 18th century (fig. 9). But there is no sign of any building on this site on the 1762 survey (fig. 41), though it is clearly marked on the survey of 1814 (fig. 44), suggesting that the whole of this building dates from the late 18th century. The plinth was presumably constructed at this time of stone – limestone and septaria - robbed from the ruins of Lord Darcy's mansion.

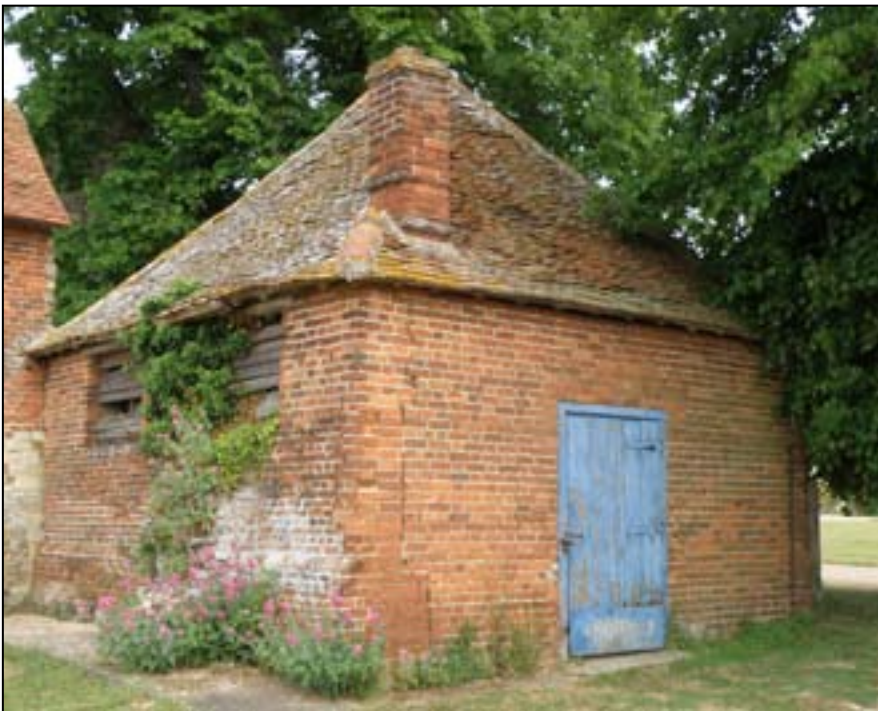
*Fig. 10. The
Drying House.*

This square brick Drying House, with a pyramidal plain tile roof and a single chimney stack at its north-west corner, has distinctive louvred openings on its west front (fig. 10).

Though probably rebuilt in its present form in the later 18th century, the chamfered brick plinth on its west front suggests that it incorporates part of a much older building, and the consistency of the size and quality of the bricks suggests that these too were re-used from an earlier building.

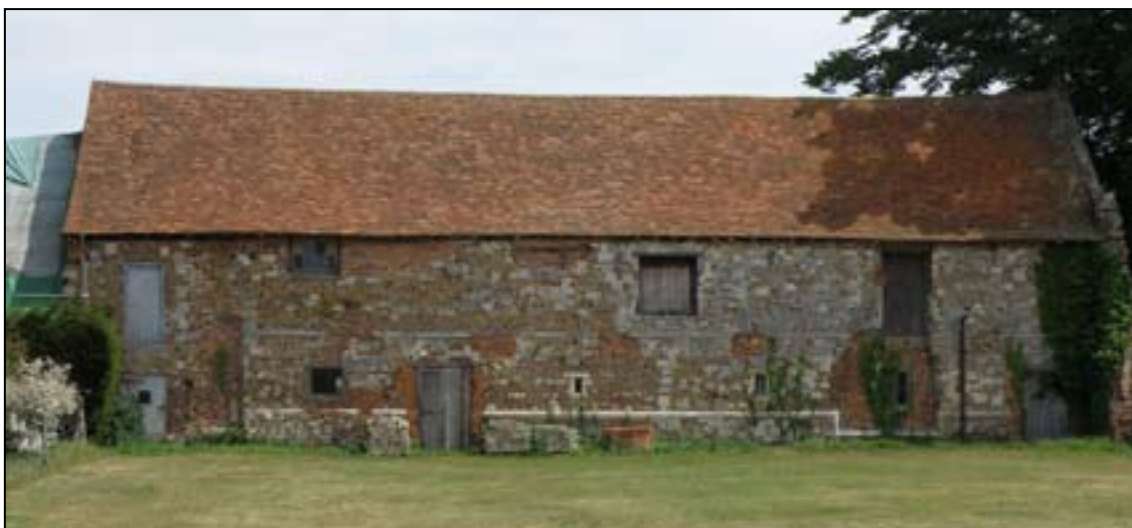
Fig. 11. The west front of the West Barn.

The irregular rubble stone walls of the West Barn are most likely 16th century, though they may well contain fragments of earlier monastic structures. They have been rebuilt, patched (with brick in places) and repaired on many occasions. Much of the stone – limestone and septaria – has been robbed from the ruins of the mid-16th century house and from the original priory. The east front has a first-floor stone band, an ashlar doorway with a stone hood, three sash windows and a number of single light ventilators. The even more irregular west front has a partial plinth and a partial first-floor stone band, and evidence of a former cart entrance to the north (fig. 11). The various openings include doors, windows and ventilators plus two taking-in doors on the upper floor. Internally there are large-scale chamfered oak beams (fig. 12). The upper floor is now unsafe and inspection of the roof was not possible. This roof is also unsafe, the roof ties have rotted and the roof is spreading, pushing the walls outwards. This fascinating architectural conundrum with its many building phases may well prove to be monastic in origin.

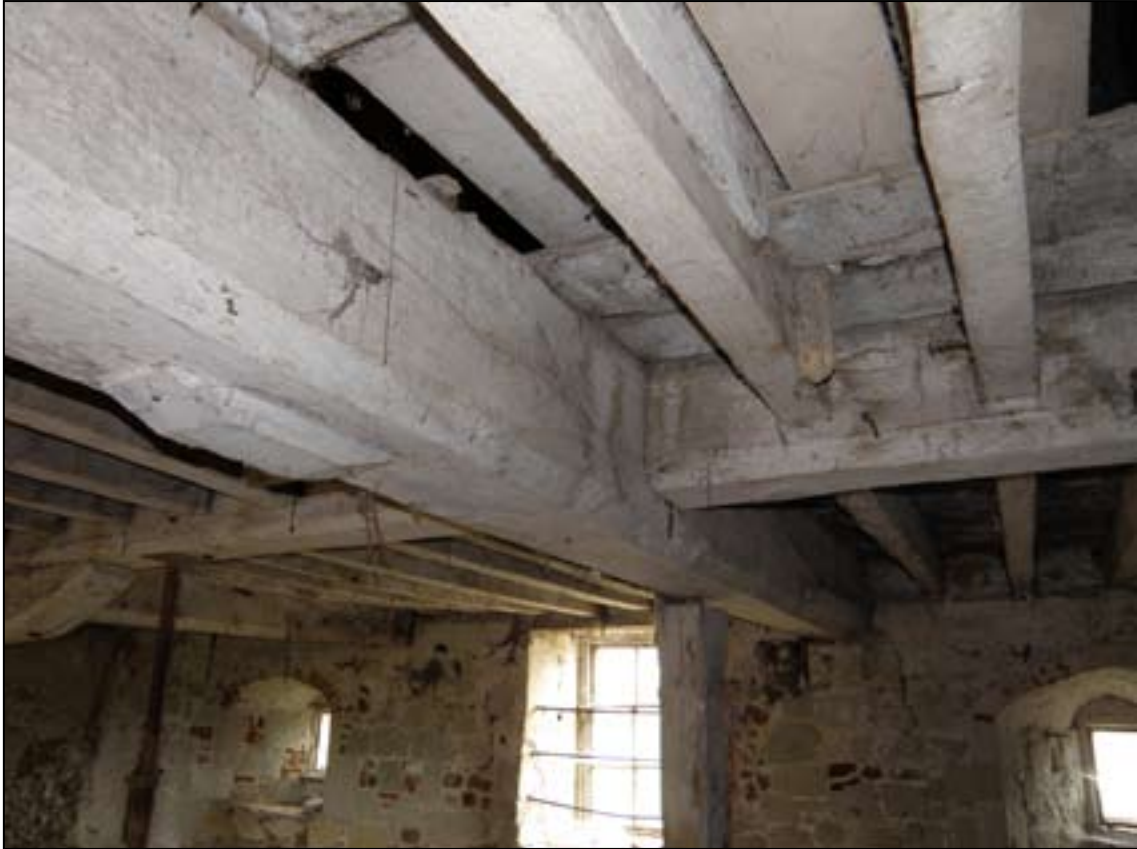
Fig. 12. The interior of the West Barn.

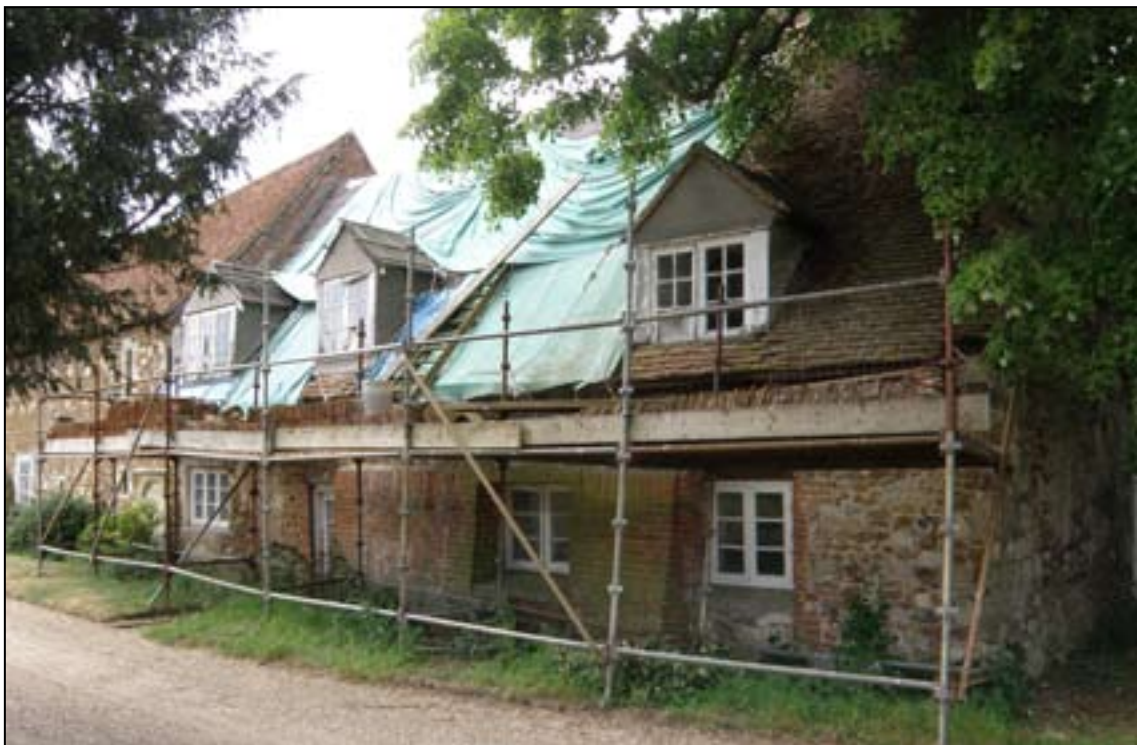
Fig. 13. The east front of the Bailiff's Cottage.

The adjoining Bailiff's Cottage (fig. 13) is built of the same mixed rubble stone as the barn, a former cushion capital can be clearly seen re-used as one of the quoins at the north-east corner of the building (fig. 14). The east wall has been buttressed and patched in brick in order to stop the overburdened roof from pushing the wall over. Recently the tiles have been removed from much of the roof in order to lighten the load on the structure. This roof timbers reputedly dates from the 13th century (not inspected). The front wall has 19th-century casement windows and three large 20th-century dormers. This building was probably converted from a farm building in the 19th century.

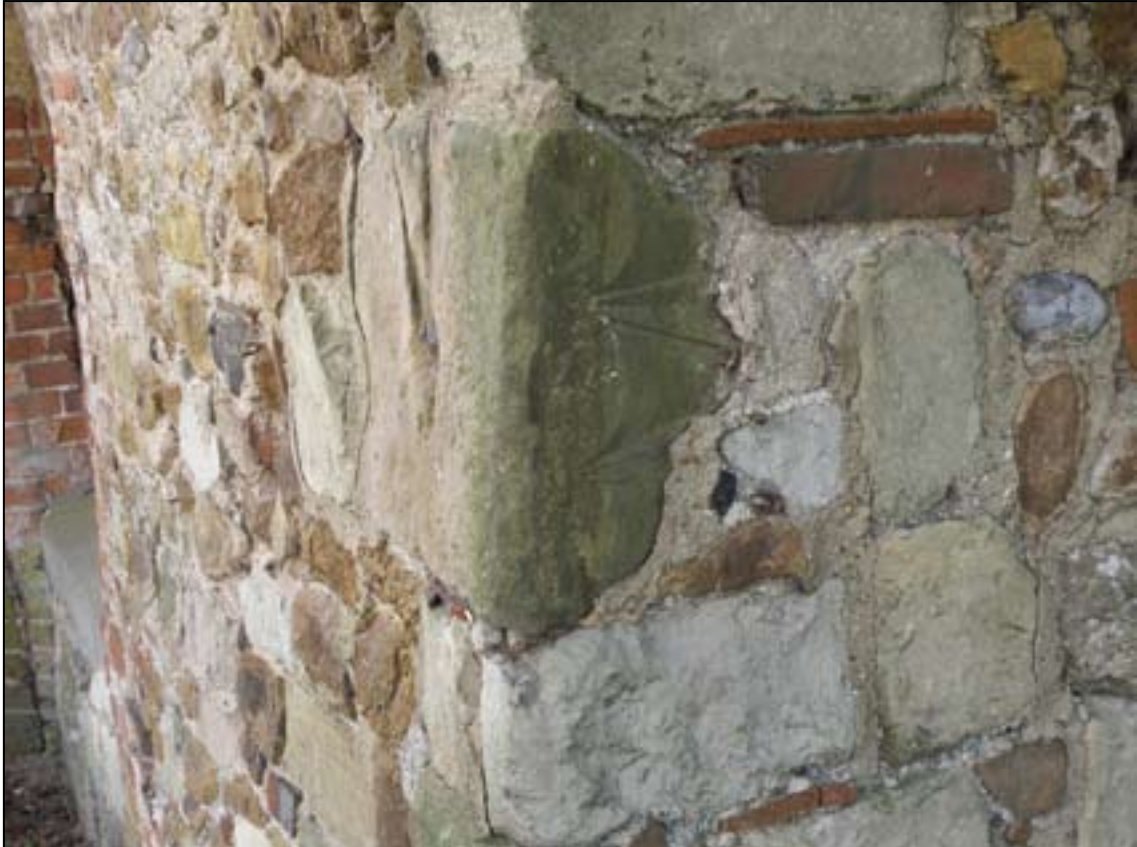
Fig. 14. A former medieval capital re-used as a corner stone to the Bailiff's Cottage.
© Pete Smith P5132889.JPG

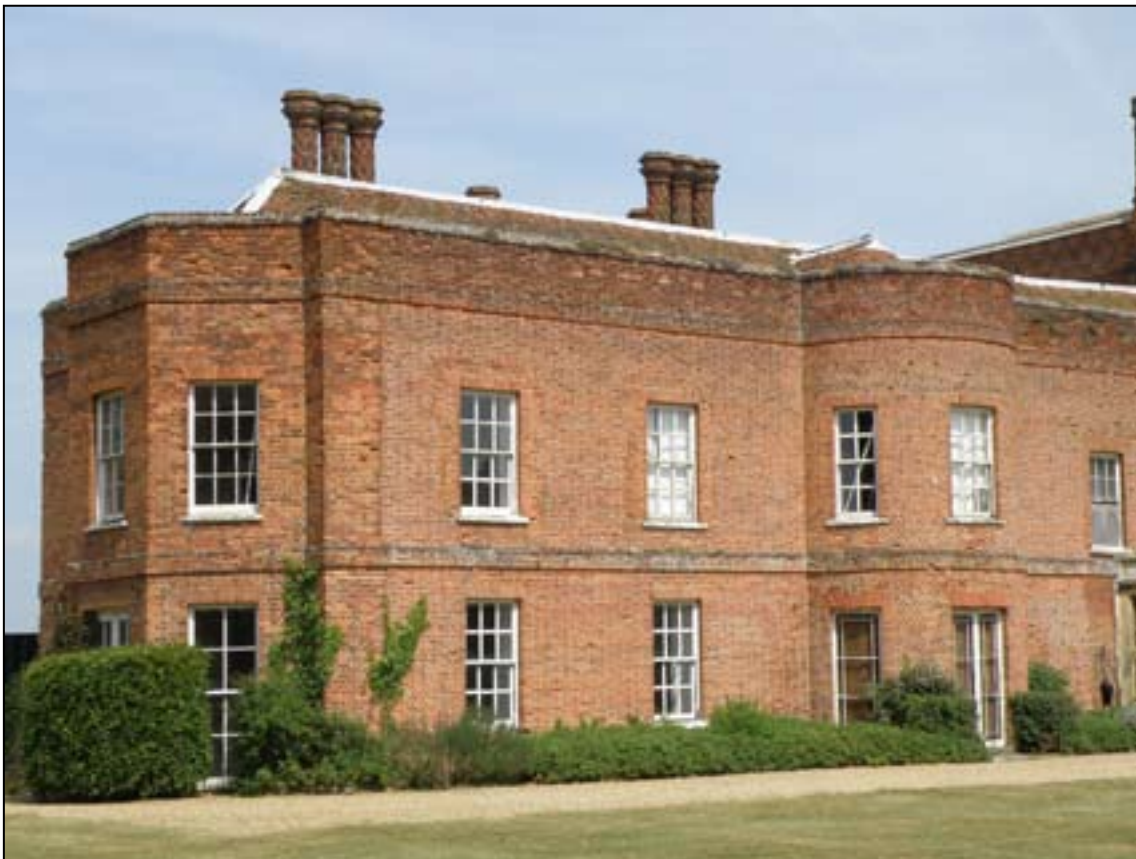
Fig. 16. The south and west fronts of the 18th Century House.
© Pete Smith P5132909A.JPG

Sometime after the 3rd Earl of Rochford made St Osyth's Priory his principal residence in 1721 he added what appears to have been a new house to the west of the Bishop's Lodging. This range was then extended right across the north side of this court, probably by William Henry Nassau de Zuylestein, the 4th Earl.¹¹ The 3rd Earl's new house was three-storey with a central doorway topped by a swan-necked pediment (fig. 15). The surviving two-storey brick range with astylar window surrounds and sashes appears to date from the mid-18th century (fig. 16). The western section of this range, which probably contained the most impressive reception rooms, was demolished in 1859. The present west front of the 18th Century House, with its canted two-storey bay window, must therefore have been built after this range was demolished (fig. 17). It is built of the similar brick to the remainder of the 18th Century House, brick which was presumably reused from the demolished range. A distinct break in the brickwork is still clearly visible at the western corner of the south front. The 18th Century House has a two-storey

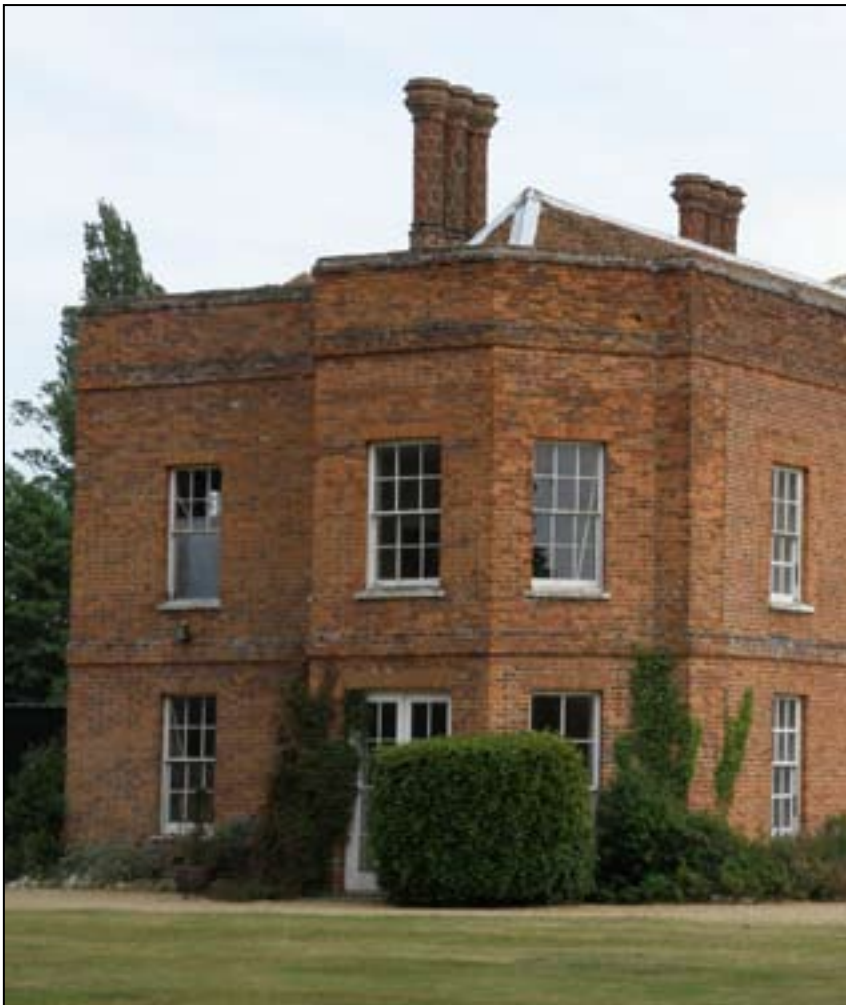
Fig. 17. The north front of the 18th Century House. This front was rebuilt in 1859 after the remainder of this wing was demolished.

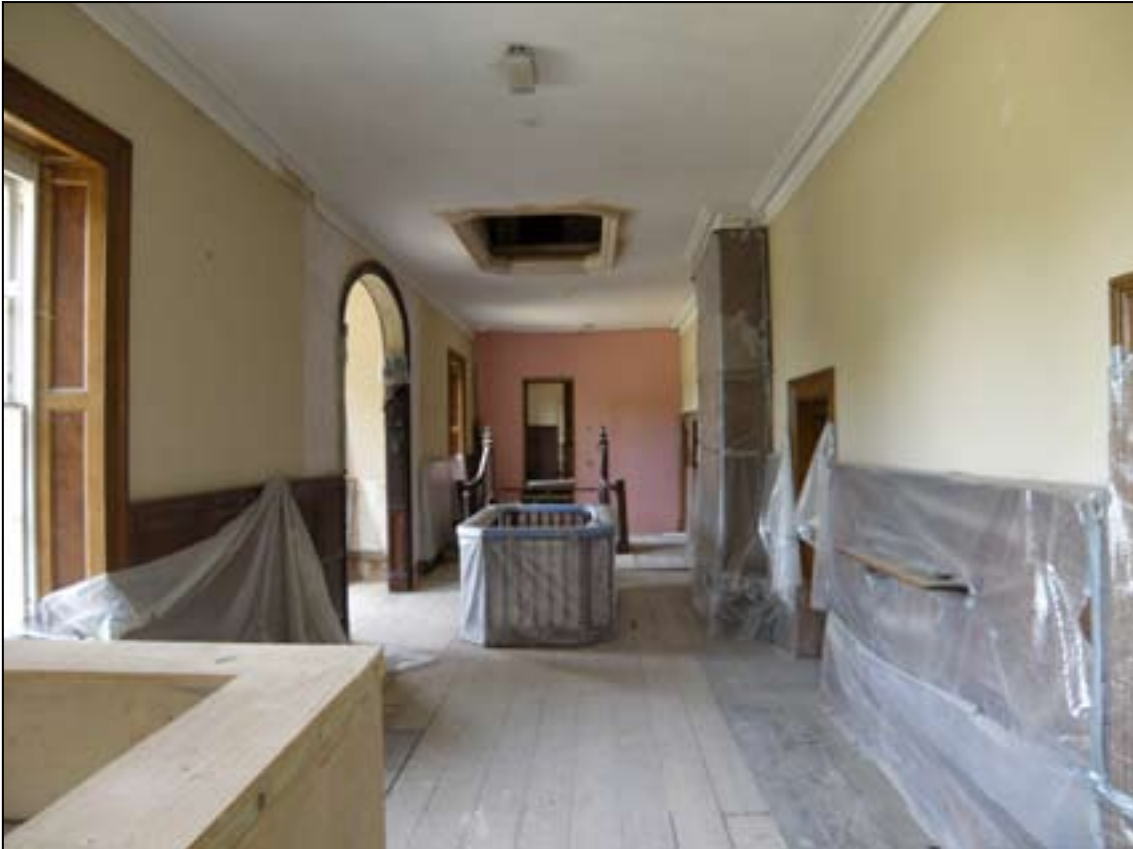
Fig. 18. The interior of the 18th Century House altered in the 19th and 20th centuries.
© Pete Smith P5132899.JPG

bow window at the centre of its south façade and a two-storey porch on its north side. The plan of this building consists of a corridor and stair on the north side (fig. 18) and a range of rooms to the south. This range has been altered internally in the 19th and 20th centuries. Two 18th-century chimney pieces survive though they may have been moved. One room has panelling made from 18th-century box pews, introduced in the late 20th century, when the rooms in this section of the house were redecorated. One of the windows contains 18th-century painted glass panels depicting various female occupations.

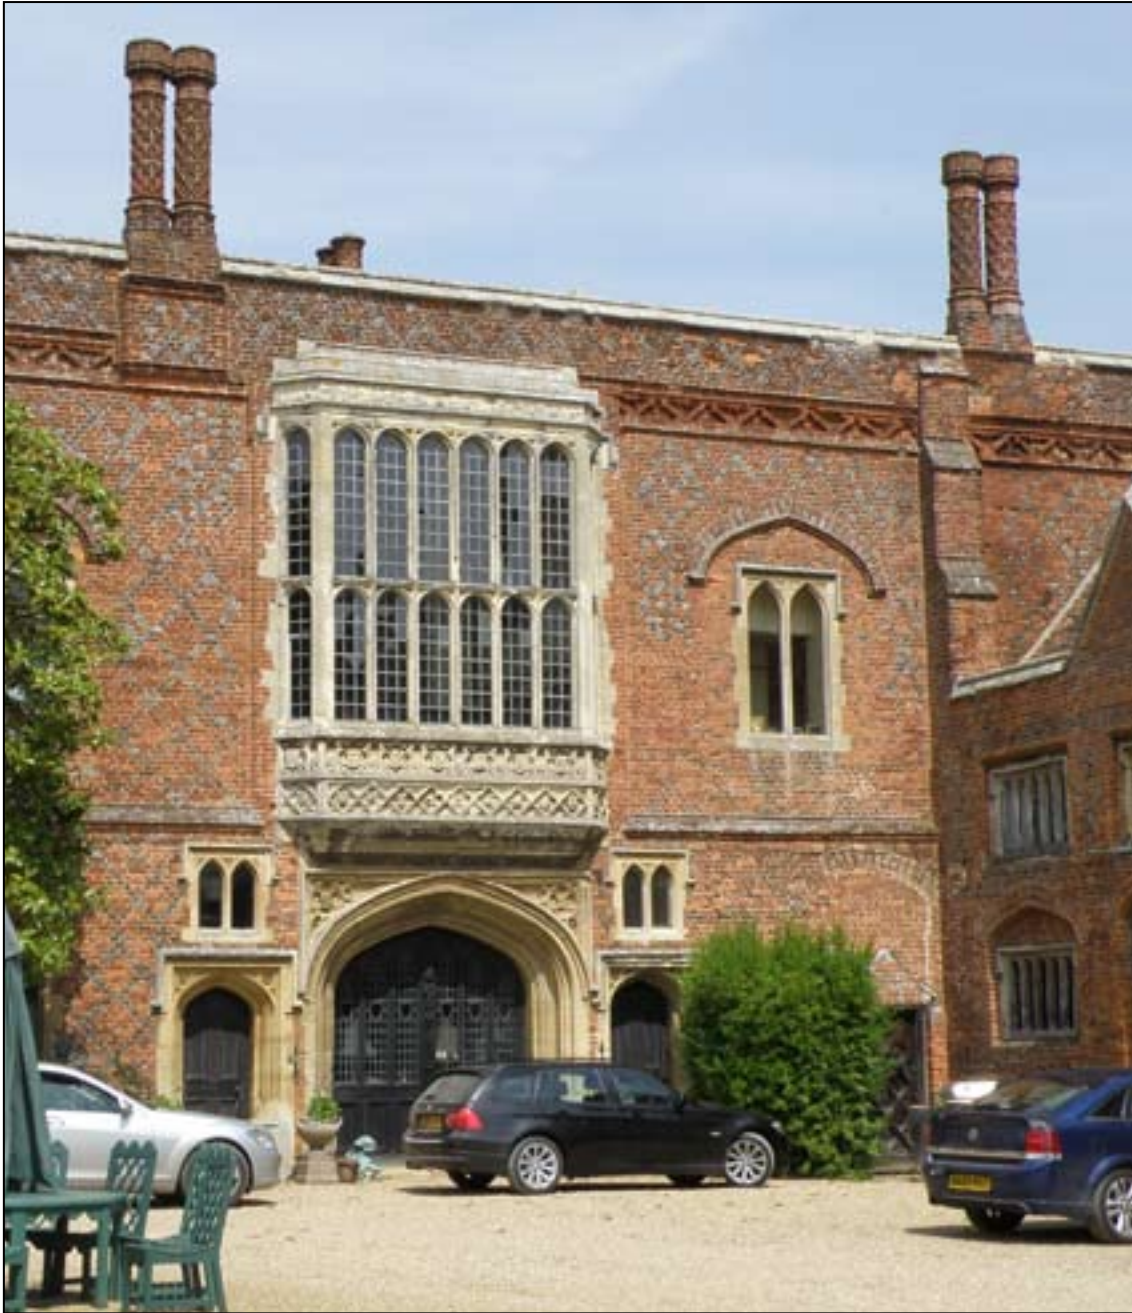
Fig. 19. The south front of the Bishop's Lodging.

The Bishop's Lodging was originally built by Abbot Vyntoner in red brick with black brick diapering in 1527 (fig. 19). After being damaged in the Civil War, this building was eventually incorporated into the new house built by the Earl of Rochford in the 18th century. It was then largely rebuilt, apart from its south wall, in 1866-69 for Sir John Johnson. This south wall is dominated by a huge first-floor oriel window, itself largely rebuilt in the 19th century, though retaining its frame and its fine carved head and carved

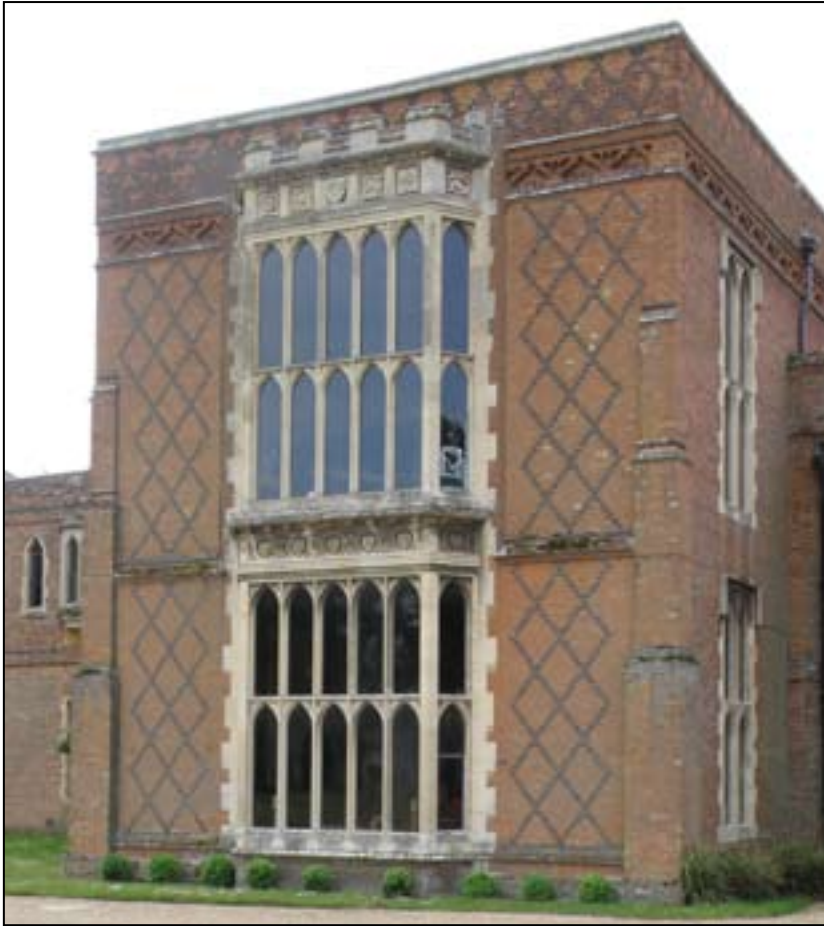
Fig. 20. The north front of the Bishop's Lodging rebuilt 1866-69.

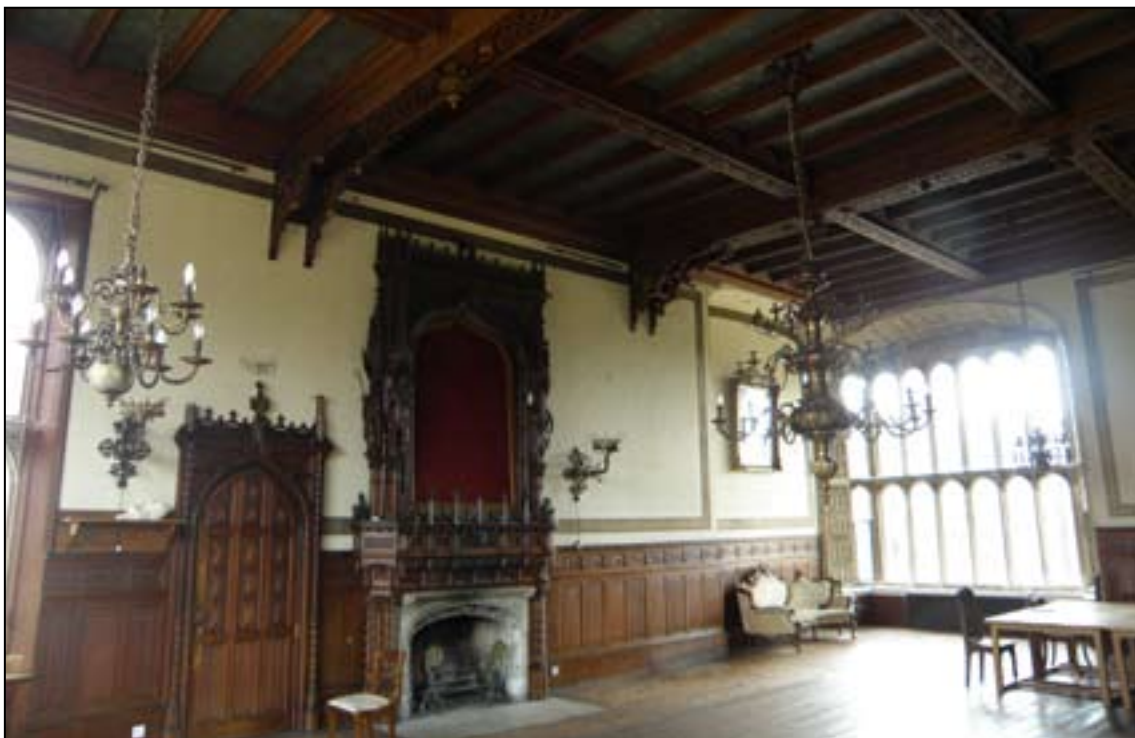
Fig. 21. The interior of the first floor room in the Bishop's Lodging rebuilt for Sir John Johnson 1866-69.

within the ceiling were painted with flowers by Edward Ladell. The elaborately decorated wooden fittings, all in the Gothic Revival style, include dado panelling, pointed arched doorcases, shutter boxes and a suitably exuberant chimney piece. The room also retains a set of fine Gothic Revival-style wall gasoliers (fig. 22). This is by far the most interesting and important 19th-century interior in the whole complex. The equally large but lower room below has a similar ceiling and plainer wooden fittings.

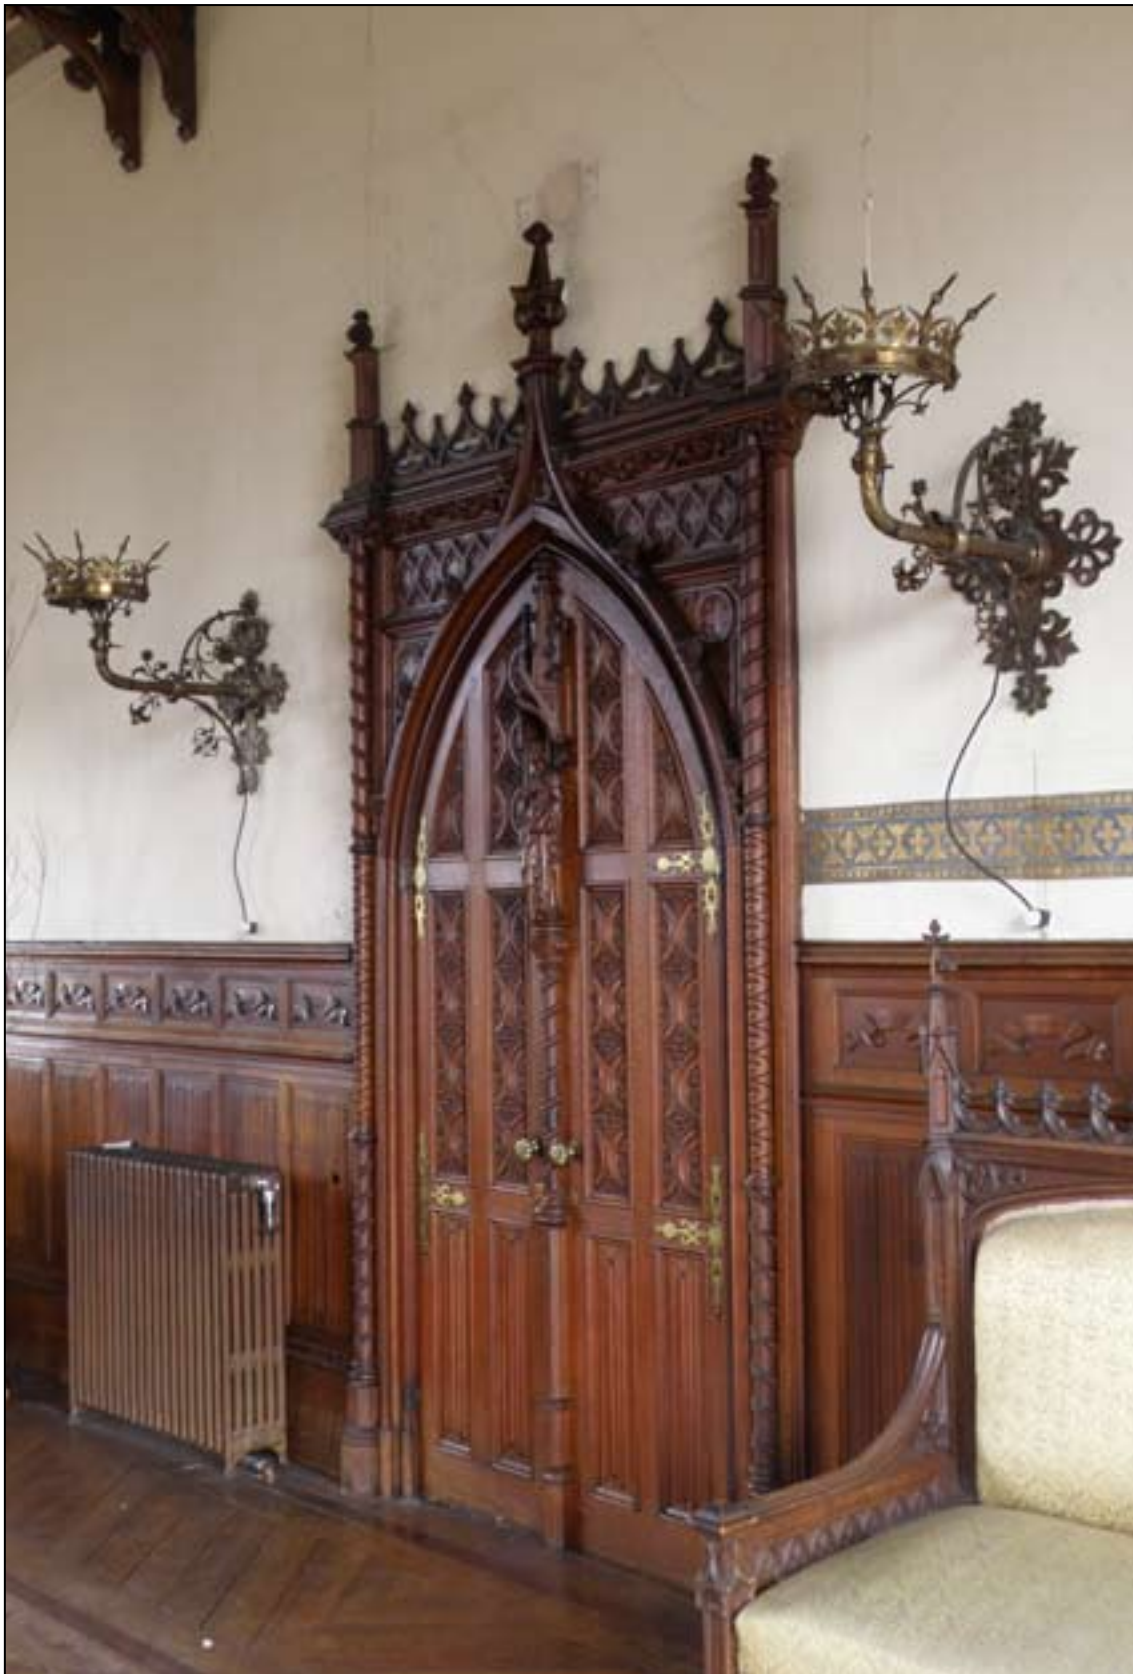
Fig. 22. The west doorway flanked by gasoliers in the first floor room of the Bishop's Lodging.
© Pete Smith P5132835.JPG
