ST OSYTH,
ESSEX
ST OSYTH'S PRIORY
HISTORIC BUILDINGS REPORT

Research Department Report Series 074-2011

**ST OSYTH'S PRIORY
ST OSYTH
ESSEX
HISTORIC BUILDINGS REPORT**

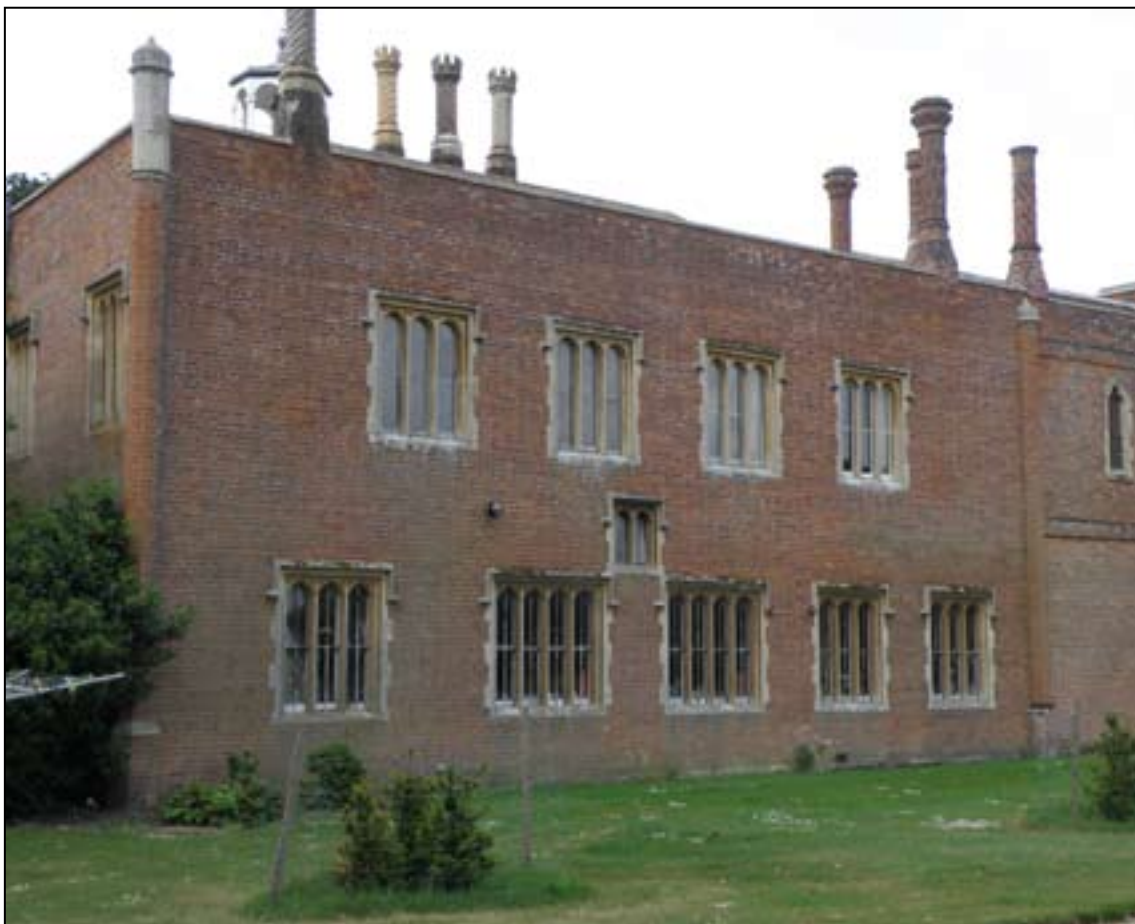
Fig. 23. The Service Wing built in the 1860s and altered internally in the 20th century.
Pete Smith P5132850.JPG

This Service Wing was added onto the east end of the Bishop's Lodging in the 1860s for Sir John Johnson. The building probably stands on the site of the original monastic kitchen. The Service Wing is built of machine-made bricks and has stone mullion windows with Tudor hood moulds (fig. 23). Its hipped slate roof is hidden behind a brick parapet. This range was extensively remodelled internally in the 1950s during the building's use as a convalescent home.

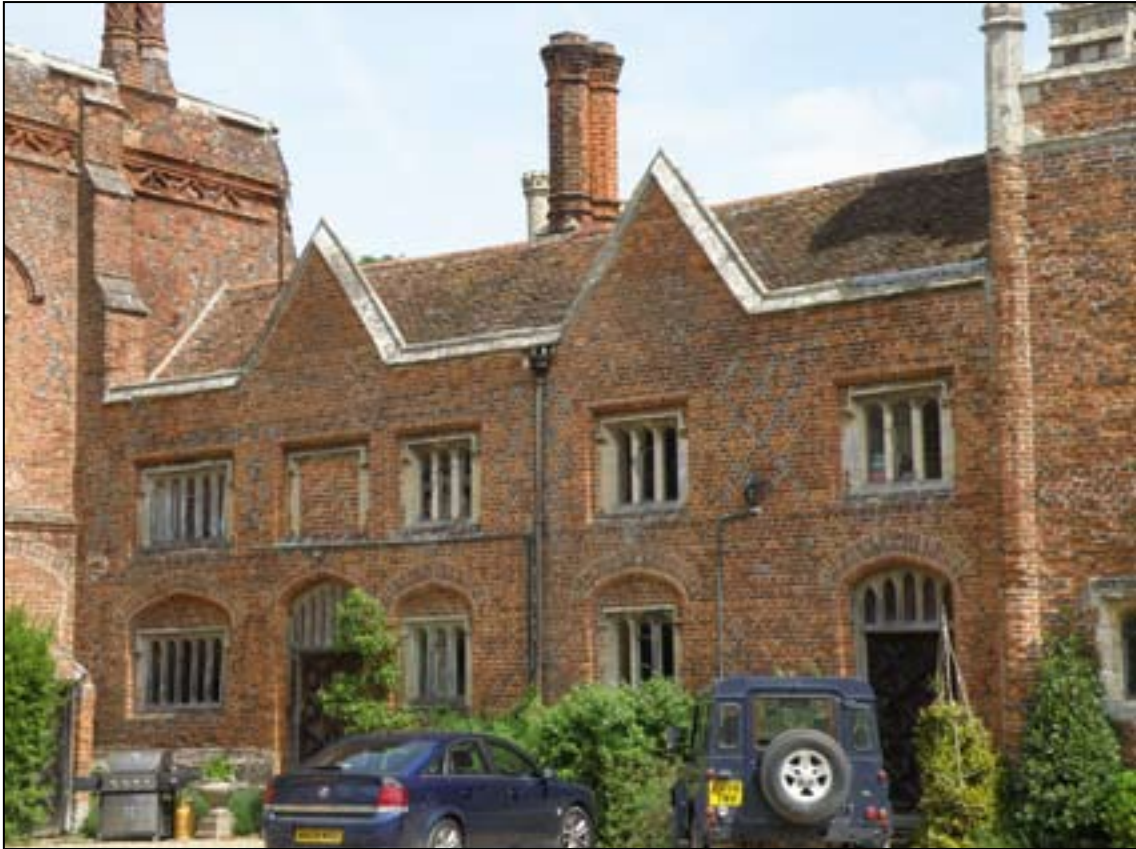
Fig. 24 The northern section of the east front of the South Wing. © Pete Smith P5132912.JPG

The northern end of this range was constructed as part the Bishop's Lodging created by Abbot Vyntoner (fig. 24). The southern section originally formed part of the northern end of the cellarer's range of the priory. It was rebuilt largely in brick for Lord Darcy in the mid-16th century (fig. 25). His additions also included the tall octagonal Clock Tower on the east side of this range, which is faced with distinctive chequer-work in two colours of stone - limestone and septaria - with flint galleting and has two-light mullion windows (fig. 26).¹² The tower is crowned by an octagonal wooden cupola with a lead roof added in the 18th century. This cupola is not shown on the engraved view of the Priory published in 1772.¹³ This tower also has copper clock dials on its south and west faces, these too date from the later 18th century.

of this range is divided into two sections: a lower two-storey section to the north which was built in 1527 as part of the Bishop's Lodging (fig. 24) and a taller two and a half-storey mid-16th century section to the south (fig. 25), both with straight gables. The brick and stone south front was built in various phases (fig. 25). It is unified by a gable and parapet with the same distinctive chequer-work and two unusual stone chimney stacks added for the 1st Lord Darcy. Internally the southern end of this range retains a number of vaulted rooms with chamfered ribs and pointed arched doorways which date from the 13th century (fig. 27). The upper floors were rebuilt in the 1860s. The northern section of this range is still shown as partially roofed in views of the priory published in 1847 (fig. 28) and 1895.¹⁴ It was reroofed and refitted for Sir John Johnson in around 1900 and all the internal fittings are of this date.

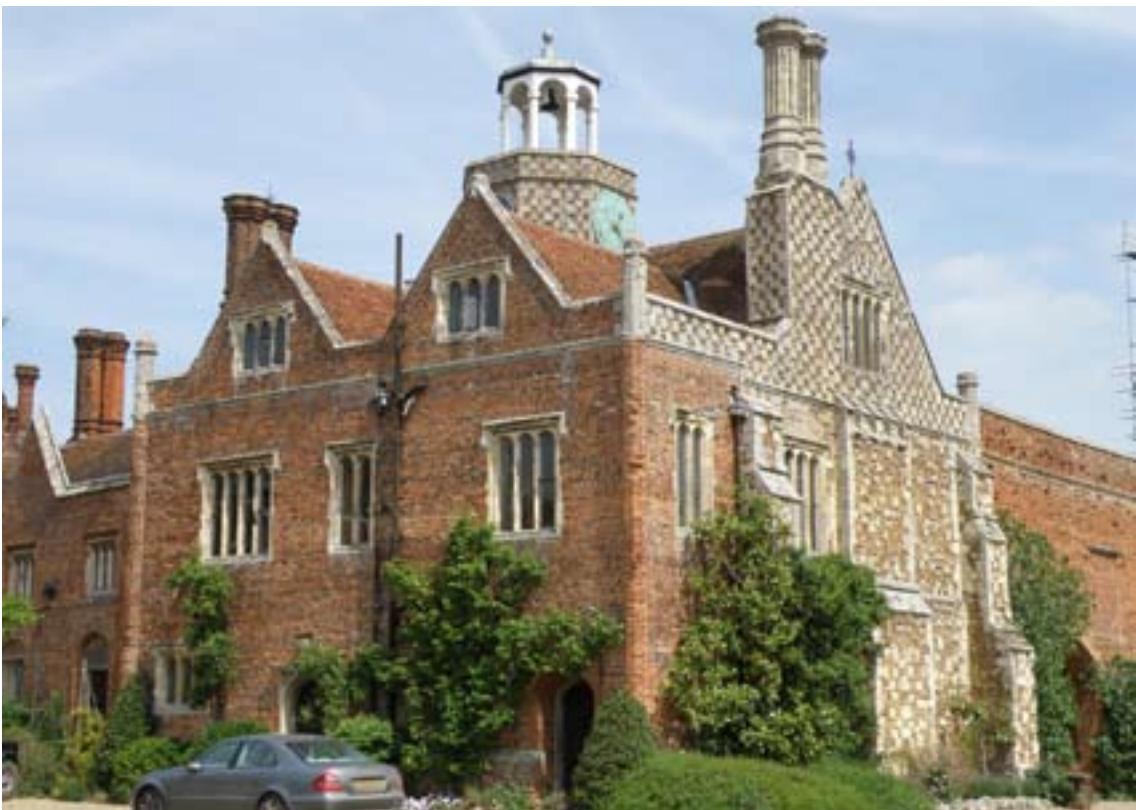
Fig. 25 The south and east fronts of the South Wing. © Pete Smith P5132913.JPG

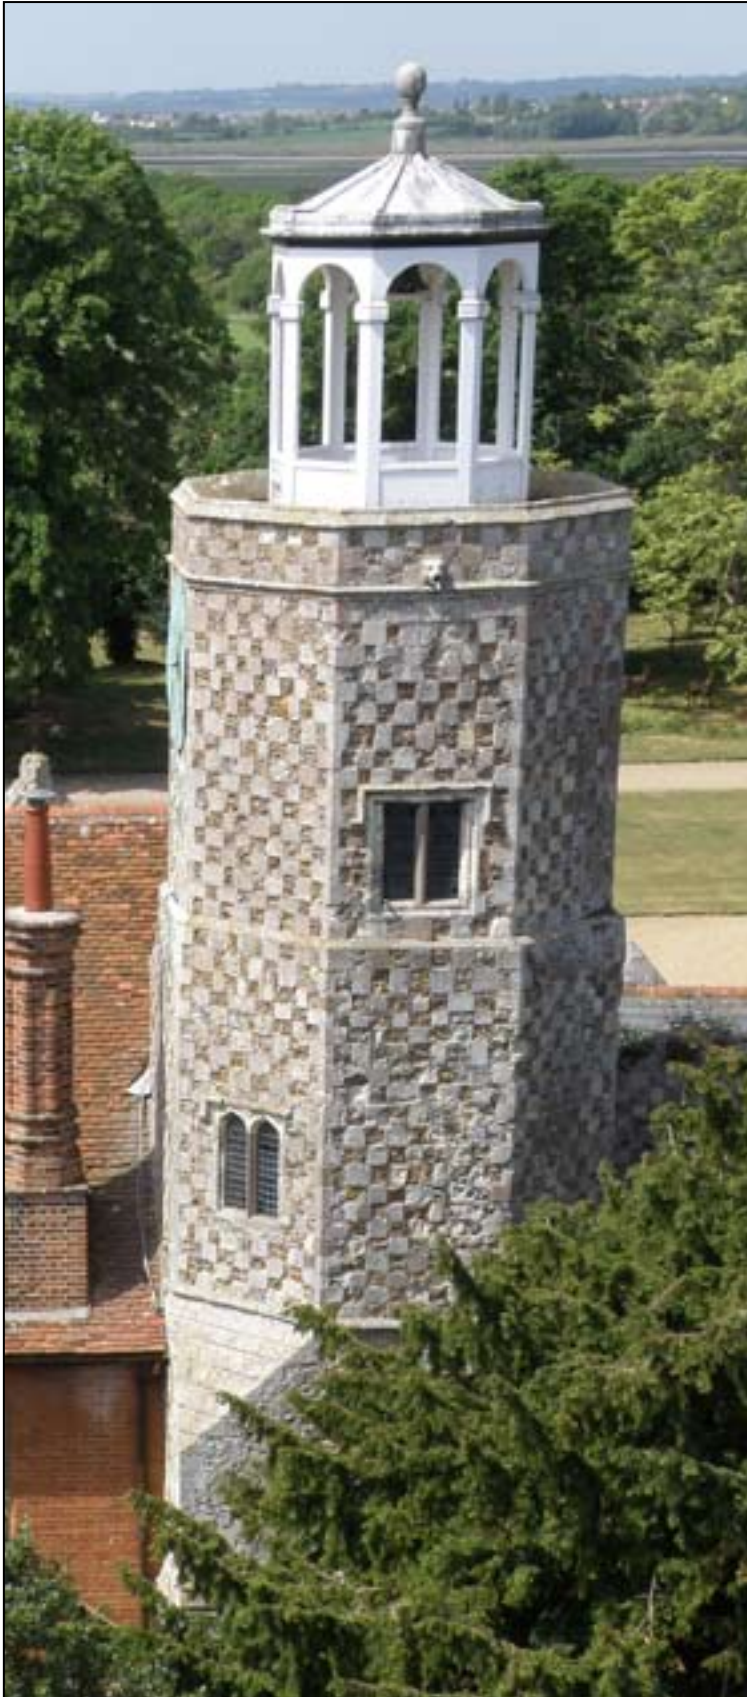
Fig. 26. The Clock Tower. © Pete Smith P5132866A.JPG

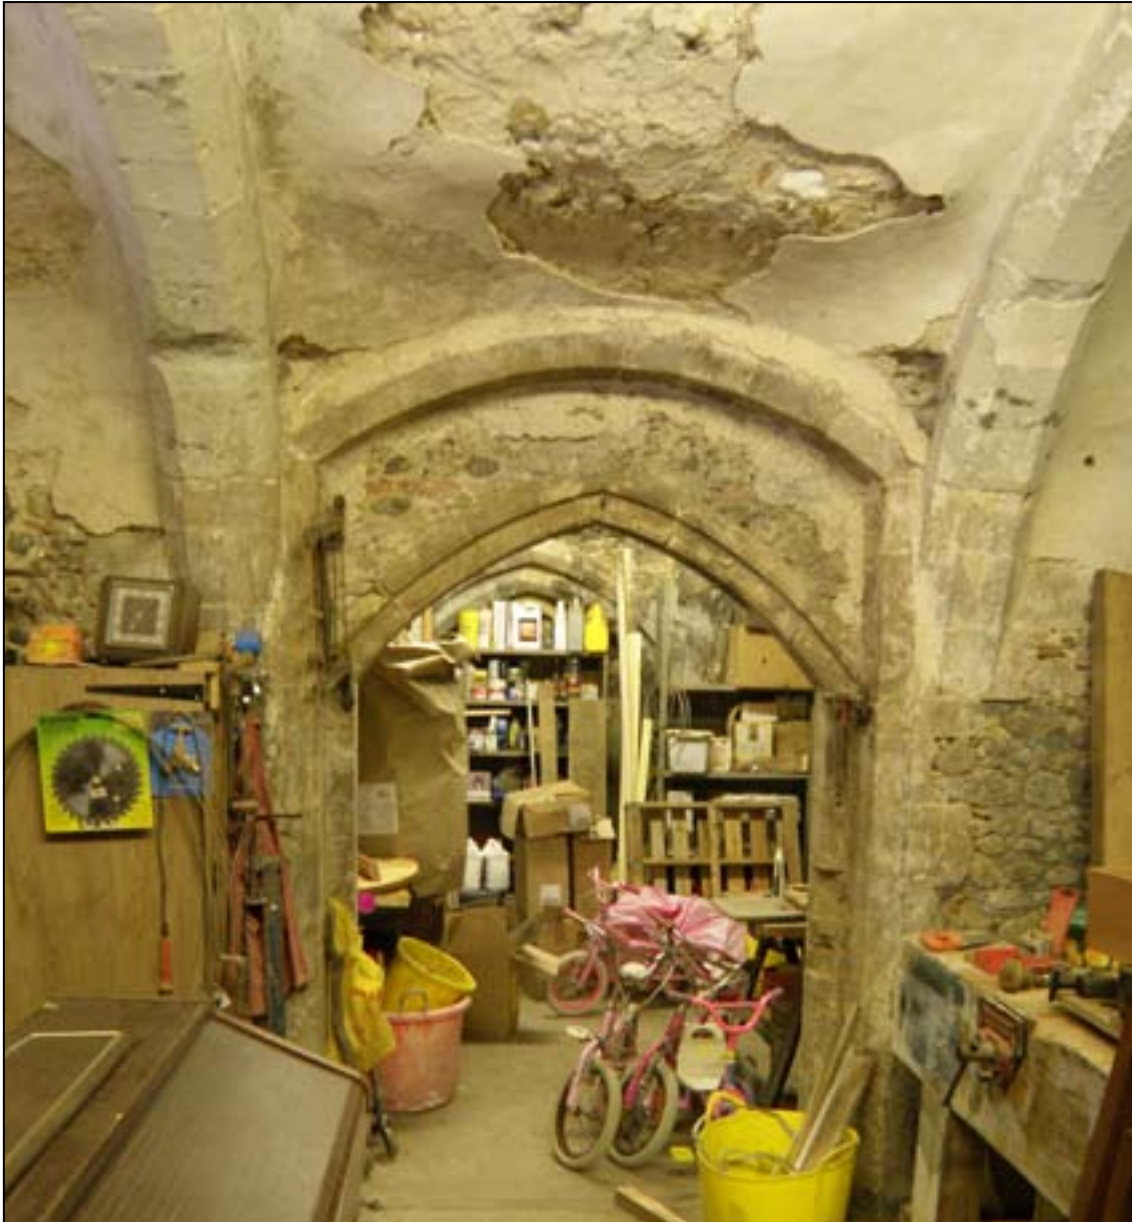
Fig. 27. The medieval vaulted rooms on the ground floor of the South Wing.
© Pete Smith P5132820.JPG

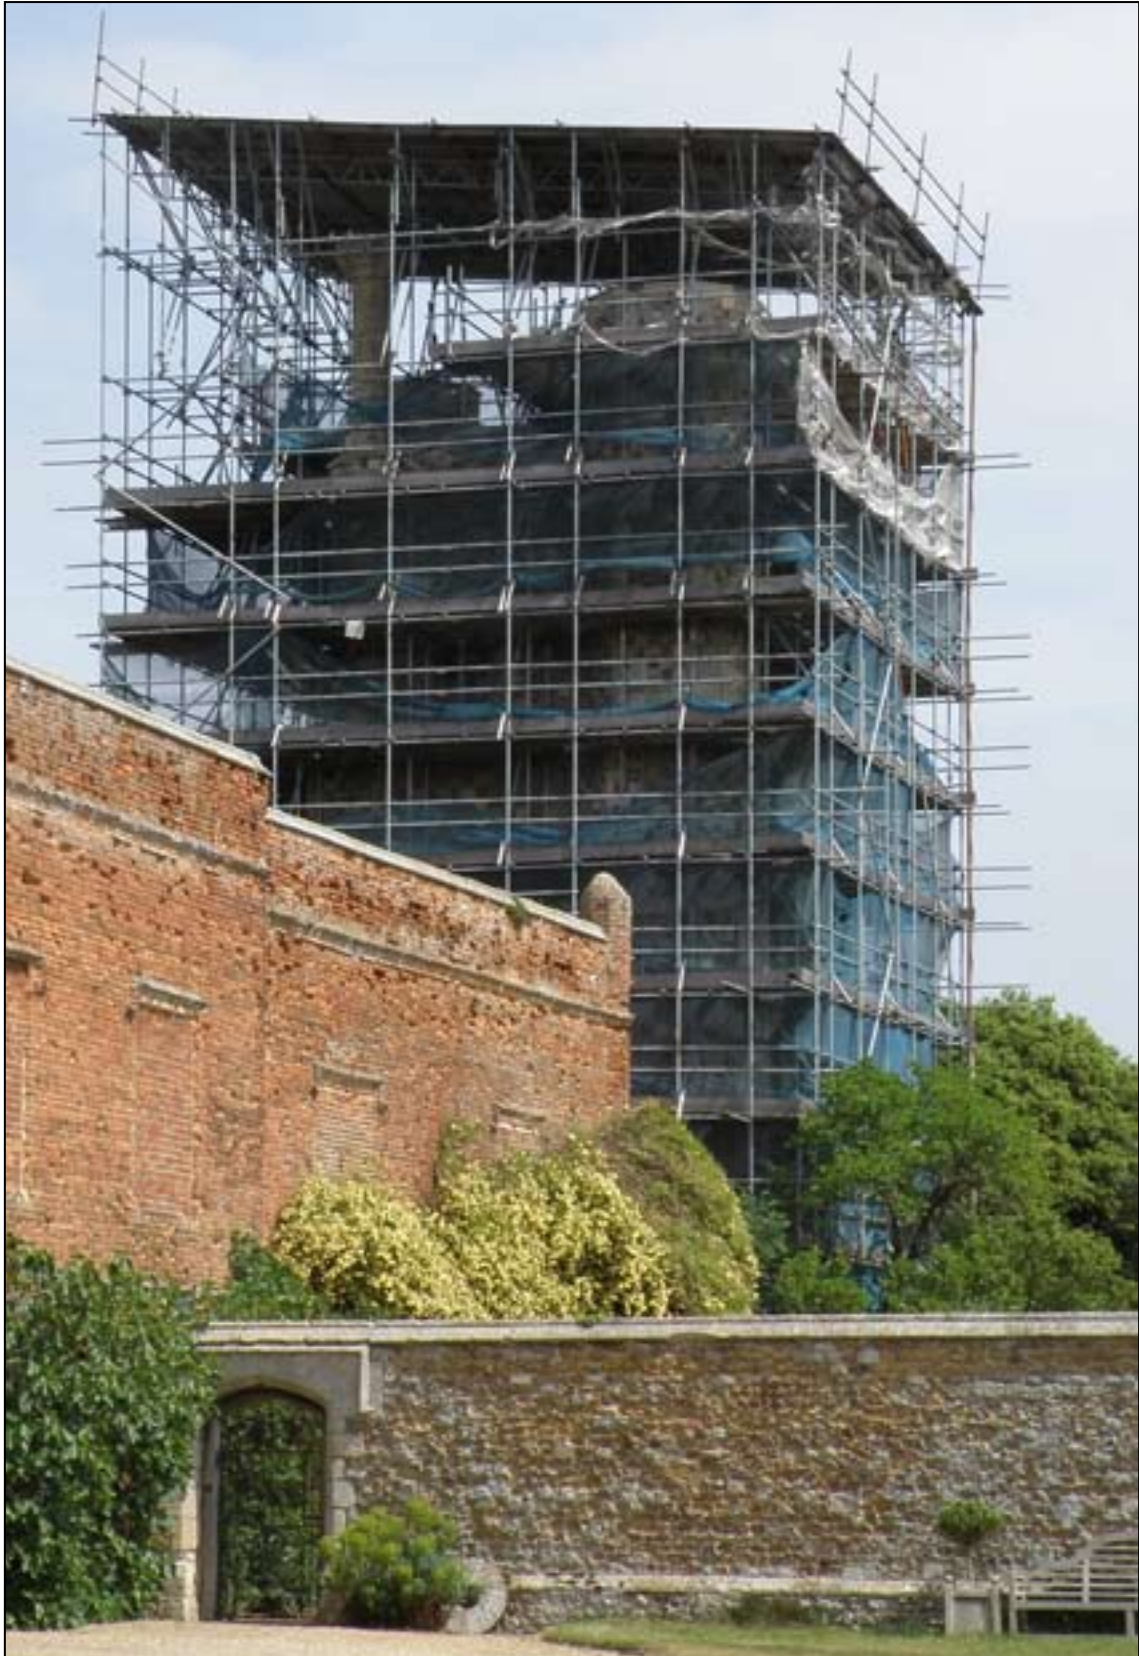
Fig. 29. The Abbot's Tower at present clad in scaffolding and undergoing restoration.
© Pete Smith P5132915A.JPG

The Abbot's Tower survives as the single most important part of Lord Darcy's new house built in the mid 16th century, and it is still the most prominent building on the site. At present the building is hidden beneath scaffolding (29). The tower has three tall octagonal corner turrets which are square in plan on the ground floor and octagonal above. The fourth corner is topped by an elaborate brick chimney stack. The tower is constructed of the distinctive chequer-work in two colours of stone, limestone and septaria, with flint galleting (fig. 30) which is indicative of the additions made for the 1st Lord Darcy. Internally the three tower rooms retain little original fabric apart from a single chimney piece with an additional early 18th-century surround (fig. 31). Unlike almost all other towers on contemporary country houses this tower was not part of a gatehouse, instead it seems to have functioned as a prospect or viewing tower. It would have provided spectacular views of the gardens and the park. It may also have functioned as a beacon given its coastal position. Stretching to the north are the substantial ruins of a further range of Lord Darcy's house. This range retains much of its east wall with extant window and door openings and at least one complete chimney stack. The tower was attached to the eastern end of the former refectory range which was also remodelled for Darcy. The fragmentary remains of the building at the eastern end of this range - the former passage to the frater range - was transformed into the Chapel by Sir

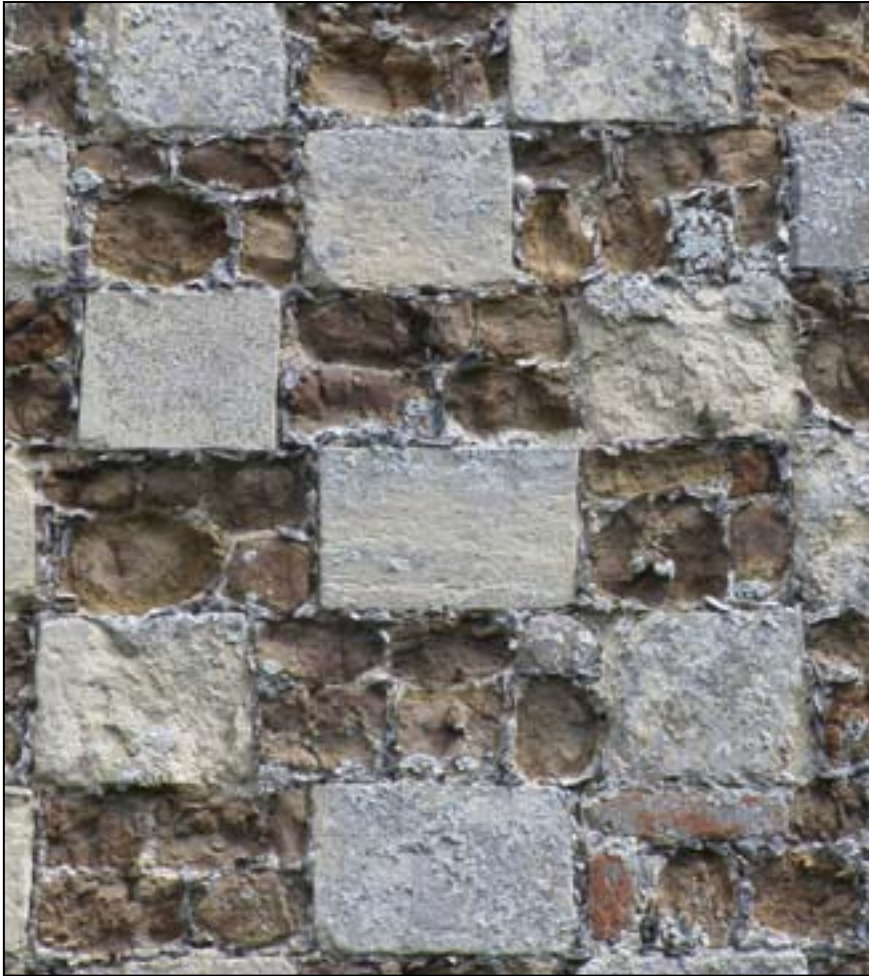
Fig. 30. A detail of the distinctive limestone and septaria chequerwork with flint galleting on the Abbot's Tower.

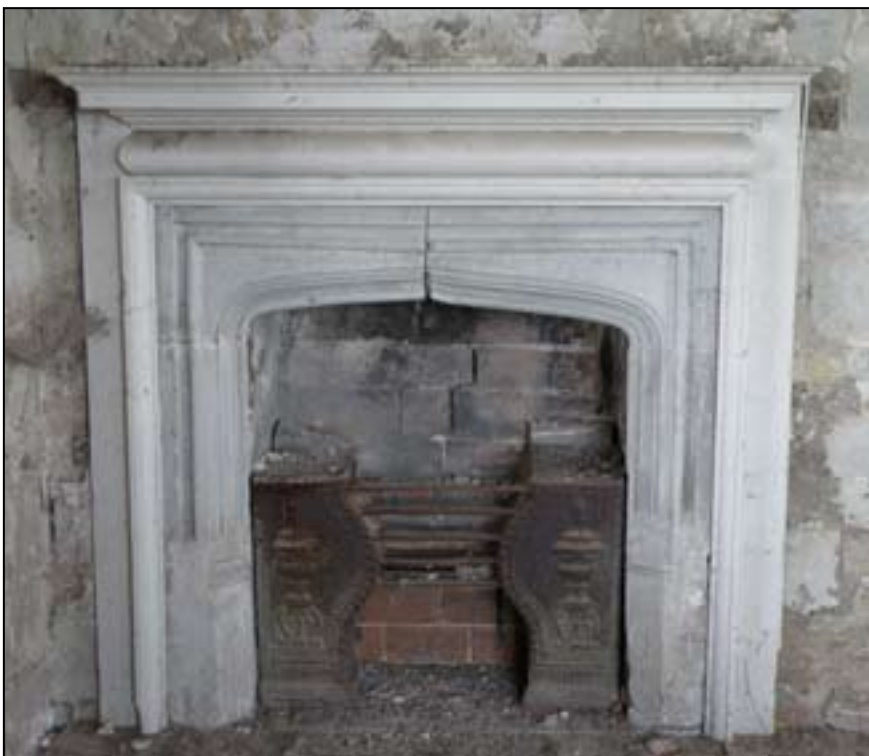
Fig. 31. A surviving 16th century fireplace with an added early 18th century fire surround, and a late 18th century basket grate in the Abbot's Tower.

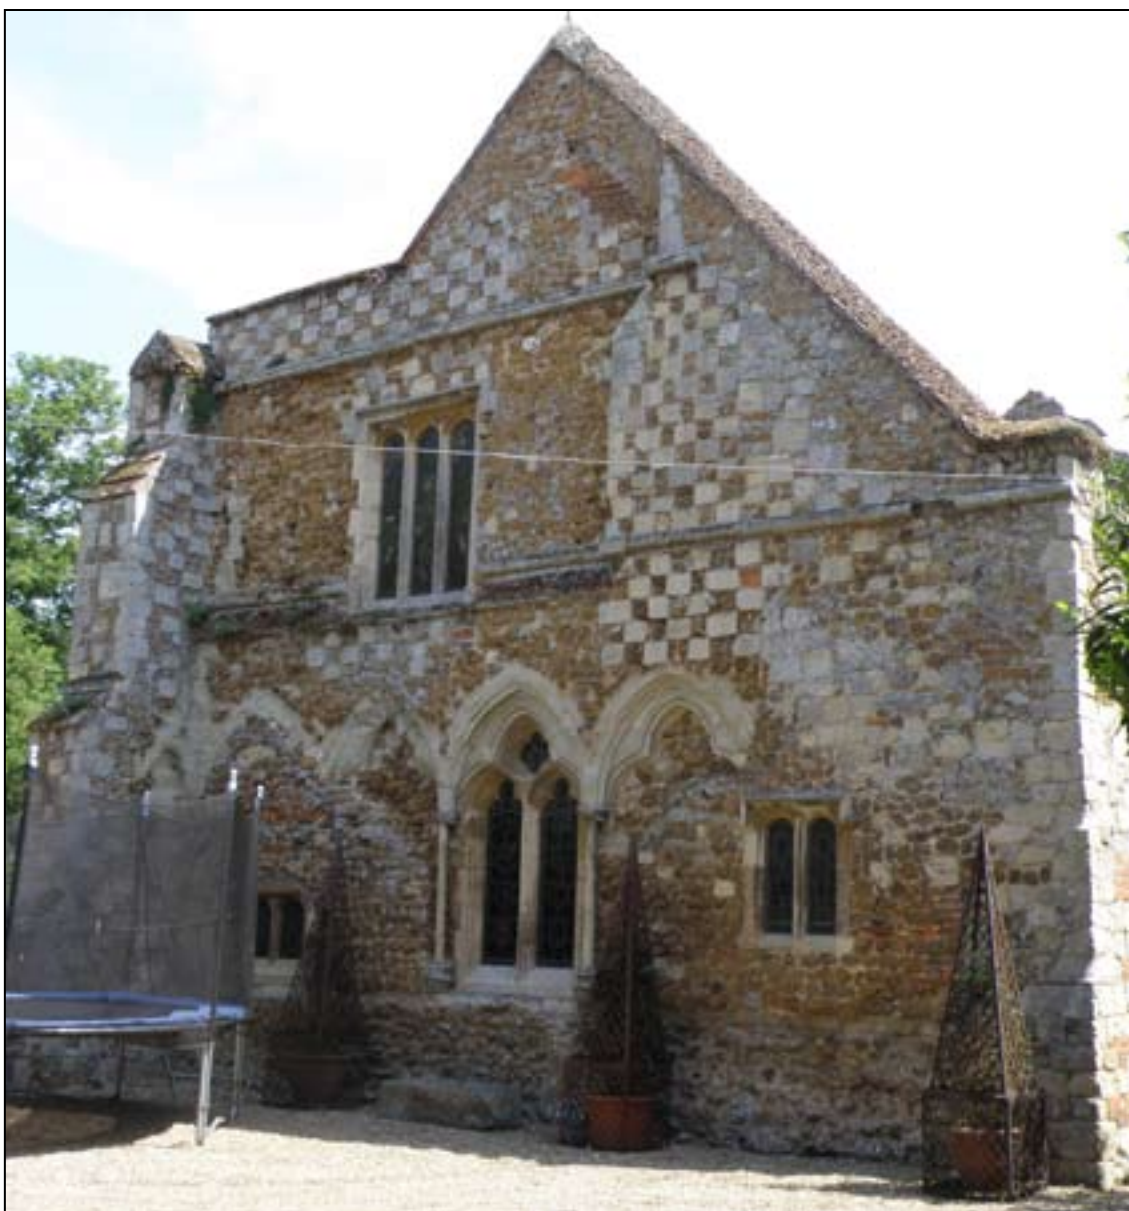
Fig. 32. The west front of the Chapel created in the late 19th century for Sir John Johnson
© Pete Smith P5132861

John Johnson in the late 19th century (fig. 32).¹⁵ This chapel incorporates important original medieval fabric, including its ribbed quadrupartite vaults of c. 1230. The earlier appearance of this space was recorded in an engraving published in 1873 (fig. 34). The present interior is an interesting mixture of the medieval and the Gothic Revival style (fig. 33). Most of the adjoining range, apart from its brick south wall (figs 29 and 35), probably built by the 2nd Lord Darcy around 1600, was severely damaged in the Civil War and then allowed to fall into a ruinous state. The surviving brick wall retains its blocked windows with Tudor hood moulds, their original brick mullions and transoms can still be seen on its northern side (fig. 36). A large brick four-centred archway was inserted through the western end of this wall in the late 19th century.

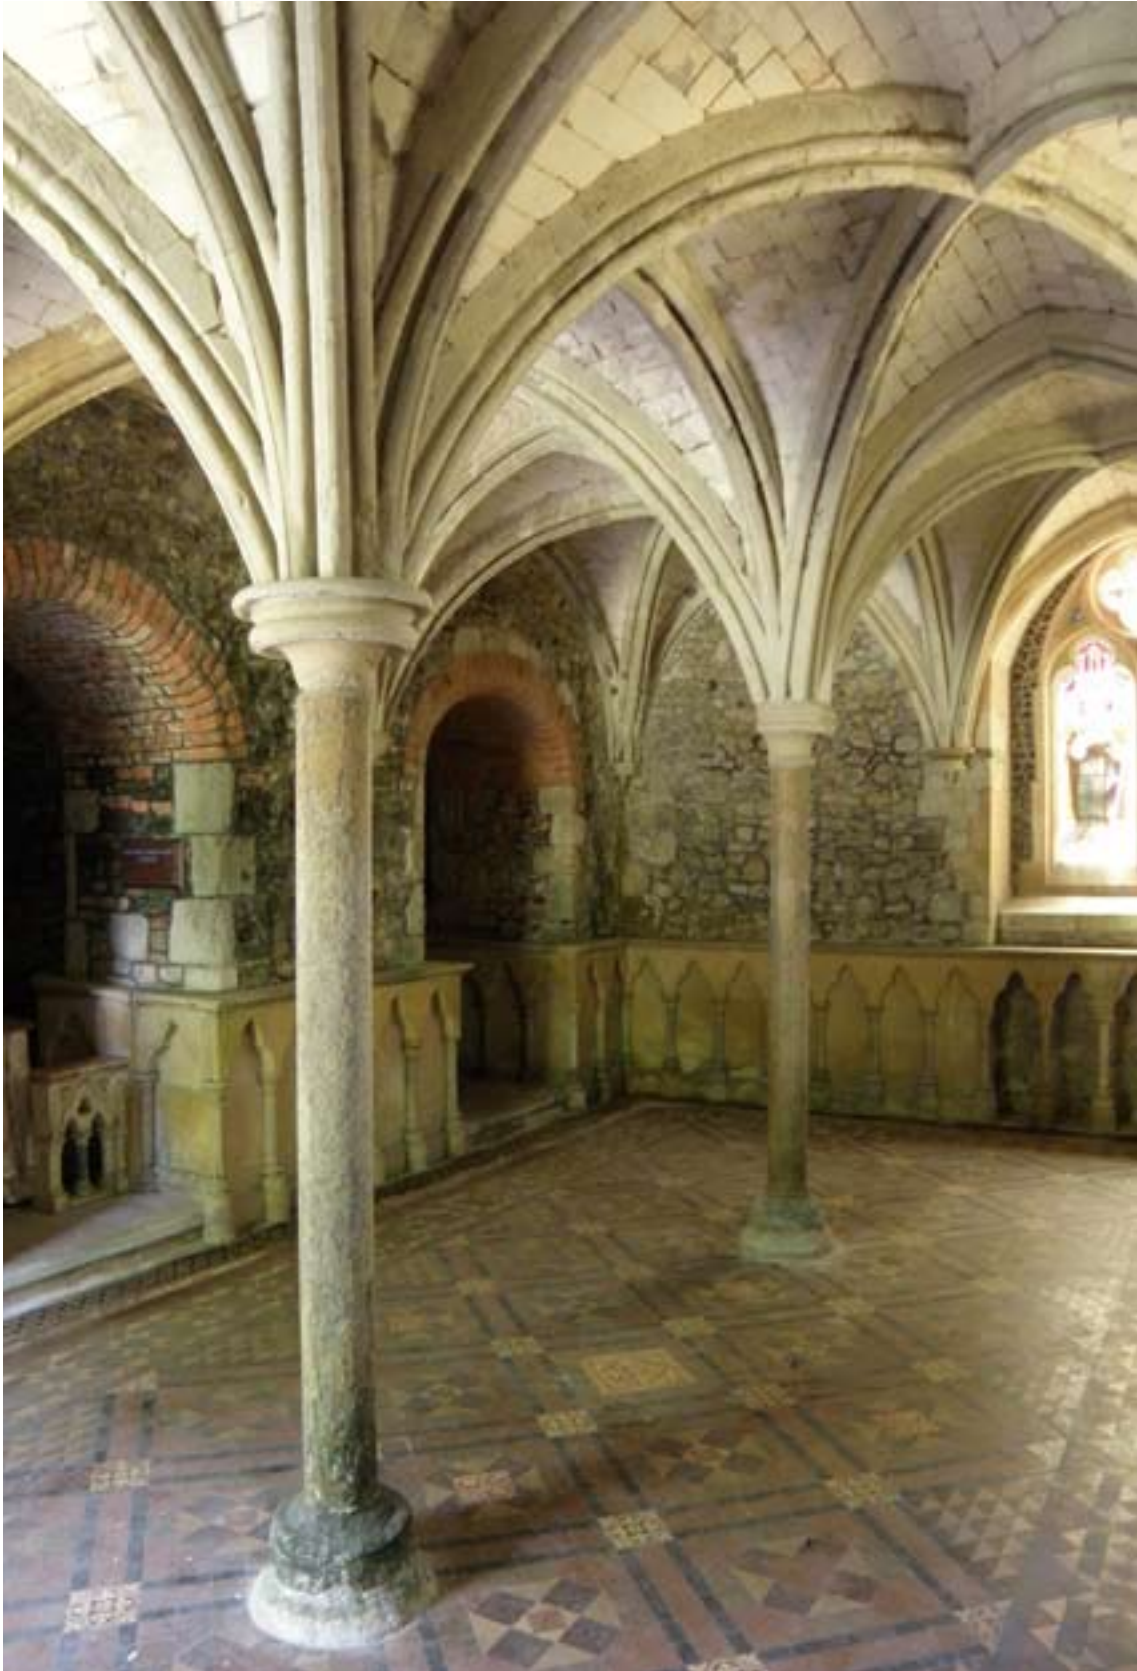
Fig. 33. The Chapel created for Sir John Johnson from the former passge to the frater range of the monastic buildings.
© Pete Smith D513856.JPG

Though the external structure of many of these buildings survives (often in poor condition) relatively little survives internally. The plain interiors of the Gatehouse survive, as does the Chapel (fig. 33), the early vaulted rooms in the Clock Tower range (fig. 27) and the rooms in the Abbot's Tower (fig. 31). But the destruction of all the interiors of Lord Darcy's house in the Civil War and the subsequent large-scale destruction of the house built to replace it in the 18th century, means that most of the surviving interiors date from after 1850. The two huge rooms in the Bishop's Lodging, so radically

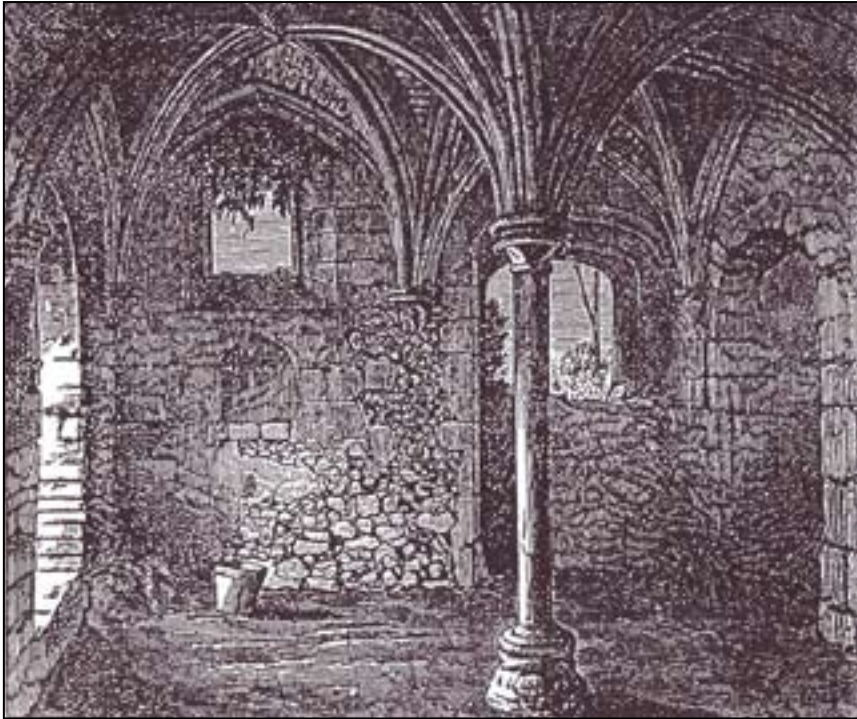
Fig. 34. An engraving published in 1873 showing the ruined former passage to the frater range of the monastic buildings before its conversion into the Chapel.

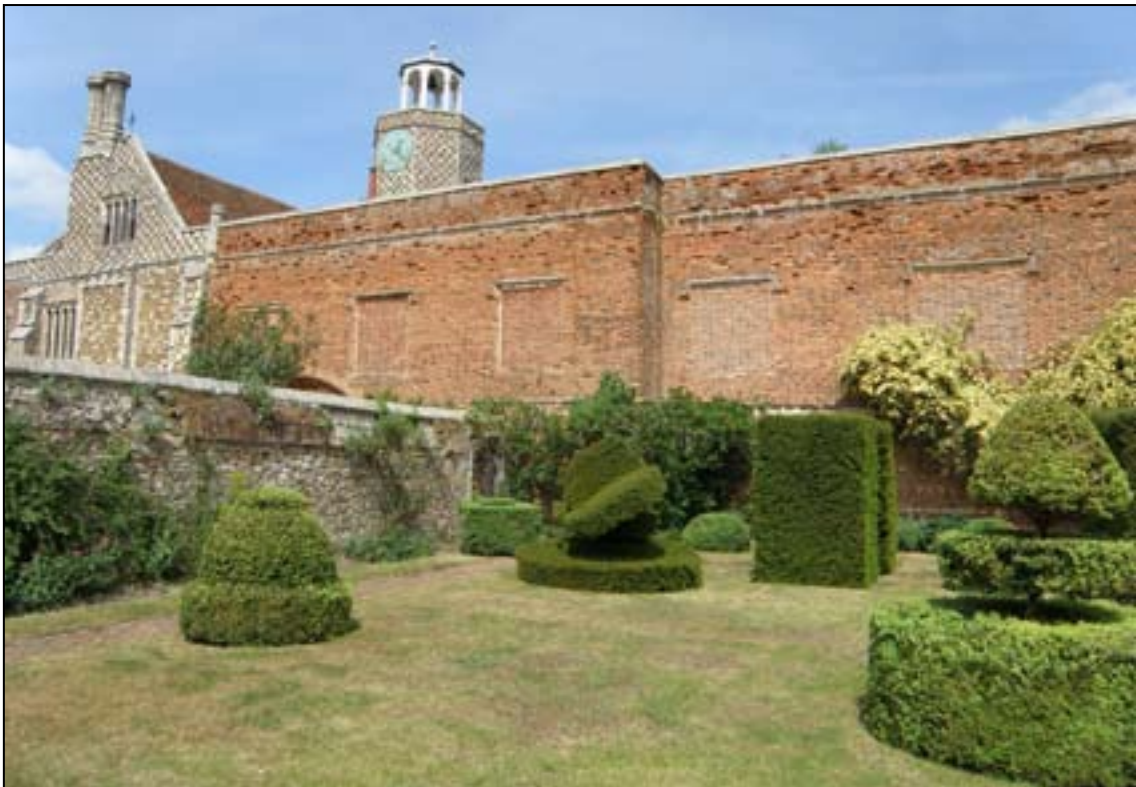
Fig. 35. The surviving brick front wall of the south range, probably built for the John, 2nd Lord Darcy c. 1600, overlooking the topiary garden created by Somerset de Chair.
© Pete Smith P5132867.JPG

During the late 20th century a series of new gardens were created for Somerset de Chair. Two rectangular formal gardens, the rose garden and the topiary garden (fig. 35), were created within the earlier walled kitchen garden, after the Vinery had been demolished. The other kitchen garden, to the east, was eventually layed out as a more informal space with lawns, shrubs and trees. The north drive across the park was abandoned and the Gatehouse once again became the main entrance. The gardens to the north of the house were thinned and the complex Victorian flower beds grassed over.

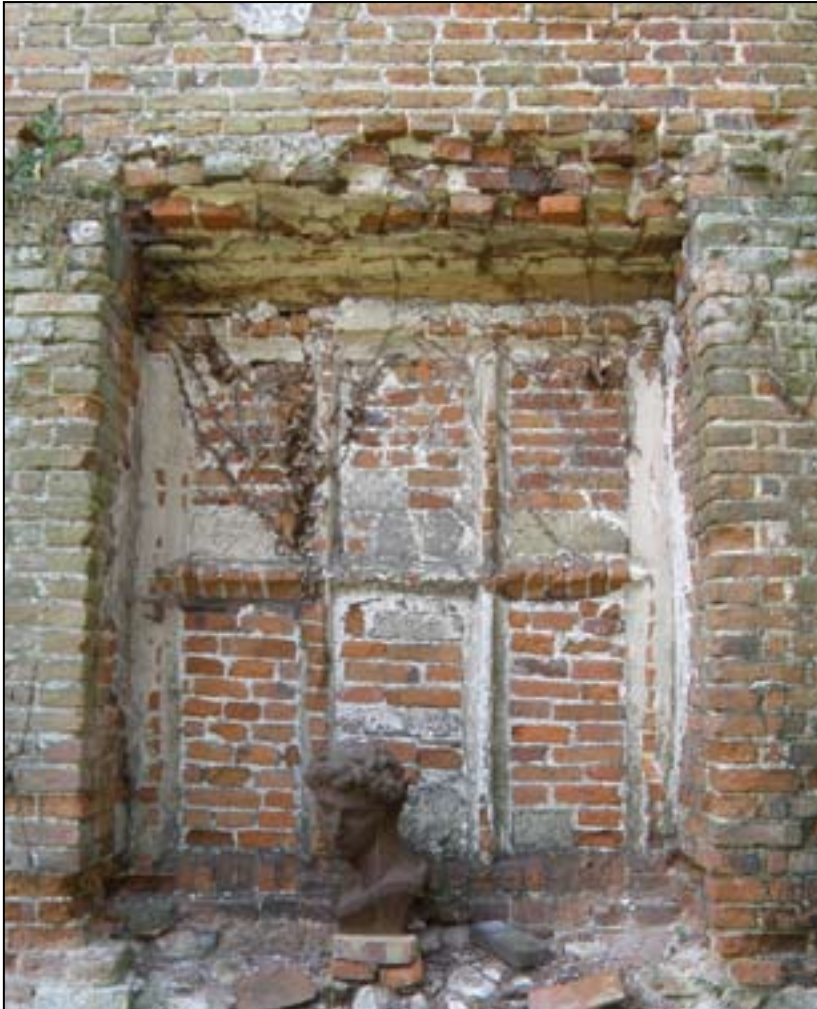
Fig. 36. One of the blocked windows in the surviving brick front wall to the south range of Lord Darcy's former house.

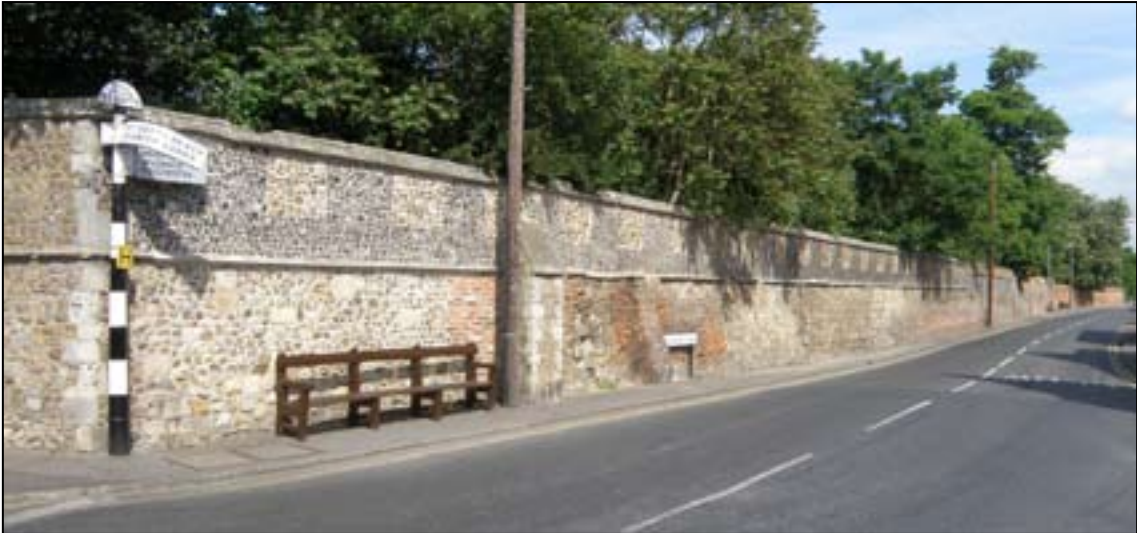
Fig. 37. The much repaired and restored Boundary Wall running along the east side of the park and the west side of Colchester Road. © Pete Smith P5132804A

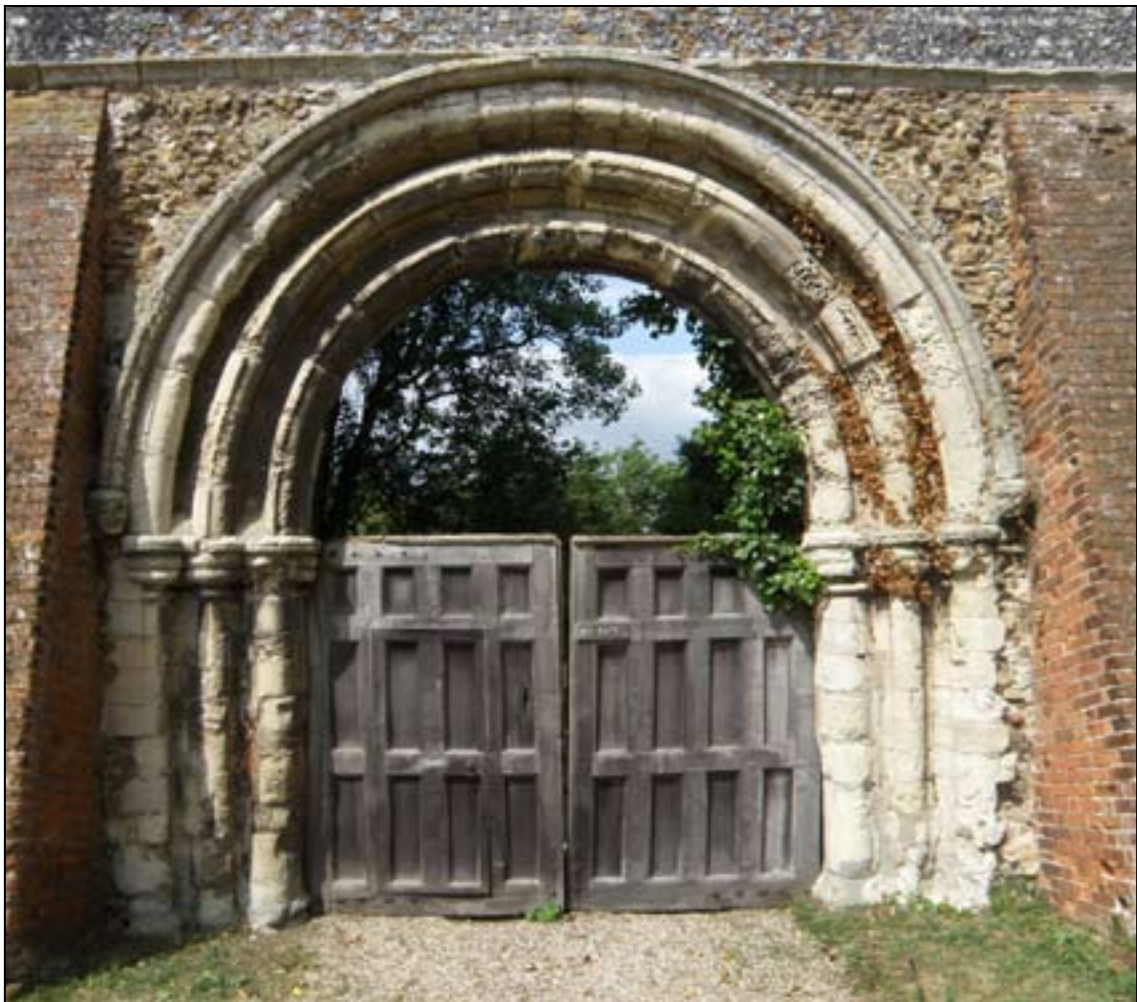
Fig. 38. The early 13th century gateway inserted into the southern section of the Boundary Walls at St Osyth's Priory © Pete Smith P5132811A

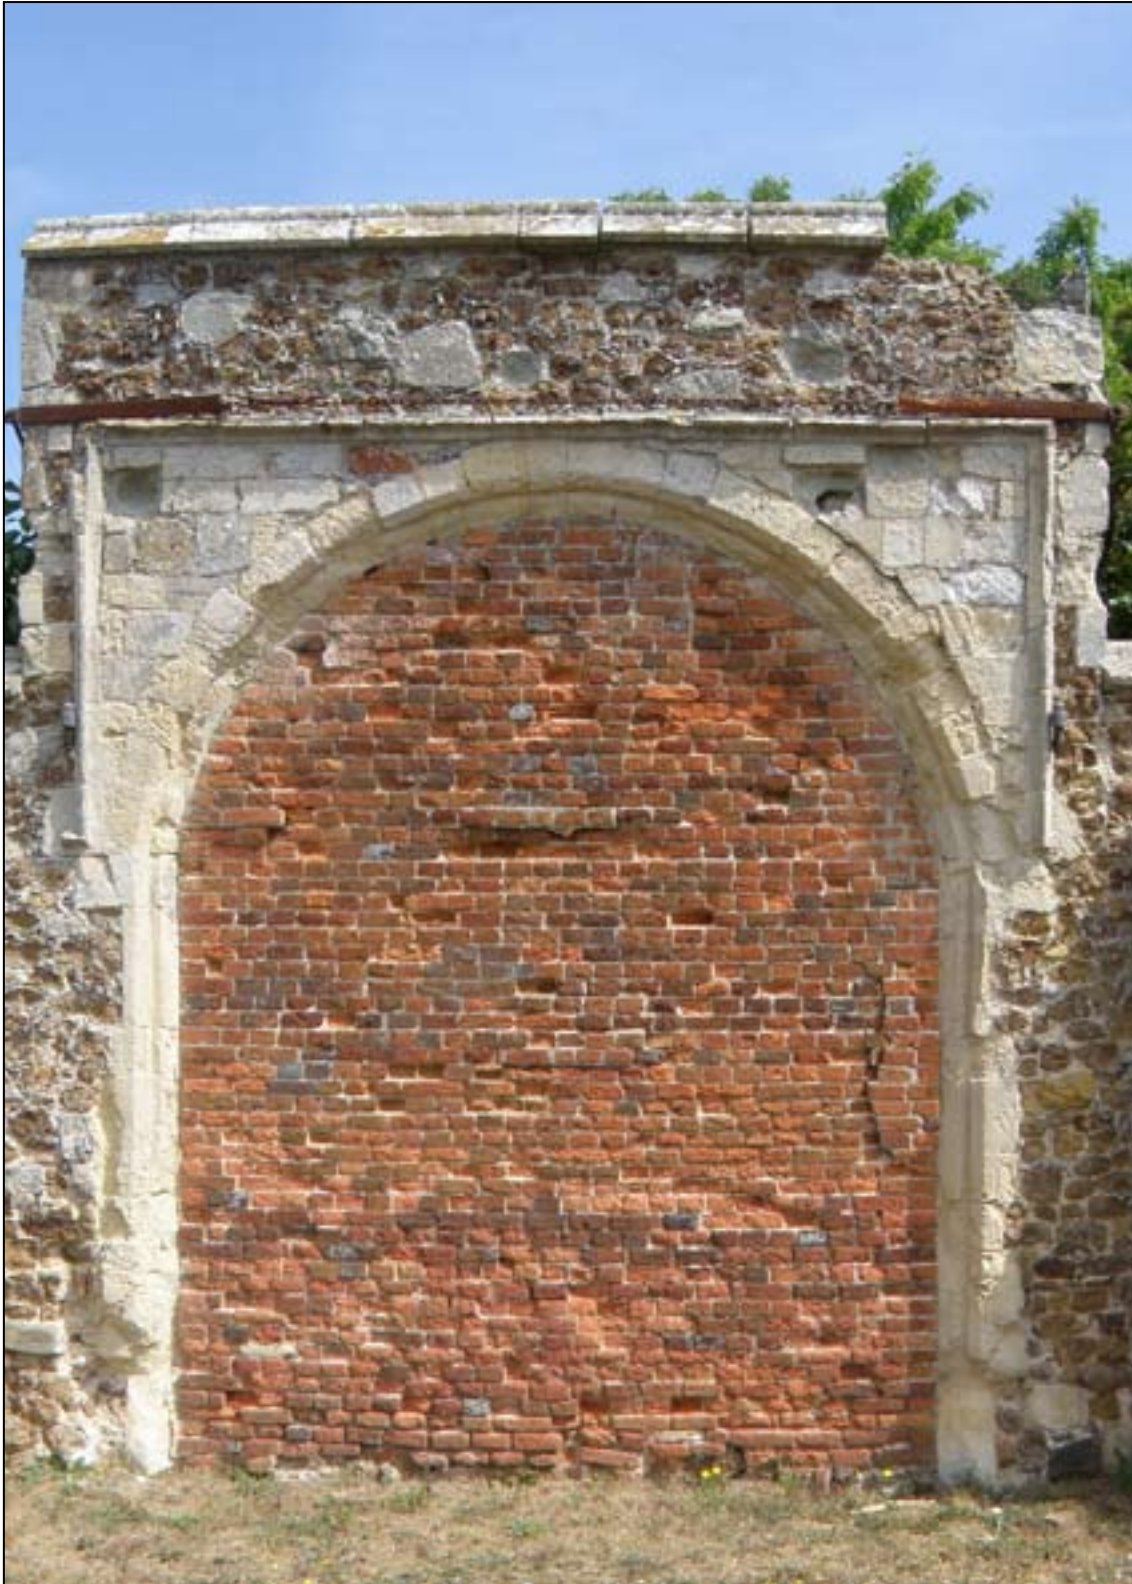
Fig. 39. The now blocked gateway inserted in the precinct wall as the main entrance to Lord Darcy's new house built in the mid-16th century.

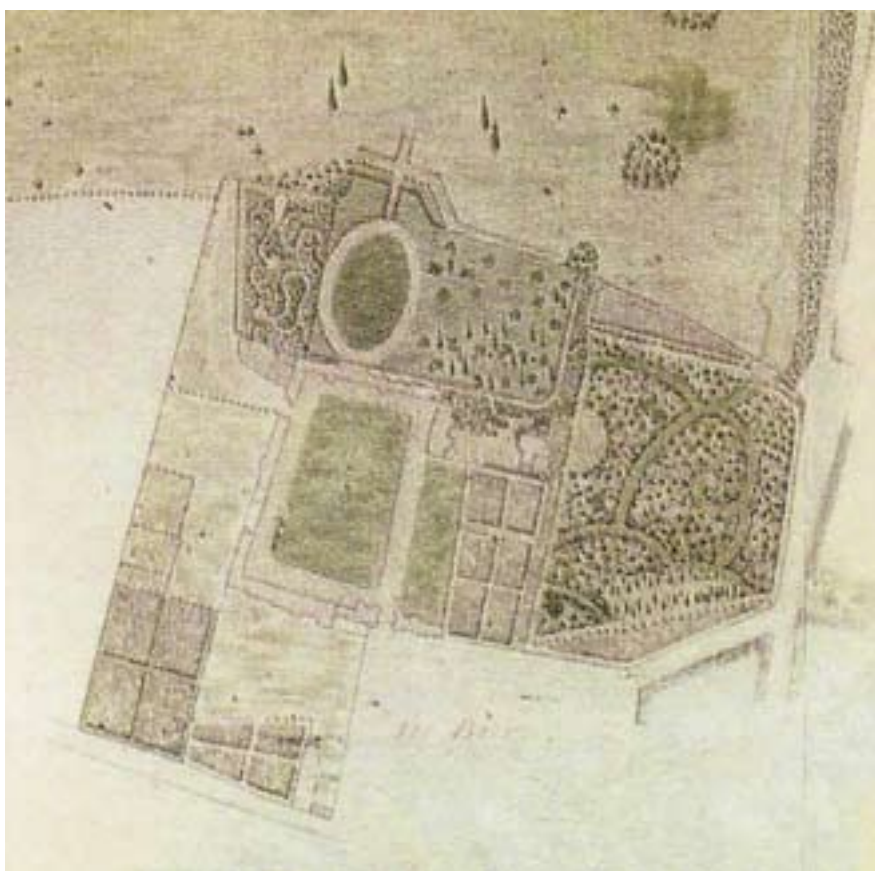
Fig. 41. A detail of Edward John Eyre's survey of 1762 showing the gardens at St Osyth's Priory.

This long low timber-framed cart-shed dates from the late 18th century (fig. 8). It is partially clad in horizontal timber boarding and has a red tile roof. This roof has staggered side purlins and a ridge-piece with bracing to the posts. This building does not appear on either the 1762 survey (fig. 41) or the 1814 survey (fig. 44), but it does appear on the 1874 OS map (fig. 45). This building is therefore either an extremely late example of this type of timber-framed structure, or more likely it was dismantled and moved to its present site sometime between 1814 and 1874.

This small rectangular Brewhouse has a deep rubble stone plinth which appears to be much earlier in origin than the brick superstructure, which is overtly late 18th century (fig. 9). But there is no sign of any building on this site on the 1762 survey (fig. 41), though it is clearly marked on the survey of 1814 (fig. 44), suggesting that the whole of this building dates from the late 18th century. The plinth was presumably constructed at this time of stone – limestone and septaria - robbed from the ruins of Lord Darcy's mansion.

Both these buildings are identifiable as part of the west range of buildings around the precinct or main court. This range is shown as virtually continuous on both the 1762 and 1814 surveys (figs 41 and 44), and these two buildings are all that survives of the service buildings constructed here for Lord Darcy; the remainder were demolished in 1859. These buildings re-use fragments of the monastic buildings and are probably also sited on monastic foundations.

The detailed survey made by Edward John Eyre in 1762 of the landscape park (fig. 40) shows the landscape garden created by the 3rd and 4th Earls of Rochford.¹⁸ Its basic layout still survives today and the layout of the gardens is also still recognisable (fig. 41). The precinct is shown down to grass, as it is now, the present walled garden was then divided into six kitchen garden beds, the informal gardens to the west were at that time a wilderness with broad grass paths and the main pleasure grounds were sited to

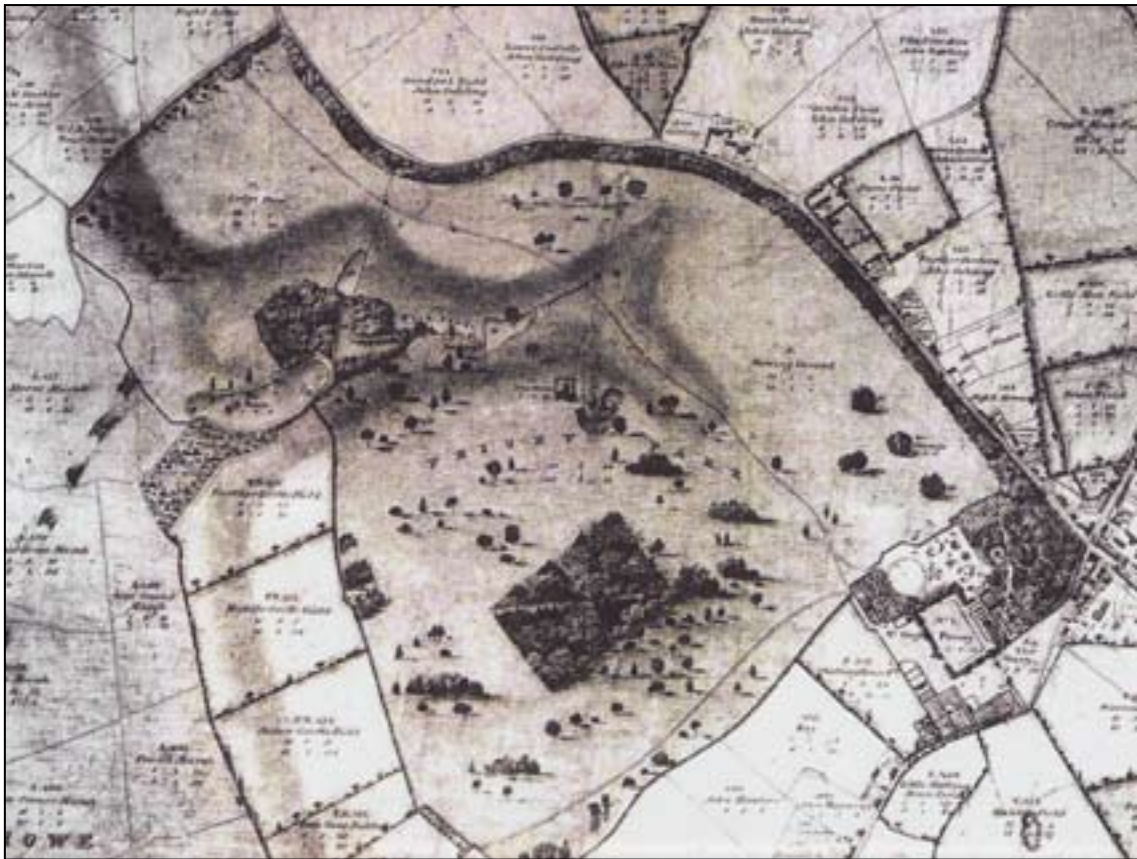
Fig. 43. John Wiggins survey of St Osyth's Priory estate of 1814 showing the house, its gardens and the park.
© Essex Record Office

A new north drive was constructed by 1777, and two lodges were subsequently built either side of the resulting new entrance to the park, they were demolished in the 1970s. This drive is the only major alteration to this landscape shown on a survey plan of 1814 by John Wiggins (fig. 43).¹⁹ This later plan also shows that the shape of the canal has been softened and the water gardens simplified. The plan shows that there had been more
