ST OSYTH,
ESSEX
ST OSYTH'S PRIORY
HISTORIC BUILDINGS REPORT

Research Department Report Series 074-2011

**ST OSYTH'S PRIORY
ST OSYTH
ESSEX
HISTORIC BUILDINGS REPORT**

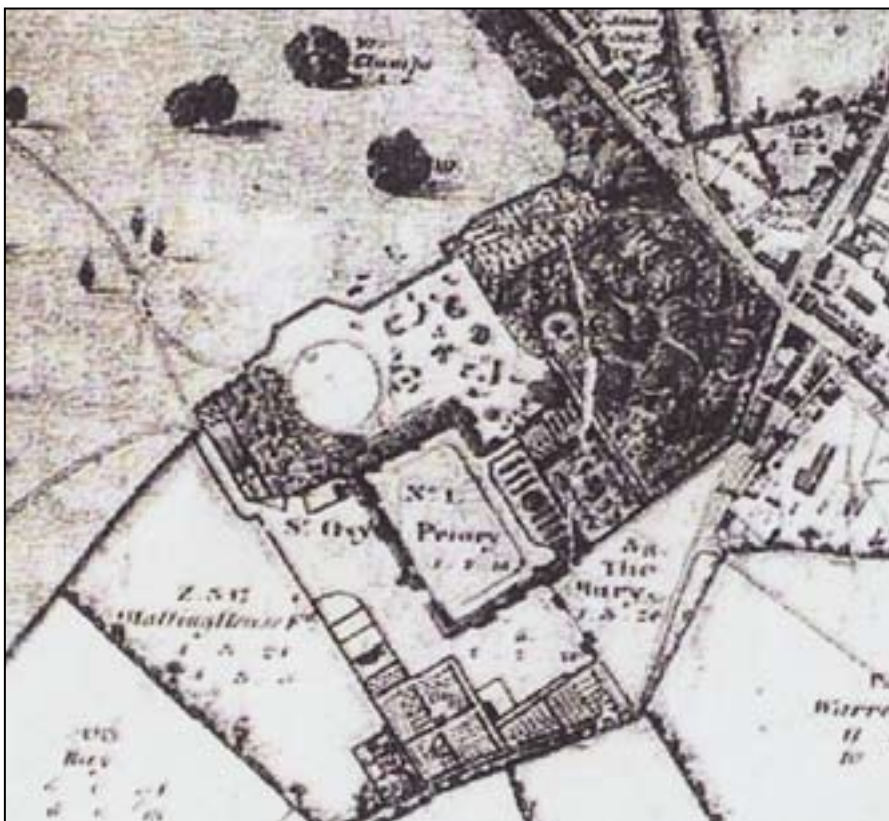
Fig. 44. A detail of John Wiggins survey of 1814 showing the gardens at St Osyth's Priory.

Both these buildings are identifiable as part of the west range of buildings around the precinct or main court. This range is shown as virtually continuous on both the 1762 and 1814 surveys (figs 41 and 44), and these two buildings are all that survives of the service buildings constructed here for Lord Darcy; the remainder were demolished in 1859. These buildings re-use fragments of the monastic buildings and are probably also sited on monastic foundations.

alteration within the gardens. A new garden had been created at the northern end of the western garden and the walled garden was now incorporated into the gardens, whilst the western section of the precinct was by this date laid out with formal beds (fig. 44).

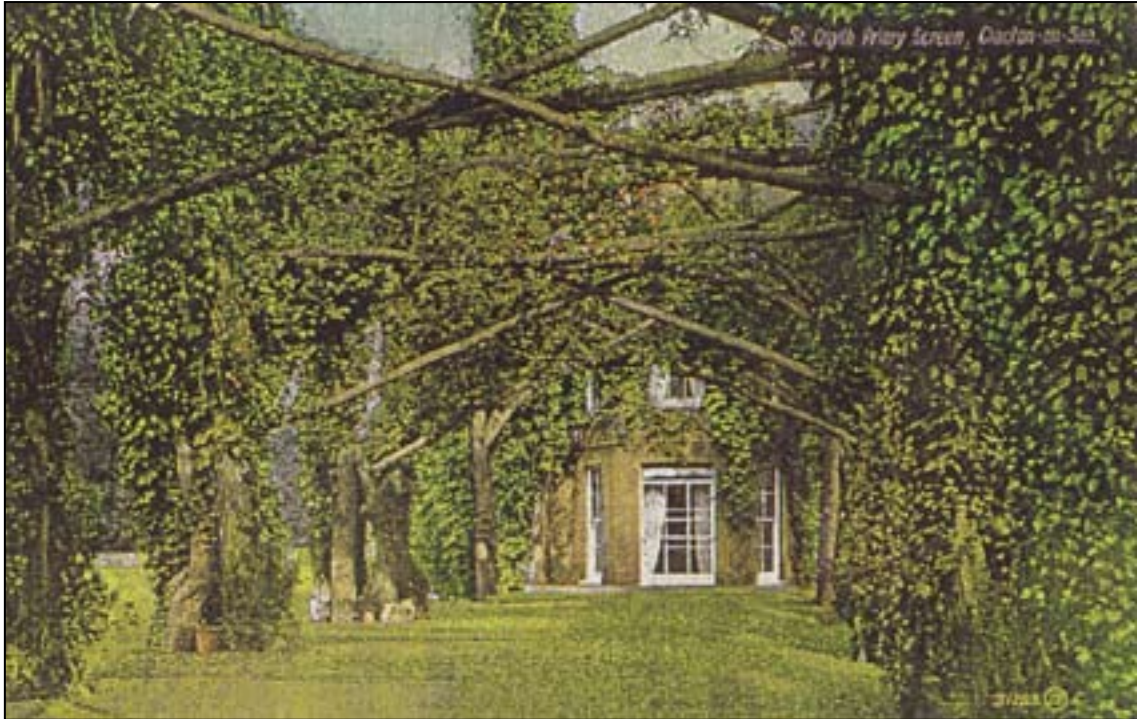
Fig. 47. An early 20th century postcard showing the Screen or pergola erected for Sir John Johnson in the late 19th century. © Debois Landscape Group

This elaborate structure was constructed of tree trunks and branches formed into pointed Gothic arches, with a parapet and finials; it was demolished in the early 20th century (fig. 47). The same article also records that 'the Priory gardens to-day cover about 10 acres, six of which are kitchen gardens, well furnished with collections of fruit and vegetables'. These kitchen gardens occupied the walled enclosure to the south of the main range of Lord Darcy's ruined house and the much larger area to the east, between the Abbot's Tower and the Colchester Road. There were a total thirteen glasshouses. The largest, dividing the southern garden into two, 'consisting of [a] large Vinery, Peach-house, stove and Cucumber house'. This garden was tended by Mr Kent, the gardener and a staff of ten men.²⁰
