THE JEWEL TOWER, ABINGDON STREET, WESTMINSTER, LONDON

TREE-RING ANALYSIS OF TIMBERS

SCIENTIFIC DATING REPORT

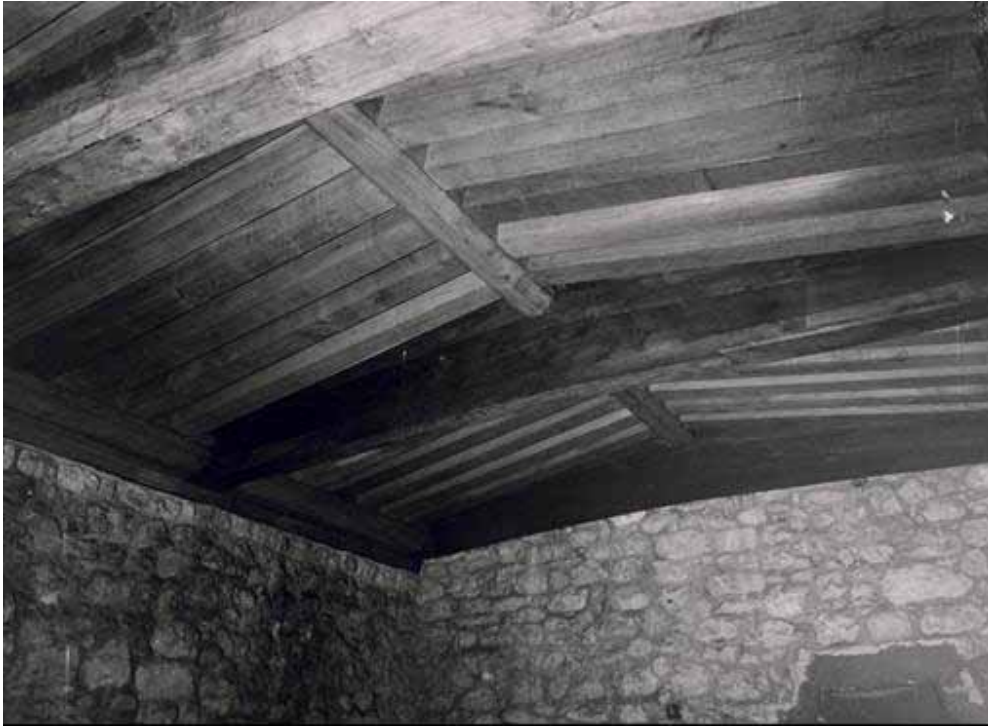
Figure 2: The roof of the main upper chamber (photograph from the National Monuments Record)

The roof was largely renewed during the twentieth century, following damage during World War Two, but is thought to contain a small number of original fourteenth-century timbers, including rafters and possibly a wallplate. A photograph in the National Monuments Record dated 17 November 1949 (Fig 2) is labelled “*The new roof of the main upper chamber looking north-west (the far wall beam and principal beam in the middle picture are original timbers repaired. The beam in the top foreground is wholly new).*”

The north tie beam (jwl01) in the main chamber is the timber described in the 1949 photograph as original. It was found on coring to be thinner than its external appearance would suggest, and to have a pine timber behind the façade which is carrying most of the structural load. The sequence obtained did not match other samples from the site and, not surprisingly in view of its short length, nor did it date against reference material. The rafters in the main chamber were all replacements (as seen in the 1949 photograph). Only two rafters in the east chamber roof were sampled; these were the only original rafters to have sufficient numbers of rings to have the potential to yield results and, in addition, both have a heartwood-sapwood boundary present. The ring-width series for jwl02 did not match other timbers from the site, and could not be dated against reference material. The core taken from the other rafter, jwl03, had broken. The two sections could not be reliably joined and unfortunately neither section contained sufficient rings to make measurement worthwhile.

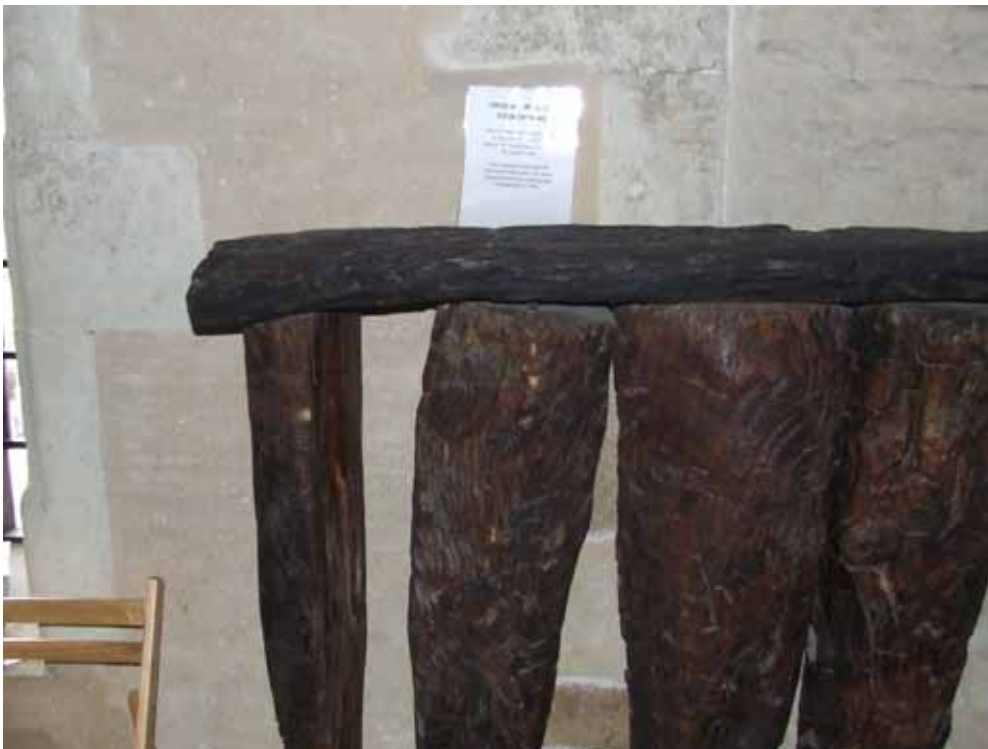
Figure 3: The elm piles and oak plate on display in the main chamber

On display in the main chamber are a series of elm piles and an oak plate which were thought to potentially represent part of the original foundations of the tower (Fig 3). A door leading to the second floor chamber is of eight lapped panels, cross-framed and heavily studded, hung from two strap hinges with the gudgeons set tightly in the stone jamb (Fig 4). Whilst the lock panel has been inserted, the door is otherwise thought to be an original fourteenth-century fitting.

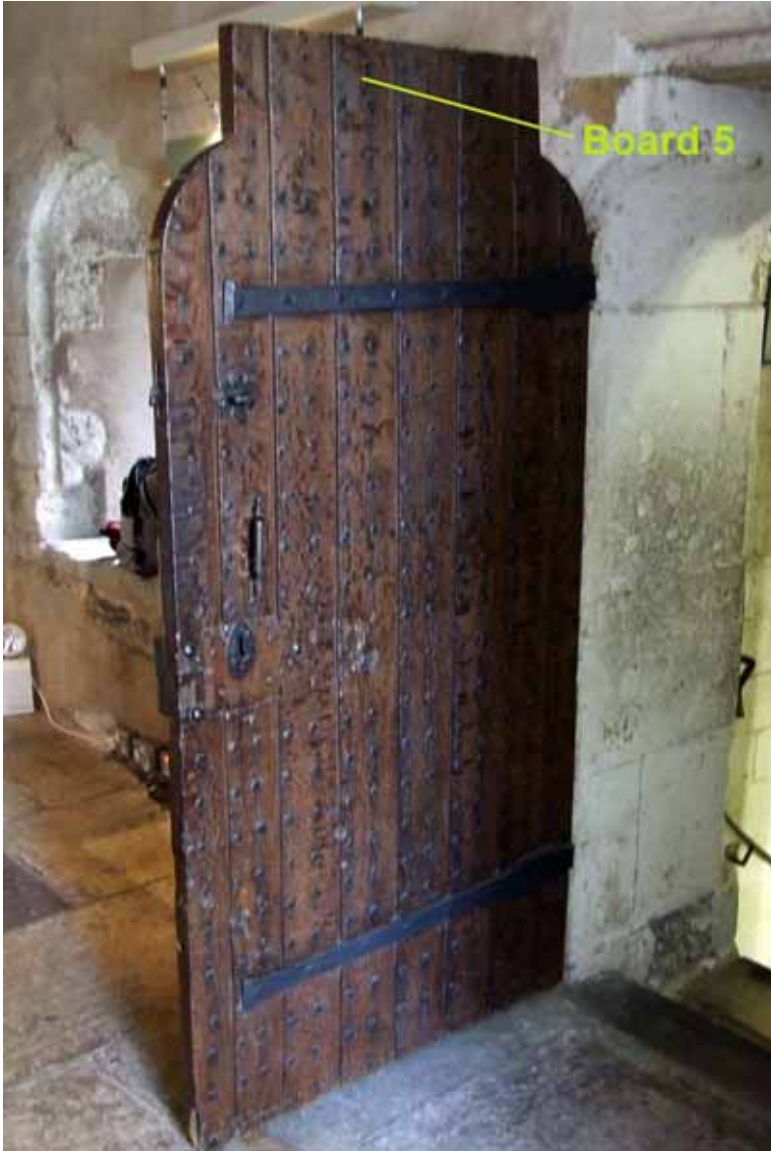
Figure 4: The door to the second floor chamber, indicating the position of the dated board

The outer boards of the door (Fig 4) were not investigated further because of the curved nature of their tops. This made cleaning, impression taking, and photographing very difficult, as well as distorting the ring width pattern. The exposed top cross-sectional surfaces of the central four boards were highly degraded but only minimal cleaning was undertaken as any greater intervention was deemed unacceptable. 'Fimo' impressions and photographs (eg Fig 6) were taken of these very slow-grown V-edged oak boards. The 'Fimo' impressions proved impossible to measure as the resolution from the minimally cleaned surface was very poor. The photographs were more useful on this occasion but were still problematic resulting in the attempted measurement of only partial sequences for each of the four central boards including two from board 5. The reliability of all but one of these sequences was considered questionable, thus only the raw data for jwlBD5i is presented in the Appendix.

All five sequences derived were compared with each other but, not surprisingly bearing in mind the potential measurement problems, no cross-matching was identified. These five sequences were subsequently compared to a wide range of reference material. Only one sequence, jwlBD5i, from the fifth board from the hinge side of the door gave any acceptable matches (Table 2). This 83-year sequence was dated to the period AD 1175–1257 against reference chronologies derived from the Baltic region and to a lesser extent Germany. This partial sequence represented the inner part of the board up to the split evident in Figure 6. The ring sequence measured after the split could not be dated, in spite of knowing its approximate date. Overall, bearing in mind the measurement difficulties, this outer part of the board contained c70 outer rings. Experience has shown that door boards (eg Miles and Bridge 2005), like boards used in room panelling, panel paintings and other art-historical objects (Tyers 2003) often had minimal amounts of sapwood trimmed from them, so, allowing for the minimum likely number of sapwood rings to be present, an estimated terminus post quem for felling of AD 1336 is obtained for this one board. It seems likely therefore that this door is original to the AD1360s building of the Jewel Tower and used oak most probably imported from the Baltic region.

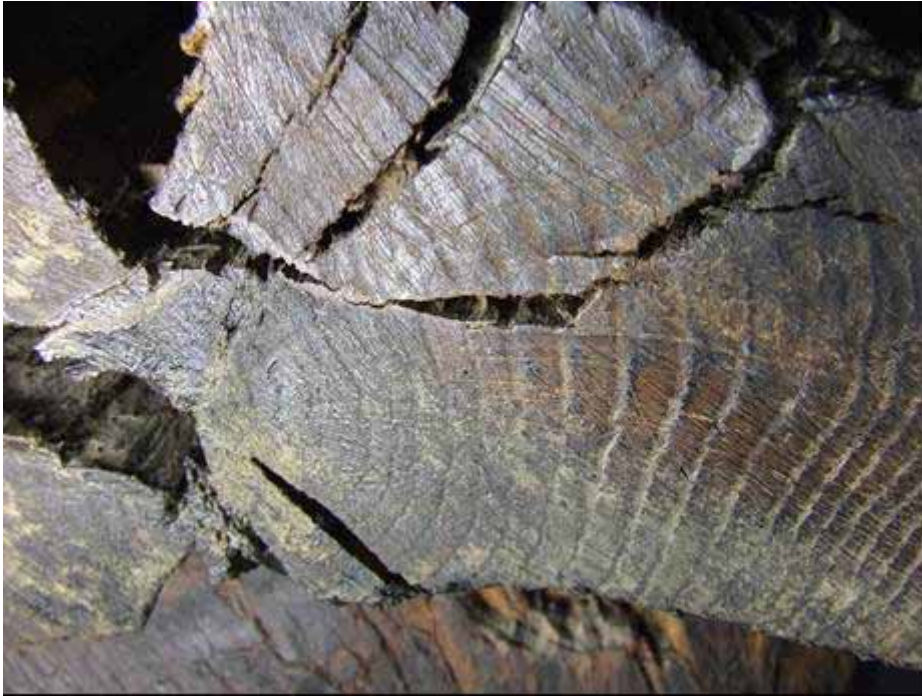
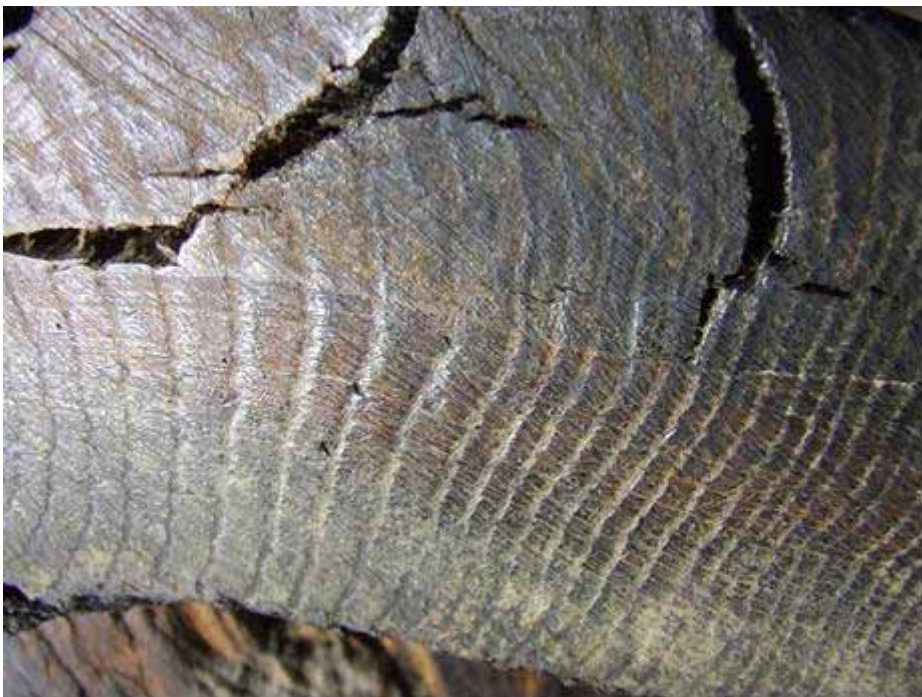
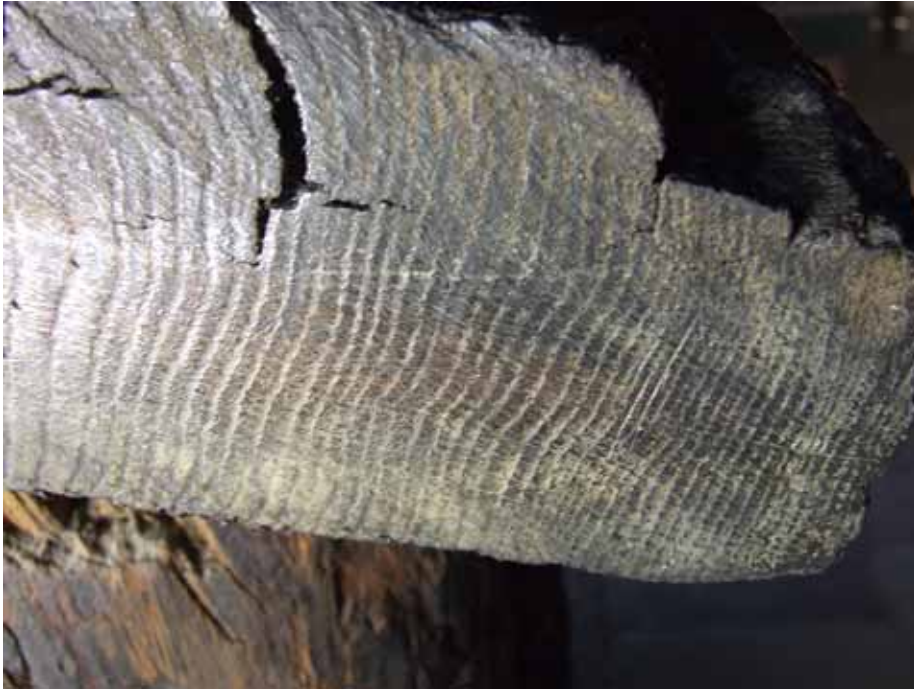
Figures 5a-c: Photographs of the cross-sectional surface of the oak plate holding the elm piles in the display in the second floor main chamber

A series of photographs of the oak plate holding the elm piles on display in the main second floor chamber (Figs 5a-c) yielded a sequence of 58 rings. This sequence, jwl05, did not match other samples from the site, nor did it give acceptable matches to the reference material. A core was taken from the most promising looking elm pile, but this produced a sequence of less than 40 rings, and was not therefore measured.

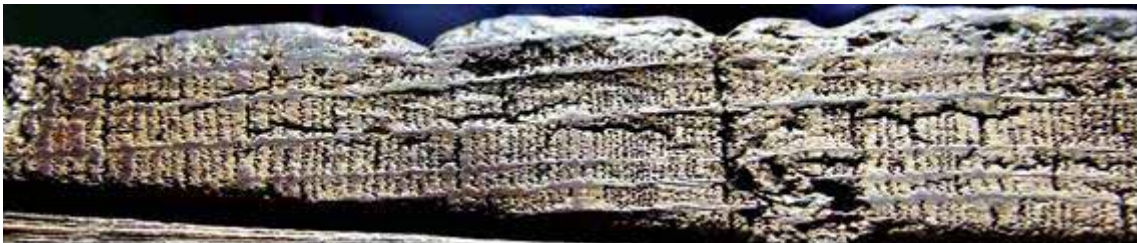
Figure 6: Photograph of board 5 of the door
