Ancient Monuments Laboratory
Report 102/97

WOOD IDENTIFICATION AND TREE-
RING ASSESSMENT OF TIMBERS
FROM AN EARLY SASH WINDOW AT
PALACE HOUSE MANSION,
NEWMARKET, SUFFOLK

I Tyers

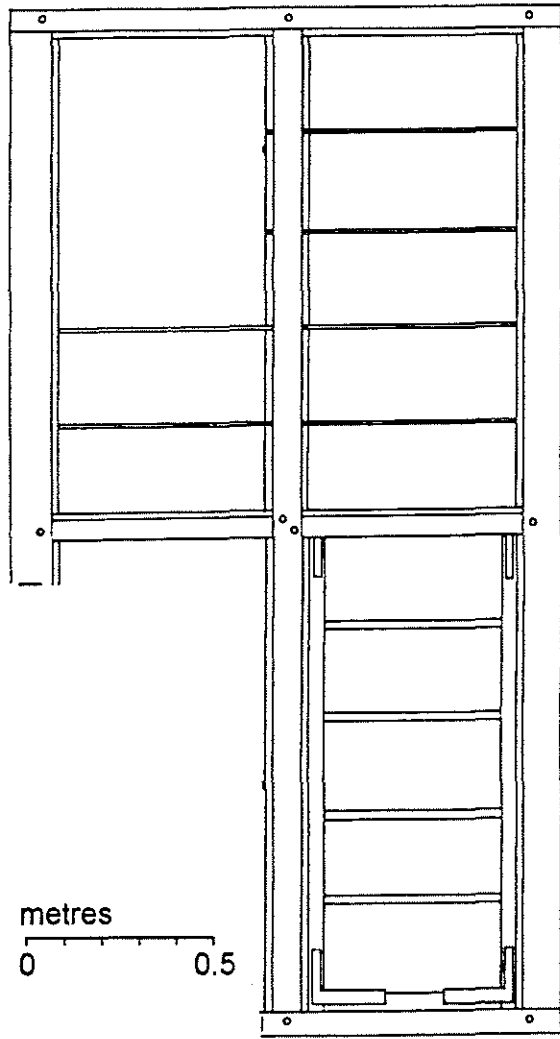
Figure 1

Palace House Mansion, Newmarket. Window external elevation (after Baggs pers comm. scale approx 1:20)

The frame is currently stored at Palace House Mansion in a purpose built wooden box. A visit to the site was arranged, the box was opened and using plans and descriptions prepared by Andy Wittrick of English Heritage's Historical Analysis and Research Team the timbers were carefully examined in an attempt to identify whether any component timbers were suitable for tree-ring analysis. Those timbers of oak, or other dendrochronologically viable species, with more than 50 annual rings, and with some survival of the original sapwood and bark-edge were sought. This report follows Wittrick's nomenclature for the frame elements. The frame alignment used is the external view (Fig 1).

The frame's two side transoms are composed of two quarter parts of an oak (*Quercus* spp.) tree. The left transom is in two parts, with the cut clearly revealing the ring sequence of the tree. Although the right transom is less easily assessed it seems highly probable both transoms are derived from the same tree. In both timbers the sapwood and bark-edge are present at similar positions, both have a similar twist to the grain, and both reveal similar growth anomalies within the visible parts of the cross-sections. In both timbers the ring pattern

shows an initially very fast-growing oak tree with a subsequent very slow-growing band followed by a recovery ending with a further very slow-growing band. Although a precise count of the rings was impossible neither transom had more than 50 rings, and the slow-growing bands prevent their use for a reliable dendrochronological analysis. The central mullion also appears to be an oak timber, but no clearly visible end grain was present. The surviving paint layers prevent a clear view of this timber's microscopic features and ring pattern. It was not felt appropriate to remove fragments to confirm its identification nor to compare the pattern with the transoms. The same problem occurs with each of the smaller vertical elements in the moving parts. It is impossible to clearly identify these timbers without more serious intervention which I felt inappropriate, although visually they appear to be oak. Except for the cill the same applies to all the transverse elements. The limited end-grain that is visible on these elements suggests they are oak and all the smaller fragments appear to be oak as well. The cill has also been cut, the end-grain visible here reveals the timber to be oak and to have no potential utility for dendrochronological analysis.
