BELSAY CASTLE, BELSAY, NORTHUMBERLAND SCIENTIFIC ANALYSIS AND HISTORIC INTERPRETATION OF DECORATED WINDOW GLASS BY HENRY GYLES OF YORK

TECHNOLOGY REPORT

Belsay Castle, Belsay, Northumberland

Scientific analysis and historic interpretation of decorated window glass by Henry Gyles of York

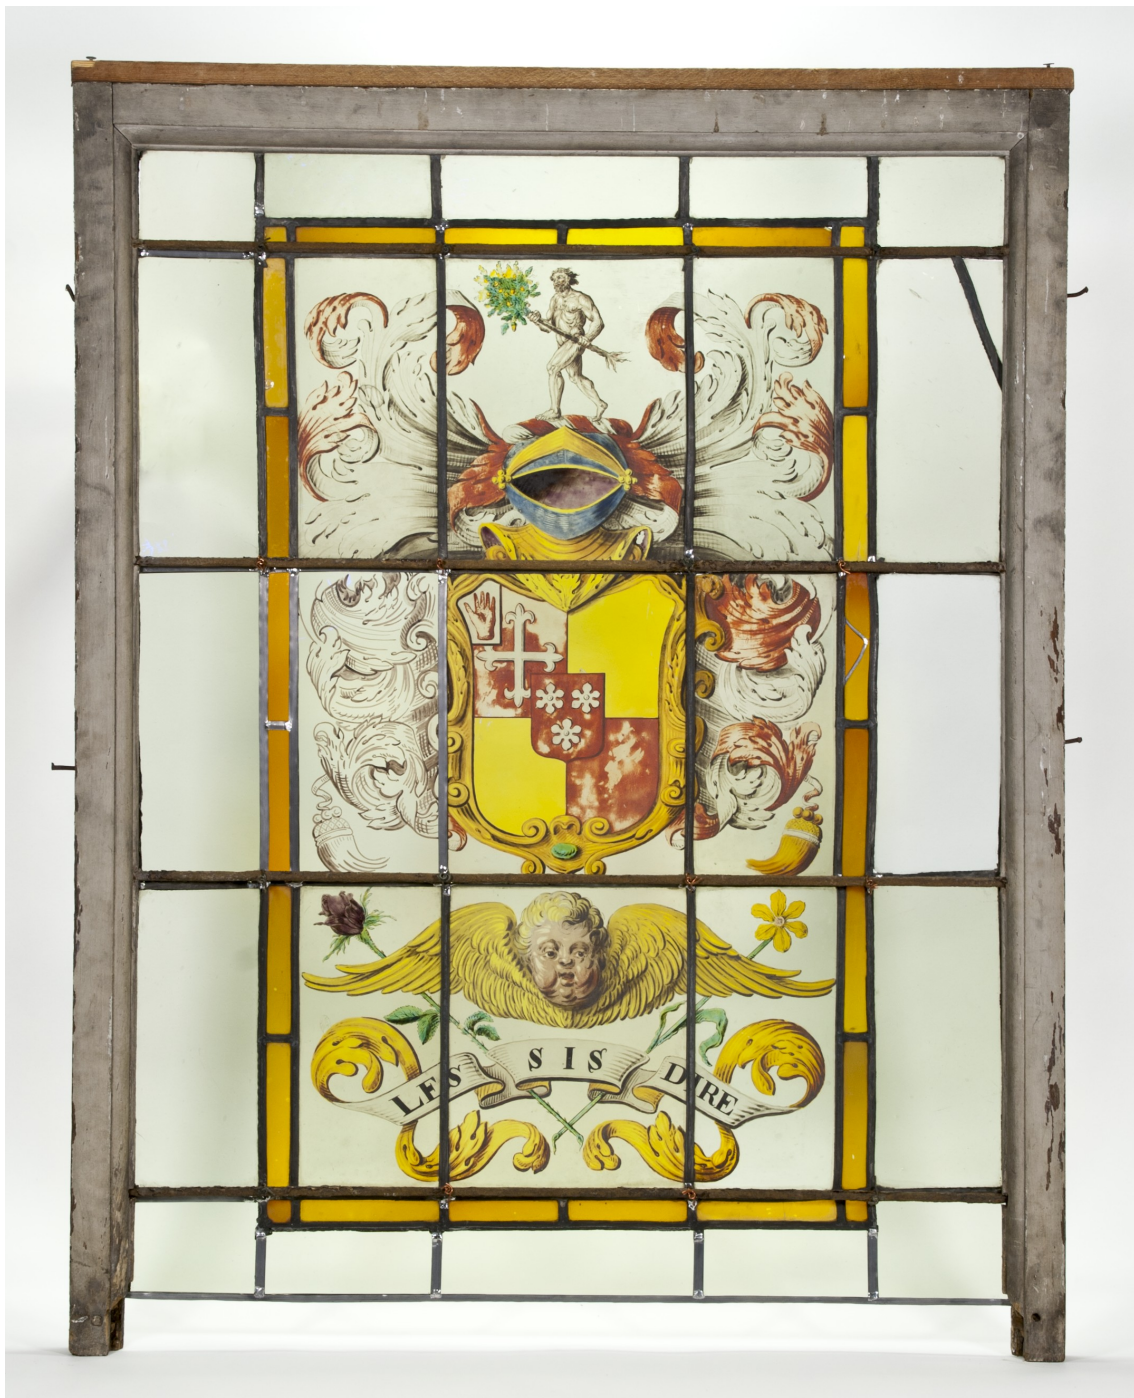
Figure 1. The complete window viewed by reflective light post-conservation 2011

The window is a painted armorial set in its original oak frame. (Figure 1) The window would have originally comprised nine panes of decorated glass surrounded by 24 small panes of amber glass and sixteen panes of undecorated colourless or pale green glass (Figure 1). The glass is crown glass of 1–2mm thickness. Some of the panes are slightly curved. The window is largely complete and in original condition with only the lower bearer of the frame and one painted pane, two amber panes and six colourless panes missing and a replaced glass panel and mending lead both in the outer border.² It has four horizontal iron square sectioned bars set into the frame; the leaded window is tied to these bars with copper alloy ties. Some of the ties are punched through the lead net as part of a later repair. The frame has layers of red paint and white paint on the inner face and a layer of white paint on the outer face. There is a single strip of modern pine (20mm deep) nailed to the top of the frame to provide support. This is probably of a mid 20th-

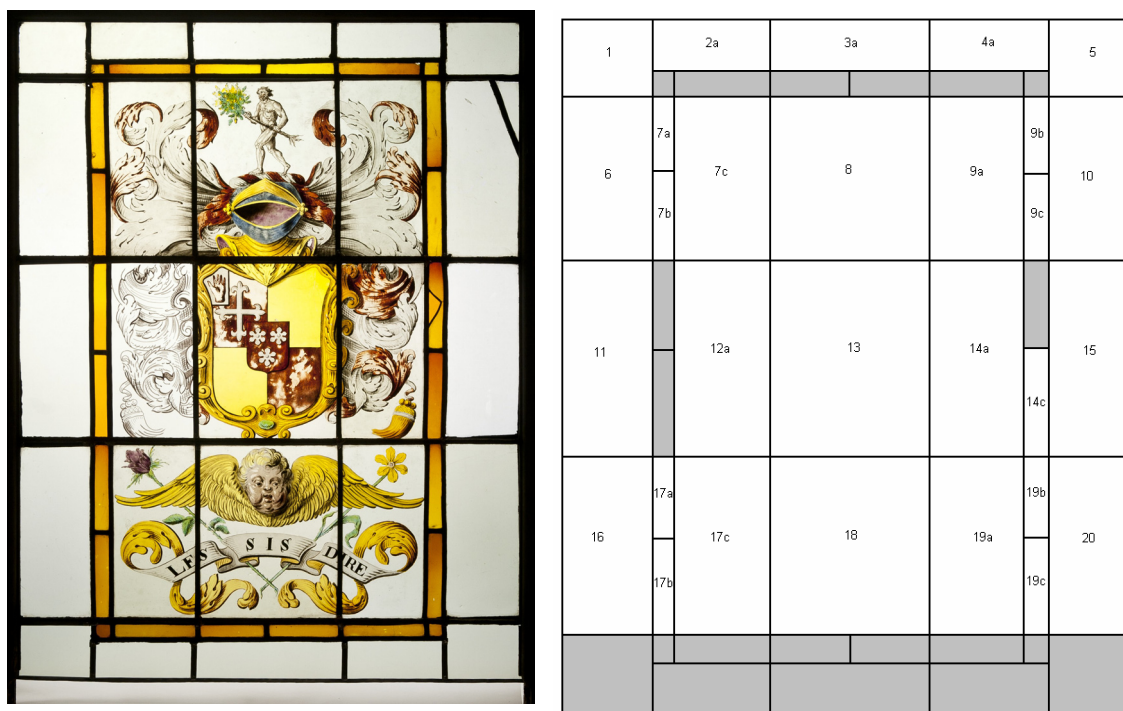
Figure 2. The Belsay window and a schematic representation indicating the pane numbering used for this report (panes shaded grey were missing or not analysed)

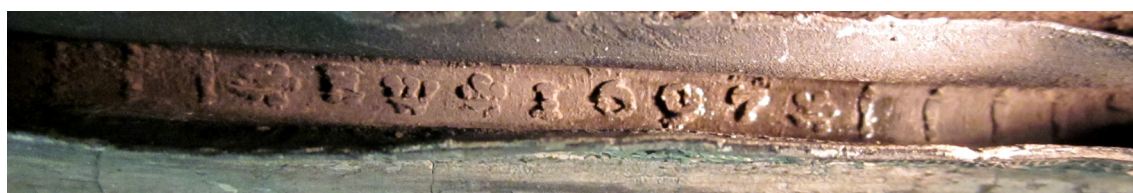
Figure 4. Inner section of EW lead came

The glass panes are held together using an 8–8.5mm wide milled lead came of flat H-profile for the painted panes and the amber border including the surrounding lead of the latter. The leads of the outer plain border are of the same profile but slightly wider at 9–9.5mm. The comes are of different origins. The core of the lead comes of the inner section are impressed with the legend *EDMOND*GILES*OE*YORKE*I665* (Figure 3). This differs slightly on each side of the core. The came holding the colourless panes,

including that inserted into the oak frame is impressed *EW* 1697* (Figure 4) on one side of the core only, the other side bearing parallel milling marks. Although not all the leads are accessible it is possible to determine and map the different types by size.

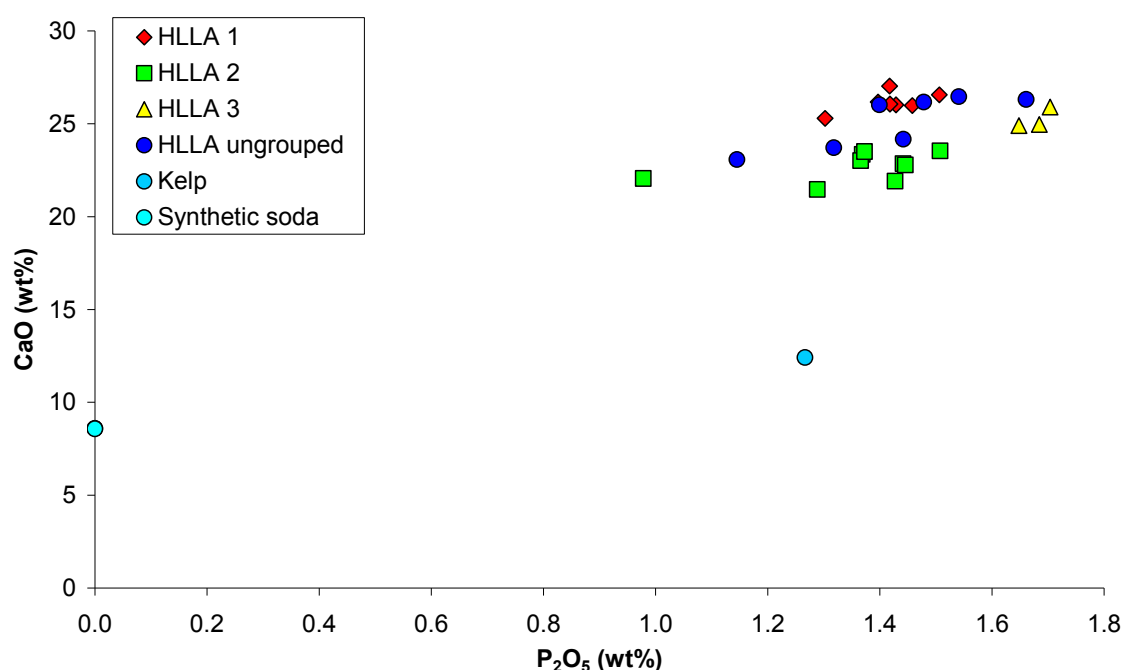
Figure 8. *CaO and P₂O₅ concentrations showing different glass types and groups*

heavier elements will be largely unaffected. Even though light elements are likely to have been underestimated using pXRF, it is still possible to assign all of the analysed glass to one of the major categories of historic window glass (cf Table 1). Most of the panes are HLLA glass but there is a single pane of kelp glass and two modern⁷ replacement panes.

Panes 11 and 12c are made of a glass which contains very low levels of minor elements. The absence of phosphorus suggests that this glass was made using synthetic soda (eg Leblanc soda) rather than alkali derived from any plant ash (Figure 8). This indicates that these panes were manufactured after the introduction of synthetic soda manufacturing technology (c1830). Pane 15 contains a sufficient range of minor elements including phosphorus to indicate that it was manufactured using alkali derived from a plant. The very high levels of strontium (Figure 9) allow the plant used to be identified as kelp (sea weed), which shows that the pane was probably between c1700 and c1830. A small amount of vessel glass was manufactured using kelp during the last few decades of the 17th century (Dungworth and Cromwell 2006) but it does not appear to have been used for window glass until the beginning of the 18th century. Given the likely date of manufacture of the Belsay window, pane 15 could be original; however, if it is a later repair or replacement, this is likely to have taken place before c1830.

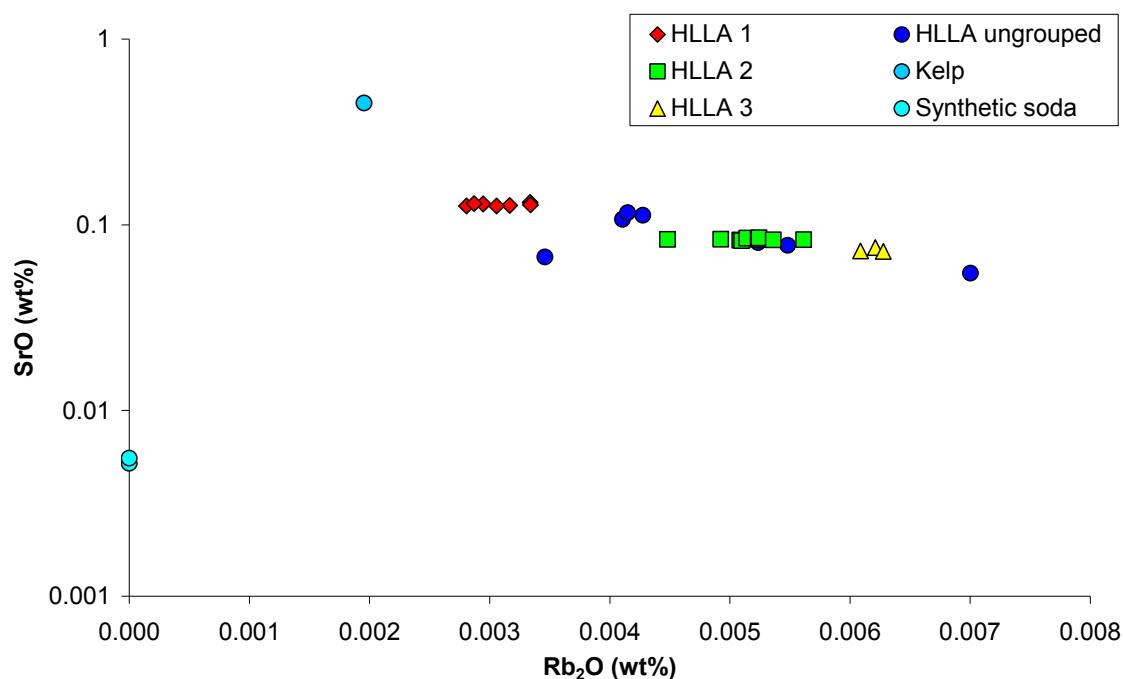
Figure 9. *SrO and Rb₂O concentrations showing different glass types and groups*

All of the remaining panes contain sufficient phosphorus to indicate that they were manufactured using a plant ash. The relatively low strontium content of these panes shows that this was a terrestrial plant ash. The high calcium content of this glass confirms that it is a HLLA type. HLLA glass was produced in England from the late 16th century and was widely used for windows until the beginning of the 18th century.

The HLLA glass comprises several compositional groups (Figure 4, Table 3) which can be defined partly through major and minor elements (Figure 3), although the groupings are even more clearly seen when trace elements are considered (Figure 4). The existence of several HLLA compositional groups probably reflects the use of glass from more than one source. HLLA 1 glass is found exclusively in the plain border around the window, while HLLA 2 and HLLA 3 are used for the central decorated panes and some HLLA 2 is used for the thin amber border (Figure 10).
