RESEARCH REPORT SERIES no. 8-2012

THE OLD COACH HOUSE AND DOVECOTE, EASTCOTE HOUSE GARDENS, HIGH ROAD, EASTCOTE, HILLINGDON, LONDON TREE-RING ANALYSIS OF TIMBERS

SCIENTIFIC DATING REPORT

Alison Arnold and Robert Howard

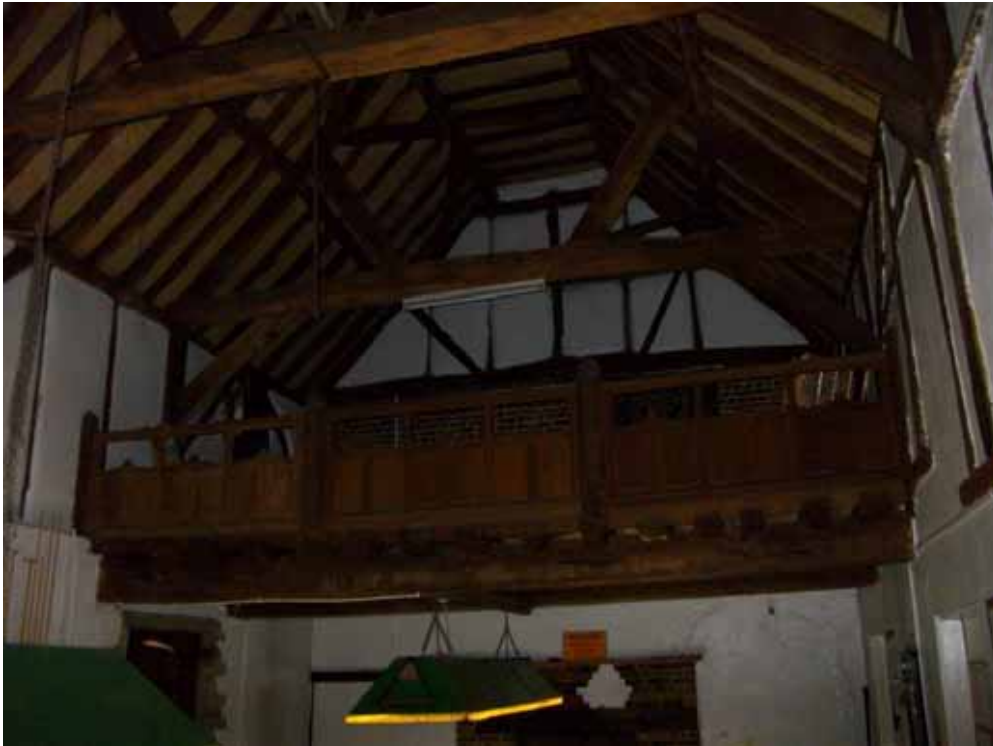
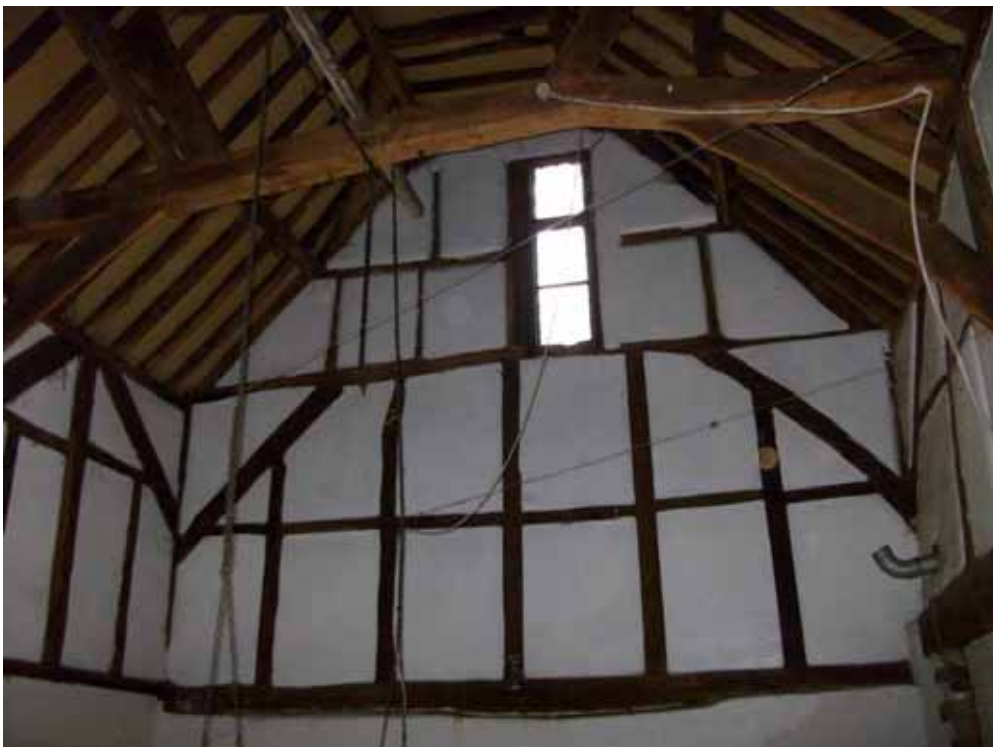
Figure 4a/b: General internal views of the Old Coach House, looking site north to south (top), and south to north (bottom)

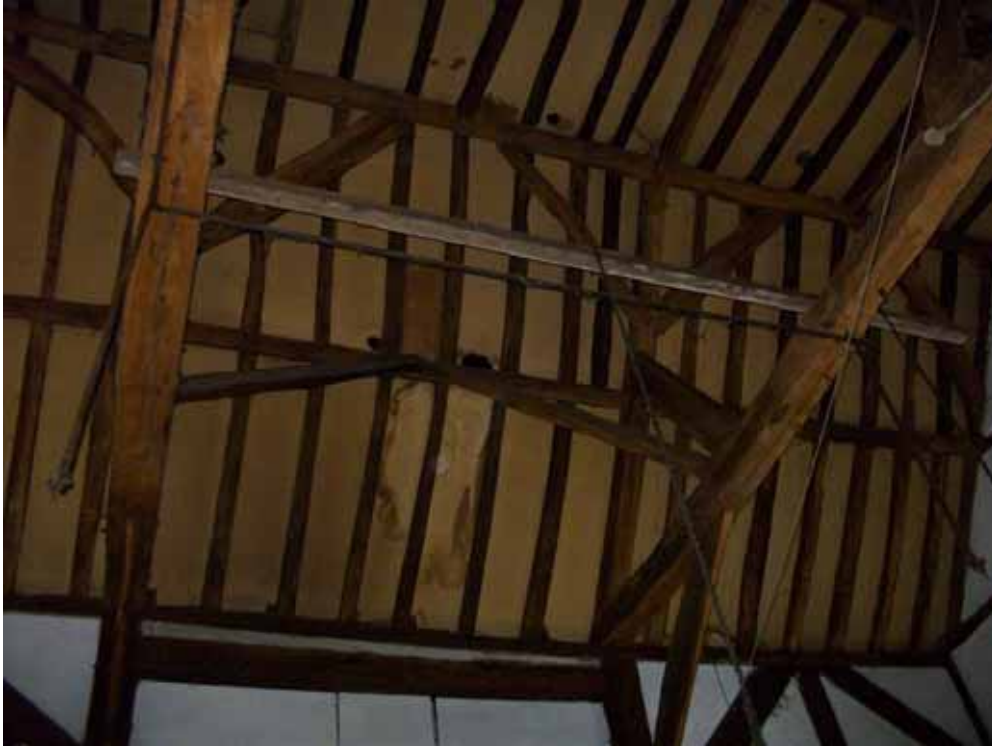
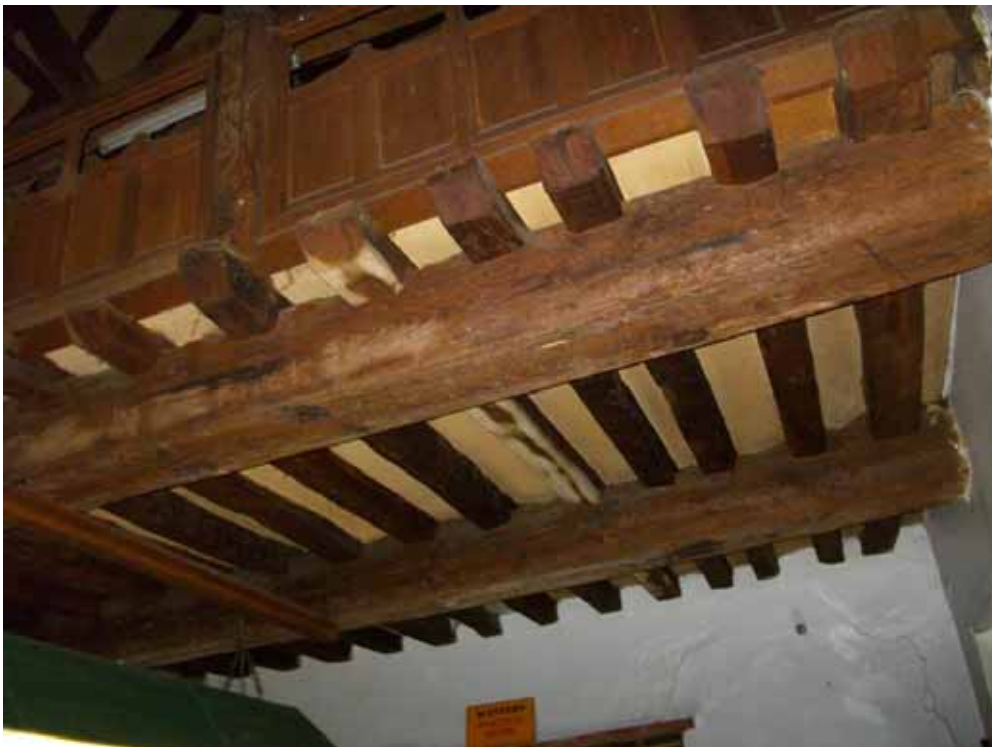
Figure 4c/d: Views of the roof (top) and the beams of the gallery (bottom)

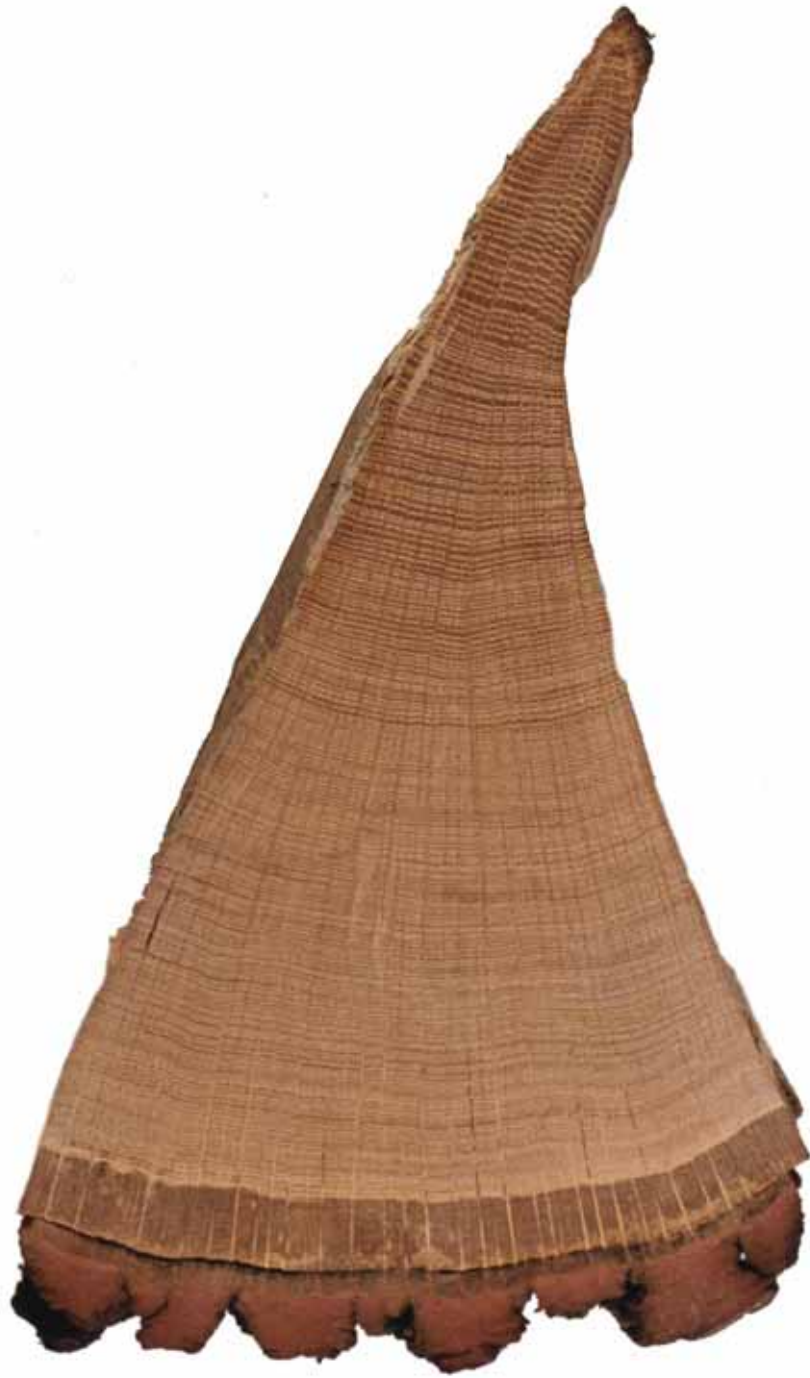
Figure A1: A wedge of oak from a tree felled in 1976. It shows the annual growth rings, one for each year from the innermost ring to the last ring on the outside just inside the bark. The year of each ring can be determined by counting back from the outside ring, which grew in 1976

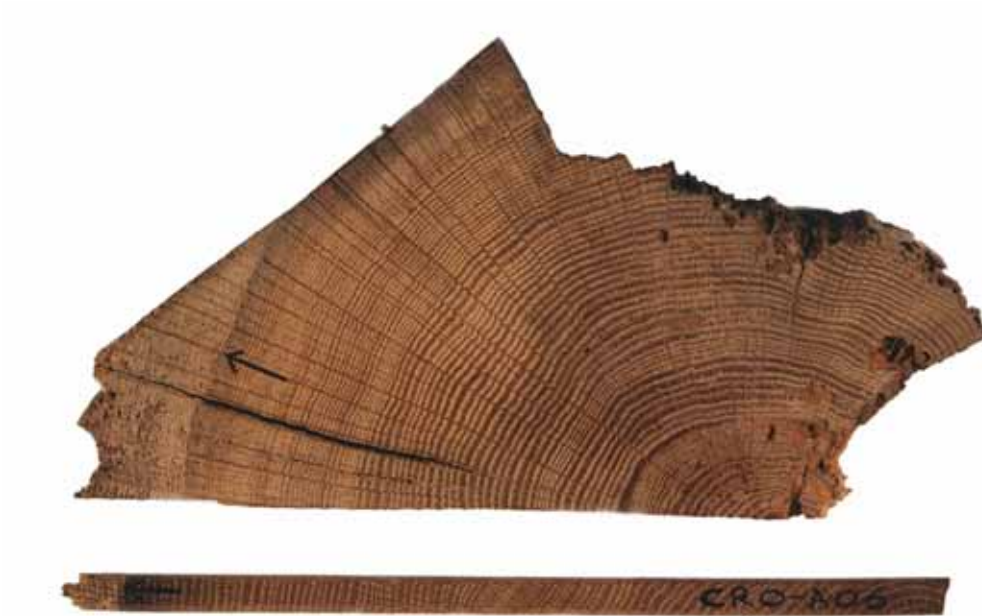
Figure A2: Cross-section of a rafter, showing sapwood rings in the left-hand corner, the arrow points to the heartwood/sapwood boundary (H/S); and a core with sapwood; again the arrow is pointing to the H/S. The core is about the size of a pencil

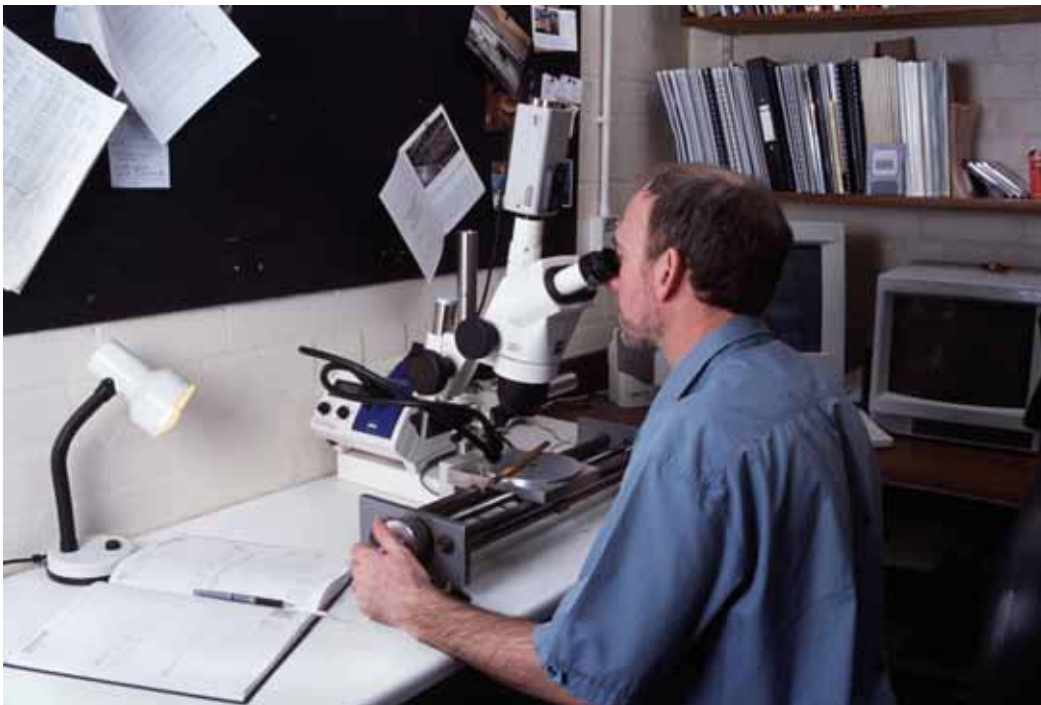
Figure A3: Measuring ring widths under a microscope. The microscope is fixed while the sample is on a moving platform. The total sequence of widths is measured twice to ensure that an error has not been made. This type of apparatus is needed to process a large number of samples on a regular basis

2. **Measuring Ring Widths.** Each core is sanded down with a belt sander using medium-grit paper and then finished by hand with flourgrade-grit paper. The rings are then clearly visible and differentiated from each other with a result very much like that shown in Figure A2. The core is then mounted on a movable table below a microscope and the ring-widths measured individually from the innermost ring to the outermost. The widths are automatically recorded in a computer file as they are measured (see Fig A3).

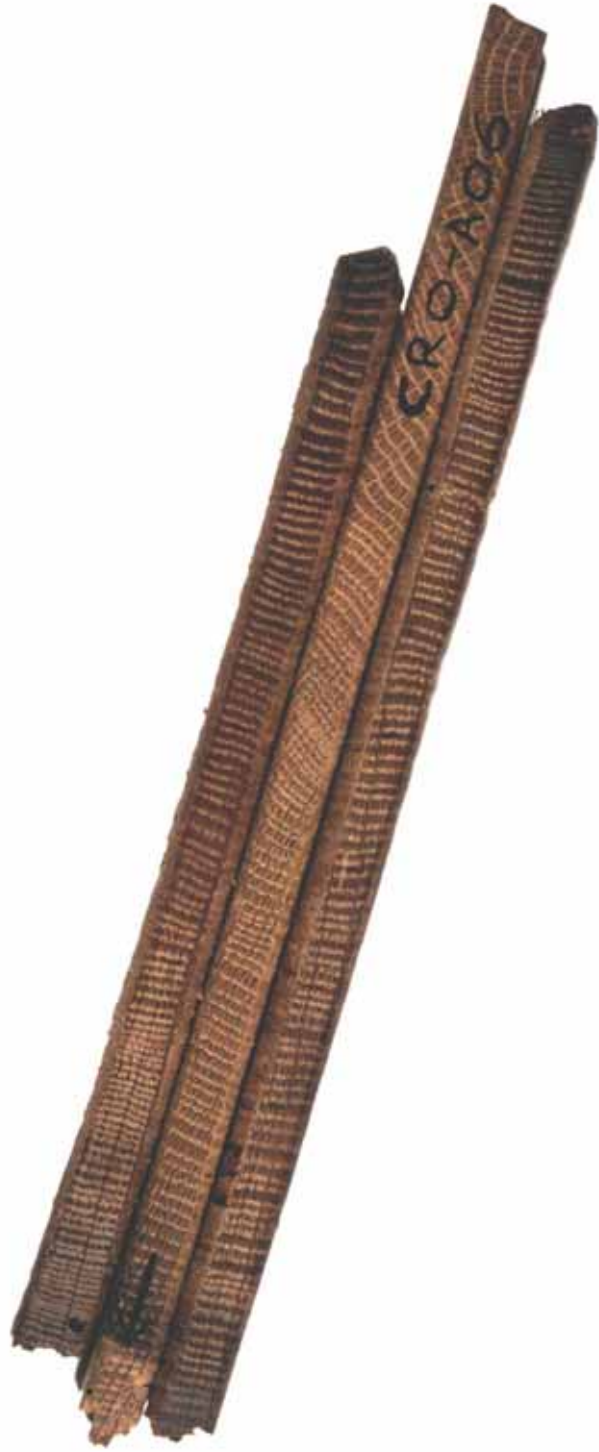
Figure A4: Three cores from timbers in a building. They come from trees growing at the same time. Notice that, although the sequences of widths look similar, they are not identical. This is typical
