RESEARCH REPORT SERIES no. 9-2012

CHURCH OF ST LAWRENCE, CHURCH LANE,
MICKLETON, GLOUCESTERSHIRE
TREE-RING ANALYSIS OF TIMBERS
FROM THE BELLFRAME

SCIENTIFIC DATING REPORT

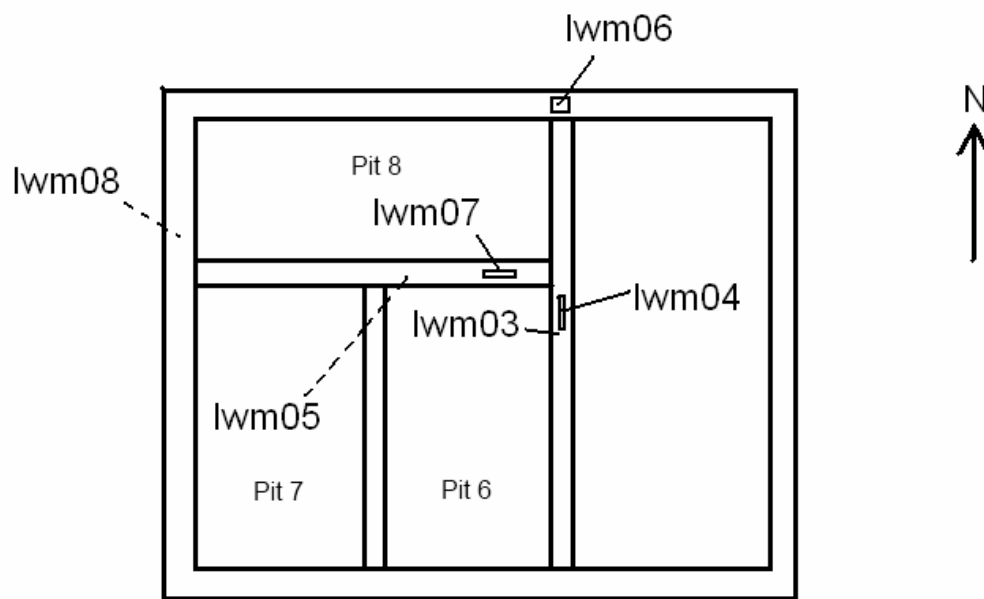
Figure 4: Sketch plan of the bellframe indicating the approximate positions of timbers sampled for dendrochronology. Dotted lines show timbers at sill level

Basic information about the samples taken is presented in Table 1 and their location within the structure is illustrated in Figures 3 and 4. All samples were measured and the data for each of the individual series presented in the Appendix.
