RESEARCH REPORT SERIES no. 11-2012

MANOR HOUSE,
1 EAST GREEN, HEIGHINGTON,
NEAR DARLINGTON, COUNTY DURHAM
TREE-RING ANALYSIS OF TIMBERS

SCIENTIFIC DATING REPORT

Alison Arnold and Robert Howard

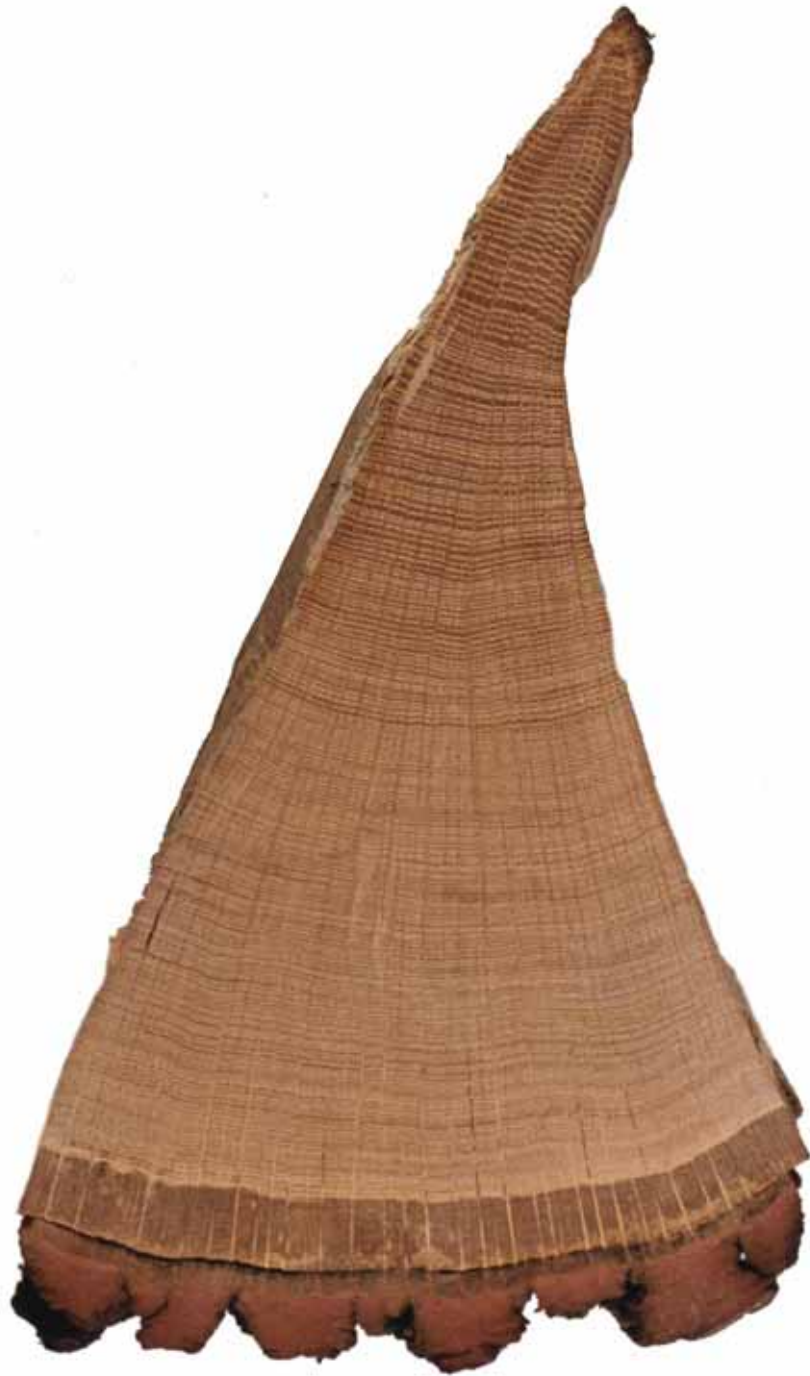
Figure A1: A wedge of oak from a tree felled in 1976. It shows the annual growth rings, one for each year from the innermost ring to the last ring on the outside just inside the bark. The year of each ring can be determined by counting back from the outside ring, which grew in 1976

If the bark is still on the sample, as in Figure A1, then the date of the last ring will be the date of felling of the oak from which it was cut. There is much evidence that in medieval times oaks cut down for building purposes were used almost immediately, usually within the year or so (Rackham 1976). Hence if bark is present on several main timbers in a building, none of which appear reused or are later insertions, and if they all have the same date for their last ring, then we can be quite confident that this is the date of construction or soon after. If there is no bark on the sample, then we have to make an estimate of the felling date; how this is done is explained below.

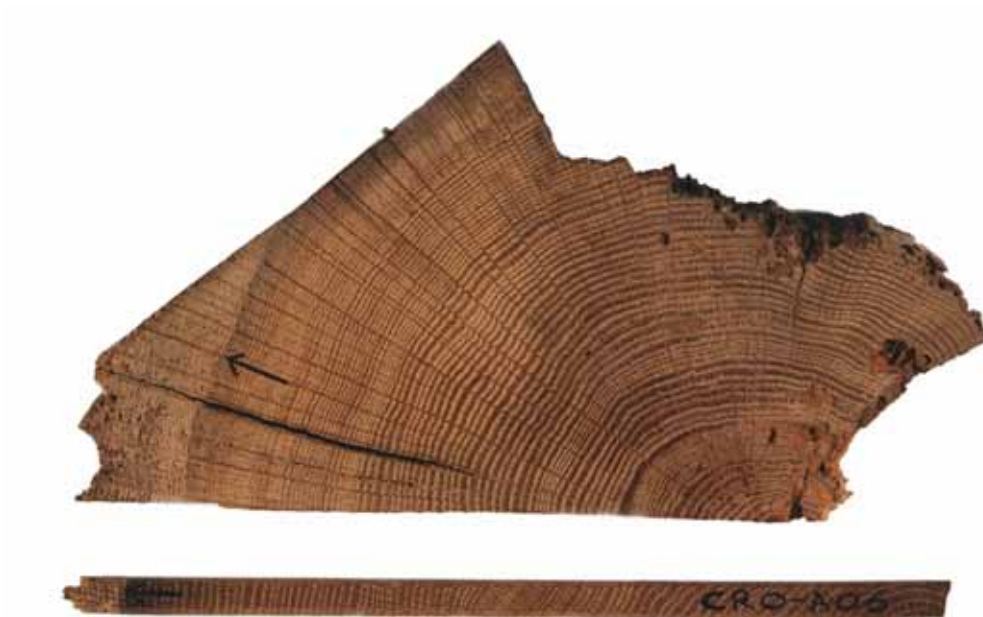
Figure A2: Cross-section of a rafter, showing sapwood rings in the left-hand corner, the arrow points to the heartwood/sapwood boundary (H/S); and a core with sapwood; again the arrow is pointing to the H/S. The core is about the size of a pencil

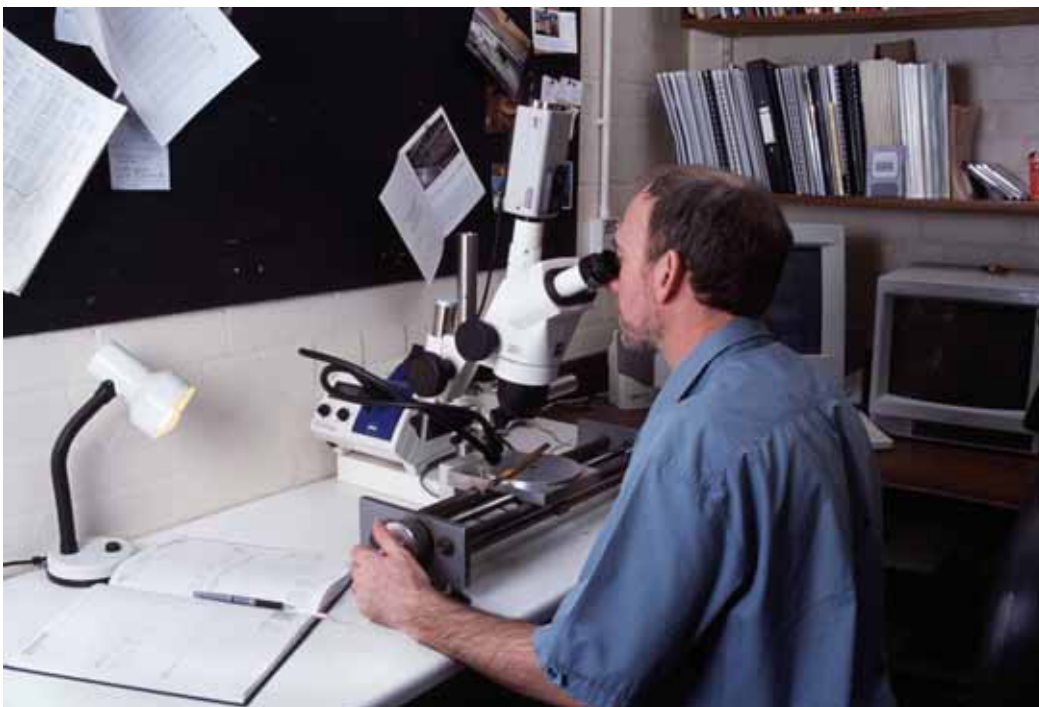
Figure A3: Measuring ring widths under a microscope. The microscope is fixed while the sample is on a moving platform. The total sequence of widths is measured twice to ensure that an error has not been made. This type of apparatus is needed to process a large number of samples on a regular basis

2. **Measuring Ring Widths.** Each core is sanded down with a belt sander using medium-grit paper and then finished by hand with flourgrade-grit paper. The rings are then clearly visible and differentiated from each other with a result very much like that shown in Figure A2. The core is then mounted on a movable table below a microscope and the ring-widths measured individually from the innermost ring to the outermost. The widths are automatically recorded in a computer file as they are measured (see Fig A3).

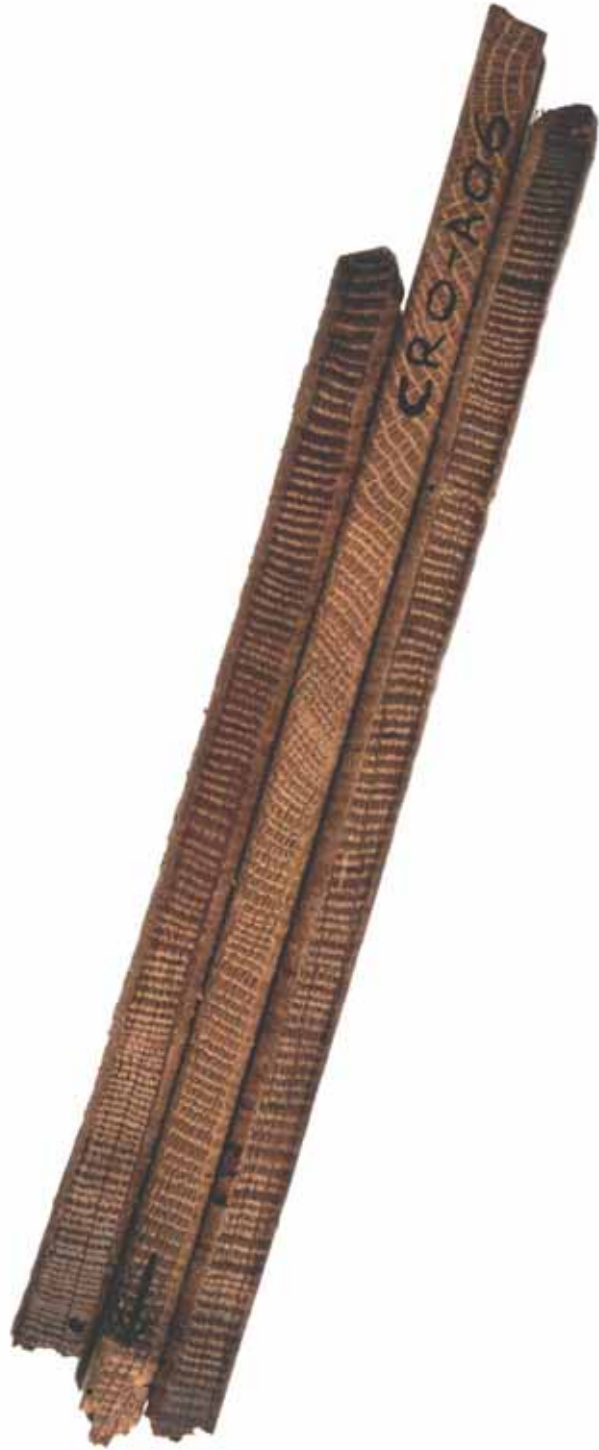
Figure A4: Three cores from timbers in a building. They come from trees growing at the same time. Notice that, although the sequences of widths look similar, they are not identical. This is typical
