RESEARCH REPORT SERIES no. 20-2012

I, 3, AND 5 HIGHER STREET,  
DARTMOUTH, DEVON  
**TREE-RING ANALYSIS OF TIMBERS**

SCIENTIFIC DATING REPORT

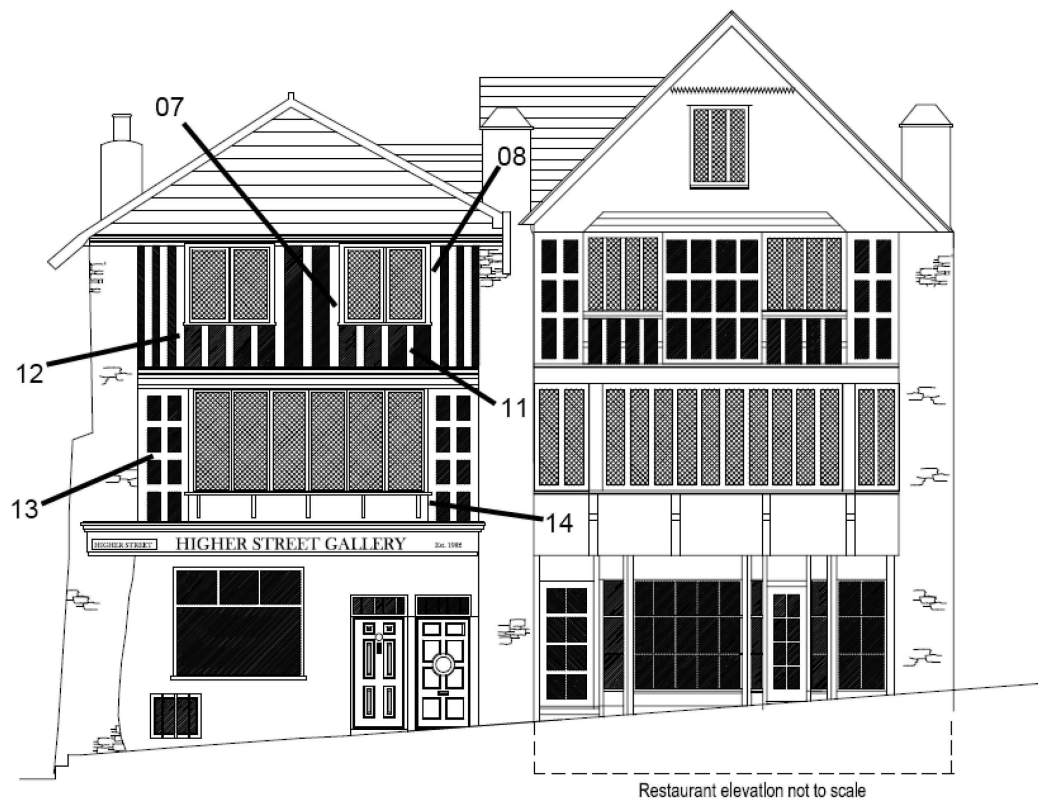
*Figure 6. Higher Street (west) elevation, showing some of the timbers sampled for dendrochronology, adapted from original drawings by BBH Chartered Architects (Dartmouth) Ltd*

A total of 16 timbers were sampled, covering a range of elements. Basic information about the samples taken is presented in Table 1 with the raw ring-width data of the measured samples being given in the Appendix. Positions of timbers sampled are shown in Figs 3-8. Four series contained less than 45 rings and these were not included in further analysis. Three series contained only 48 rings, less than desirable, but these were measured in the hope that these relatively short series might match others from this site, especially as one of them retained complete sapwood.

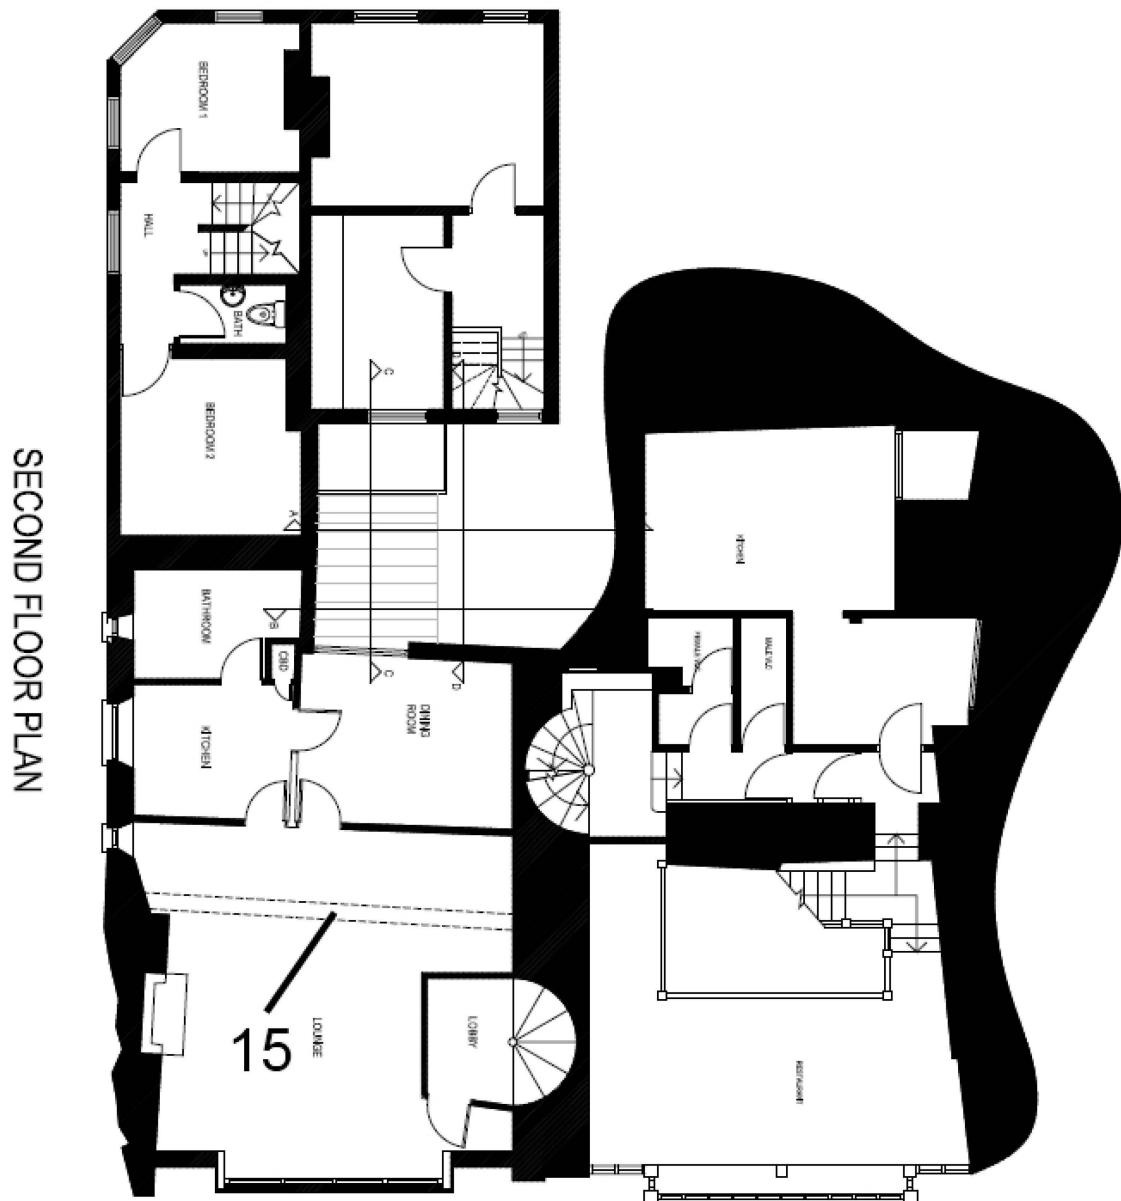
Figure 7. Second-floor plan showing the location of sample 15, adapted from original drawings by BBH Chartered Architects (Dartmouth) Ltd

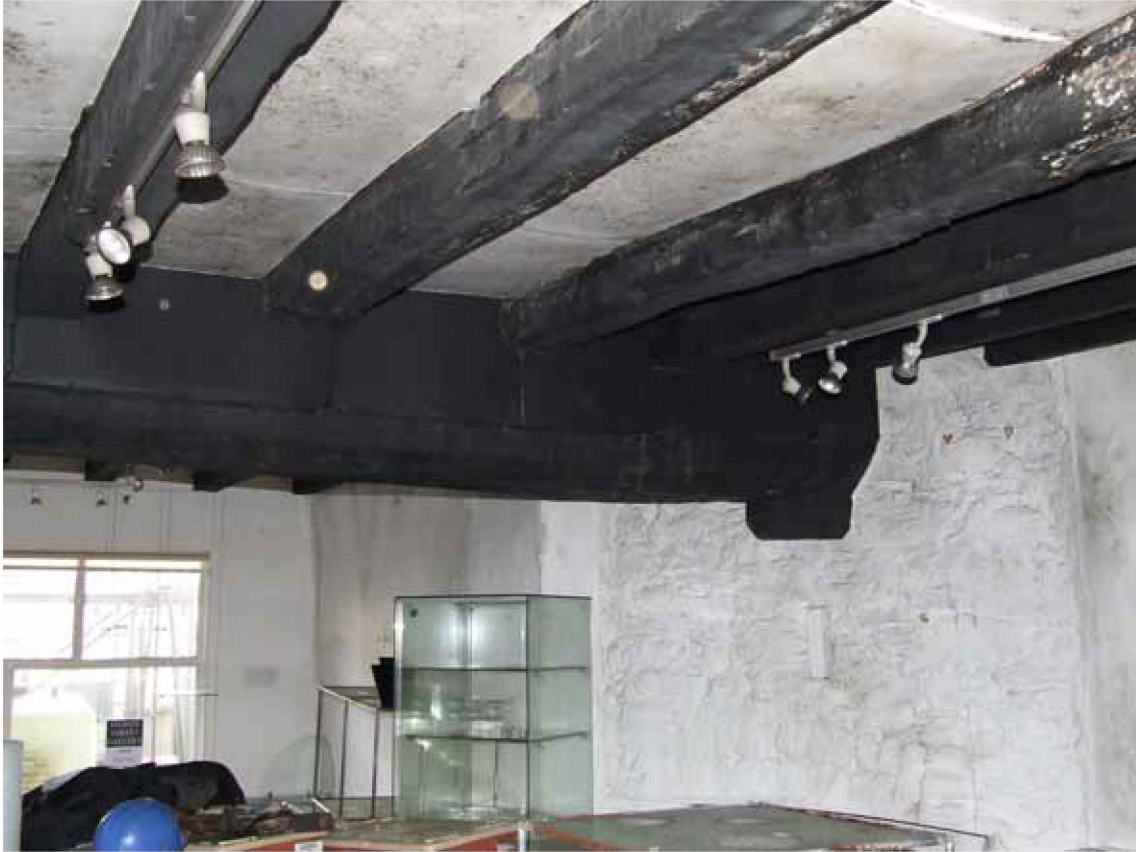
*Figure 8. View of the north-south beam (centre of photograph) sampled as dtm 16*
