# THE BRITISH MUSEUM BINDERY AND 1–2 MONTAGUE PLACE, LONDON BOROUGH OF CAMDEN

## HISTORIC BUILDINGS REPORT

Research Department Report Series 60-2009

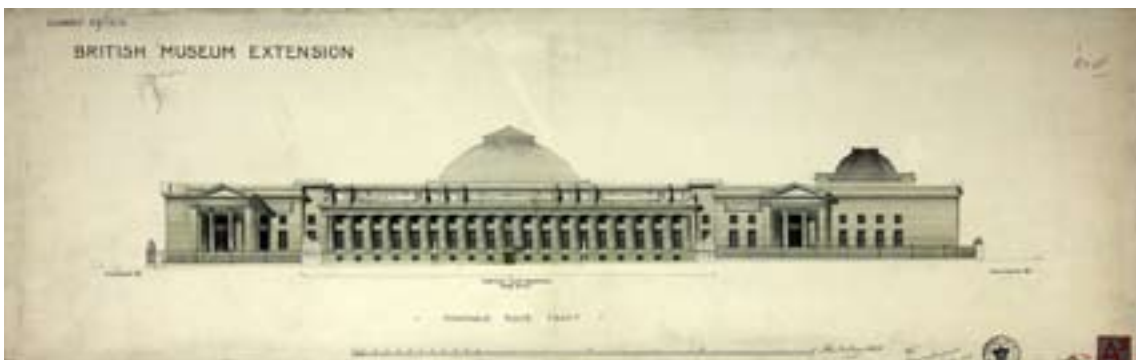
Figure 3 British Museum extension, Montague Place front, drawing by John James Burnet, 1905. Copyright The National Archives (hereafter TNA) (WORK 33/1212)

Burnet's view from Montague Place (fig. 3) shows the King Edward VII Galleries as the central portion with the outer wings planned for later execution. The central dome is the dome of the Reading Room and the dome to the right would have been a domed

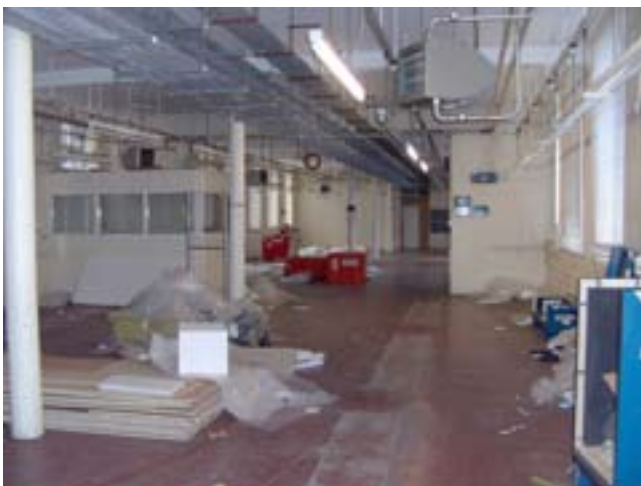
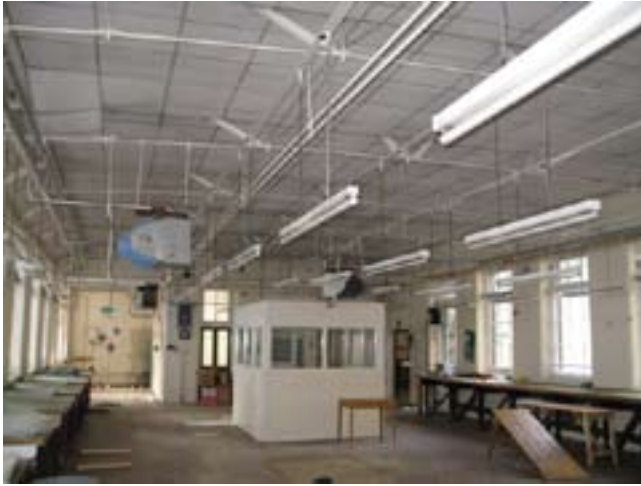
Figure 14 Interior view of the Bindery, ground floor.  
Copyright English Heritage (DP070362)

date from 1957–58.<sup>33</sup> The original herringbone woodblock floor on the first floor survives under linoleum sheeting. Alterations include the replacement of the sanitary ware and the light fittings, as well as the introduction of fan-assisted hot water convectors suspended from the ceiling of the workshops (c.1956) (figs 14 and 15).<sup>34</sup>

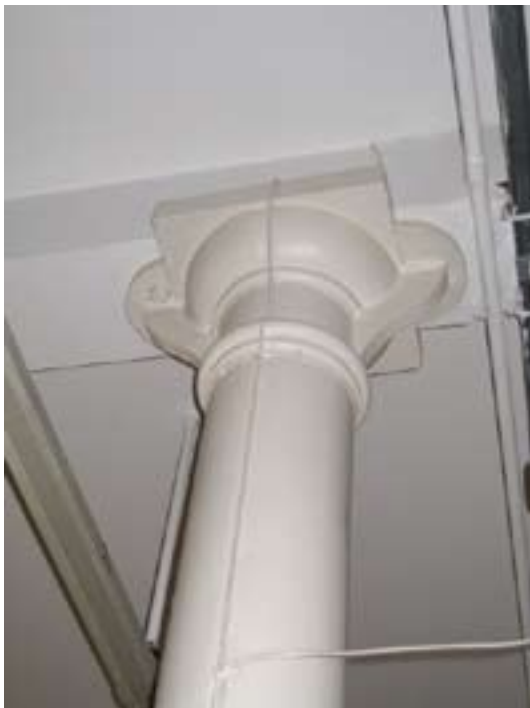
Brick cross-walls, originally fitted with heavy ‘fireproof’ metal doors, and compartmentalized stairs at the ends of the building, are illustrative of the attempts to minimize or halt the spread of fire in a building that housed inherently risky processes. Besides fire-resistance the internal use of iron, steel and concrete helped to open up

Figure 16 Cast iron column, ground floor, Bindery. Copyright English Heritage (DP070364)

the interiors, maximizing light penetration on both floors, both of which were robust enough to accommodate heavy workbenches, presses and other hand-operated machinery.

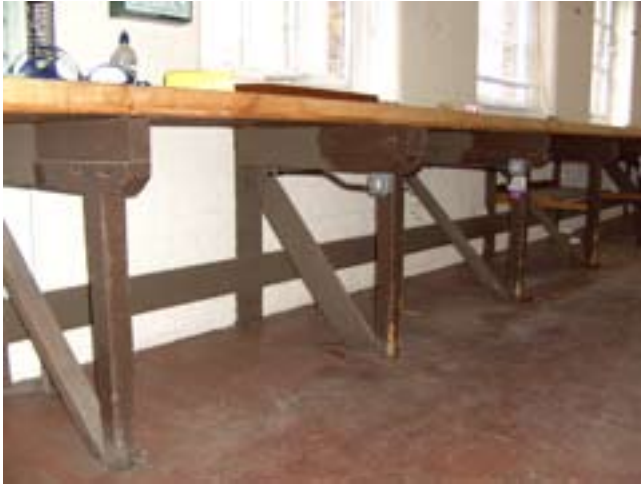
Figure 19 Bindery workbenches, showing the original substructure. Copyright English Heritage (DP070365)

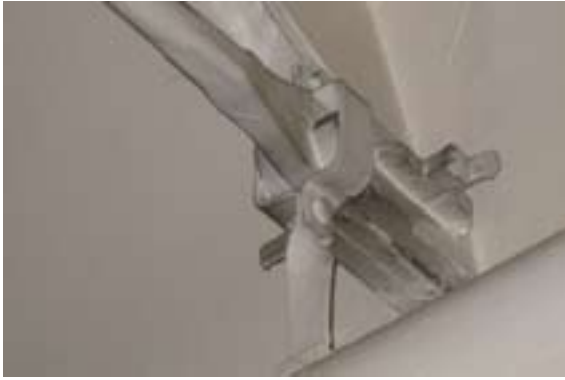
Figure 21 Gib and cotter joint, the British Museum Bindery, 1898. Copyright English Heritage (DP070367)

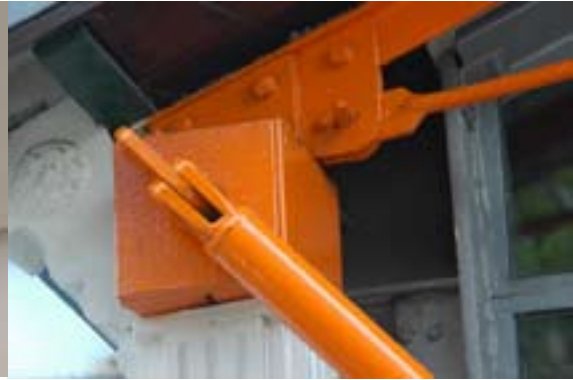
Figure 22 Gib and cotter joint, the 'Fish' restaurant, Cathedral Street, Southwark, 1897. Copyright English Heritage (DP070368)

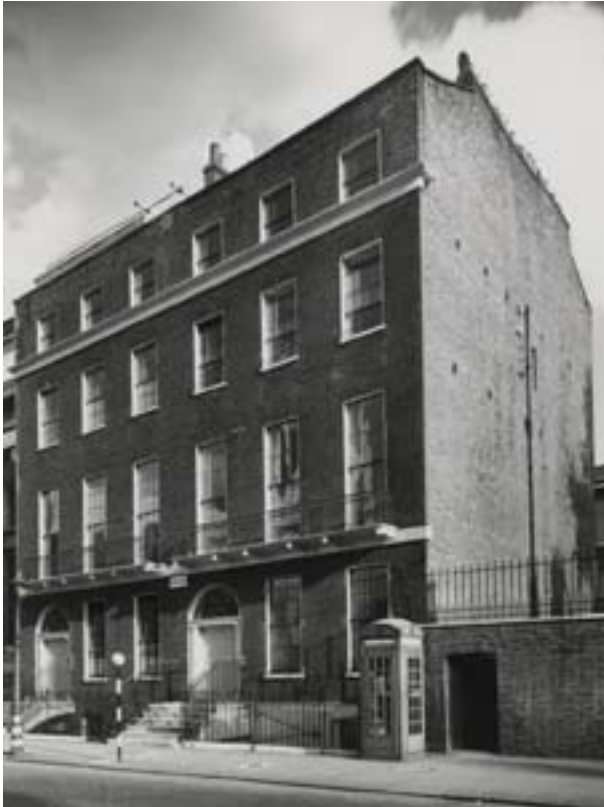
Figure 27 1 and 2 Montague Place, 1950.  
 Copyright City of London, London Metropolitan  
 Archives (SC/PHL/01/164/JMI3932)

A comparison of the original and the facsimile façade shows how closely the details were copied (figs 27, 29 and 31). However, there are subtle differences. Most noticeably the 1970s façade has standardised the sash windows. While in 1961 the windows of the top two storeys of both houses had similar three-over-three sashes in the attic and six-over-six windows in the second floor, the detailing of the glazing bars on the lower two storeys varied (fig. 29). The first floor had nine-over-nine sashes in No. 2 which were replaced in the

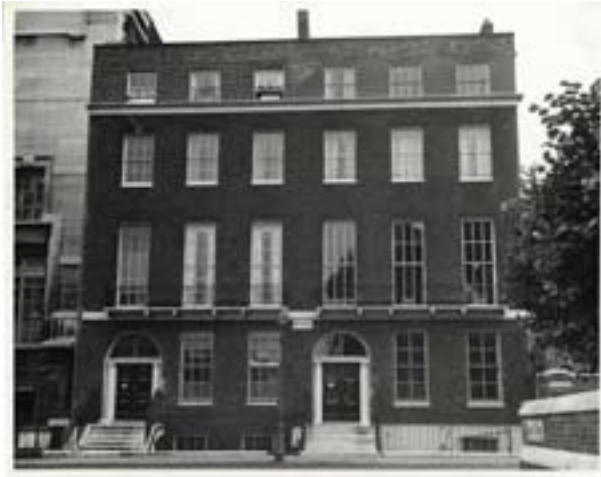
*Figure 29 1 and 2 Montague Place, 1961, photo from the Building Preservation Order. Copyright Camden Local Studies and Archive Centre (H.S.917)*

Discussions about the future use of the two buildings frequently mention the shabby condition of the interior and in 1958–59 during roof repairs additional work to brick parapets and chimney stacks was found to be necessary (fig. 29).<sup>74</sup> J. H. Davey from the Ministry of Works recommended in 1961 that No. 1 could be let to tenants if the Museum could not make a satisfactory case for the use of the two houses – however, he advised against letting the lower part of No. 2 (presumably because of its bad state of repair).<sup>75</sup>

replica with six-over-six windows similar to those in No.1 (figs 29 and 31). Likewise, the replica building features on the ground floor six-over-six sashes which in 1961 could be found in the windows of No. 2, while No.1 had four-over-four sashes. No. 2 also seems to have had horns on some of its sash windows, to whose replication the condition of the Listed Building Consent might have referred (figs 27 and 29).

Another departure from the predecessor building concerns the basement windows. In 1961, No. 1 had one basement window and No. 2 two (fig. 29). In the 1970s building, the basement windows have been reduced to one in the eastern half of the façade (which replicates No. 2), with a door in

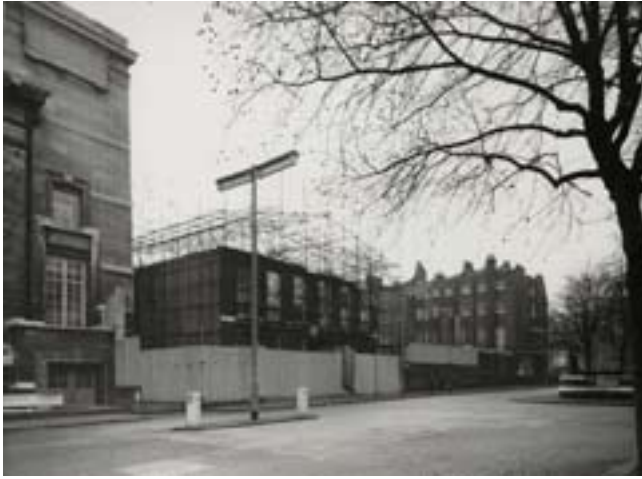
Photographic evidence shows that in 1969 both houses were already in the process of demolition, with only part of the façade still standing (fig. 30).<sup>84</sup> According to Robert Chitham, formerly of the GLC's Historic Buildings Division, the GLC stipulated a classical building to replace Nos 1 and 2, and the Museum's architects proposed a building with replica façade.<sup>85</sup>

Figure 30 1 and 2 Montague Place during demolition, 1969. Copyright City of London, London Metropolitan Archives (SC/PHL/01/164/69.342)

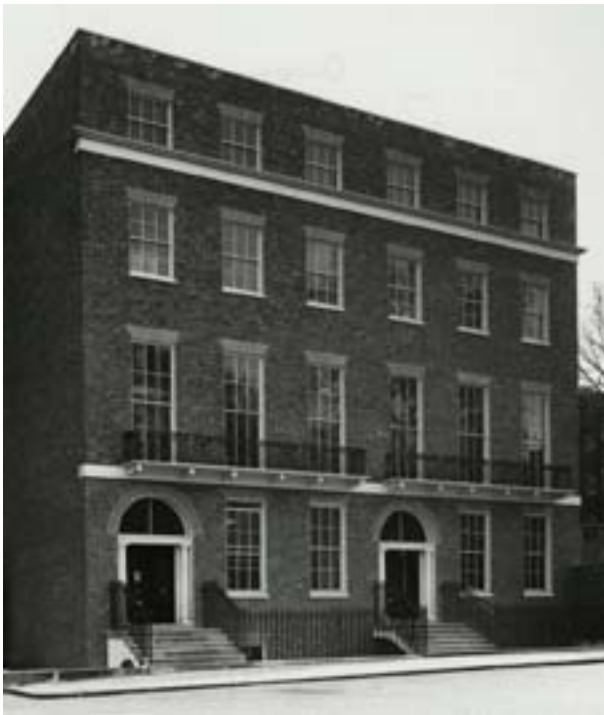
Figure 31 1–2 Montague Place, after the rebuilding, 1973. Copyright City of London, London Metropolitan Archives (SC/PHL/01/164/73.3759)

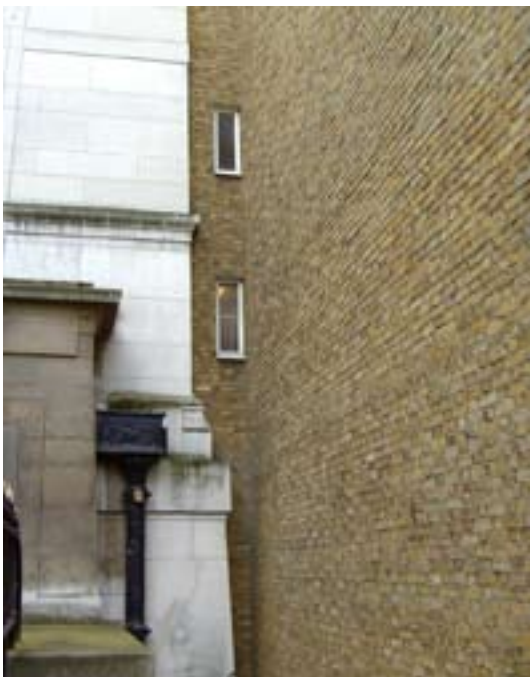
Figure 33 Windows between the King Edward VII Galleries and 1–2 Montague Place. Copyright English Heritage (DP070370)

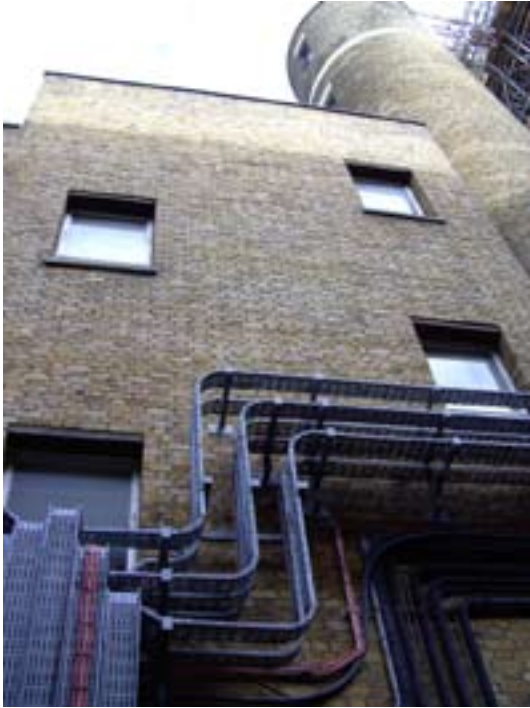
To the west, the elevation features six windows which light kitchens and lavatories, three each on the top two floors. Two of these are three-over-three sashes, which are, together with those on the front elevation, the only sash windows of the building. (In the view of 1950 of the same elevation, there are only two slim windows (fig. 27).) At the re-entrant corner on the west side are two windows at first floor level. The west elevation of the rear block has one window on the first floor and two small square lavatory windows on the second floor. The rear elevation is three storeys tall and five windows wide, two of which are staircase windows at differing levels (fig. 34).

Figure 34 Rear elevation of 1–2 Montague Place, adjoining the staircase tower of the King Edward VII Galleries. Copyright English Heritage (DP070371)

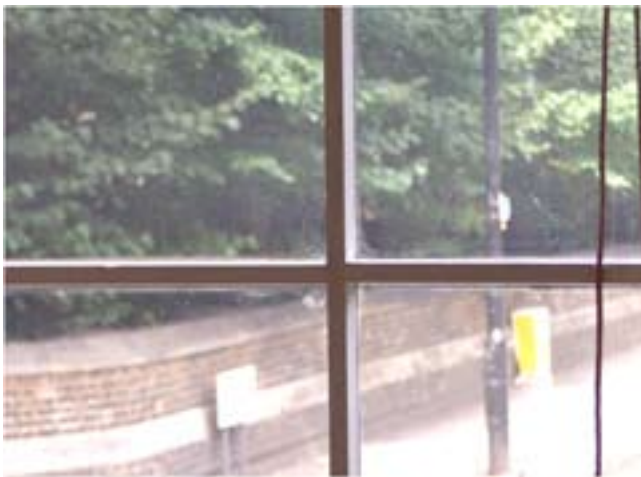
In general, the replica is only superficial and does not extend beyond the frontal view of the façade. Neither the original plan form nor other elevations were replicated. At a closer examination, the pretence of the façade becomes apparent: there are no

Figure 37 First-floor window, glazing bars without mouldings. Copyright English Heritage (DP070374)
