RESEARCH REPORT SERIES no. 18-2012

# HALL FARM BARN, MAIN STREET, HORKSTOW, NORTH LINCOLNSHIRE TREE-RING ANALYSIS OF TIMBERS

SCIENTIFIC DATING REPORT

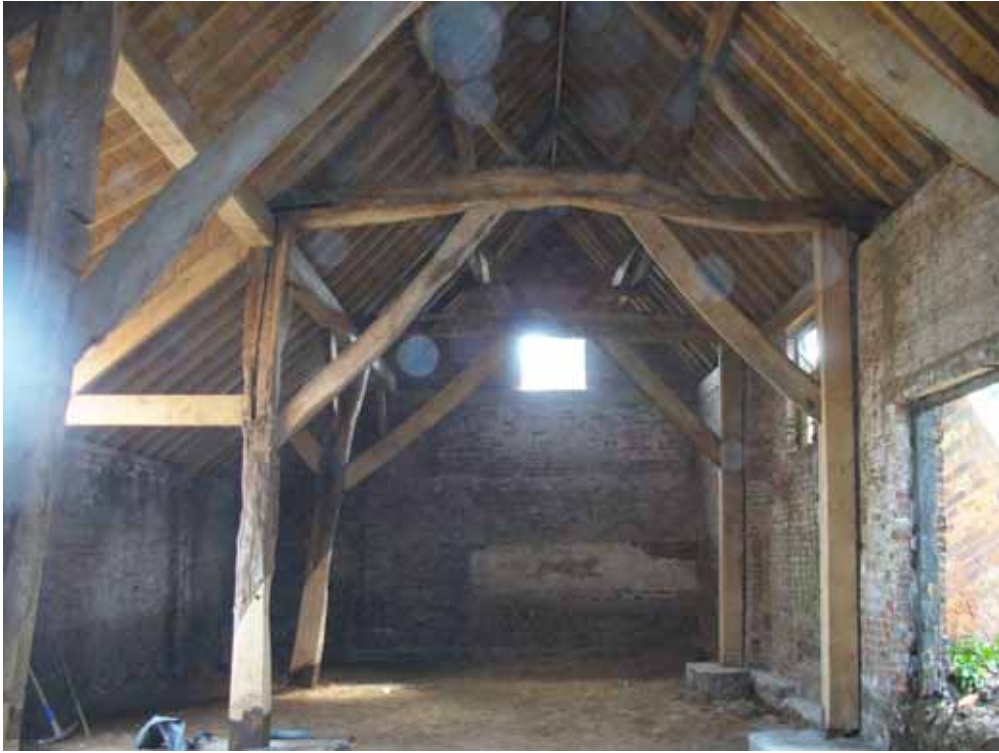
*Figure 5: View of the trusses looking east*

Each truss comprises what would originally have been north and south aisle posts with a tiebeam. Slightly curved braces rise from the aisle posts to the tiebeams, there then being raking queen struts from the tiebeams to the principal rafters. These trusses support a single row of purlins to each pitch of the roof. The north aisle posts now support an aisle plate, and there are short ties between the north aisle posts and the north wall plate (Fig 5).

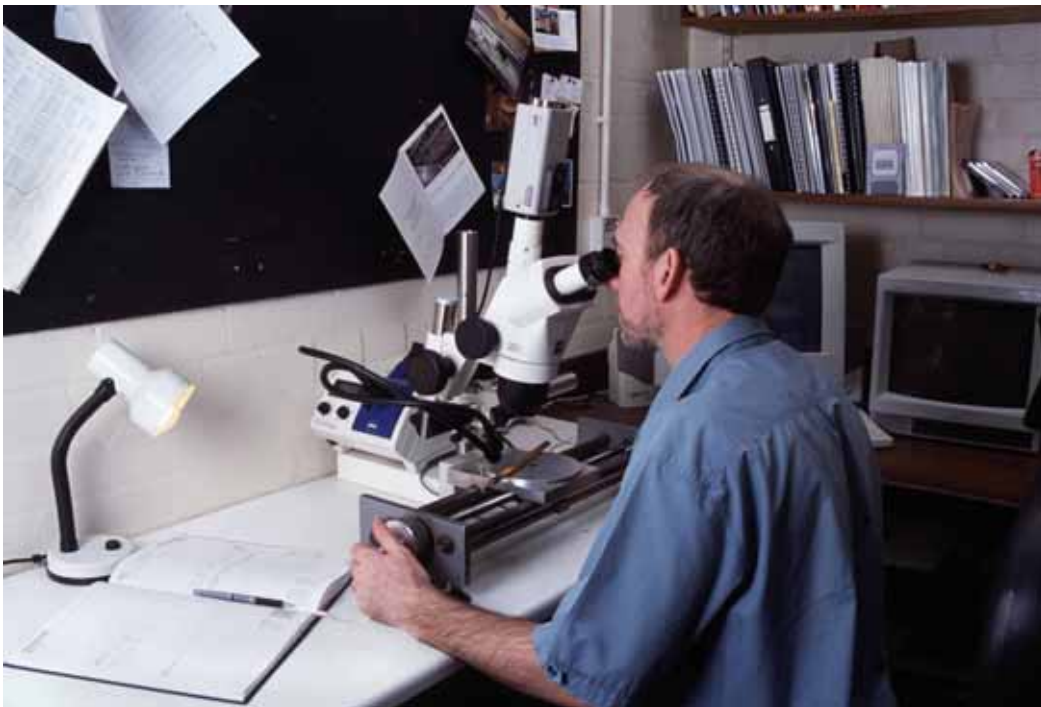
*Figure A3: Measuring ring widths under a microscope. The microscope is fixed while the sample is on a moving platform. The total sequence of widths is measured twice to ensure that an error has not been made. This type of apparatus is needed to process a large number of samples on a regular basis*

2. **Measuring Ring Widths.** Each core is sanded down with a belt sander using medium-grit paper and then finished by hand with flourgrade-grit paper. The rings are then clearly visible and differentiated from each other with a result very much like that shown in Figure A2. The core is then mounted on a movable table below a microscope and the ring-widths measured individually from the innermost ring to the outermost. The widths are automatically recorded in a computer file as they are measured (see Fig A3).
