Cliffe Fort, Hoo Peninsula, Medway, Kent

Investigation and analysis of the 19th-century Coastal Artillery Fort

Research Report Series 015-2011

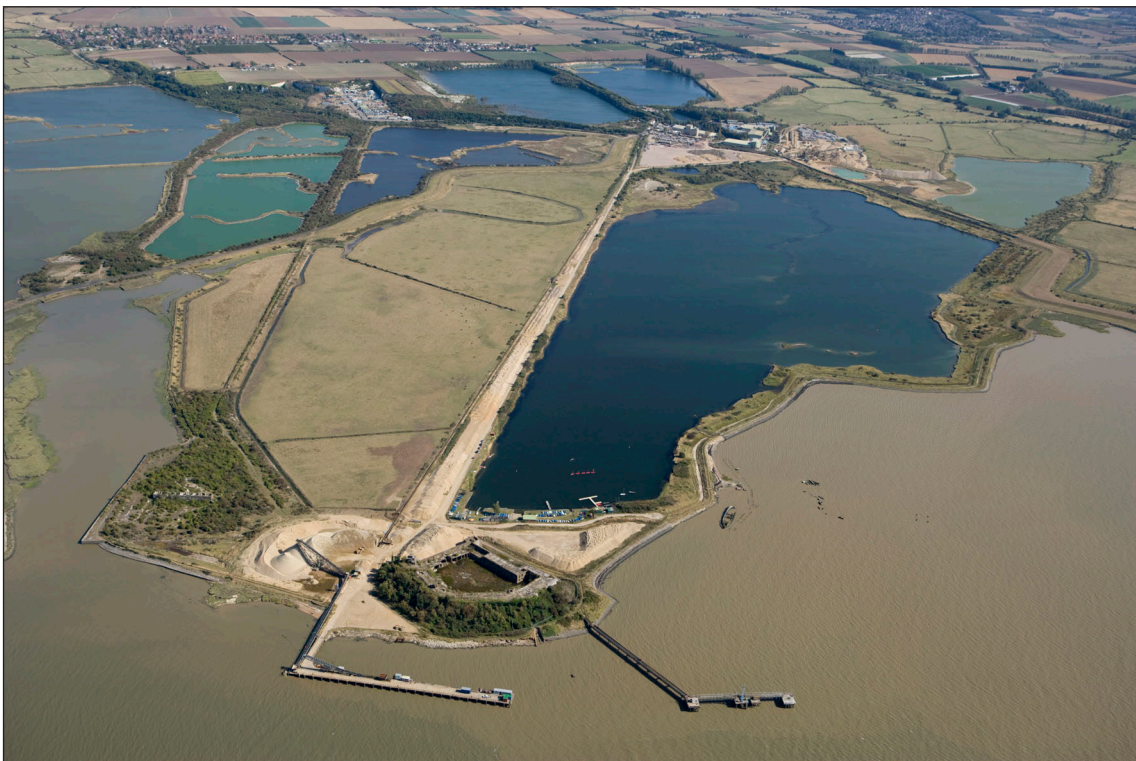
Figure 2: The topographic setting of Cliffe Fort. (HEA 26474/018)

Cliffe Fort is located on the south bank of the River Thames, between Higham and Cliffe Creeks, at the point where the river turns north before heading east once more towards the Thames Estuary. It now appears isolated within the extensive quarries relating to the former Portland cement works (Fig 2). The fort is located to the north of Shornemead Fort and opposite the Coalhouse Fort at East Tilbury in Essex (Fig 3).

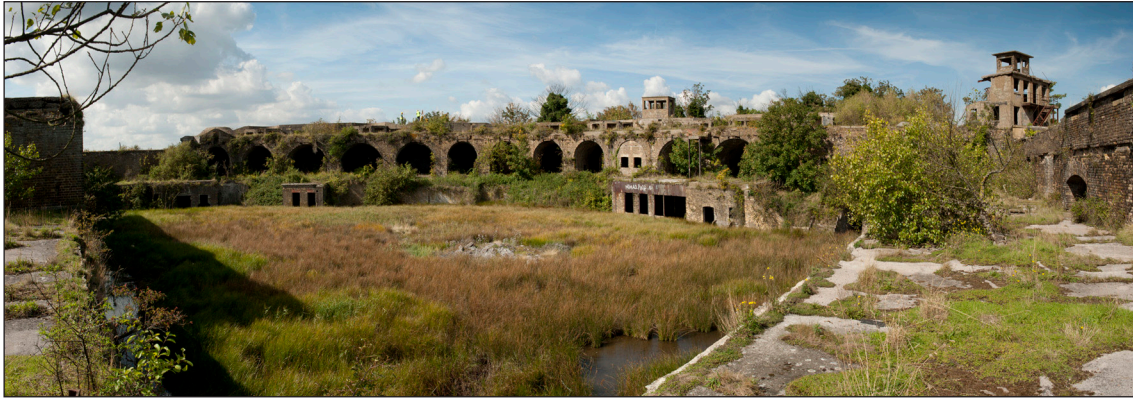
Figure 5: The interior of the fort in September 2010 from the south-east corner. From right to left, the main features that can be seen are the gorge wall with the recess for the murder holes over the entrance, the First World War Battery Observation Post, the gun casemates with the Submarine Mining Test and Engine Rooms below and the early-20th century barbettes and emplacements for breech loading guns on the roof. (DP 097569)

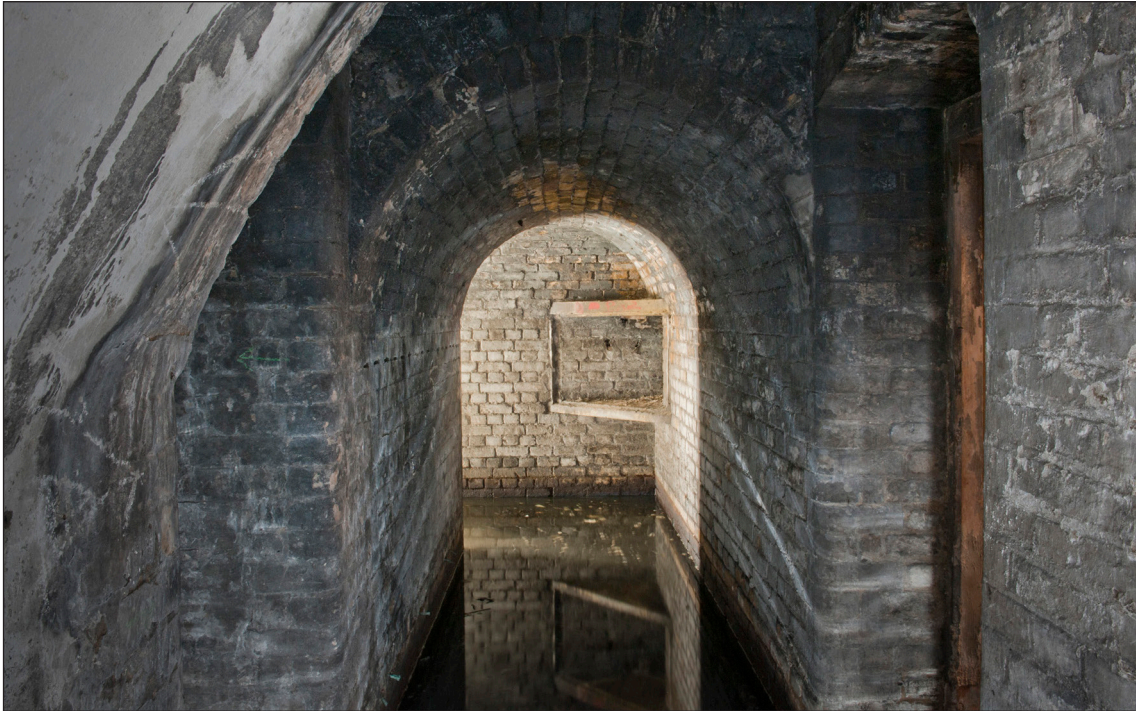
Figure 7: View looking south from a branch shifting passage into the intermediate dog-leg entrance passage. The area of white render and disturbed brickwork in the foreground on the left of the picture indicates the position of the removed wall. Beyond this is the crossing with the main lighting passage. The angled light box for the 90 degree turn in the dog-leg passage can be seen in the background. (DP 097426)

these were concentrated at the north end of the basement (see Chapter 9). The large sandstone slab lintel that has replaced the vaulting is set level with the top of the lighting passage vault. This utilitarian arrangement is not used in the other shifting passages which are properly vaulted.

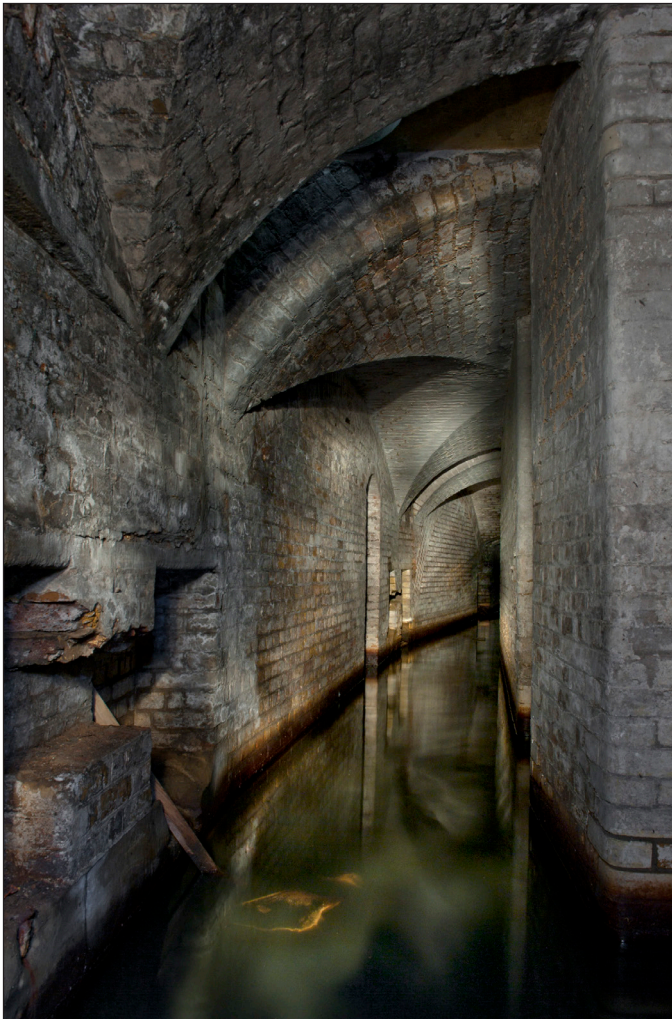
Figure 8: The shifting passage looking north-east. At the base of the wall on the left side of the picture are the recesses for the ammunition lift winches. Located out of shot to the right are the end walls of the ammunition stores. A shaft for the ammunition lift rises from the recess at the top of the vault. The arched headed opening in the middle distance is the blocked entrance to the demolished caponier. (DP097444)

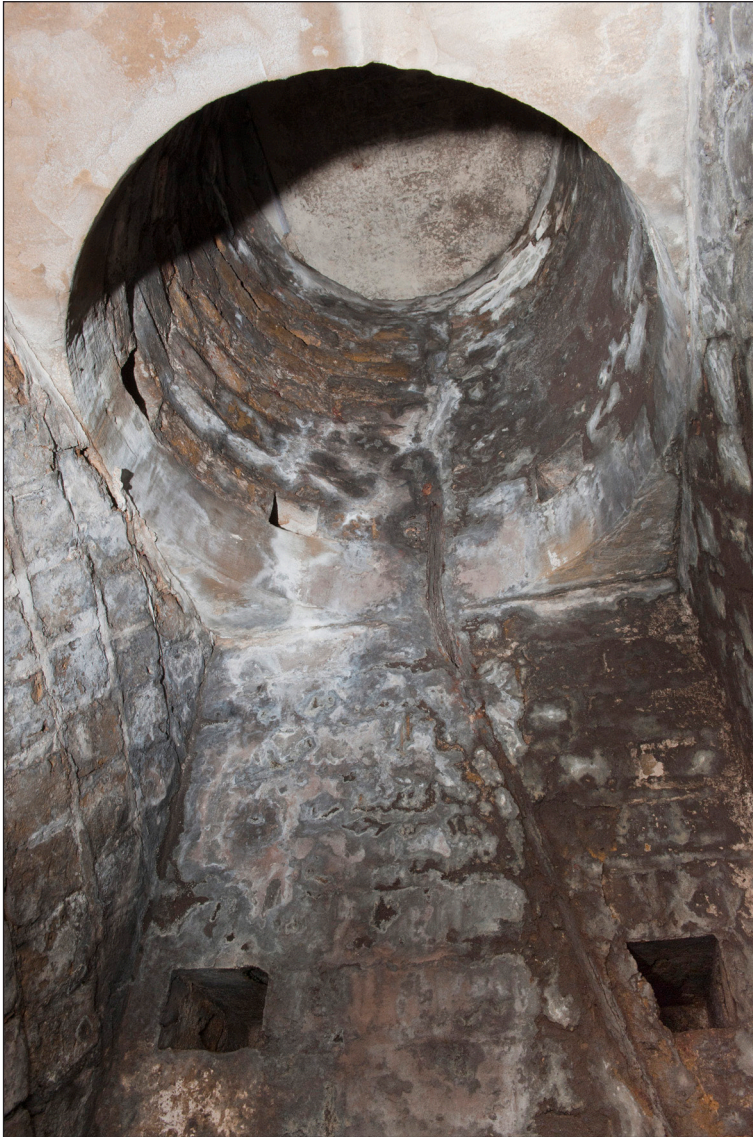
Figure 9: Detail of No 3 Shell Lift looking upwards towards the gun floor. The sockets for the collar anchors can be seen. (DP097451)

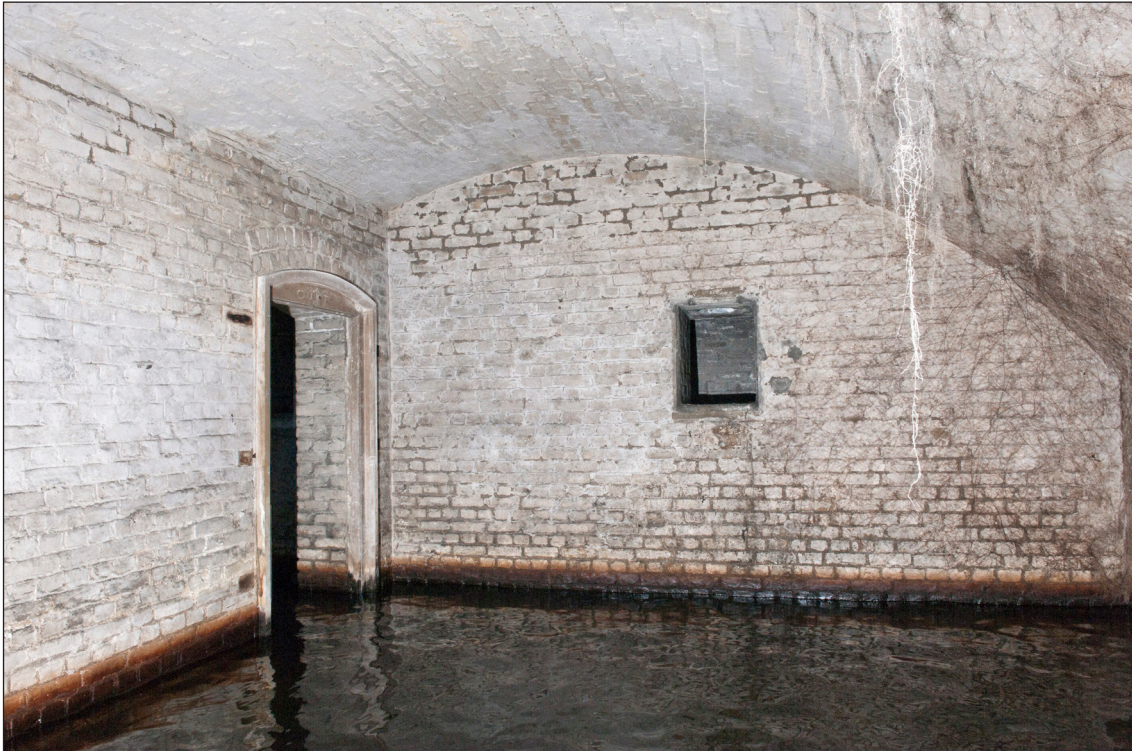
Figure 10: Interior of No 5 Spare Shell Store [92] which retains the plan and appearance of the ammunition stores as built. Note the light box in the rear wall and the sturdy timber door-frame with pegged joints and retained by noggins set in the brickwork. (DP097445)

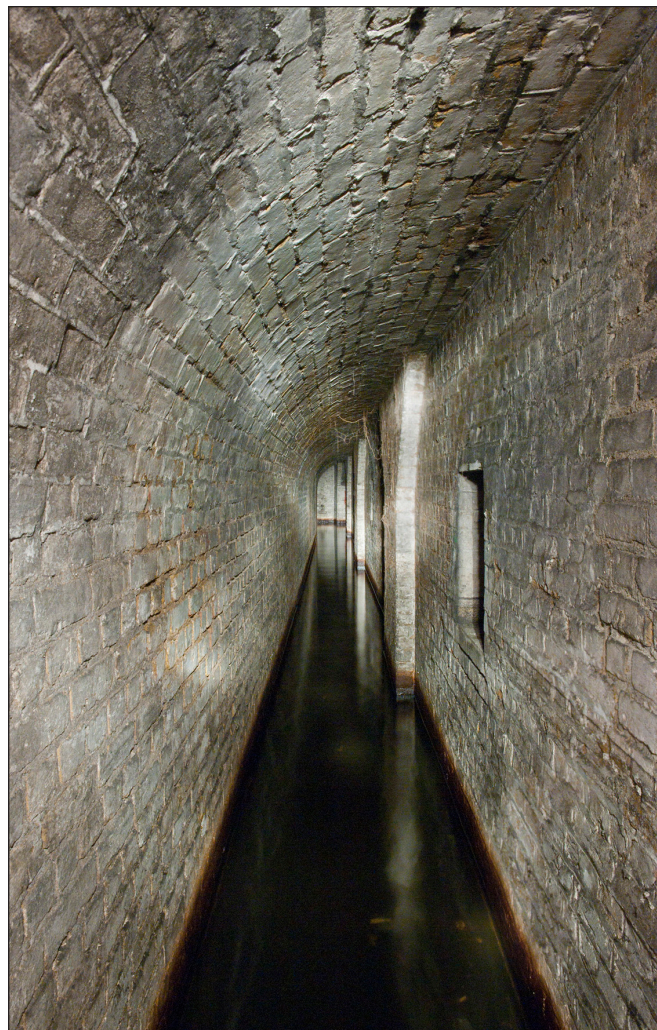
Figure 11: The main lighting passage looking south-west showing the restricted height of the passage and its slightly irregular vault. An opening for the light box in the end wall of the ammunition store can be seen in the wall on the right of the photograph. (DP097416)

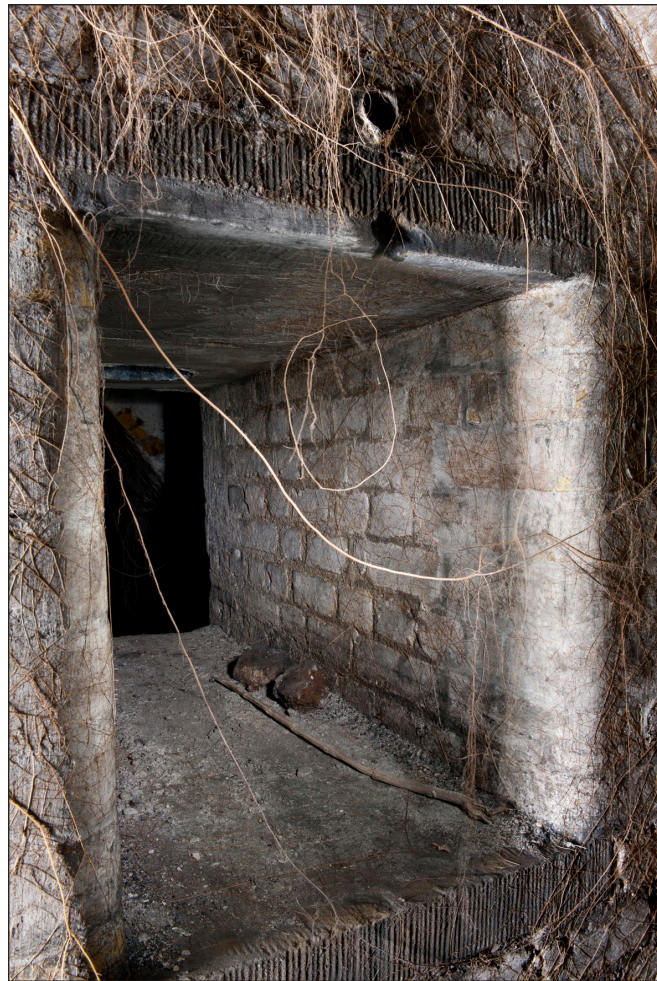
Figure 12: Close up view of a light box from the lighting passage side. The vent pipe positioned just above the masonry lintel provided the oxygen source for the lamp flame. (DP097416)

The north wall of the lighting passage is formed by the end walls of the passages and stores in the casemates. Square openings for the magazine lights are pierced through these walls, set at an average height of 1.3m. The light boxes have a tooled sandstone sill and lintel, each rebated along with the brick jambs to allow the flush fitting of a brass-framed glass pane on the store or shifting passage side. In the soffit of the lintel is a funnel-shaped vent and this is connected to a vent tube that emerges in the wall of the light passage above the light box (Fig 12). The clearest example of

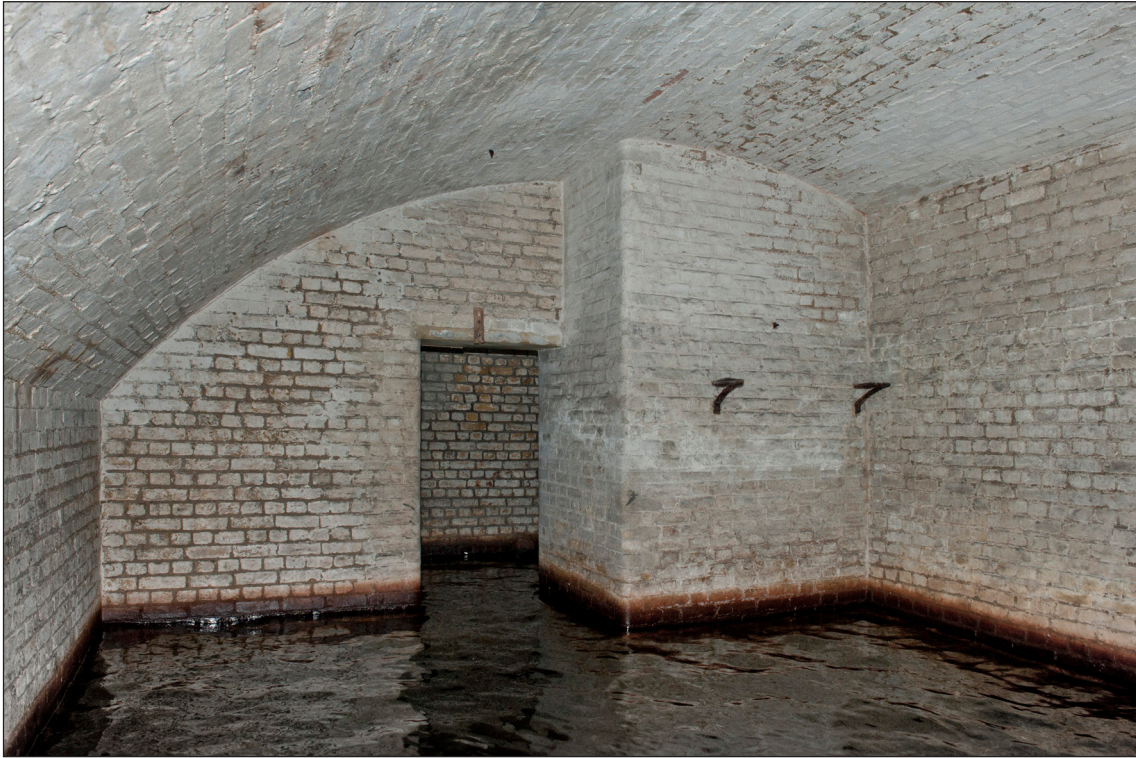
Figure 13: Interior of No 4 Cartridge Store [91] rebuilt for the insertion of a branch lighting passage. The end wall of this passage is to the right of the inserted doorway into the shifting passage. The wall brackets supported the fuse and primer box. (DP097453)

The new front wall has its entrance beneath a sandstone slab lintel (Fig 13). In many stores this work is neatly executed, suggesting that the entire wall was demolished and rebuilt, but several stores have areas of disturbed brickwork, cut bricks and slivers showing where the lintel has been inserted. A variety of door frames can be found beneath these lintels and only the one in No 2 Cartridge Store [86], which has

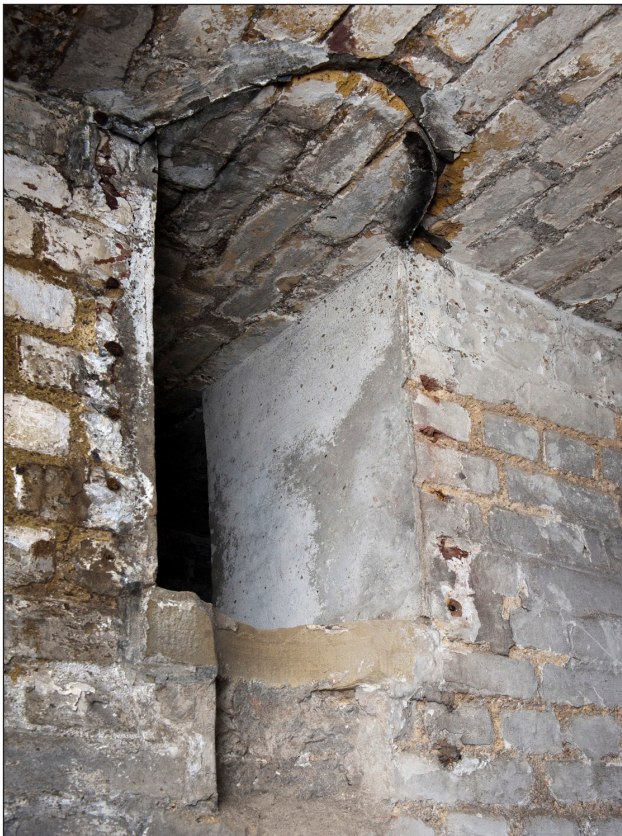
Figure 14: Inserted opening for No 16 light box at the springing of the shifting passage vault. The witness marks shows the position of the cover. The glass pane was set in the foot of the opening below the sandstone sill. (DP097437)

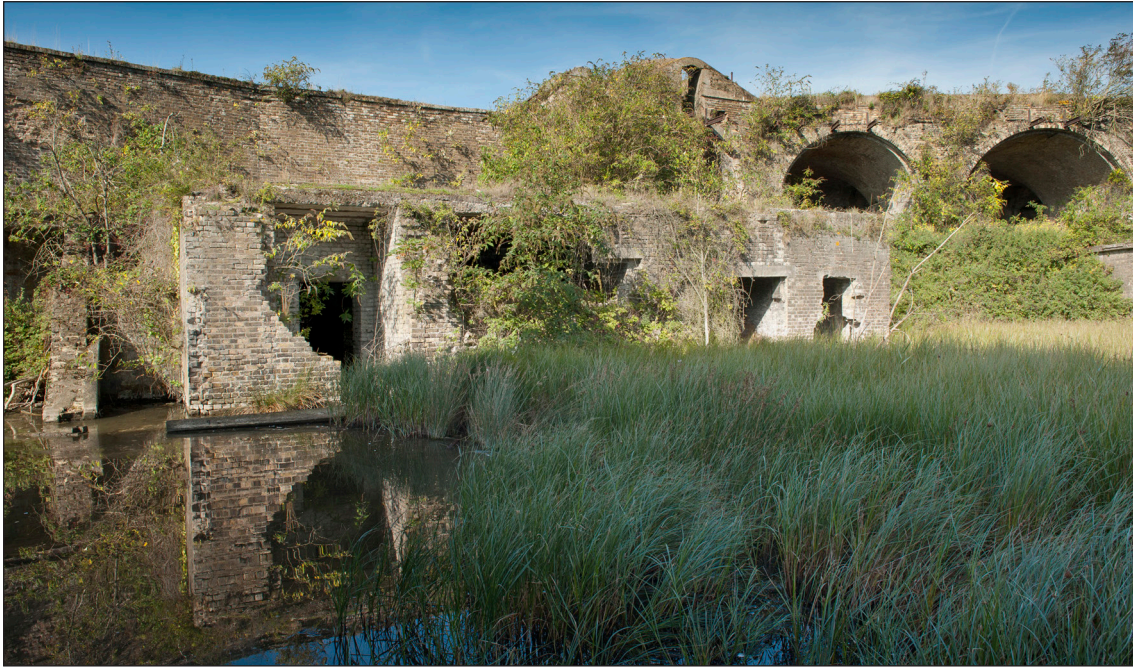
Figure 15: The former Laboratory [61], later converted to the entrance and stores for the Brennan installation. Above and behind is the traverse at the rear of the open battery. Casemate 15 is to the right with the back of the Brennan observation post above it. (DP097566)

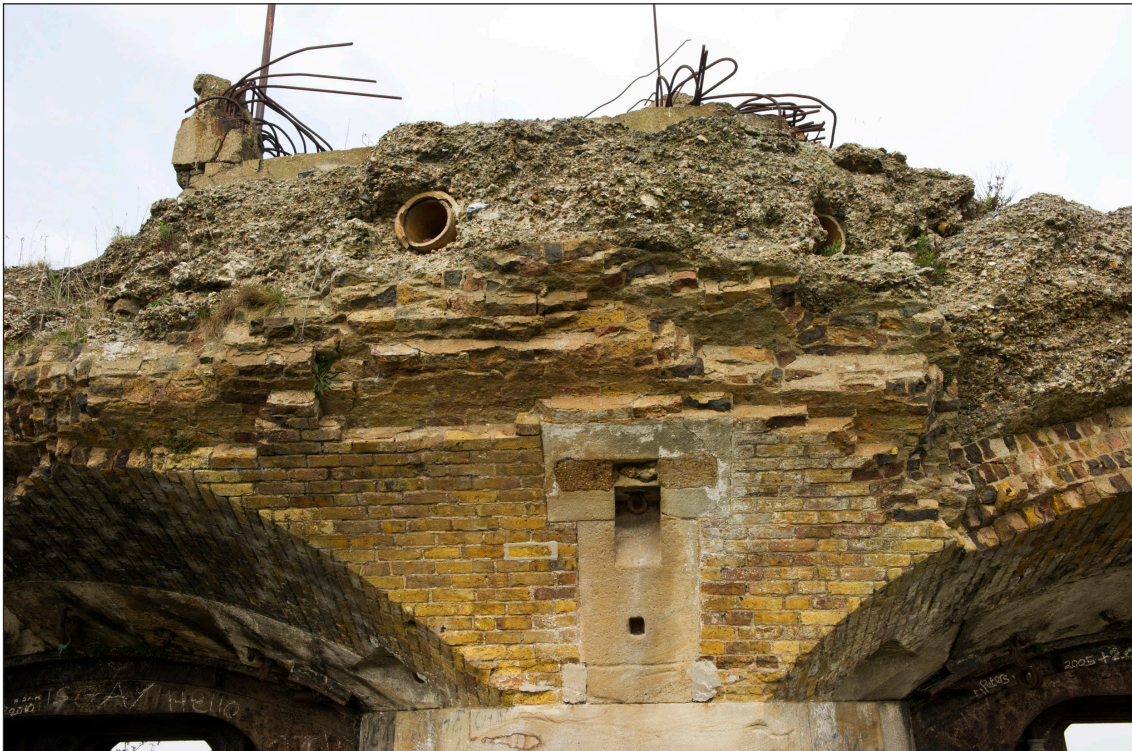
Figure 16: Detail view of the partly demolished casemated battery at Shornemead Fort. This shows the method of construction and the concrete fill used to bombproof the casemates. The earthenware ventilator pipe buried in the bombproofing and the masonry mounting for the ammunition hoist are visible. The reinforcing rods and concrete sections on the roof relate to a demolished Second World War structure. (DP097526)

The battery of Cliffe Fort is a two-storey colonnade of brick-built arched casemates running around the north and west sides of the fort and describing a gradual curve as it follows the shoreline. The casemates spring from masonry and rubble walling, while those in the basement storey spring from brick-built piers. The battery casemates have a gun position at the front with living quarters to the rear. Due to its use as a magazine the front wall of the basement incorporates a substantial thickness of masonry acting as a shell proof layer and supporting the base of the gun positions above. The structure sits on the 14ft deep concrete foundation raft poured in 1861 (TNA: WO30/108/154; see Chapter 5). Both the basement and the first floor of the colonnade are bombproofed. Study of the now partially demolished Shornemead Fort and the sections included with the 1899 record plan of Cliffe Fort (TNA: WO78/4963) indicate that this takes the form of several feet of loose aggregate concrete poured over the brick vaulting (Fig 16).

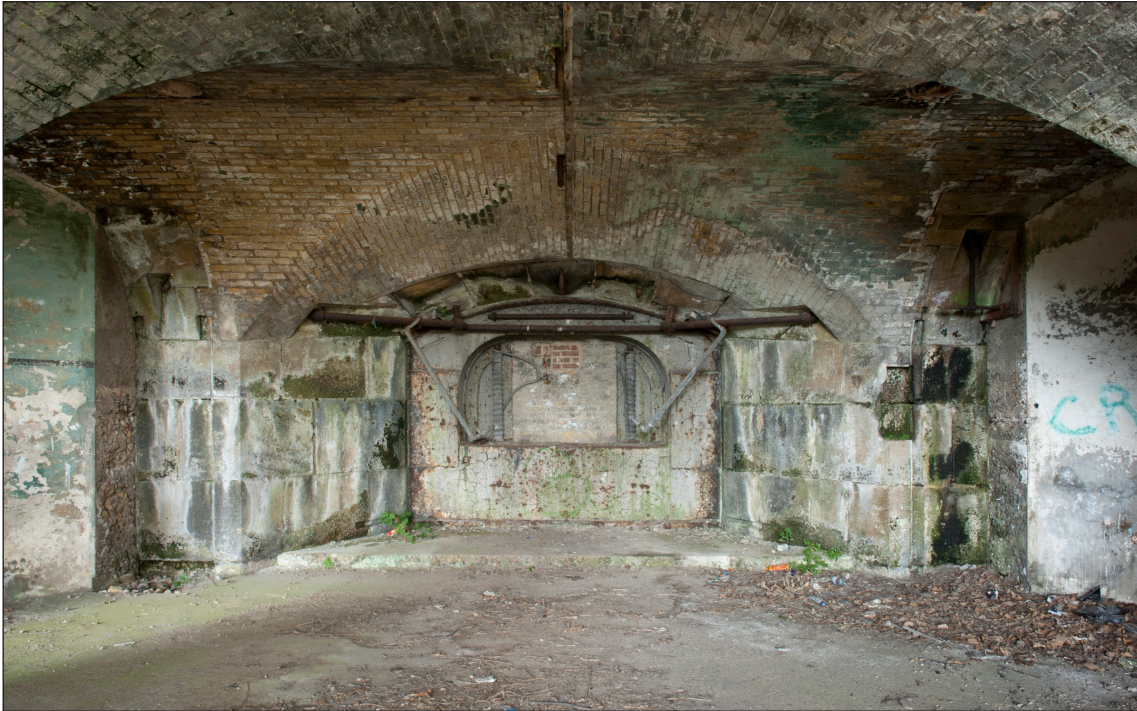
Figure 18: Interior of Casemate 4 looking towards the shield and embrasure. Note the two cheek pieces to the shield face, two sets of mantlet bars and the granite base at the foot of the shield. Just visible flanking the casemate are the edges of the later concrete traverses filling the gun positions of casemates 3 and 5. (DP097600)

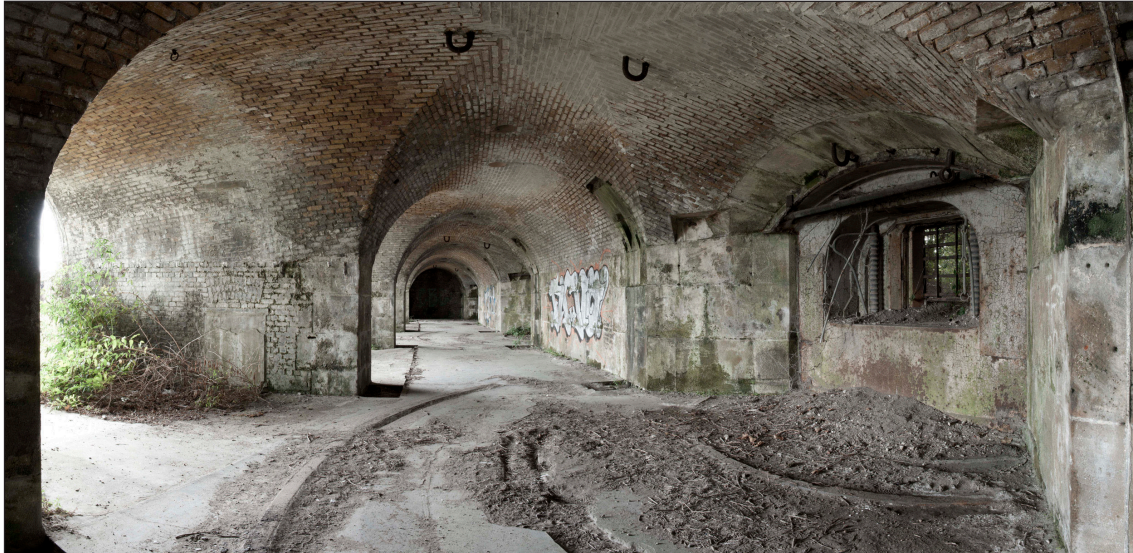
Figure 19: Interior of casemates 10 to 14, looking south showing the open casemated gun floor on the west side of the battery. The change in the direction of the vaulting between the gun positions and the elongated piers of the blind casemates can be clearly seen as can the gun slinging hoops set in the vault and the course of the removed racer rails in the floor. (DP097616)

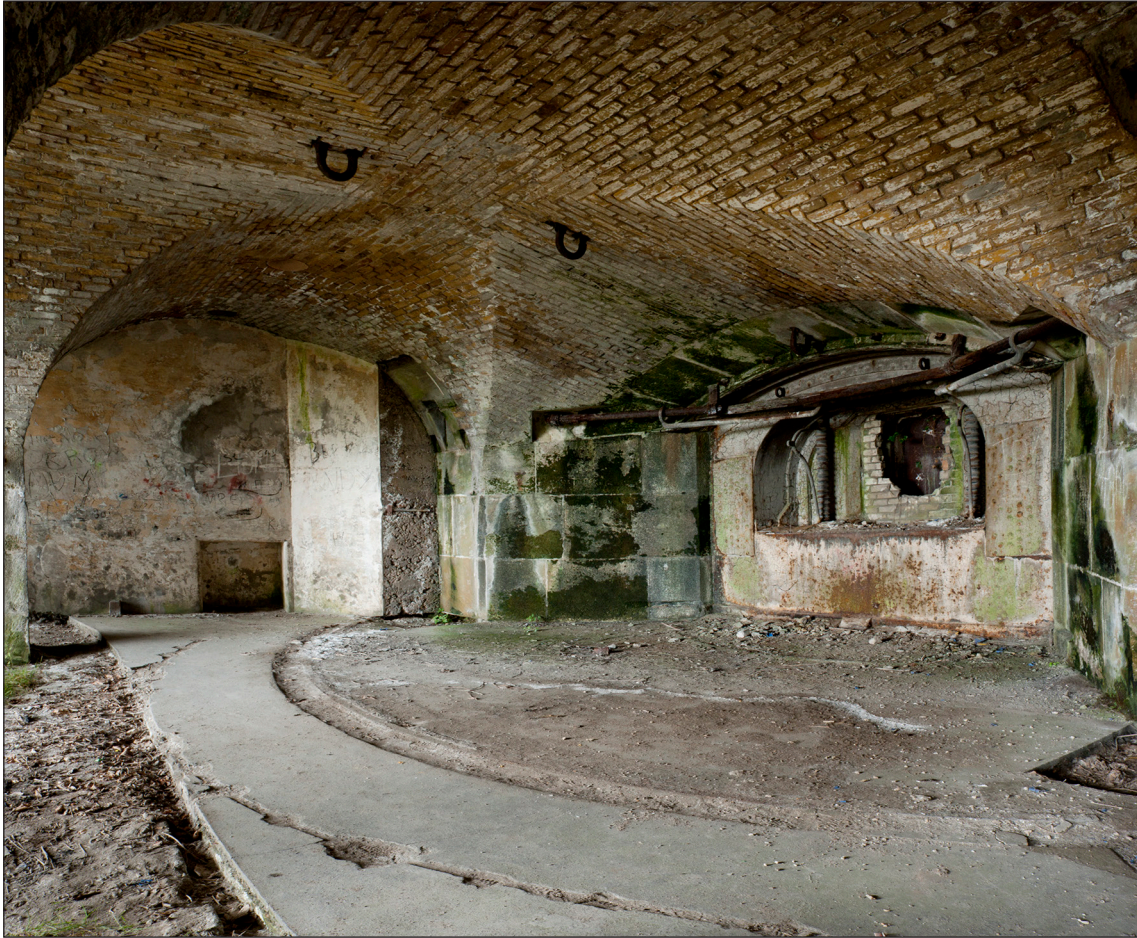
Figure 20: The remains of two racer rails for the 11-inch RML embedded in the floor of Casemate 8. The narrow slot for the training arc extends beyond the limit of the concrete floor in the northern portion of the casemate, suggesting another floor surface has been removed, perhaps timber boards. (DP097607)

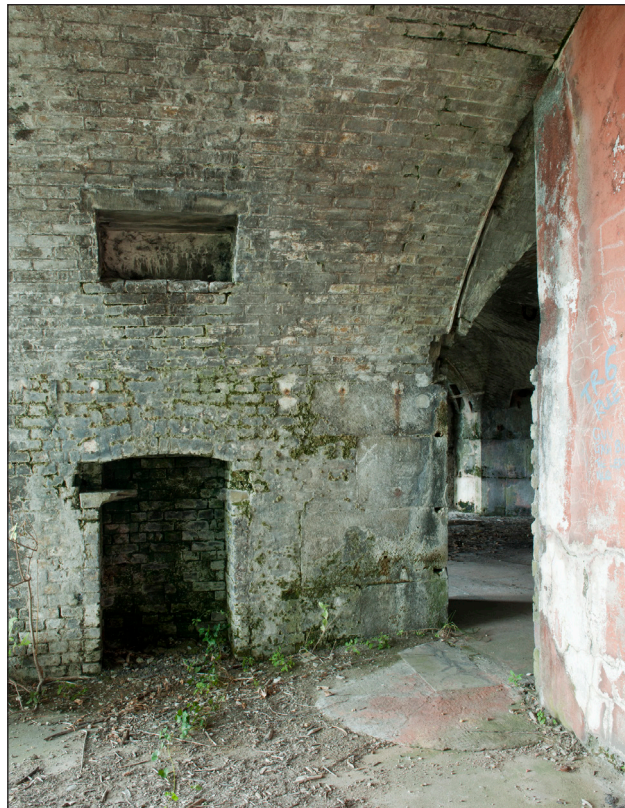
Figure 21: Detail in Casemate 5 of what is thought to be the original fireplace and air vent for the living casemates. The edge of a concrete traverse, painted orange brown, can be seen on the right of the picture. (DP 097601)

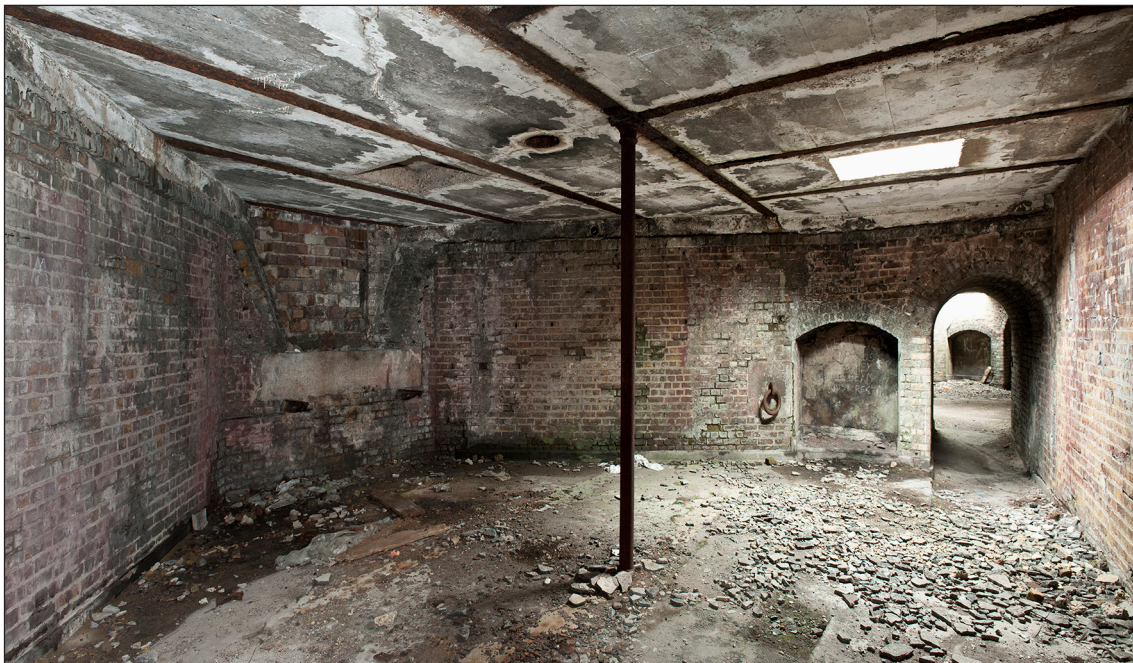
Figure 22: The southern former open gun emplacement looking north towards the second open emplacement. The blocked brick gun embrasure can be seen to the left of the image whilst the ring and set back associated with traversing the gun can be seen to the right adjacent to the passage which connects this emplacement to the one to the north. (DP097650)

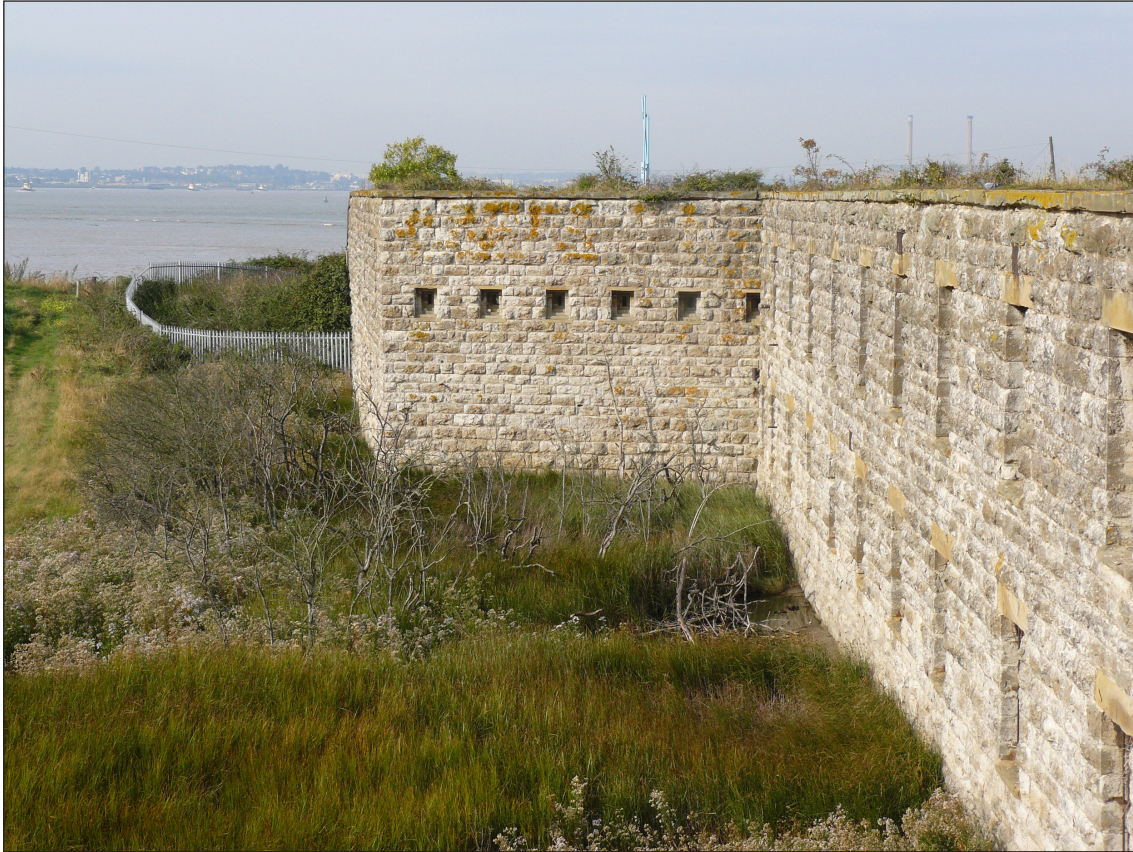
Figure 23: The loopholed flank wall of the south-west bastion looking west
© Historic England

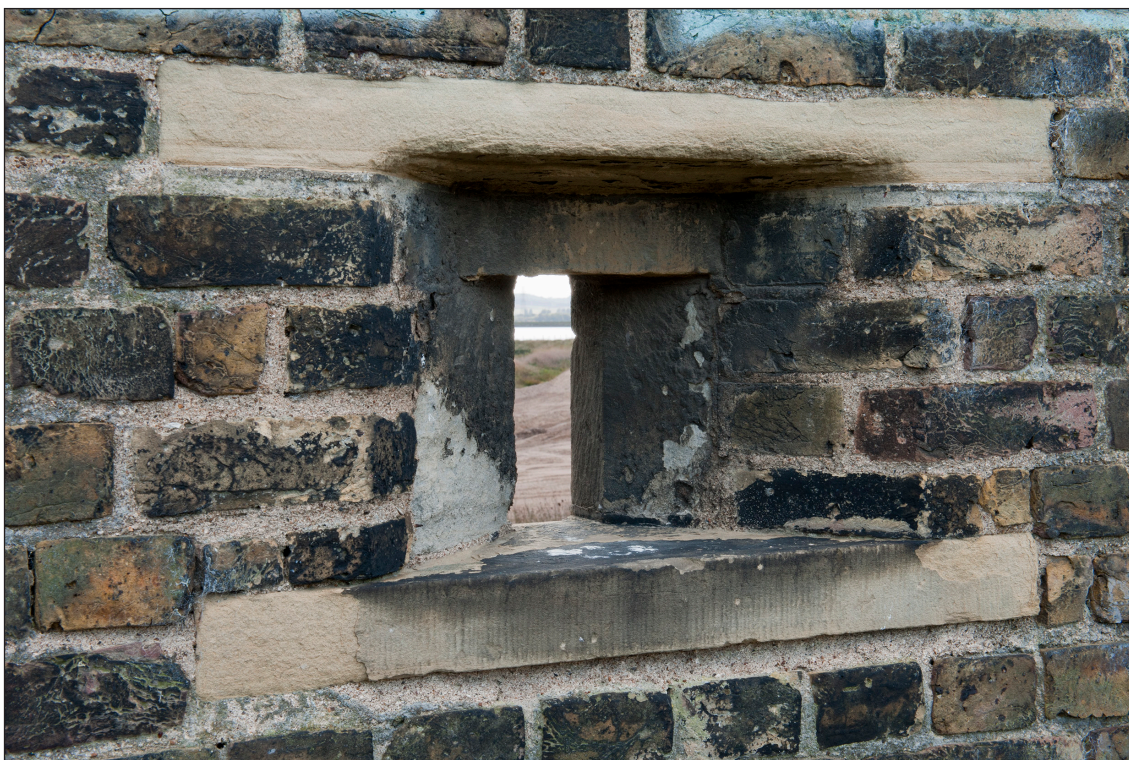
Figure 24: The interior of a loophole in the southern face wall of the fort. (DP 097575)

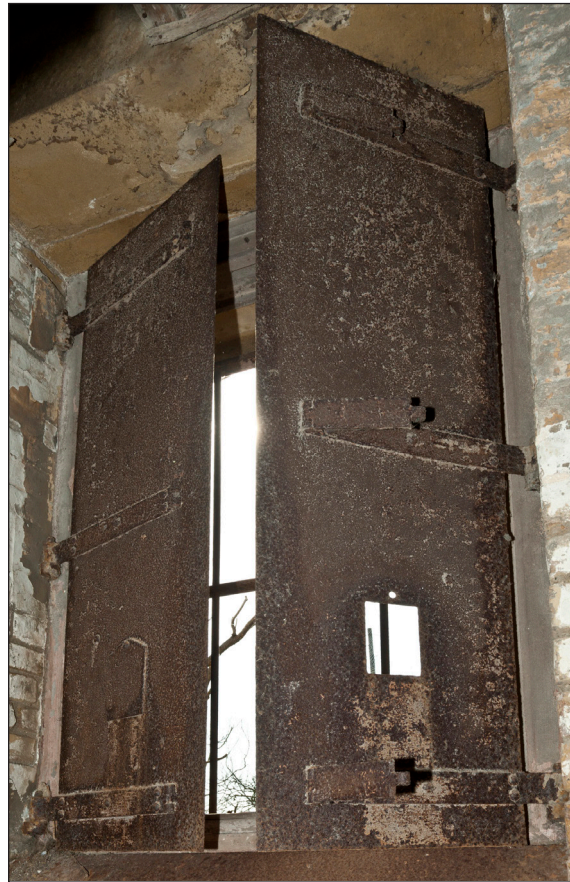
Figure 25: The iron loopholed shutters in one of the barrack rooms [46]. Note the hinged cover over the loophole at the bottom of the left-hand shutter and the locking hasp on the centre hinge of the right-hand shutter. (DP 097506)

The most prominent fittings are pintles from which hung pairs of wrought-iron looped shutters in nearly all of the windows in both ranges (Fig 25). Each shutter is formed from a single piece of wrought-iron plate with a 0.1-0.15m by 0.1m looped hole with a hinged cover plate set in the centre and is hung on three strap hinges riveted into place. The pintles for the hinges are mortared into the sills of the window openings immediately behind the inner face of the sash frame. The shutters are held closed with hinged hasps on the outer end of each hinge plate. The hasps are usually on the left hand of the pair and are hinged in a socket formed from the rolled ends of the hinge plate. Similar rolled ends to the hinge plates on the other shutter form the staple.

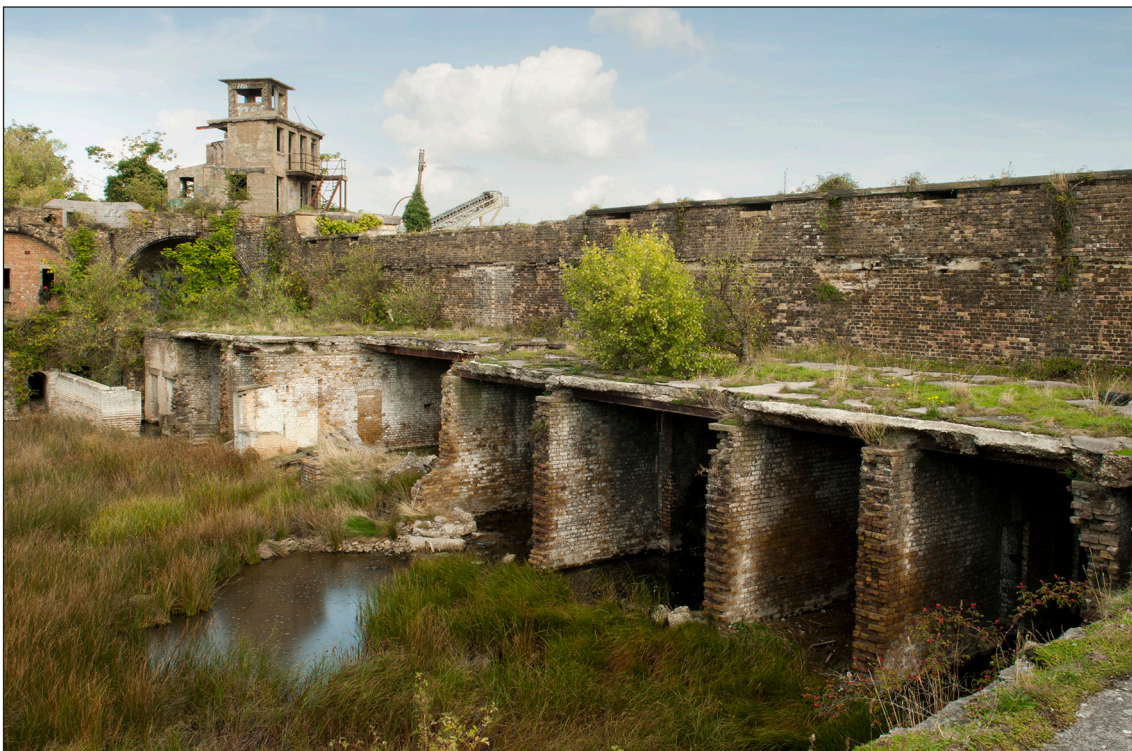
Figure 26: The fort interior in September 2010, from the southern range looking north-east. The fort entrance is in the centre of the picture and is flanked by the remains of the east range buildings which have had their front walls demolished. At the top of the gorge wall the loopholes set beneath the capping stones can be clearly seen. The horizontal scar beneath them indicates the course of the removed chemin de ronde. (DP097577)

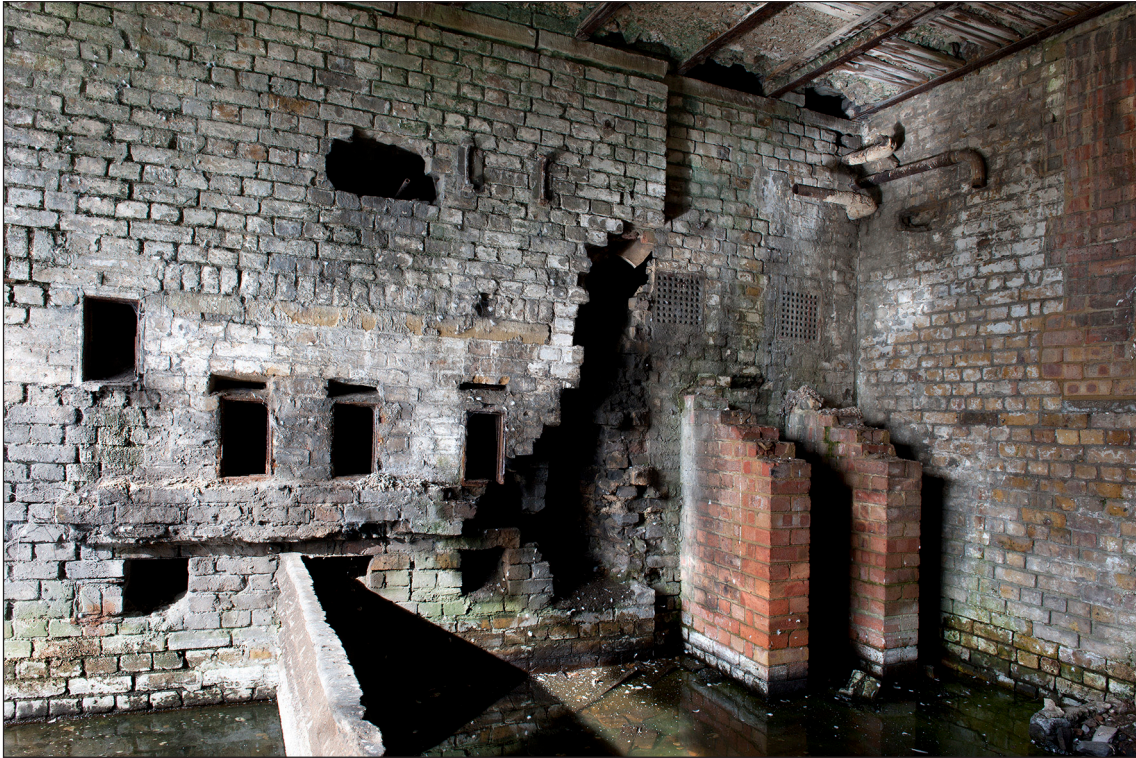
Figure 27: The north wall of the Cook House. The position of the ovens is marked by the iron-framed rectangular openings. Evidence of later reuse can also be seen in the form of the low concrete wall and red-brick boiler footings. (DP097464)

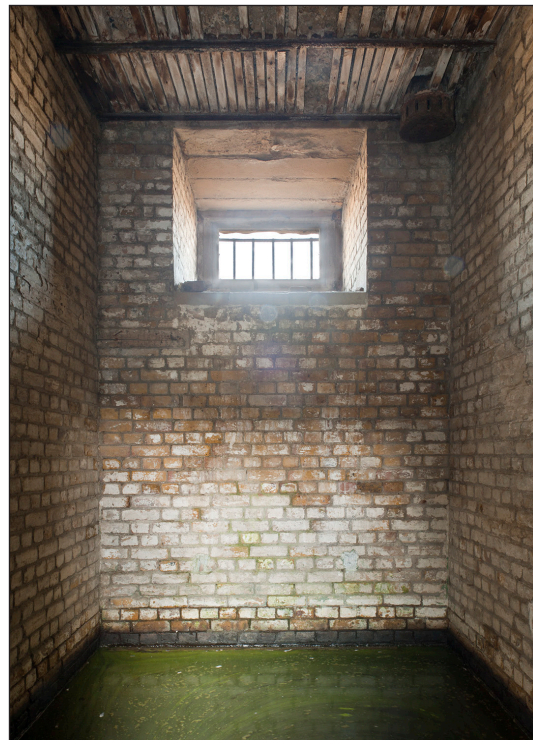
Figure 28: The high-set window of the eastern cell. (DP097466)

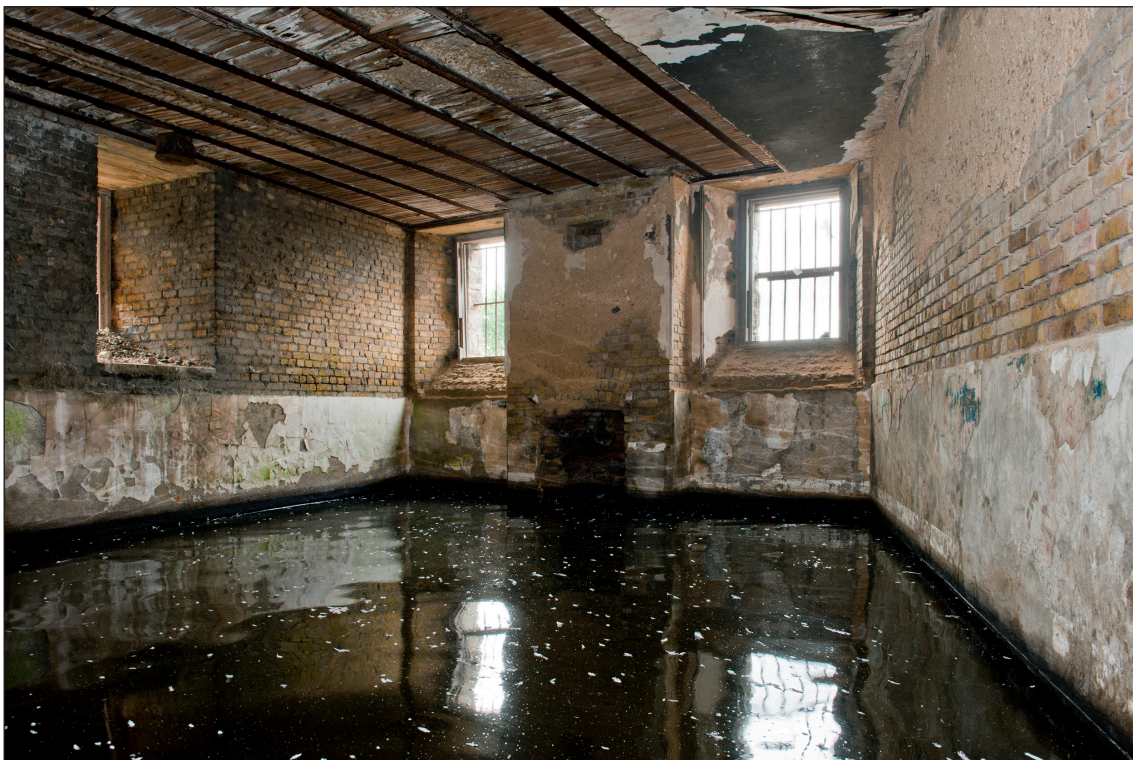
Figure 29: The interior of the Officers' Mess Room [37]. The remains of decorative plasterwork can be seen on each corner of the chimney breast and on the lower portion of each wall. Patches of ceiling plaster still adhere to the laths infilling the Fox and Barratt type roof. The iron shutters and their sills have been removed from each window opening. (DP 097470)

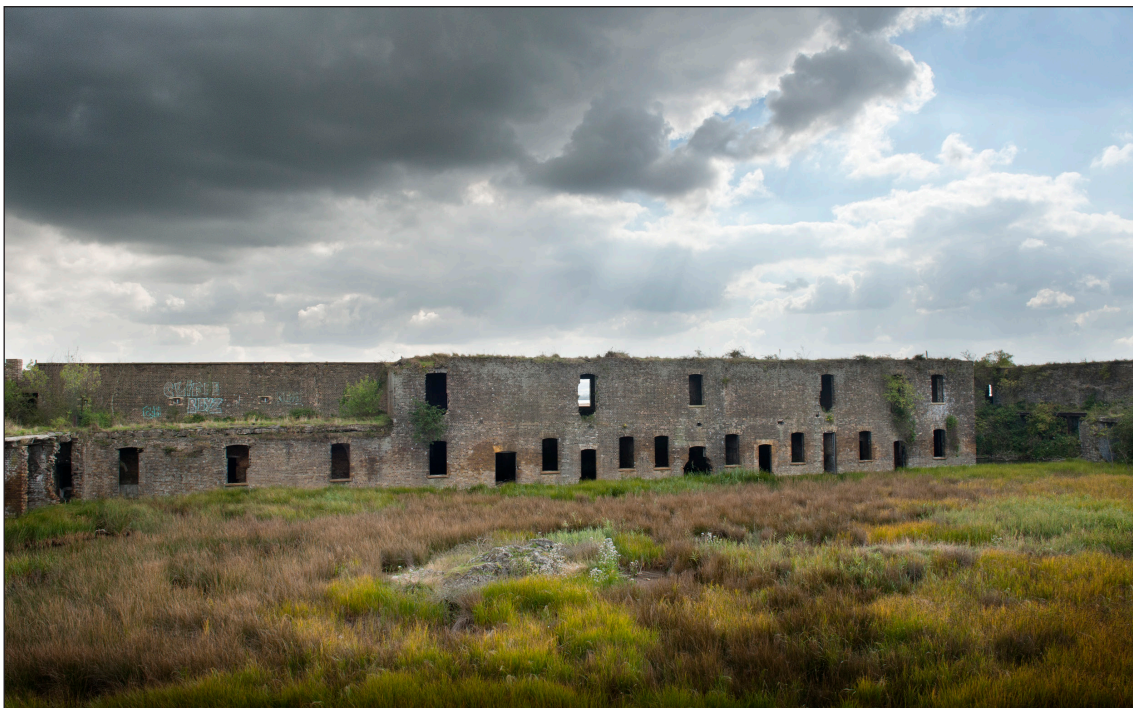
Figure 30: View of the south range across the parade ground. On the left are the single storey officers' quarters with loopedholed parapet above. The two-storey section on the right has the barracks on the ground floor with the hospital above. (DP 097500)

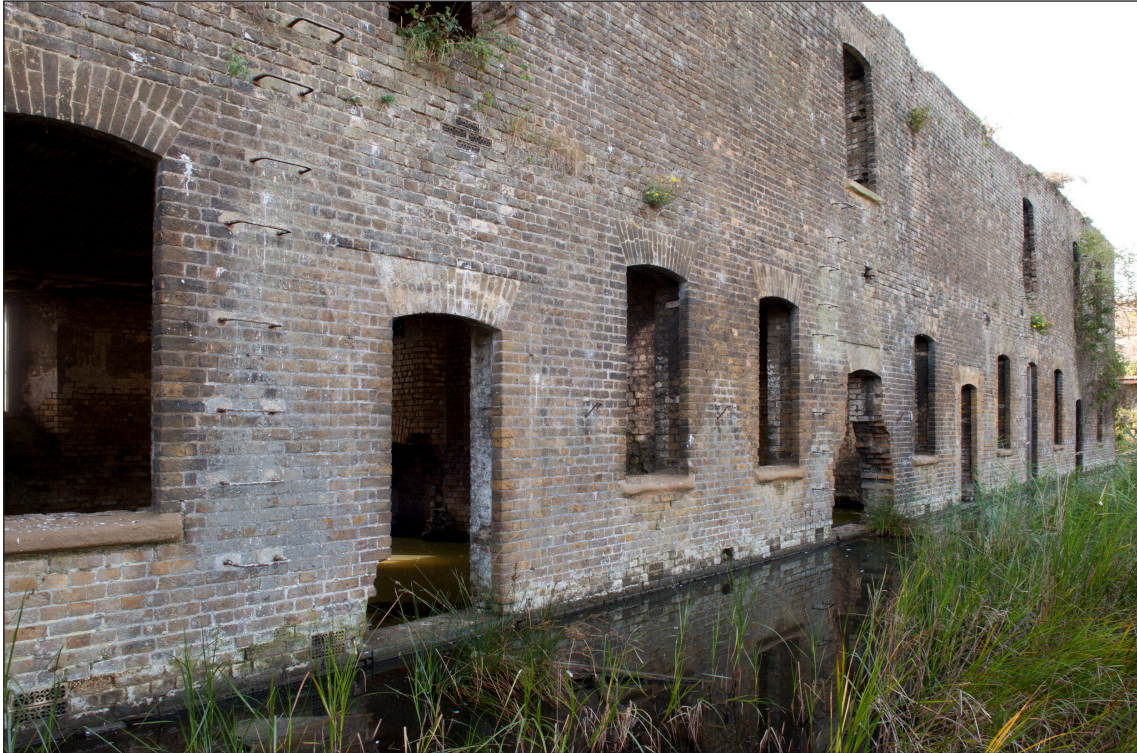
Figure 31: The north elevation of the south range showing details of the windows and doors and the iron staples of the fire escape. (DP097488)
