Cliffe Fort, Hoo Peninsula, Medway, Kent

Investigation and analysis of the 19th-century Coastal Artillery Fort

Research Report Series 015-2011

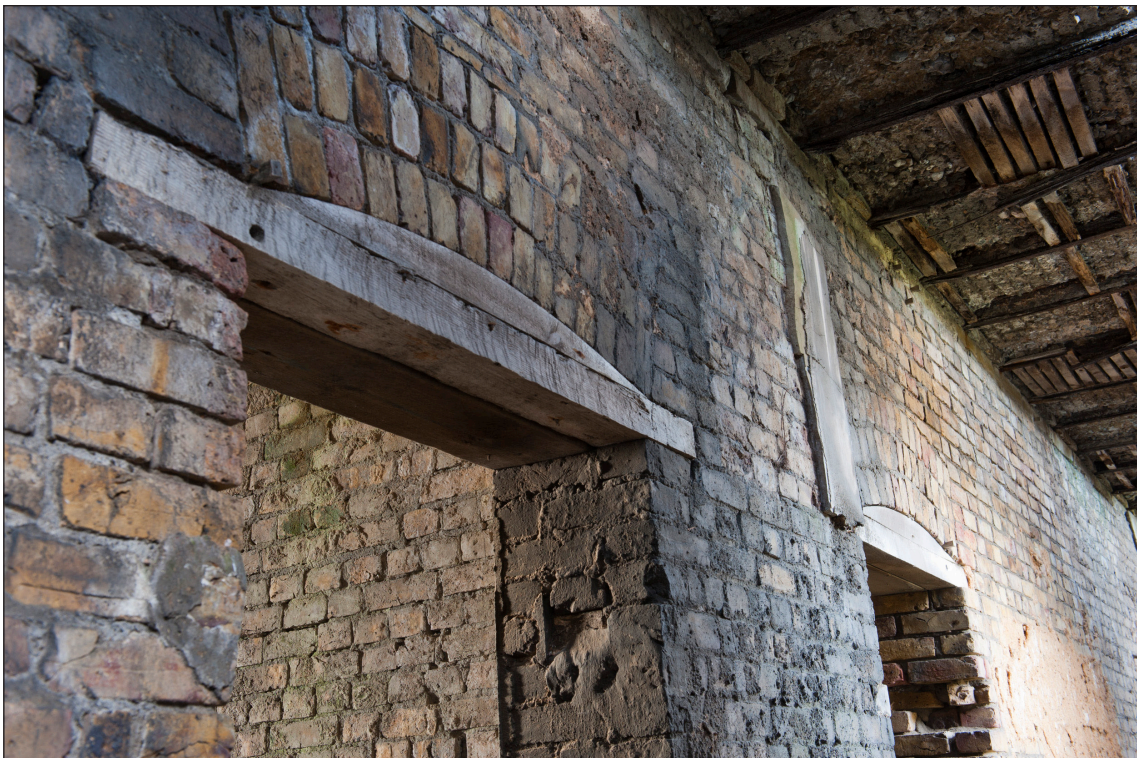
Figure 32: Reinforced door heads and patched cracks in the north wall of the officers' quarters may be evidence of subsidence of the south range. (DP 097474)

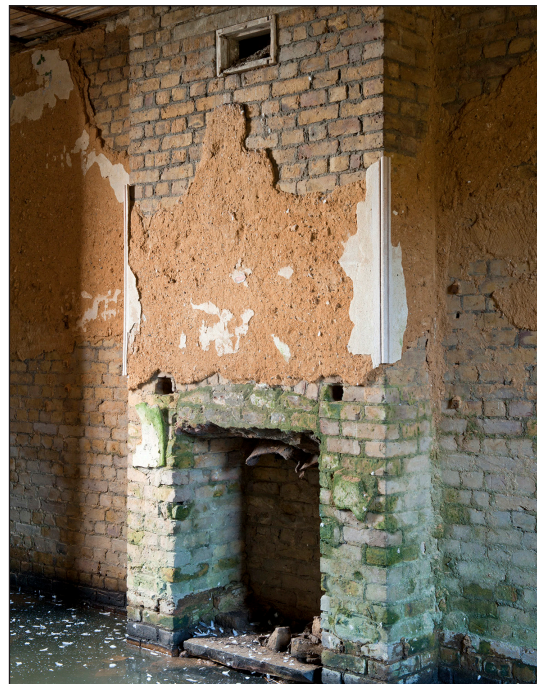
Figure 33: A chimney stack in the one of the officers' rooms with remains of the plaster moulding indicating the better quality decoration of these higher status rooms. (DP097480)

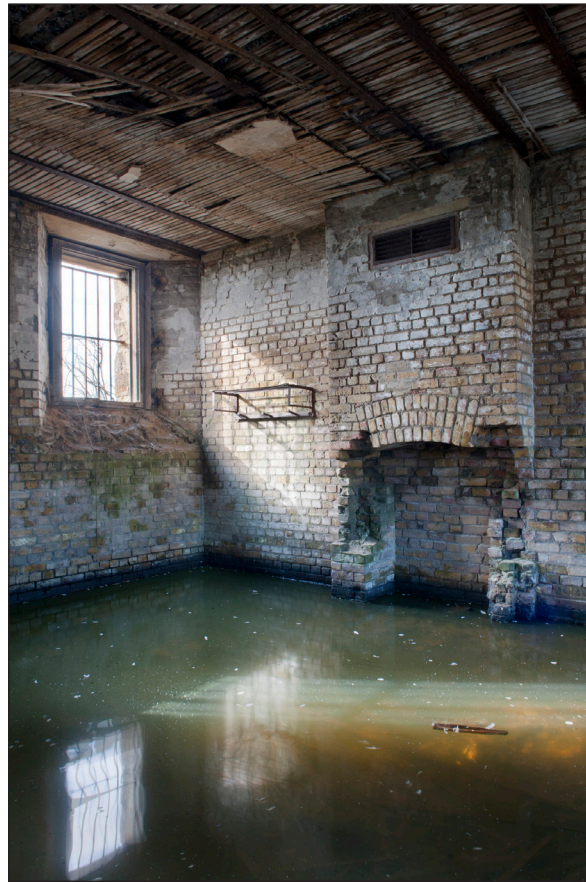
Figure 34: The interior of a Barrack Room intended for nine men [45]. The vent above the fireplace and the equipment rack set midway up the wall to the left of the chimney breast are visible. The iron shutters and the accompanying sill have been removed from the window. (DP 097489)

Evidence for the provision of nine standard barrack accoutrement shelves is visible. The standard 1864 pattern accoutrement shelf had a slatted wrought-iron shelf supported on brackets of the same material projecting from the wall. Below this was a back board with three circular section iron pegs. Each shelf corresponded to a bed space and was accompanied by a further wooden clasp for a rifle to the left of the bed head. They were introduced in 1832 with a modified pattern adopted in 1864 (McDonald 1983, 4). In this barrack room one complete accoutrement shelf survives on the west wall to the south of stack (Fig 34), two to the north of the stack are fragmentary and remains on the east wall suggest a further six bed spaces. Below these units are the wooden plugs for the securing the rifle clasps to the wall, one for each bed space.

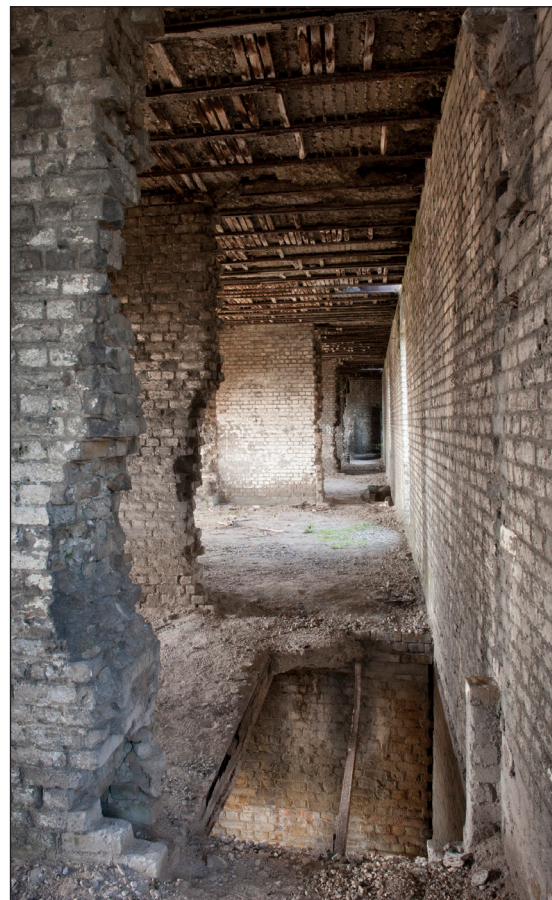
Figure 35: View looking west along the hospital corridor. The Fox and Barratt construction of the barrack room ceilings can be seen through the hole in the corridor floor. (DP 097498)

The south wall of the passage, containing the entrances to the wards and hospital kitchen as identified on the 1899 plan (TNA: WO78/4963; App Fig 2), has been removed completely (Fig 35). The plan shows that each room has a single centrally-placed doorway. The walls have been removed in a systematic fashion leaving no evidence of thresholds. Most of the partition walls for the hospital sergeant's room and the store remain but the partition walls between the other rooms have all been dismantled. All the window openings in the south wall – the gorge face – have splayed jambs and the mounting points for iron shutters; set backs in the brickwork remain as evidence for sash frames and their accompanying boxes. The remaining interior walls of all the rooms were whitewashed with no traces of plaster. All the rooms other than the store room have a ventilator in the ceiling.

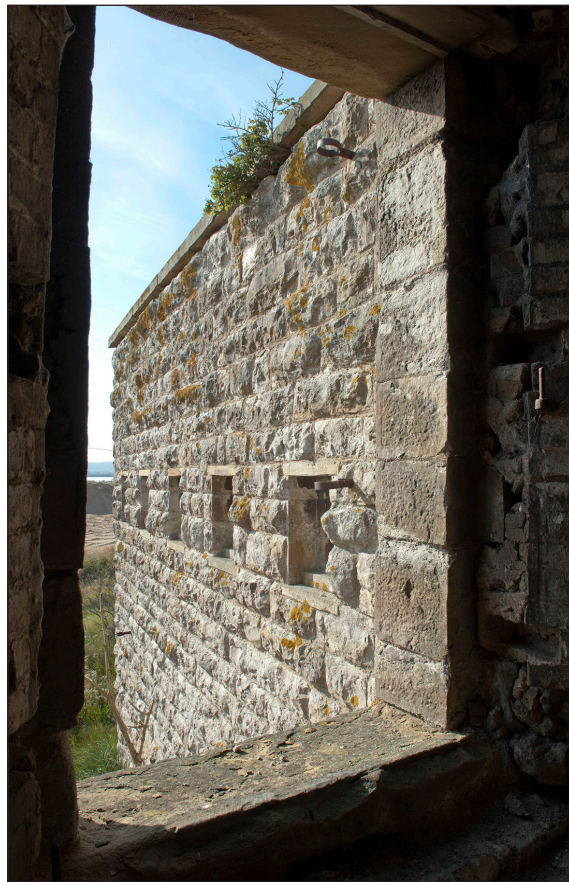
Figure 36: Loopholes on the eastern face of the south-eastern demi-bastion as seen from the hospital lavatory. Iron brackets that held downpipes can also be seen. (DP 097504)

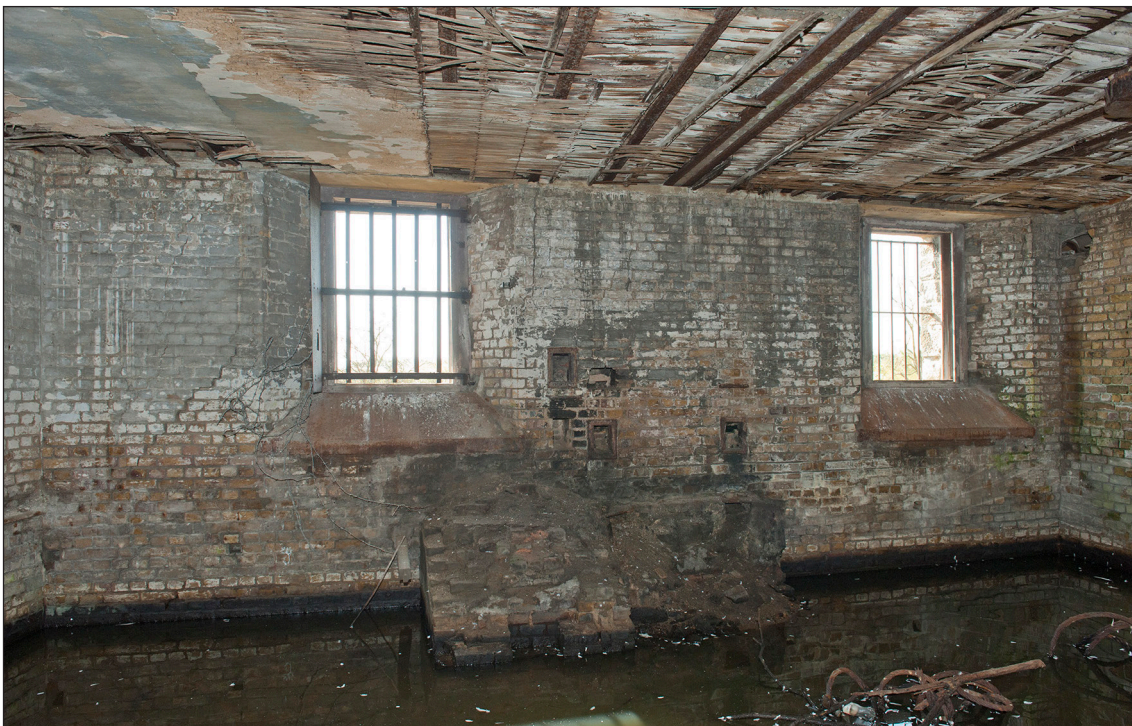
Figure 37: The brick bases for the washing coppers on the south wall of the Wash House and Laundry. (DP097511)

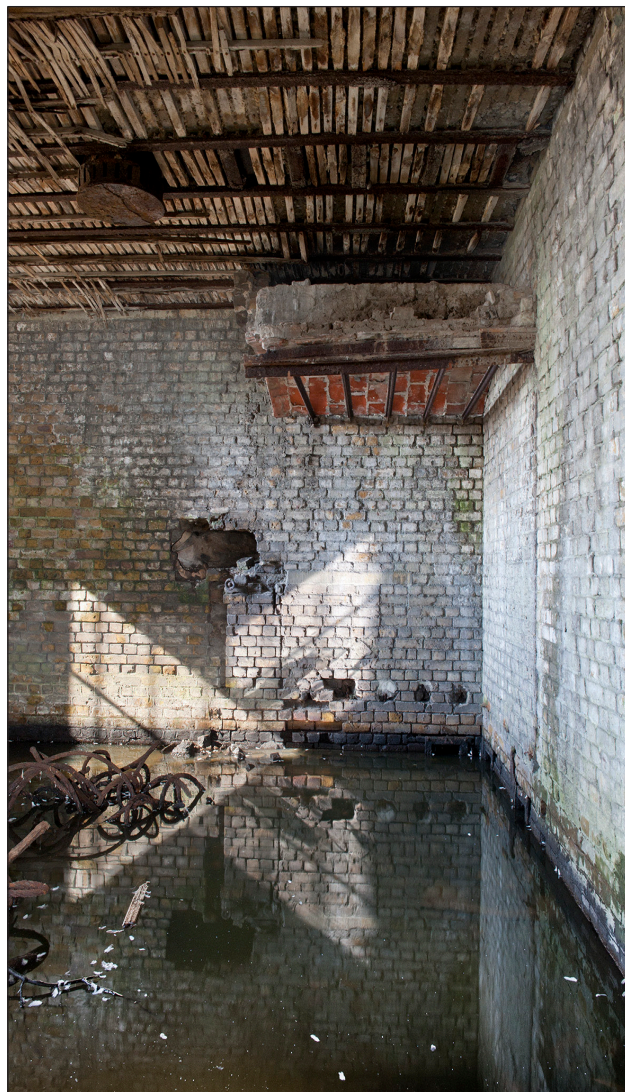
Figure 38: Possible remains of hot-air closet in north-western corner of the Wash Room and Laundry. (DP097512)
