9. THE LATER 19TH CENTURY AND EARLY 20TH CENTURY

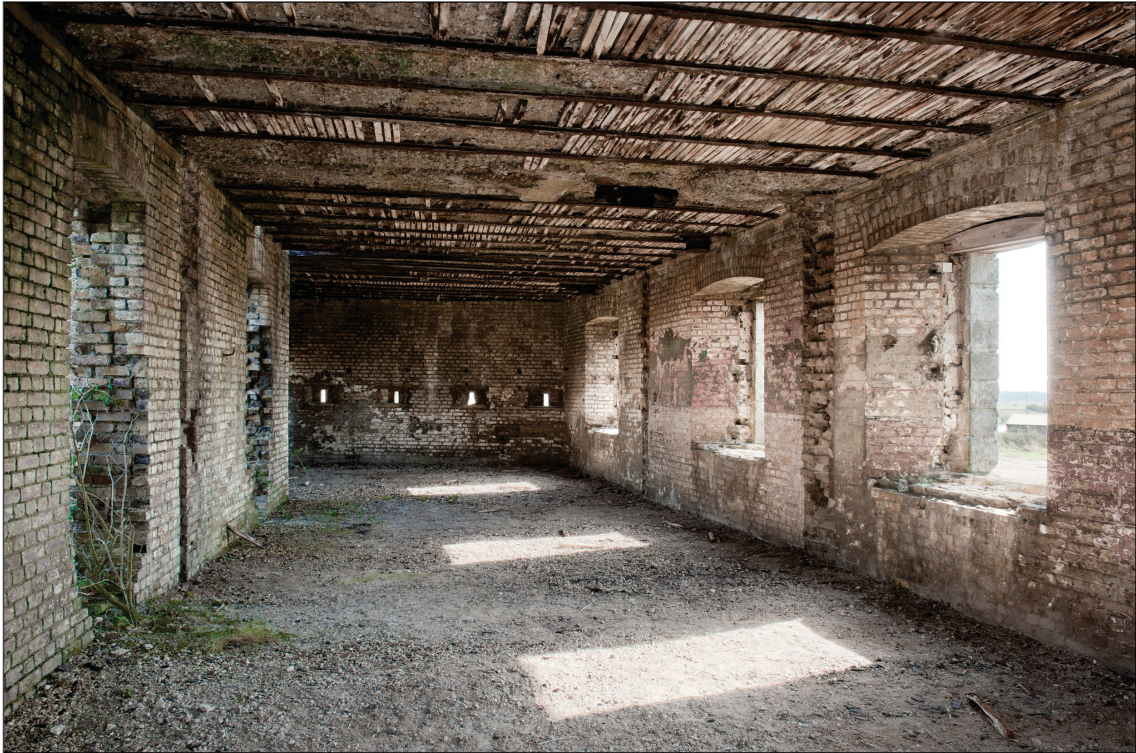
Figure 39: The space formerly occupied by the Bar, NCOs' Room and Tap Room, looking east. (DP097515)

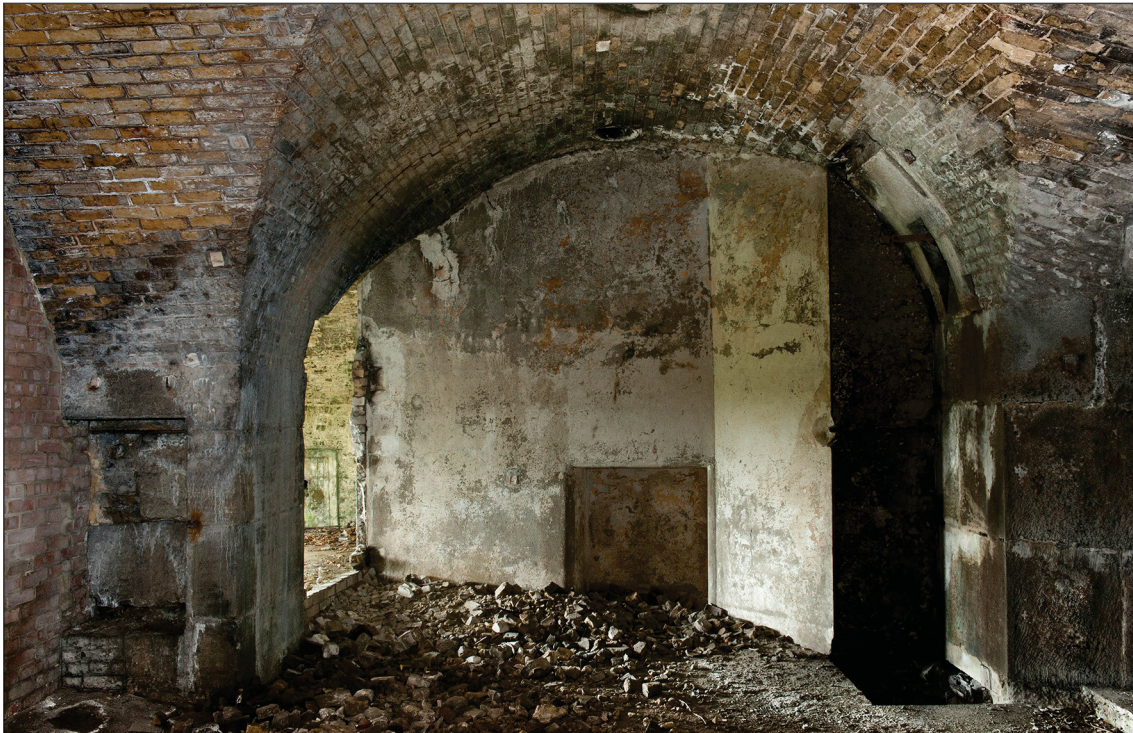
Figure 41: View from Casemate 2 west into Casemate 3 where the gun position has been filled with a concrete traverse and an ammunition recess created. (DP097588)

Each redundant gun position was filled with concrete but its associated living casemate was left open. Modifications to the bombproof roof were difficult to identify due to vegetation growth and deterioration of the surface and it is not clear whether the concrete was poured through specially created holes in the vault or barrowed in from the interior of the fort. Tip lines and shuttering marks are visible in the concrete exposed by removing the timber boxing from the ammunition lifts in casemates 2, 6 and 8. To compensate for the loss of floor space around each gun the opportunity was taken to provide recesses for ready-use ammunition. These are incorporated into the traverse in the flanks of each gun position with the surrounding walls rendered and whitewashed. In Casemate 8 the speaking tube has been relocated and now rises up against the position of the ammunition hoist cover.

Within the living casemates the traverses form a smooth, flat, vertical wall of concrete to the north, extending from floor to vault with the shuttering marks from the concrete pouring occasionally visible. The floors of these casemates, whether originally paving or boards, have been taken up for the pouring of the traverses and replaced with a screeded, poured concrete floor. Space has been left between the casemate and traverse walls for intercommunicating doors between each gun position. Scars from frames and hinges (in Casemate 8 these are let into the pier quoins) show that ledged and braced doors were hung on pintle hinges beneath boarded transoms and opened into the gun positions.

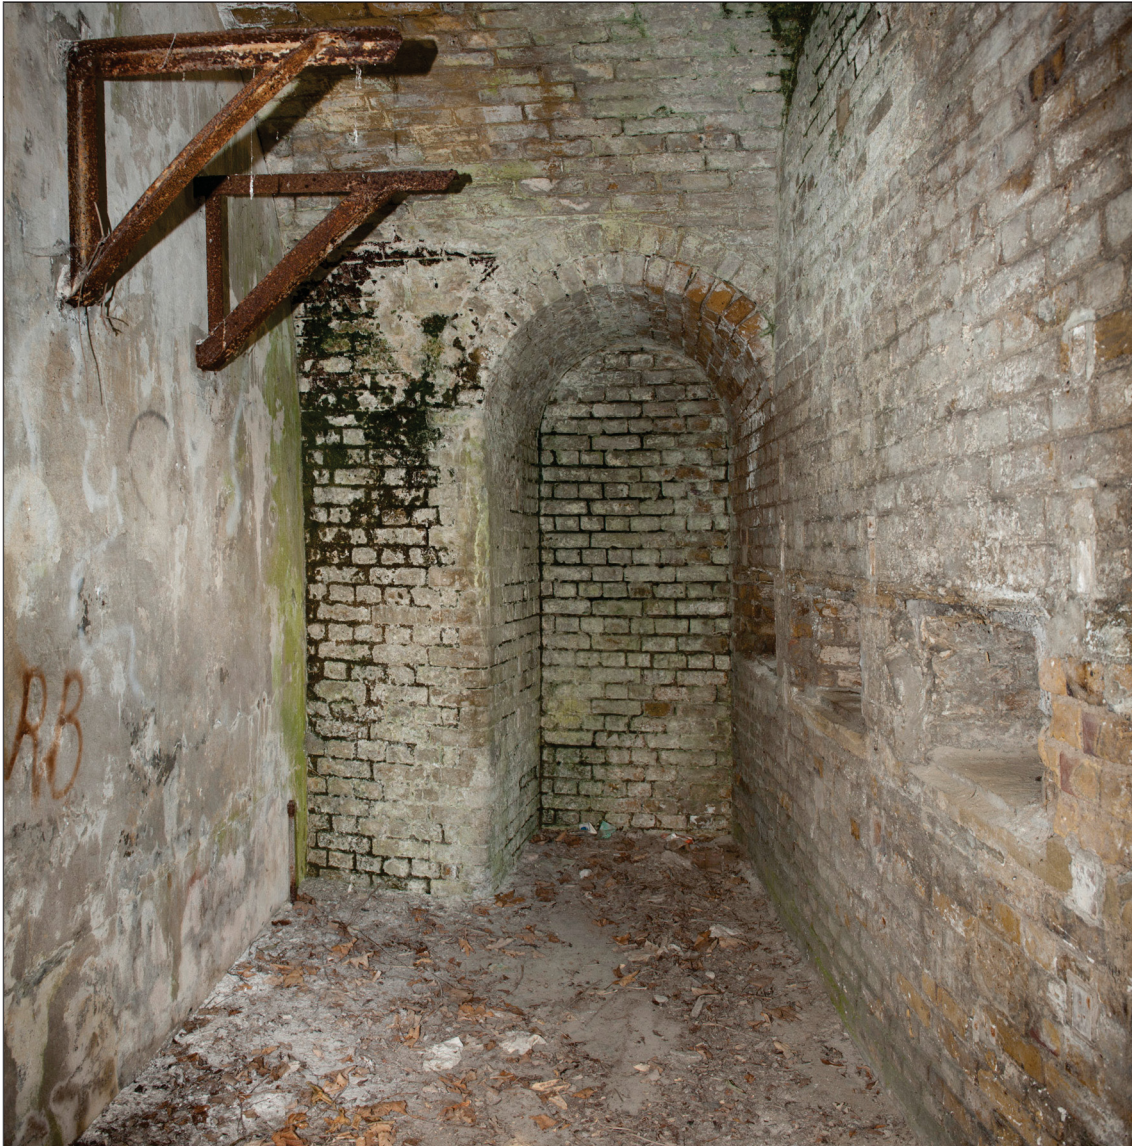
Figure 42: The south-east corner of Casemate 1. To retain access to the loopholes in the bastion wall on the right-hand side of the picture this corner of the casemate was not filled with concrete when the rest of the position was converted to a traverse. The smooth concrete wall of the traverse is on the left-hand side (the brackets are later additions). (DP097610)

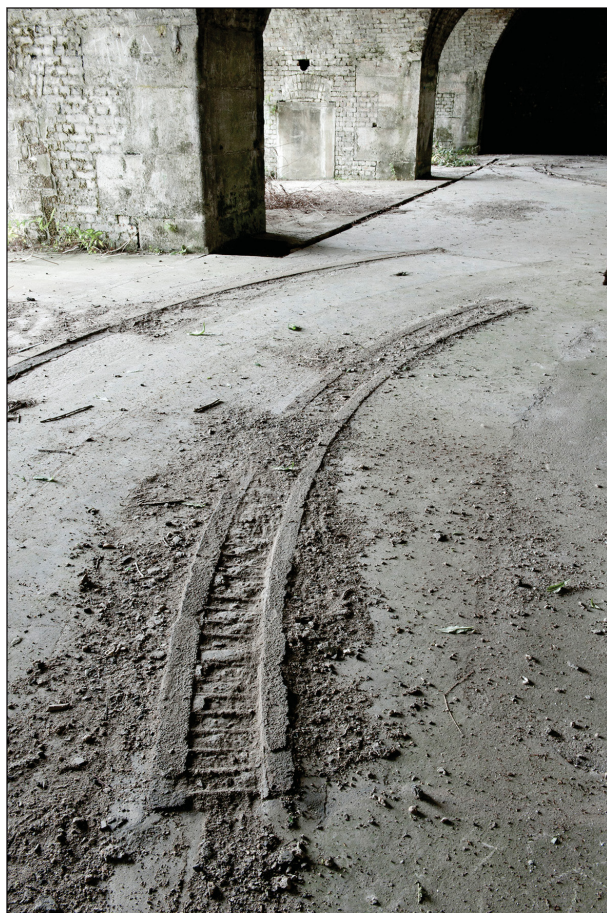
Figure 43: The cogged racer rail in Casemate 12 suggesting that alterations were made to the carriages in this casemate. (DP097629)

embedded in granite sets date from the original construction of the fort and the mounting of the 11-inch RMLs. The inner racer of this phase is 11.5 cm wide and positioned 2.4m from the face of the gun shield. A cement-filled channel (presumably where a racer rail has been removed) in an arc of granite sets set at 4.04m from the shield face is witness to the position of the outer racer. Cracks in the concrete floor show where this racer would have extended into Casemate 9 before it was infilled. This set of racers was replaced with rails embedded in concrete. The 6.5cm wide wrought-iron inner racer of this set is closer to the shield, at 1.31m from the inner face. Its associated outer racer is set at 3.79m from the shield face in a channel, 30cm wide, which has been cut out of the concrete leaving a formed edge on one side.

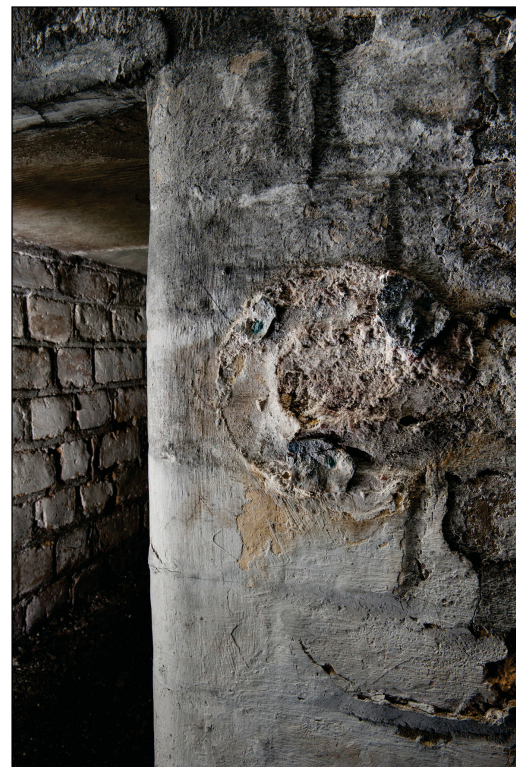
Figure 44: Lightbox to No 13 Cartridge Store showing the position of a copper number plate. (DP097434).

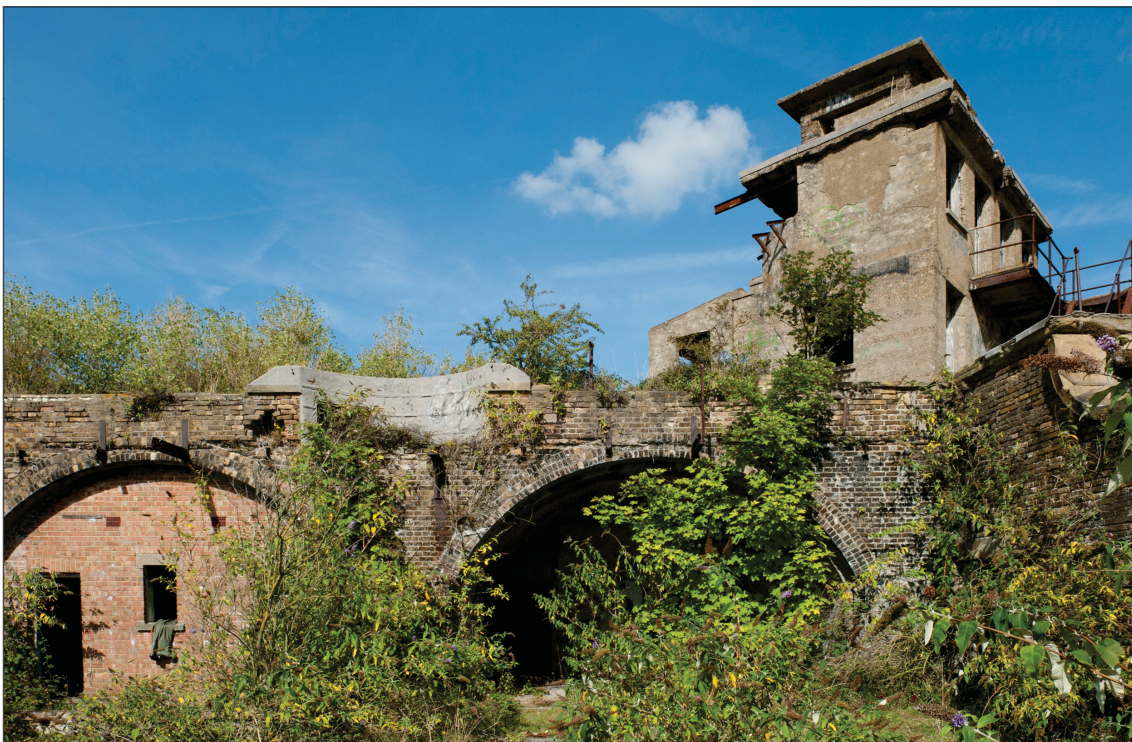
Figure 45: Exterior of Casemates 2 and 3 showing the semi-circular recess for the DRF position and the stanchions for its associated walkway set in the parapet wall above the casemates. The circa 1913 Battery Observation Post can be seen above. (DP 097568)

The three DRF positions are located at the inner edge of the roof of the casemated battery and were served by a metal walkway (labelled balcony on the 1899 plan) that ran below the parapet. Each position is different, with a semi-circular parapet to the northern position, above casemates 2 and 3 (Fig 45 and 54), a rectangular parapet to the central one above Casemate 7 and a V-shaped parapet to the southern one which is located above Casemate 15 adjacent to the end wall of the open battery. The 1899 plan shows that all incorporated the standard centrally-placed pillar for the mounting of the DRF telescope. The recesses are very neatly inserted into the parapet. The surrounding brickwork in the relevant section of parapet has been taken down and rebuilt to form the corners of each recess. The recesses were neatly capped with a moulded-stone parapet but this is now incorporated into the base of a shallow barbette which has been covered in asphalt and blended into the casemate roof. There is no visible evidence for the DRF pillars.

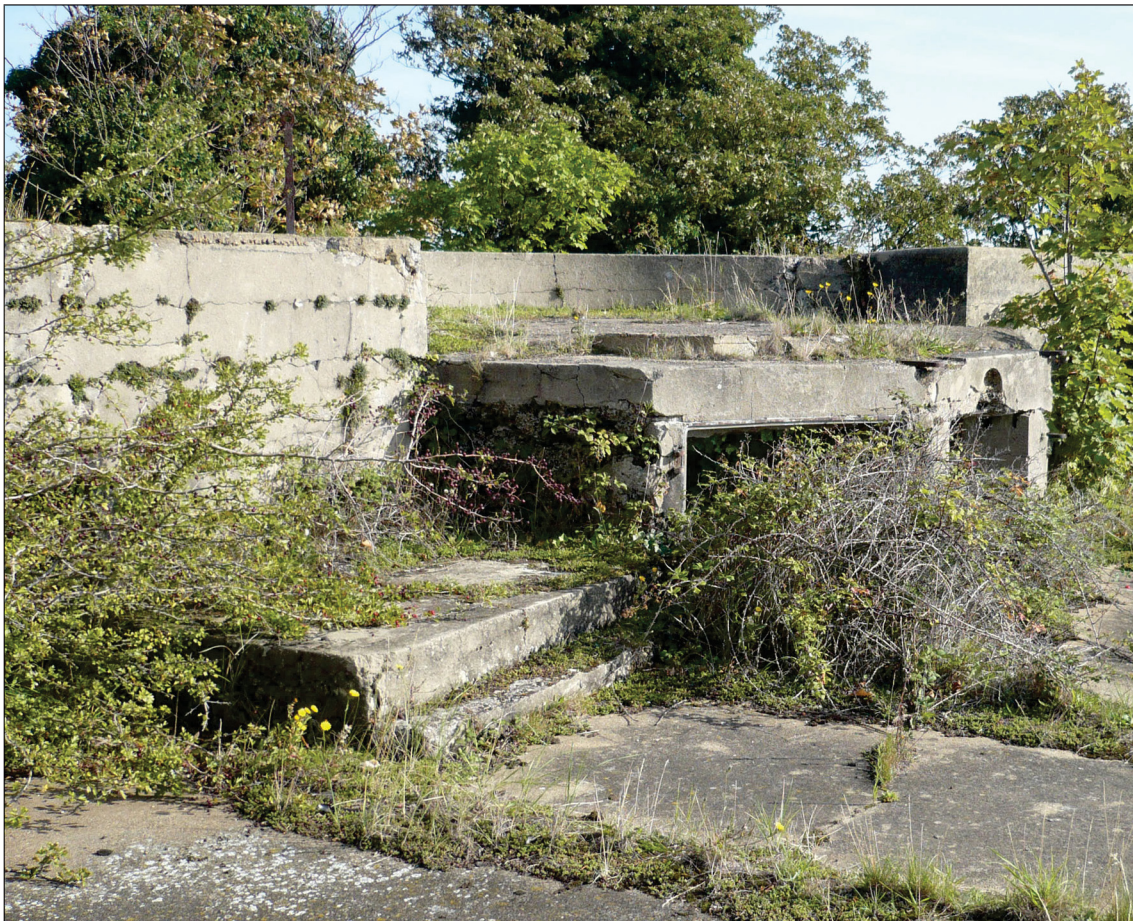
Figure 46: Shallow steps protruding from one of the flank walls of the 12-pounder battery which may represent the remains of an earlier rooftop battery
© Historic England

Fragmentary evidence for an early rooftop battery possibly survives at Cliffe (App Fig 8). Two of the three gun positions were probably subsumed in the later 12-pounder QF positions at the south end of the roof above casemates 14 and 15. The third gun position may have been at the north end of the roof above Casemate 6, incorporated in the south flank wall of a later 12-pounder position. Projecting from this wall is a flat concrete slab with a single broad step down on to the roof which does not appear to be related to the 12-pounder battery and in form resembles the set of shallow steps found at the rear of the 6-pounder positions in the East Tilbury battery (Fig 46).

It is possible that rebuilding for the later 12-pounders above casemates 14 and 15 involved the replacement of the original barbettes by the larger 12-pounder version, but retained the earlier flanking walls. Possible evidence can be seen at the junction

of these barbettes and their flanking walls with a pronounced vertical joint and colour difference between the two areas; this is particularly apparent on the north side of the most southerly position. The flanking walls exhibit ready-use locker arrangements with the same characteristics noted at the East Tilbury Wing Battery, such as rebates for frames but no evidence for hinges. At the foot of the covered way between the 12-pounder positions is a smaller locker similar in size (0.34m by 0.20m) to the fuse locker described at the East Tilbury battery. A similar sized locker can be seen on the south side of the stepped concrete slab above Casemate 6.

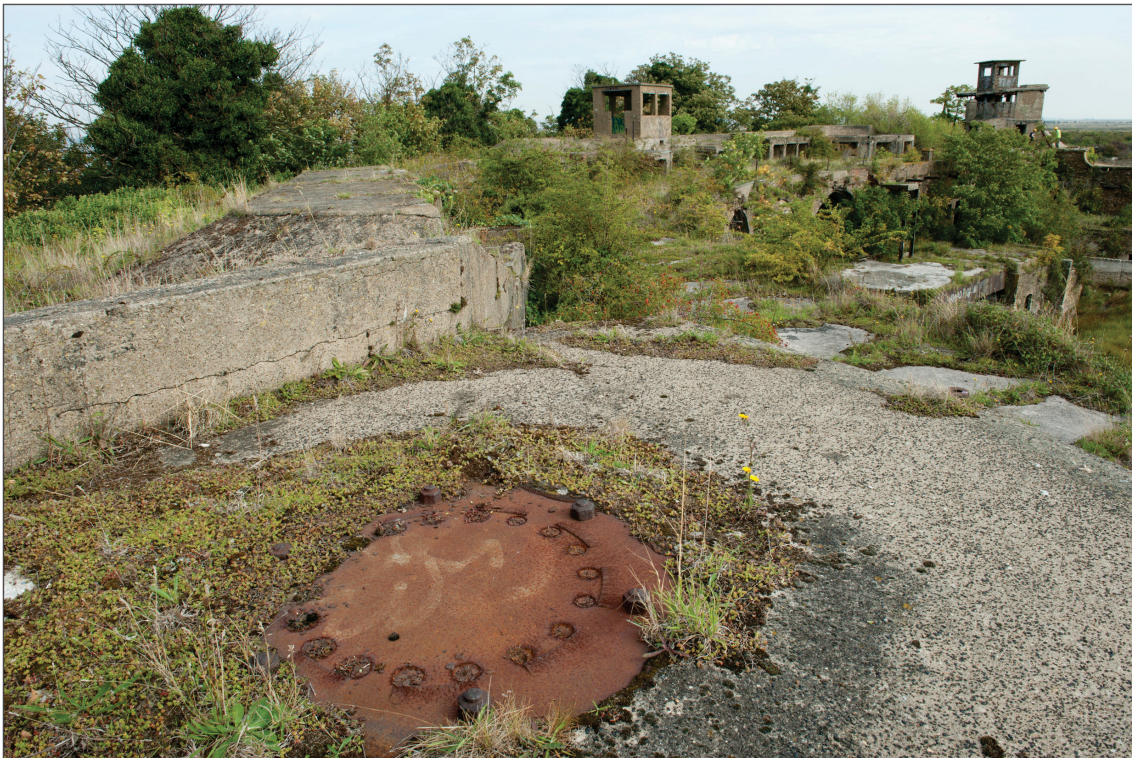
Figure 47: View of the north end of the fort roof from the 12-pounder B group, with a holdfast for this weapon in the foreground. The hut in the centre of the photograph dates from the Second World War; beyond it are the 6-inch gun positions and the associated BOP tower. (DP097739)

As built the holdfast consisted of a circular metal plate, fixed into the concrete platform with six large hexagonal securing bolts towards the outer edge set for a radius of 0.48m (1ft 7in). Within the ring of bolts is a circle of raised flanges and within them nine pairs of holes. The plate was placed centrally in the polygonal gun floor and was the standard pattern of holdfast for the small calibres of QF guns (Lowry 1995, 94). This arrangement is shown on the 1899 plan (TNA: WO78/4963; App Fig 3) but only No 1 position (to the north) in the B group survives in its original form (Fig 47; App Fig 8). The other two surviving emplacements exhibit an array of adaptor plates and additional bolts that relate to later mountings. In common with all examples of this type of emplacement, all have the metal fittings for a removable protective rail around the rear face.

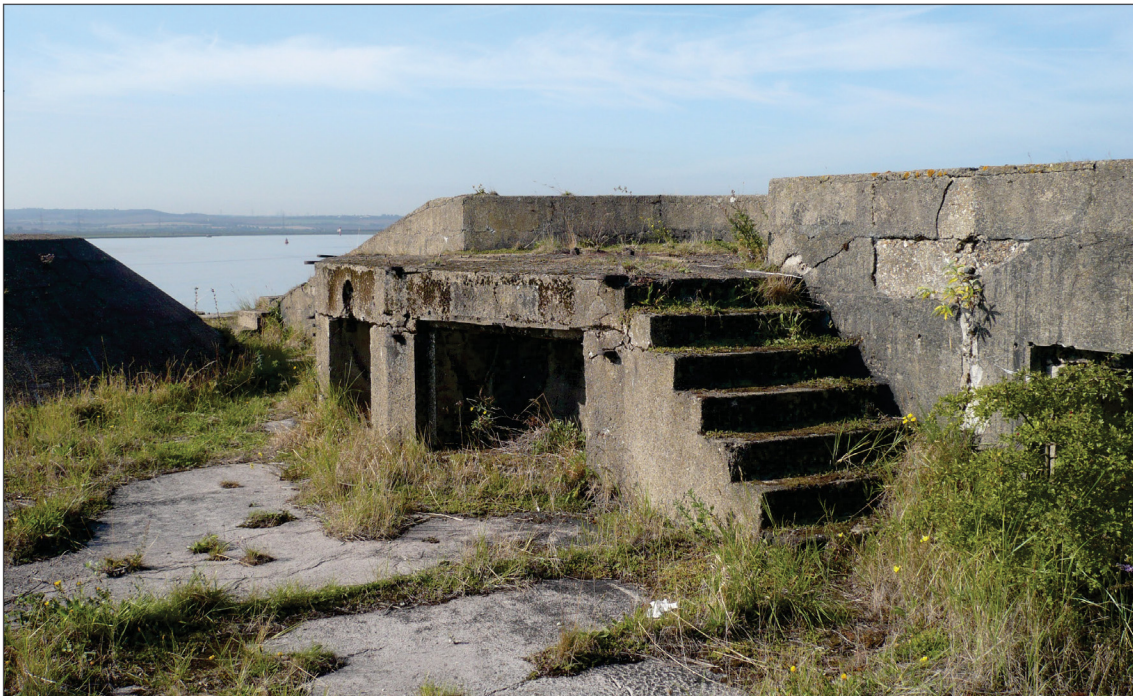
Figure 48: The most southerly of the surviving 12-pounder gun emplacements with ammunition lockers, steps to the gun floor and metal brackets for the guard rail visible at the rear of the emplacement. © Historic England

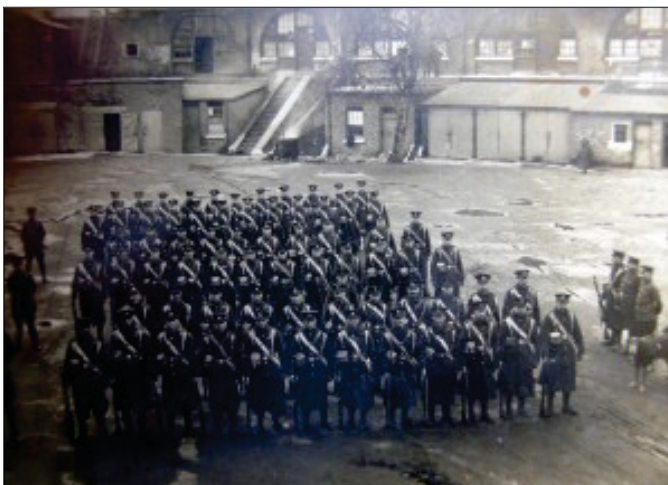
Figure 49: The parade ground dated circa 1915 by the equipment of the men on parade. Behind and to the right are the QF Gun Shed and the Stores RA and RE. To the left of the picture an open door, the entrance to the Brennan Torpedo installation, disused at this time, can be seen. Courtesy of Victor Smith

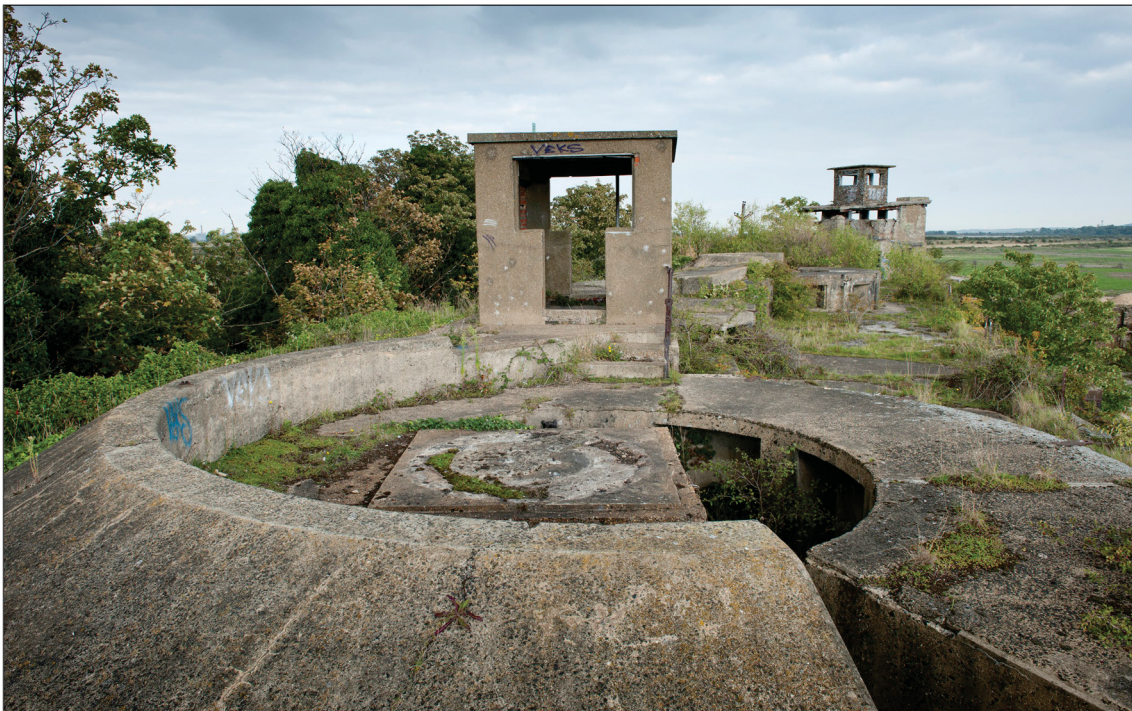
Figure 51: The western barbette of the 6-inch gun emplacements, the large concrete block (for mounting a Second World War 6-pounder gun) cast in the original gun pit can be seen in the centre of the photograph. (DP097671)

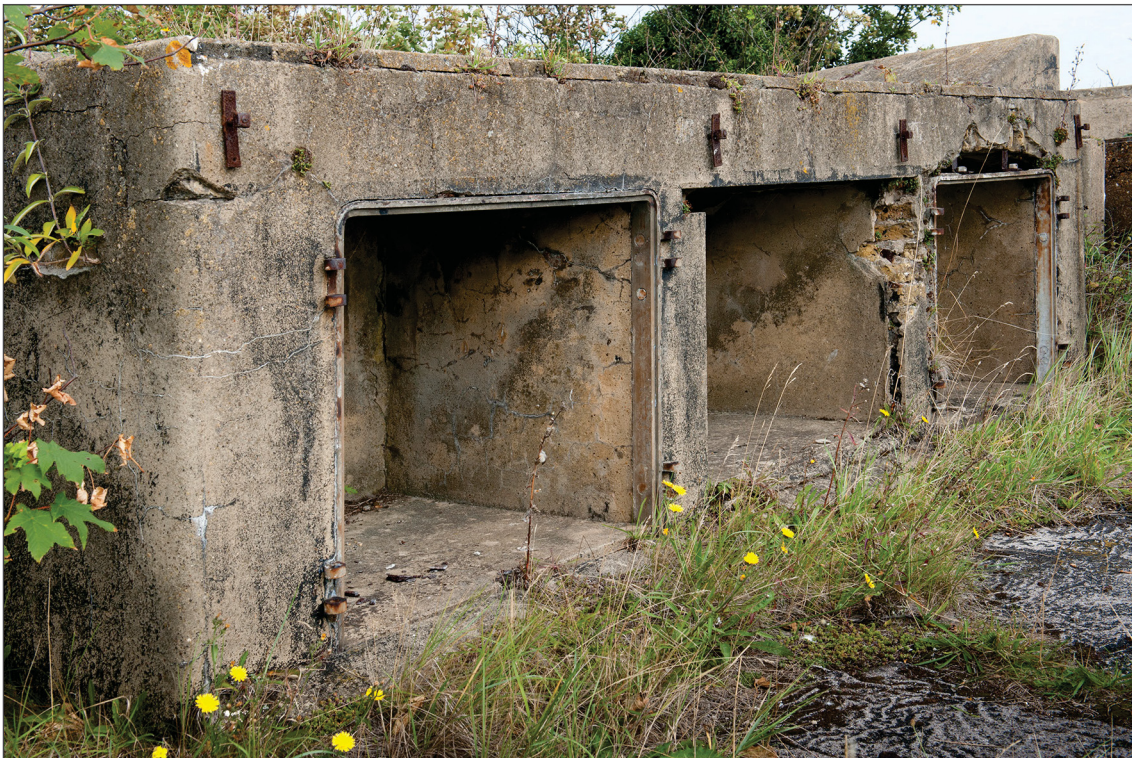
Figure 52: Ammunition lockers associated with the western 6-inch gun position. Hinges for doors on the two flanking cartridge lockers are visible as well as bolts that carried a rain hood above all three lockers. (DP097746)

recesses for the storage of cartridges and shells. Gun position 1 has five lockers in the outward/working floor face and four in the pit face. The external lockers measure 0.9m high, 0.9m deep and 1.07m wide and all have rebates for a metal frame and a pair of pintle hinges at each side for mounting doors. This is usually evidence for cartridge storage but the 1913 plan (Fig 50) clearly labels two of the recesses for shell storage. The design of 6-inch positions at Landguard (which is thought to conform to the generic plan for these positions) was provided with a large number of cartridge recesses and a single shell recess in the wing wall (Brown et al 2004, 48). This recess is present in the wing wall to the east of gun position 1 but is equipped as a cartridge recess and labelled on the plan as such. As is conventional for these positions, a row of large bolts above the lockers indicates the position of a galvanised hood for suspending a waterproof curtain over the ready-use lockers (Fig 52). The hood is indicated on the section in the 1913 drawing with the notation 'expanded metal'. The remains of two bulkhead light fittings can be seen above the lockers along with a junction box and the course of a connecting metal conduit indicated by a pronounced mortar line.

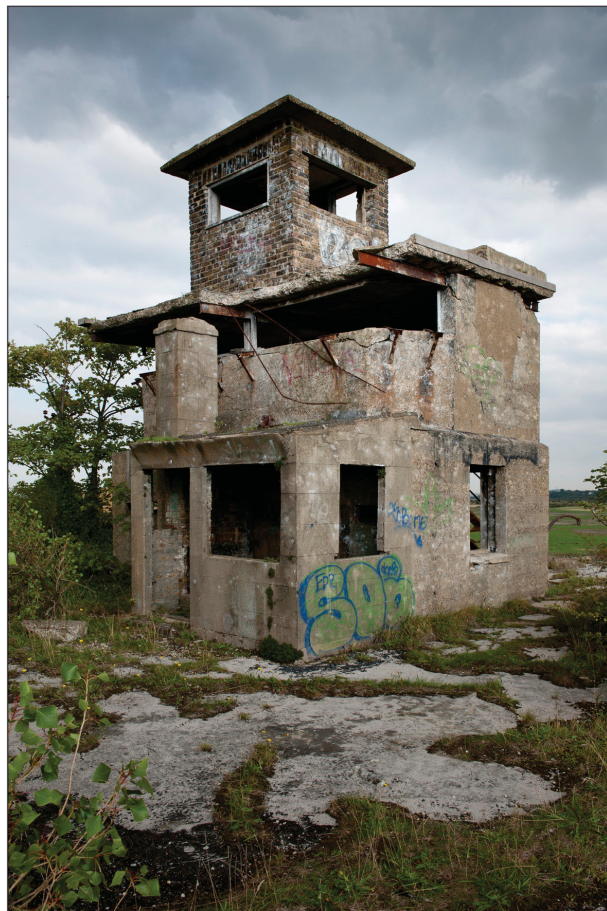
Figure 53: The Battery Observation Position looking east. The chimney stack of the projecting single-storey structure obscures the view from the observation slits. The hut on the roof dates from the Second World War. (DP097671)

The combined BOP and ELD at Cliffe is built on the north-east end of the roof above Casemate 1 and adjacent to gun position 1 of the 6-inch battery (Fig 53; App Fig 8). It is orientated to face west with views across the Thames to Coalhouse point. Unlike the Landguard (Brown et al 2004, 48), Heugh

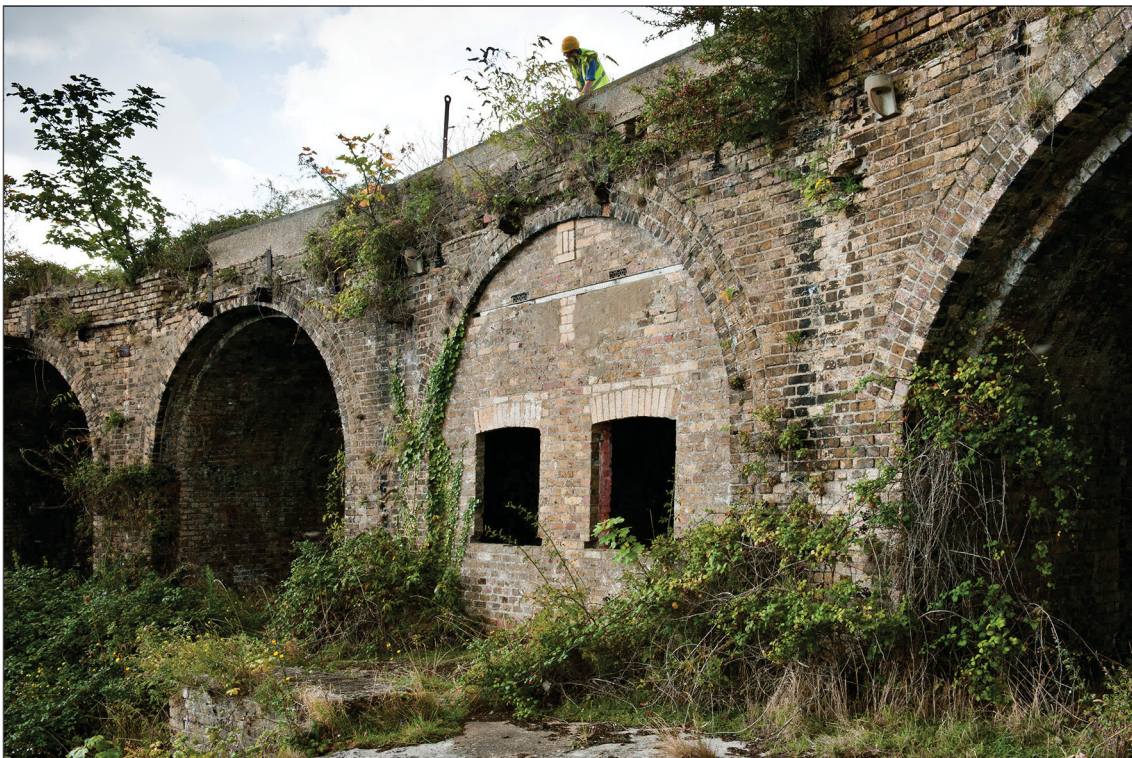
Figure 55: Casemate 6 was probably enclosed with a permanent brick wall at the time the 6-inch battery was built on the roof in order to provide a crew shelter. (DP097599)

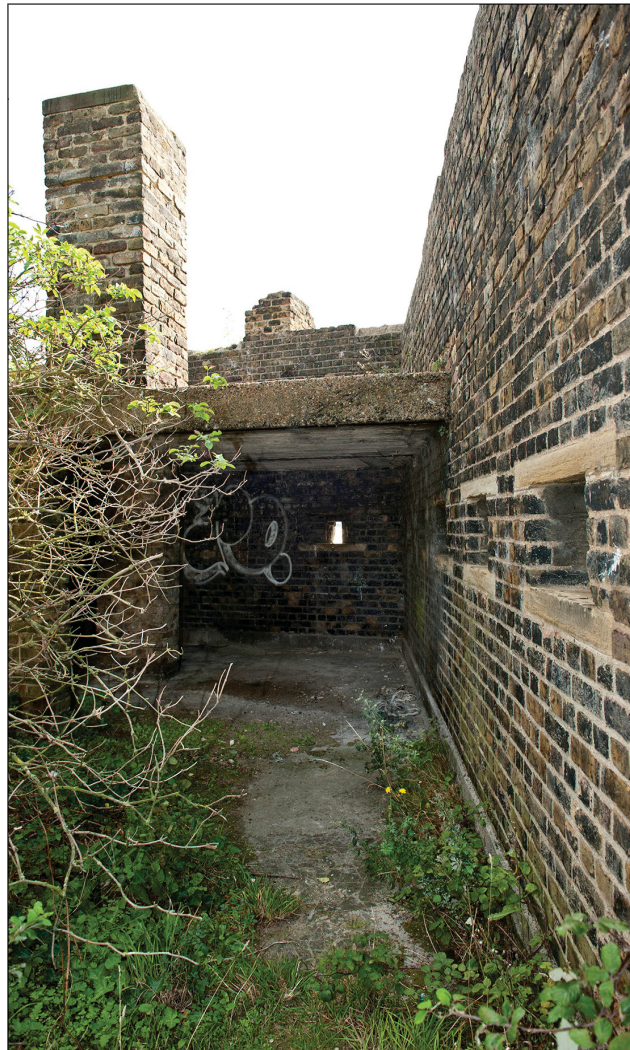
slab walkway of the *chemin de ronde* has been replaced by a concrete slab extending across the bastion and sitting on two steel or iron beams running east-west. These beams sit on sandstone pads let into joist pockets cut into the walls and are supported mid-way along their lengths by brick piers. On top of this slab, at its western edge, are two further piers, 1.8m high, constructed of bricks which have been recovered from inside the fort; several are whitewashed. These are opposed by two shorter brick piers constructed on top of the parapet wall after removal of the capstones. The alignment of these piers along with a thin layer of concrete obviously intended to level out the top of the tall piers suggest that they supported a roof over the concrete platform; this is visible on the 1941 aerial photograph. Two well-formed embrasures in the east face (overlooking the main landward approach to the fort) using the piers as jambs with further brickwork forming the embrasure indicate the defensive nature of the position. There is no obvious evidence for a ladder or steps to this platform and it may have been reached via the remaining sections of *chemin de ronde*.

Figure 56: The probable First World War defensive position constructed in the south-east demi-bastion. (DP097579)

A defensive position was probably constructed on the roof of the south-east bastion in this period (Fig 56; App Fig 8). Its construction date is not clear but it is visible on a 1941 aerial photograph (RAF 26UK1455/2045 14-MAR-1941). Unlike other features from the Second World War which are surrounded by evidence of very recent construction, the roofed position on the south-east bastion appears established and undisturbed by the recent work.

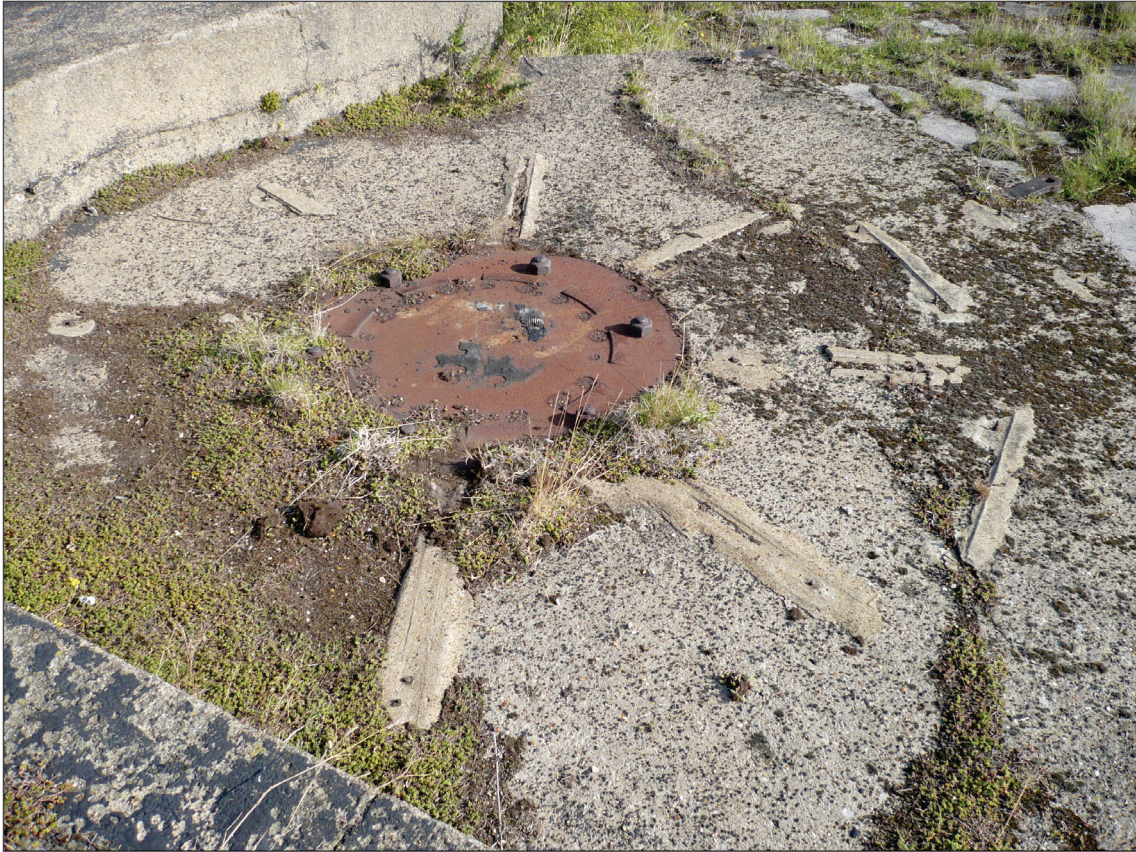
Figure 57: Most southerly 12-pounder emplacement with possible evidence of adaptation at a later date. (DP097777)

Evidence in the former B group of 12-pounder gun positions, above casemates 10 through 14, suggests that these gun positions were also reused. The southern-most of the two emplacements has the same holdfast plate which has been drilled with two extra holes at the very eastern edge and is covered over with a layer of bitumen which may be part of the very new coat of black paint covering the 6-inch barbette and the parapet that can be seen on the 1941 British Pathe newsreel. A series of 7 or possibly 8 radiating cement scars are visible beyond the holdfast plate. Each scar has a stud at each end and a witness mark for a batten or plate suggesting that it may have supported a platform around the gun. Two pairs of similar scars beyond the holdfast to the east may relate in some way to the firing angle of the gun (Fig 57).

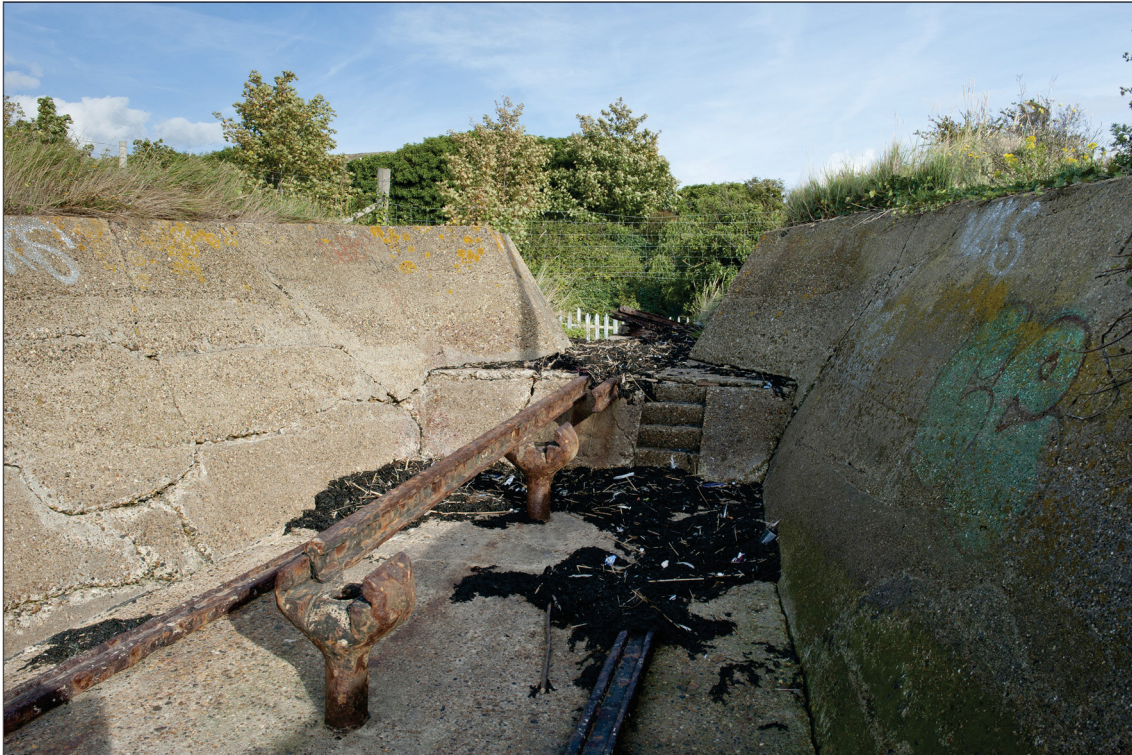
Figure 58: The north slipway and launching rail looking back towards the open battery of Cliffe Fort. The slots for the timber boards mentioned in the letter of 1889 are in the flanking walls above the short flight of steps. (DP097353)

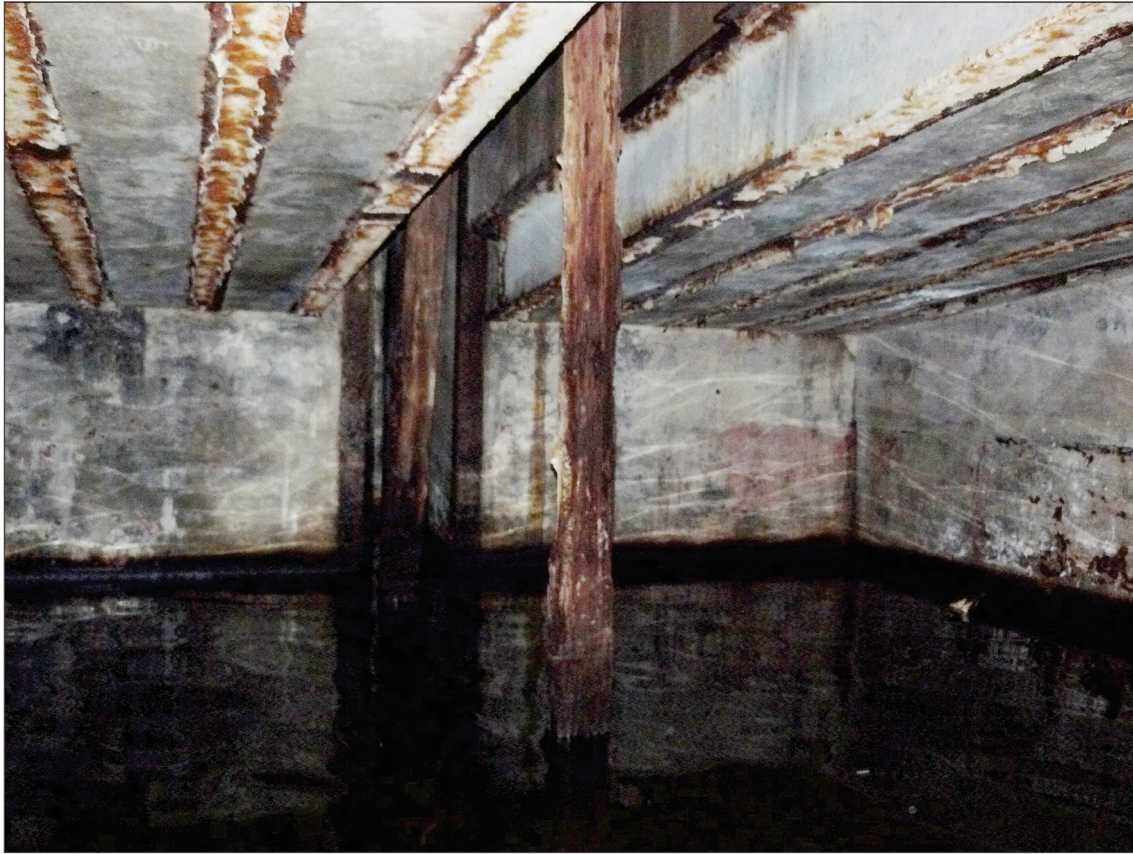
Figure 60: The interior of the Torpedo Store looking west and showing the slope of the roof to accommodate the top of the south launching slipway. The vertical timbers in the foreground mark the course of the torpedo handling slot © Wayne Cocroft

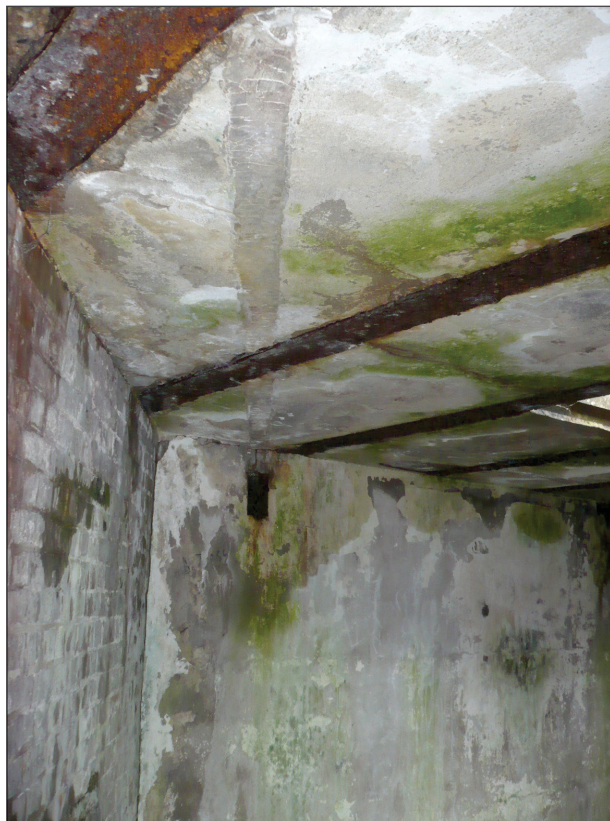
Between the torpedo and the slot the wire had to be threaded onto the pulley carriage running on a beam suspended over the torpedo launching rail (Beanse 1997, 26). It appears that the front of the northern gun position of the open battery was extensively modified to accommodate this beam. The survey revealed that, in this position, the embrasure, its surrounding wall and the immediate flanking walls on the north side were removed and the resulting space filled with concrete to produce a block 4m deep rising to the full height of the surrounding traverse walls (2.5m). The front (west) face of the block is topped with an angled kerb of concrete slabs. The outline of this work, along with the position of the boiler exhaust flue is shown on the 1899 roof plan (TNA: WO78/4963; App Fig 3). Examination of the south-west corner of the concrete block from inside the gun position shows the cut stub of an iron beam protruding from the top of this corner. This stub aligns with a witness mark running across the roof and into the wall of the gun position (Fig 61). Extrapolation of the 1993 and recent surveys suggests that for the pulley beam to align with the southern slipway it would have to be located in this corner of the block and this cut off end may be its remains. As there is no direct access from the slipway to the interior of the position, it can only be assumed that the beam protruded back into the gun position as a counterweight.

Figure 61: The interior of the north gun position of the former open battery looking west, showing the position of the pulley beam for the original south slipway. The cut off end of this beam is visible as a dark coloured square in the wall with a corresponding witness mark running along the ceiling.

This projection, and the interior of the gun position, probably served no other purpose as, in this phase, the torpedo, its rails, wire runs and pulley beam were located outside the fort on the torpedo store roof.

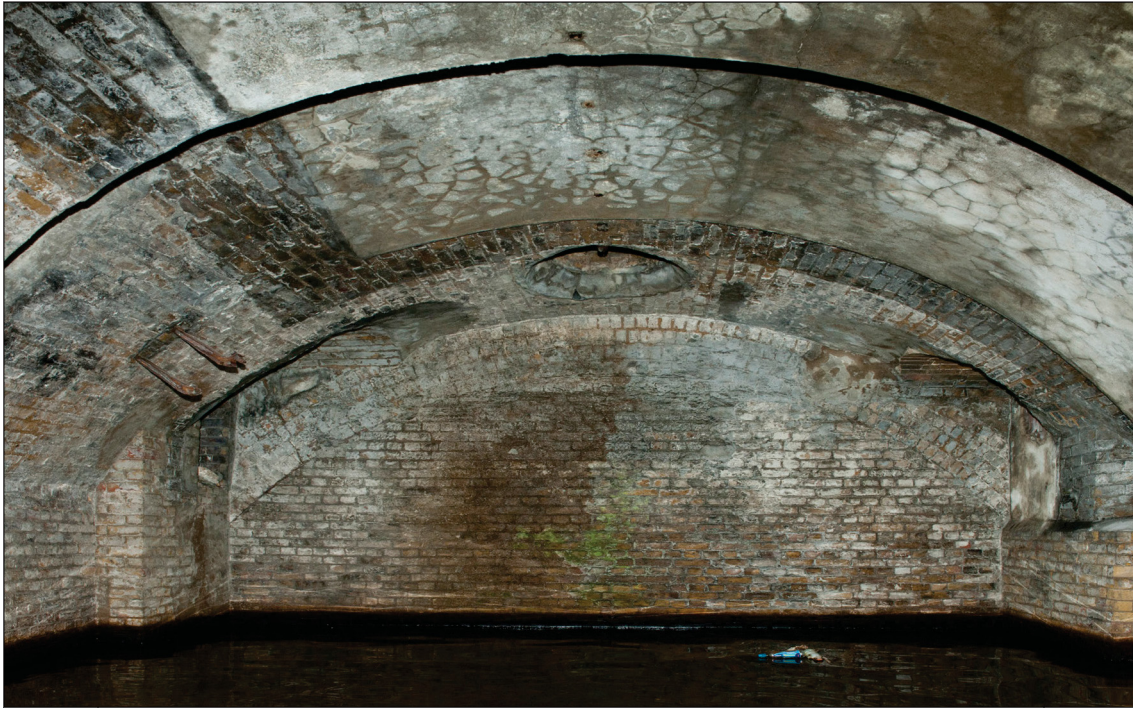
Figure 62: The interior of the former boiler room and oil store looking west. The scar of the removed wall between the ammunition store and the shifting passage is visible on the vault along with the shaft for the ammunition lift to the former open battery. The brick piers beneath the vaulted openings to the blocked shifting passage are the remains of the base and flues for the Cornish boilers. (DP 097540)

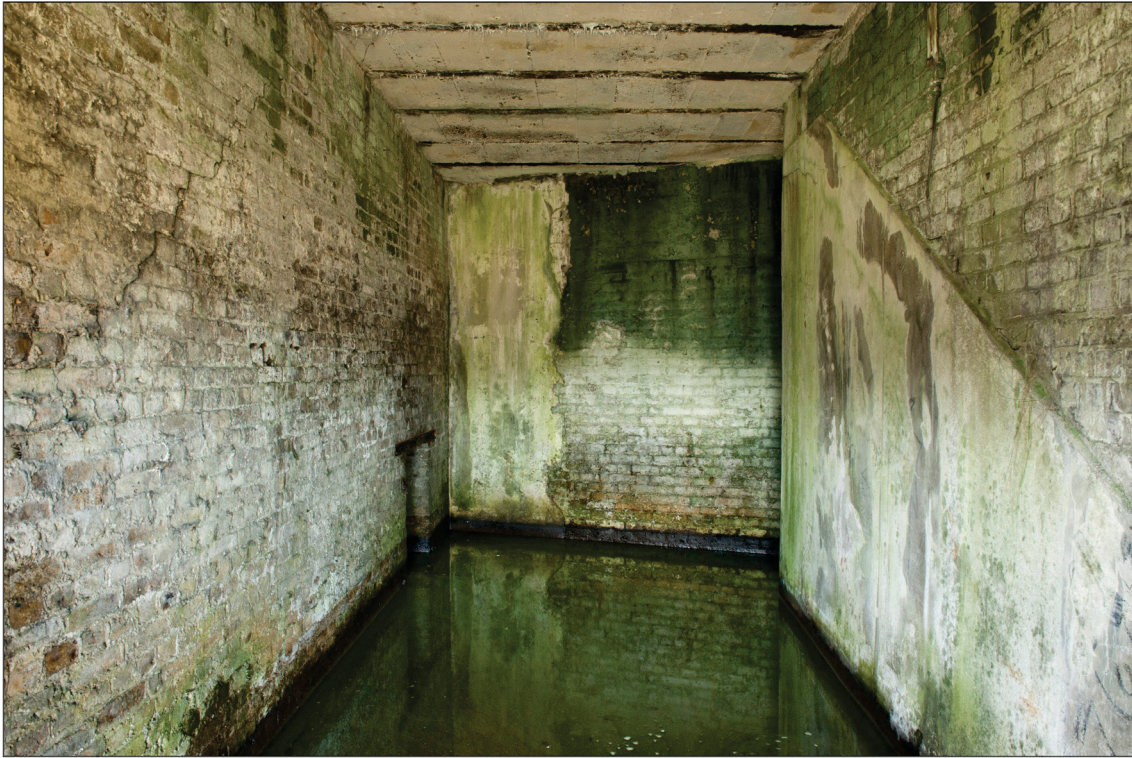
Figure 63: The interior of the coal store with the coal hatch at the base of the left hand wall and the render on the right hand wall marking the line of the original traverse. (DP097545)

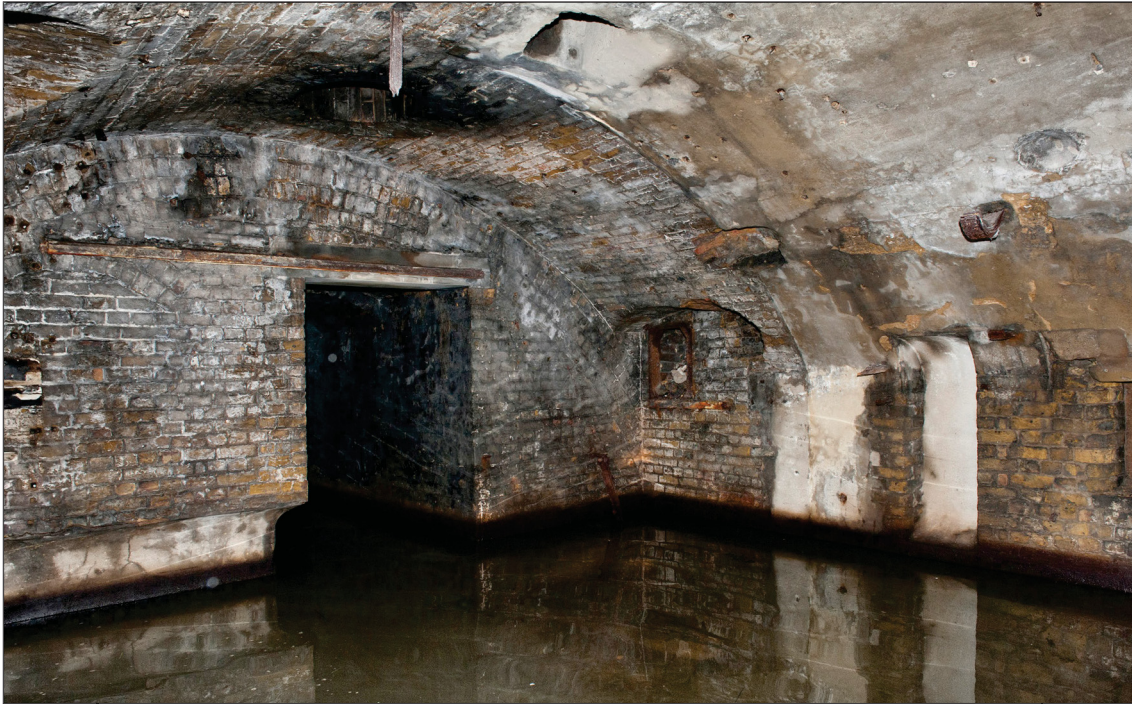
Figure 64: The interior of the Engine Room looking west. The entrance to the Torpedo Store is in the centre of the frame and to its left is the segmental head for the entrance to the caponier. In the vault, and surrounded by light coloured concrete, is the shaft pierced for the driving wire to the north slipway. The projecting iron strap is possibly a support for a pulley wheel. The deep recess at the foot of the wall on the left marks the course of the sea water supply pipes to the surface condenser. On the right the blocked arched headed opening for the shifting passage has a metal framed opening for a flue rodding point inserted in its centre. (DP097535)

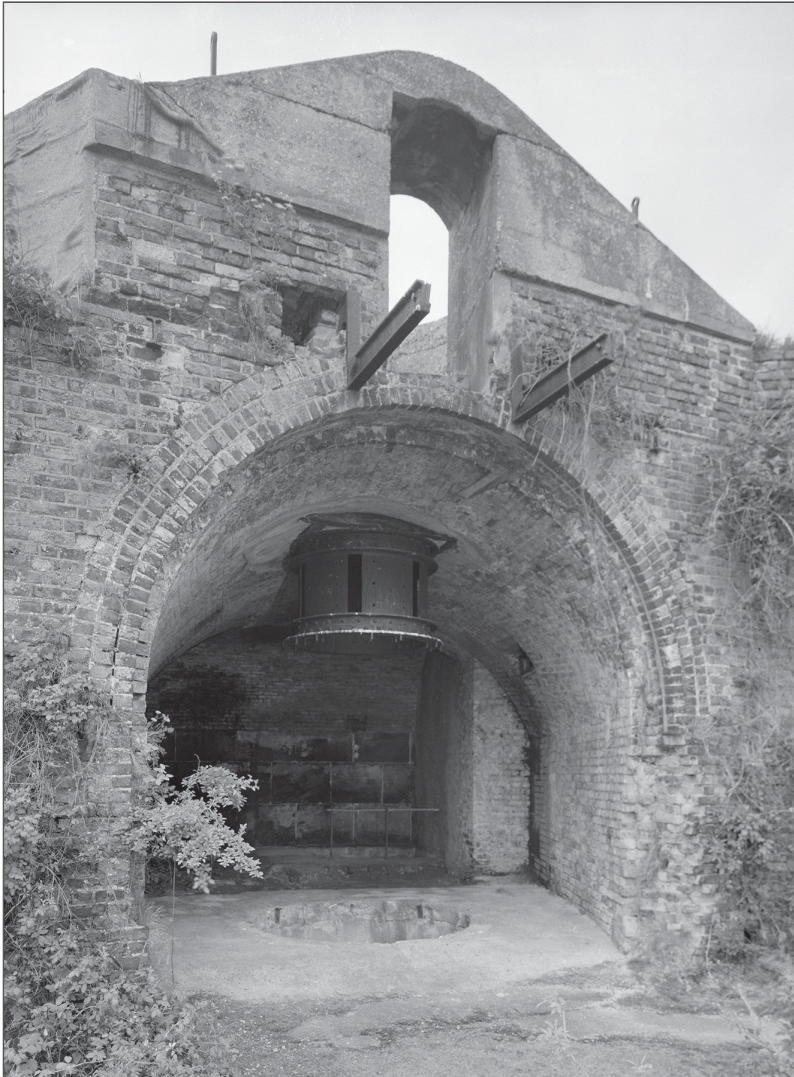
Figure 66: The gable end of what was probably the original Brennan observation position above Casemate 15. The later concrete cone for the rising tower appears to have engulfed the earlier handrail stanchions. (bb93_20789)
