9. THE LATER 19TH CENTURY AND EARLY 20TH CENTURY

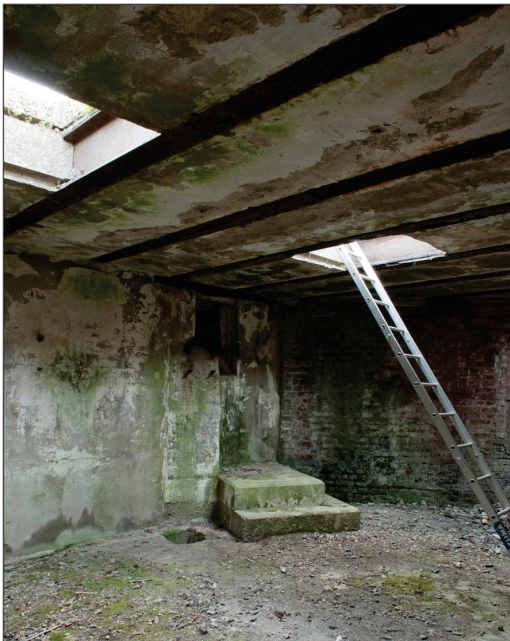
Figure 67: The opening for the north slipway pulley beam in the concrete block that occupies the embrasure of the former northern open gun position. It is located just below the ceiling with the securing studs for a pulley and the shaft leading down to the Engine Room on its left side. On their right is the short flight of concrete steps for access to the pulley beam. (DP097783)

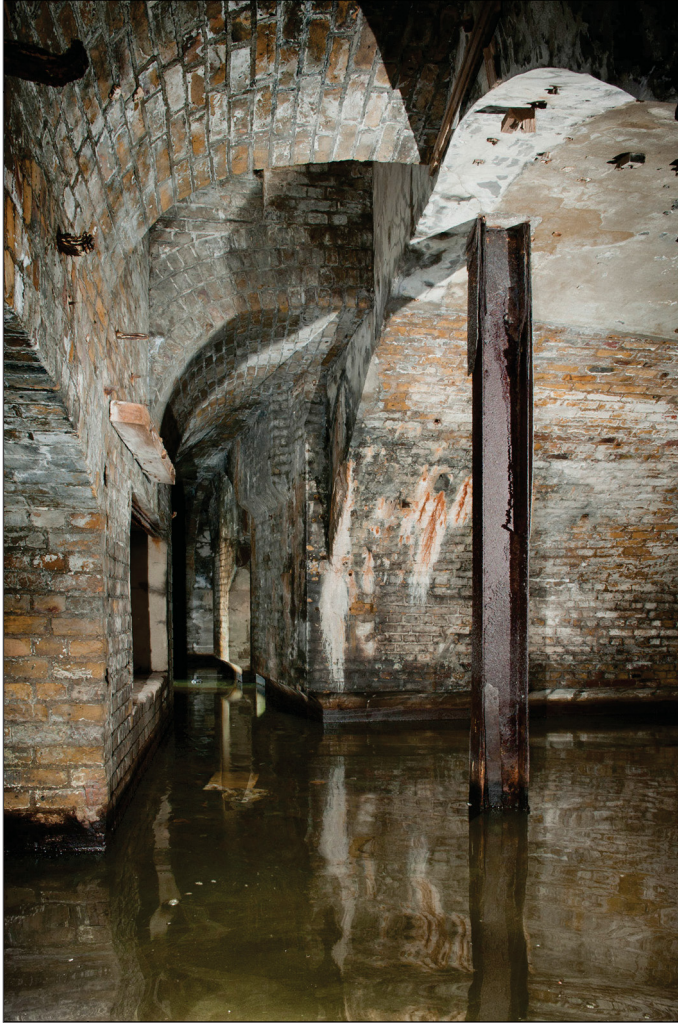
Figure 68: The former lighting passage running at the rear of the Brennan Installation. The Engine Room is in the vaulted casemate to the right with the later condenser tank and pumps in the adjacent casemate, the entrance to which is just visible at the end of the passage. The rectangular recess visible in the wall on the left side may be connected with the support for the engine steering beam. The manhole that opens into the former open gun emplacement above is in the cut out section of the lighting passage vault. (DP 097528)

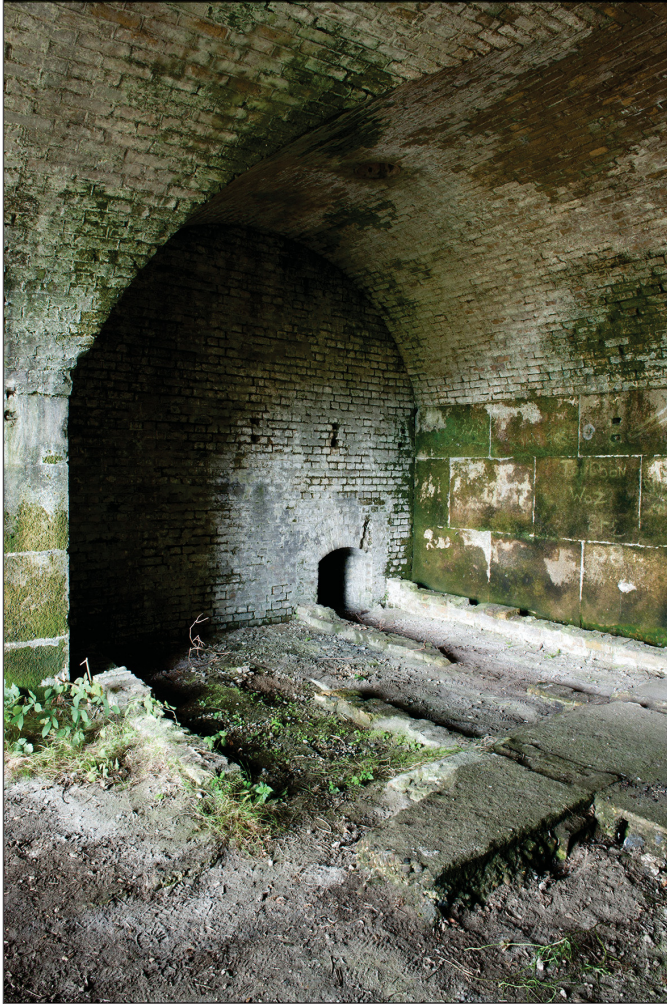
Figure 69: The southern wall of Casemate 15 showing the low tunnel that may have been inserted to enable the installation of the machinery for the rising tower. (DP097642)

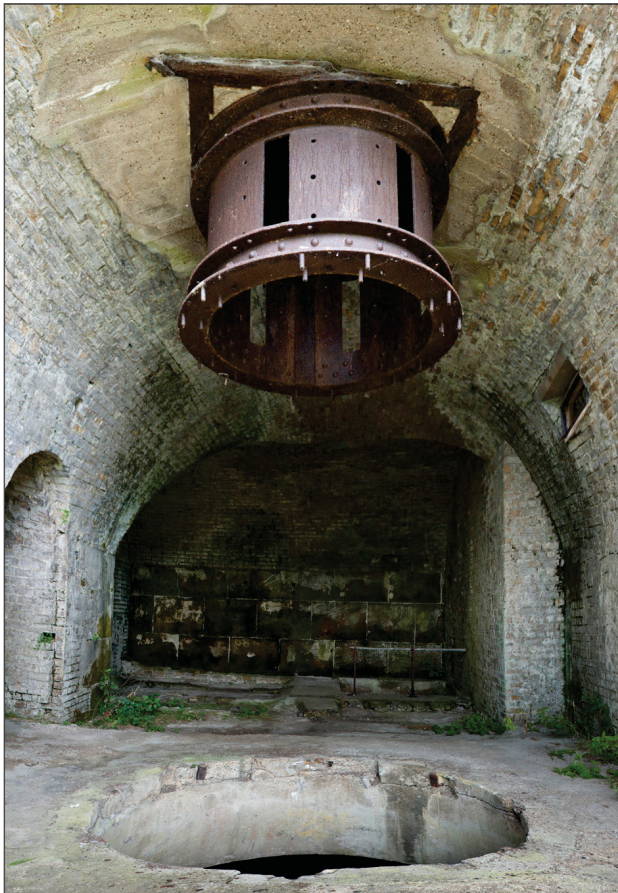
Figure 70: The interior of Casemate 15 looking west with the iron collar for the rising tower set in the vault. The corresponding hole visible in the floor opens into the former lighting passage and casemate below. On the right hand side of the photograph is the corner of the brick wall inserted to support the 6-pounder gun battery on the roof. The arched doorway on the left hand side of the picture leads to the former open gun positions. (DP097638)

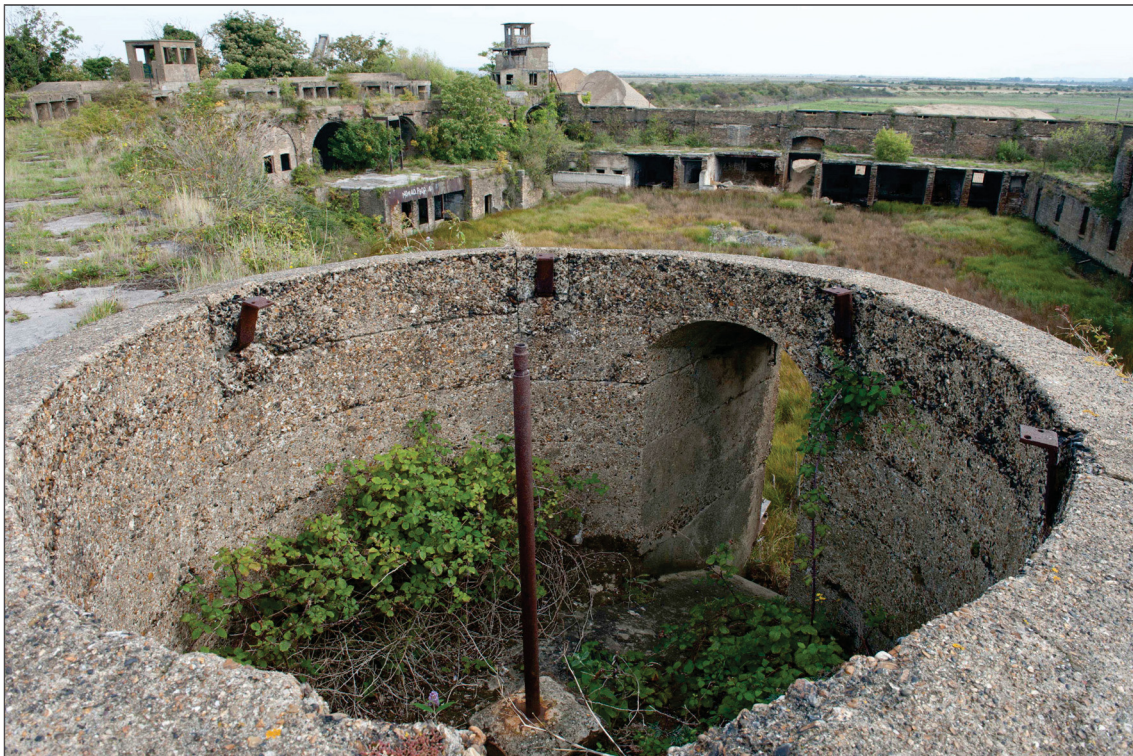
Figure 71: The interior of the collar for the rising tower looking north. The horizontal marks in the sides of the cone mark successive pours of concrete. The steeply sloped ramp between the interior of the cone and the opening in the gable end of the earlier observation position can be seen on the right hand side of the picture. The rod set in the centre is thought to be a mounting for a Second World War light machine gun sitting on an inserted timber floor. (DP097558)

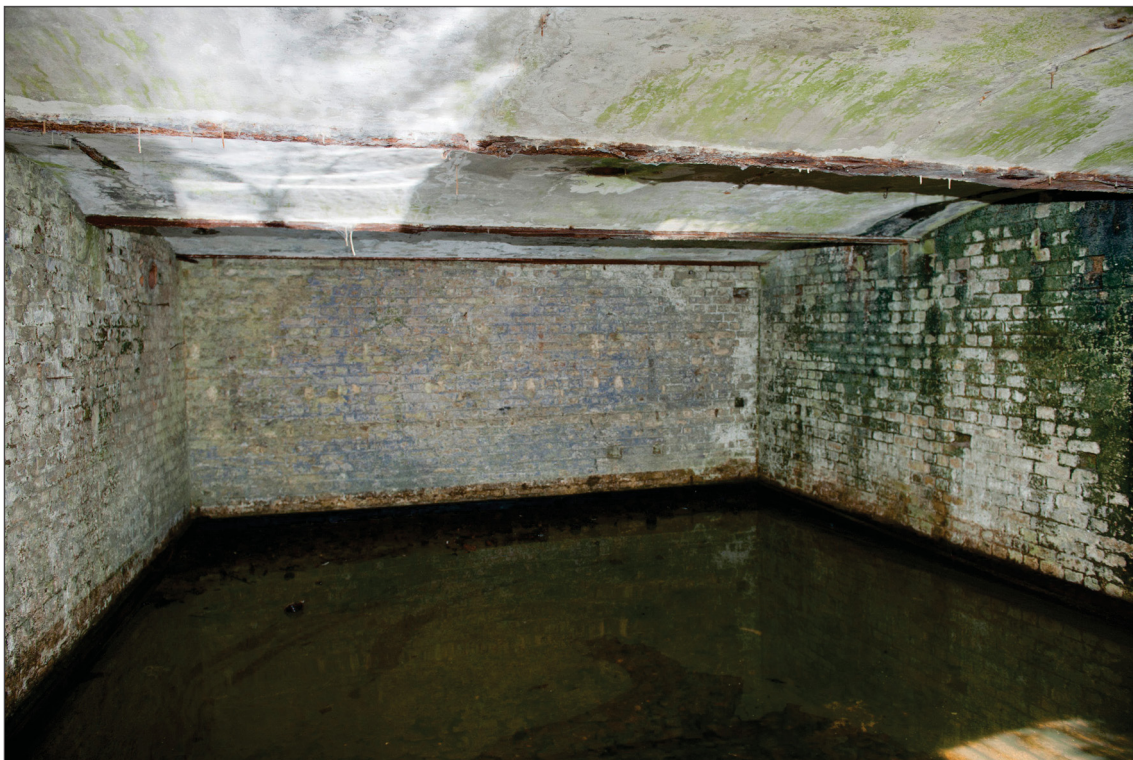
Figure 72: The interior of the Test Room [72] showing the vaulted roof and the various marks on the walls showing the positions of the connection boards and benches. (DP 097565)

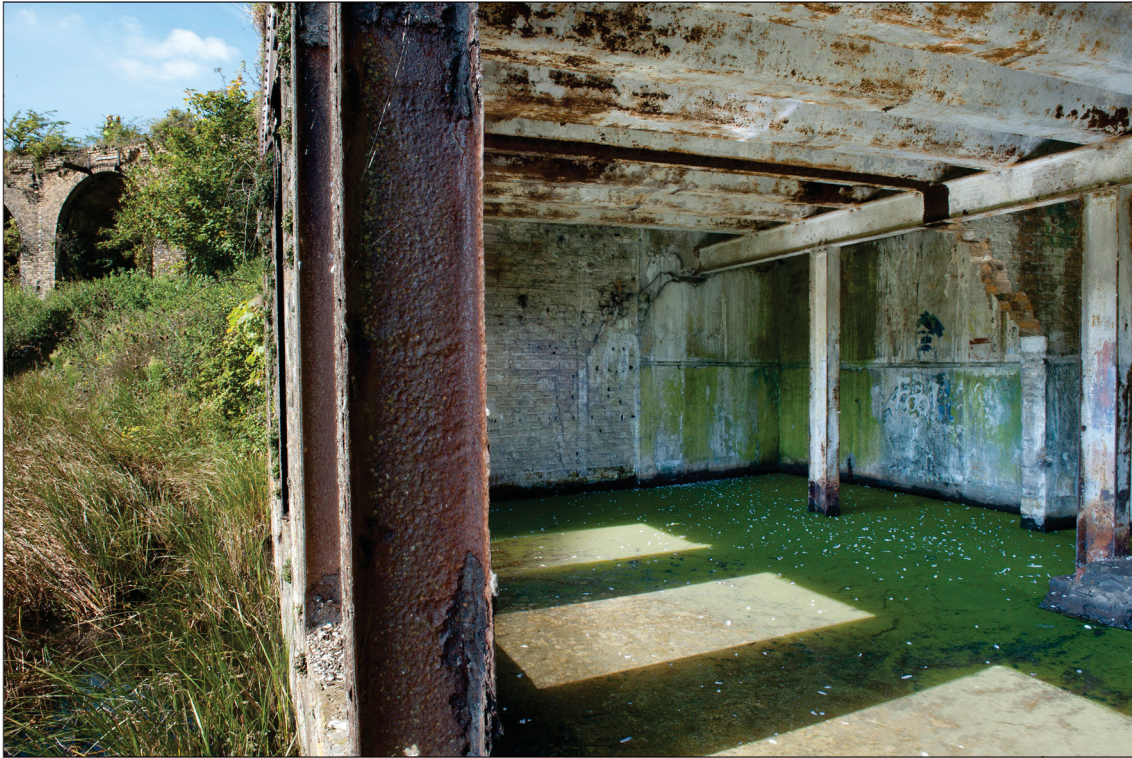
Figure 73: The interior of the Engine and Dynamo House [70, 71]. The later (presumed Second World War) steel-beam and ribbed-section roof can be clearly seen. The black stripe running across the roof indicates the position of the former dividing wall between the Engine and Dynamo Rooms. The corner of the engine base can just be seen to the right of the picture. (DP 097558)

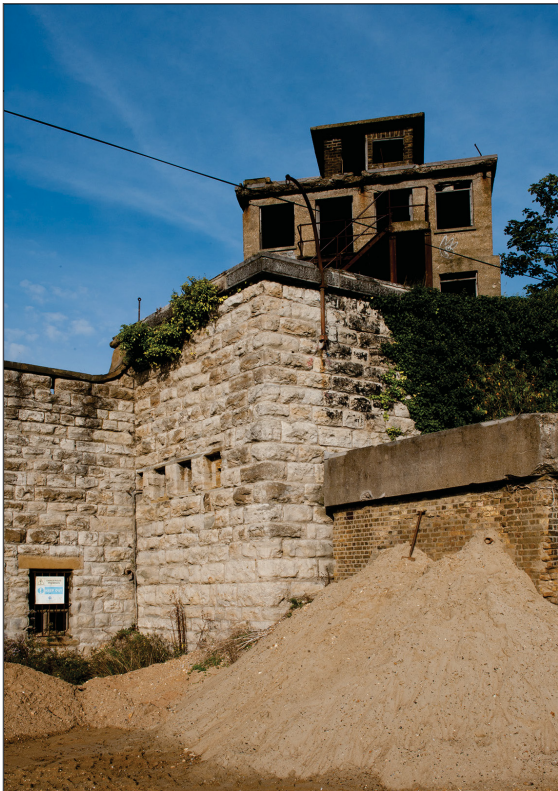
Figure 74: The external oil store located outside the north-east bastion. (DP097698)

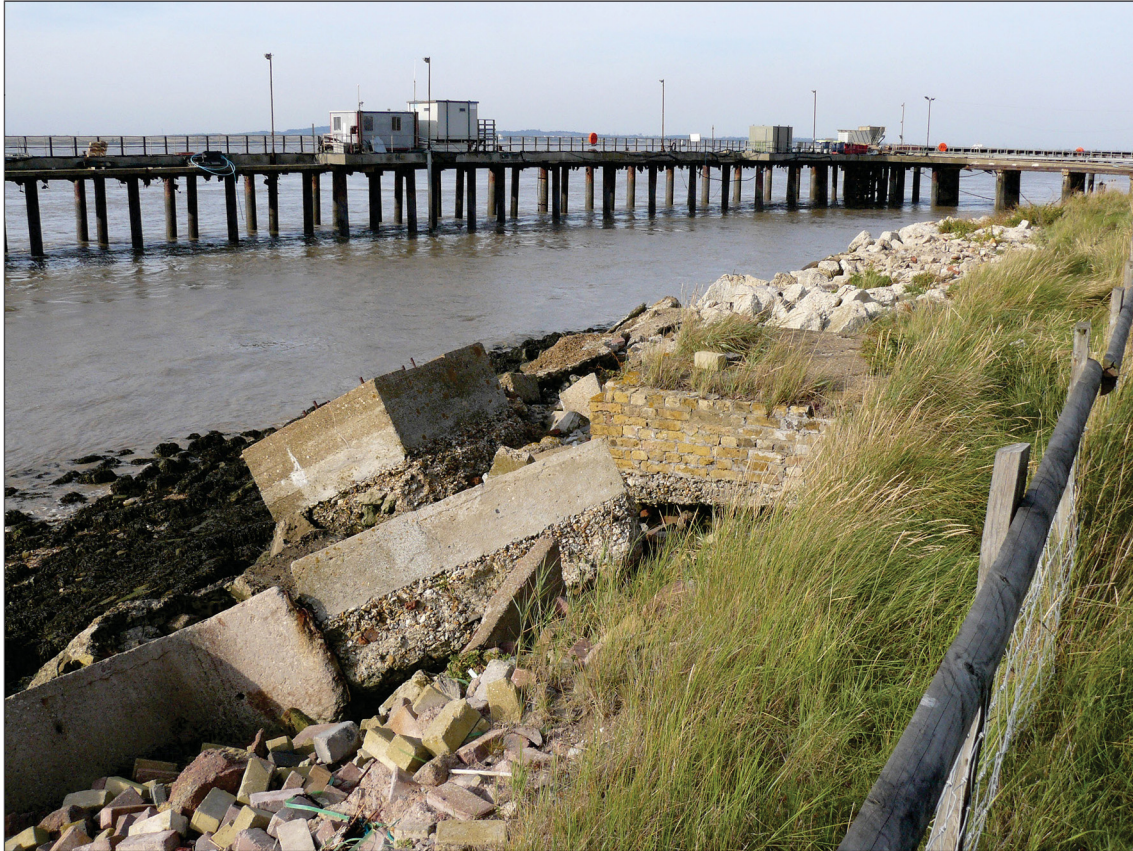
Figure 75: The possible remains of either a brick-built Submarine Mining Observation Post or a fixed-beam searchlight position on the shoreline to the north of the fort. (DP 097726)

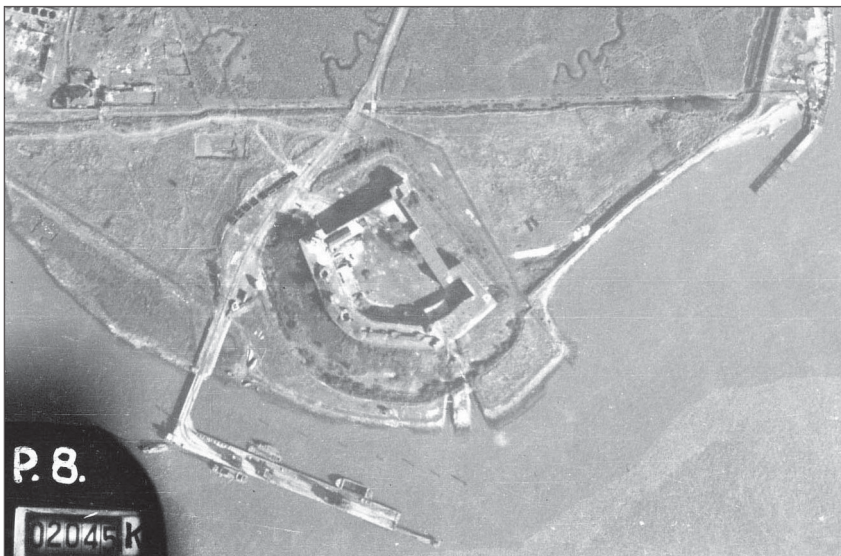
Figure 76: Cliffe Fort on an extract from an aerial photograph taken in 1941. The areas with white highlights may indicate construction work. RAF 26/UK/1455 2045 14-March-1941 Historic England (HEA) RAF Photography

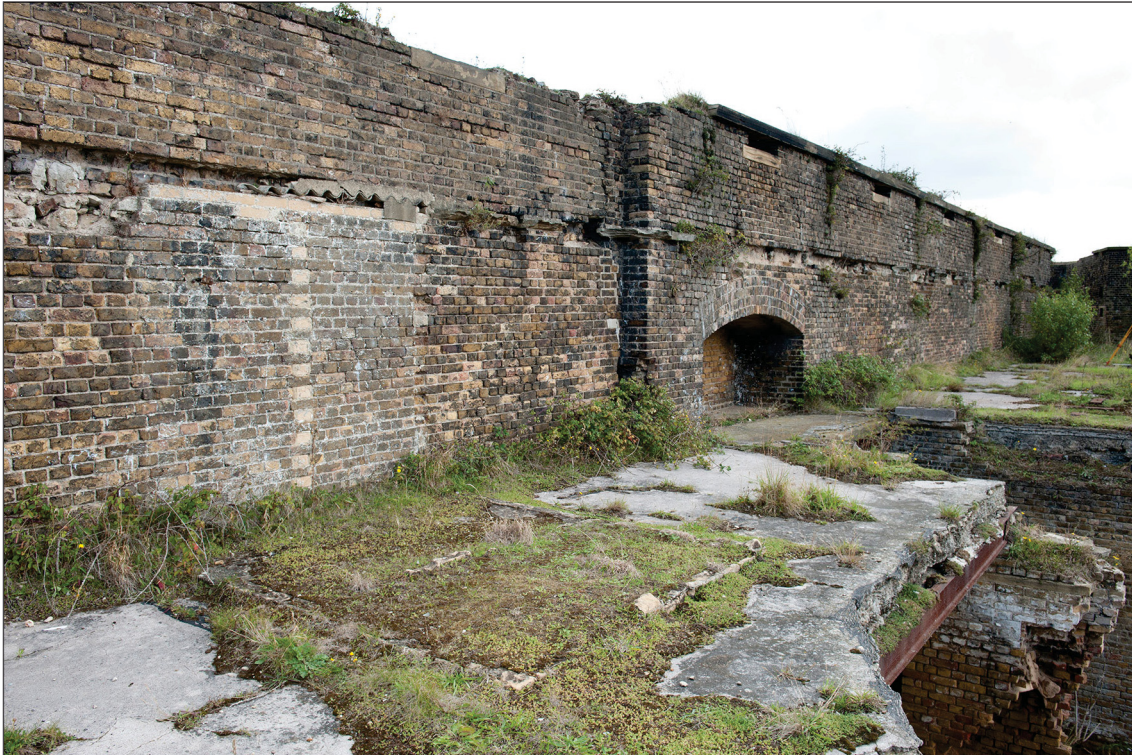
Figure 77: Former position of the possible signals hut on the roof of the entrance range. (DP097582)

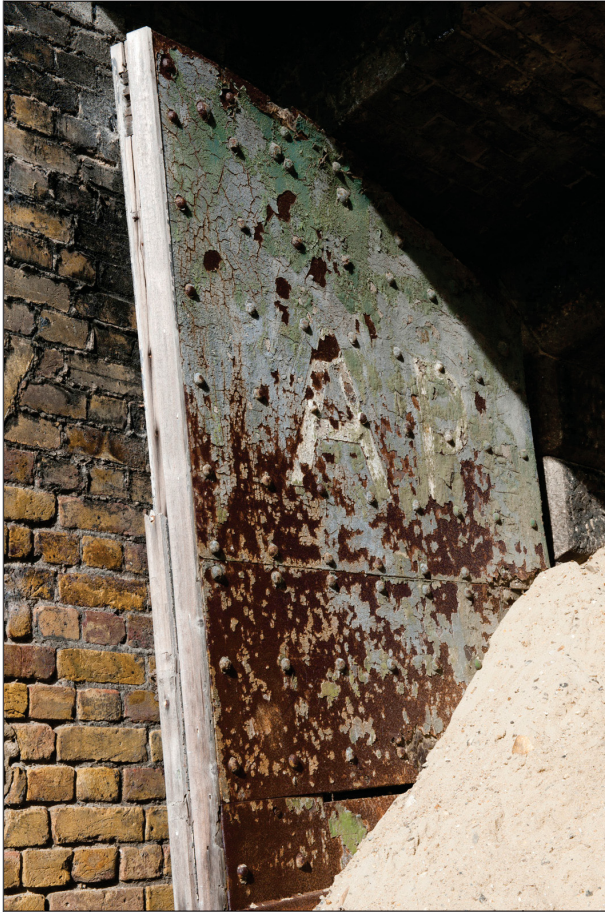
Figure 78: The right-hand leaf of the front doors to the fort. Evidence for the occupation of the fort by the Royal Naval Auxiliary Patrol is provided by the letters 'A P' on a background of flaking naval grey paint. (DP097676)

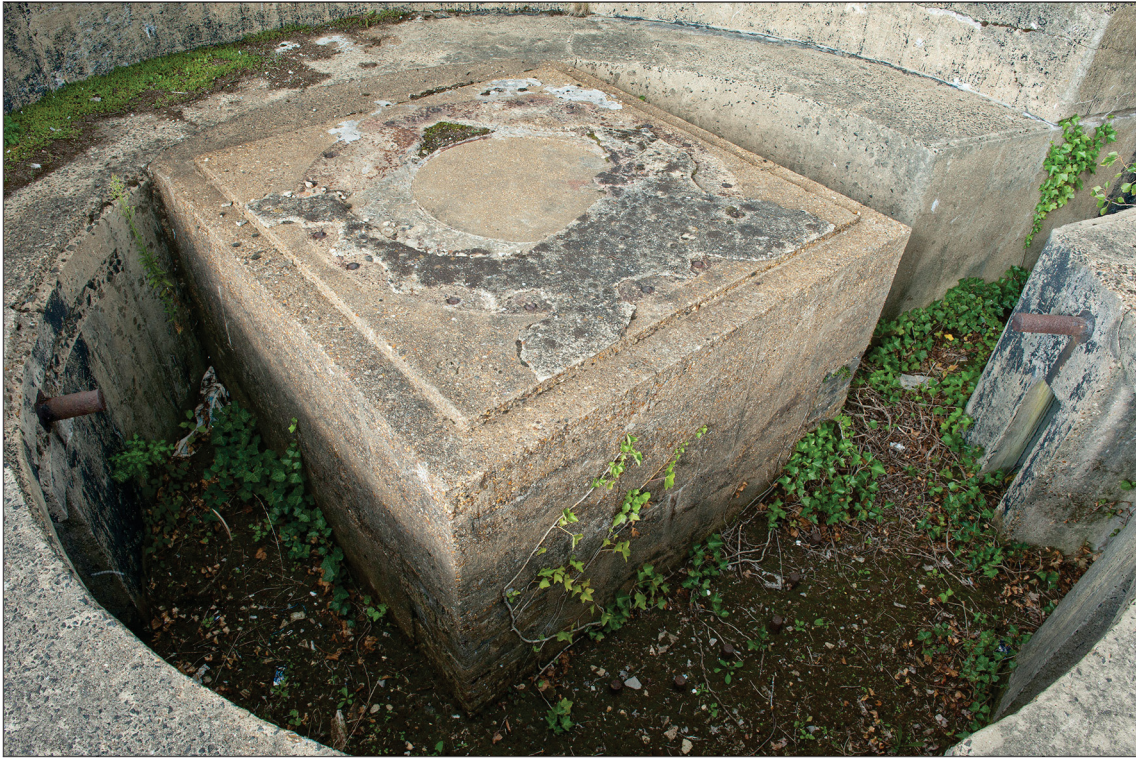
Figure 79: Concrete block inserted to modify the 6-inch gun emplacements during the Second World War. (DP097671)

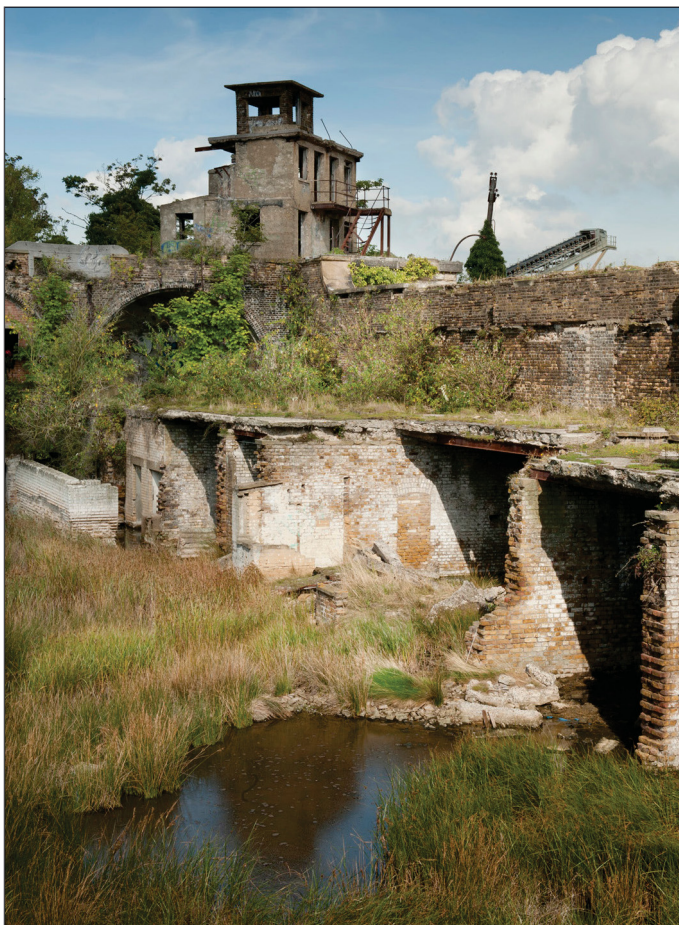
Figure 80: The north end of the East range. In the foreground are the remains of the Guard House and the cell block. Beyond them are the Ablutions and Latrines with their new front wall and the heavily weathered modesty wall in front. On the right hand side of the picture, the lighter coloured patch on the parapet wall is the position of the brick outbuilding to the demolished timber hut which extended from here to the left hand side of the frame. (DP097523)

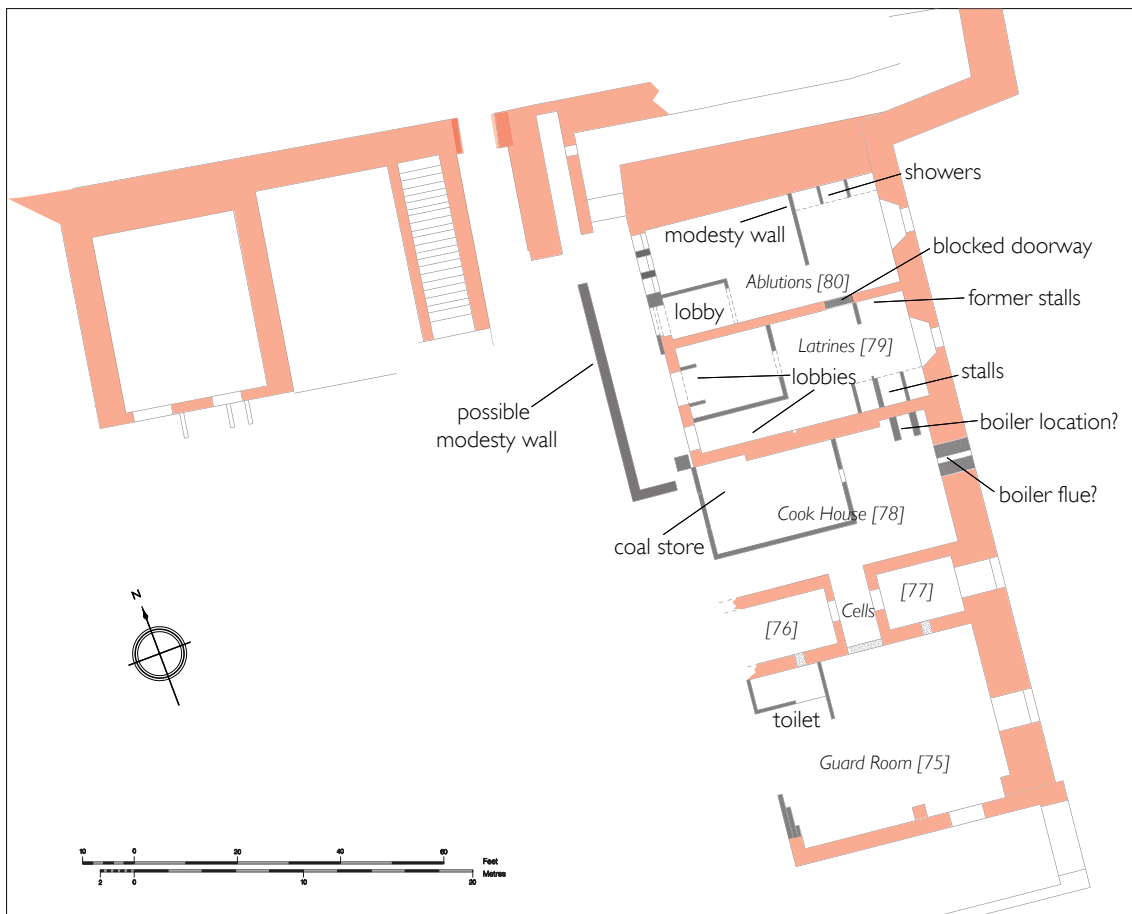
Figure 81: Sketch survey of the rebuilt northern end of the entrance range based on field measurements and the 1899 basement plan (TNA: WO78/4963). The possible Second World War additions and alterations are shown in light grey.
