RESEARCH REPORT SERIES no. 108-2011

# THE READER'S HOUSE, LUDLOW, SHROPSHIRE

## TREE-RING ANALYSIS OF TIMBERS

SCIENTIFIC DATING REPORT

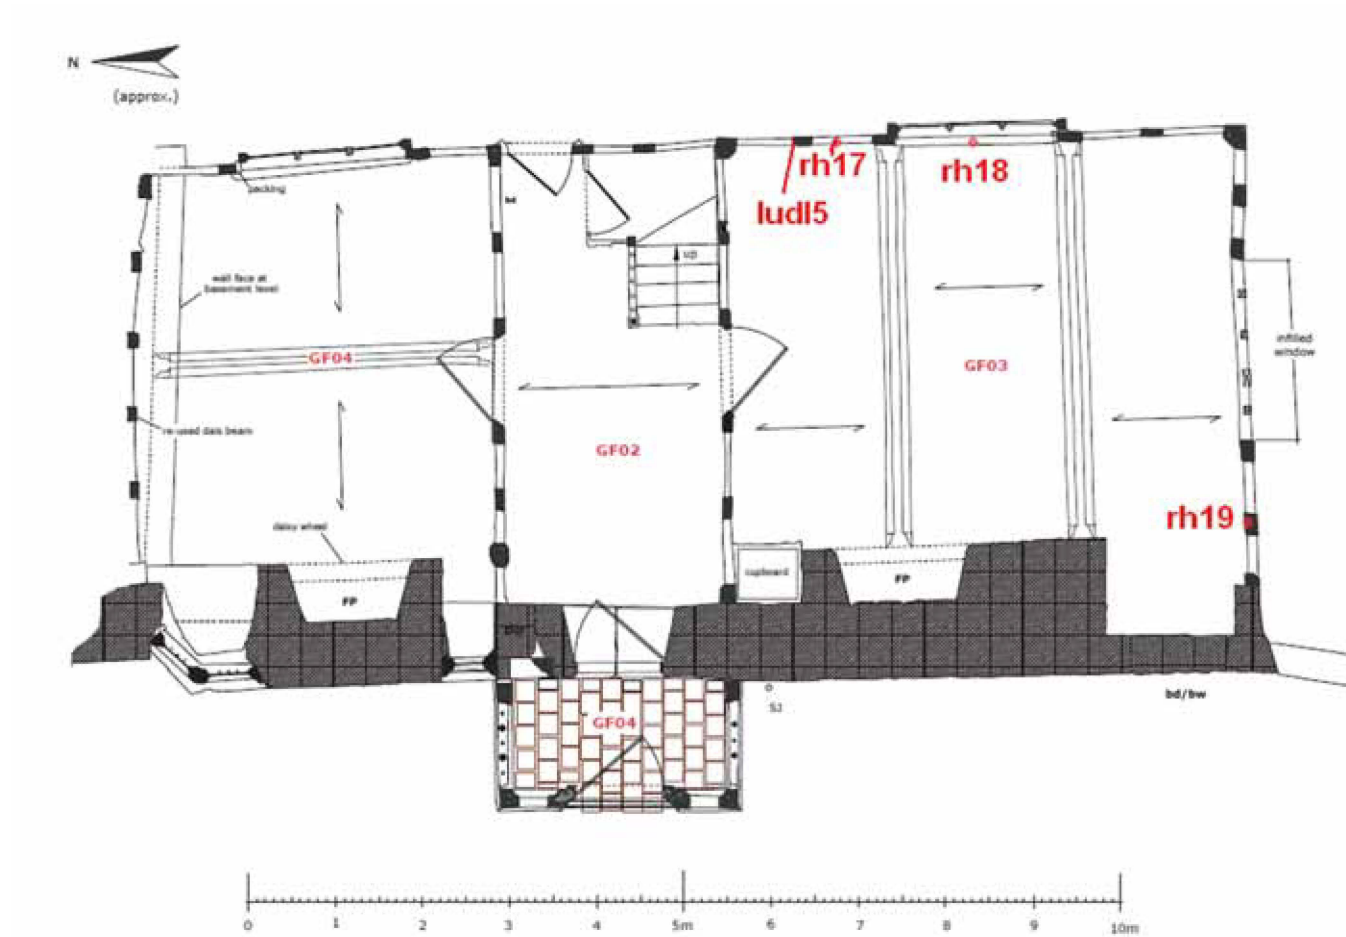
Figure 5: Ground-floor plan, showing timbers sampled for dendrochronology (after Tyler)

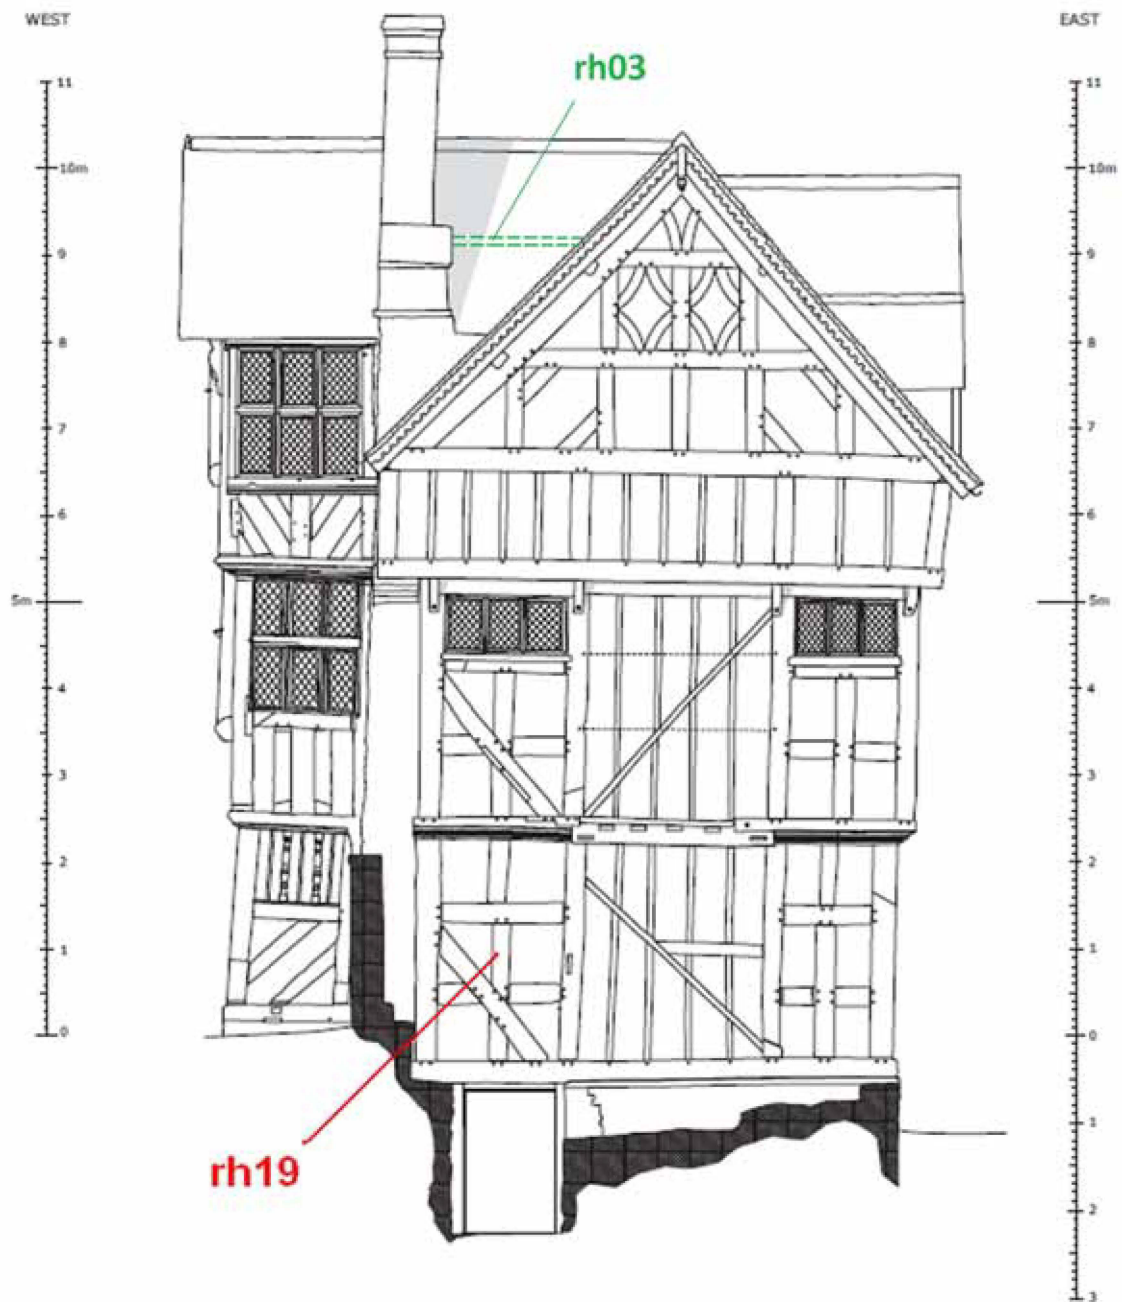
Figure 7: South elevation, showing timbers sampled for dendrochronology (after Tyler). Sample rh03 is shown in its approximate position, and is therefore shown in a different colour

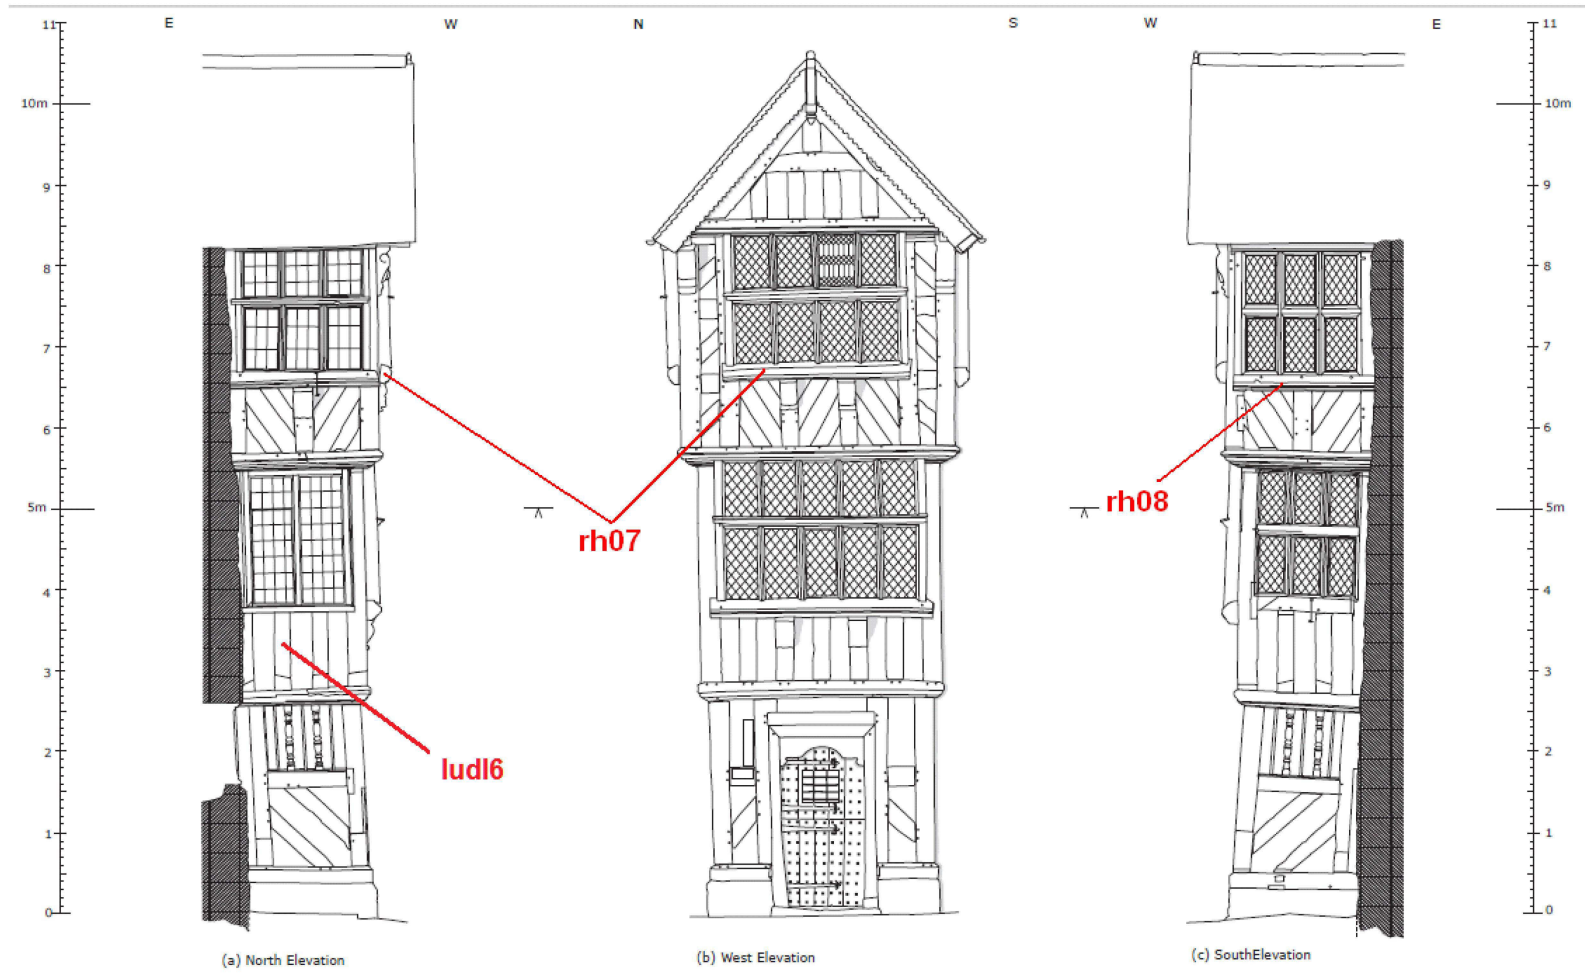
Figure 11: The porch, showing timbers sampled for dendrochronology (after Tyler)

In addition, it had been suggested that the porch may have been a later addition, and samples were therefore sought to confirm or deny this hypothesis. It was noted during the assessment that the north wall of the property was rather different in character, having generally much smaller timbers, and whilst it would have been of interest to date this wall, none of the timbers were found to be suitable, as they contained too few rings. There was some question from the building analysis as to whether the second-floor ceilings were primary or inserted, and sampling was directed to timbers that may be capable of answering this question. Two octagonal posts in the basement were almost certainly brought into the house from elsewhere, but their dates were of intrinsic interest to the property, so these too were sampled.

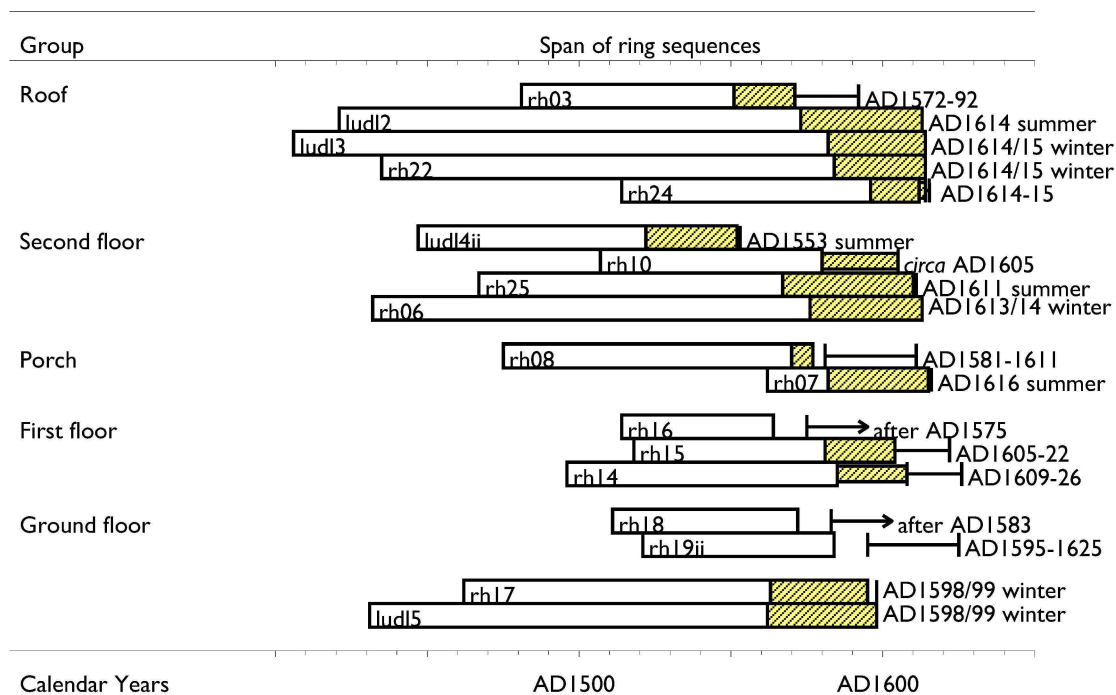
Figure 12: Bar diagram showing the relative positions of overlap between the dated series, along with their likely interpreted felling dates, sorted by area. Yellow hatched sections represent sapwood, and narrow sections are additional unmeasured rings

When considered overall there is a preponderance of material felled in the AD 1610s throughout the building and the disparate nature of the felling dates or felling date ranges obtained for the other dated timbers suggests, at the very least, a major rebuild and more likely indicates that the building was actually constructed in the mid AD 1610s (Figs 12 and 13). This would certainly agree with the inscribed date of '1616' on the porch. In this instance the earlier material would therefore appear to have been either stockpiled or reused, although evidence of reuse is clearly lacking on some of these earlier timbers. Nevertheless it seems unlikely that the tiebeam (Iud14) felled in the summer AD 1553 had been stockpiled for over 60 years.

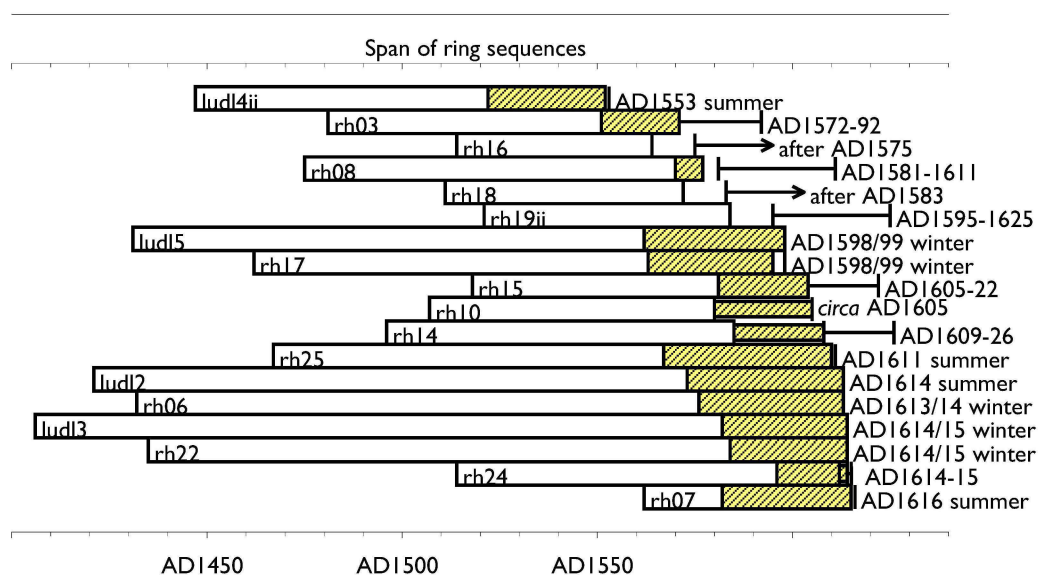
Figure 13: Bar diagram showing the relative positions of overlap between the dated series, along with their likely interpreted felling dates. Yellow hatched sections represent sapwood, and narrow sections are additional unmeasured rings
