RESEARCH REPORT SERIES no. 23-2012

KENILWORTH CASTLE, WARWICKSHIRE SURVEY OF POSSIBLE ELIZABETHAN STAIRWELL IN SOUTHWEST CORNER TOWER OF THE KEEP

**Survey of possible Elizabethan stairwell in southwest corner
tower of the Keep**

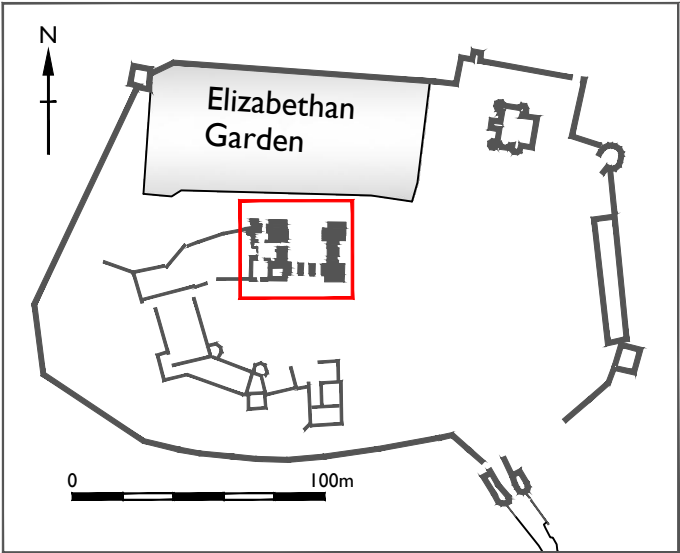
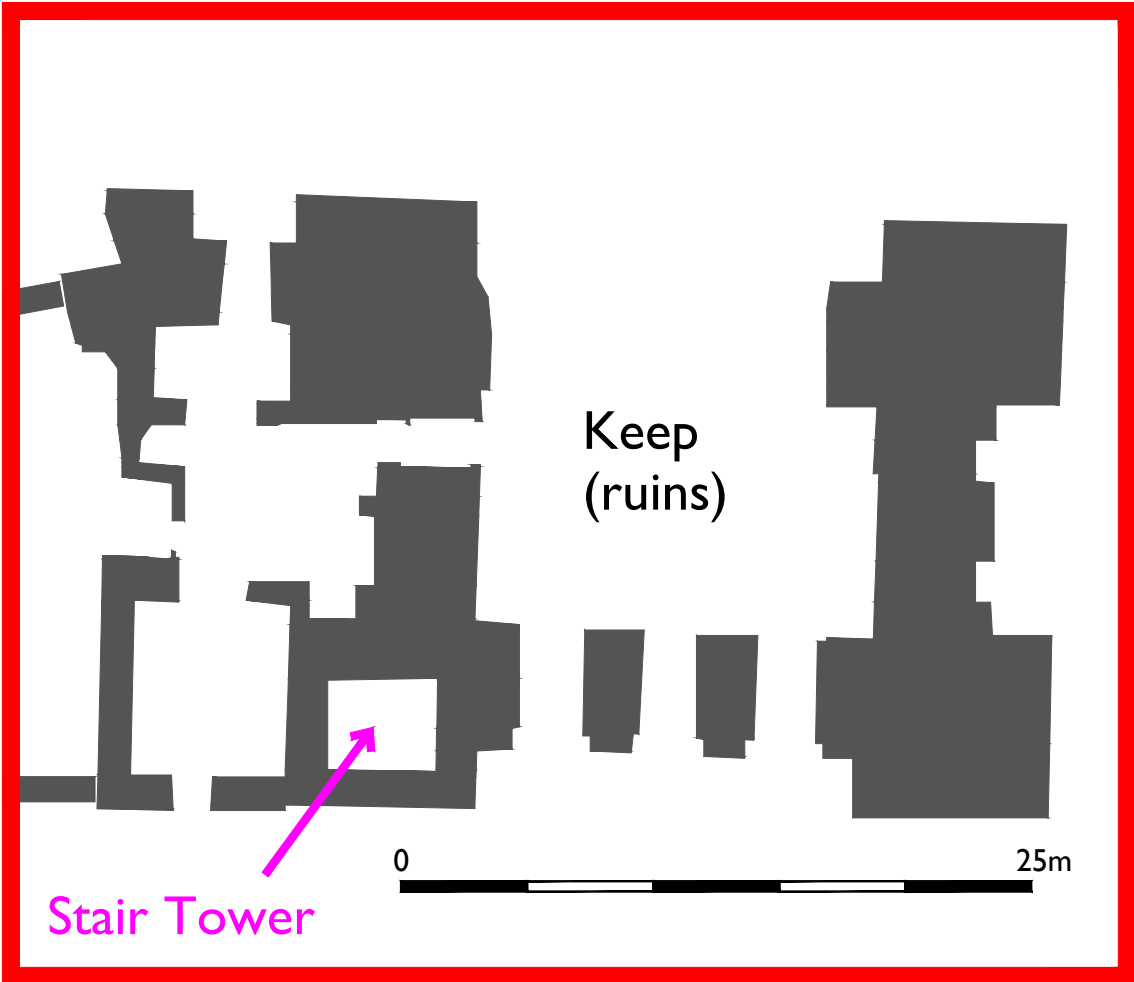
Fig. 1: Kenilworth Castle keep, stair tower location plan

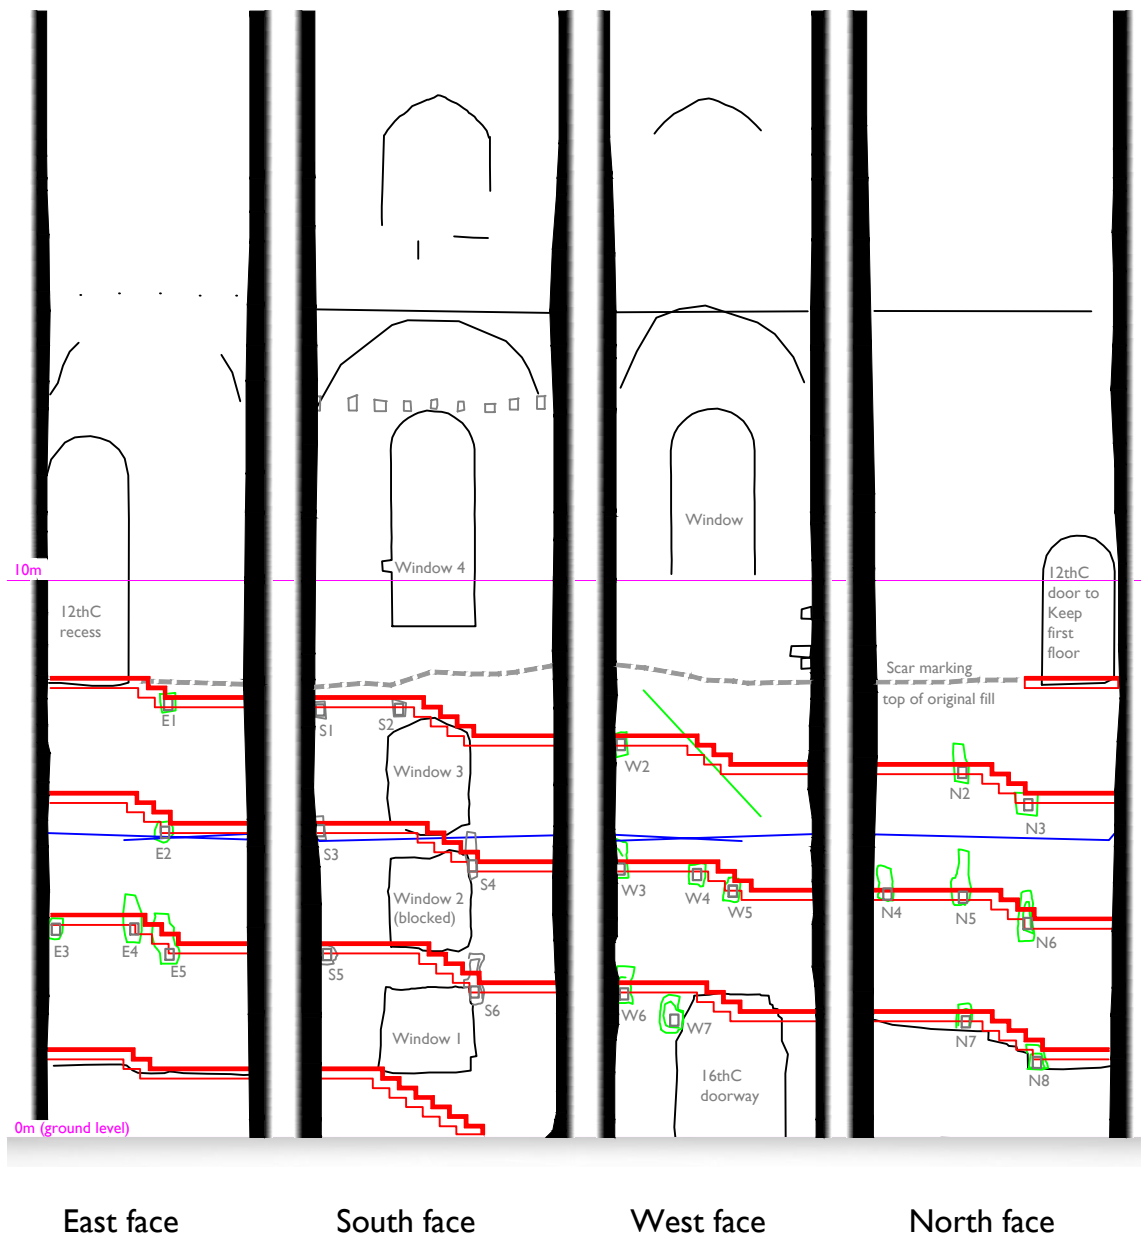
Fig. 2: Kenilworth Castle keep, SW corner stair tower surveyed elevations and stair reconstruction with half top landing

The fieldwork was carried out on 23 & 24 May 2007 by Thomas Cromwell and Dave Fellows, with digital photography by Bill Blake of the Metric Survey team. Valuable interpretive input was provided on site by Dr Morris, who also undertook an unscaled reconstruction that differs from that presented here only in minor details. All beam-slot and window designations in Figs 2&3 are from R K Morris (*pers comm*).

The survey data was set out in AutoCAD. After data processing the four sides of the tower were laid out across a single view so that the beam slots could be compared across each elevation. (see figs 2&3)

The most likely arrangement (see fig 2) starts with a landing in front of the doors in the northeast corner that lead into the first floor main chamber and the recess in the south wall of the keep. There need to be two steps down as the stairs follow the east wall, turning clockwise around the tower as it descends. Steps down are then located at the midpoint of each wall, in a pattern of three steps each on the east and west faces, four on the south face, and a mix of three and four on the north face. The final descent is a long flight of six steps along the south face.

The width of the stair is not certain, but if the position of the steps in the centre of the walls is indicative of the space between the landings then these could have been about five feet (1.55m) wide, leaving a rectangular “light well” measuring about $1\frac{1}{2}\times 3$ feet (0.5m x 1m). This would assume a structure built around four timber uprights, each measuring perhaps 4 or 6 inches square. If so, then the steps at the base of the staircase had to follow the south wall rather than project out centrally to meet the door in the west wall. The three windows on the south wall (including the middle one which is now blocked) are spaced perfectly to provide light to each lift of stairs.

Head-room averages at just over $6\frac{1}{2}$ feet (or 2 metres), except at the first quarter-turn under the landing at the top (in the northeast corner), where the stairs have only 6 feet (1.8m) of clearance.

In the southwest corner, where the lowest run of stairs pass across the door in the west wall, there are two slots at the south end of the west wall that suggest the steps down were offset to the left of the doorway. If so, the steps would have had to be built on the corner rather than as a straight flight, which is unusual compared to the rest of the structure. It is equally possible that the steps were in the middle (to match the rest), and that the beam slots are simply missing with the robbed-out doorway, so this option is shown in the reconstructions.

At the lowest run on the north side the evidence suggests a flight of four steps instead of three as seen above, and the projecting stonework then limits the lowest flight on the east wall to only two steps. If however the north side had only three steps, the remaining step could be moved around to the east side for symmetry.

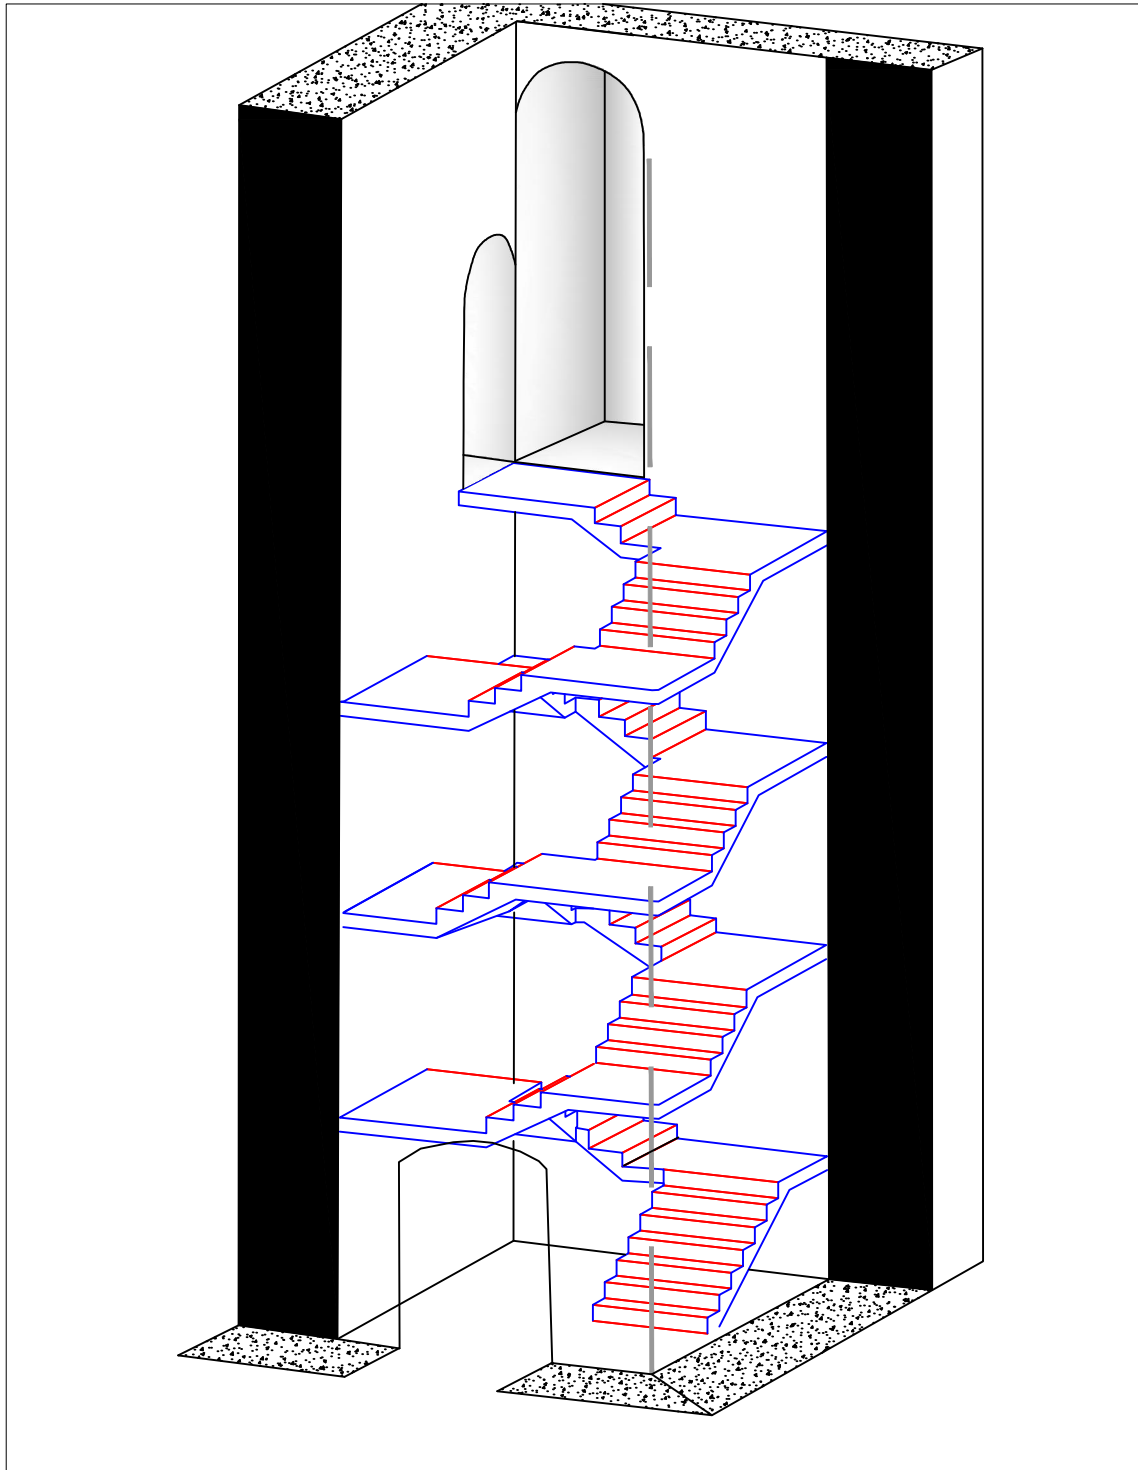
Fig 4. Isometric cut-away of stair tower viewed from the southwest, showing possible stair arrangement. Bannisters and supports omitted for clarity. Note that door at top is on the left - the archway on the right is a deep niche with solid back wall.
