RESEARCH REPORT SERIES no. 26-2012

HAILES ABBEY, STANWAY, GLOUCESTERSHIRE HAILES ABBEY CULVERT EVALUATION ASSESSMENT REPORT

Hailes Abbey Culvert Evaluation Assessment Report

Compiled by Andrew Lowerre

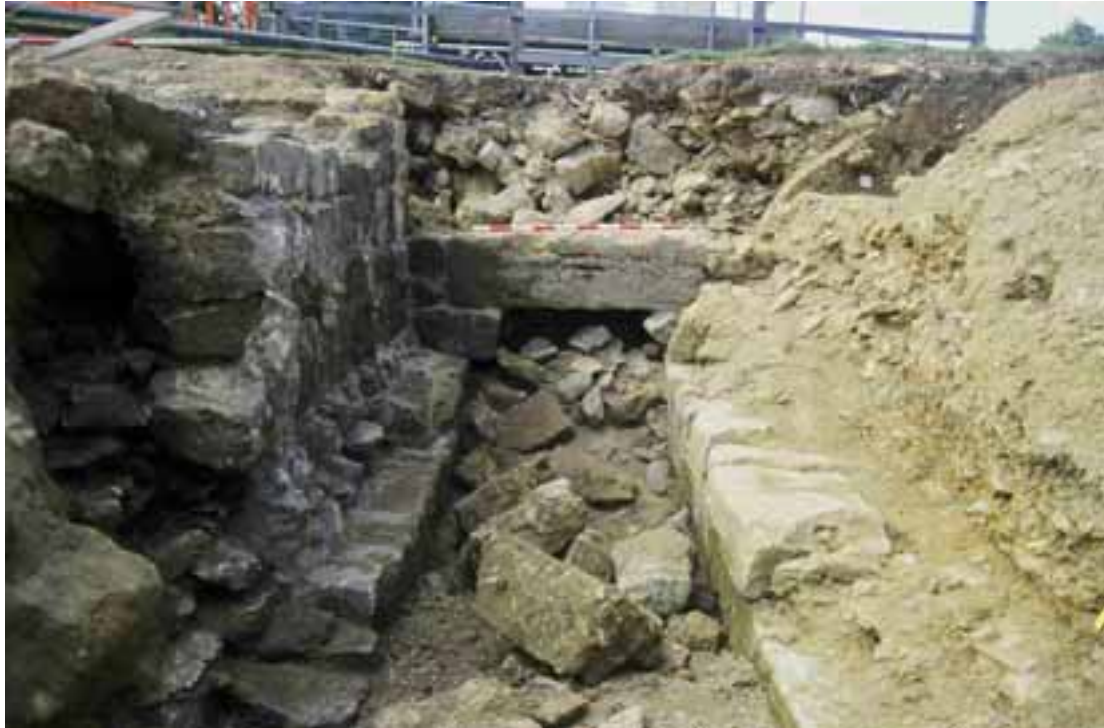
Figure 7: Excavated culvert (looking north-west), showing culvert walls [1052] (left) and [1051] (right), with re-pointed section of culvert wall [1053] on the left; modern rubble fill [1001] is in the centre (photo by D Stirk)

Facing stones for the south side of the culvert (context [1052]) were missing from that part of the wall south-east of the re-pointed section. The fact that the rubble core was

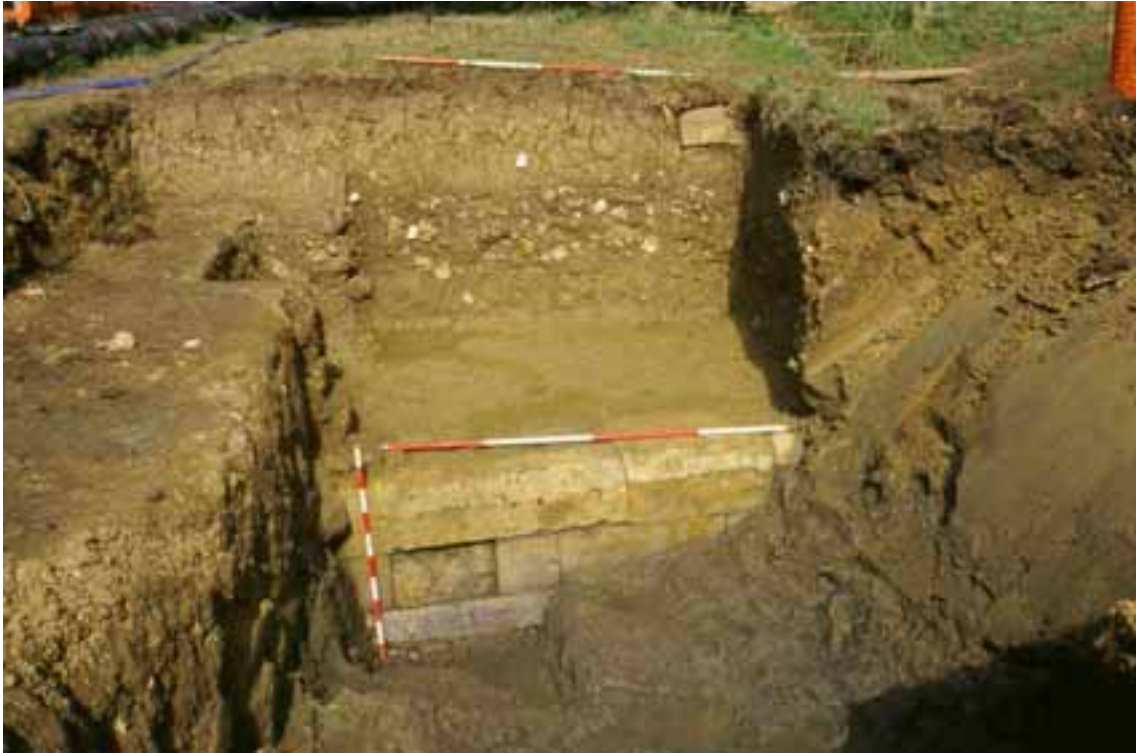
Figure 11: Contexts [4032] (masonry) and [4007] (soil bank) (looking north)

Four courses of masonry, context [4032], were exposed during the excavation of the first test pit in Trench D, aligned north-east to south-west. The top of the masonry lay at 102.13mOD, about 1.4m below the modern ground surface. The exposed portion of the wall consisted of alternating chamfered and vertically faced courses. The lowest course of this wall was not seen. All the blocks showed signs of chisel dressing, and some were stained by the leaching of iron in the ground water. It is possible that there may have been one or more courses of masonry above those seen during excavation, but which have been robbed away. Context [4032] appears to be the masonry front or revetment to a dam and is almost certainly medieval in date (see Figure 10 and Figure 11).

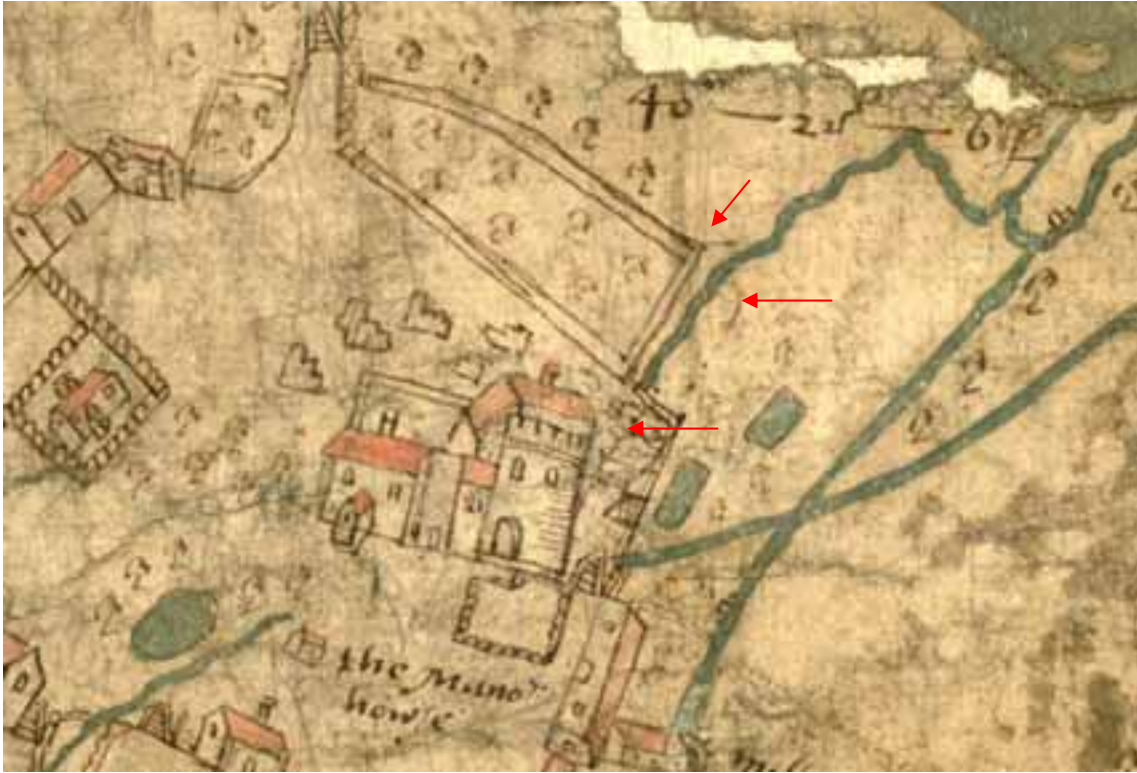
Figure 13: Detail from Treswell's 1587 map (MF/1/59, The National Archives UK), showing possible outline of former pond and line of culvert. North is to the left of the image

Trench B seems to be located directly over the south-east corner of the walled enclosure shown on the 1587 map (see Figure 13). The dry-stone walls noted above were probably flattened once Hailes was abandoned as a manor house. The rubble from wall [2018],

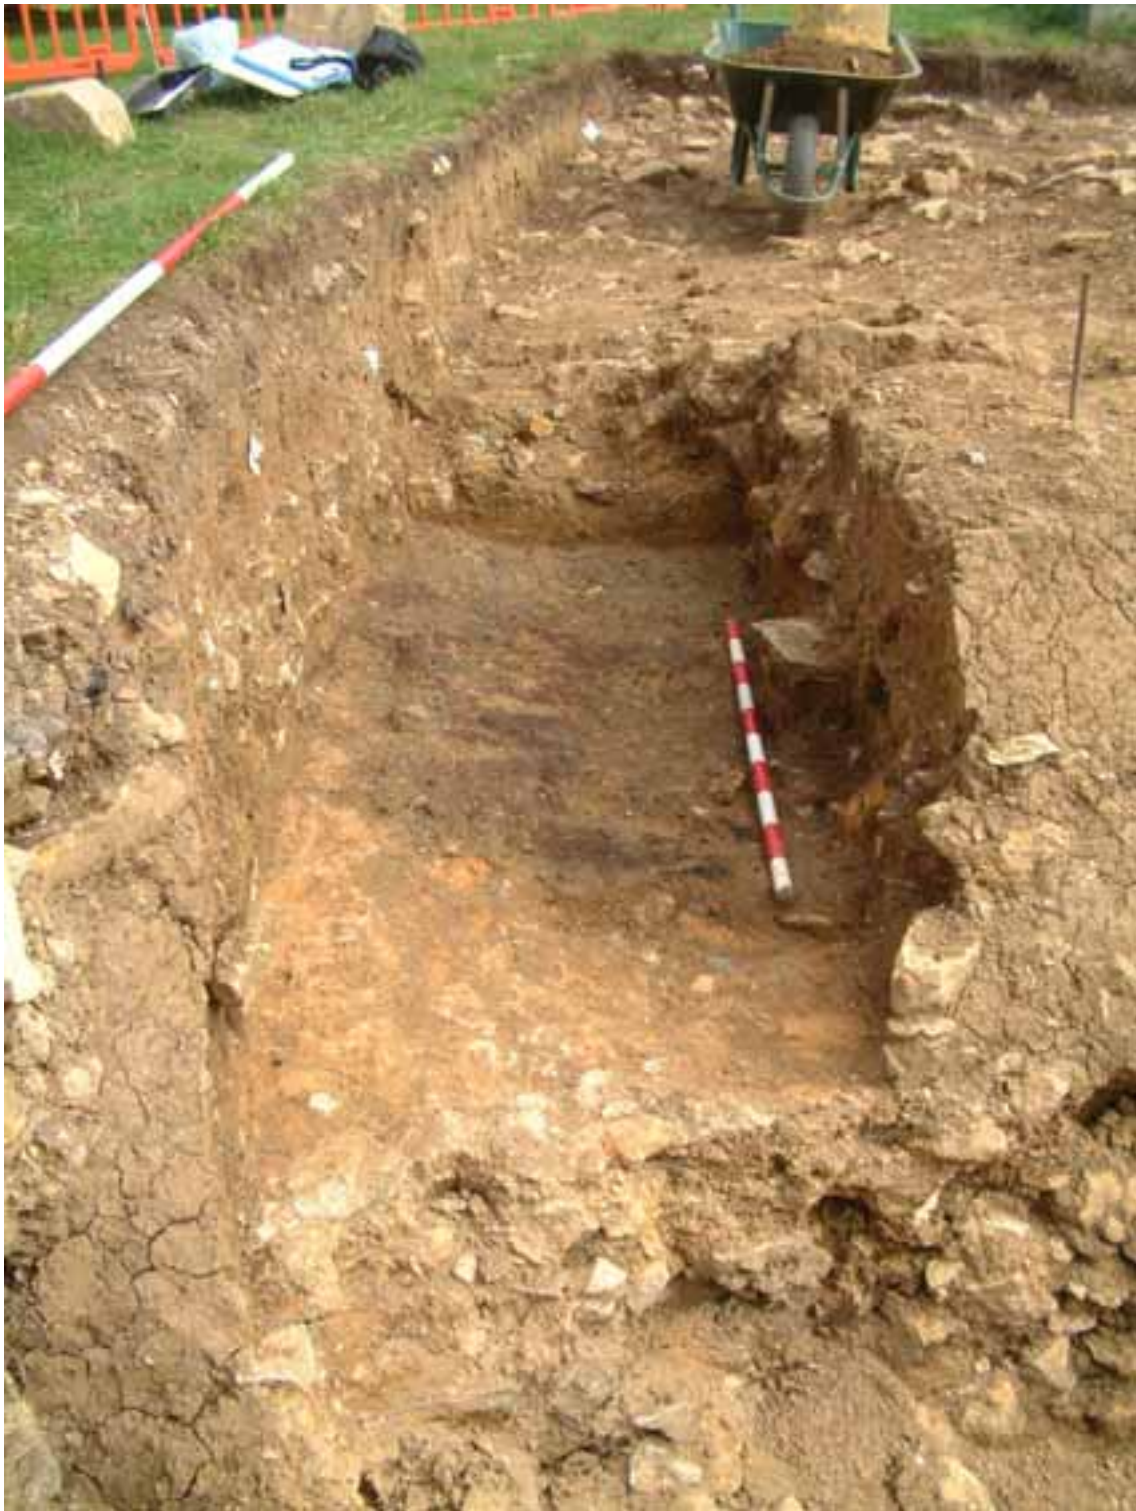
Figure 16: Context [1034] (darker soil) (looking north-east) (photo by D Stirk)

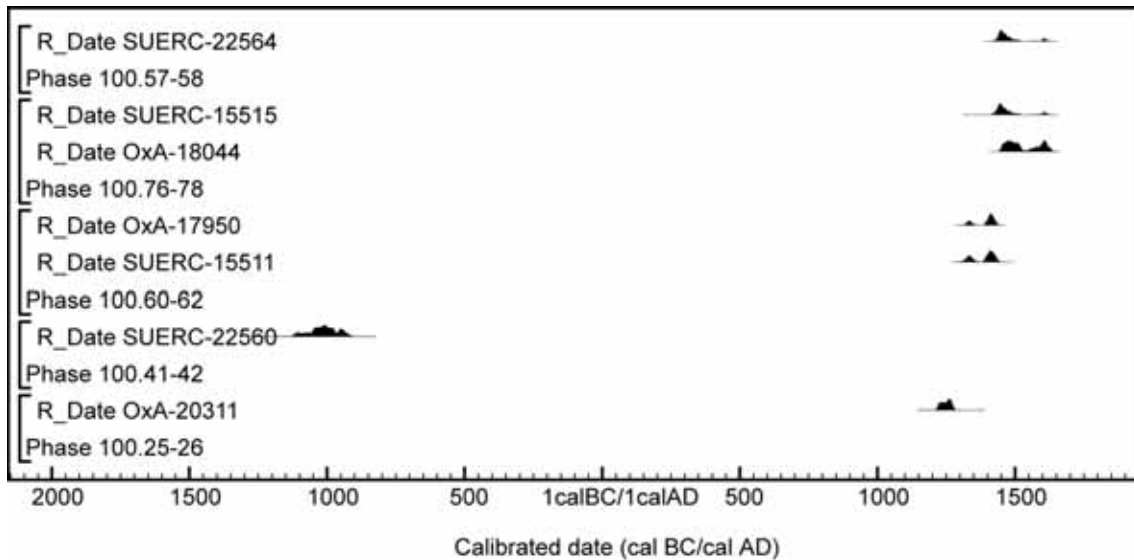
Figure 19: Calibration by the probability method (Stuiver and Reimer 1993) of radiocarbon results. The height of each distribution is proportional to the probability that the sample is of the corresponding calendar date (prepared by J Meadows)

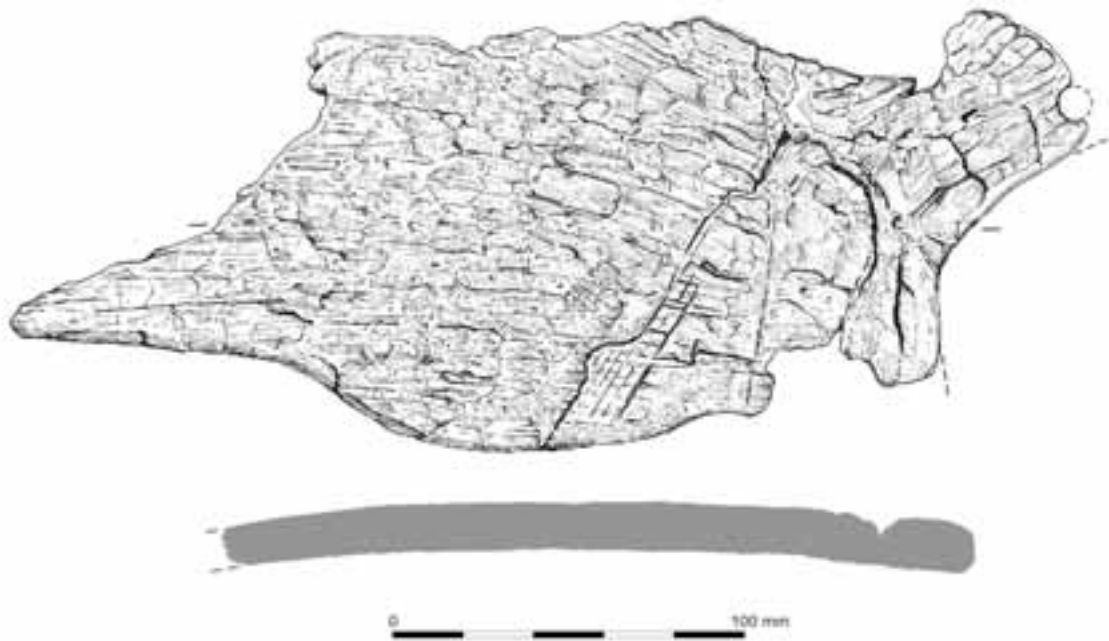
Figure 21: Wood fragment, Small Find 576, after conservation (drawn by C Evans)

The object is a wooden plank, 310mm in length, 100-125mm in width and 15-32mm high, recovered from context [4012]. There are 'cut-marks' visible, as well as one treenail or wooden peg-nail hole (see Figure 21). One possible interpretation is that the object is a fragment or repair patch 'tingle' (Allen *et al*/2005, 293) of clinker-built boat planking, re-used as part of a water control mechanism between the pond and culvert.

All the edges of the fragment have been substantially altered by decay although one face survives with only moderate weathering and is shown in Figure 21. The fragment is c 0.31m long by c 100-125mm wide and 15-32mm thick. The grain and macroscopic character shown that it is tangentially faced, rather knotty and of one of our two oaks or a hybrid. The parent tree was fairly fast-grown which is typical of much late medieval timber. At first, from a view of the drawing it looked as if the opposed sloping marks on the best preserved face were those left by the later medieval practice of see-sawing (Goodburn 1992, 115). However, on close examination the saw marks were seen to be fine cut marks such as would have been left by using the plank fragment as a cutting board. Another explanation might have been the use of the fragment as a support to hew another timber on in a carpenter's yard. The thin straight marks could also have been left by a broad axe.

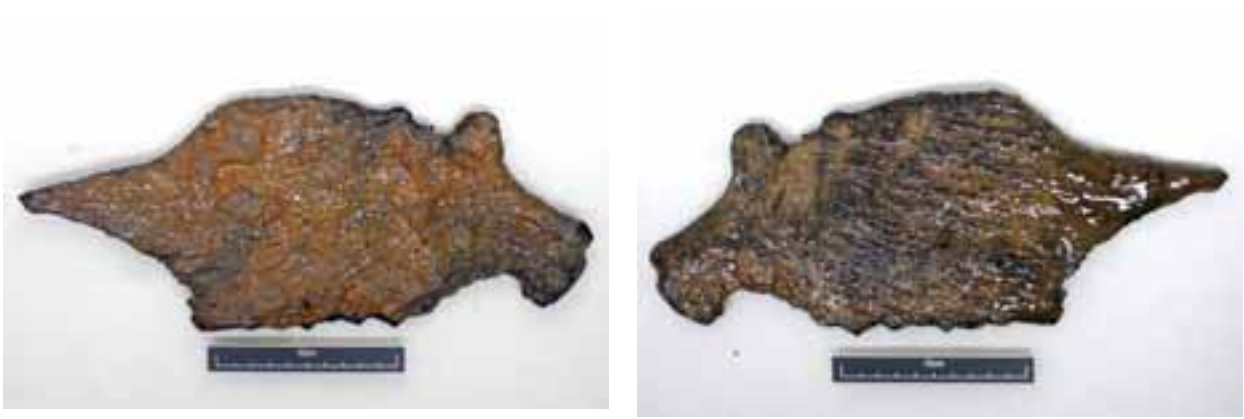
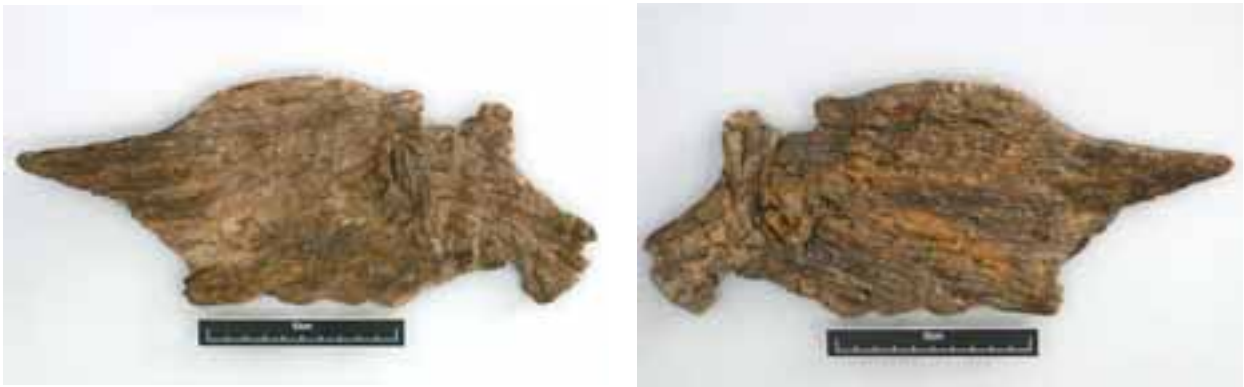
Figure 24: Small Find 576 before and after conservation treatment (photos by K Graham)

SF576 was recommended for remedial conservation, ie, stabilisation prior to deposition. Following an assessment by Sandra Rowntree and preliminary illustration by Chris Evans, the wood was conserved in 2011 as part of a waterlogged wood programme being undertaken by the Archaeological Conservation Team. The conservation involved a two-stage pre-treatment with Polyethylene Glycol (PEG) and freeze drying (see Appendix IV).

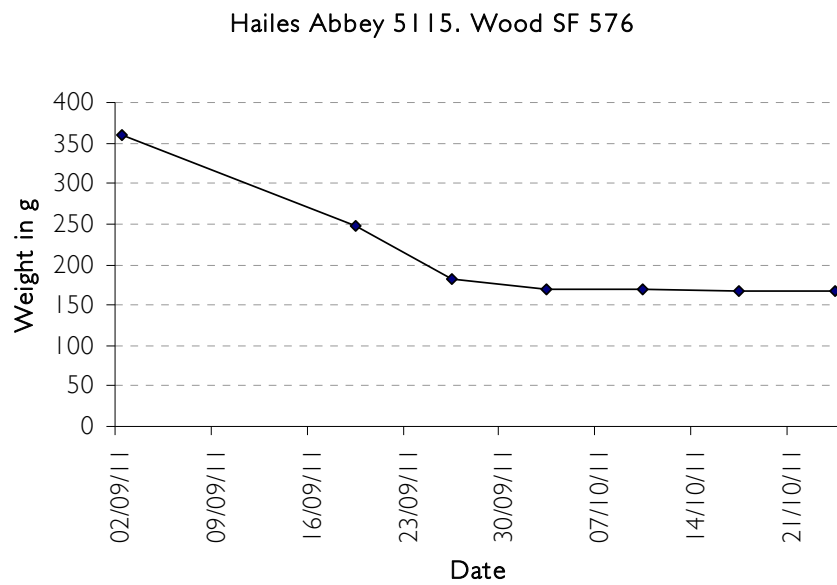
Figure 25: Drying graph for conservation treatment of Small Find 576
