THE OLD MANOR HOUSE, ROSEBERY ROAD, MANNINGHAM, BRADFORD, WEST YORKSHIRE AN HISTORICAL AND ARCHITECTURAL SURVEY

HISTORIC BUILDINGS REPORT

Allison Borden and Colum Giles

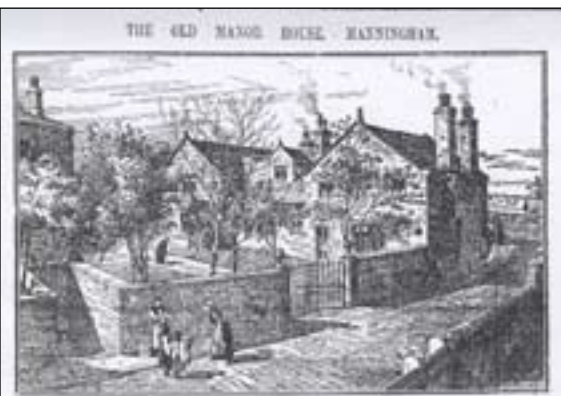
Fig 3: 1889 sketch

Important visual evidence for the form of the house before major alterations of the late 19th century is provided by a map of 1878 and by a sketch published in the *Illustrated Weekly Telegraph* in 1889.¹³ The 1878 map (Fig 2) shows the plan of the house as a range lying on the west side of Skinner Lane, with a slight projection from the south elevation for the west cross wing and additions of minor structures against the west and north sides of the early building. The plan also shows that the house was then subdivided into two dwellings. The 1889 view (Fig 3) is what appears to be an accurate representation of the south elevation of the house, showing it to be of hall-and-cross-

wings form with two-storeyed wings flanking a central hall range, the low eaves of which indicate the former existence of an aisled structure in this part of the building. This drawing will be used in the discussion of the building's evolution.

The 1889 sketch of the house before the loss of its east end (See Figure 3) allows a speculative reconstruction of the plan and function of the east wing. The wing included the main entrance to the house: a door with shallow-arched head lay adjacent to the firewindow of the housebody and doubtless led into a passage behind the reredos of

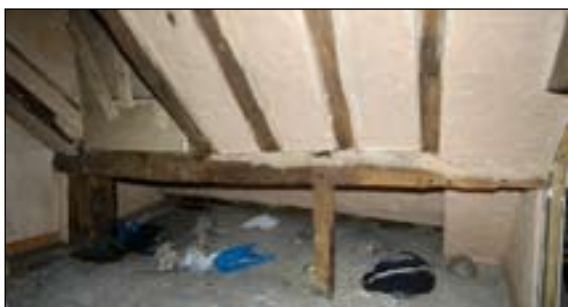
Fig 6: south arcade plate, view from north (DP071430 © English Heritage)

The arcade plates run in an east-west direction, spanning between the later end wall of the house to the east and the 17th-century cross wing to the west. Keyed scarf joints (see sketch detail, Appendix) at the east end of both arcade plates indicate that the plates continued further east, into that part of the building which was lost when Rosebery Road was created (Figs 6, 7). Both plates show a consistent pattern of pegged mortices in their soffit: approximately one-third along their length from the west is a single-pegged

mortice for the tenon of a main post (see Appendix, a, b on plan) demarcating a bay division, and double-pegged mortices, angled on the side towards the post, took braces between post and plate. A further angled mortice at the east end of both plates, close to the scarf joints, shows the position of a brace down to a main post (c, d on plan), lost when the east end of the building was demolished. Each plate shows, on its upper side above the positions of the lost posts, shouldered dovetail seatings for tie-beams (a-b and c-d on plan). Bay divisions in this range were, therefore, marked by main posts and tie-beams, and the plates indicate that within the surviving building there was a full-width bay and, at the west end, a part bay, approximately one-third the length of the full bay.

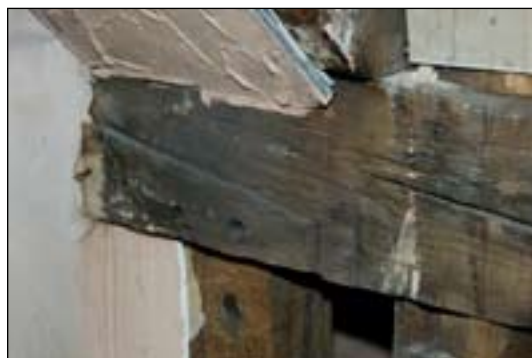
Fig 7: detail of scarf joint in arcade plate (DP071435 © English Heritage)

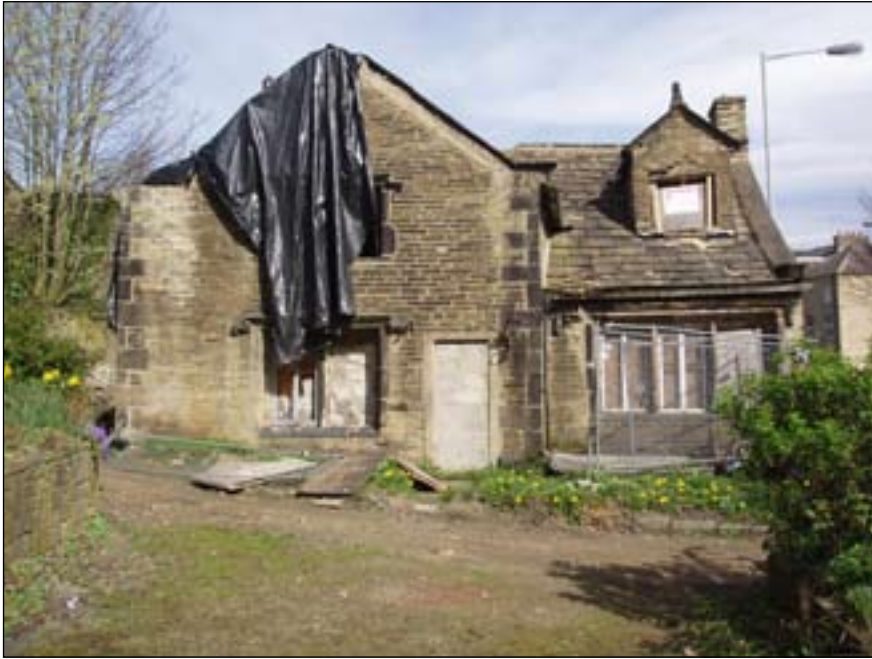
Fig 9: south elevation, with cross wing to left and housebody to right (© English Heritage)

The 17th-century house survives substantially in the area of the housebody and upper cross wing (Fig 9). The cross wing projects slightly from the main range and is gabled to north and south, and the main range has, on the south front, a long stone-slate roof rising from the low eaves above the housebody window. The masonry of both ranges is of shallow-coursed sandstone with gritstone quoins to the corners of the wing, and the wing has shaped kneelers on the main elevation (Fig 10). The bonding of the masonry at the junction of main range and wing indicates that the two parts were rebuilt at the same time. The windows, where they survive in part on the south front, have gritstone surrounds and simple hood moulds. On the south elevation ground-floor windows were

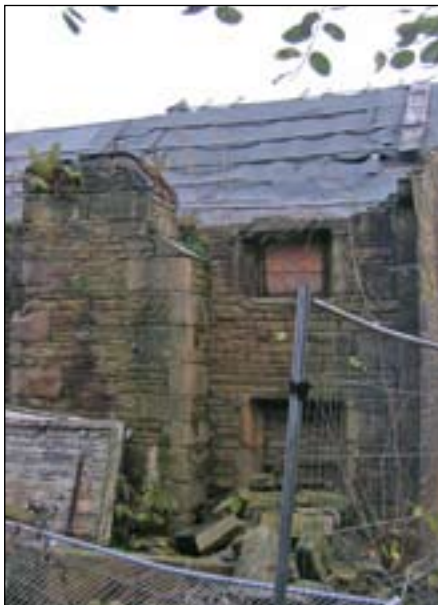
Fig 10: west wing, west wall, showing quoined masonry and external stack (© English Heritage)

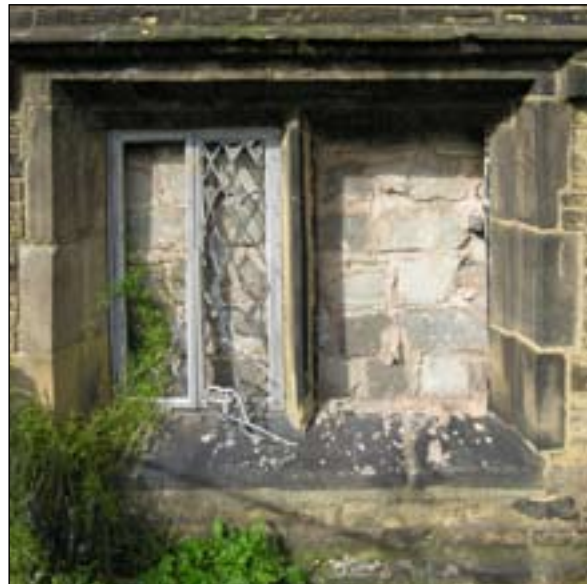
Fig 11: west wing, south wall: formerly mullioned and transomed window (© English Heritage)

mullioned and transomed, but the first floor was lit by simple mullioned windows. The surrounds indicate that mullions and transoms were deeply recessed rather than flush with the wall face (Fig 11).

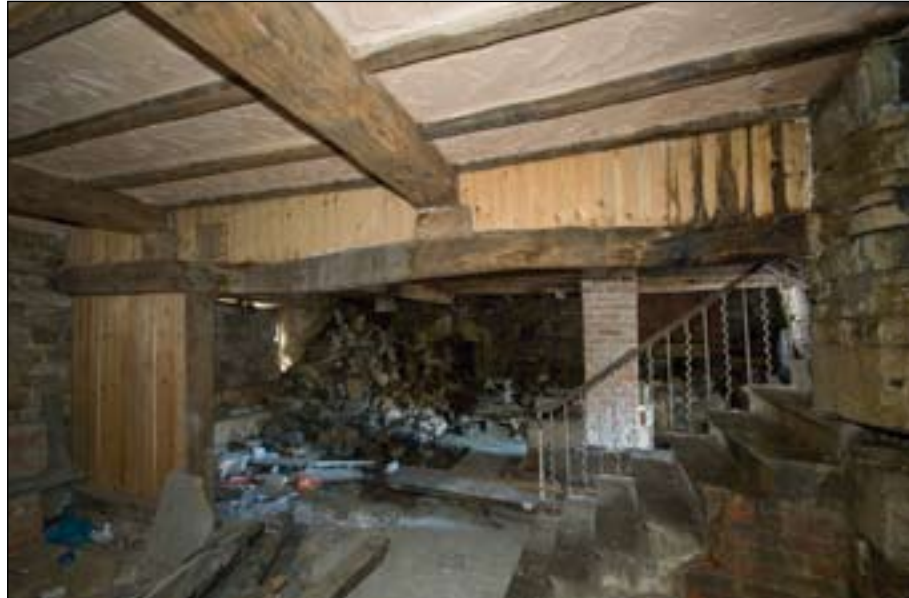
Fig 12: the housebody, view to west into parlour wing (DP071447 © English Heritage)

single-storey room. The ceiling is formed of spine beams, stop-chamfered at their west ends, and plain unchamfered joists (Fig 12). The arcade posts of the aisled structure were removed to clear space, although - certainly to the front, perhaps also at the rear - the area of the former aisle was included as part of the room. Perpetuating the likely layout of the medieval room, the housebody was heated by a fireplace or firehood at its lower (east) end, the fire area being lit by the two-light mullioned and transomed window shown on the 1889 sketch. This end of the room was lost on the truncation of the building when Rosebery Road was created. It is likely that the housebody continued to provide the principal living room of the house, albeit in modernised form, just as it had done in the medieval period: in the absence of an identifiable kitchen elsewhere in the house in its 17th century form, it is probable that the housebody also retained the principal cooking hearth.

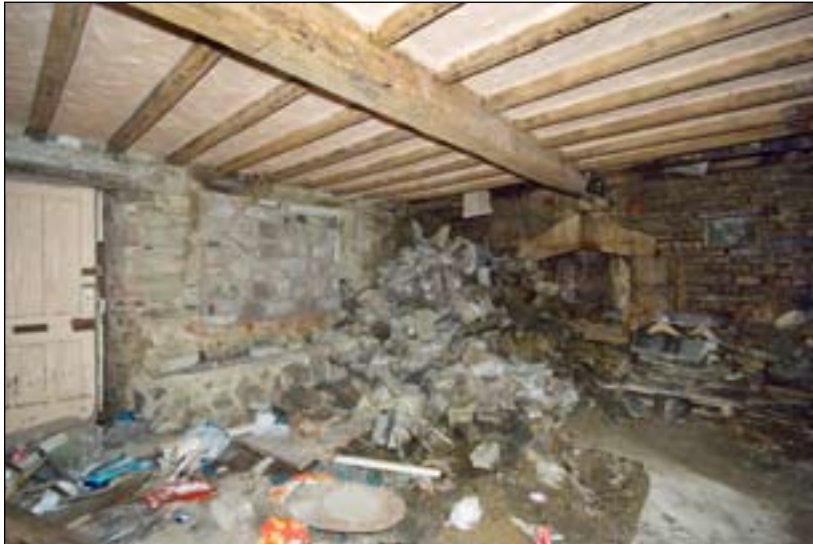
Fig 13: west wing, parlour, showing fireplace on west wall (DP071440 © English Heritage)

on the west wall: the fireplace survives and has a straight-arched head within a massive triangular lintel and a moulded surround over lintel and jambs (Figs 13, 14). The single ceiling beam is stop-chamfered at both ends. It is likely that a timber screen divided the parlour from the northern bay of the wing: a re-set ceiling beam in this area has a groove in its soffit for such a screen and may well have been part of this dividing wall. The northern bay provided a small unheated room to the west and a stair to the east. The western room has received many later modifications but may originally have been a small unheated parlour or service room. Within its western wall is a timber lintel for a wooden-mullioned window (Fig 15), possibly re-set in its present position but if in its original site indicating that the superior fenestration of the south elevation, where ground-floor windows had deeply recessed stone mullions and transoms, was not carried round to the sides and rear of the house. The stair area, in the north-east corner of the wing immediately beside the connecting door to the housebody, was lit by a small rectangular window, now blocked, in the wing's north wall (Fig 16). The original stair has been replaced, but its position, close to the housebody, is a well-established plan feature giving easy access between the main living room and the chambers.

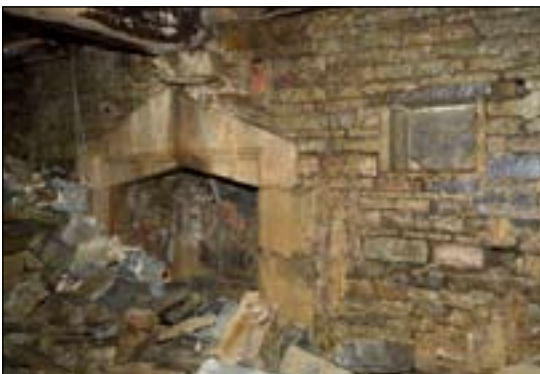
Fig 14: west wing, parlour, detail of fireplace (DP071442 © English Heritage)

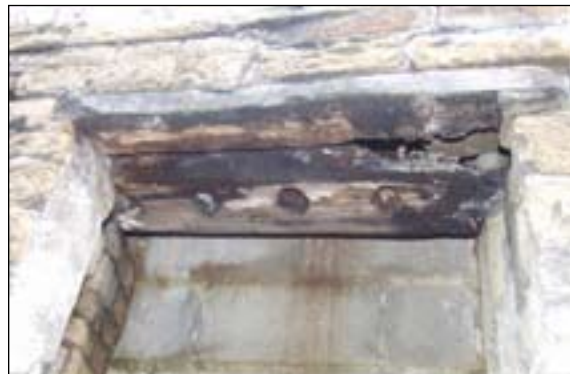
Fig 15: lintel of timber-mullioned window, west cross wing, west wall north end (© English Heritage)

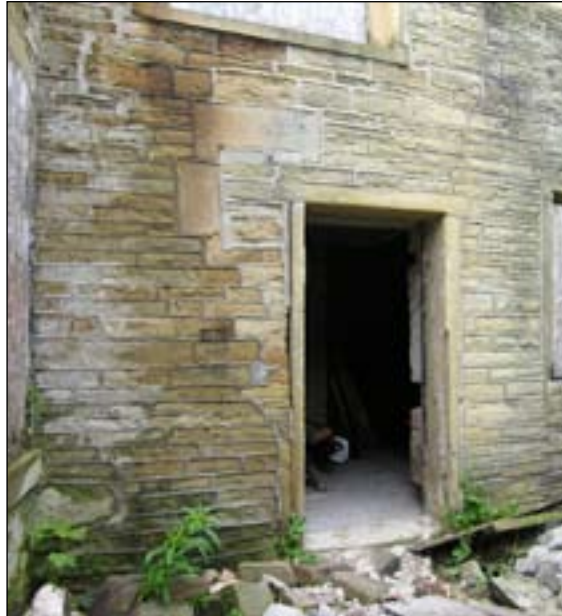
Fig 16: west wing, north wall, blocked raised window for original stair (© English Heritage)

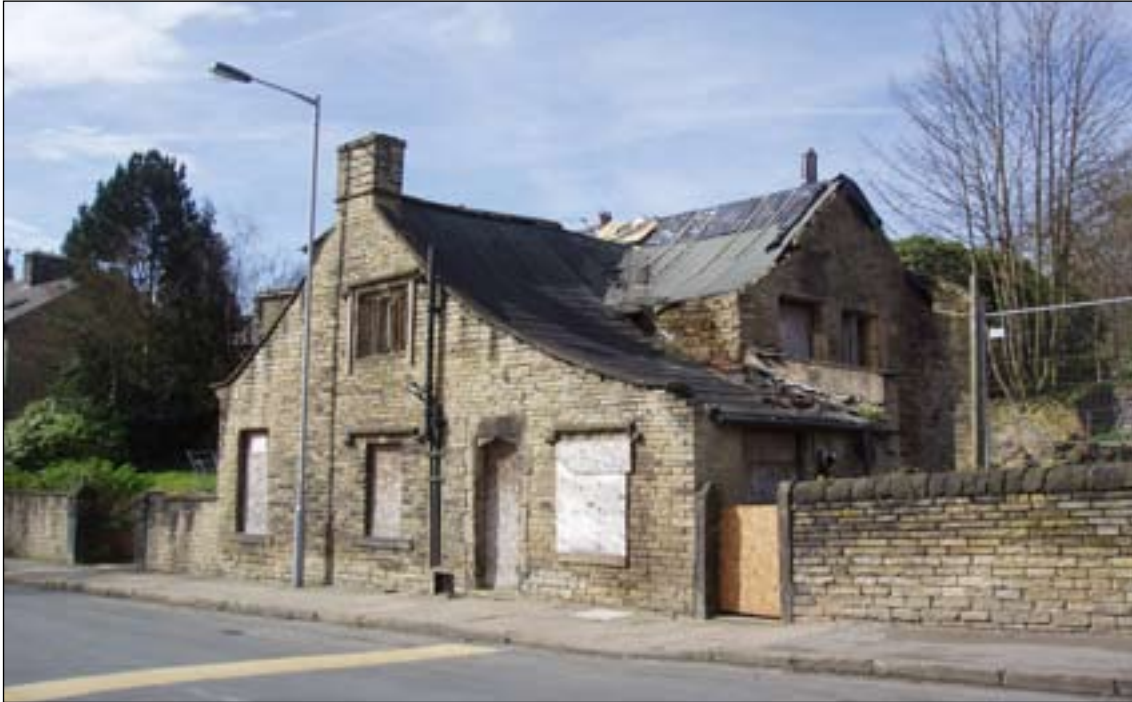
Fig 19: Old Manor House from north-east: the aisled structure of the medieval house was retained in the 17th century rebuilding in the area of the housebody: the roof sweeps down to single-storey height to both north and south (© English Heritage)

in stone. The form of the medieval aisled house was, however, perpetuated in part: despite the removal of the arcade structure, the front aisle was contained within the housebody and the sweeping roof line of the medieval house was retained on both north and south roof slopes in the surviving housebody bay (Fig 19). Because the south wall of the housebody was not raised to two-storey height, the newly-created chamber was contained within what was, effectively, the roof space, akin to an attic. It provided adequate headroom only in the central area and was clearly a room of low status. If a firehood heated the housebody below, the chamber must have been unheated, and may have been used principally as a storeroom, a common use for housebody chambers in local houses. The 1889 sketch, however, suggests that heating was later provided, for the chimney stack serving the central range has two chimney pots, one certainly serving the housebody fireplace and the other probably for a fireplace in the chamber. How the chamber was lit is not clear. A dormer window in the south roof slope provides lighting today, but on the evidence of its stonework this appears to date only from the 19th century (Fig 20). It is likely that it replaced an earlier means of lighting the room. Also unclear is the means of access to the chamber. Present-day access from the west wing is a later contrivance, created by inserting a doorway in the wing's side wall (necessitating the removal of part of the timber wall and the cutting of the wing's wall plate). It is probable, therefore, that the

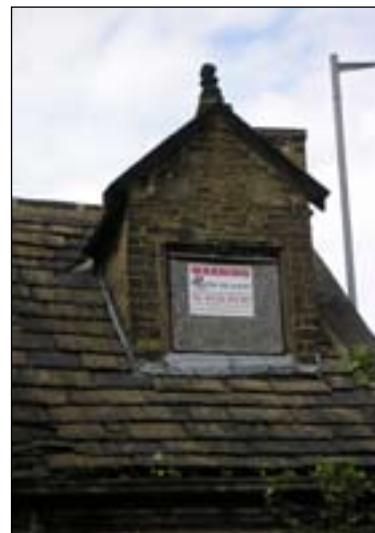
Fig 20: detail of dormer window lighting housebody chamber (© English Heritage)

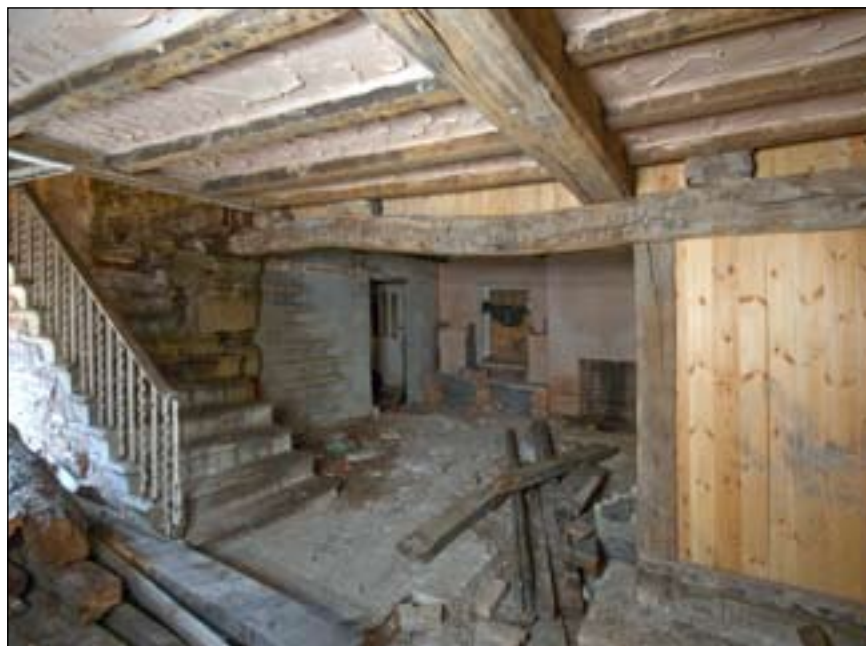
Fig 23: west wing, view to north-east showing inserted stone stair with iron balusters (DP071458 © English Heritage)

a divided dwelling was the replacement of the original stair in the west wing with a larger stair in the same position (Fig 23). A new and larger stair window was inserted in the north wall of the wing, above the earlier smaller window which was blocked at the same time (Fig 24). The stair itself has stone steps with a rounded-nose profile, a rounded handrail, and a balustrade with alternate straight and wavy iron balusters of slender section. The balusters are not convincingly of 19th century date, but the stair itself, and its stair window, are credibly of this date, but later in the century rather than earlier. It is possible that this alteration was made either very late in the period of the house's subdivision, or perhaps even after the loss of the east end of the house, when the reduced Old Manor House may have reverted to single occupation.

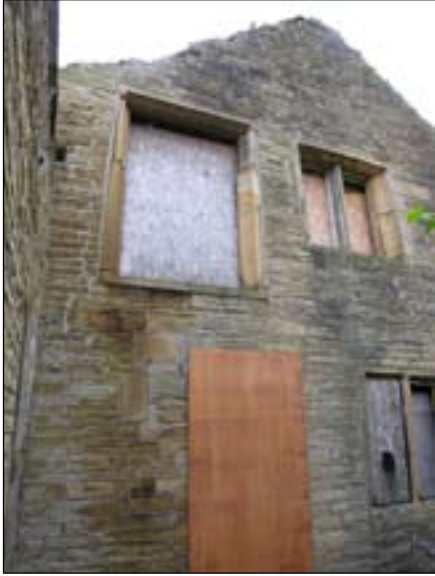
Fig 24: large stair window in west wing, north wall (© English Heritage)

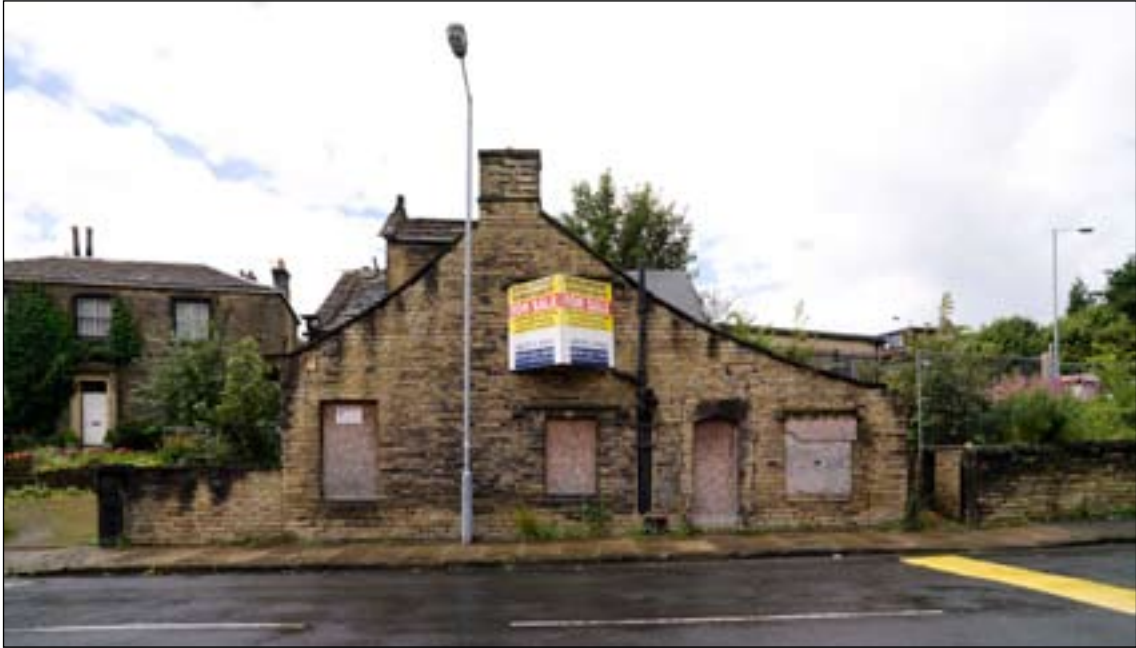
Fig 25: east wall, built on the truncation of the house c.1890 (DP065452 © English Heritage)

The major change to the house in the late 19th century was the loss of its eastern end on the occasion of the widening of Rosebery Road c.1890. The cross wing and part of the housebody range shown on the 1889 sketch were removed at this date. A new east wall was constructed to close the truncated building; the wall includes a re-set 17th-century doorway. The main range retained its aisled form at the rear, but the north wall was rebuilt to provide a larger outshut behind the former housebody (Figs 25, 26). This alteration may have caused the re-positioning at a higher level of the north arcade plate of the medieval structure, but the medieval roof was retained.
