RESEARCH REPORT SERIES no. 40-2012

# CHURCH OF ST PETER, WEST LISS, HAMPSHIRE

## TREE-RING DATING OF TIMBERS

SCIENTIFIC DATING REPORT

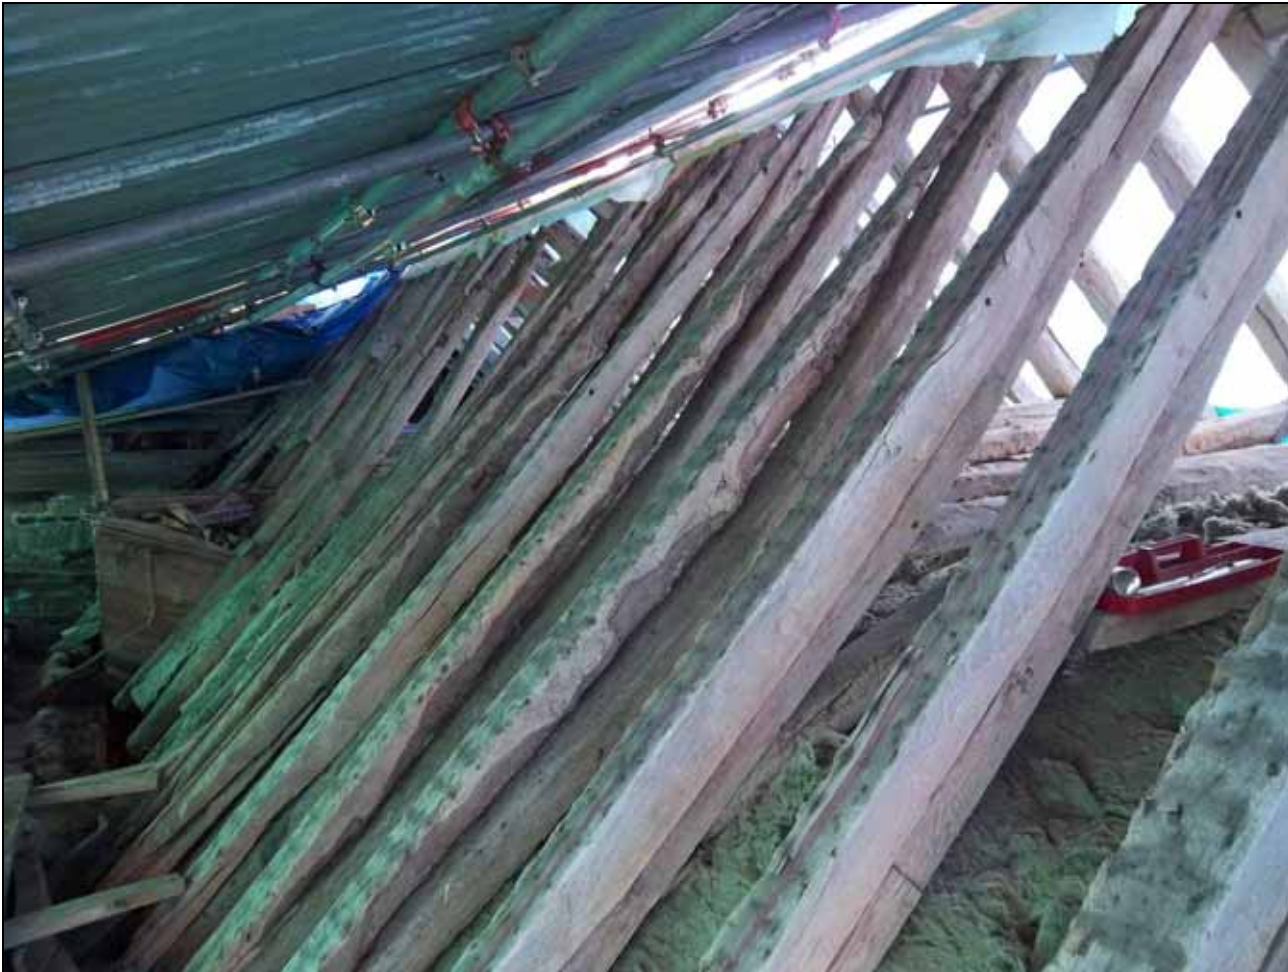
*Figure 4: Nave roof showing the backing rafters (photograph taken from the south-east). Photograph Robert Howard*

The roof consists of 19 frames of common rafters with collars, and arch braces. At some point 'backing rafters' have been attached to the rear of the common rafters on the south side, presumably for strengthening purposes (Fig 4). Some of the timbers are thought to be reused. This roof is thought to date from the early thirteenth century.

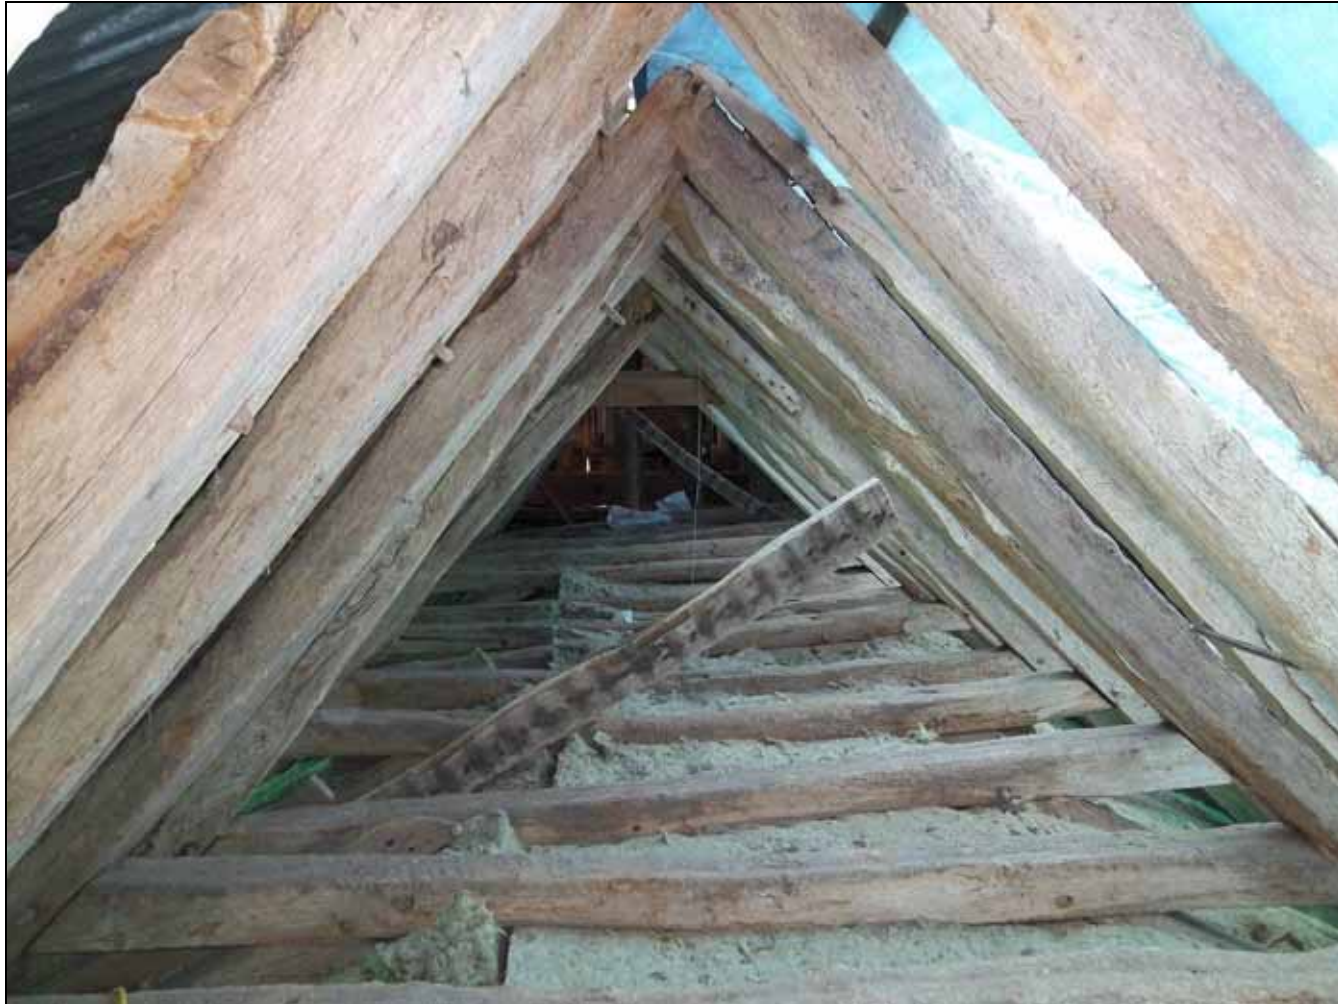
*Figure 5: South aisle roof (photograph taken from the west). Photograph Robert Howard*

The construction of this roof is similar to that of the nave, with each of the 26 frames again consisting of common rafters, collars, and arch braces (Fig 5). Some of these rafters also have the strengthening 'backing rafters and higher 'modern' collars. Some of the rafters show signs of reuse in the form of empty mortices. This roof is believed to be late-thirteenth century in date.

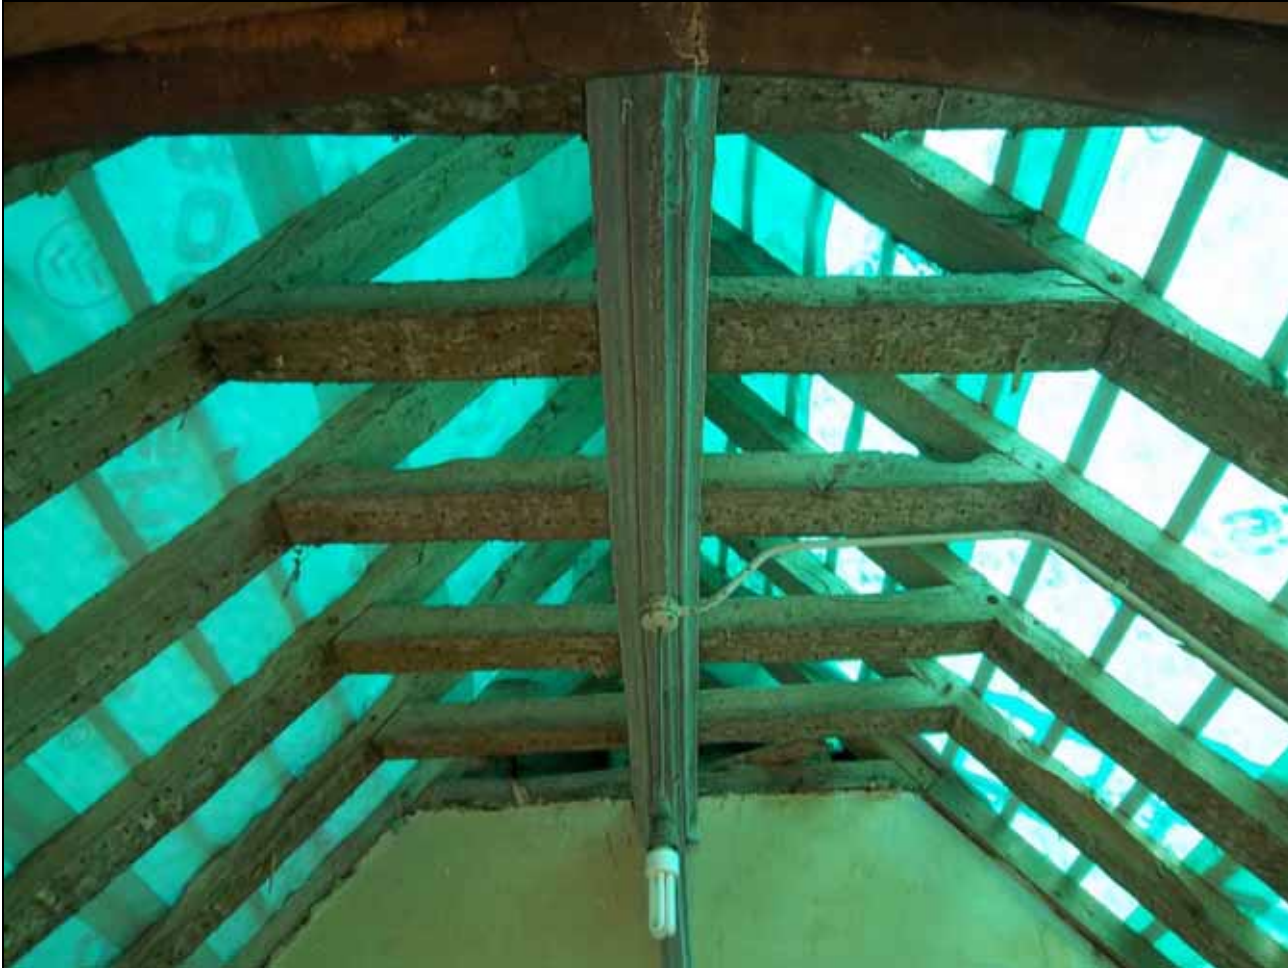
*Figure 6: Porch roof (photograph taken from the south). Photograph Robert Howard*

This very simple roof has six frames of common rafters and collars. The seventh (most northernmost frame) also has a tiebeam with empty mortices from which arch braces may have once run to now removed posts (Fig 6). The south porch has an inscribed date of '1639' commemorating its gift by Henry James.

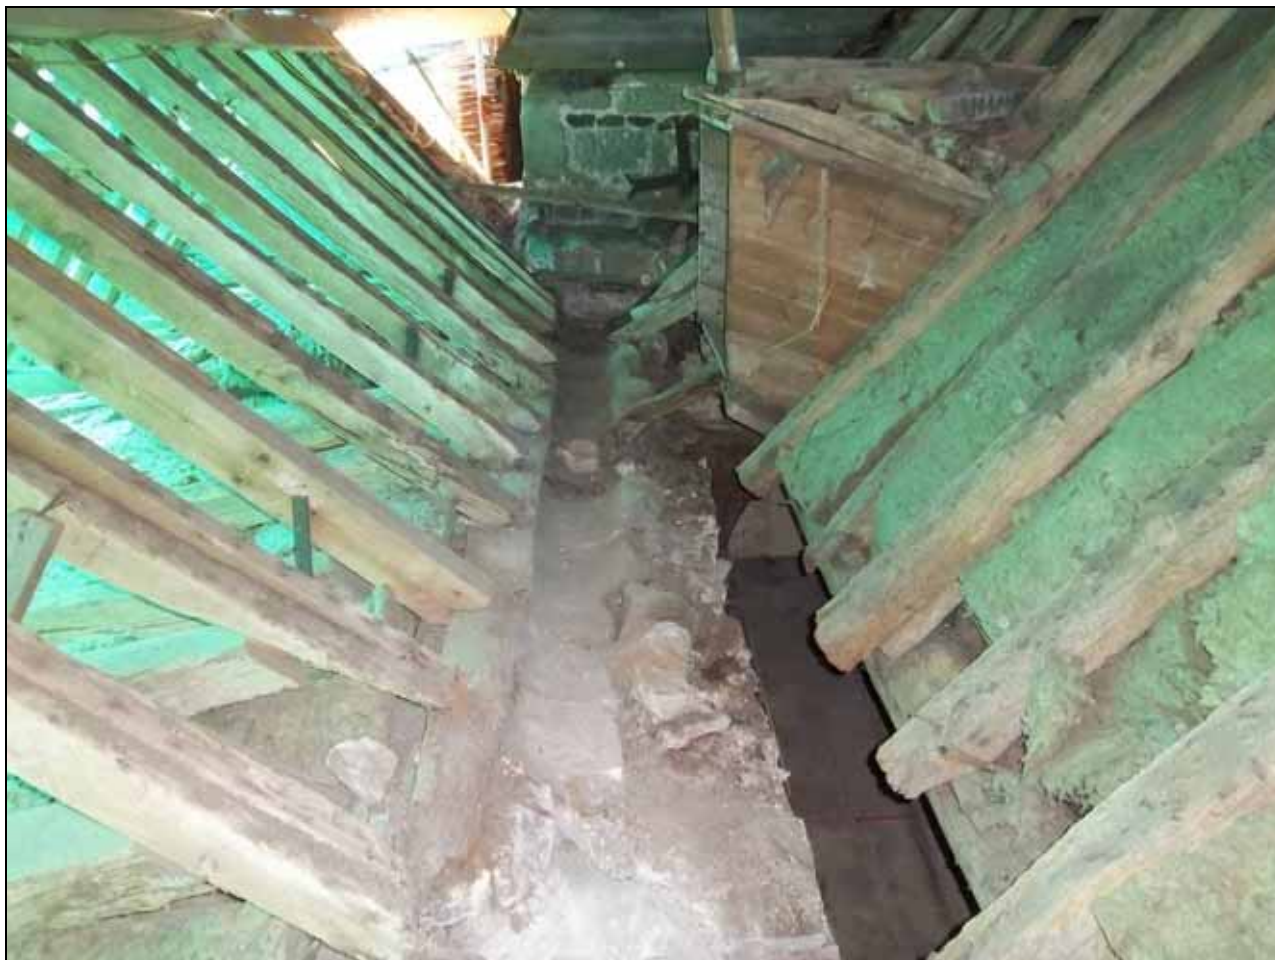
*Figure 7: Stone gully between south aisle (to left) and nave (to right) roofs. Photograph Robert Howard*

The timber which supported the valley gutter between the nave and south aisle roofs has been dated to AD 1581–1606 and is hence clearly broadly coeval with reused collars from the nave roof.

By association with the south aisle roof the unusual stone valley gutter it is suggested that this is pre *c* AD 1616 but it is not possible to conjecture how much earlier this could have been due to the lack of significantly earlier timbers being identified in either the nave or south-aisle roofs.

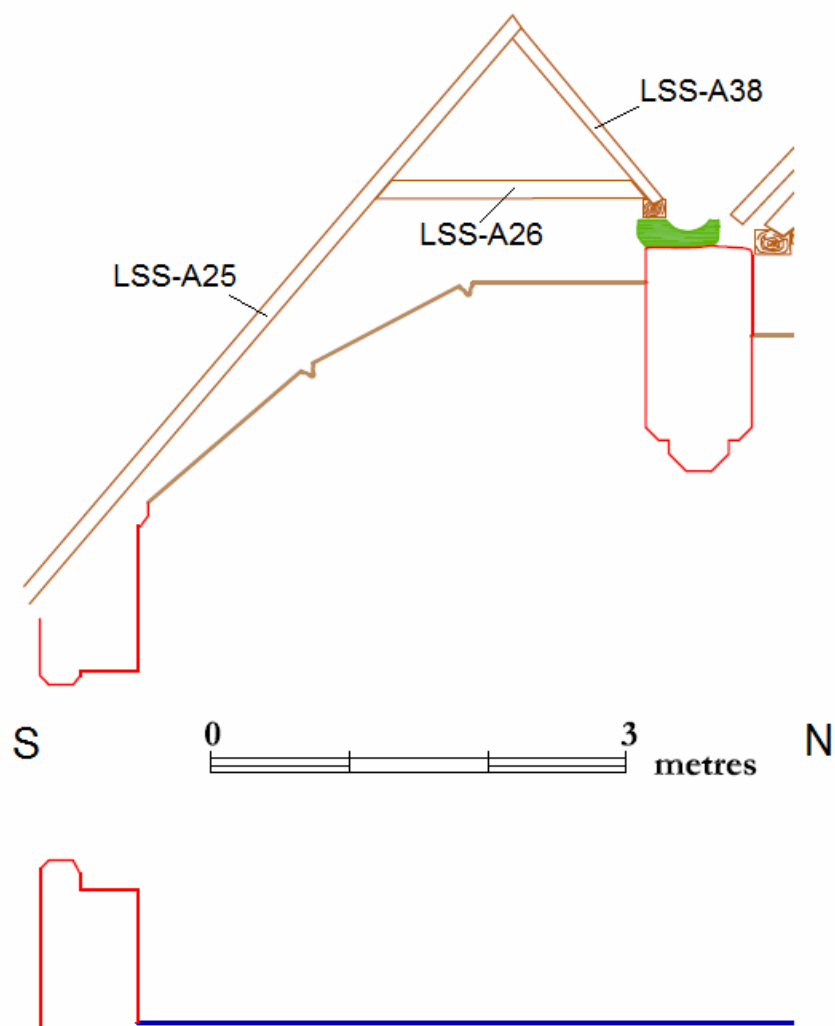
Figure 25: South aisle; frame 5, showing the location of samples LSS-A25, LSS-A26, and LSS-A38 (John Crook)

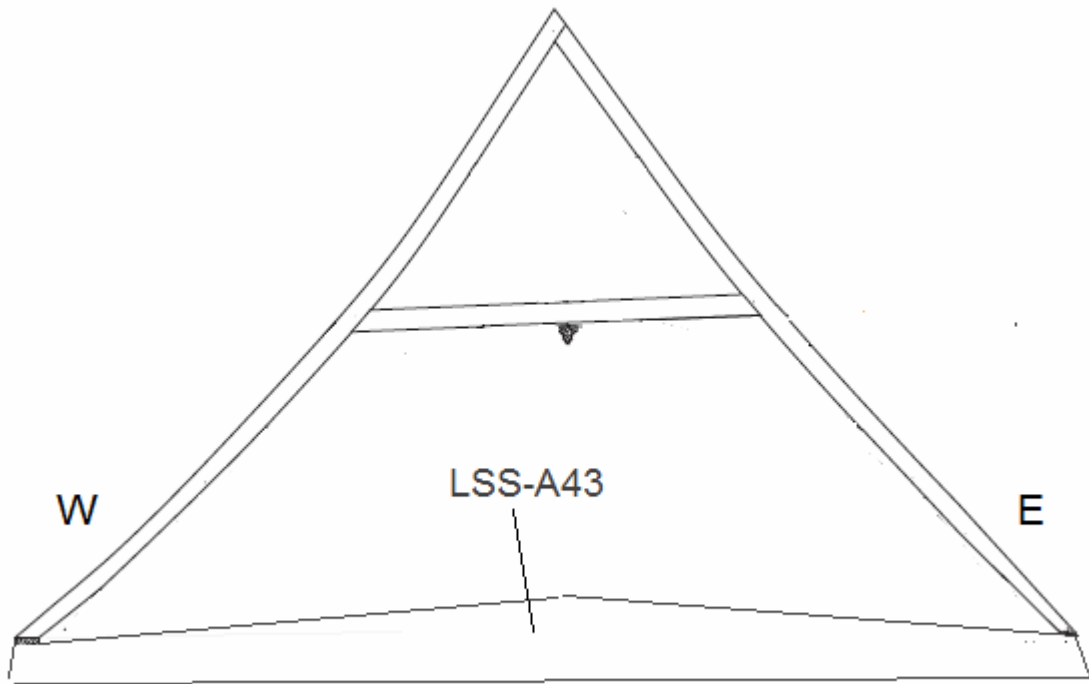
Figure 38: Porch; frame 1, showing the location of sample LSS-A43

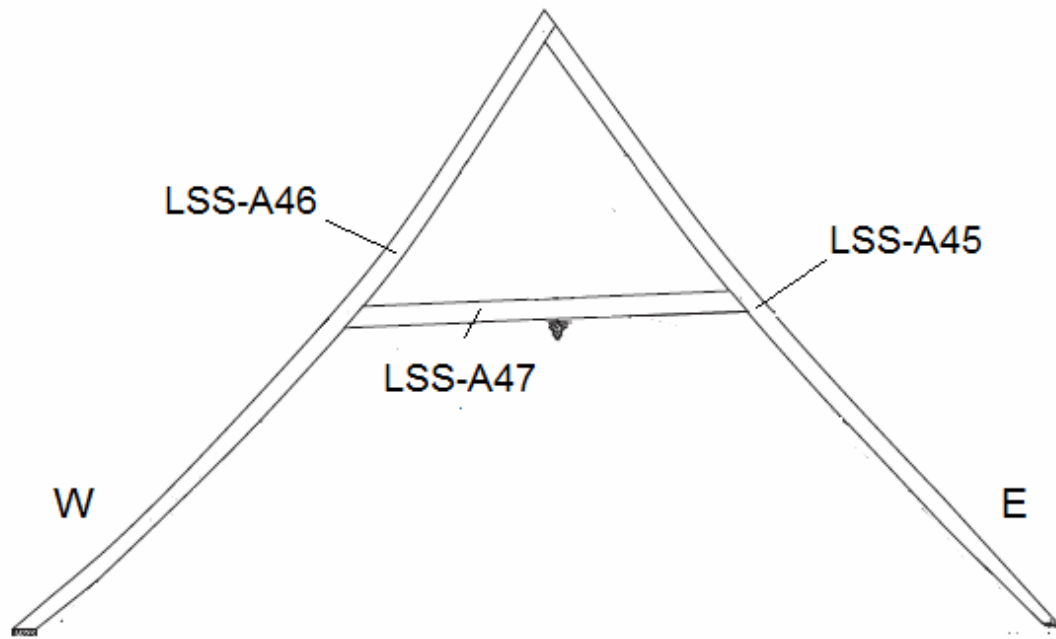
Figure 40: Porch; frame 3, showing the location of samples LSS-A45–7

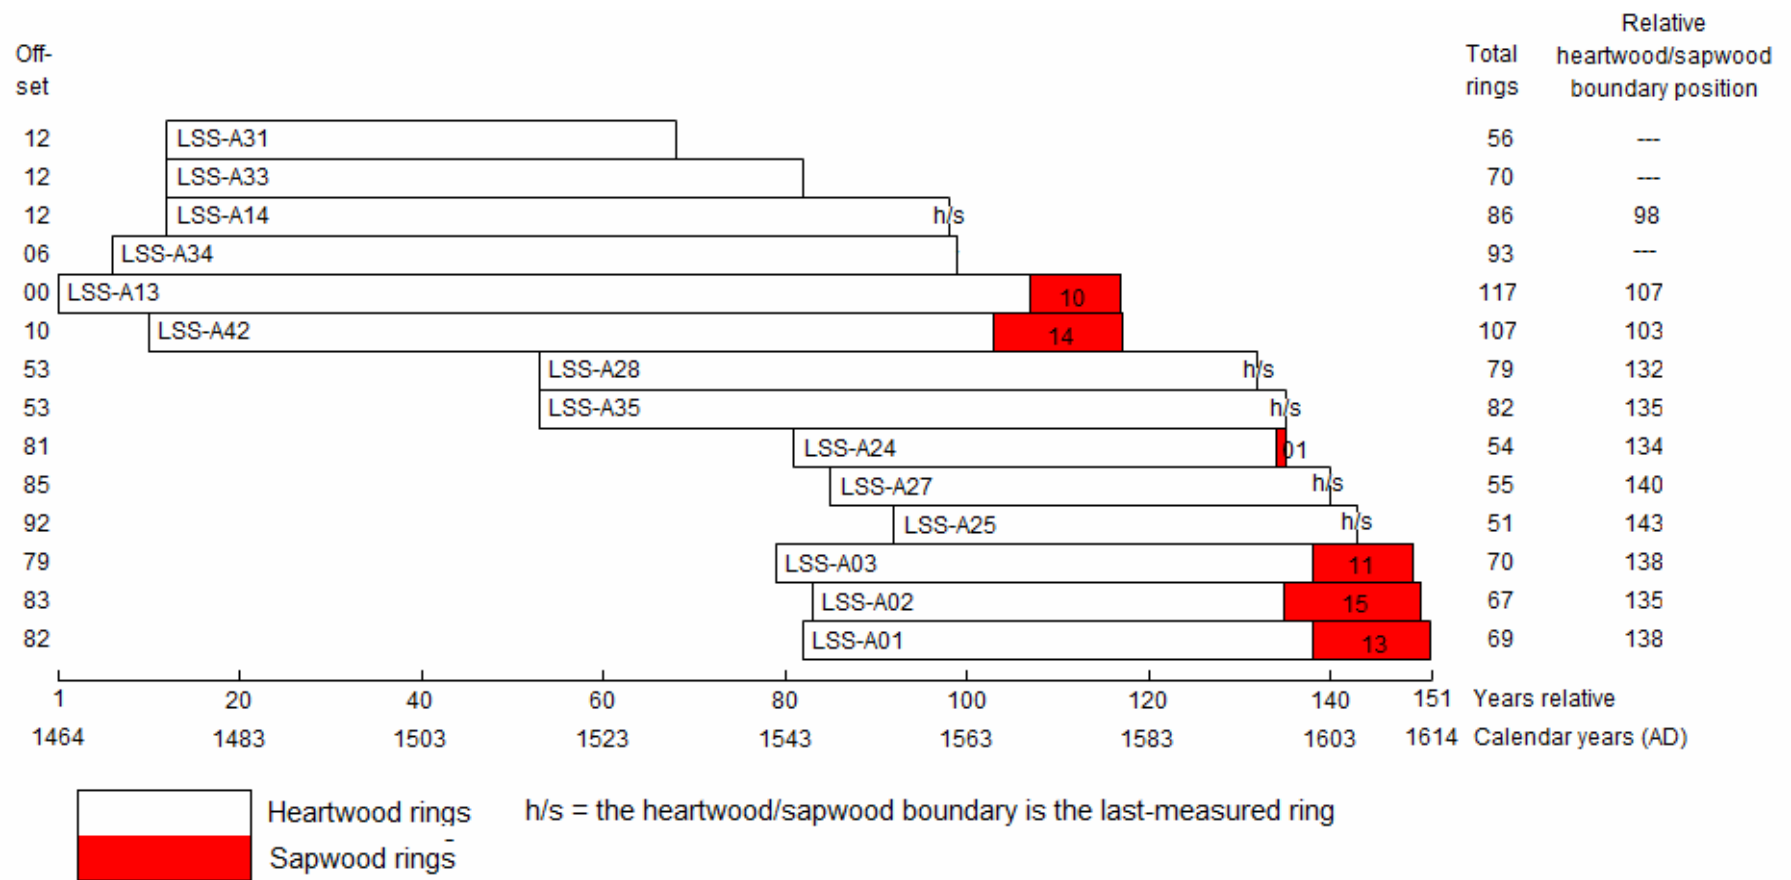
Figure 44: Bar diagram of samples in site sequence LSSASQ01

Firstly, 14 samples matched each other and were combined at the relevant offset positions to form LSSASQ01, a site sequence of 151 rings (Fig 44). This site sequence was compared against a series of relevant reference chronologies where it was found to match consistently and securely at a first-ring date of AD 1464 and a last-measured ring date of AD 1614. The evidence for this dating is given in Table 2.

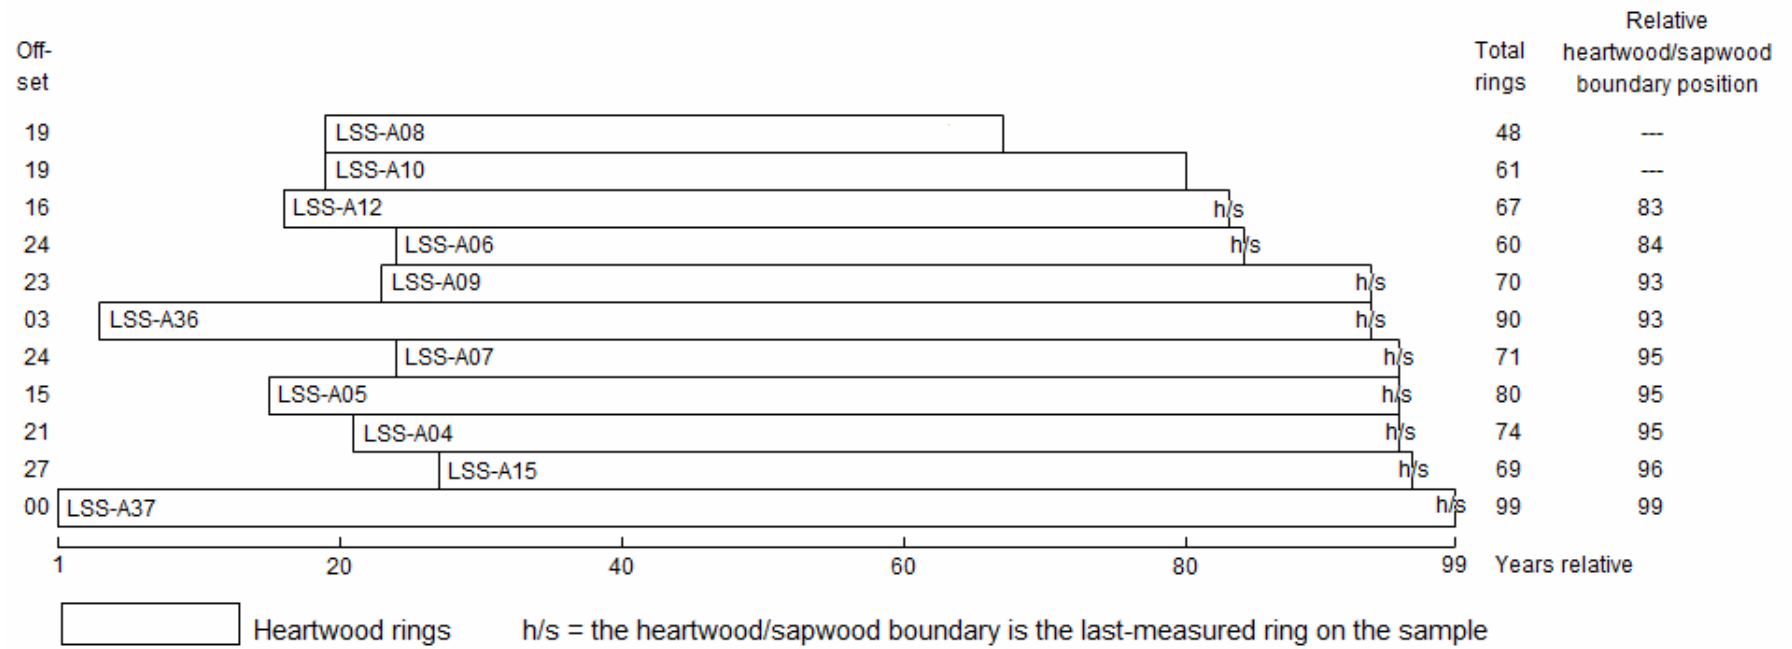
Figure 45: Bar diagram of samples in undated site sequence LSSASQ02

A further 11 samples matched each other and were combined at the relevant offset positions to form LSSASQ02, a site sequence of 99 rings (Fig 45). This site sequence was compared against a series of relevant reference chronologies for oak but no conclusive matching could be found and it therefore remains undated.

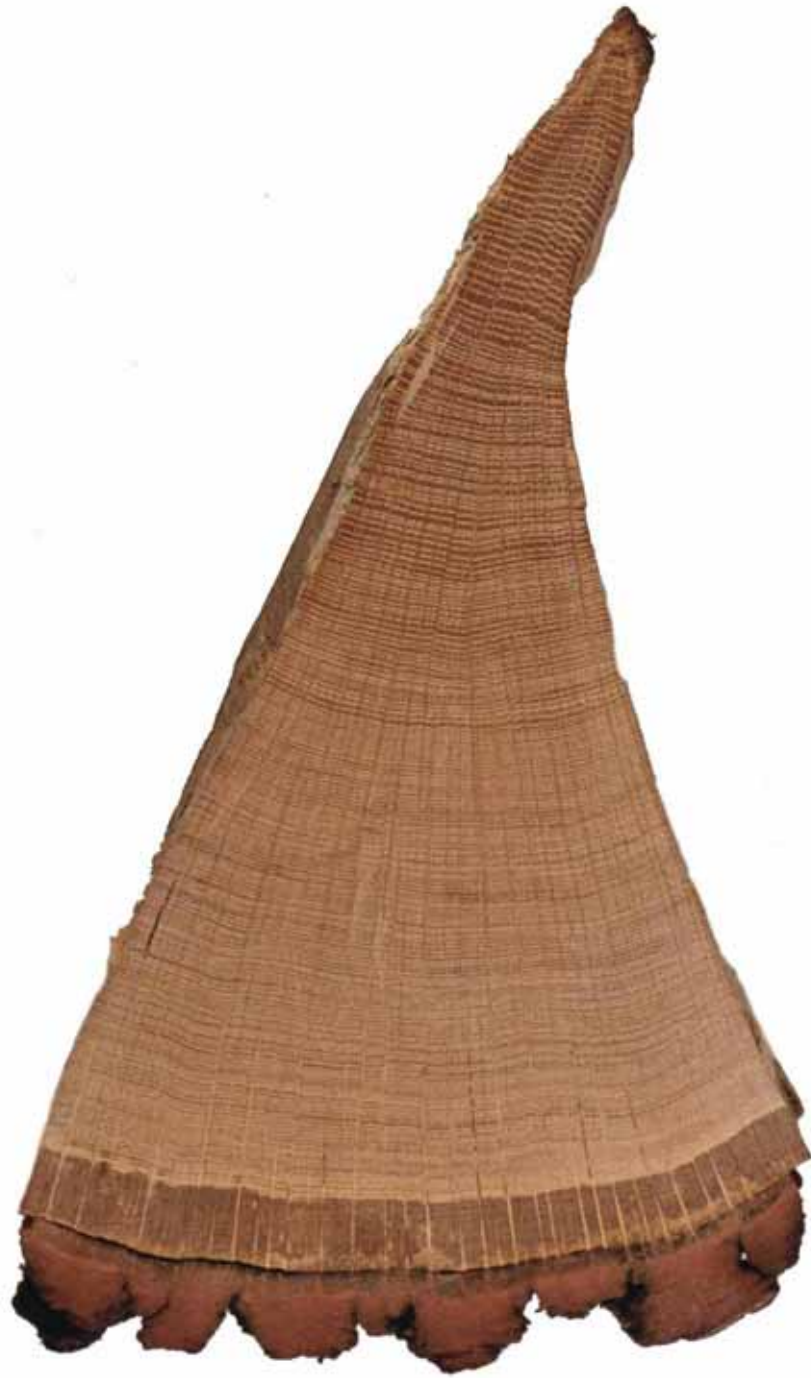
*Figure A1: A wedge of oak from a tree felled in 1976. It shows the annual growth rings, one for each year from the innermost ring to the last ring on the outside just inside the bark. The year of each ring can be determined by counting back from the outside ring, which grew in 1976*

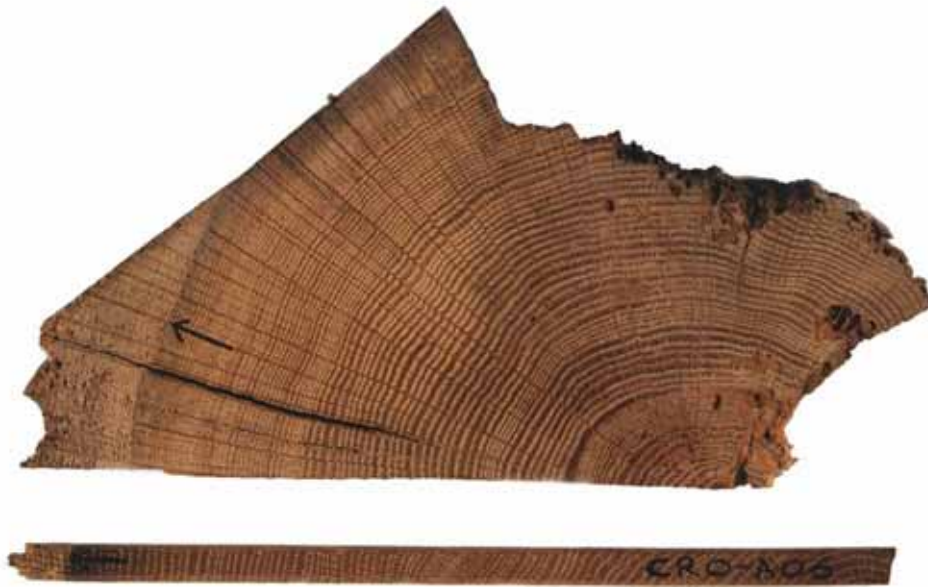
Figure A2: Cross-section of a rafter, showing sapwood rings in the left-hand corner, the arrow points to the heartwood/sapwood boundary (H/S); and a core with sapwood; again the arrow is pointing to the H/S. The core is about the size of a pencil

Quite often some, though not all, of the original outer rings are missing on a timber. The outer rings on an oak, called sapwood rings, are usually lighter than the inner rings, the heartwood, and so are relatively easy to identify. For example, sapwood can be seen in the corner of the rafter and at the outer end of the core in Figure A2, both indicated by arrows. More importantly for dendrochronology, the sapwood is relatively soft and so liable to insect attack and wear and tear. The builder, therefore, may remove some of the sapwood for precisely these reasons. Nevertheless, if at least some of the sapwood rings are left on a sample, we will know that not too many rings have been lost since felling so that the date of the last ring on the sample is only a few years before the date of the original last ring on the tree, and so to the date of felling.

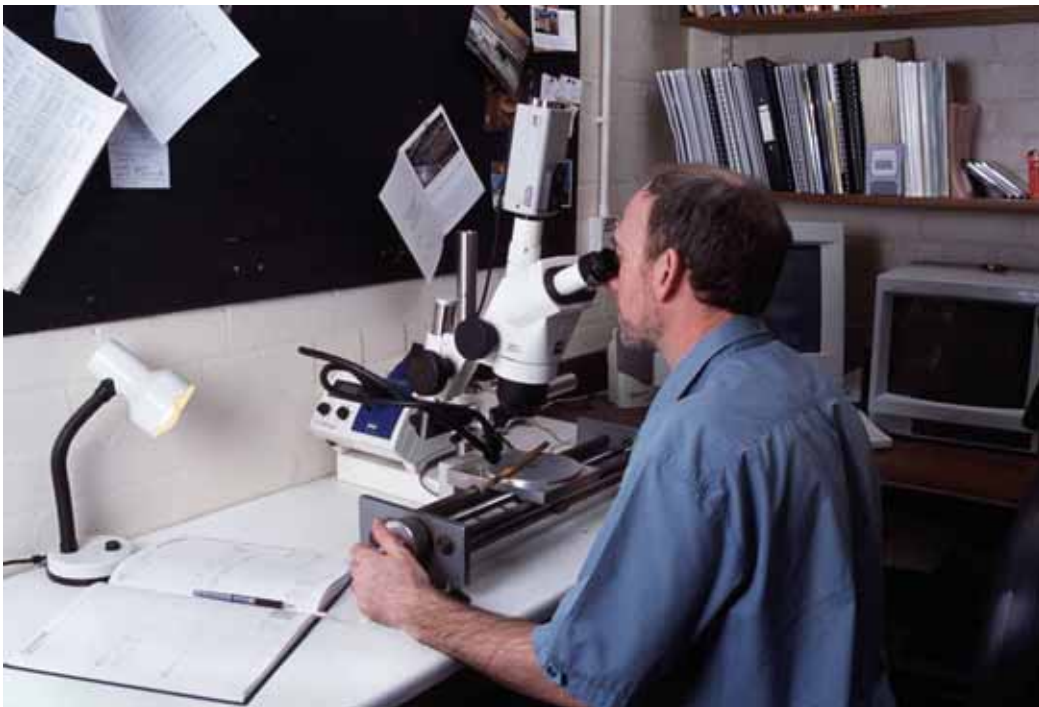
Figure A3: Measuring ring widths under a microscope. The microscope is fixed while the sample is on a moving platform. The total sequence of widths is measured twice to ensure that an error has not been made. This type of apparatus is needed to process a large number of samples on a regular basis

2. **Measuring Ring Widths.** Each core is sanded down with a belt sander using medium-grit paper and then finished by hand with flourgrade-grit paper. The rings are then clearly visible and differentiated from each other with a result very much like that shown in Figure A2. The core is then mounted on a movable table below a microscope and the ring-widths measured individually from the innermost ring to the outermost. The widths are automatically recorded in a computer file as they are measured (see Fig A3).

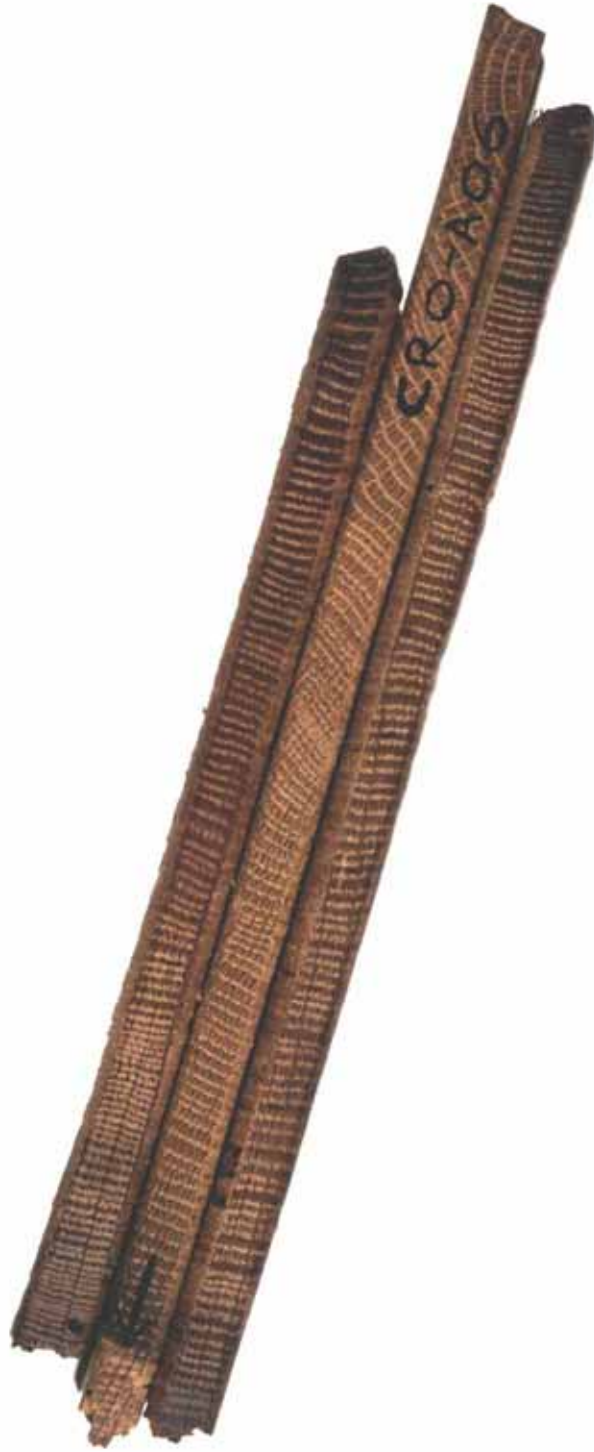
Figure A4: Three cores from timbers in a building. They come from trees growing at the same time. Notice that, although the sequences of widths look similar, they are not identical. This is typical
