RESEARCH REPORT SERIES no. 52-2012

84 RAVENSDOWNE,  
BERWICK-UPON-TWEED,  
NORTHUMBERLAND  
AN INVESTIGATION AND  
STATEMENT OF SIGNIFICANCE

HISTORIC BUILDINGS REPORT

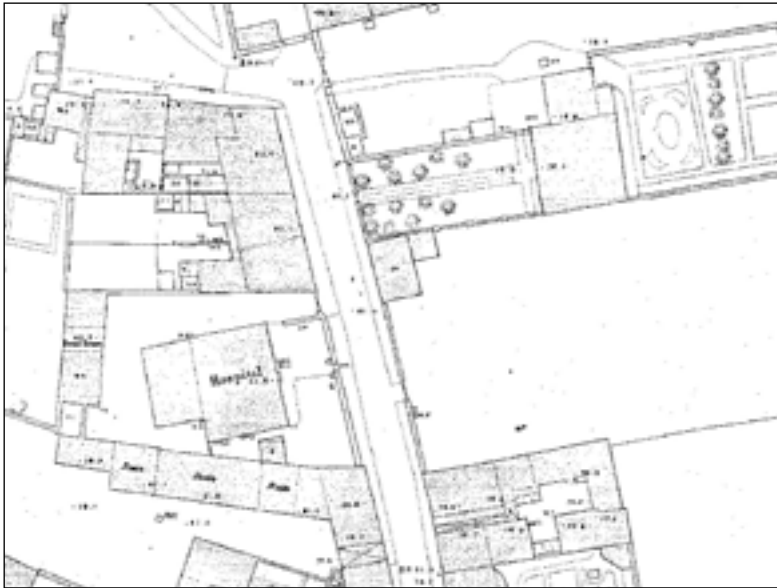
Figure 1. Ordnance Survey map of 1852 showing an L-shaped building on a large plot now occupied by 84 Ravensdowne.

The first indication of a structure occupying the site of what is now 84 Ravensdowne is shown on Lowrey's map of 1844 on which a small rectangular building is depicted in the top left corner of plot 4.<sup>11</sup> Further detail is given of this building on the first Ordnance Survey map of 1852 (Fig 1).<sup>12</sup> This shows an 'L' shaped building standing square to the road marked 'Ch', which, in Ordnance Survey shorthand, can indicate either a 'church', 'club house' or 'coach house'. The plot of land on which it sits is otherwise divided from

the road by a wall with gated access to the south. A pump and water trough are also shown within the plot.

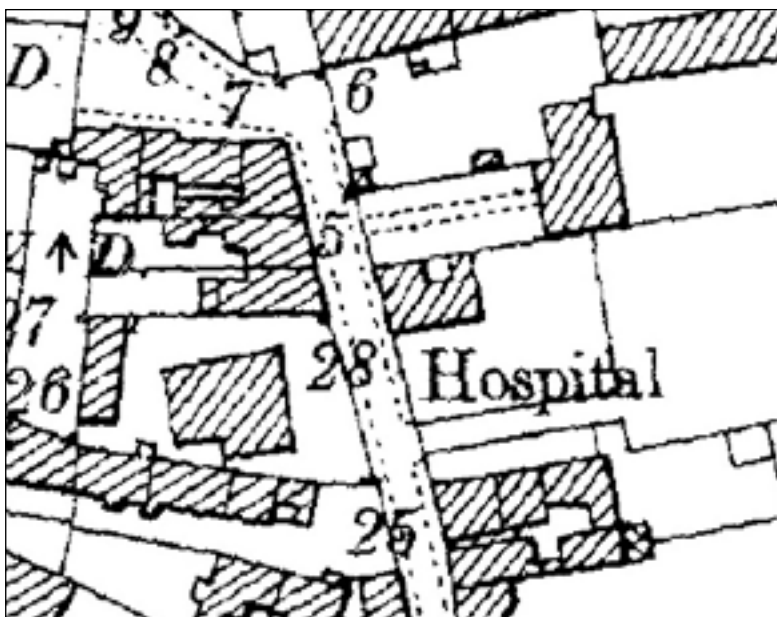
Figure 2. Ordnance Survey map of 1897 showing 84 Ravensdowne.

It is not until the 1897 Ordnance Survey map<sup>13</sup> that there is published evidence of further change (Fig 2). The land south of Ordnance House was by then divided up into smaller plots and an irregular 'U' shaped building stood in the same position as the building marked 'Ch' in 1852. The same building is represented on later Ordnance Survey maps, such as that of 1924,<sup>14</sup> which also shows that the land to the east of the house was used as a 'Bowling Green'.

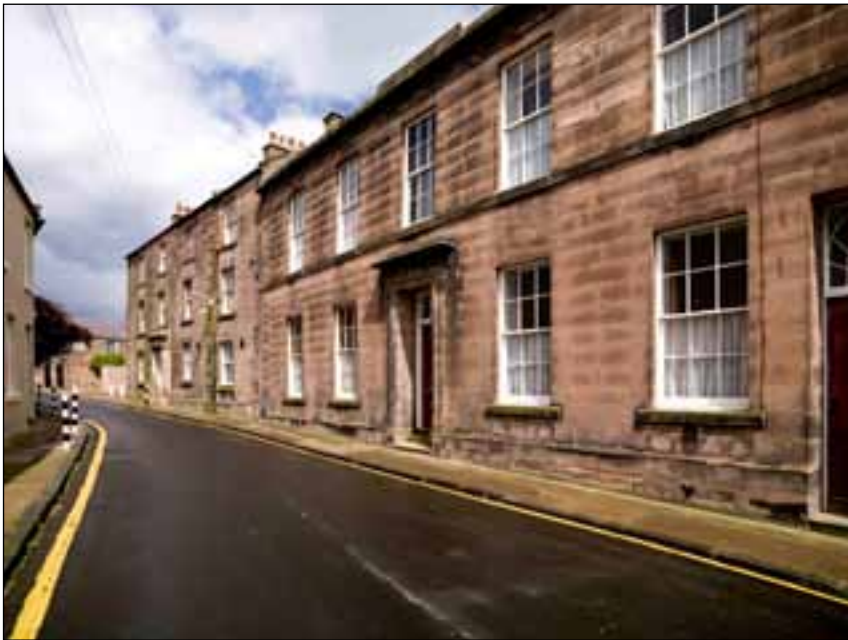
*Figure 4. The point at which Ravensdowne narrows. Note, No. 84 is in the background, to the far left (Photograph: Bob Skingle 2008 DP065186 © English Heritage).*

Ravensdowne, as has already been noted, is situated on the eastern side of Berwick-upon-Tweed within the town defences. It continues the line of Palace Street East northwards, rising steeply up to the junction of Woolmarket before ascending more gently northwards, terminating near Berwick Barracks on Parade. The gentle curve of the street reflects the line of the town wall to the east. Towards the northern end of Ravensdowne the roadway narrows and eventually veers sharply west, then continues north as it skirts around the barrack walls (Fig 4).

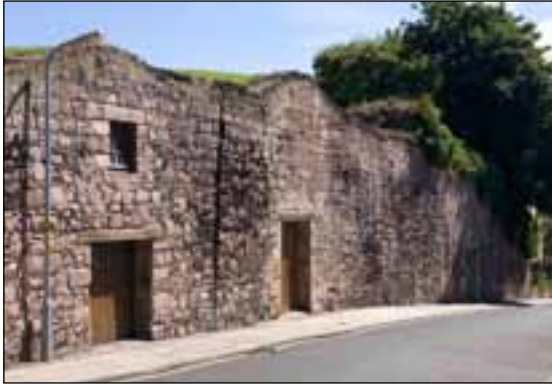
Figure 6. Ice houses on the east side of Ravensdowne  
(Photograph: Bob Skingle 2008 DP065251 © English Heritage).

Although mainly domestic in character, there is some evidence of commercial and even light industrial activity in Ravensdowne. For example, the icehouses, used by the fishing industry for the storage of fish, with their tall stone walls facing onto the east side of Ravensdowne, are still extant (Fig 6).<sup>38</sup> The 1852 Ordnance Survey map shows a large timber yard and fish smoking house to the rear of the elegant houses on the east side of lower Ravensdowne. A rope works also existed well into the twentieth century and was situated between the ice houses, the doors of which opened directly onto Ravensdowne. Other small-scale commercial activity also appears to have been carried out from residential houses including Mr Bowlam's Land Agent offices located at No. 76 (Fig 7). The census of 1881 indicates that Mr Bowlam and his large family resided in 72 Ravensdowne.

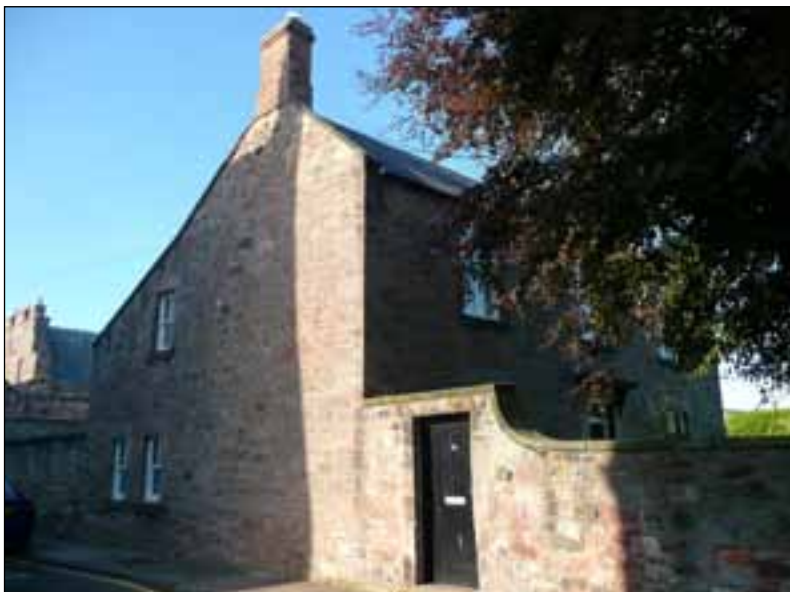
Figure 8. Western elevation of No. 84 aligned with the street  
(Photograph: Kirsty Tuthill 2011 © English Heritage).

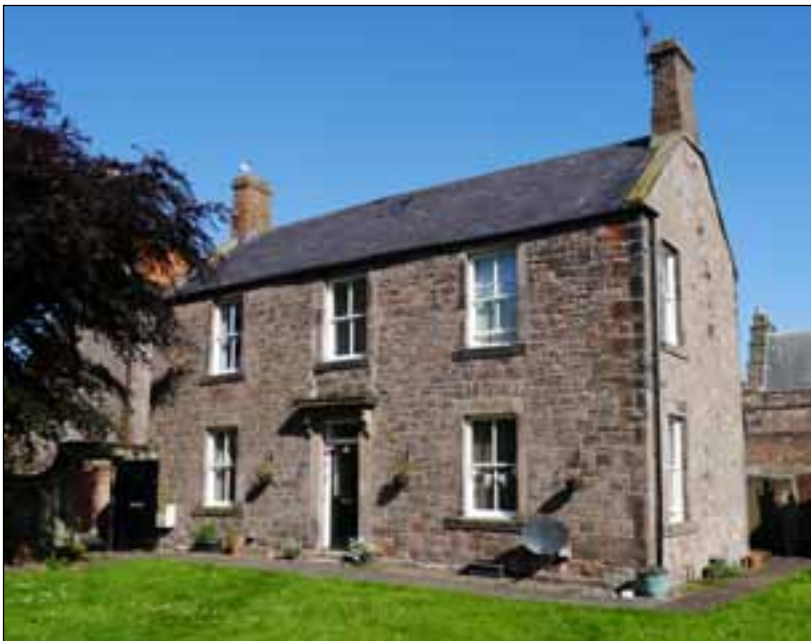
No. 84 Ravensdowne is two storeys high, with a symmetrical principle elevation of three bays (Fig 9). The main body of the house is one room deep. A two storeyed wing at the rear makes the whole 'L' shaped in plan. The house is built of solid stone walls, with roughly coursed rectangular blocks of the local pink-grey sandstone on an ashlar

*Figure 9. Front elevation  
(Photograph: Simon Taylor 2012  
© English Heritage).*

plinth and has ashlar quoins to the corners. The less publicly visible elevations are of poorer-quality stonework. The house has a pitched slate roof with raised copings, a small centrally placed roof light which is probably a modern insertion, modern plastic guttering and end chimney stacks of brick. The house's slightly irregular plan is the result of the western gable respecting the alignment of Ravensdowne, rather than this wall being set at right angles to its south facing façade (see appendix).

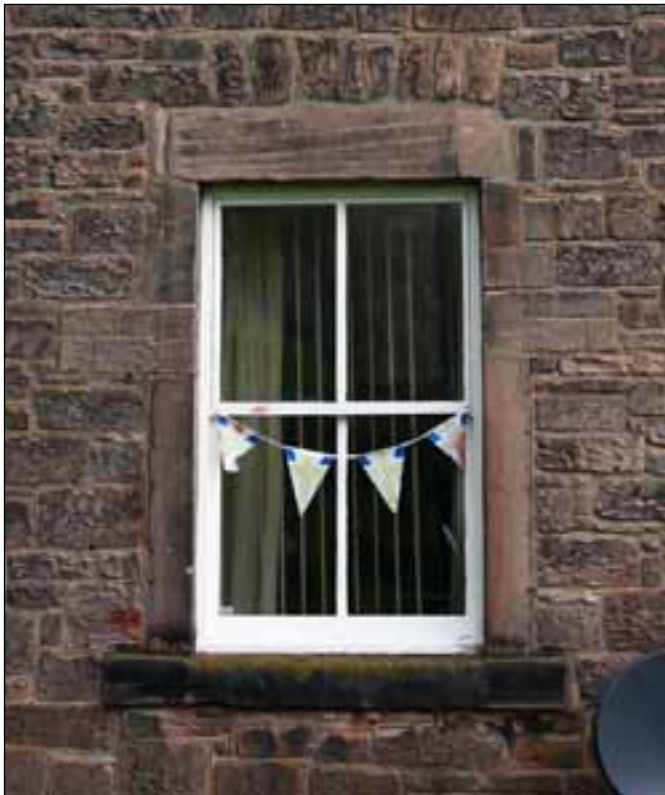
The central door is flanked by sliding sash windows to the ground floor, with three similarly proportioned and evenly spaced windows to the first floor. All windows have stone sills and interrupted stone jambs, whilst there are stone relieving arches above the ground floor lintels. All the sashes and their boxes are recent replacements but are probably not dissimilar to the originals. Although the window openings appear superficially similar, none of the monolithic window jambs, lintels or sills are of equal length or width. This has been partially masked on the jambs and lintels by deliberate tooling, creating false edges on some stones, whilst others have been tooled to imitate coursed stone blocks (Fig 10). This gives the impression around each window of stone jambs and lintels of similar dimensions.

*Figure 10. Window with interrupted jambs tooled to imitate coursed stone  
(Photograph: Simon Taylor 2012  
© English Heritage).*

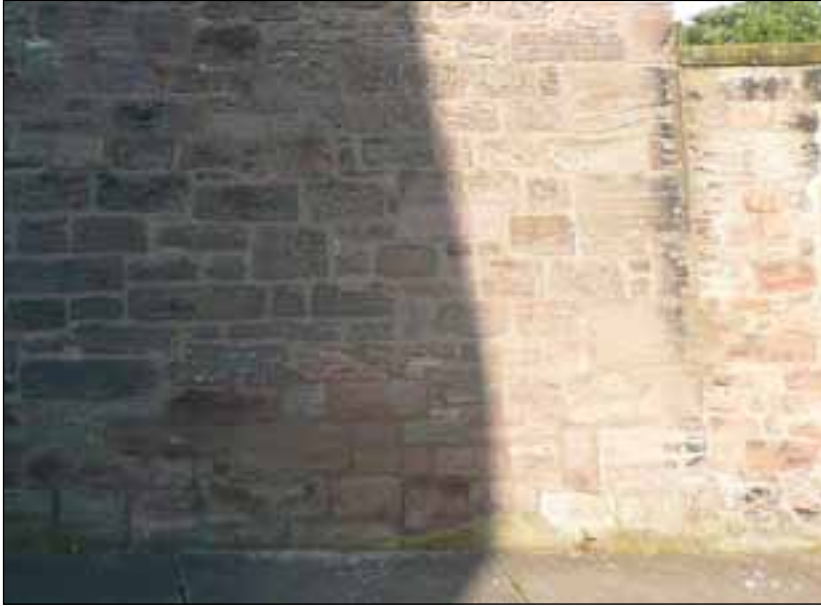
A possible ragged joint is evident 1.5 metres from the right edge of the west boundary wall, rising about 1.8 metres from the ground, which might suggest the extent of part of the earlier wall of the coach house, shown on the Ordnance Survey map of 1852, incorporated into the fabric of the replacement house (Fig 12). The joint itself is not, however, sufficient in itself to categorically support this hypothesis. The coach house was aligned to the street in much the same way as the present building, but no other wall of the present house corresponds to its footprint. For example, the north wall of the present house is aligned with the northern plot boundary, but the north wall of the coach house, as depicted on the 1852 Ordnance Survey map, is not. The most likely scenario was that the coach house was completely dismantled to make way for Riddle's new house.

*Figure 12. Possible ragged joint on the western elevation (Photograph: Kirsty Tuthill 2011 © English Heritage).*

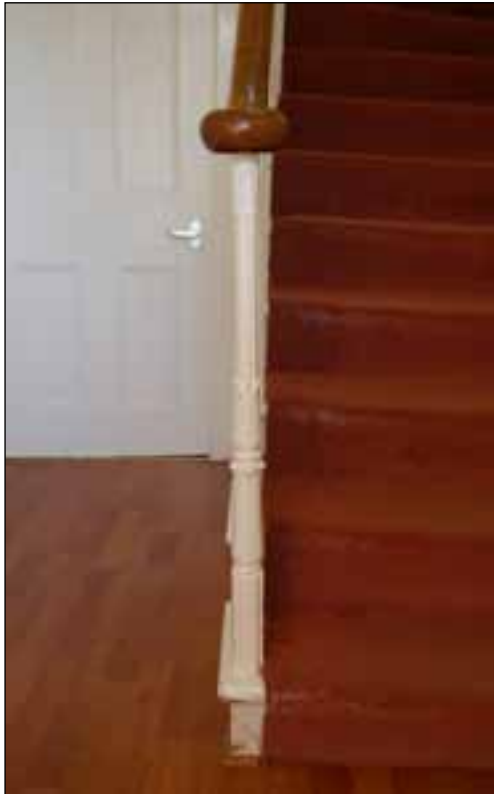
The original open-string dog-leg stairs has continuous winders, two simple square-section balusters per tread and a slender embellished newel post of cast iron which resembles the rising stem of a plant or flower. The newel is topped with a circular cap and joined to a handrail (Fig 14). Each tread end is carved to resemble a console-like bracket. The stairwell is lit by a north facing window.

*Figure 14. Newel post  
(Photograph: Simon Taylor 2012 ©  
English Heritage).*

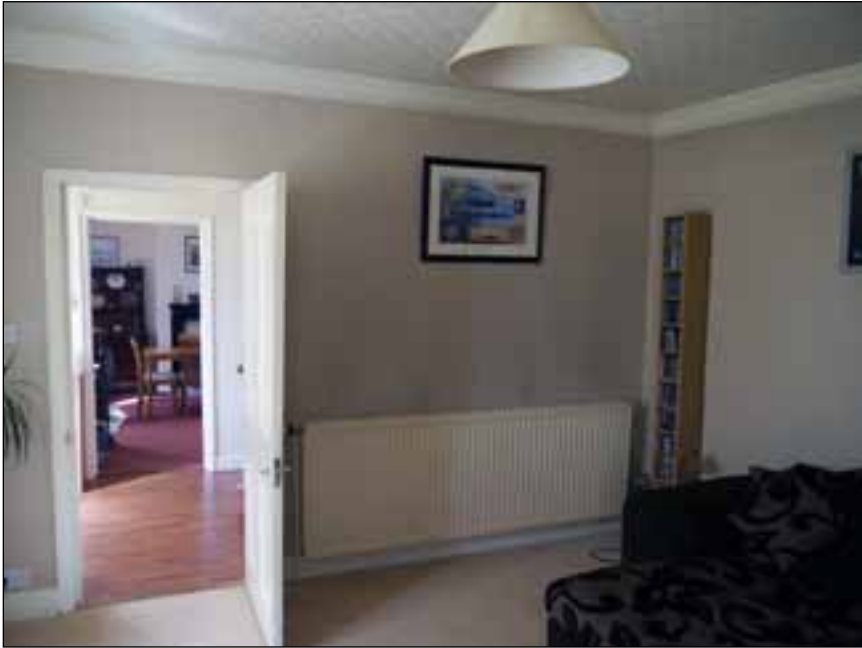
Turning to the right, one enters the present living room which would have been the parlour (Fig 15). The original moulded four-panelled door has its architrave but like most of the doors in the house, the original door furniture has been lost. The room enjoys views of the garden through south and east facing windows, making it a bright and pleasant room. Both windows have splayed reveals indicating that the window openings were probably once furnished with shutters. Records indicate that both the shutters and their boxes were removed in 1989.<sup>46</sup> The room would have been heated by a fireplace in the centre of the east wall, to the left of the east window. The flue is contained entirely within the thickness of east wall but the opening is now partially blocked and completely obscured by a modern gas fire and surround. The present cornice, with egg and dart moulding, and the ceiling rose are modern and no other evidence remains to indicate the nature of any original decorative plasterwork. The square-topped skirting is modern.

*Figure 15. Present living room, formerly the parlour, with a view through to the hall and dining room. (Photograph: Simon Taylor 2012 © English Heritage).*

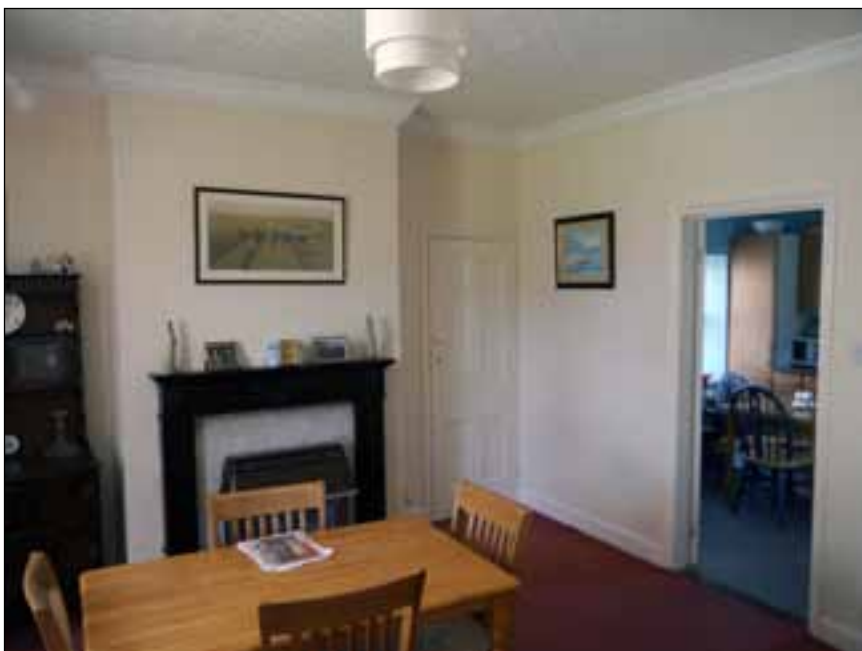
The original living kitchen is also reached from the entrance hall through the opposite doorway (Fig 16). At present it is used as a dining room and is lit by a single central south

facing window with splayed reveals. The room is almost rhomboidal in shape, caused by the walls' alignments with Ravensdowne and the boundary of the old Ordnance House plot. The original fireplace has been replaced and ceiling decorations are modern. We do, however, know that the room once had a picture rail which was photographed in the later 20th century before it was removed.<sup>47</sup> The room does retain its original door, architrave and skirting which is finished with a simple roll top. It also has two built-in storage cupboards, with their original doors and locks. One cupboard with four panels is located to the right of the projecting chimney breast whilst the other cupboard is built into the south facing wall; its door has two panels and is crudely constructed to fit the opening.

*Figure 16. Present dining room, formerly the living kitchen, with view through to the present kitchen in the rear wing. (Photograph: Simon Taylor 2012 © English Heritage).*

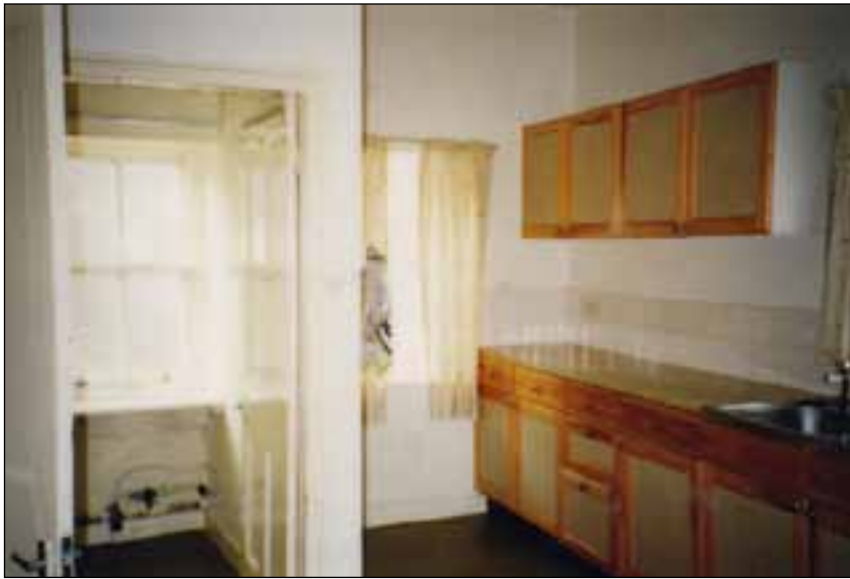
The present kitchen, also a rhomboid in shape, is reached from the dining room. This was probably originally a large scullery and is now lit by four windows to the west, north and east. The back door, which would have led out into a small yard and outside store is located to the right (east). A boxed-in flue in the north-east corner of the room, which has a small single chimney externally, suggests a copper may have once occupied the corner: a fairly typical arrangement to provide heated water for washing food, utensils and clothes. We know from records that this room was once divided,<sup>48</sup> with a larder in the south-west corner, lit by a single window (Fig 17). This window has a recess beneath the sill which might suggest a blocked door to the street. However, there is no external evidence for this and it is more likely that the recess provided more storage space beneath the full-width stone sill which served as a shelf.

*Figure 17. Present kitchen showing former larder, photo taken in 2002 (Photograph: English Heritage Estates Office © English Heritage).*

Finally, the most recent major change has been to the layout of the kitchen. Originally a scullery with separate larder, the wall separating the two was removed to create a larger kitchen. No records have been found to confirm when this took place, but a photograph taken during an inspection of 2002 shows the wall to be still extant (Fig 17).

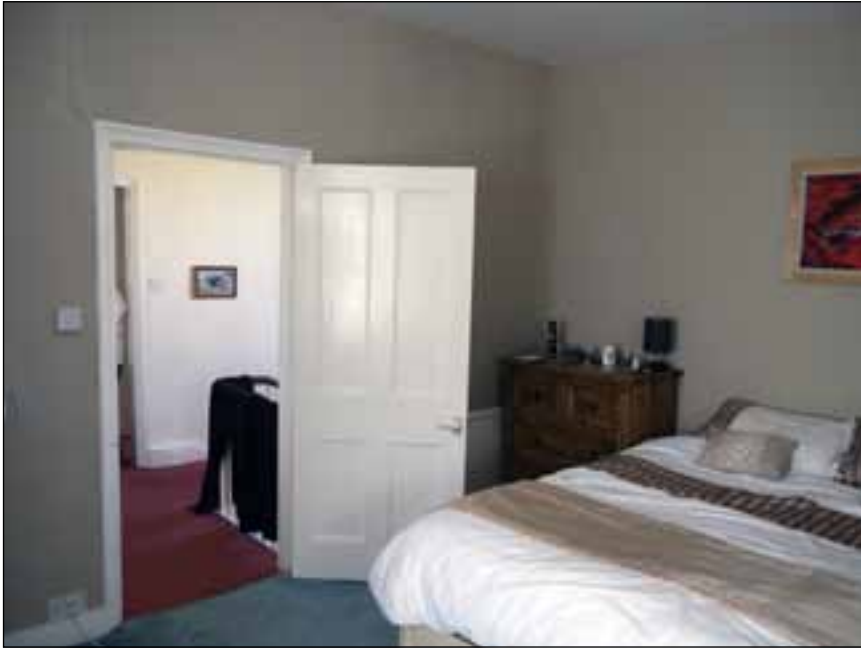
At the top of the stairs is a very small central box room. The large splayed south-facing window seems oversized for such a small space, and although the skirting, four-panelled door and architrave appear to be early, on the landing side the wall bisects the architrave of the neighbouring doorframes. This indicates the wall was inserted later, creating an additional room out of the large landing. The bedroom above the parlour (Fig 18) has two splayed window openings which look to the south and east. Apart from the original door and architrave there are no other original features in this room and the fireplace has been removed and blocked. On the opposite side of the stairs, an opening with architrave indicates the original position of the doorway into the bedroom above the living kitchen. The door has been removed and a corridor has been inserted into the east side of the bedroom giving direct access to the rooms in the rear wing from the landing. The room above the living kitchen has a single splayed window facing south. It is also rhomboidal in shape, similar to the living kitchen room below. A full-height cupboard has been built in-between the bedroom door and south wall. There is a shallow projecting chimney breast on the western wall but evidence of the fireplace has now been removed. The north wall of the room is also a later insertion, reducing the size of the room to allow the creation of the corridor.

*Figure 18. Main bedroom with a view through to the landing and stairs.*
