RESEARCH REPORT SERIES no. 54-2012

SUNDON PARK, LOWER SUNDON, BEDFORDSHIRE ARCHAEOLOGICAL DESK-BASED ASSESSMENT

Archaeological Desk-Based Assessment

NGR: TL 0500 2676

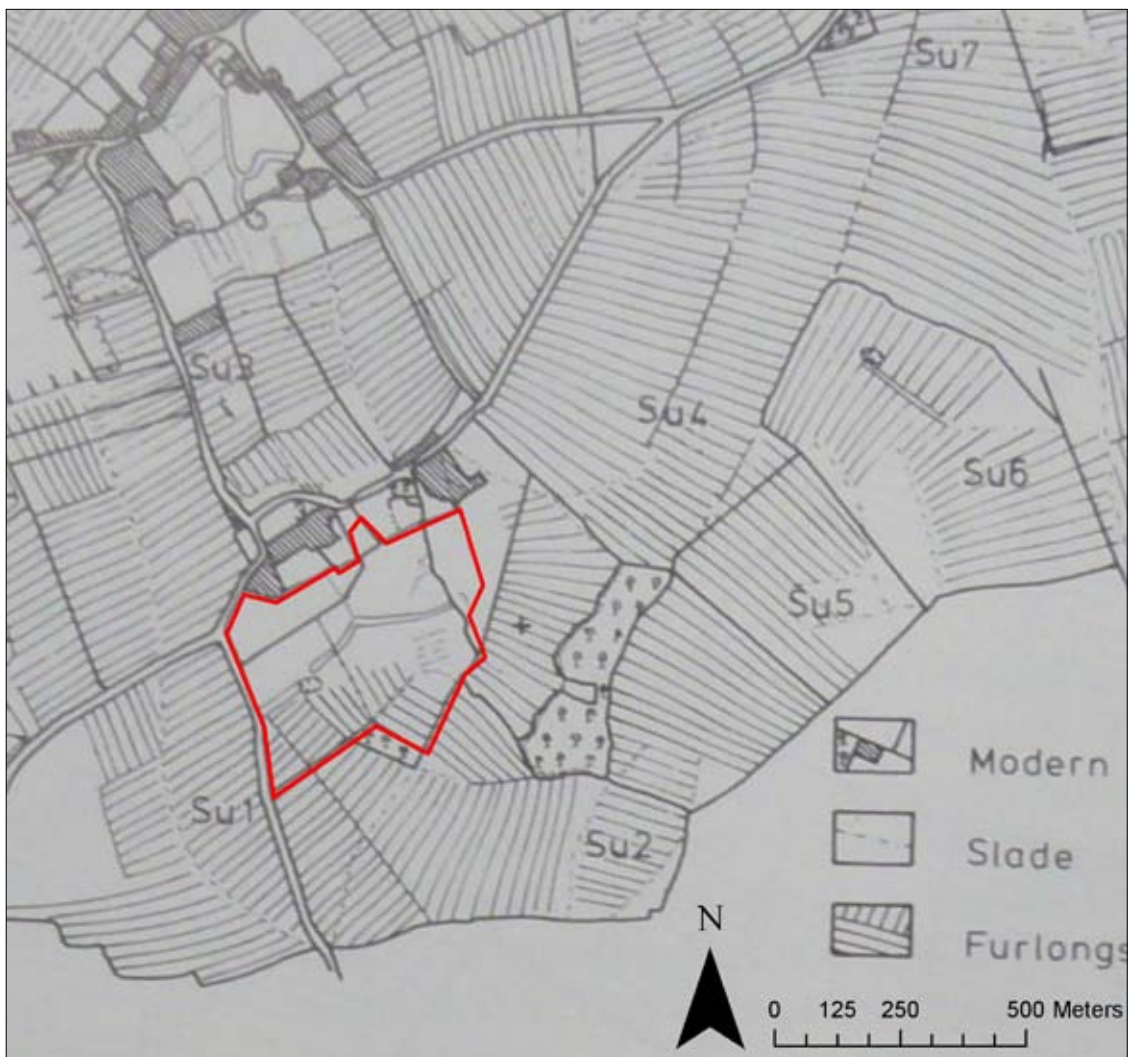
Figure 3. Upper and Lower Sundon, with ridge-and-furrow (Hall 1977/1991). Central Bedfordshire HER

A parish field survey of Sundon was conducted by David Hall in 1977-78, published in 1991. Its methodology consisted of recording field boundaries, headlands and ridge-and-furrow patterns so that open field patterns could be reconstructed. Most fields over 100m width were walked and artefact scatters recorded with the aim of discovering new sites. Several sites of Iron Age and Roman date were identified from pottery scatters in the area to the southeastern part of the parish. Hall describes Upper and Lower Sundon as shrunken vills, and points out that Sundon Wood in the Study Area has a linear bank around it, strongly indicating it is medieval in date (Hall 1991). His plan of the open field patterns of Sundon parish, showing dispersed settlements of Upper and Lower Sundon in the context of the agricultural hinterland, is reproduced in Figure 3.

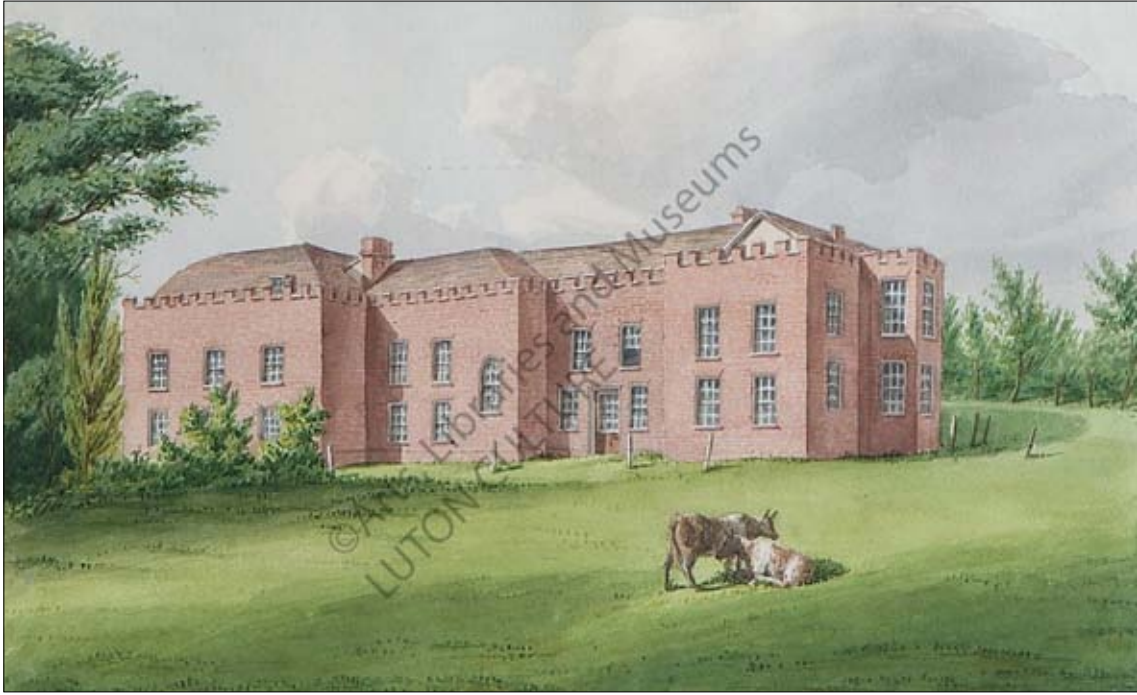
Figure 5. Sundon House – frontal view. Viewed from northwest. Painted by Thomas Fisher between 1812 and 1822. Original in Wardown Park Museum, Luton, Accession 1993/246, ©Luton Culture

The rectangular area to the east of the house, approximately 80 x 70m, is still clearly labelled as 'garden'. The plan of the house can be taken together with the frontal and rear views depicted in the paintings by Fisher and Shepherd in Figures 5 and 6 to give an all-round perspective on the house and its landscaped grounds at this time.

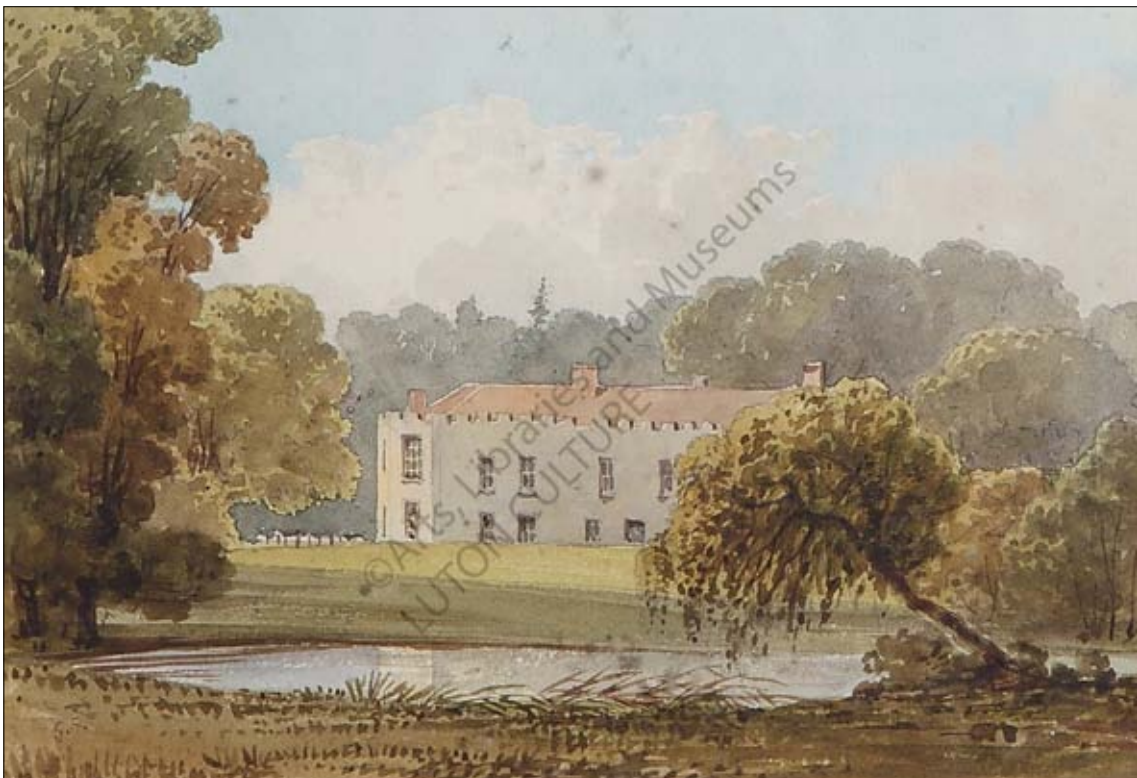
Figure 6. Sundon House – rear view. Viewed from southeast. Painted by George Shepherd between 1812 and 1822. Original in Wardown Park Museum, Luton, Accession 1993/249, ©Luton Culture

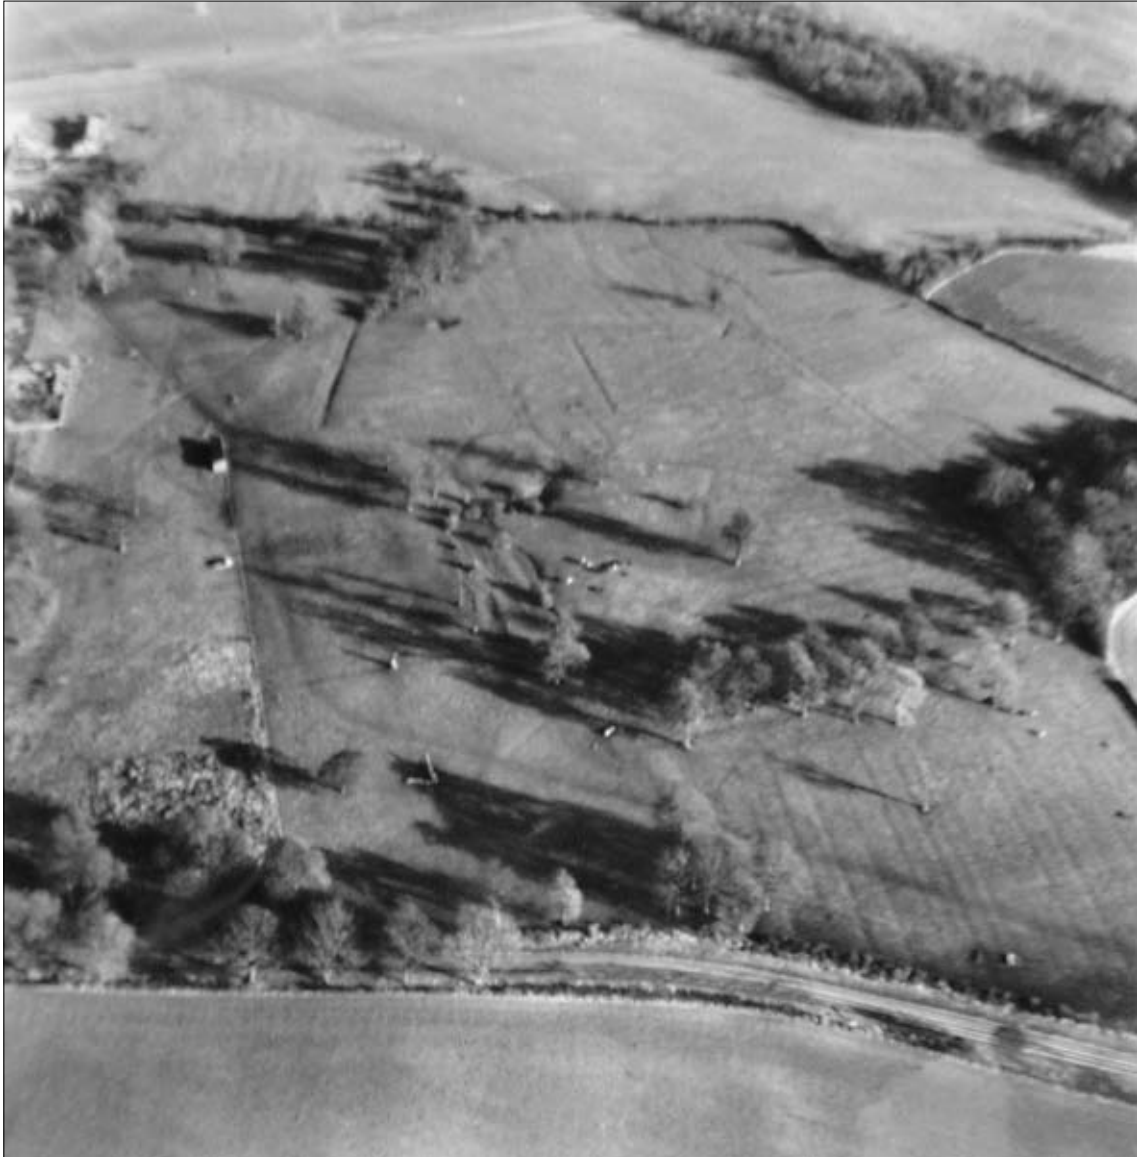
Figure 7. Oblique aerial photo, looking east, showing polygonal feature near centre of image. Copyright reserved Cambridge University Collection of Aerial Photographs (BRV23 1974-12-13)

Aerial photographs held by Central Bedfordshire Council were examined. Those found to be of particular relevance to the Study Area are listed in the References section. Figure 7 shows the area in an aerial photograph of 1974, looking obliquely towards the northeast. Numerous earthworks are visible, including many linear features (hollow ways, driveways, drainage channels, field boundaries). The partially wooded character of the Study Area is apparent. In the centre of the photo is an enigmatic polygonal feature, up to 45m wide, next to the linear ponds. This feature will be discussed later.

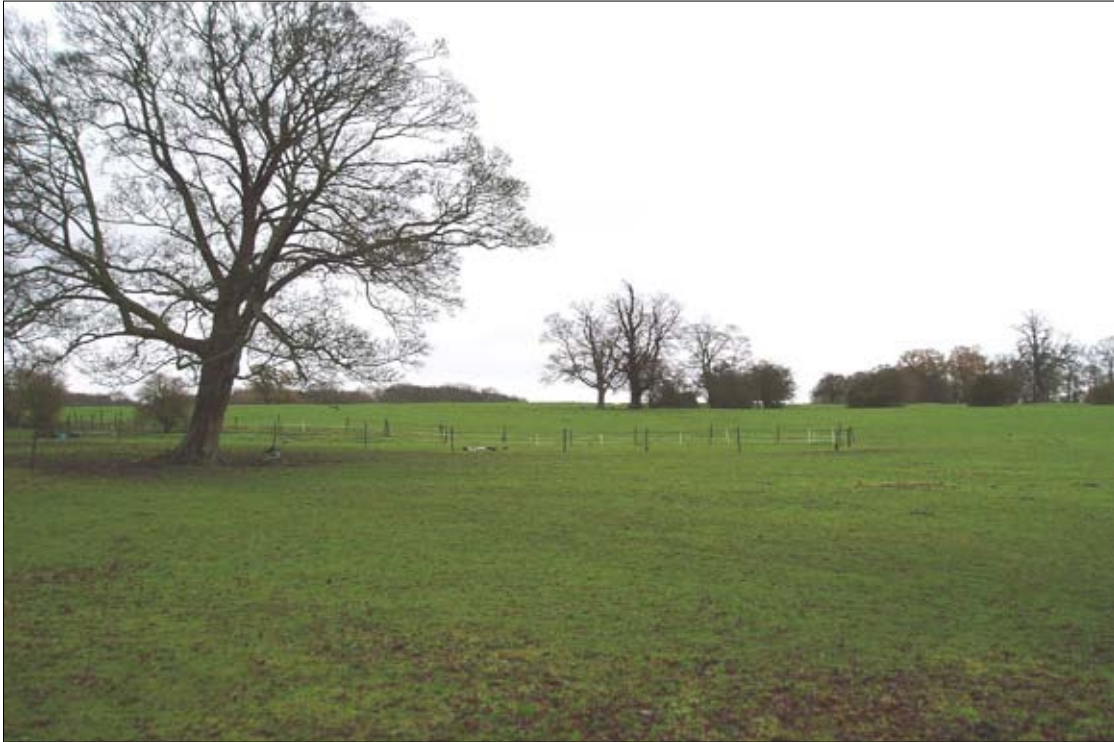
Figure 9. Photo looking southeast across former site of manor house towards the pond from churchyard. © English Heritage, December 2012. For a photo of the same scene in summer, see the cover image

The photographs in Figures 9 and 10 were taken from the churchyard in December, 2012.

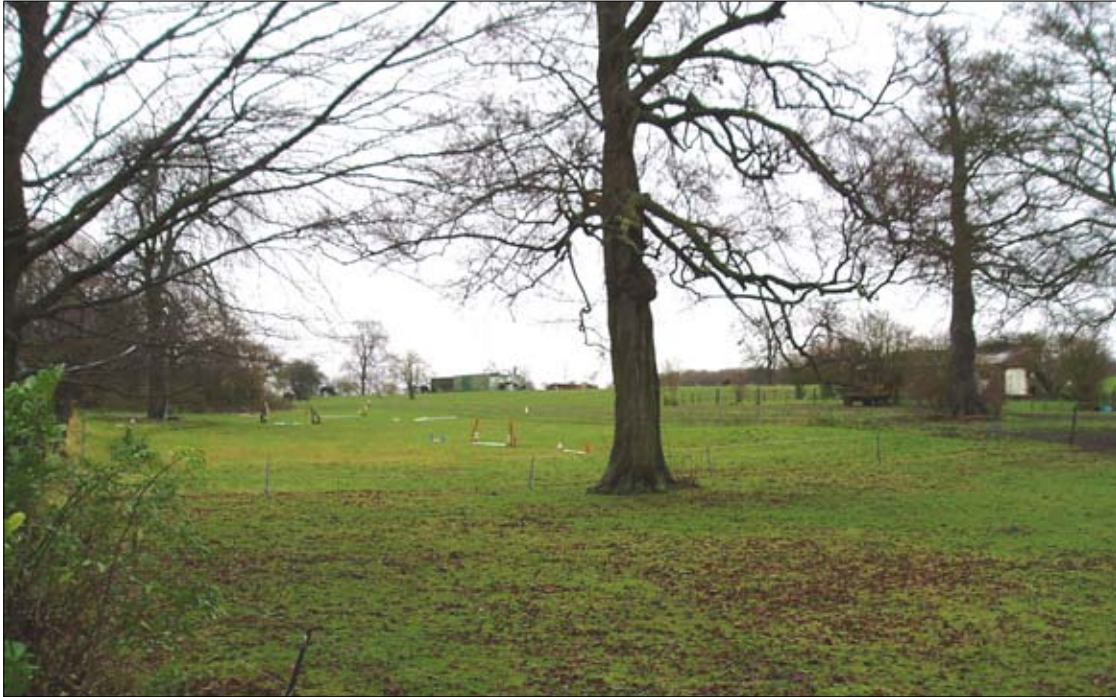
Figure 10. Photo looking east over garden area and towards Sundon Wood, from churchyard. © English Heritage, December 2012

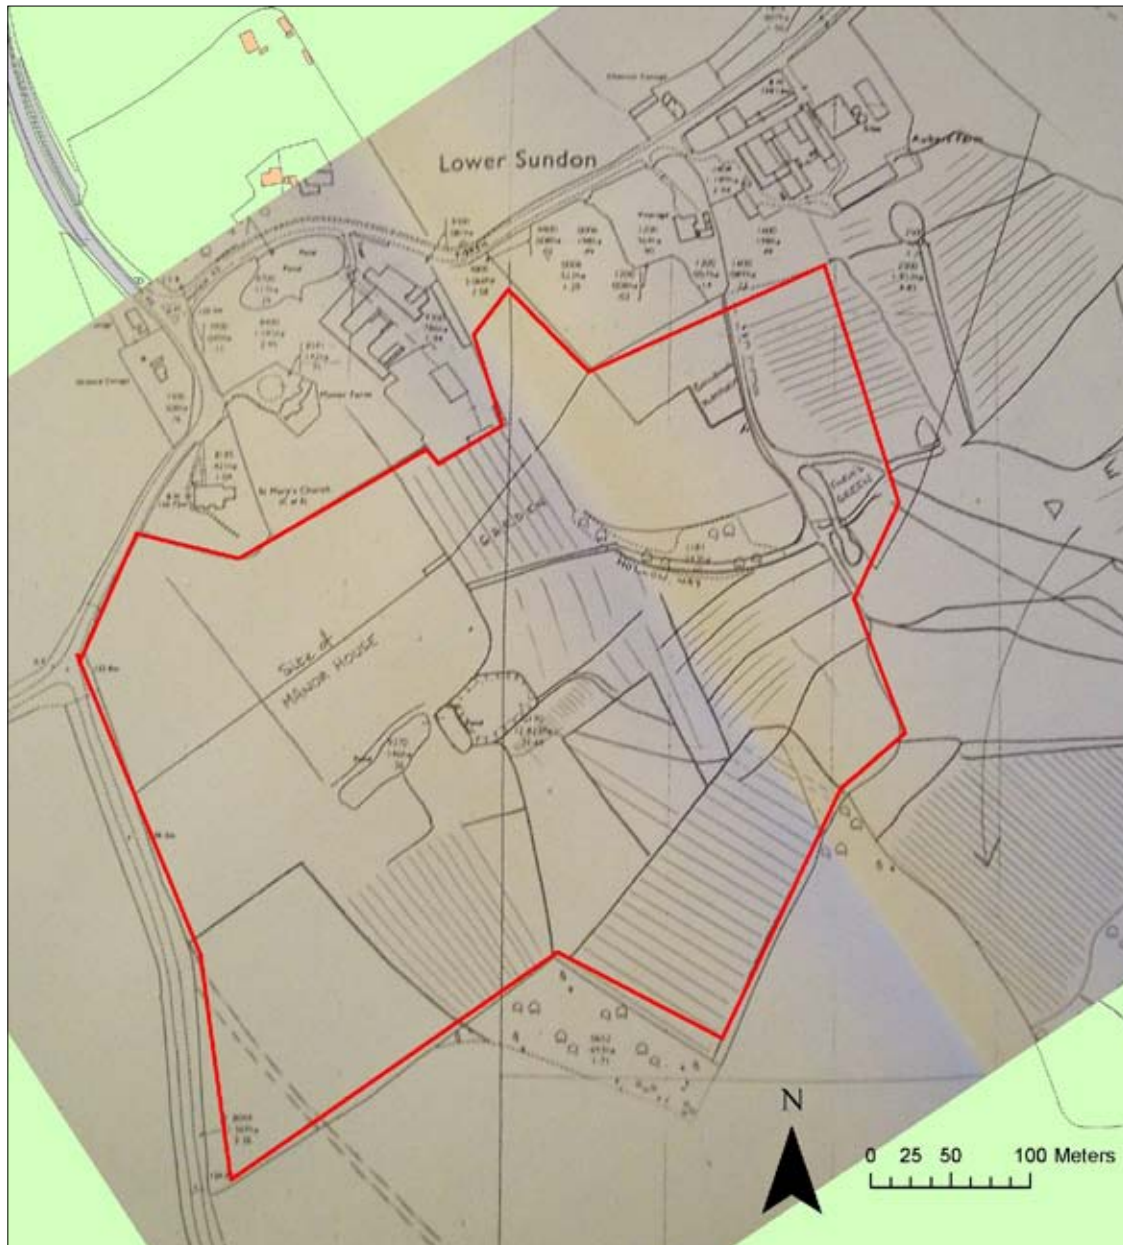
Figure 16. Sketch plan by Angela Simco (1991), showing patterns of ridge and furrow and other earthworks (Central Bedfordshire Council HER) with modern Ordnance Survey map as base. Study Area shown in red. ©Crown Copyright and database right 2009. All rights reserved. Ordnance Survey Licence number 100019088

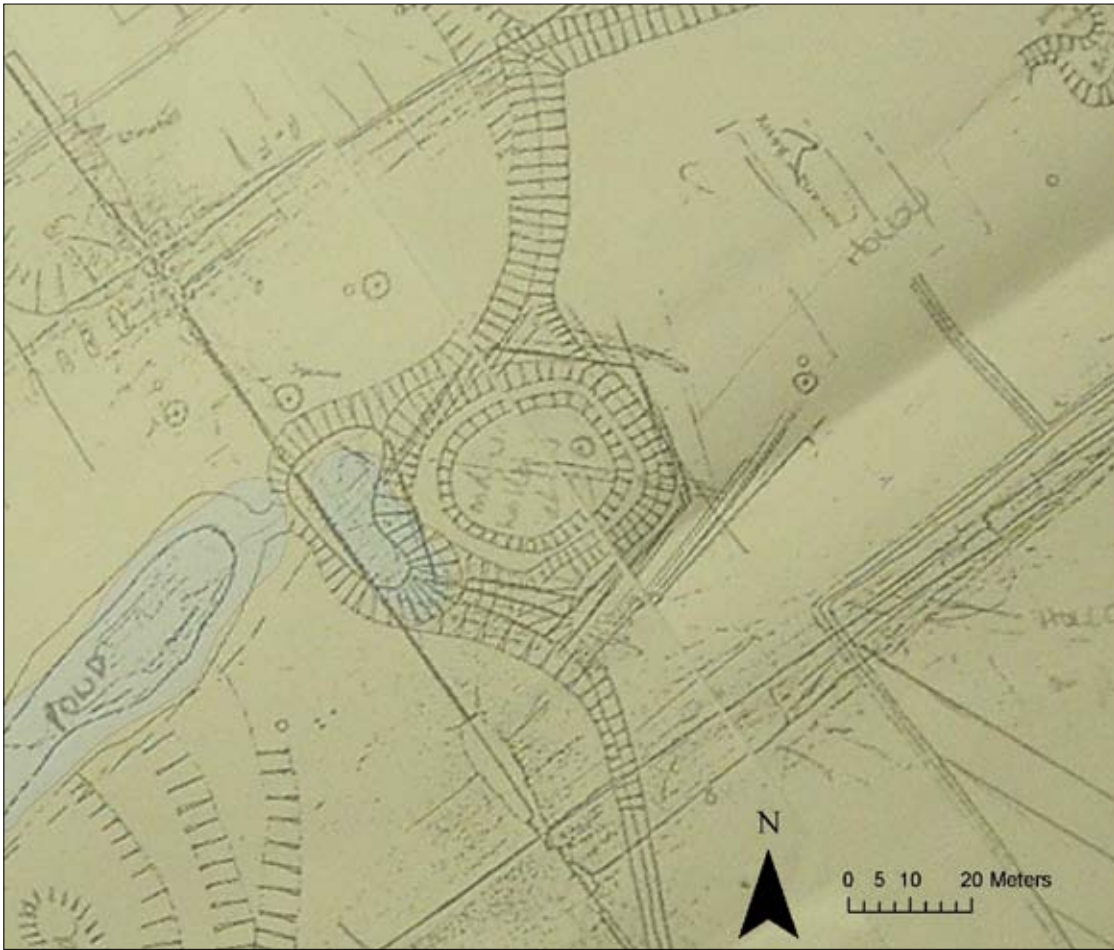
Figure 17. Detail of earthwork survey plan by Manshead Archaeological Society in 1970s, showing the polygonal feature (Central Bedfordshire Council HER)

The function and date of the earthwork is unknown. It is discussed in this section only because it could be of medieval date – on the grounds that adjacent medieval closes appear to respect its shape, as if formed around an existing feature. Its function may be connected with the nearby manor house and adjacent fishponds, and any interpretation will have to take account of its context and perhaps later use within the manorial home park. In the absence of excavated or geophysical evidence it is only possible to speculate on function, but it is possible that there was a building connected in some way with the management of the deer park and the activities that took place there. For example, it could be an earthen enclosure within which a kennels for hunting dogs was located (see Liddiard 2007, 116, for a 15th century print of a kennels set within a polygonal enclosure of roughly comparable dimensions). However, an early post-medieval date and an ornamental function for the earthwork must also be considered.

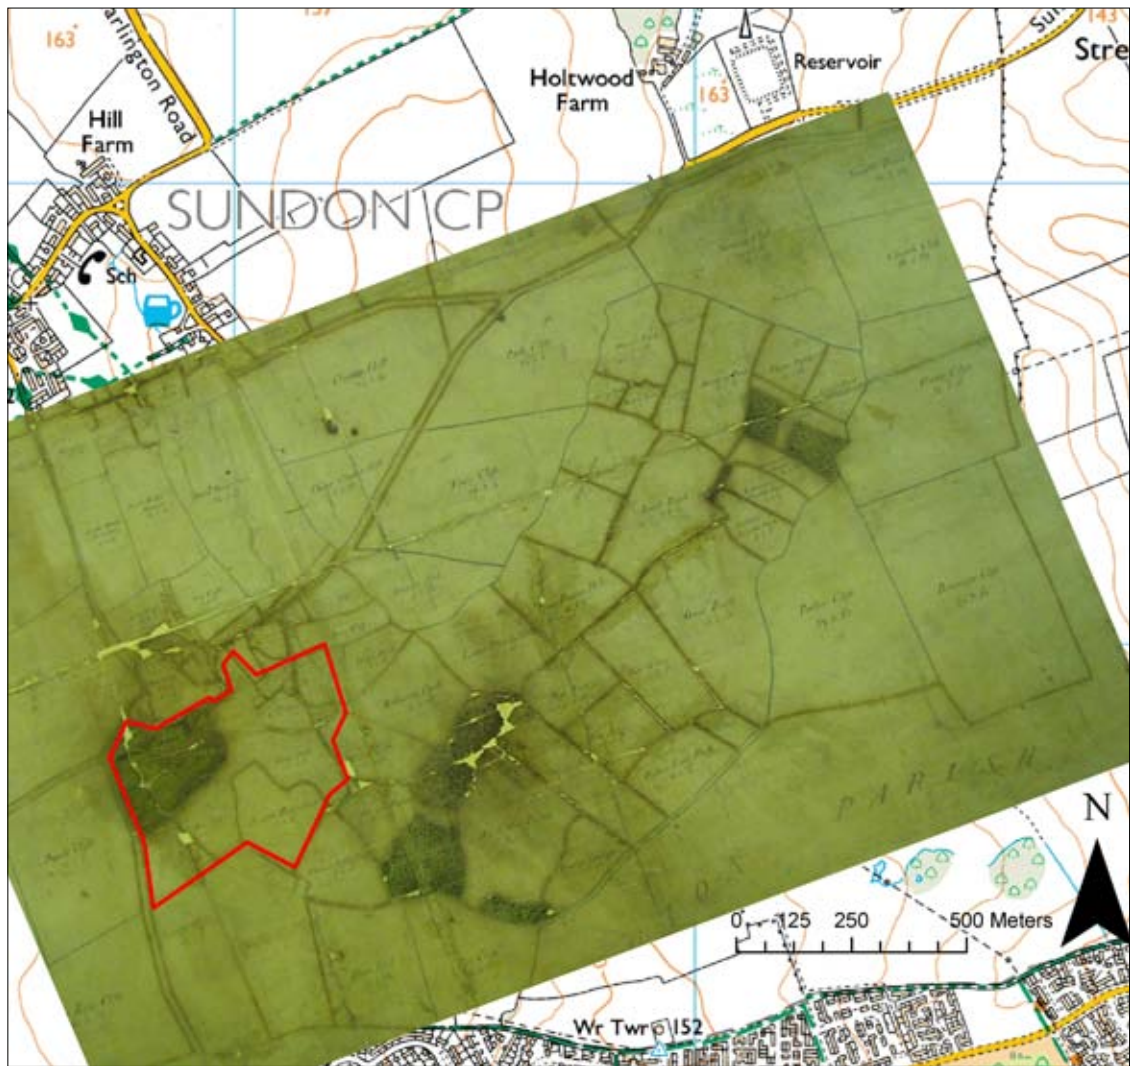
Figure 18a. Study Area on the 1810-20 estate copy of the Enclosure Award map of 1769 (Bedfordshire and Luton Archive and Record Service T42/608B), with modern OS map as base. ©Crown Copyright and database right 2009. All rights reserved. Ordnance Survey Licence number 100019088

The (1810-20 estate copy of the) 1769 map is also notable for giving the earliest cartographic representation of Sundon House, built by Thomas Cheyne in the early 17th century (perhaps on the site of or incorporating parts of the earlier medieval house) and extensively altered in 1735. Driveways leading up to the front of the house (facing northwards away from the park and fishpond) are also depicted, as is the drive or track leading from the manor house to Finches Green. Land in front of the house and to the

rear, between the house and the pond, is labelled 'lawn'. To the east of the house is a rectangular area, measuring approximately 90m x 80m, labelled 'garden'.

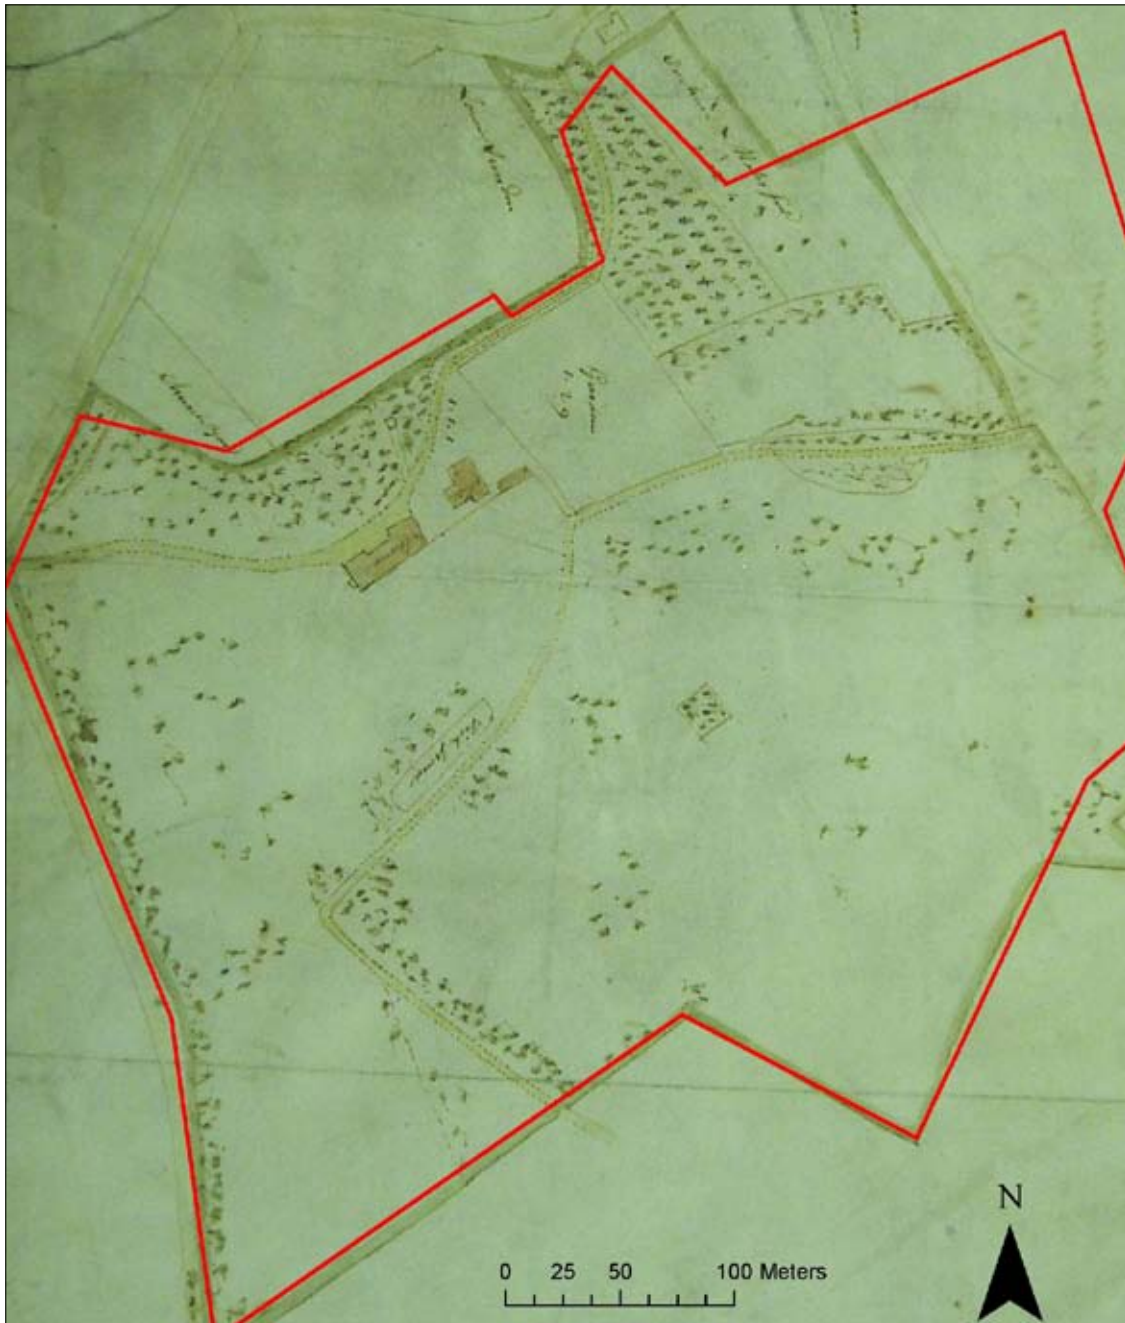
Figure 20. Study Area on 1827 Plan of Sundon Park, prior to demolition of house (Bedfordshire and Luton Archive and Record Service T42/605)

The same house (slightly extended towards the southwest) and much the same layout of driveways is shown on the 1827 plan of Sundon Park, surveyed immediately prior to its demolition (Figure 20).

By this time the pond has been foreshortened to half its former length. Finches Green and the houses along the north-south lane are not marked. Positions of house and nearby stable block along with associated drives and paths are accurately shown.

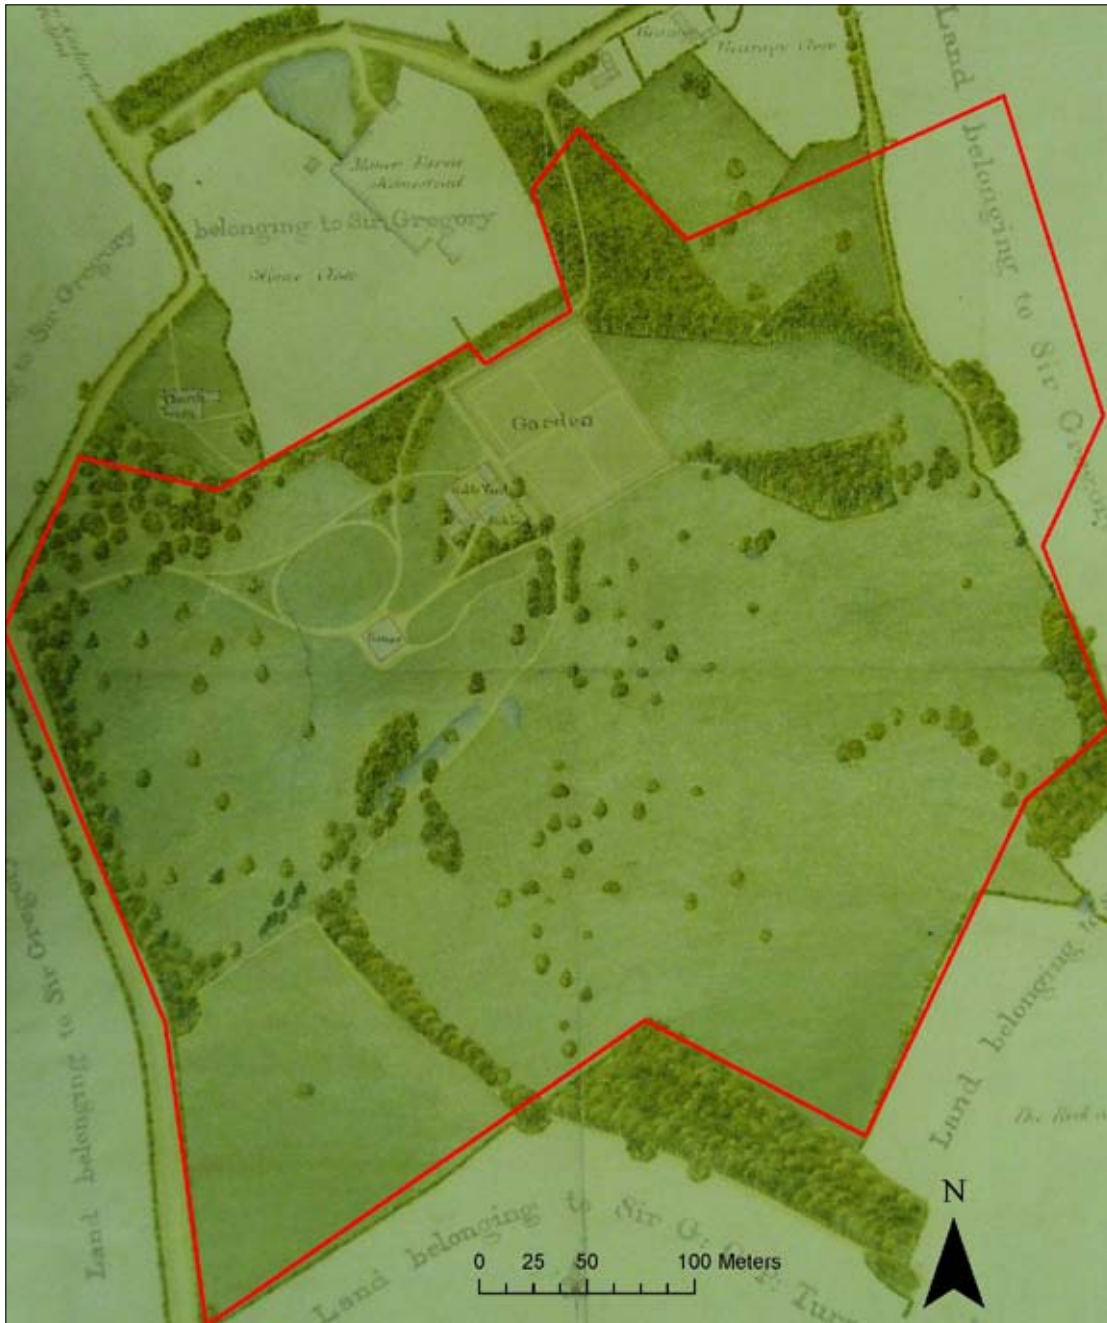
Figure 21. Study Area on a second 1827 Plan of Sundon Park, showing proposed new house (Bedfordshire and Luton Archive and Record Service T42/606)

A second plan of 1827 (Figure 21) shows the old house and most of the stable block now demolished, together with the design for a new and smaller house just to the south.

Although this was never built, and the proposed re-configuration of carriage-drives never laid out, the plan still gives a good impression of the broader layout of Sundon Park at the time of house demolition - at least once the planned but unstated features have been subtracted from the scene.
