RESEARCH REPORT SERIES no. 5-2013

# FELTON PARK HALL GREENHOUSE, FELTON, NORTHUMBERLAND CHEMICAL ANALYSIS OF WINDOW GLASS

TECHNOLOGY REPORT

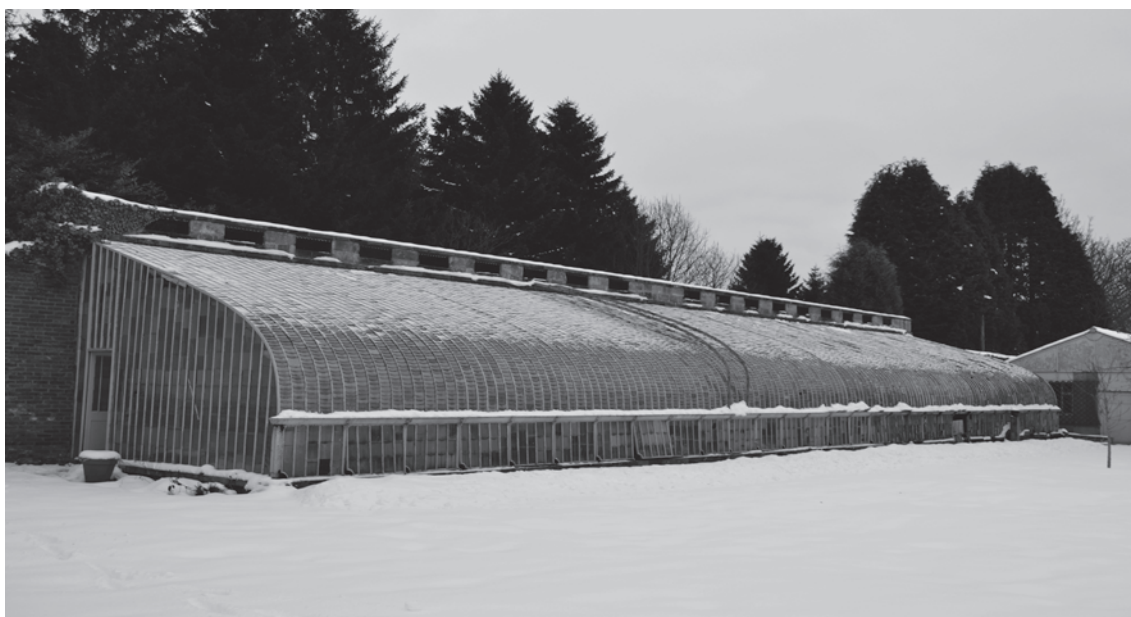
*Figure 1. Felton Park Hall Greenhouse.*

To the east of Felton Park Hall stands a lean-to cast and wrought iron greenhouse (Fig 1) with a potting shed that incorporates an 18th-century garden wall. The greenhouse, considered to have been constructed c1830, displays a 'curved pent roof and fish scale glazing' (Pevsner and Richards 1972, 281). English Heritage, as part of the 'Building at Risk'

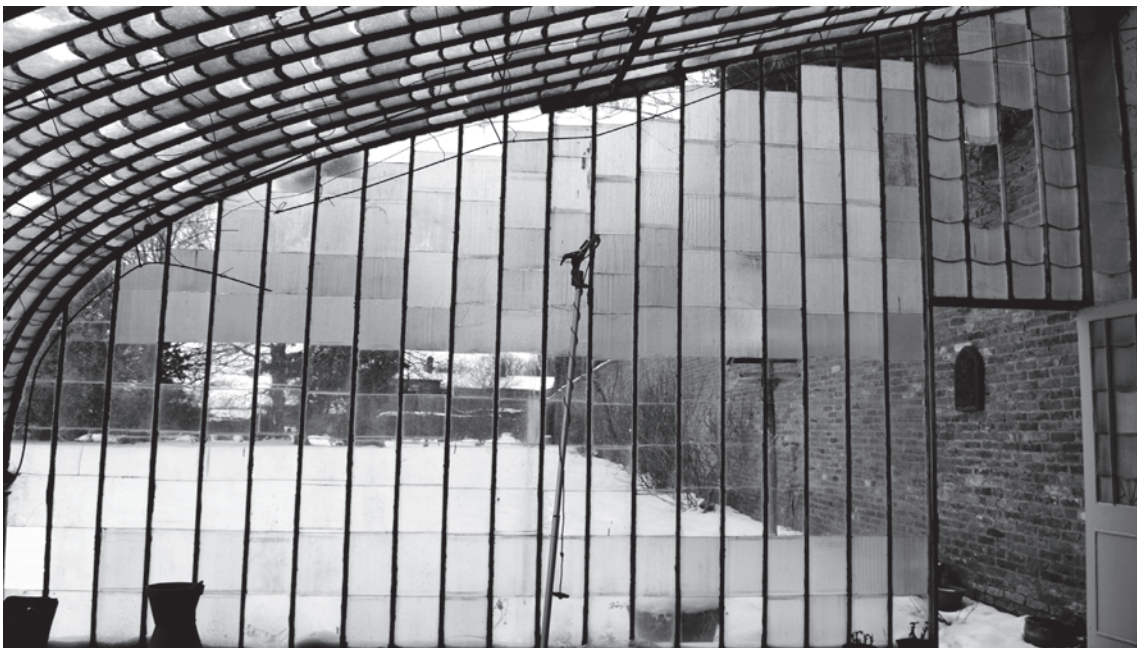
*Figure 2. The west end of the greenhouse, comprising of an iron door complete with fish scale glazing. This can also be seen in the panel about the door. The glass in this end wall varies in thickness and chemical composition, and hence manufacturing dates.*

Batch 2 consisted of 21 samples, containing only plain flat glass, without colour or texture, from each area of the greenhouse: both east and west end glass walls (Figure 2), the south-east and south-west windows (Figure 1) and the central dividing glass wall (Figure 8). The samples ranged in thickness from 1.6mm to 3.6mm with some variation in thickness discernible in most samples. Many of the samples provided distorted images

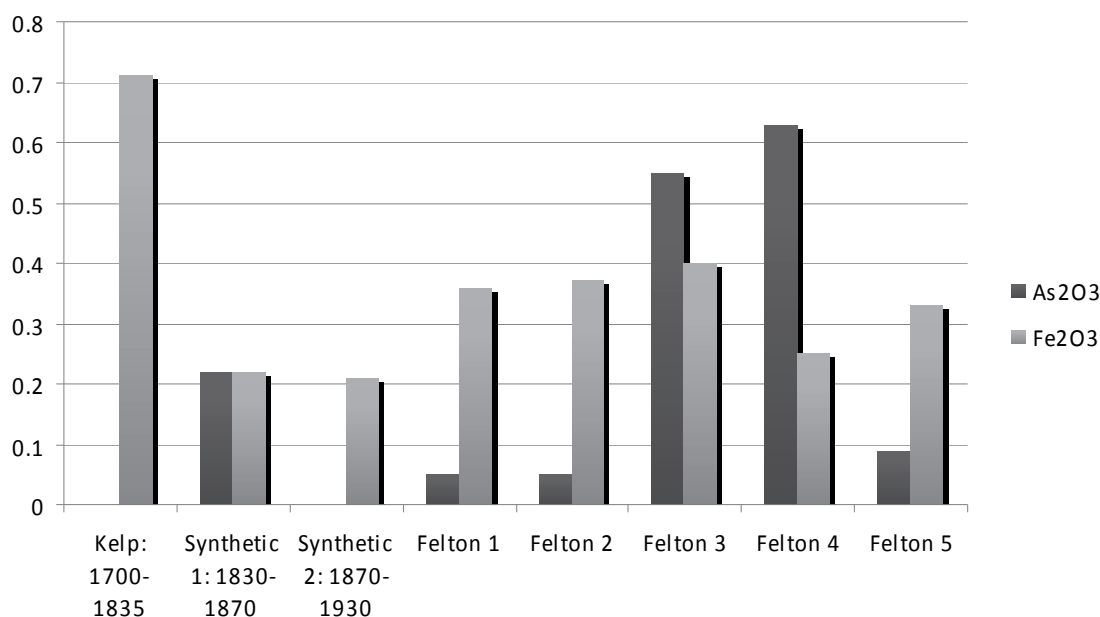
Figure 5. The iron and arsenic composition of Felton Park Hall greenhouse window glass. The elevated arsenic composition is consistent with production from 1830 to 1870
