# OAKHAM CASTLE, CASTLE LANE, OAKHAM, RUTLAND

# TREE-RING ANALYSIS OF TIMBERS

SCIENTIFIC DATING REPORT

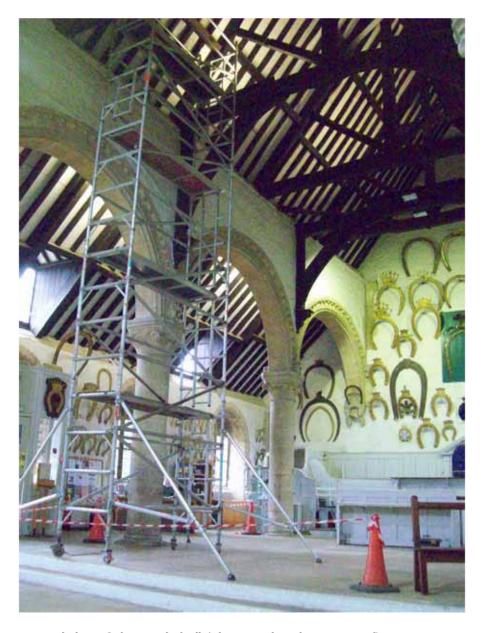
Figure 3: General view of the Castle hall (photograph Robert Howard)

The earliest structures of Oakham Castle (Figs 1 and 2) are thought to date to the AD 1080s when a timber hall, defended by a keep with a motte and ditch, is first mentioned. Later, in AD 1340, the inner bailey of the castle is described as containing a building with four rooms, a chapel, a kitchen, gaol, stables, and barns. There was also an aisled stone hall, presumably a replacement for the earlier timber one. The site is further described at this time as being 'well walled', the stone curtain believed to have been built in the thirteenth century, and 'with a drawbridge' across a moat. Beyond the walls there were gardens and fishponds.

Almost all of these structures have since disappeared, with only parts of the curtain wall and the stone hall now remaining. It is this stone hall which is referred to as 'Oakham Castle'. On the basis of the stylistic evidence of the arcade capitals (almost identical to those of the choir at Canterbury Cathedral, begun in AD 1175) it is believed that the hall was built *c* AD 1180–90, almost certainly for Walkelin de Ferrers (died AD 1201), and if correct, Oakham would be the earliest hall of any English castle to survive so completely.

Internally a series of piers and arcades divide the body of the hall into four bays, whereas the present roof, which has traditionally been believed to be a later replacement, is of six bays formed by five king-post trusses and the two gable end walls (Fig 3). In addition to king-posts, tiebeams, and principal rafters, the trusses have collars and angled struts from the shouldered base of the king-post to the principal rafters. Also, in addition to the five trusses there are two lateral, intermediate beams at arcade top level, between trusses 1–2 and 4–5. These beams are supported by curved arch-braces which spring from short wall-posts.

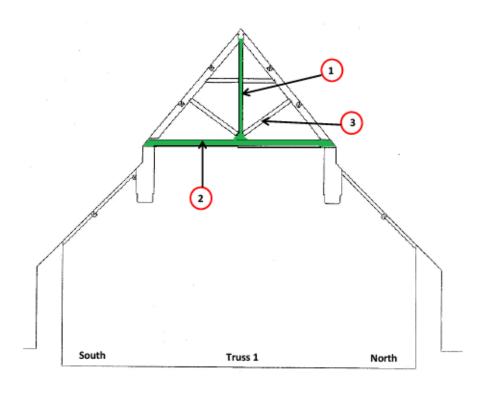
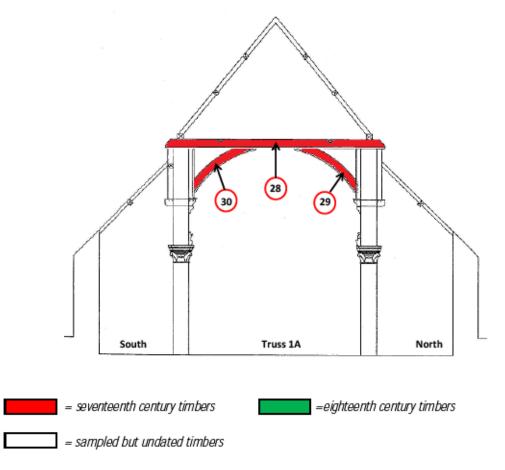
Figure 4a/b: Cross sections of the trusses to show sampled timbers (after Nick Hill)

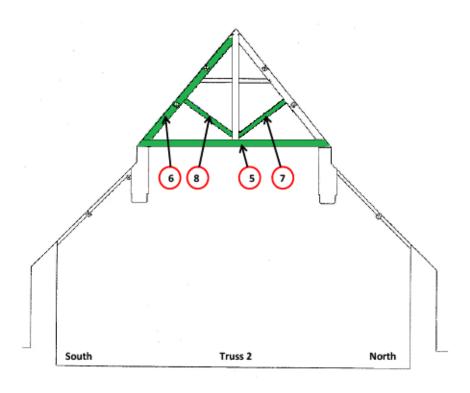
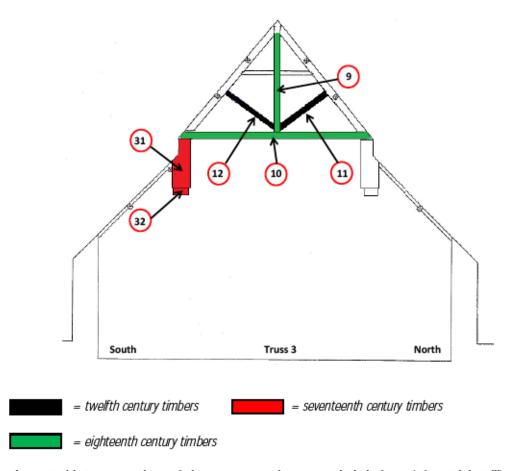
Figure 4c/d: Cross sections of the trusses to show sampled timbers (after Nick Hill)

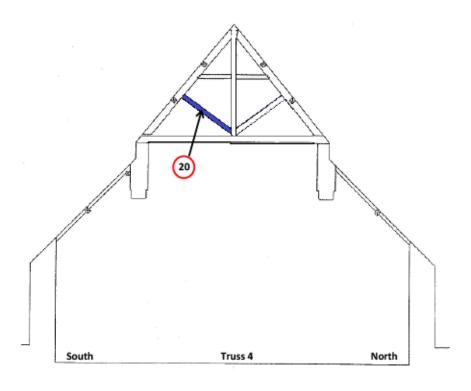
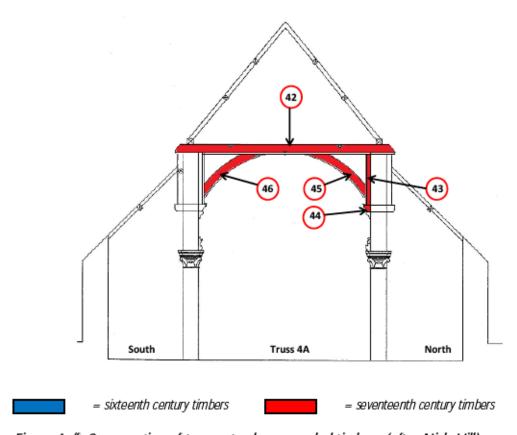
Figure 4e/f: Cross section of trusses to show sampled timbers (after Nick Hill)

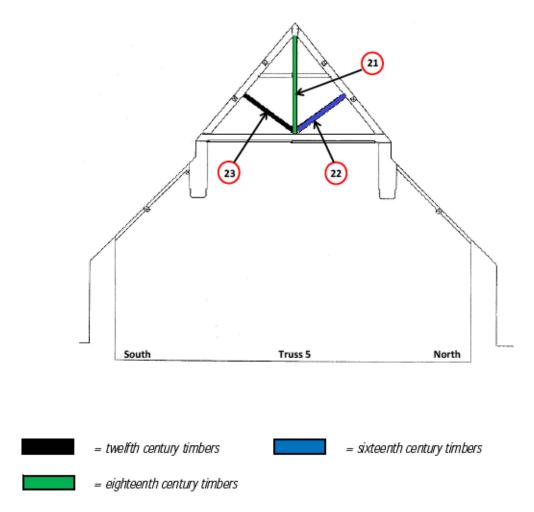
Figure 4g: Cross section of trusses to show sampled timbers (after Nick Hill)

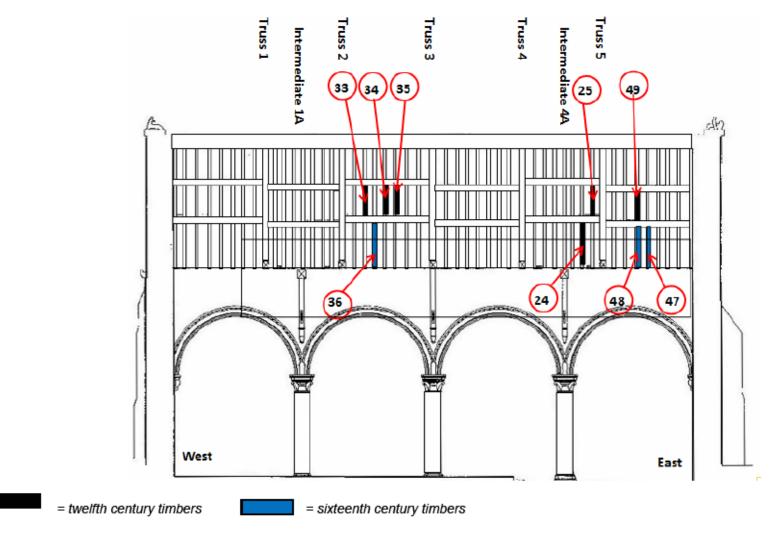
Figure 4h: Long-section looking north to show sampled timbers (after Nick Hill)

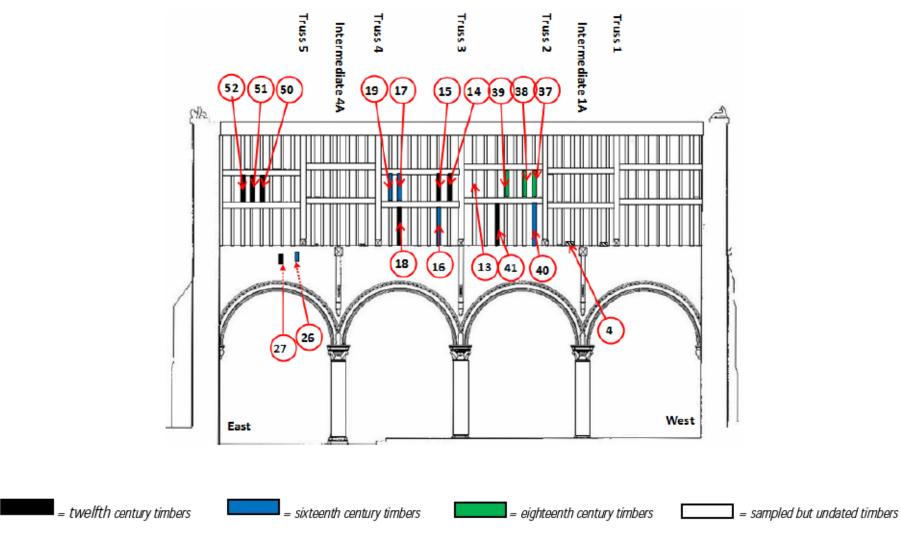
Figure 4i: Long-section looking south to show sampled timbers (after Nick Hill)

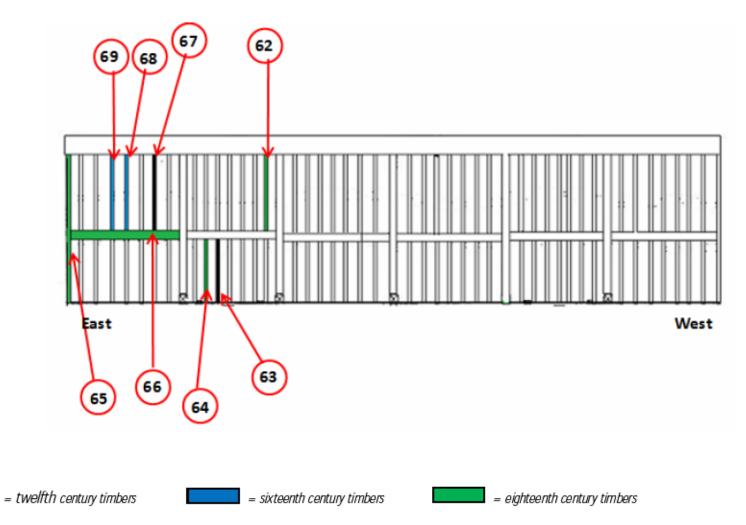
Figure 4k: South aisle roof to show sampled timbers (after Nick Hill)

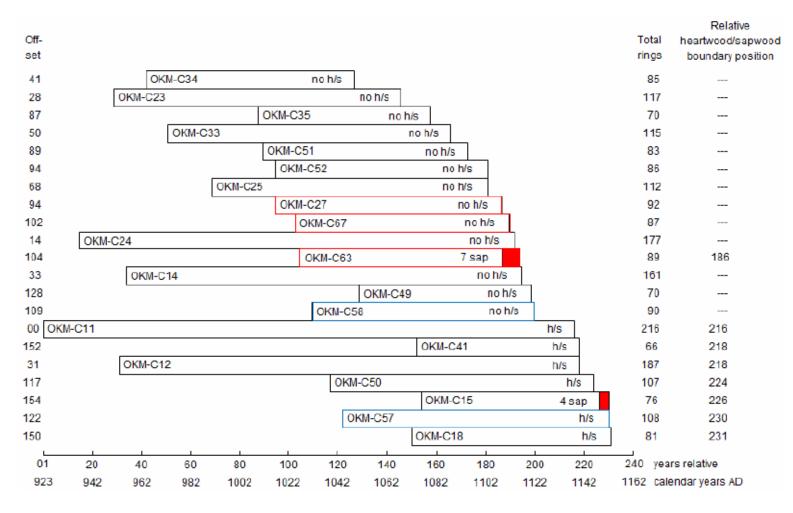
White fill = heartwood rings; shaded fill = sapwood rings; h/s = the heartwood/sapwood ring is the last ring on the sample Black outline \_\_\_\_\_ = hall timbers, \_\_\_\_\_ = north aisle timbers, \_\_\_\_ = south aisle timbers

Figure 5: Bar diagram of the samples in site chronology OKMCSQ01

The earliest dated material detected in this programme of analysis appears to be represented by the 21 samples of site chronology OKMCSQ01 (Fig 5) which are mostly timbers from the main hall roof with three from the south aisle roof and two from the north aisle roof. The majority of these timbers show clear evidence for reuse. None of the 21 samples in this site chronology retains complete sapwood and it is thus not possible to give a precise felling date for any of the timbers represented. Seven of these samples do, however, retain the heartwood/sapwood boundary at a relatively consistent position and date, this meaning that they are likely to represent a single, or fairly close-set, phase of felling. Within these seven samples the sapwood boundary varies by 15 years from AD 1138 (OKM-C11) to AD 1153 (OKM-C18), the average date of the boundary on the seven samples being AD 1145. Using a 95% confidence limit of 15–40 rings for the amount of sapwood these trees might have had would give the timbers represented an estimated felling date in the range AD 1160–85.

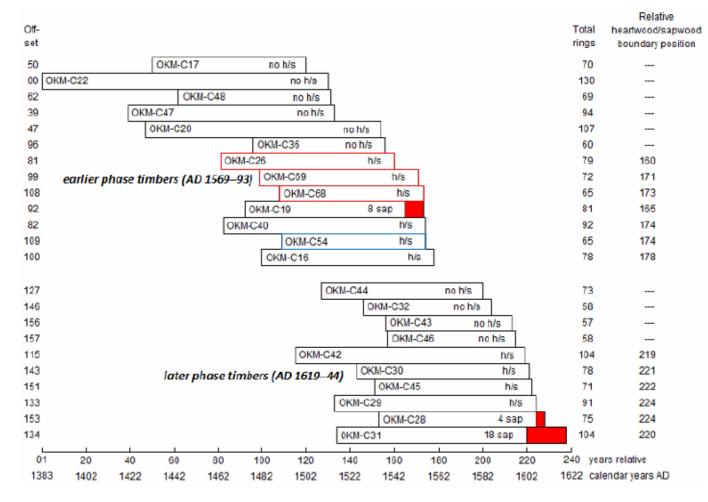
White fill = heartwood rings; shaded fill = sapwood rings; h/s = the heartwood/sapwood ring is the last ring on the sample Black outline = hall timbers, = north aisle timbers, = south aisle timbers

Figure 6: Bar diagram of the samples in site chronology OKMCSQ02

Site chronology OKMCSQ02 would appear to represent two distinct phases of felling amongst its 23 constituent samples (Fig 6), an earlier sub-group and a slightly later sub-group. Again, none of the samples in this site chronology retains complete sapwood and it is not possible to give a precise felling date for any of the timbers.

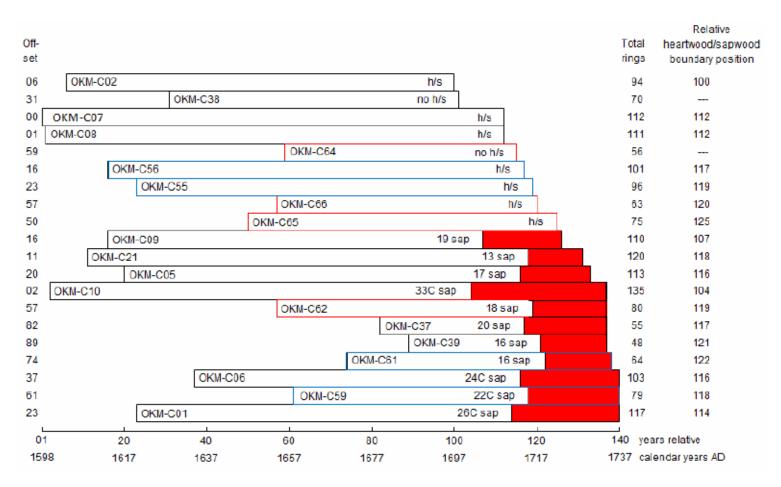
White fill = heartwood rings; shaded fill = sapwood rings; h/s = the heartwood/sapwood ring is the last ring on the sample C = complete sapwood is retained on the sample; the last measured ring date is the felling date of the tree represented Black outline = hall timbers, = north aisle timbers, = south aisle timbers

Figure 7: Bar diagram of the samples in site chrsonology OKMCSQ03

The latest episode of felling is represented by the 20 dated samples of site chronology OKMCSQ03 (Fig 7), which are predominantly from timbers of the hall roof, but also includes four north-aisle timbers and four south-aisle timbers. None of the sampled timbers show any evidence for reuse. Four of these samples, OKM-C01, C06, C10, and C59, retain complete sapwood, this meaning they have the last growth ring produced by the tree represented before they were cut down. Sample OKM-C10, from the hall, has a last complete sapwood ring date of AD 1734, and samples OAK-C01, C06, again from the hall, and C59, from the north aisle, have identical complete sapwood ring dates of AD 1737. These are thus the felling dates of the trees represented, there appearing to be no obvious difference in date between the hall and the north aisle.

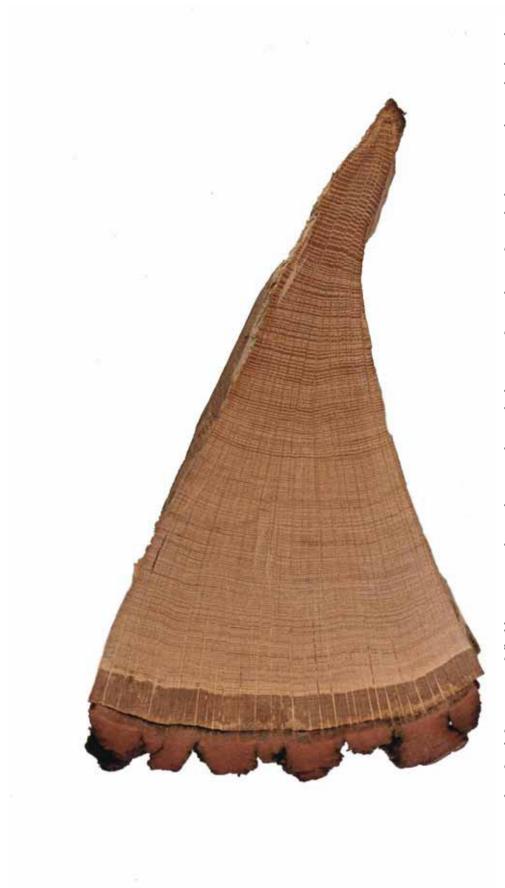
Figure A1: A wedge of oak from a tree felled in 1976. It shows the annual growth rings, one for each year from the innermost ring to the last ring on the outside just inside the bark. The year of each ring can be determined by counting back from the outside ring, which grew in 1976

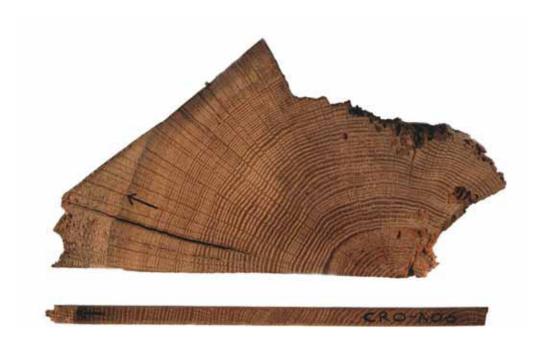
Figure A2: Cross-section of a rafter, showing sapwood rings in the left-hand corner, the arrow points to the heartwood/sapwood boundary (H/S); and a core with sapwood; again the arrow is pointing to the H/S. The core is about the size of a pencil

Quite often some, though not all, of the original outer rings are missing on a timber. The outer rings on an oak, called sapwood rings, are usually lighter than the inner rings, the heartwood, and so are relatively easy to identify. For example, sapwood can be seen in the corner of the rafter and at the outer end of the core in Figure A2, both indicated by arrows. More importantly for dendrochronology, the sapwood is relatively soft and so liable to insect attack and wear and tear. The builder, therefore, may remove some of the sapwood for precisely these reasons. Nevertheless, if at least some of the sapwood rings are left on a sample, we will know that not too many rings have been lost since felling so that the date of the last ring on the sample is only a few years before the date of the original last ring on the tree, and so to the date of felling.

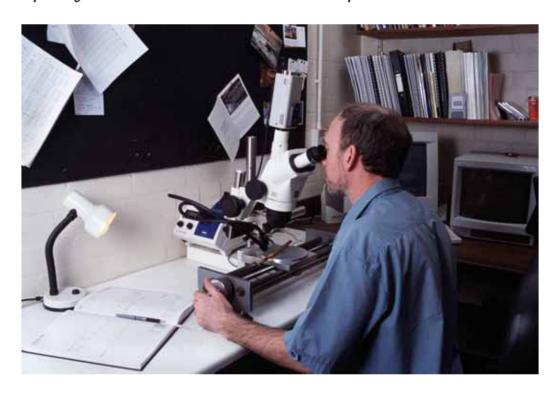
Figure A3: Measuring ring widths under a microscope. The microscope is fixed while the sample is on a moving platform. The total sequence of widths is measured twice to ensure that an error has not been made. This type of apparatus is needed to process a large number of samples on a regular basis

- 2. Measuring Ring Widths. Each core is sanded down with a belt sander using medium-grit paper and then finished by hand with flourgrade-grit paper. The rings are then clearly visible and differentiated from each other with a result very much like that shown in Figure A2. The core is then mounted on a movable table below a microscope and the ring-widths measured individually from the innermost ring to the outermost. The widths are automatically recorded in a computer file as they are measured (see Fig A3).

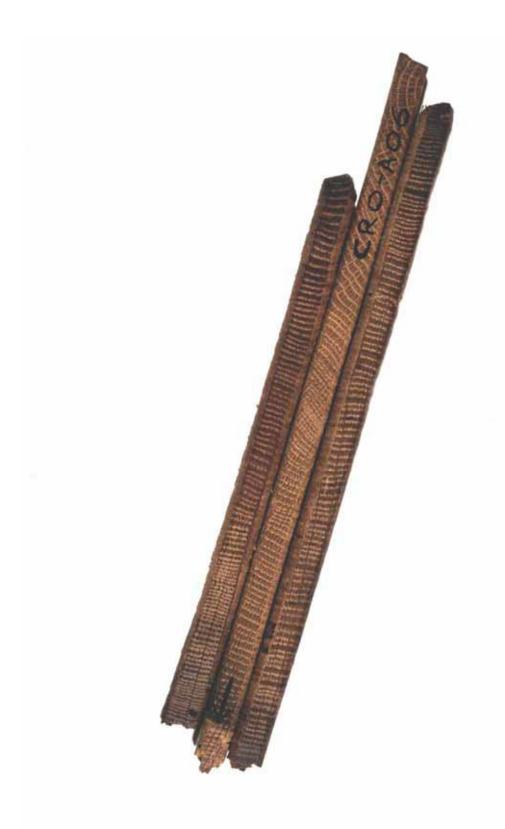
Figure A4: Three cores from timbers in a building. They come from trees growing at the same time. Notice that, although the sequences of widths look similar, they are not identical. This is typical

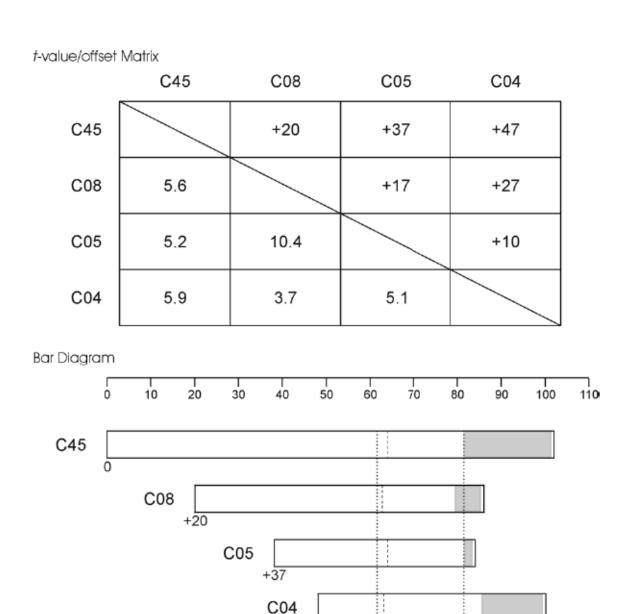
SITE SEQUENCE

The bar diagram represents these sequences without the rings themselves. The length of the bar is proportional to the number of rings in the sequence. Here the four sequences are set at relative positions (offsets) to each other at which they have maximum correlation as measured by the t-values. The t-value/offset matrix contains the maximum t-values below the diagonal and the offsets above it. Thus, the maximum t-value between C08 and C45 occurs at the offset of +20 rings and the t-value is then 5.6. The site sequence is composed of the average of the corresponding widths, as illustrated with one width

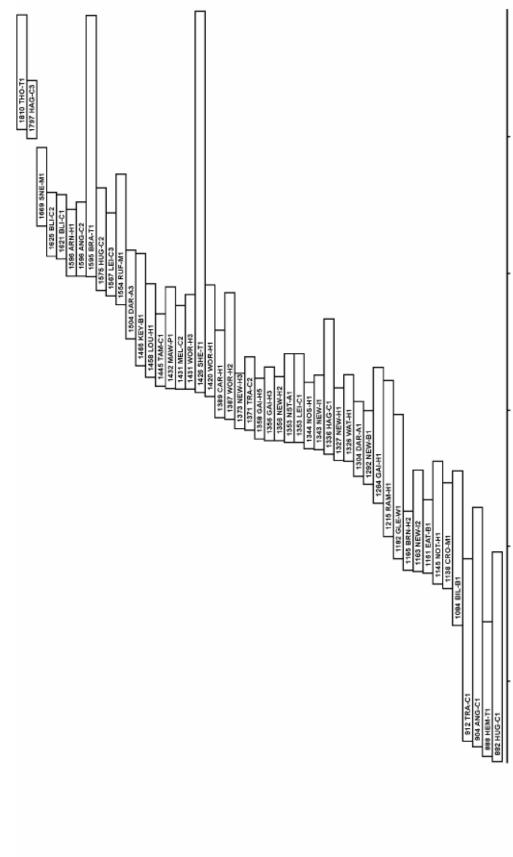
Figure A6: Bar diagram shöWing the relative positions and dates of the first rings of the compositent site sequences in the East Midlands Master Dendrochronological Sequence, EM08/87

sequence of widths whose dates are known and this means beginning with a sequence from an oak tree whose date of felling is known. In Figure A6 such a sequence is SHE-T, which came from a tree in Sherwood Forest which was blown down in a recent gale. After this other sequences which cross-match with it are added and gradually the sequence is 'pushed back in time' as far as the age of samples will allow. This process is illustrated in Figure A6. We have a master chronological sequence of widths for Nottinghamshire and East Midlands oak for each year from AD 882 to 1981. It is described in great detail in Laxton and Litton (1988), but the components it contains are shown here in the form of a bar diagram. As can be seen, it is well replicated in that for each year in this period there are several sample sequences having widths for that year. The master is the average of these. This master can now be used to date oak from this area and from the surrounding areas where the climate is very similar to that in the East Midlands. The Laboratory has also constructed a master for Kent (Laxton and Litton) 1989). The method the Laboratory uses to construct a master sequence, such as the East Midlands and Kent, is completely objective and uses the Litton-Zainodin grouping procedure (Laxton et al 1988). Other laboratories and individuals have constructed masters for other areas and have made them available. As well as these masters, local (dated) site chronologies can be used to date other buildings from nearby. The Laboratory has hundreds of these site sequences from many parts of England and Wales covering many short periods.

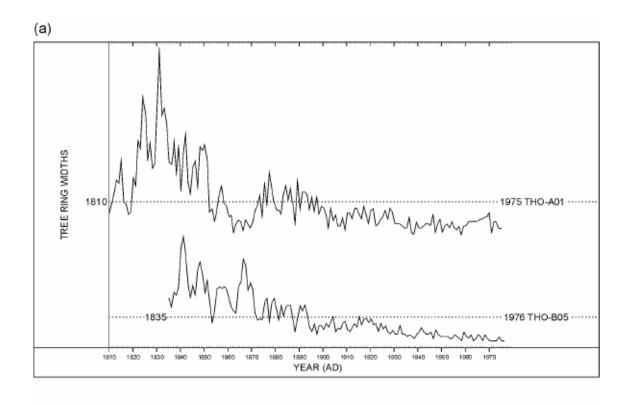
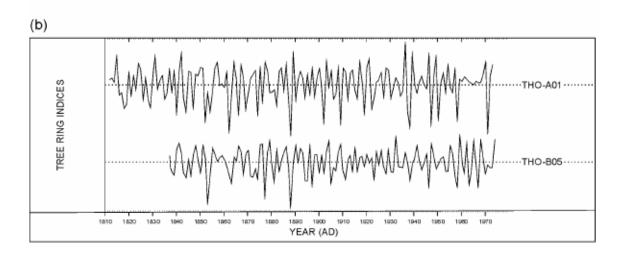
Figure A7 (a): The raw ring-widths of two samples, THO-A01 and THO-B05, whose felling dates are known

Here the ring widths are plotted vertically, one for each year, so that peaks represent wide rings and troughs narrow ones. Notice the growth-trends in each; on average the earlier rings of the young tree are wider than the later ones of the older tree in both sequences
