APETHORPE HALL, APETHORPE, NORTHAMPTONSHIRE OPENING UP: VOLUME FOUR

HISTORIC BUILDING REPORT

Nick Hill

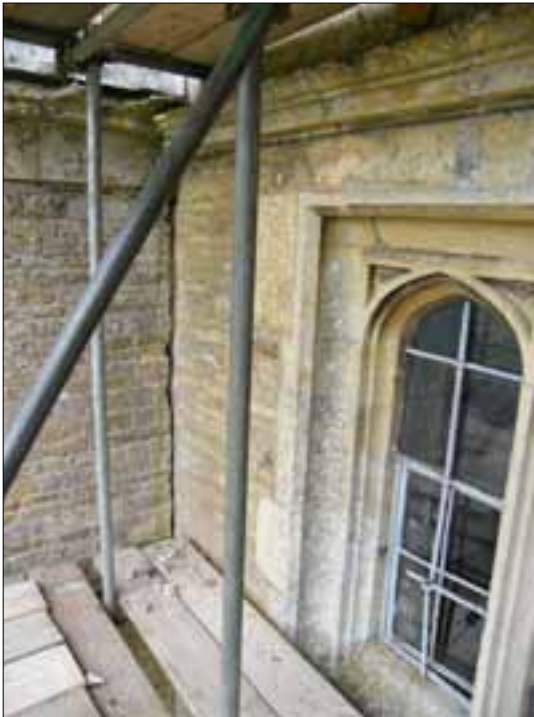
Fig 1.1 Junction of the north face of the Gatehouse tower (right) with the Library block (left) (Nick Hill).

A plaster finish to the masonry of the north face of the gatehouse has been trapped and preserved behind the 1740s addition of the Library block (figs 1.1 and 1.2). The Library masonry abuts the tower with a straight joint, and the plaster finish runs in behind this for the upper two storeys of the tower. The plaster is around 15mm thick, with no clearly discernible paint finish. It has been marked out with imitation ashlar joints, scribed or pressed into the plaster finish. The plasterwork pre-dates the 1740s addition, and might be the original late 15th century work. Early plasterwork can be seen surviving over rubble masonry on various parts of the main north and south faces to the tower on early photos, but was later removed in these locations.

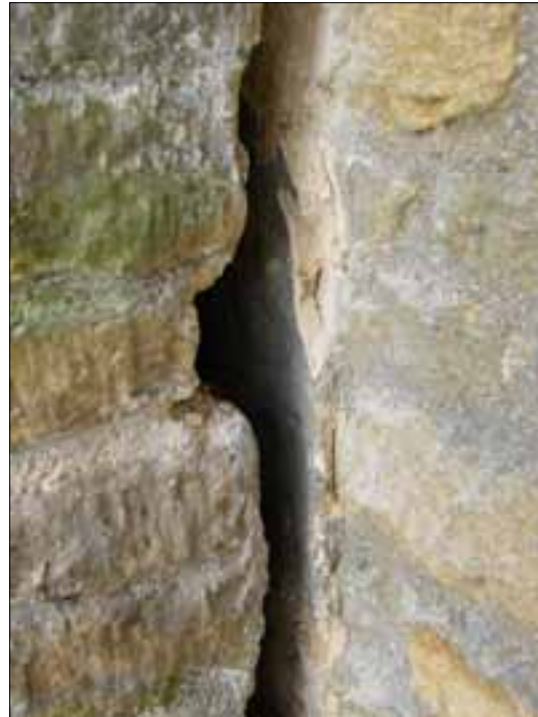
Fig 1.2 Plaster finish to rubble masonry of gatehouse, trapped by addition of Library block. An ashlar joint pressed into the plaster face is visible (Nick Hill).

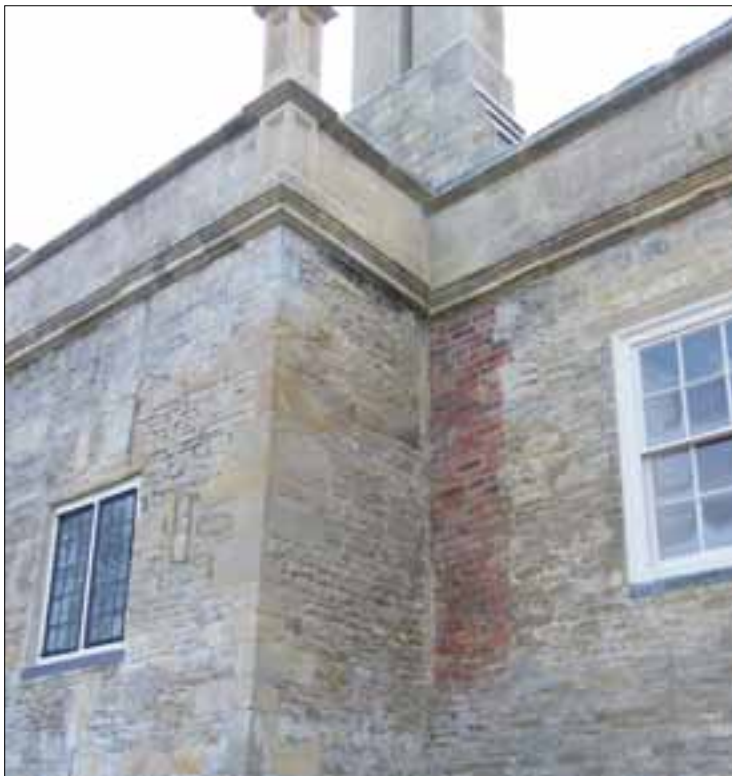
Fig 2.1 Junction of garderobe block with north wall of north range (Nick Hill).

A plaster finish to the wall of the north elevation of the north range has been trapped and preserved behind the later addition of the garderobe block (figs 2.1, 2.2 and 2.3). The north range wall here has a later inserted chimneystack of brick, but it seems the plaster finish, which would have been applied to earlier rubble masonry, has survived the insertion of the brick stack. The plaster finish survives only to the first floor section of the wall junction, as the ground floor walling has been refaced.

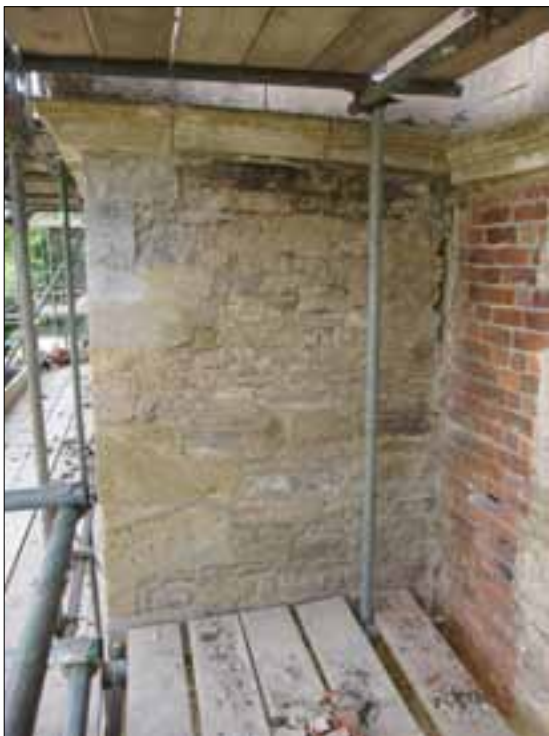
Fig 2.2 Junction of garderobe block (left) and north wall of the north range (right) (Nick Hill).

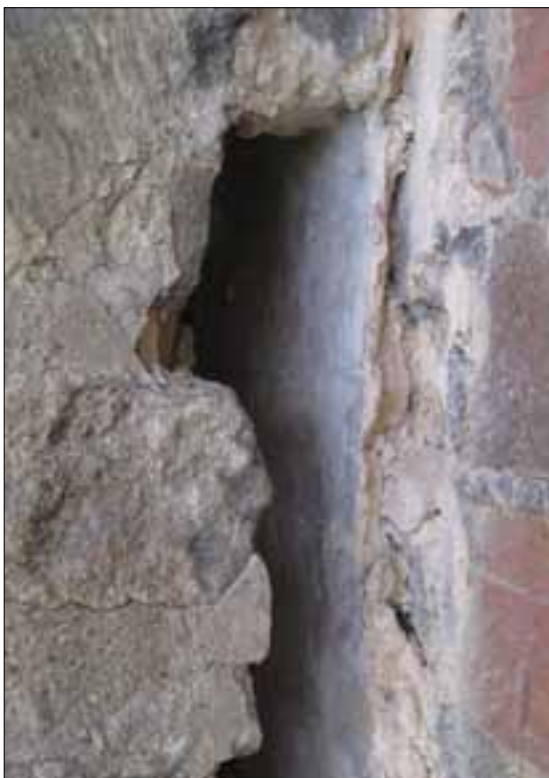
Fig 2.3 Plaster finish to north range, trapped by addition of western section of garderobe block (to left) (Nick Hill).

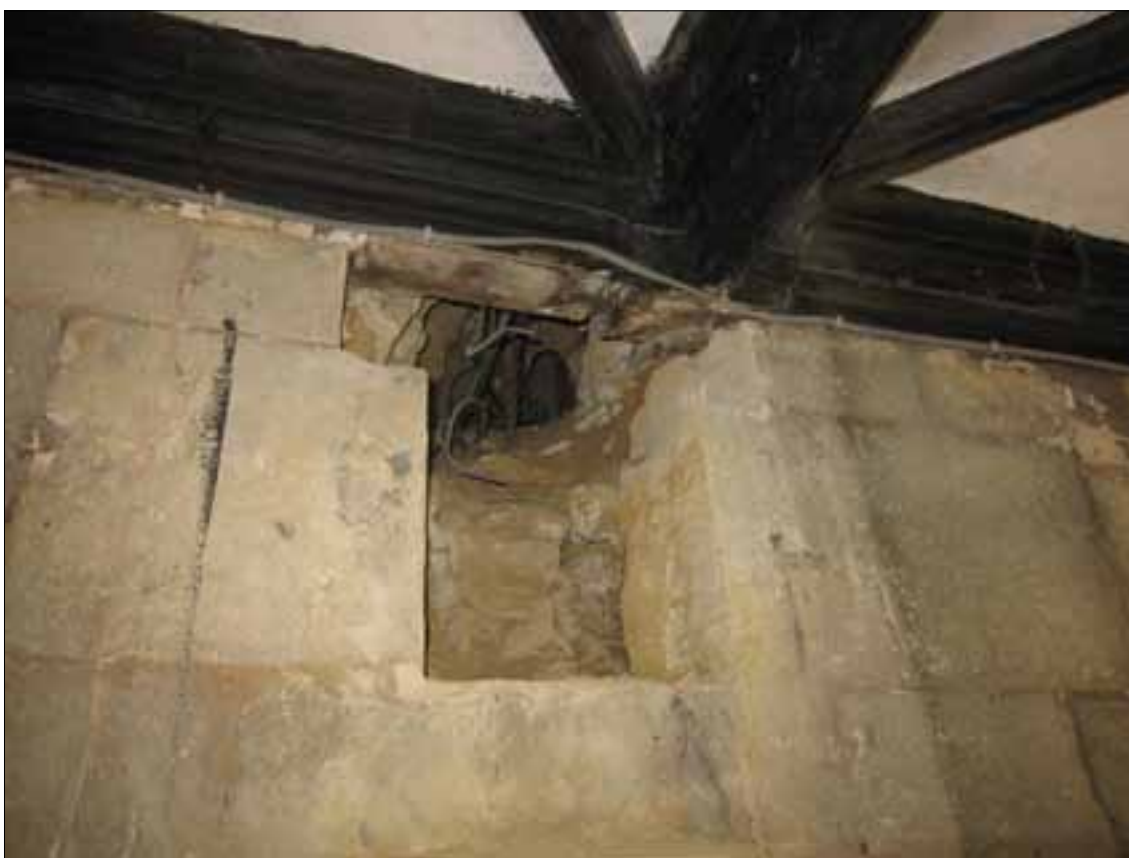
Fig 3.1 East face of Gatehouse entry, with stone ashlar lining (Nick Hill).

Several blocks of ashlar masonry were cut out for repair to the east wall here (figs 3.1 and 3.2). It was observed that the ashlar is well bonded to the rubble core of the wall structure and is of irregular thickness. It is also set in the same clay-based mortar as the wall core. This indicates that the ashlar facing to the east (and west) walls of the entry area is the original late 15th century finish, not a later re-facing. Mason's marks were previously noted on the stone blocks here, which also indicated that the stone facing is original. It is interesting that an expensive ashlar finish was used here, in contrast to the external walling, where ashlar was used only for dressings, with plaster finish on rubble stone for the main wall faces. This entrance area was clearly an important space.

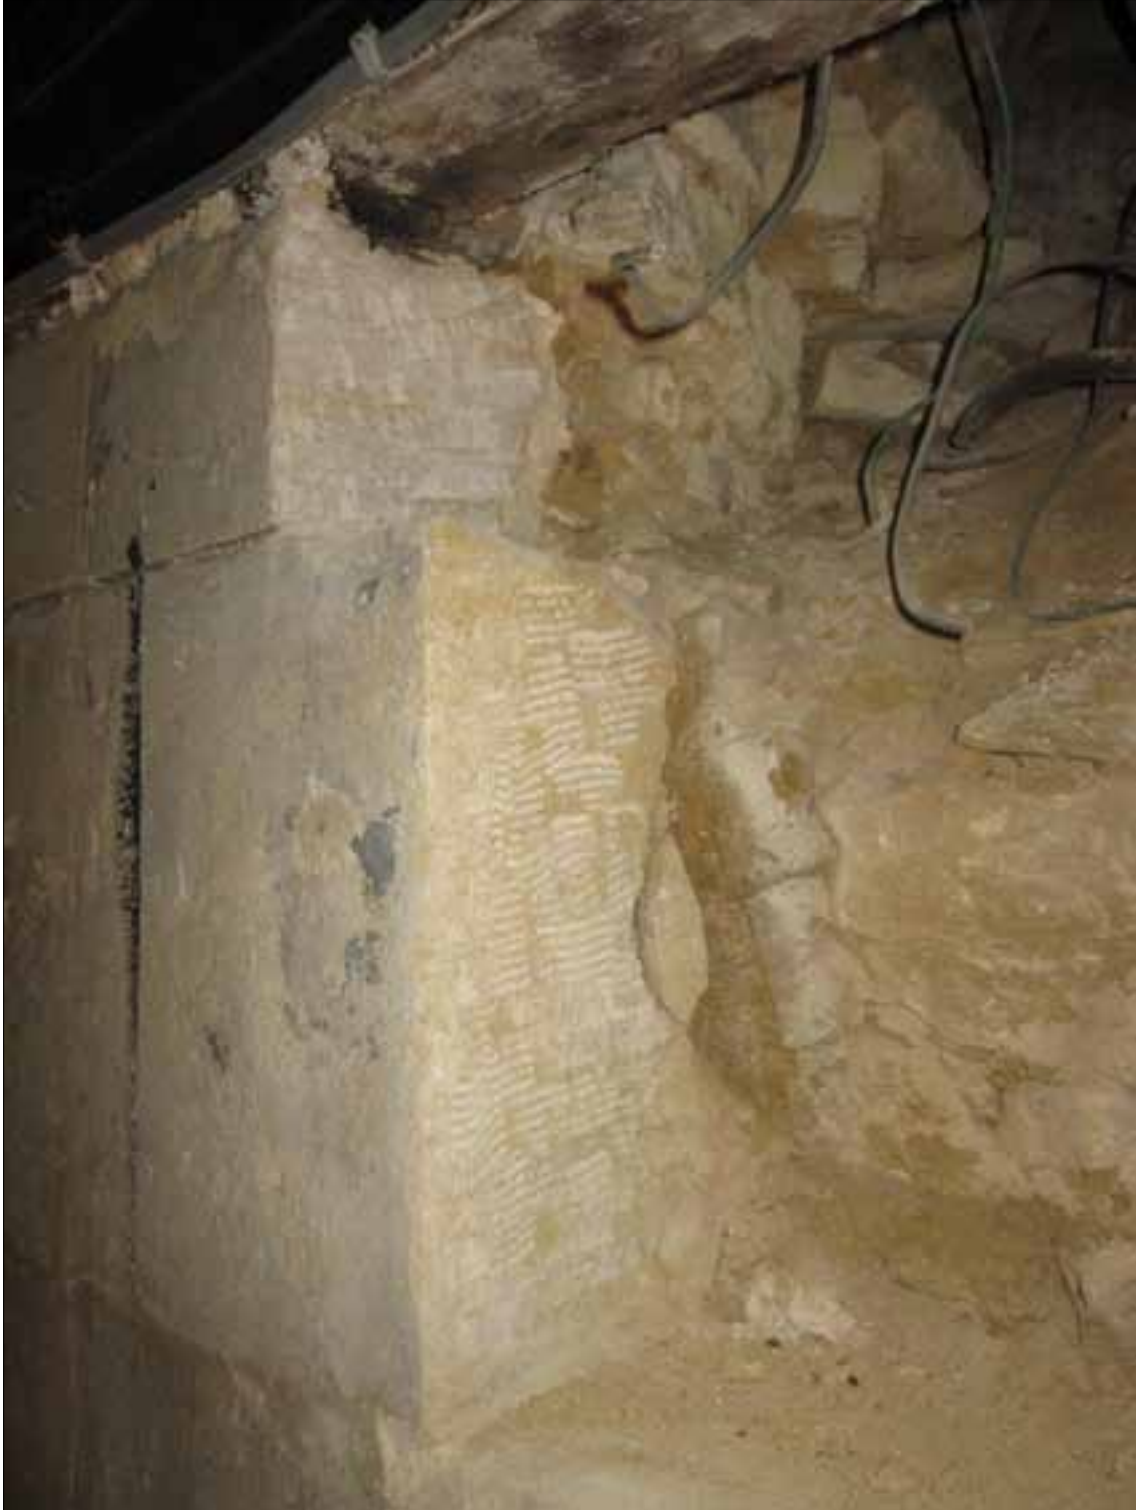
Fig 3.2 Detail of stone ashlar lining, which is well bonded and integral to the 15th-century wall structure of the Gatehouse (Nick Hill).

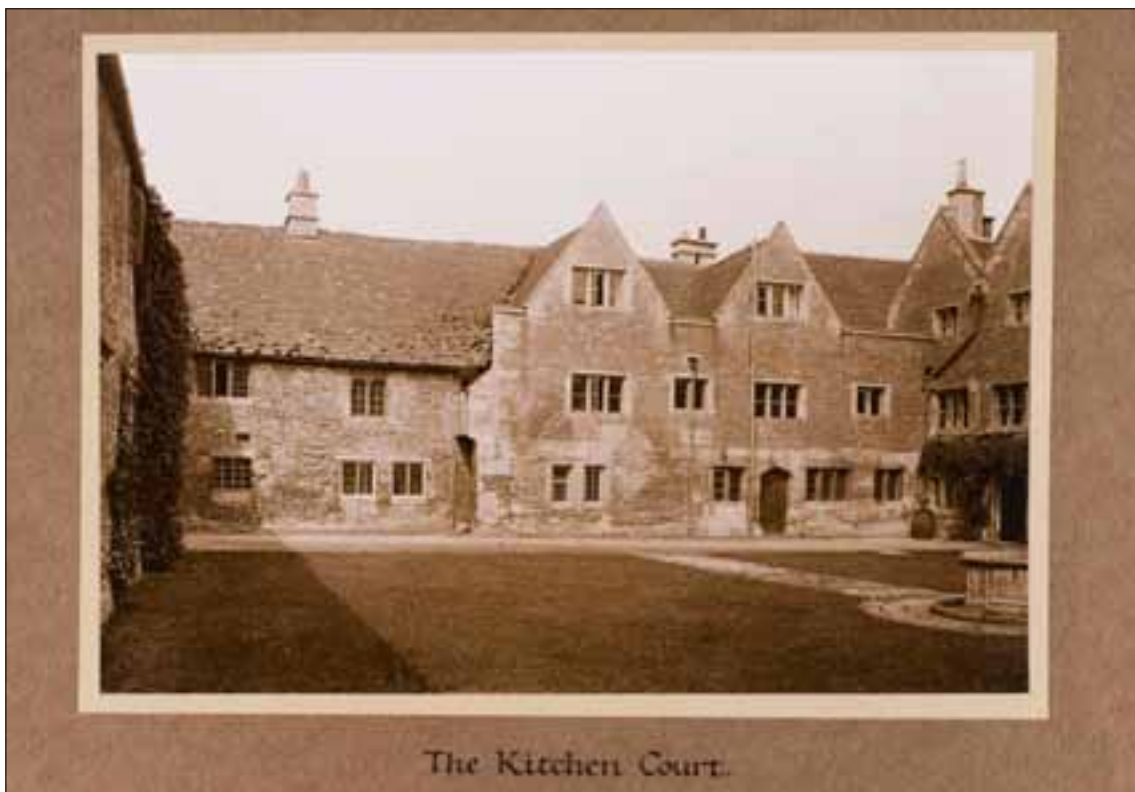
Fig 4.1 North elevation of Kitchen Court in 1922 (courtesy of Lord Brassey).

Opening up was undertaken around the external doorway at the west end of corridor NI.08. This doorway was cut through in the school era for access to the new dining room block (demolished in 2005-6). The doorway has been removed and the previous detail of a window (as shown on Brassey album photo of 1922, fig 4.1) has been restored.

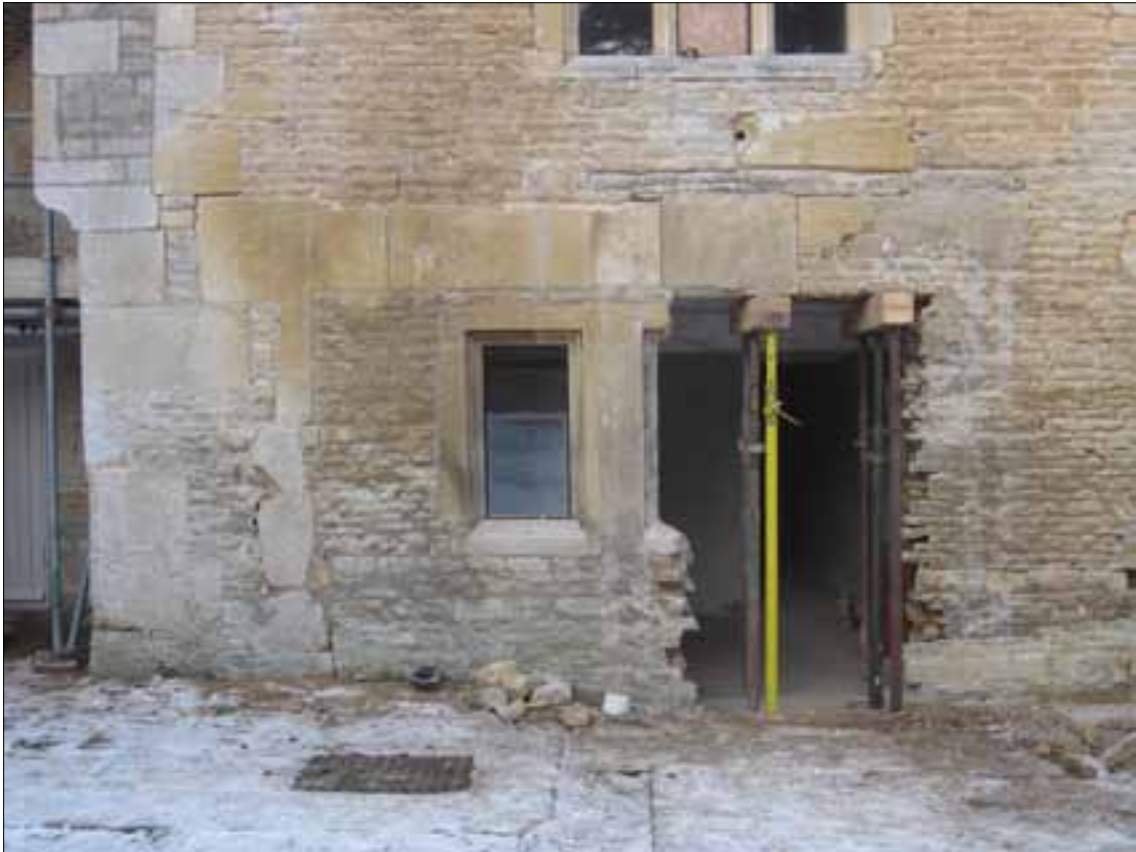
Opening up (fig 4.2) enabled inspection of more detail to the former opening here, which had a row of three large ashlar blocks across its head. This former opening is shown as a wide window on the 1858 plan. By the time of the 1913 plan, the area of NI.06a had been re-formed, with a paired set of windows (as seen on the 1922 photo see fig 4.1).

Fig 4.2 Opening up of north wall of Kitchen Court, where modern window was inserted in place of mid-20th-century doorway (Nick Hill).

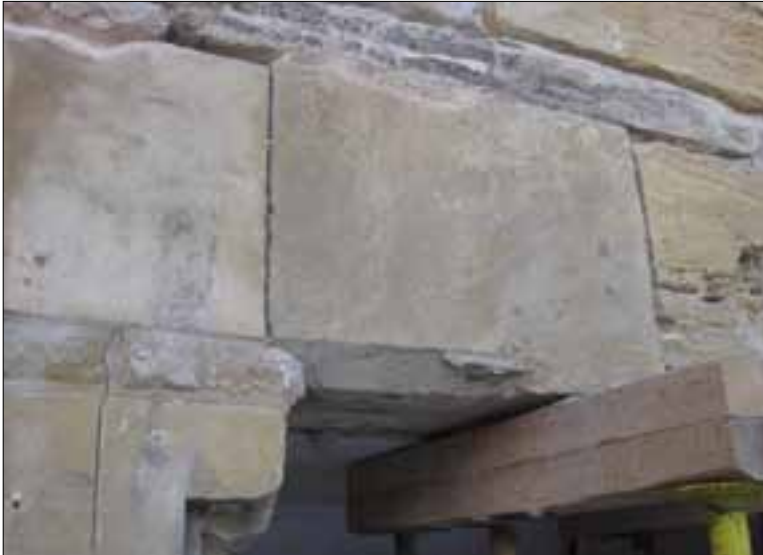
Fig 4.3 Lintel block with chamfer (Nick Hill).

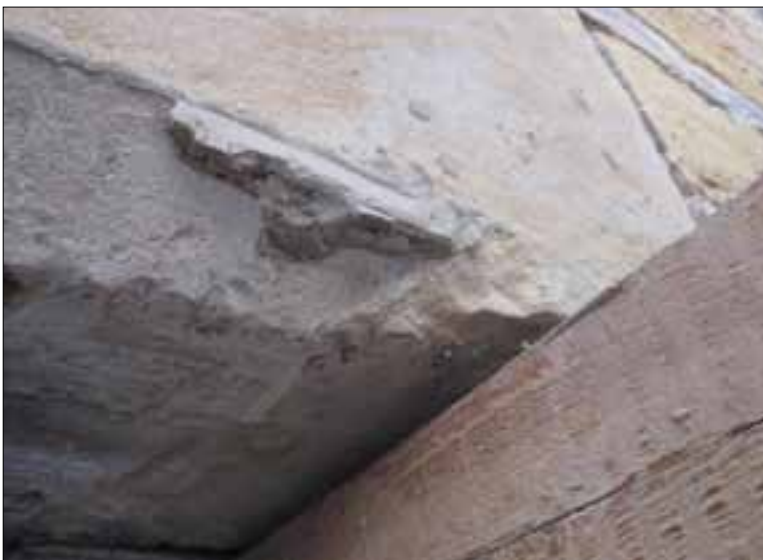
Fig 4.4 Detail of chamfer, with remains of mitred return to jamb (Nick Hill).

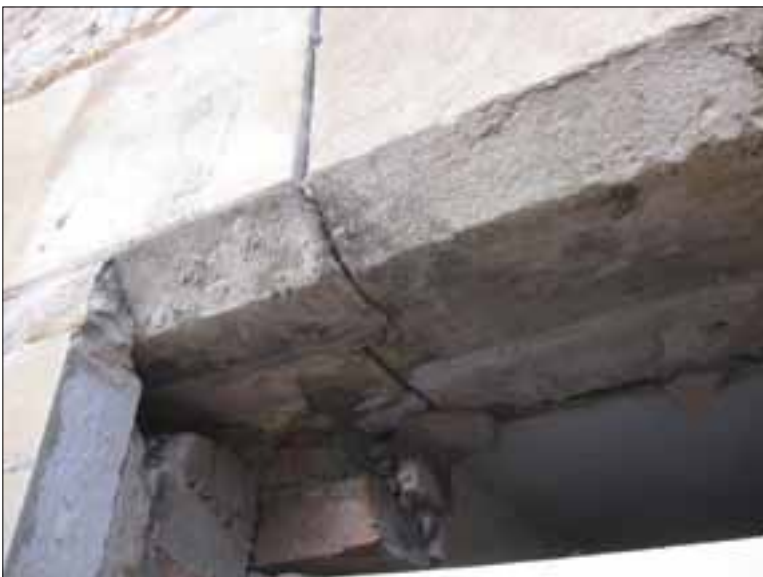
Fig 4.5 Joggled joint to lintel blocks, visible on soffit (Nick Hill).

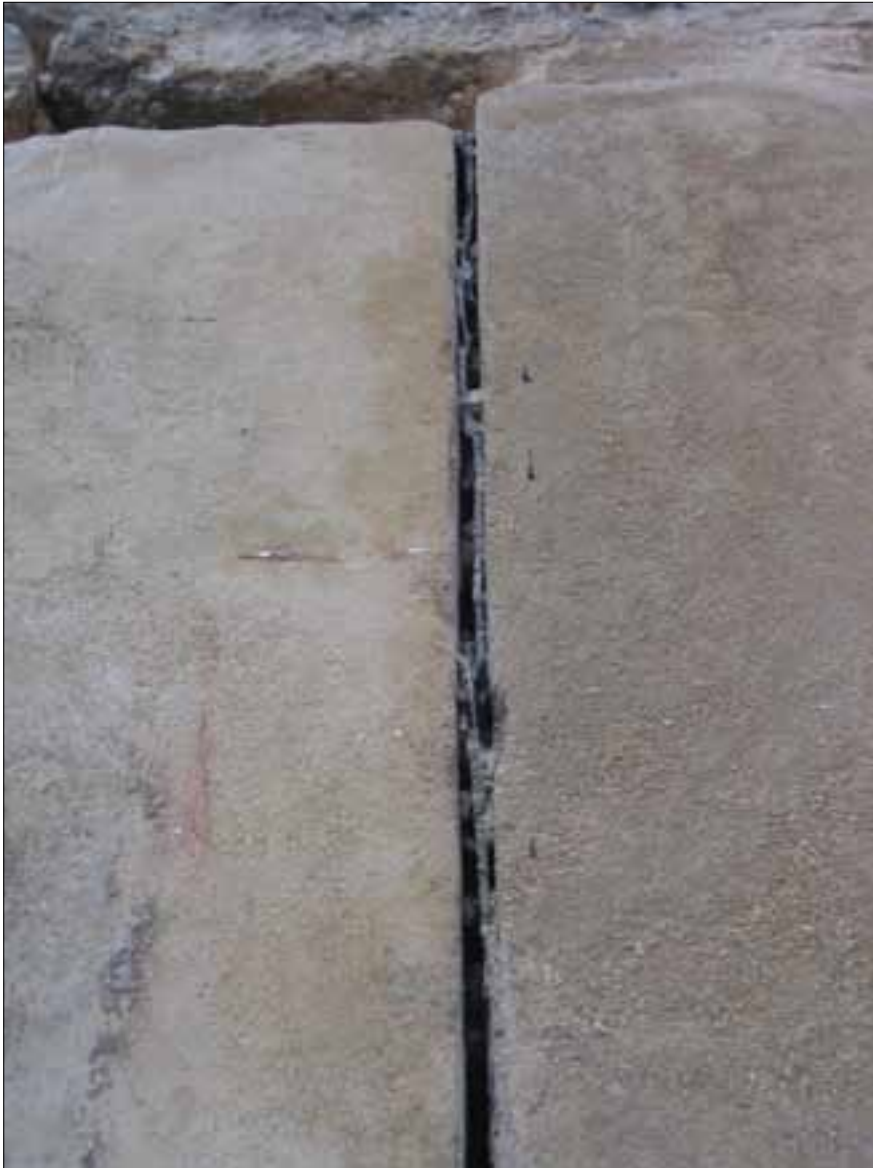
Fig 4.6 Ashlar joint filled with lead, poured in when molten (Nick Hill).

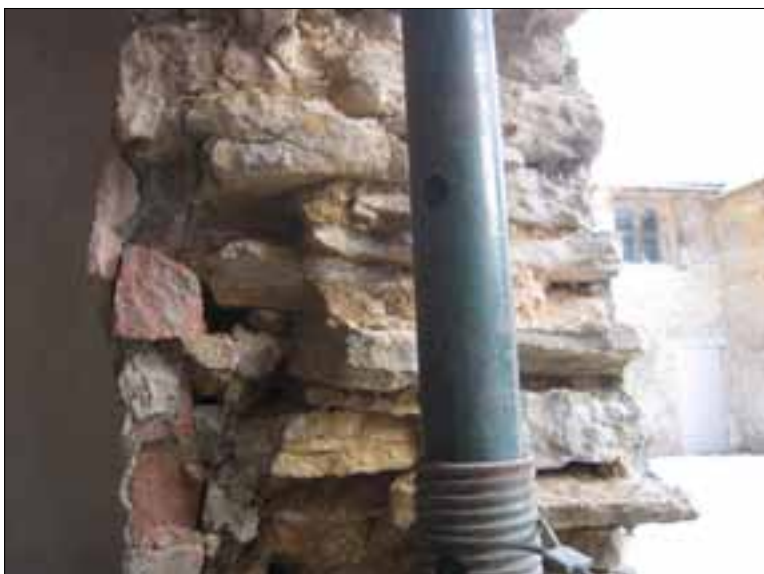
Fig 4.7 Wall core to east side of opening, with stone rubble laid in clay mortar and modern brick facing (Nick Hill).

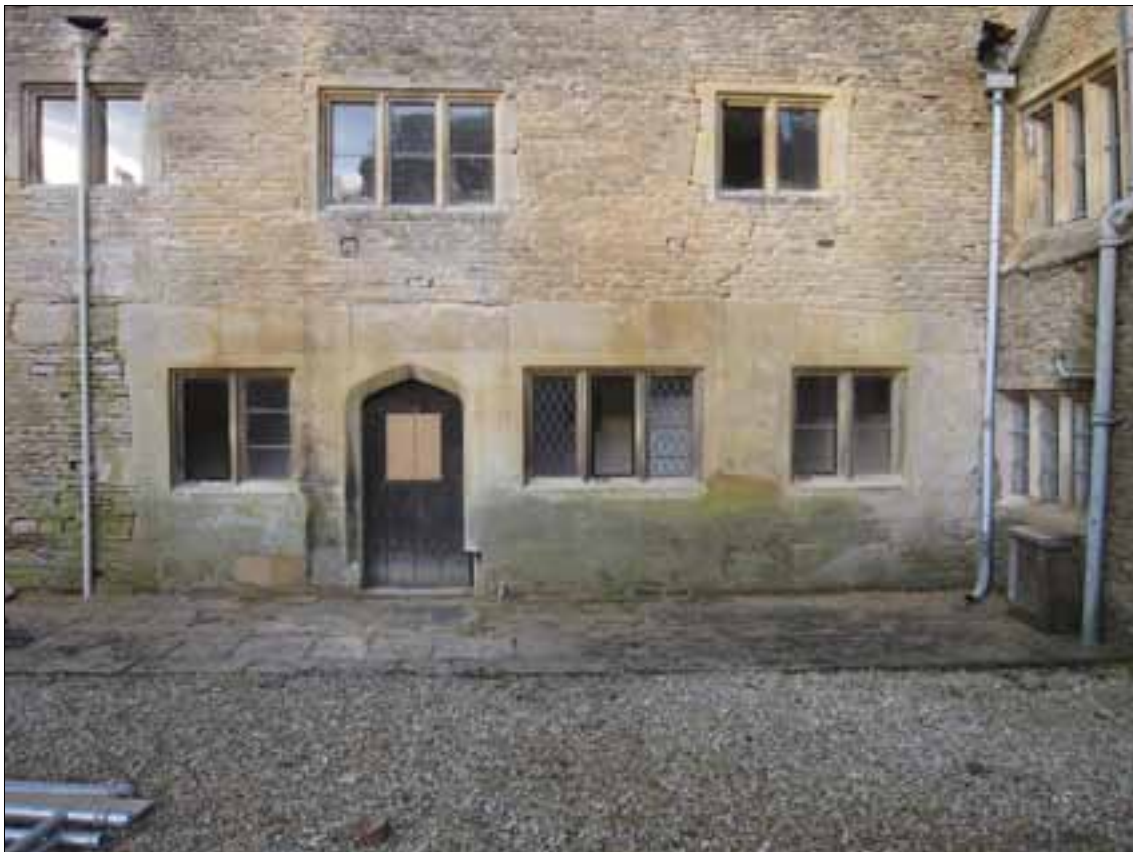
There is a further row of seven similar ashlar blocks to the east, running from the west jamb of the west window of NI.08 up to the corner junction with the hall range (fig 4.8). Raking out has indicated that these blocks also all have lead jointing to the fine vertical joints, and that the west and east jambs are square-edged. The detail at the head has not been exposed, but it seems likely that this was chamfered, as the infill blocks overlap the original masonry, indicating that the infill is cut to fill in the former chamfer. The walling above, where various areas have been raked out for repointing etc, is largely of good lime mortar, but clay mortar is visible in one or two places. The original ashlar blocks to both sections are of a fine-grained, brownish coloured limestone, with some shell, occasionally visible as narrow banding, which may be King's Cliffe stone, but could be Stamford stone (as it is very fine-grained). The large size of the stone blocks indicates that this could not be reused material.

Fig 4.8 Row of seven ashlar blocks to east, with later infill of doorway and three windows (Nick Hill)..

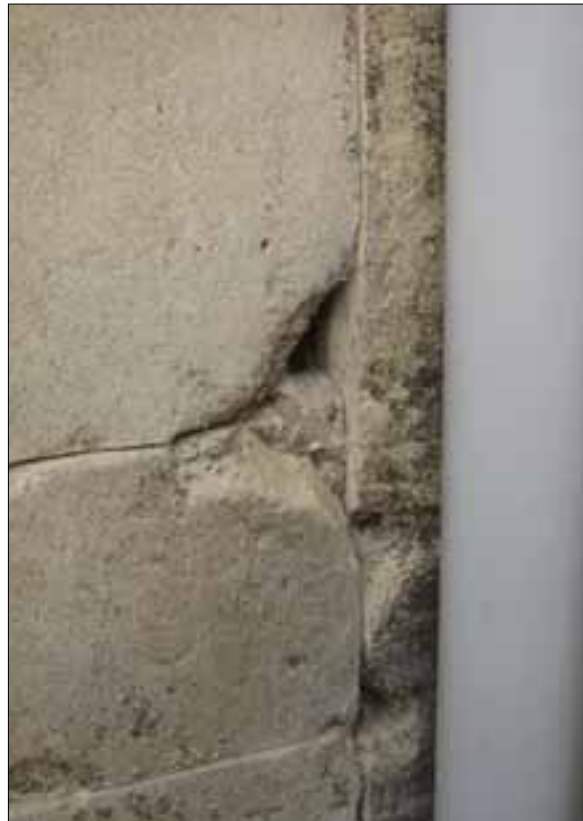
Fig 4.9 East jamb of former eastern opening, with square reveal (Nick Hill).

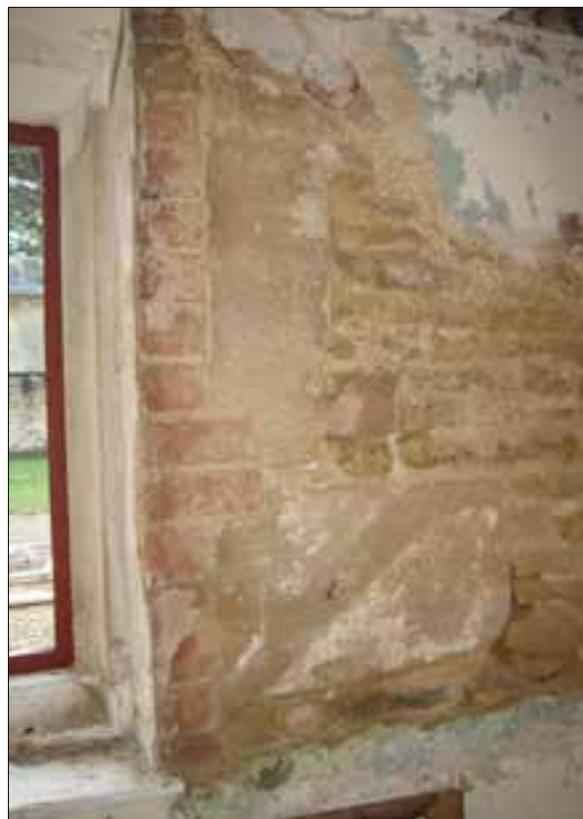
Fig 4.10 West jamb of west window to the former eastern opening, with 18th or 19th-century brickwork cut into the original jamb (Nick Hill).

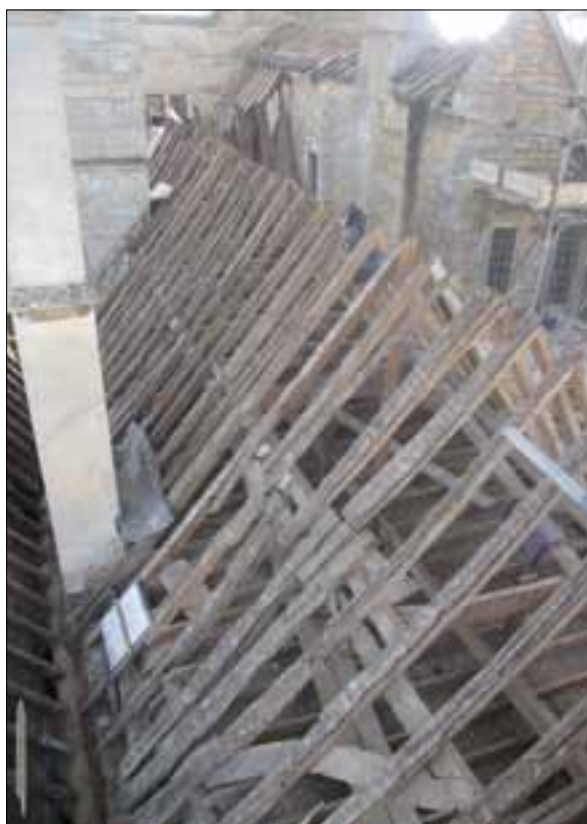
Fig 5.1 View over roof of H2.11 from the west (Nick Hill).

No tree-ring dating has been carried out to this roof. This roof is in two sections (figs 5.1 and 5.2). That to the east is arch-braced, of the same type as other late 15th-century roofs over the great chamber and parlour blocks, and is probably also late 15th century. That to the west has a single A-frame truss, which may be of the same or later date. The two sections were previously divided by a masonry wall containing chimneystacks, as shown on the 1858 plan, but removed in 1912-13, as shown on the 1913 plan.

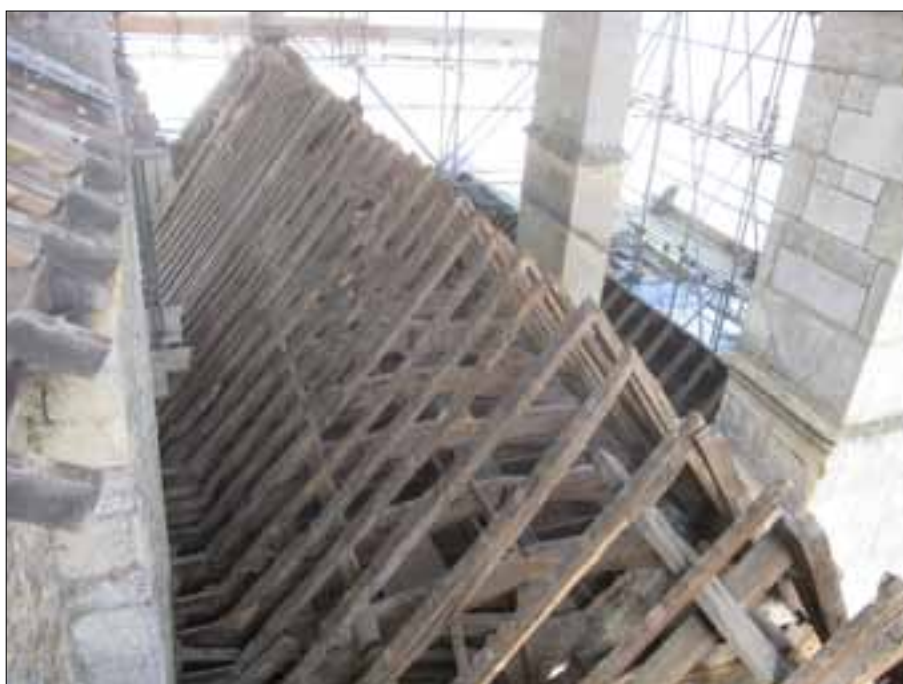
Fig 5.2 View over roof of H2.11 from the east (Nick Hill).

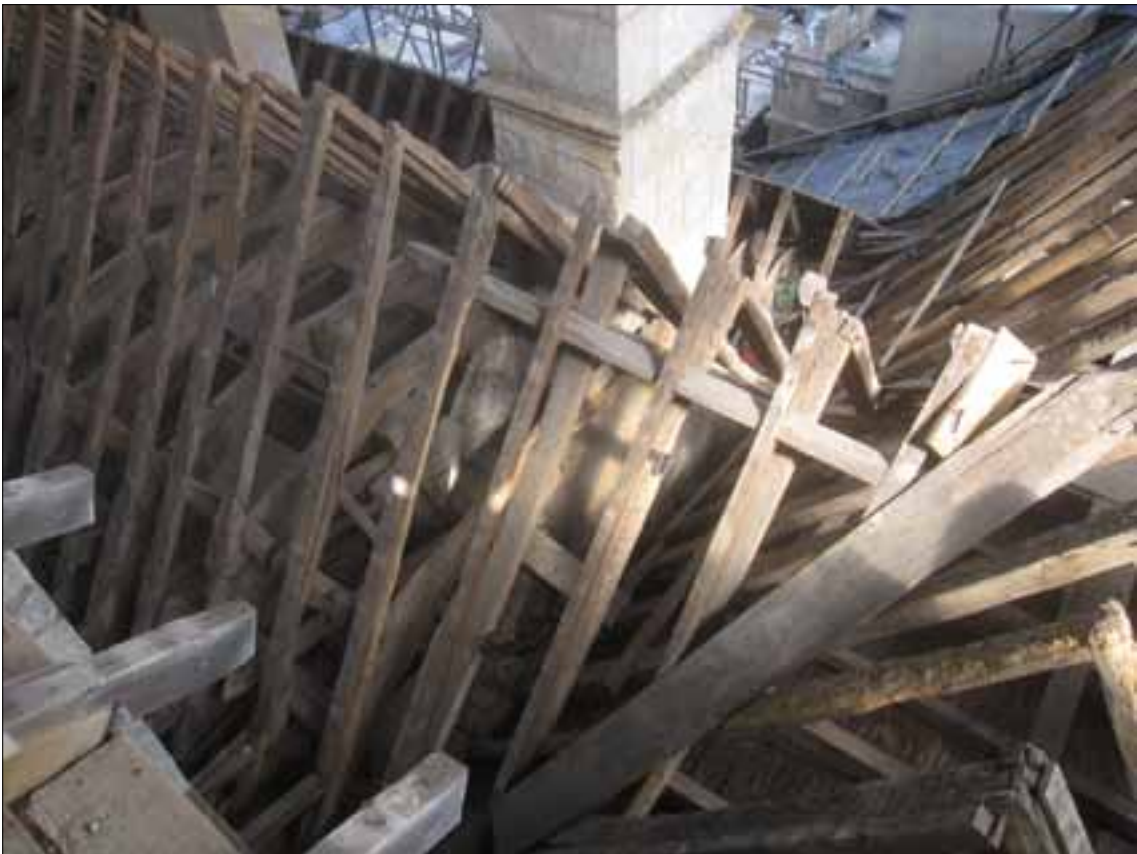
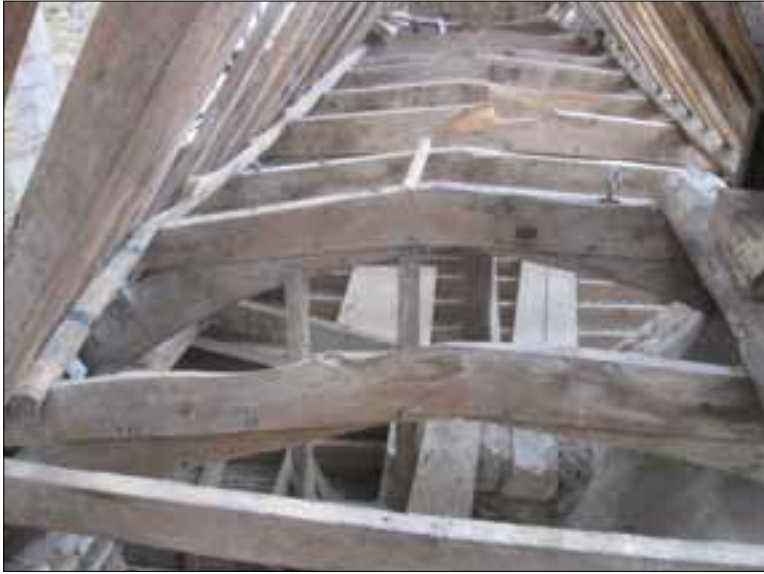
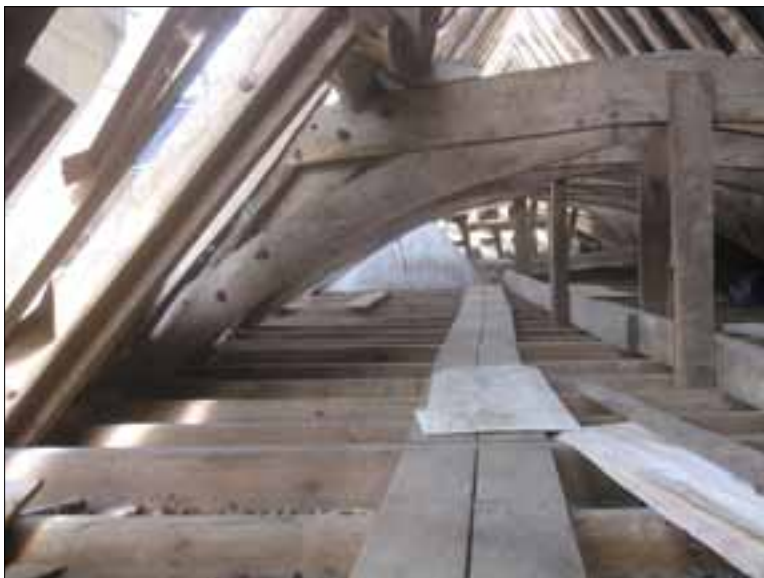
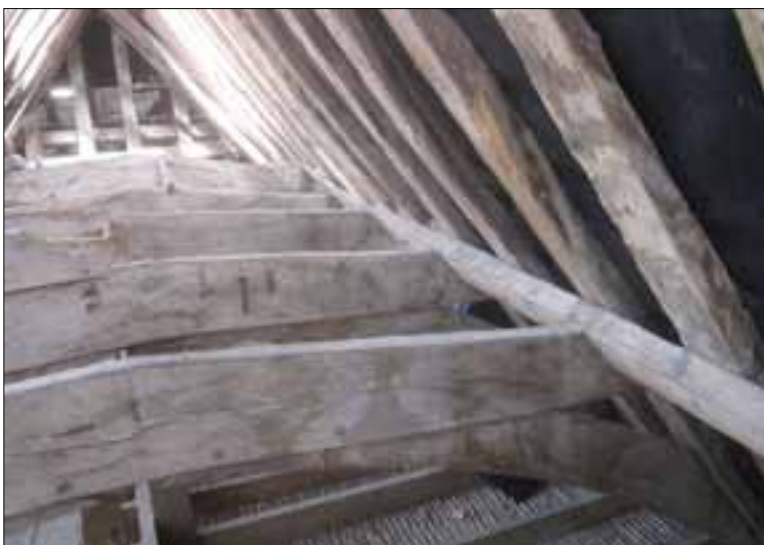
Fig 5.3 East end of roof H2.11, abutting parlour block (Nick Hill).

Fig 5.4 East section of roof H2.11, looking west (Nick Hill).

Fig 5.5 East section of roof H2.11, looking east (Nick Hill).

Fig 5.6 East section of roof H2.11, looking east (Nick Hill).

The east section is of the same vaulted type as over H2.10/12 (parlour block) and H2.06/7 (great chamber crosswing block), but with a shallower vault (figs 5.3 to 5.6). A-frame common rafter trusses with collar, arch-braces, clasped purlin and no ridge. The principal rafters do not diminish at the purlin height. The main section has eight original trusses (T2-T9) set at c.800mm centres, with a further truss (T1) in the valley junction with the parlour roof at the east end. Between these trusses are set pairs of common rafters, with no collars or braces; these provided support for the roofing slates, but not for the barrel-vaulted ceiling. The truss collars are cranked, with tenoned/pegged joints to the rafters and arch-braces. Bridle joint to rafter apex. The rafters to the intermediate rafter couples are pegged to purlins, but the main truss rafters are not. The original purlins are in a single length, with no scarf joints. Evidence shows this roof had no wind-braces. The original vaulted ceiling had laths with a long span from one truss to the next – hand-made nails, lath marks and a few pieces of lath survive. It seems this ceiling survived until the 1912-13 alterations.

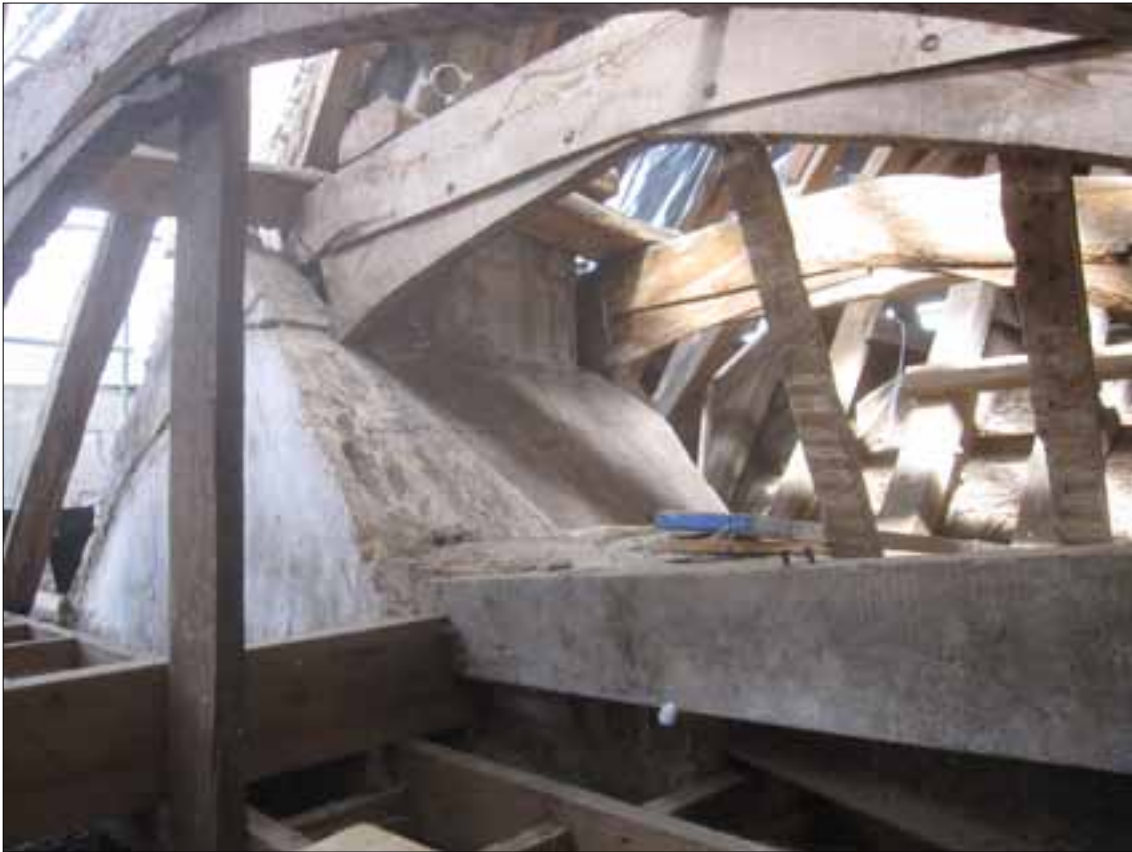
Fig 5.7 Truss T2 with south end cut off by inserted chimneystack, and canted joists to support the end of the vaulted ceiling (Nick Hill).

At the east end, to fit the line of the cross wall at the junction of H2.11 to H2.12, there is an end to the vault – simply two slanting nailed-on joists survive to show this, with some pieces of lath (fig 5.8). The next truss to the east (T2) has no nails to underside, and has much thinner arch-braces, showing that it was never designed to receive a vaulted ceiling. The stack to the north here appears to be a later insertion, as it cuts into and is built around the north end of both trusses T2 and T3 and the clasped purlin (fig 5.7). But the west face of the stack has the vault line on it too, with whitewash and a small V indent to receive the ends of the laths, so the barrel vault was made good after the insertion of the stack.

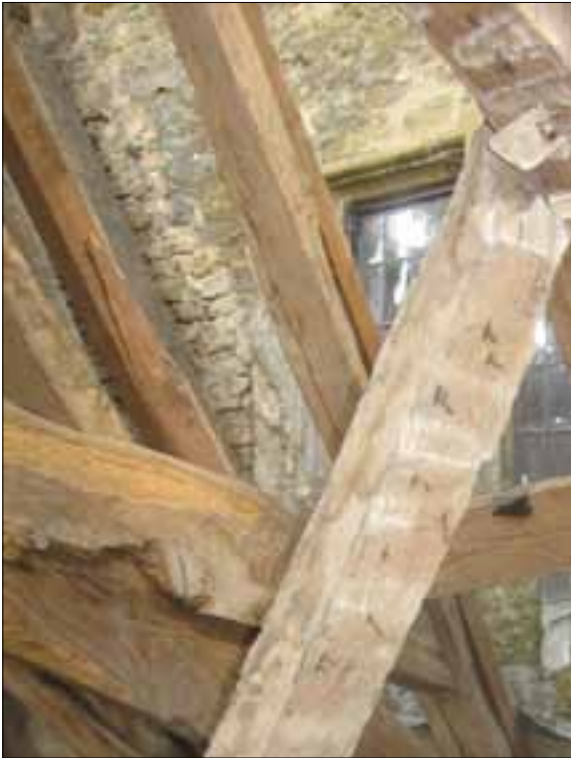
Fig 5.8 Detail of canted joists to support the end of the vaulted ceiling (Nick Hill).

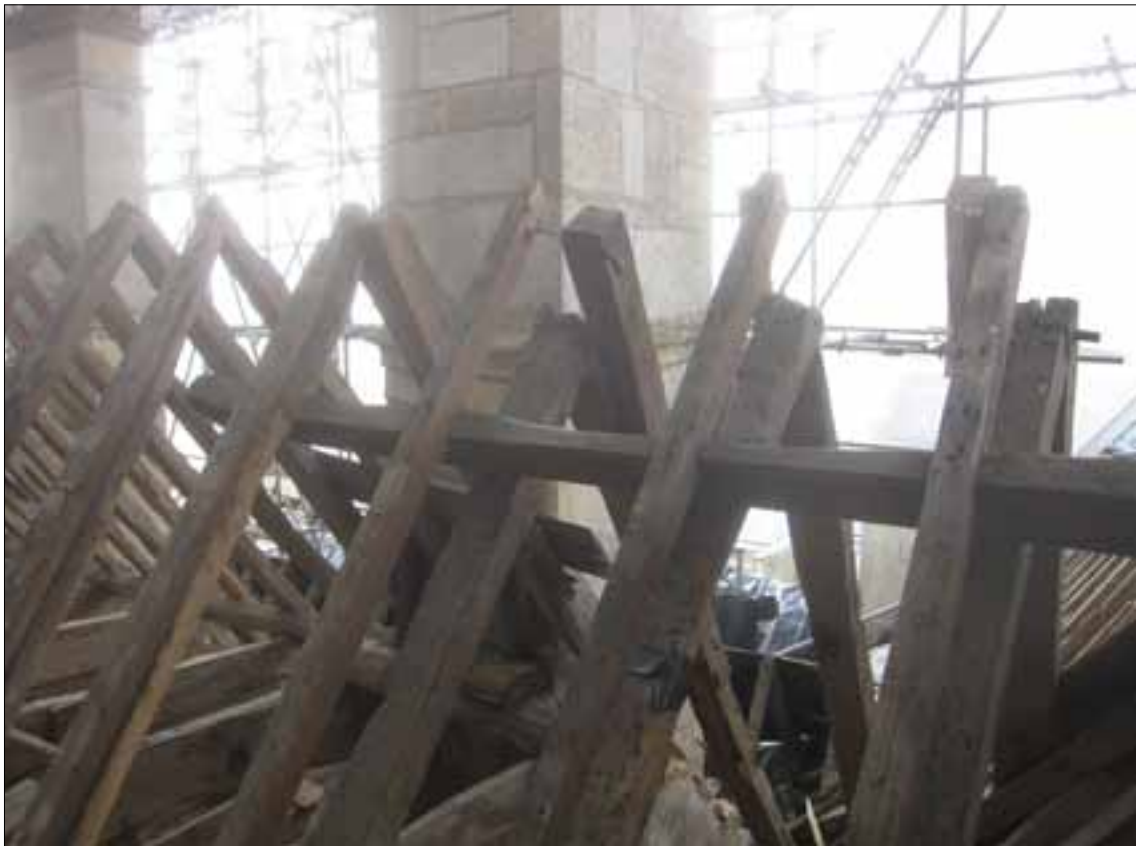
Fig 5.9 The three rafter couples at the east end of the roof which are off-set and lower than the rest of the structure (Nick Hill).

The valley junction to H2.12 to the east is intact and original, a neatly framed lay-on valley rafter triangle, all neatly jointed at angles. Truss T1 has a simple dovetail lapped collar, fixed with a single peg, the face side being to the east. There is no clasped purlin here, which terminated at T2. There are no nails (except a few strays) to the backs of rafters in the valley joint area – nails for roofing laths would be evident if this valley area had ever been roofed. So this roof appears to be the same date as H2.10/12 to east. No indication of other junctions abutting, eg: to north. The first three valley rafter couples, up to truss T1 have the apex set c.250mm lower and offset to the north compared to the main roof trusses (fig 5.9). This is a key diagnostic feature. The evidence indicates that the roof over H2.10/2.12 to the parlour block incorporated, from the start, a small projecting roof of gabled form. As this projecting roof does not align with the main roof
