APETHORPE HALL, APETHORPE, NORTHAMPTONSHIRE OPENING UP: VOLUME FOUR

HISTORIC BUILDING REPORT

Nick Hill

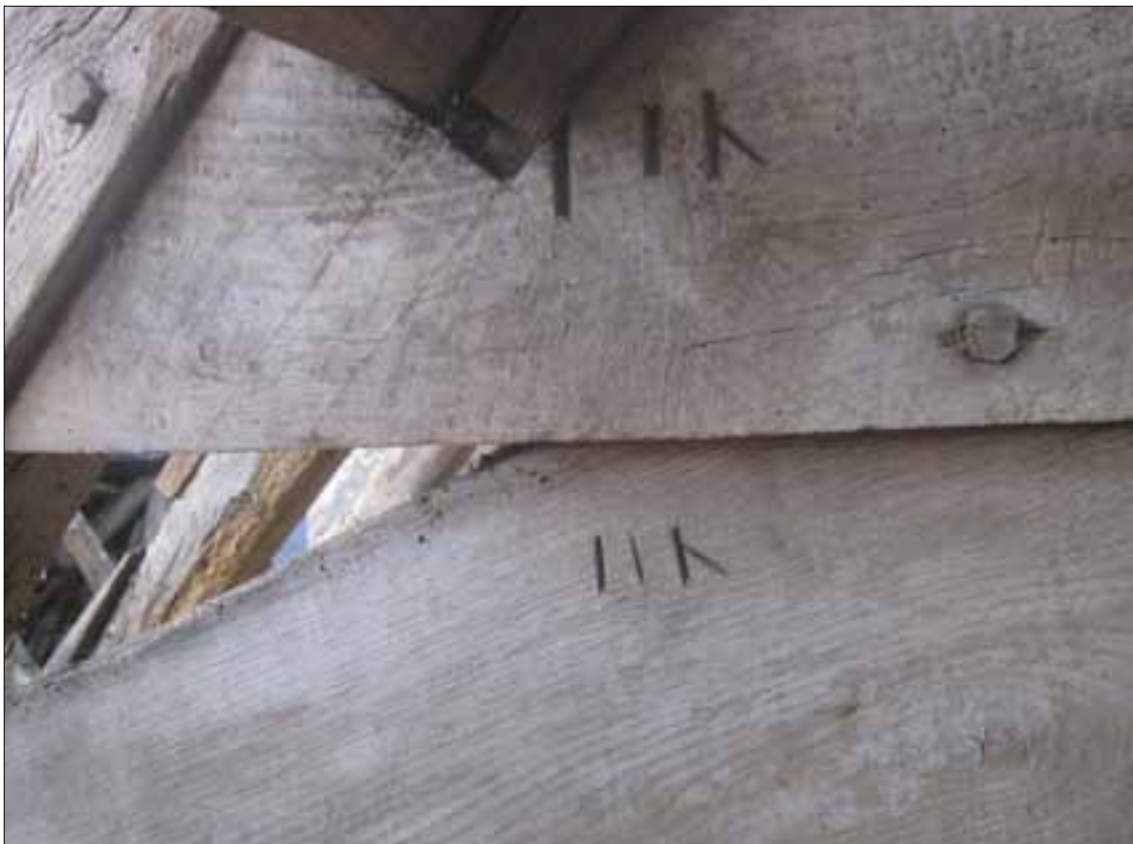
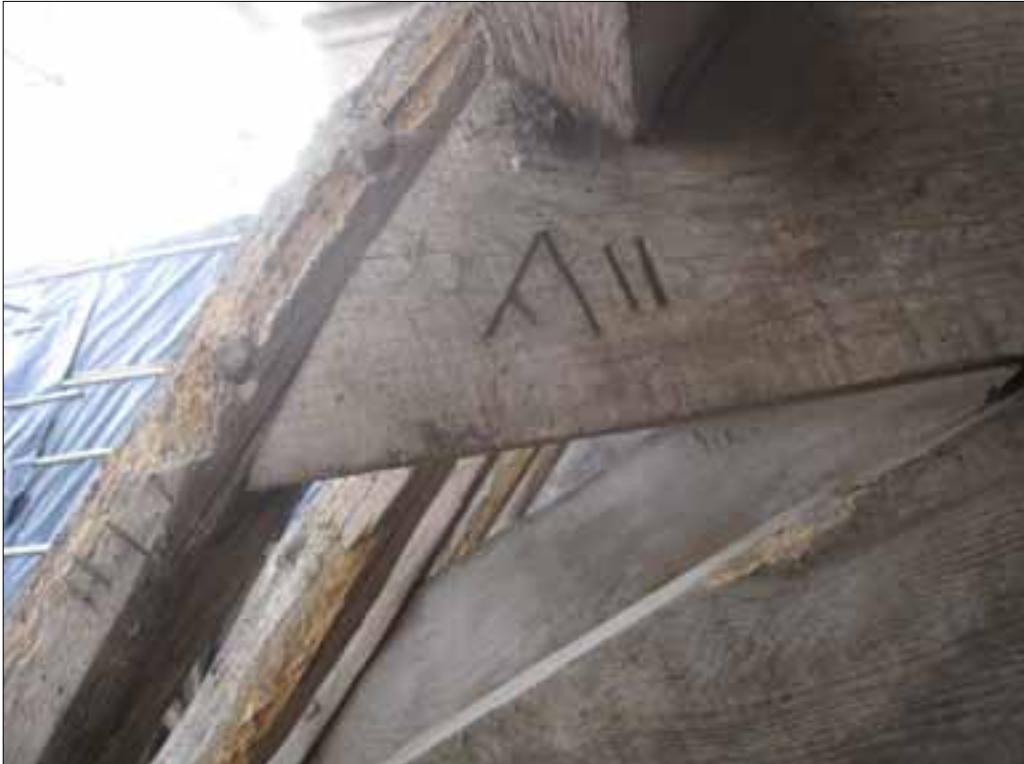
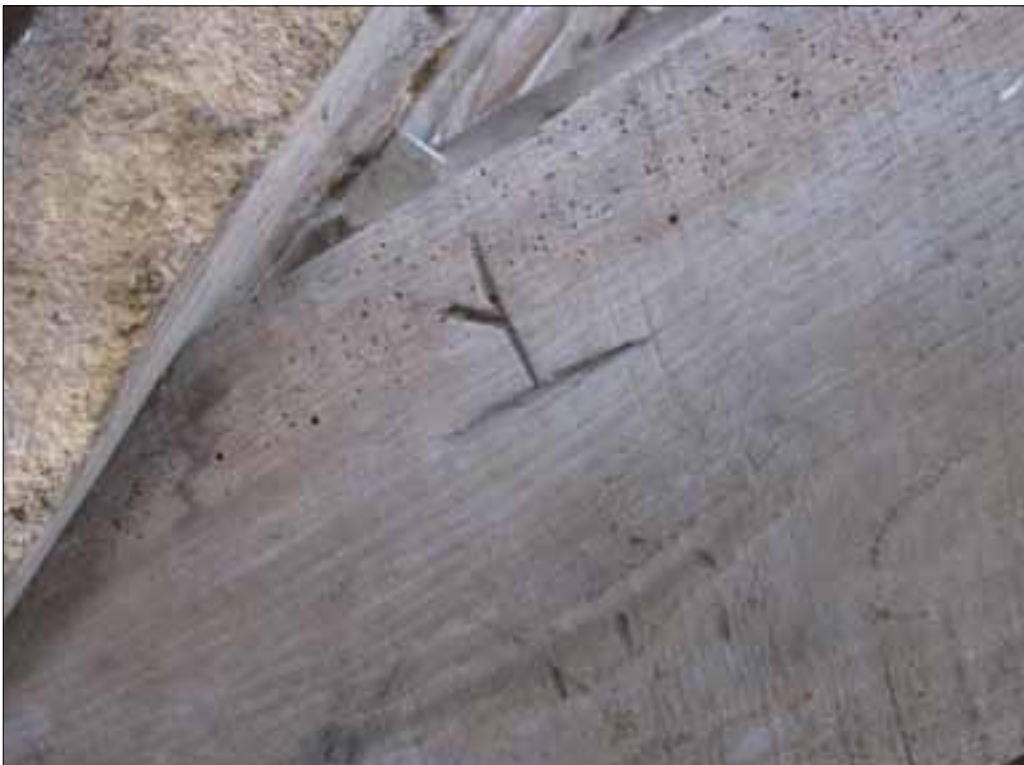
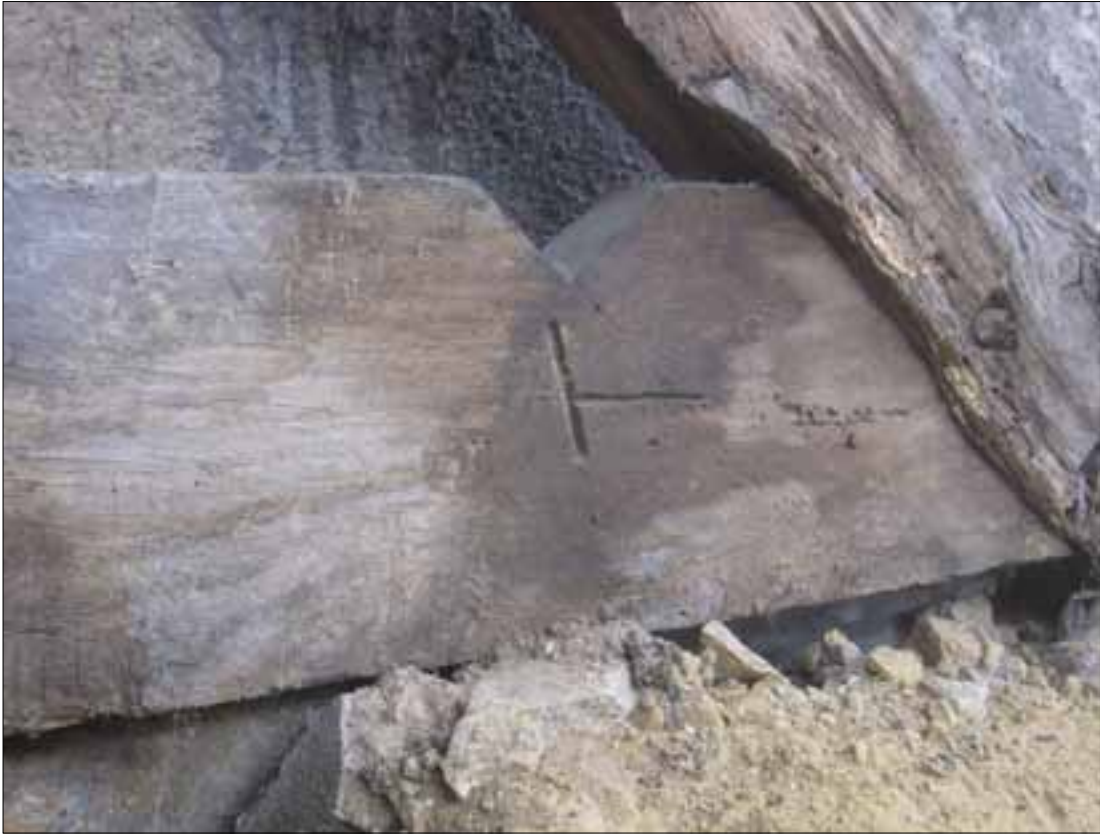
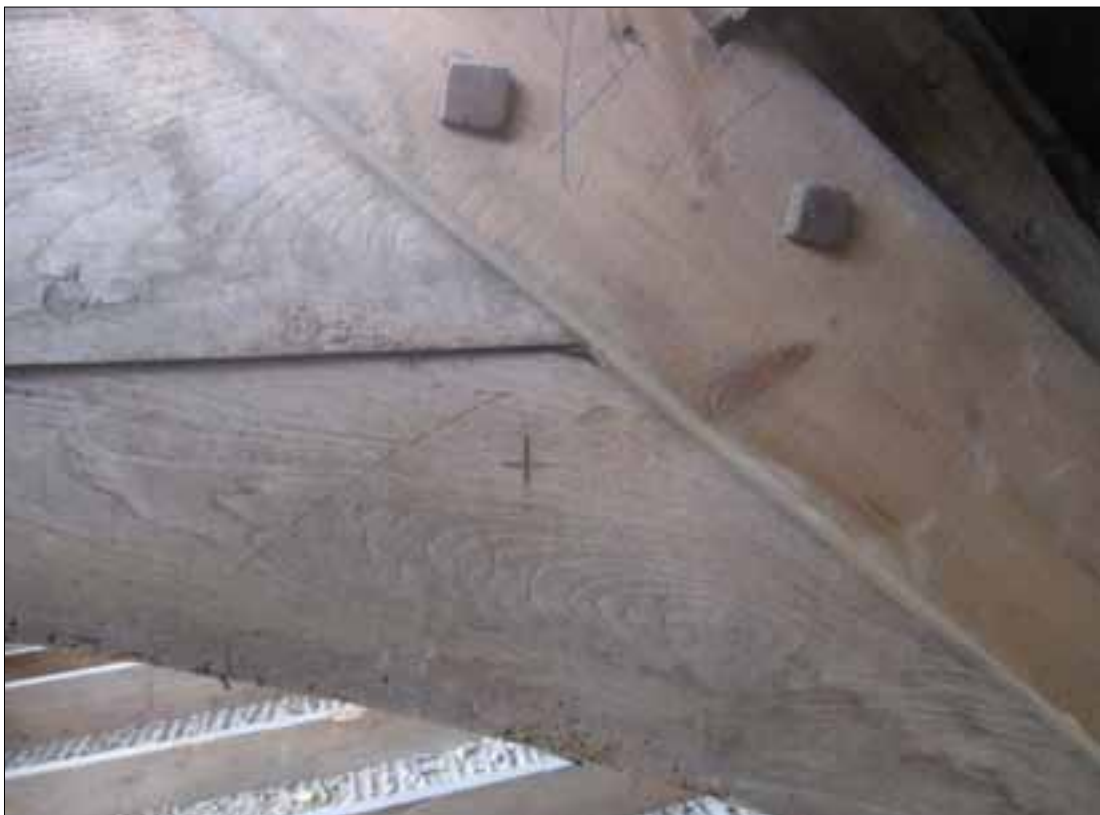
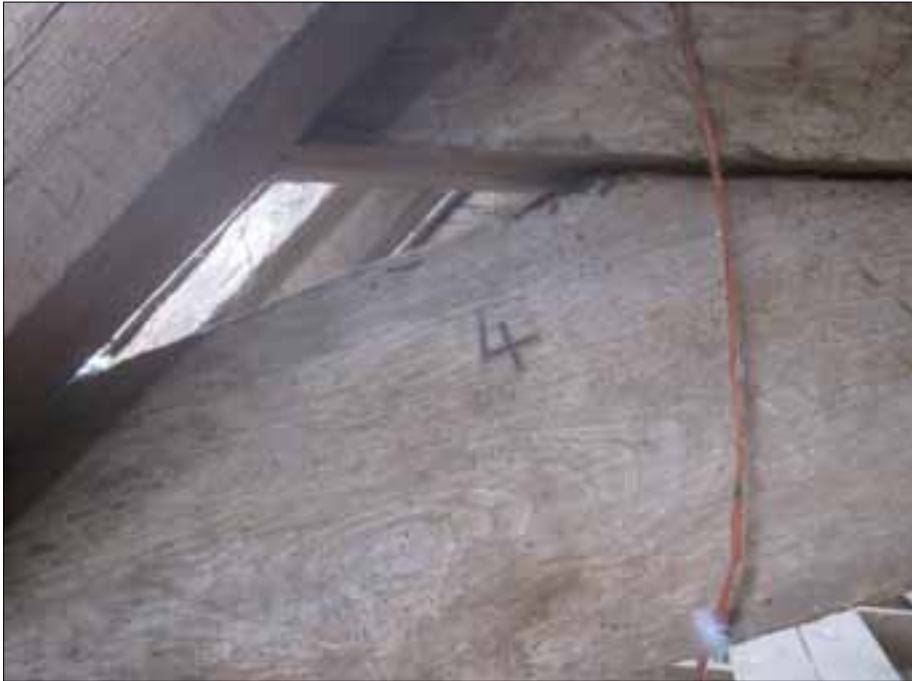
Fig 5.10 Carpenter's mark to truss T5: III with a tag (Nick Hill).

Fig 5.11 Carpenter's mark to truss T6: VII with a tag (Nick Hill).

Fig 5.12 Carpenter's mark to truss T2, south end (Nick Hill).

Fig 5.13 Carpenter's mark to truss T2, north end (Nick Hill).

Fig 5.14 Carpenter's mark to truss T8, south end (Nick Hill).

Fig 5.15 Carpenter's mark to truss T8, north end (Nick Hill).

Trusses T2-T9 have a full set of carpenters' marks – short and chisel-cut, unlike other marks in adjoining 15th-century roofs (figs 5.10 to 5.15). Such marks usually indicate a later date, of 17th or 18th centuries, but those here appear original and in situ, not a later re-working. The marks are on the collar, rafter and brace, as far as they survive. Marks also survive to the apex of the two rafters of T4, though some other apexes seem never to have had marks. All marks are on the west face of the trusses, except for the end truss T9, where it is on the east face, no doubt as this was against the lost masonry cross-wall. There are no marks on T1. The marks to the left side of the truss are distinguished by an additional 'tag', with no 'tag' to the right side. Standard Roman numerals, not in the truss sequence, are used as follows:

T3: II
T4: IIII
T5: III
T6: VII
T7: I
T9: V

Marks to T2 and T8 have other forms. The numerals VI and VIII are, for some reason, not used.

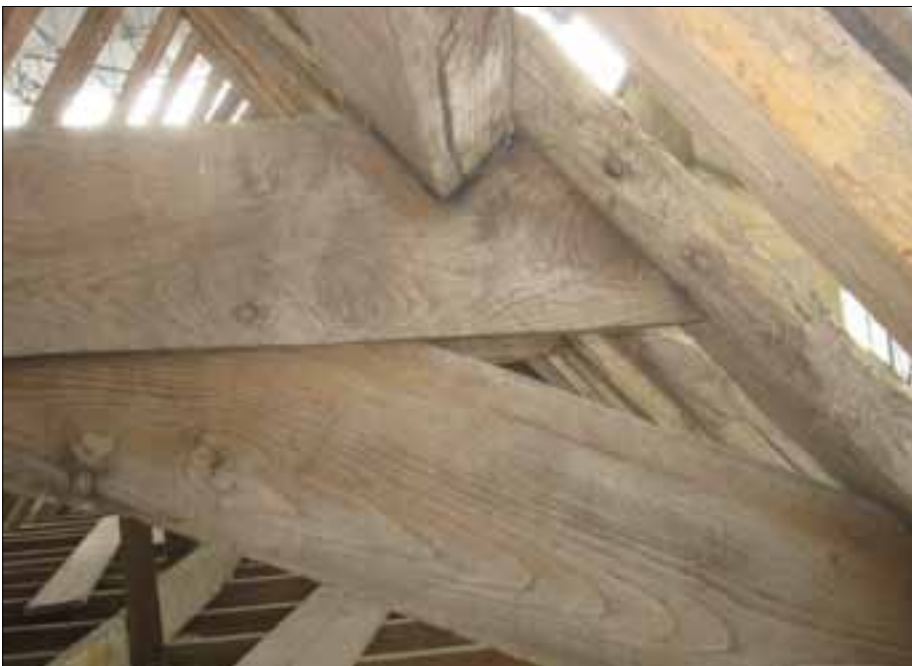
Fig 5.16 Detail of clasped purlin joint to east section of roof. Note the setting-out line and filler block for enlarged cut-out to receive purlin (Nick Hill).

Knife-cut marks to set out the cutting of joints are also visible around the collar/rafter junction, particularly for the cut-out to receive the clasped purlin (Fig 5.16). An oddity is that several of these cut-outs have an enlarged cut-out, now filled with a packer; though also with knife-cut setting out marks. These larger cut-outs appear to be original, not a later re-working, and may have been made to ease insertion of the clasped purlin.

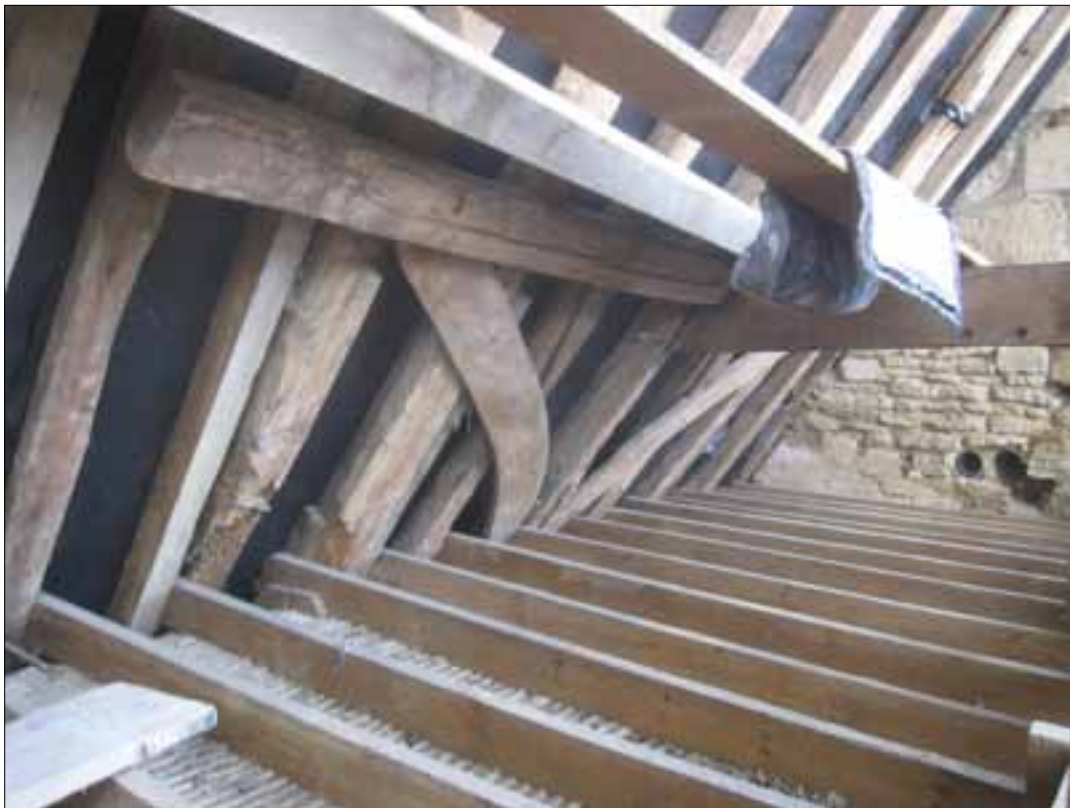
Fig 5.17 West section of roof H2.11, looking west (Nick Hill).

At the former cross-wall position, the structure changes, though later repairs/bodging obscure this somewhat. There is a single truss (T10) to the centre of this section, of A-frame type with a flat (not cranked) collar; missing arch-braces, clasped purlin and no ridge (figs 5.17 to 5.20). The principal rafters do not diminish at the purlin height. The collar is dovetail-lapped to the rafters, not tenoned. The missing arch braces have only short mortices, with two pegs, to the collar and rafter, so were not of the full arching form seen in the east roof. The 'face' side of the truss is to west. Slightly curving wind-braces rise from principal to purlin, though one of the original four is missing to north-east. These braces are tenoned and pegged at the foot, but lapped with a nailed (not pegged) joint at the top (to the purlins). Lath nails for a former sloping ceiling line survive on the underside of the principal rafters. The purlins (in a single length) bear into the masonry of the west gable wall, and show marks where they used to bear into the missing cross-wall. Many of the rafter couples are probably original, but have been much re-set. The rafters are not generally pegged to the purlins.

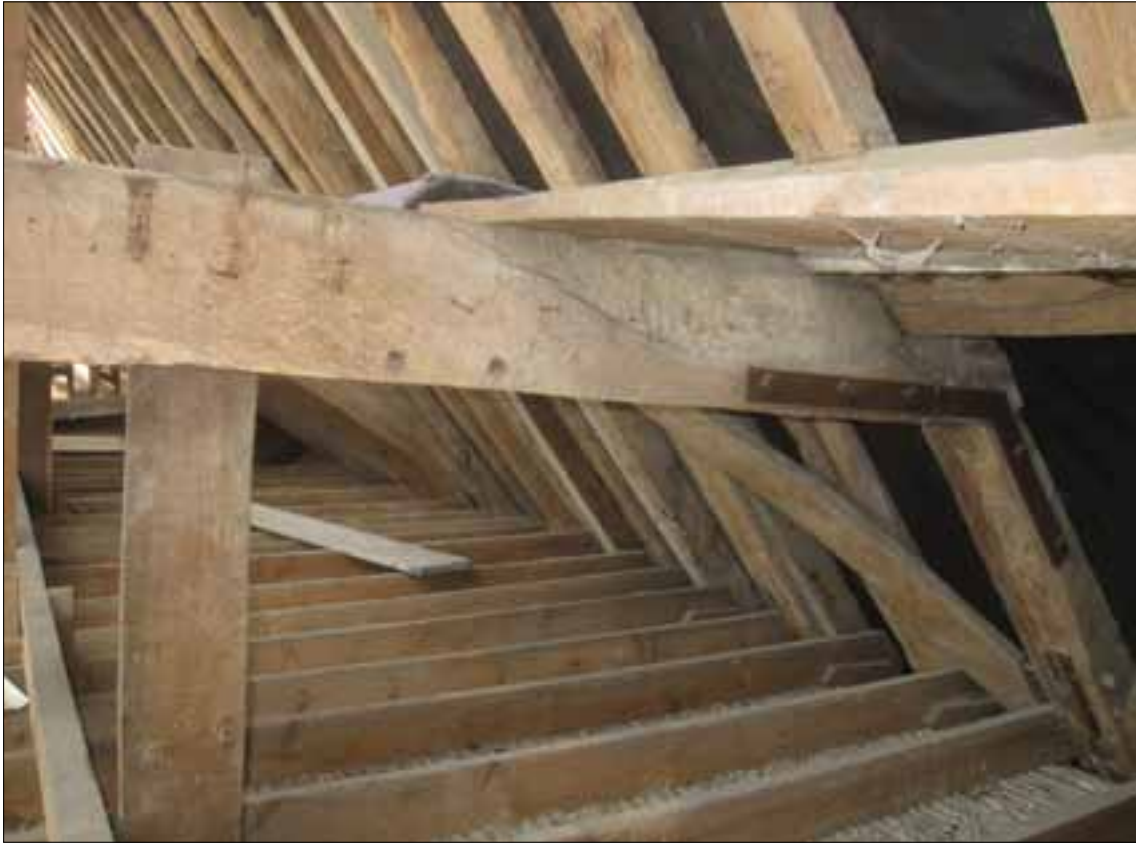
Fig 5.18 Truss T10 of west section, west face – note missing arch-brace (Nick Hill).

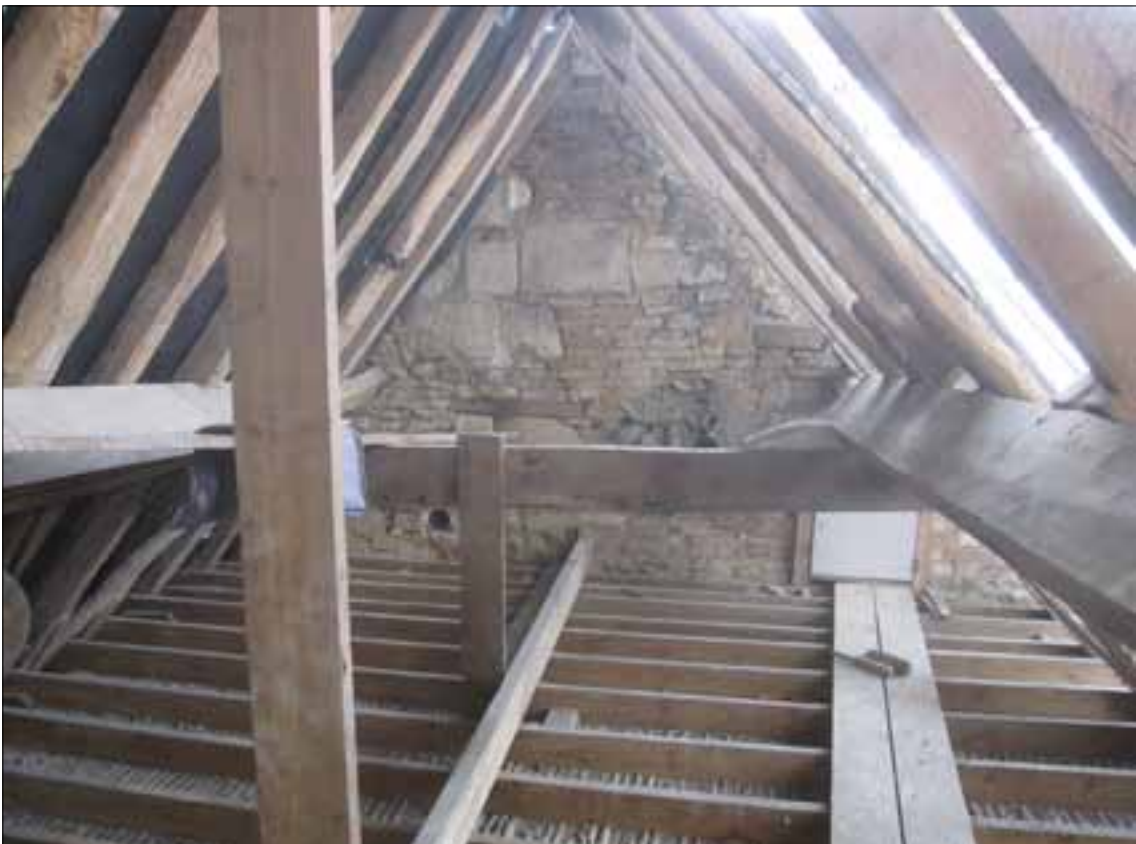
Fig 5.19 West section of roof, looking towards west gable (Nick Hill).

The gable at the west end has early brick (around 16th to 17th century) to the apex, a flue, and various large ashlar blocks, possibly re-set.

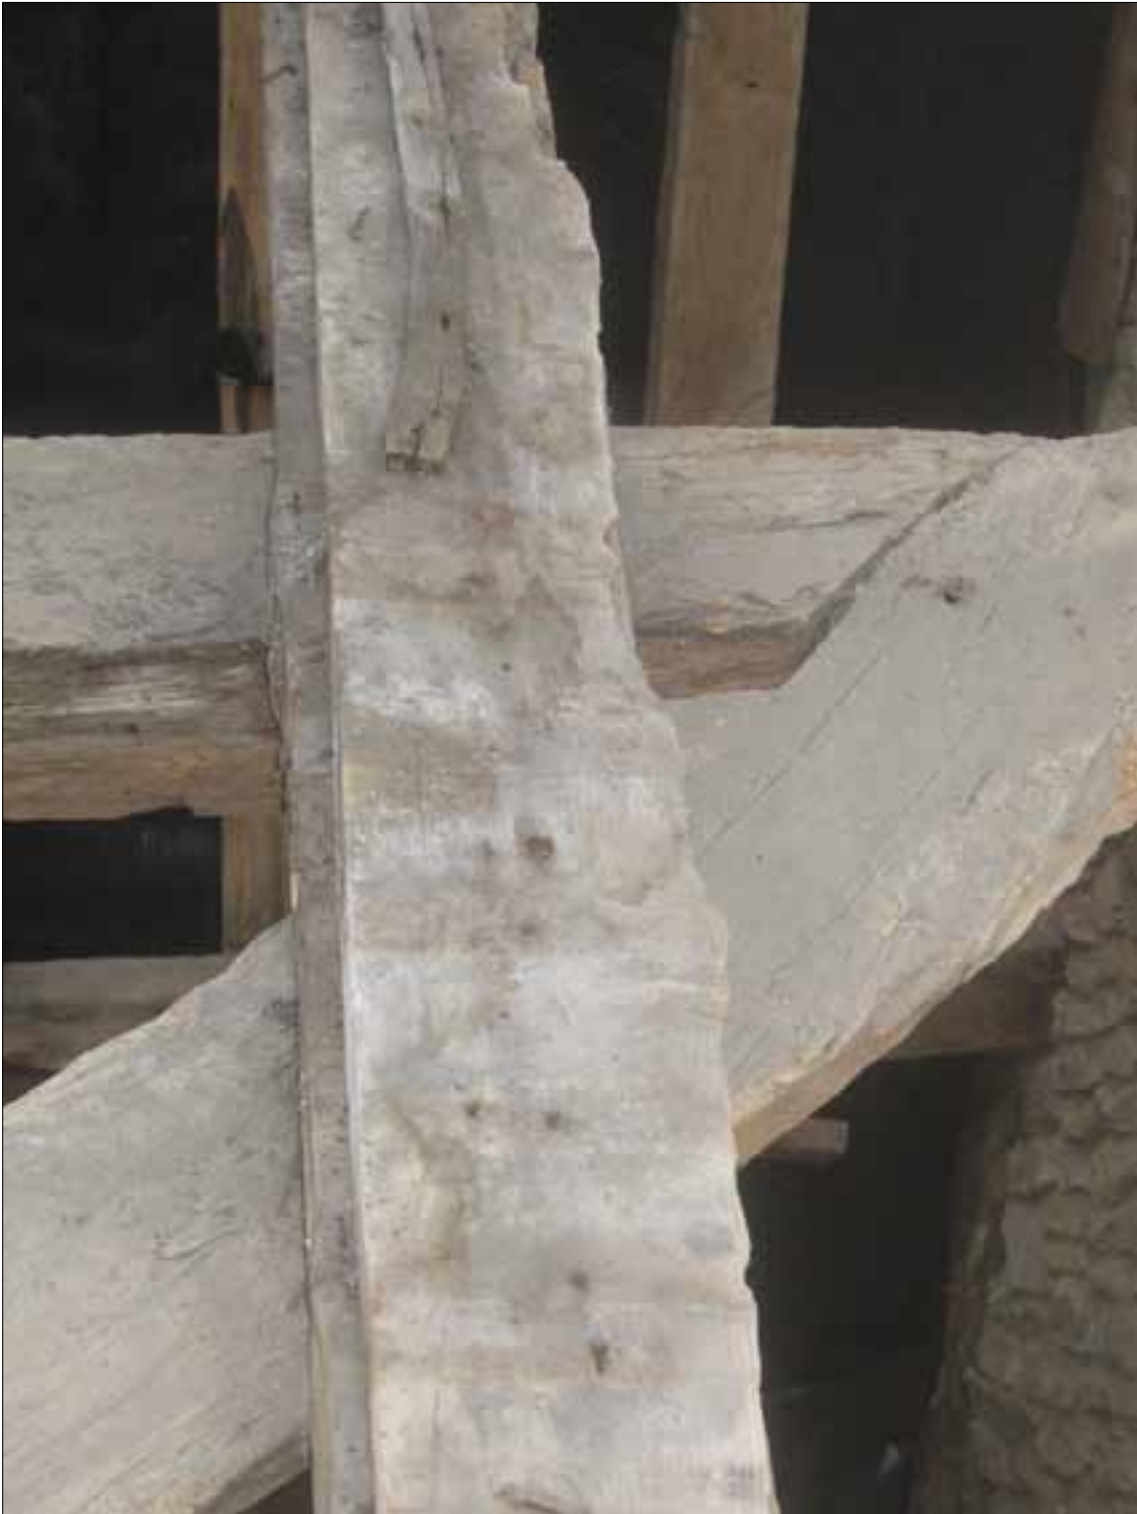
Fig 5.20 Detail of wind-brace to west section of roof, with original lapped and nailed joint to purlin (Nick Hill).
