RESEARCH REPORT SERIES no. 3-2014

# WARBSTOW BURY WARBSTOW

## ARCHAEOLOGICAL SURVEY REPORT

NGR: SX 2013 9074

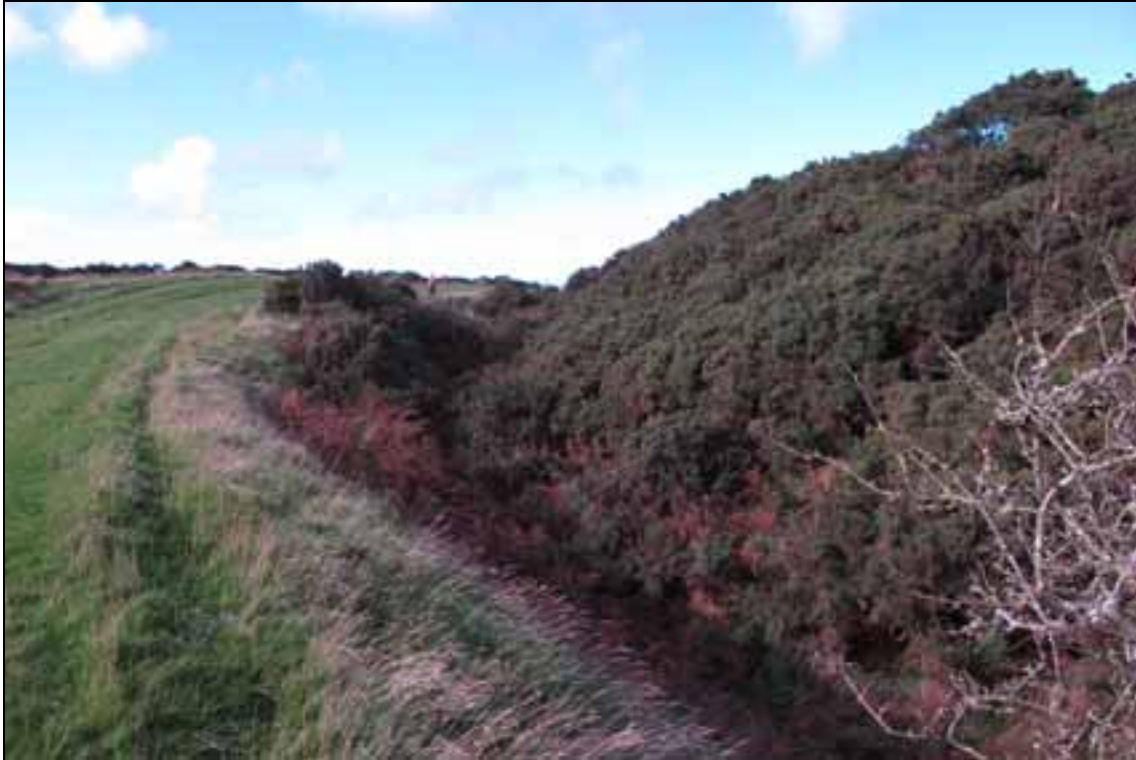
*Fig 2: The south-western side of the inner ramparts, looking north-west from the gap between the circuits, where the vegetation is particularly obstructive. Photograph by Mark Bowden © English Heritage*

A HLF (Heritage Lottery Funded) project is underway to tackle the vegetation on the hillfort, and it was noticeable at the time of survey (October 2013) that this process had made a significant difference in some areas.

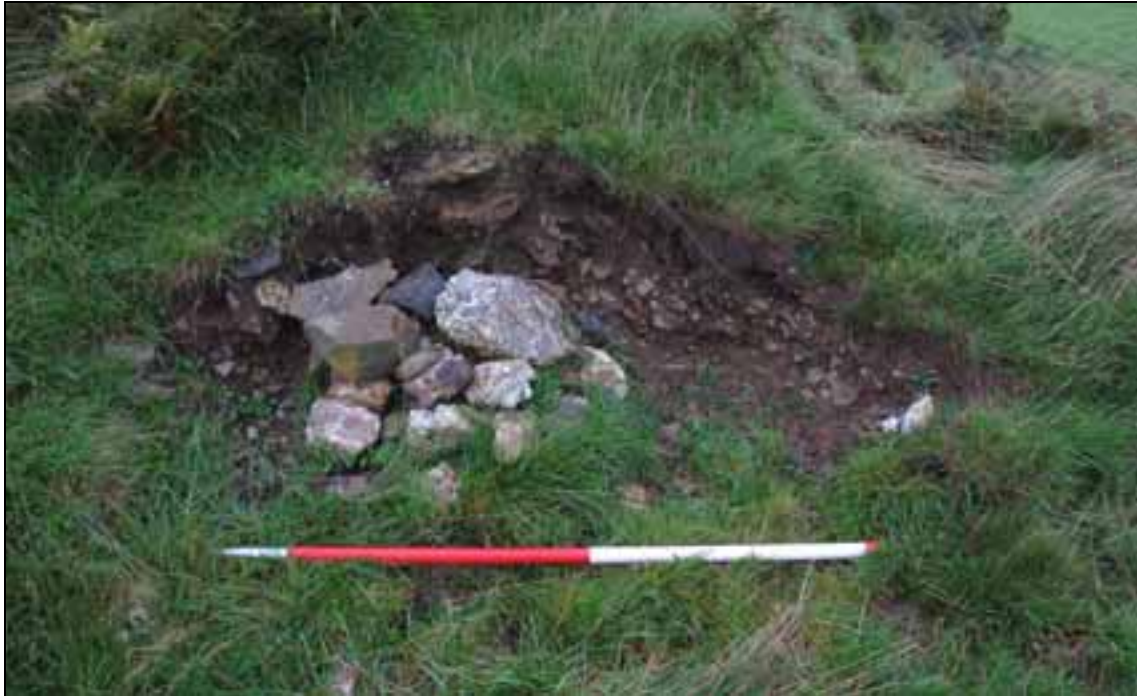
Other intrusion risks include the sheep scrapes and tracks through the ramparts, and holes in the ramparts dug by badgers and rabbits. It would appear that in some cases, stones and rubble from the earthworks have been placed in the sheep scrapes to prevent further damage.

*Fig 6: Sheep scrape at the western entrance of the inner rampart filled with stone to prevent further damage. Photograph by Mark Bowden © English Heritage*

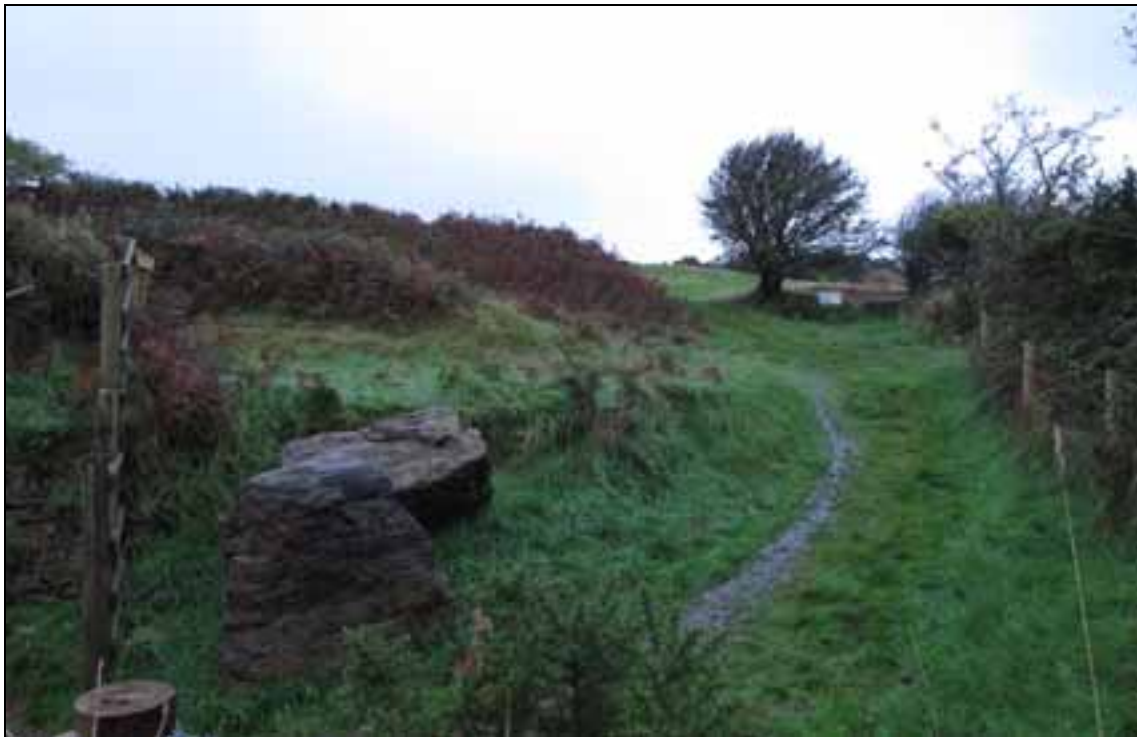
The footpath from the car park leads past the counterscarp bank of the outer rampart. At this point, it appears only to be present on the west, where a slight rise then merges into the bank c6.5m from the fence line. The gradient of the slope and bank can be seen in Fig 8.

*Fig 8: The site entrance from the south-east. The footpath from the car park leads towards the existing entrance to the hillfort, with the counterscarp bank to the outer rampart on the left. Note also the water flowing from the interior down the footpath. Photograph by Mark Bowden © English Heritage*

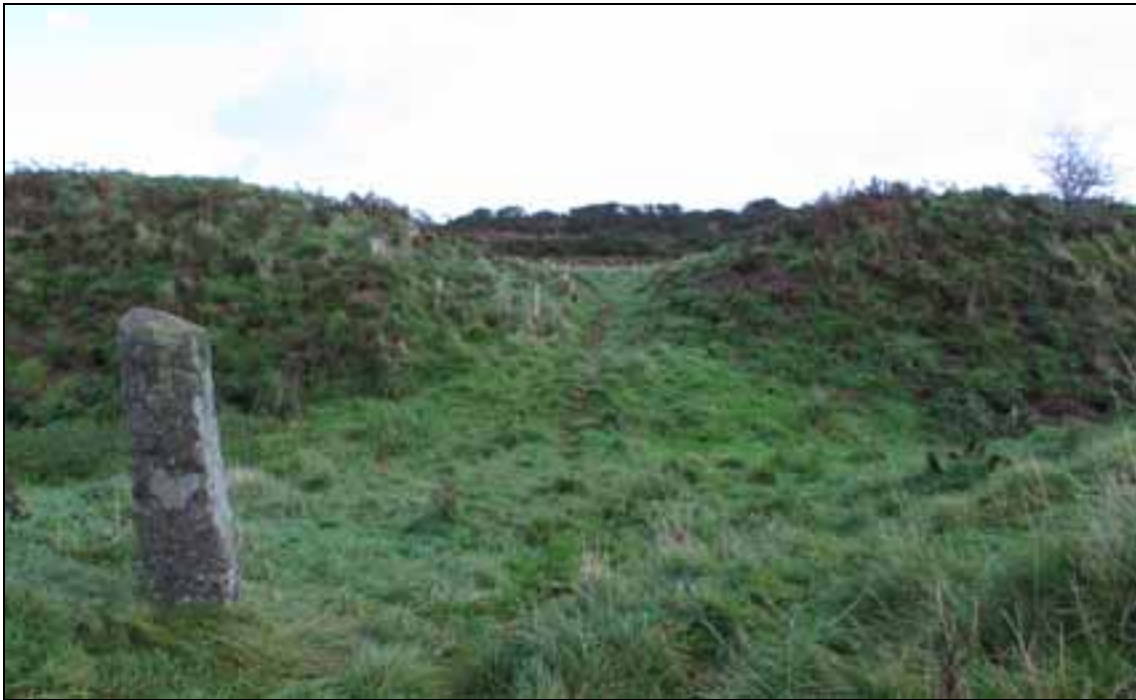
There are some intrusions to the outer counterscarp bank which include the pathways of livestock (and possibly visitors) crossing the ramparts, which have been recorded at four points along the south-western side (Fig 5). Each of these corresponds to a nearby pathway eroded through the respective ditch-slope and bank. At one point in particular (A, Fig 7), there is pathway up to 5.25m wide, with a remaining gatepost on the outside of the rampart. The pathway here is relatively well flattened in comparison to other routes, and has clearly been a significant route of entry to the hillfort from the south-west in recent centuries. The current and former field boundary is present further north on the rampart, which is followed by another cut into the outer rampart. This is much less substantial, but it may be that these were the entry routes to the two adjacent fields.

*Fig 9: Pathway and gatepost at the south-western side of the outer rampart. Photograph by Mark Bowden © English Heritage*

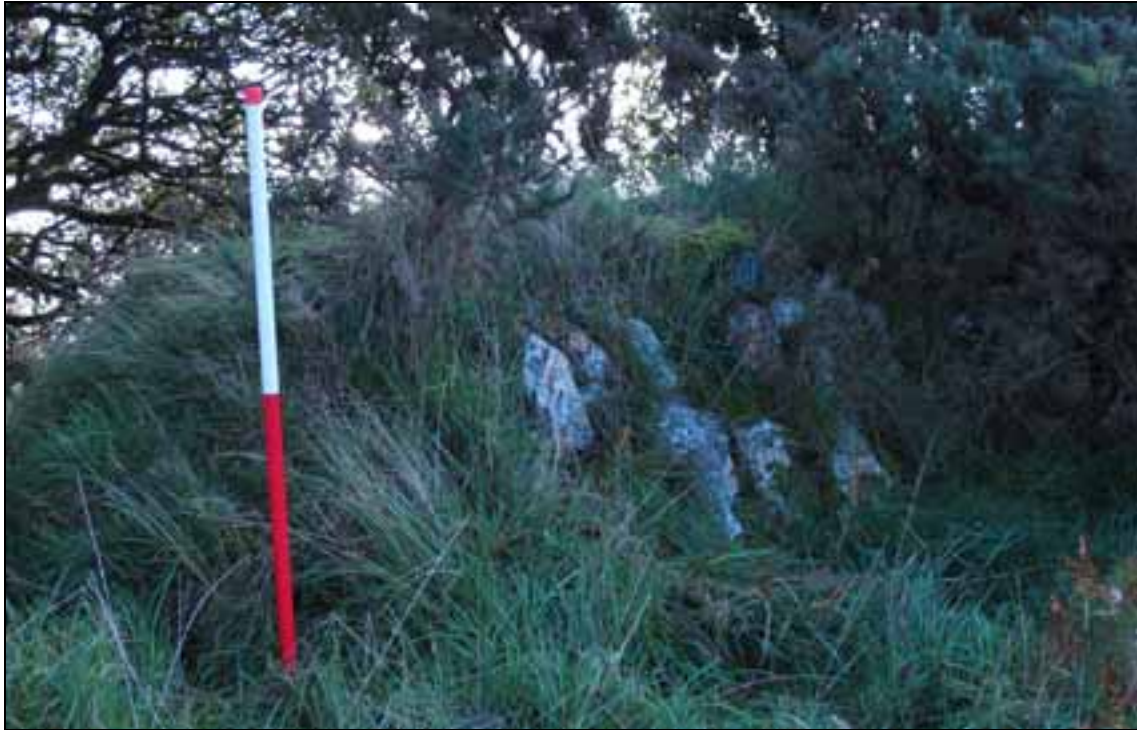
In the south, the upper slope of the bank is almost vertical, which continues to be the case along most of the rampart on its eastern side. Sections of exposed stone walling close to the south-eastern entrance may provide an explanation for this. It is not possible to interpret whether this wall was part of the original construction of the outer rampart, part of a later phase involving other rampart modifications, or an individual phase unrelated to any other phase of construction on the site. However, it is in this area that

the First Edition OS Map (1889, 1:10560) shows the field boundary encompassing the existing rampart bank, which may have been enhanced by the addition of stone walling. A section of the outer counterscarp bank has been destroyed by ploughing in this area (D, Fig 7).

*Fig 10: Section of exposed stone wall on the inner face of the outer rampart close to the south-east entrance. Photograph by Mark Bowden © English Heritage*

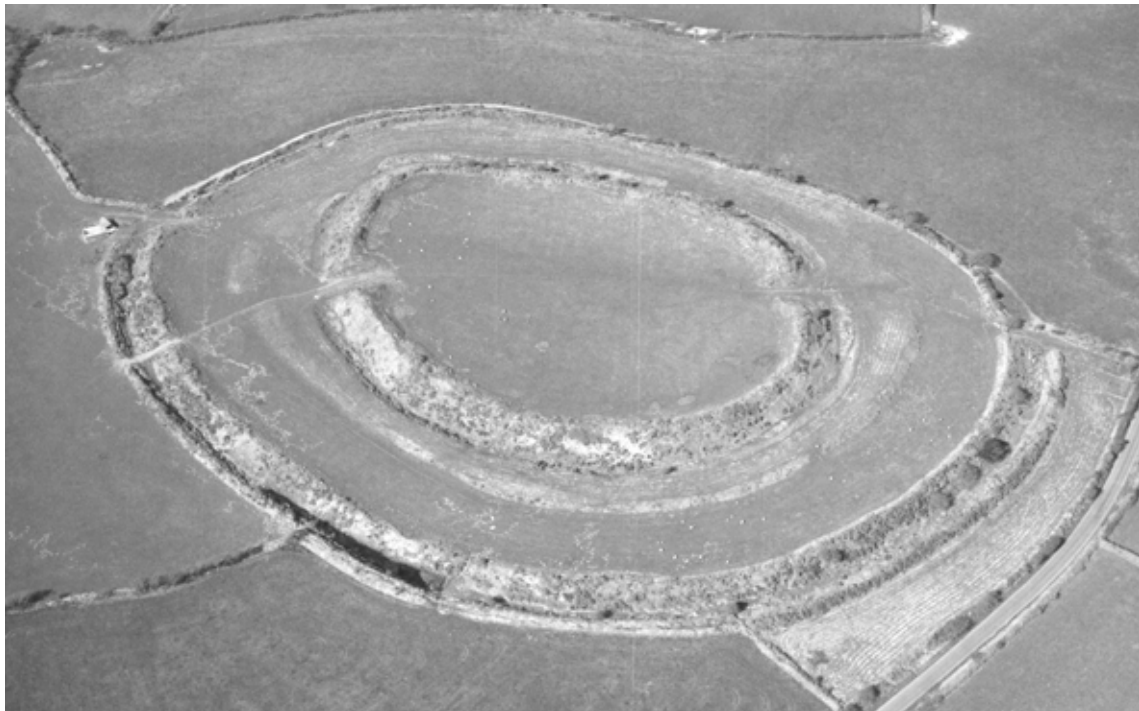
New interpretations regarding the middle circuit have been possible due to the recording of additional slight earthworks which continue from the previously recorded rampart ends. On the northern side, the remains of the rampart could be traced as a spread scarp curving round back towards the inner rampart for an additional 56m, while the equivalent earthwork on the south-east could not be followed for more than 8m, at which point it is no longer traceable beneath the bracken. The inner rampart therefore appears to overlie the former position of the middle circuit on the eastern side of the hillfort, indicating that the middle rampart in fact pre-dates the construction of the inner rampart. The similarities in form between the middle and outer ramparts supports this further, as it is likely that the middle rampart was the first phase at this site, and was followed by the outer rampart which was constructed to reflect the form of the rampart of the first phase. The continuation of the middle rampart on the southern side can be seen in some aerial photographs (Fig 11).

*Fig 11: Warbstow Bury hillfort from the west, showing the continuation of the middle rampart beyond the entrances on the eastern side, and the external building with dislodged roof on the far left. CCR 5122/81 22-APR-1987 © Historic Environment Record, Cornwall Council.*

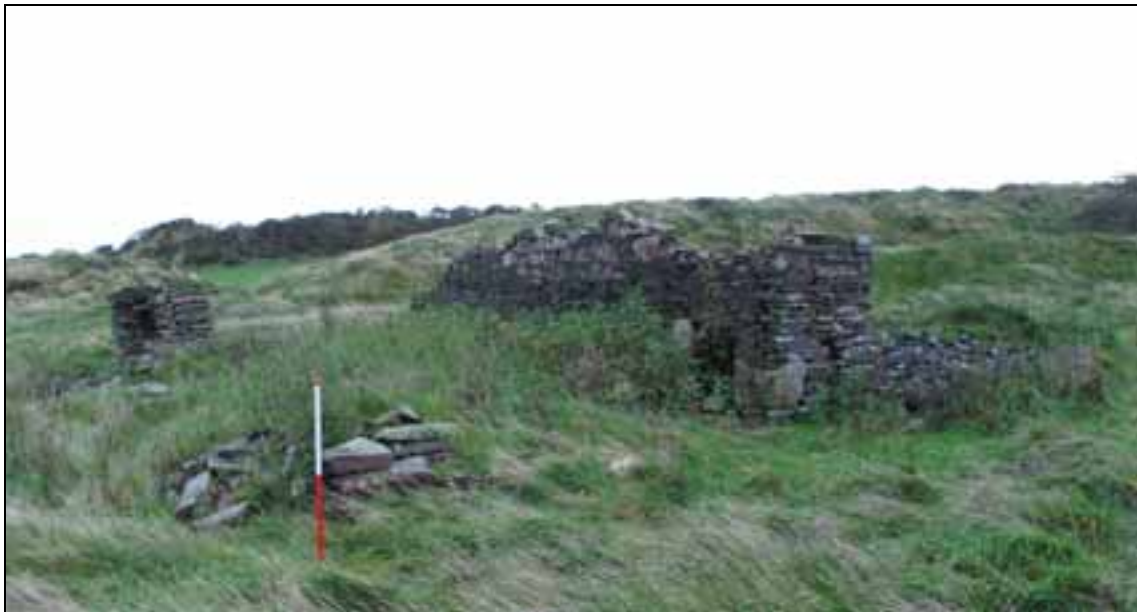
Seventeen metres west of the north-west outer entrance are the remains of a stone-walled building. The surviving walls, no higher than 2m, are of stone resembling the type used for the wall at the south-east site entrance. Rubble from the walls surrounds the c5m by c8m building, which sits on a slight platform above the level of the footpath from the hillfort entrance.

*Fig 16: The remains of the stone-walled building. Photograph by Mark Bowden © English Heritage*

There are two symmetrical gaps in the centre of the shorter sides of the building, with hinges fastened into the adjacent stone, presumably to support doors, indicating that this

Within the walls are fallen stones, corrugated iron sheets, and wire resembling that seen on the inner rampart side to maintain erosion. Corrugated iron sheets have also been noted at a few other locations across the site, in ditches and hidden in vegetation. These may be remains from one of the Second World War sentry posts although it is most likely that these are from agricultural buildings.
