RESEARCH REPORT SERIES no. 52-2013

ST MARY'S MARSHES, HOO ST MARY, MEDWAY, KENT

AN ASSESSMENT OF THE LATE 19TH CENTURY EXPLOSIVES MAGAZINES

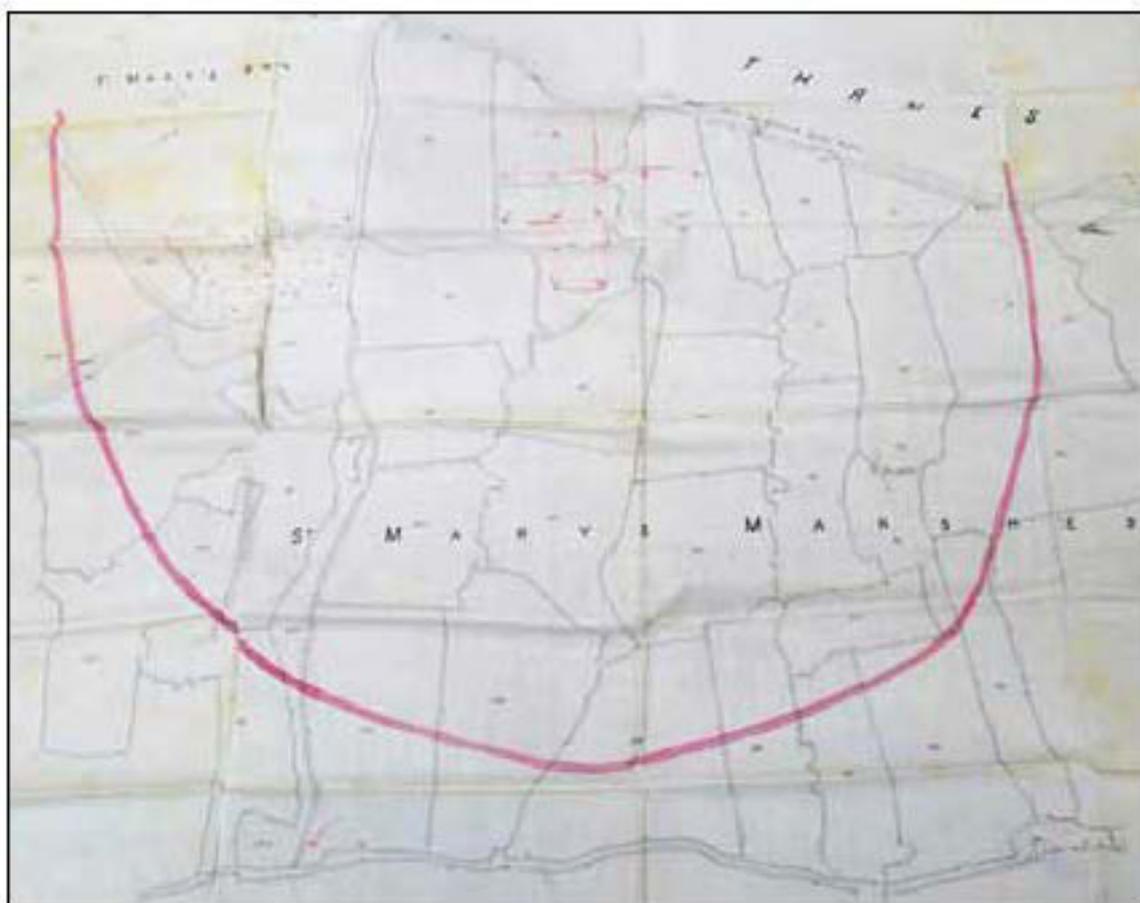
Figure 2: Plan showing the exclusion zone around the proposed site, where further building would not be permitted, and the location, to the south-west, of the proposed caretaker's cottage which was never built (MALSC DRc/Egz/151/2 – Permission of the Dean and Chapter of Rochester).

Correspondence held in the archives of the Dean and Chapter of Rochester Cathedral demonstrates that a series of explosives stores, tramways and a caretakers cottage were being planned for land at St Mary's Marshes by late 1891 (MALSC DRc/Egz/151/1). Only an acre of land was thought to be needed for the actual site of the magazines, though a large exclusion zone of 324 acres, where no houses should be built, would be necessary and it seems that there was some initial local opposition to the locating of the magazines on the marshes (Figure 2).

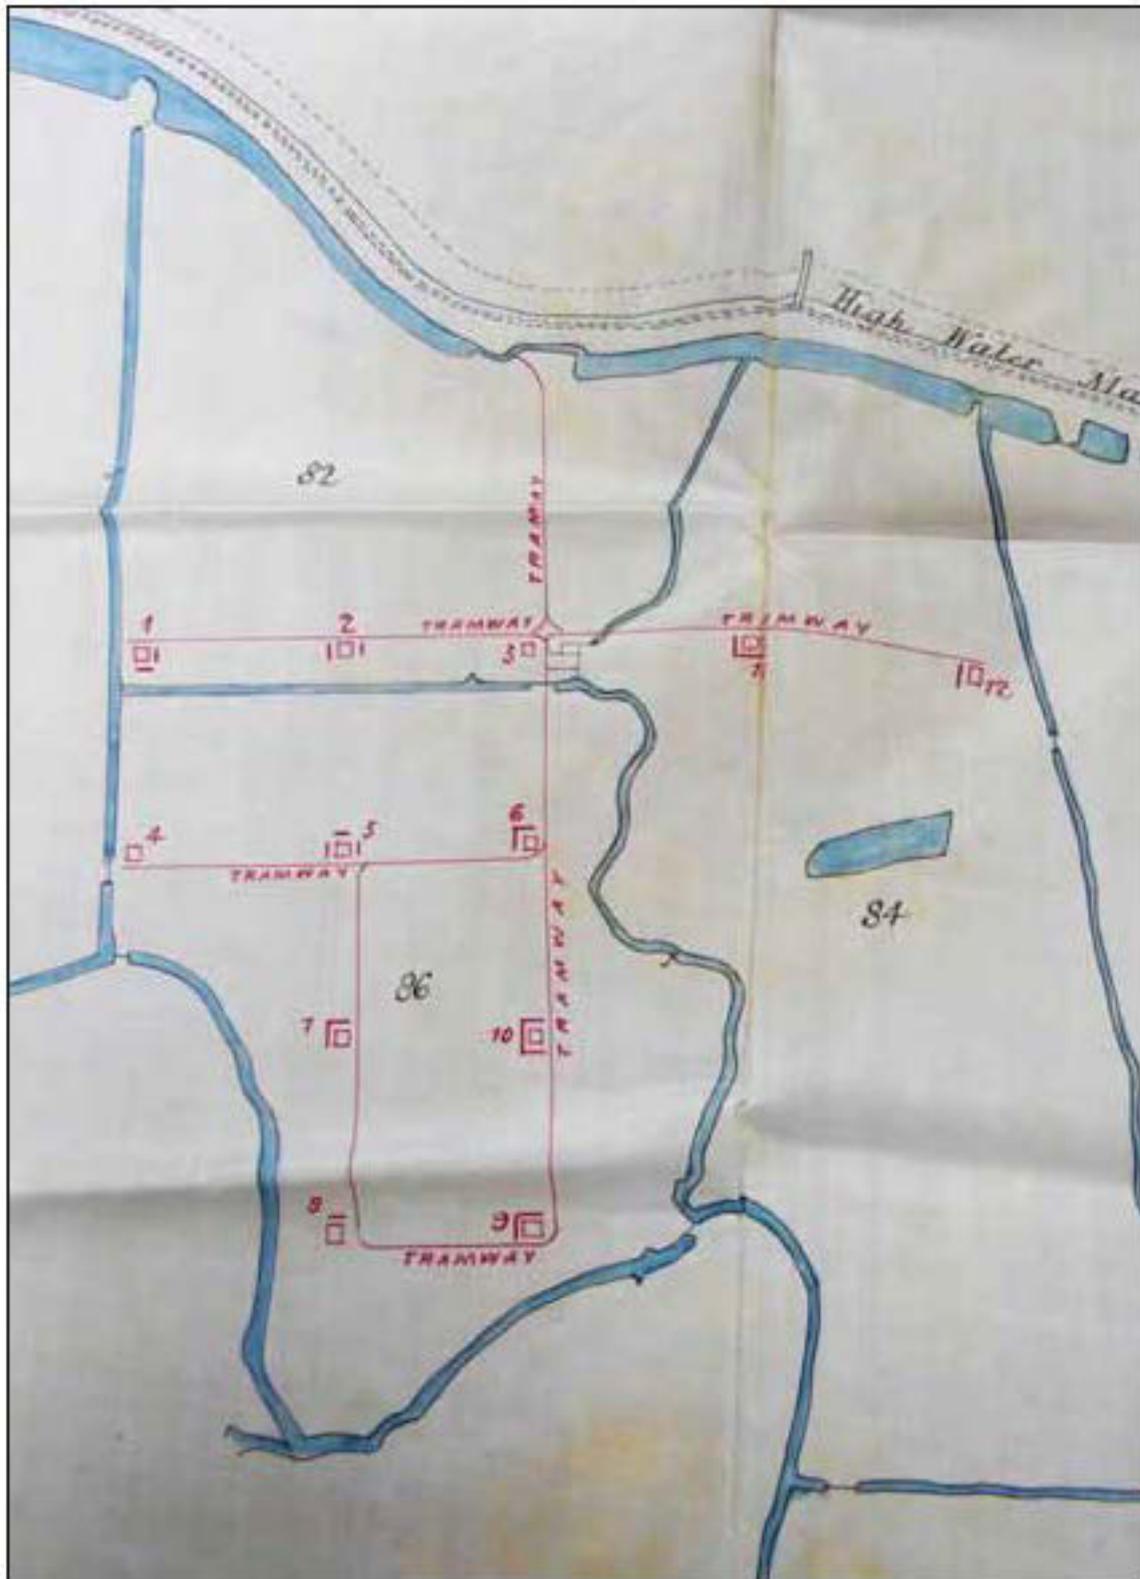
Figure 3: The planned layout of the site from the 1892 lease showing the proposed arrangement of 12 magazines with individual bund layouts and the suggested tramway network (MALSC DRcEgz 15112 – Permission of the Dean and Chapter of Rochester).

The plans that accompany the lease (MALSC DRc/Egz/151/2) depict a layout which does not appear to have been fully realised (Figure 3). The proposed layout consisted of 12 magazines occupying three separate parcels of land in an irregular, though geometric, arrangement. The magazines are linked to each other and to the river by a tramway and all have varying arrangements of earthwork bunds depending on their particular position in relation to the other magazines. A second plan marks the extent of the exclusion zone around the site where no new building would be permitted, restricted land adding up to over 440 acres, more than originally anticipated (Figure 2). This plan also shows a proposed caretaker's cottage to the south-west of the site (TQ 7966 7792) that was never built.

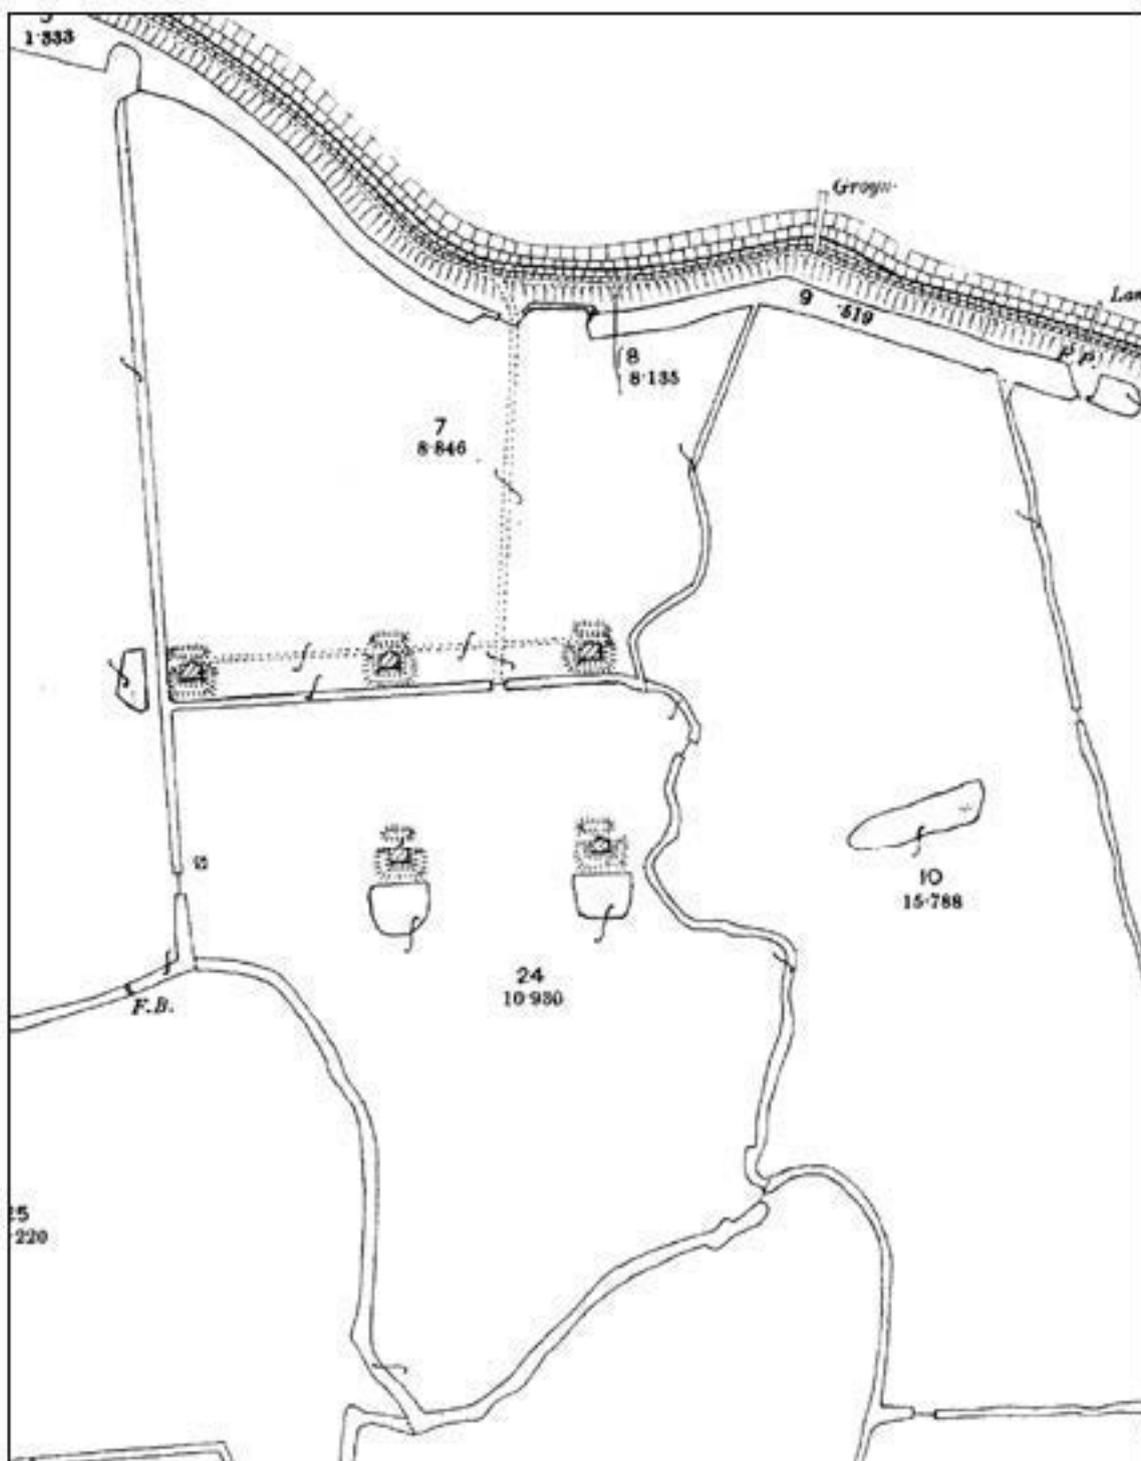
Figure 4: The Ordnance Survey 2nd edition 25 inch map (revised 1895 published 1897) showing the first phase of construction of the magazine complex. © and database right Crown Copyright and Landmark Information Group Ltd (All rights reserved 2013) Licence numbers 000394 and TP0024

The 2nd edition 25 inch Ordnance Survey map, revised in 1895 and published 1897, shows that five magazines had been built, three arranged along an existing east-west drainage ditch and two to the south (Figure 4). All five are surrounded by earthwork bunds and the three to the north are linked via an east-west track (possibly a tramway) which leads to a north-south track that heads directly to the river. The two magazines to the south and the mostly westerly of the three northern magazines have large ponds adjacent, presumed to be borrow pits for the earthwork bunds. A small building, approximately 12 feet square and located beyond the western end of the two magazines to the south, may represent the packing shed mentioned above.

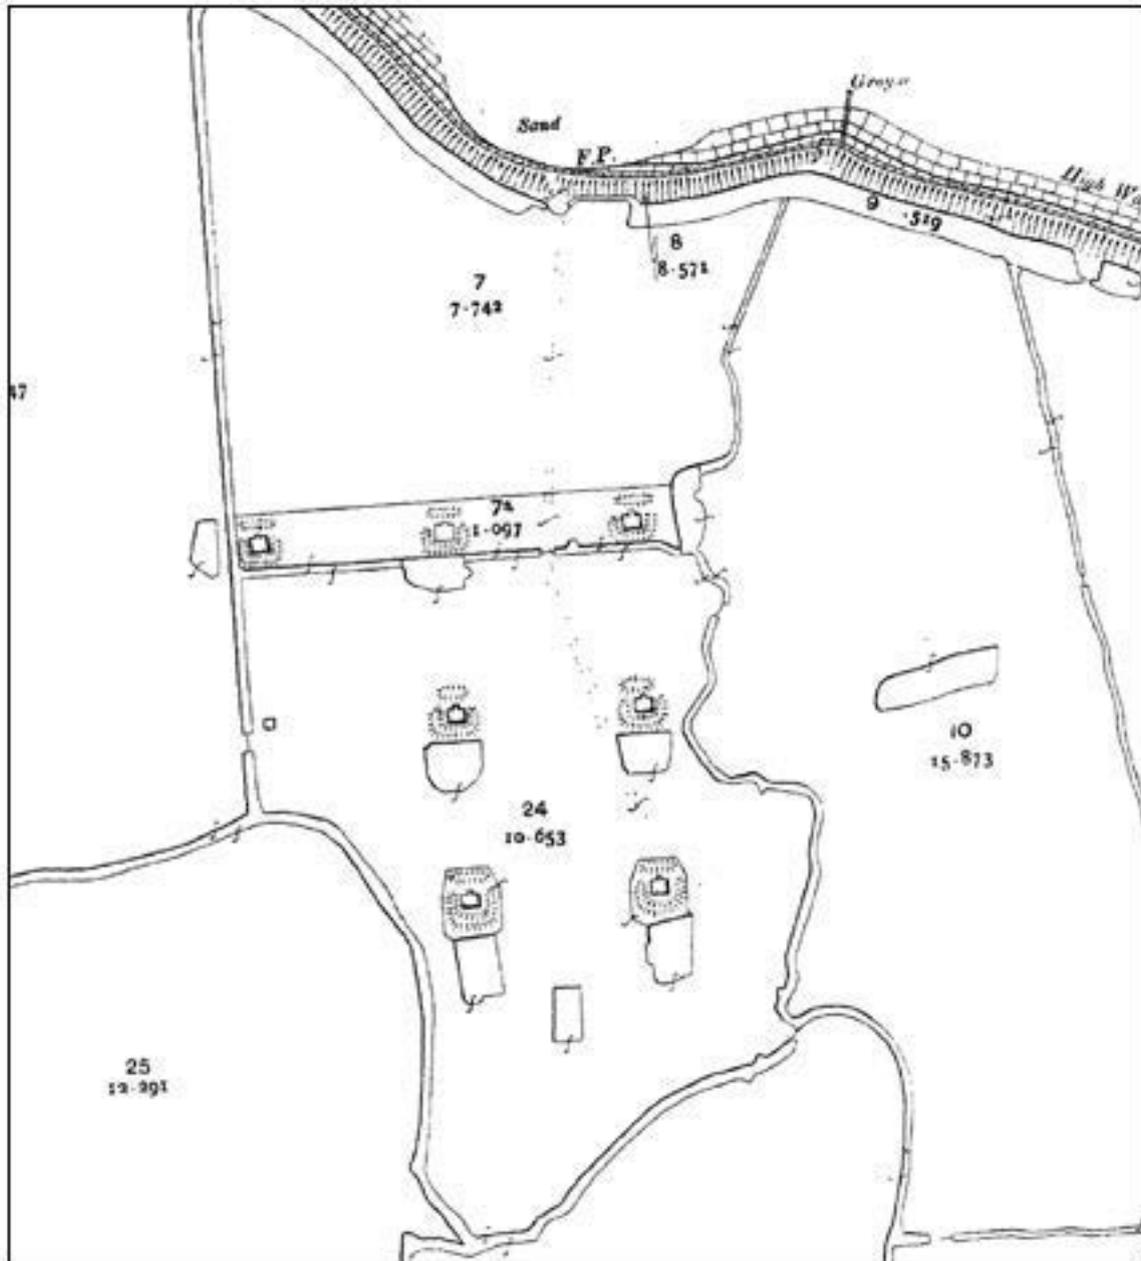
Figure 5: The Ordnance Survey 3rd edition map (revised 1906, published 1908) which shows the additional two magazines that were constructed to the south of the first five buildings. © and database right Crown Copyright and Landmark Information Group Ltd (All rights reserved 2013) Licence numbers D00394 and TP0024

The two additional magazines are depicted to the south of the initial group on the 3rd edition 25 inch Ordnance Survey map (revised 1906 and published 1908; Figure 5). These extra magazines are also depicted with earthwork bunds and associated borrow pits. In addition, these two magazines are depicted within their own fenced enclosure and, by 1906, a fence has also appeared around the three northern magazines. Two further borrow pits have also appeared, one adjacent to the middle of the three northern magazines and a square one at the southern end of the site. The track can be seen continuing across the southern half of the field and heading for a causeway across the drainage ditch in the south-eastern corner of the field. The small square structure (which may represent the packing shed) is also still shown on the western side of the site, close to the drainage ditch. An additional pond or possible borrow pit is also visible to the south of the southern row of magazines. This pond and an associated earthwork have been identified from aerial photographs as the possible site of a never-completed eighth magazine (Ed Carpenter, EHA (NMR) TQ77NE181).

Evidence from the historic Ordnance Survey maps may suggest that it was the central magazine of the northernmost row which was destroyed by the fire. The Ordnance Survey 3rd edition map (revised 1906, published 1908) depicts this magazine with a much thinner line than the others (Figure 5) and on the Inland Revenue map of 1910 (which used the same 1906/1908 Ordnance Survey base map) the same magazine is not hatched suggesting that, unlike the others, it is no longer roofed (TNA IR124/6/9).

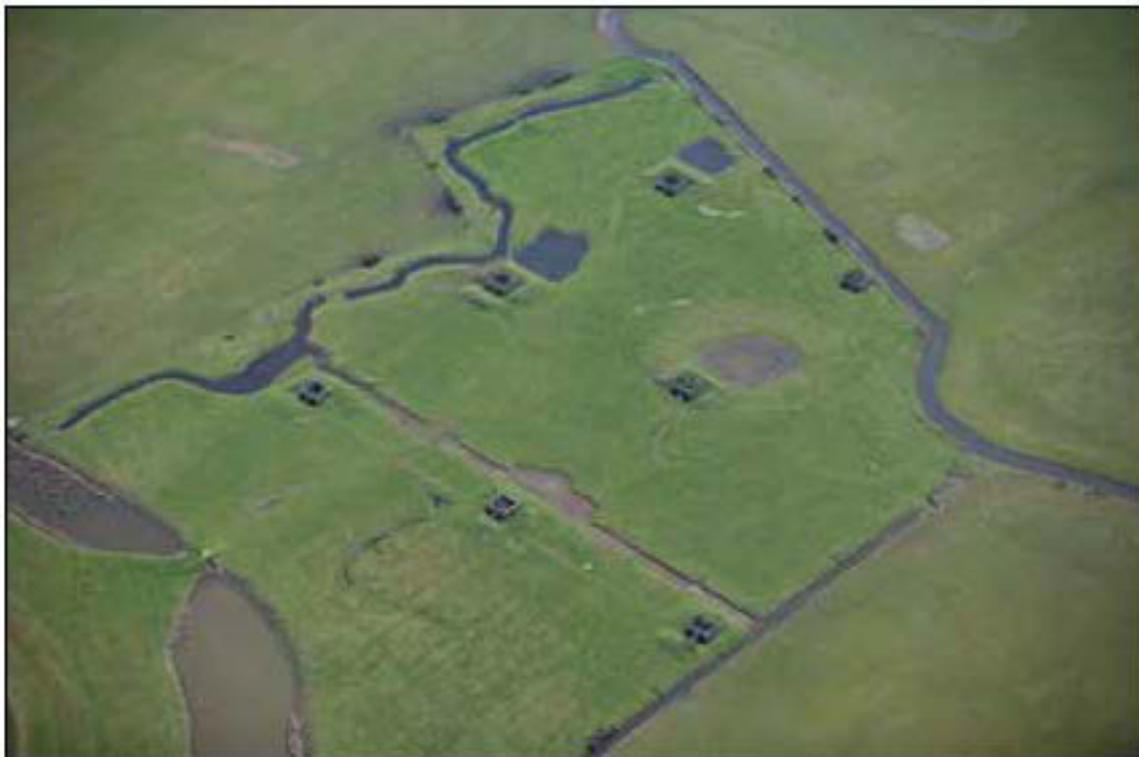
Figure 6: The magazine complex as seen from the north-west. NMR 26598/D190 6-APR-2010 English Heritage

The site consists of seven almost identical concrete buildings (see Figures 6 and 7). The magazines are arranged in a grid pattern with a distance of approximately 70m between each magazine. The magazines are all approximately 7.1m by 6.2m in plan and 4m in height to the apex of the gable (see Figures 21, 22 and 23). There are no discernable differences in size between the two phases of construction suggested in the previous section. Each building is formed of coarse mass concrete around 0.45 m in thickness which was covered externally with a concrete render 1cm thick and incised with an 'ashlar block' design (Figure 8). The two most southerly magazines and the eastern magazine of the central row all show a pink staining of the concrete render on the eastern elevation, perhaps caused by differential weathering.

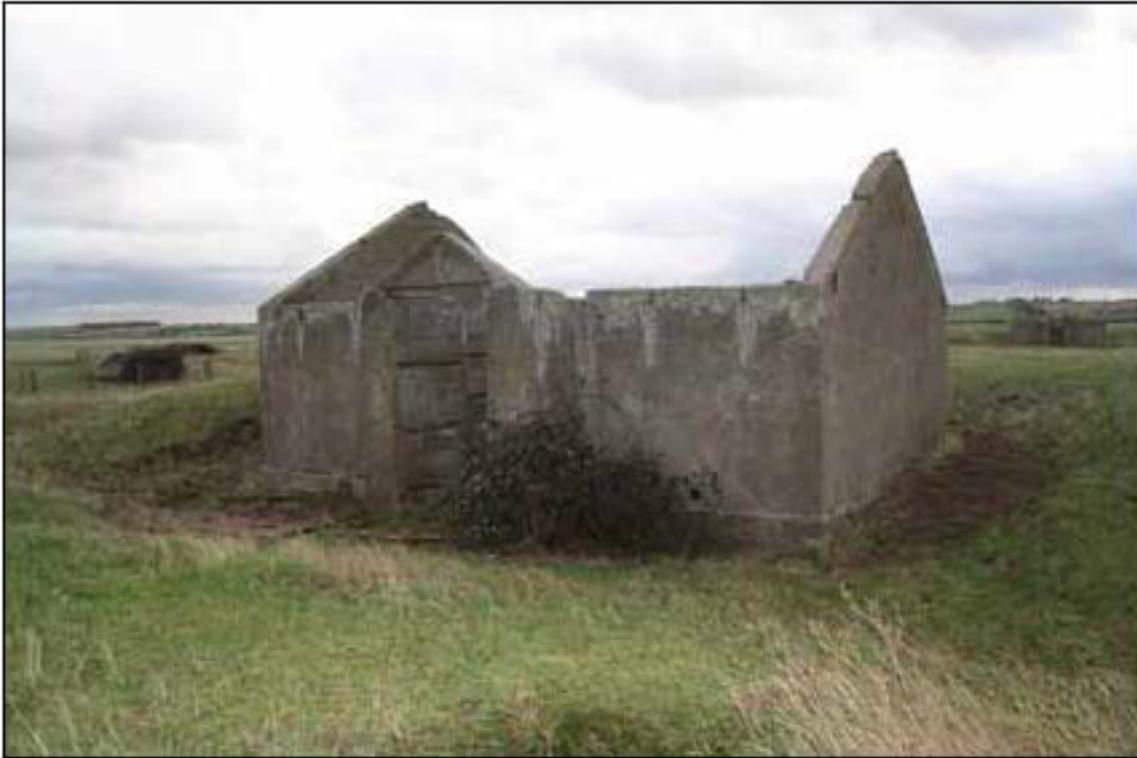
Figure 7: An example of a typical magazine building (eastern magazine in central row).

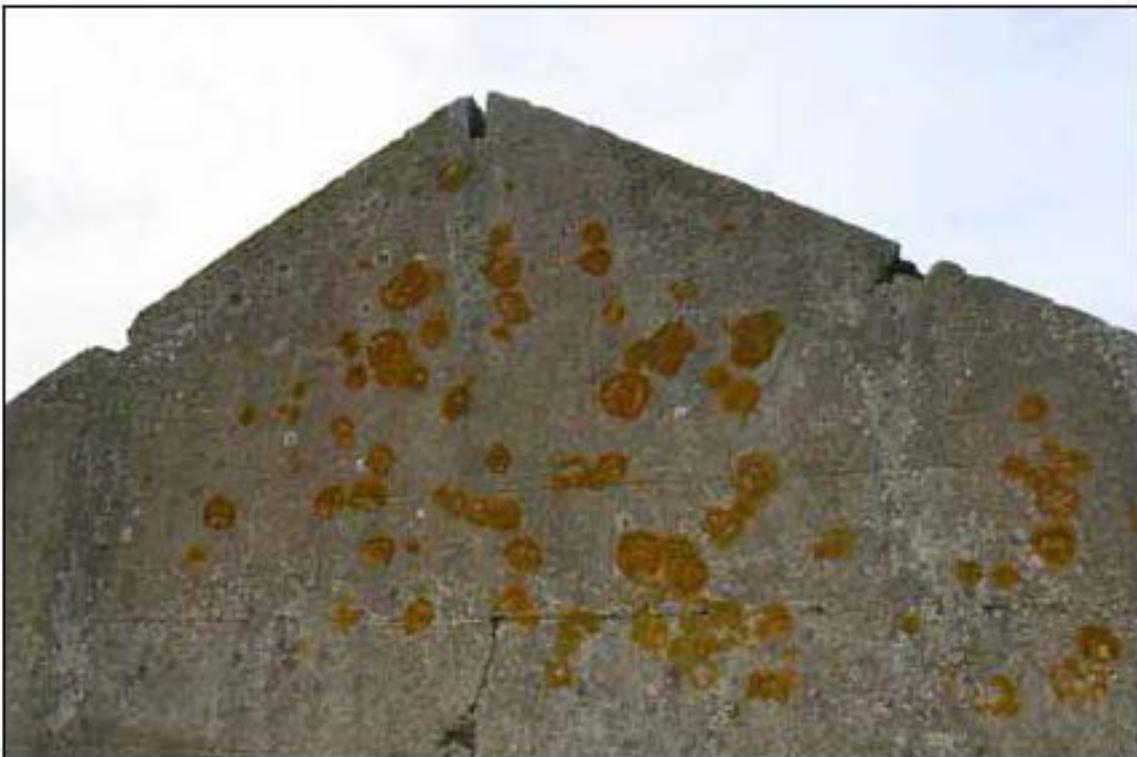
Figure 8: Gable end of a magazine showing the 'ashlar pattern' incised into the concrete render and the three slots which carried the roof purlins.

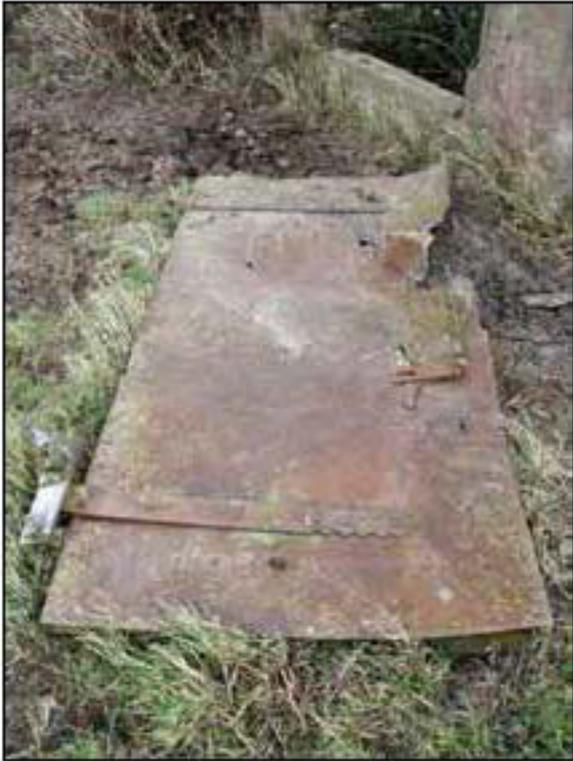
Figure 9A: Surviving metal-clad wooden magazine door.

Each of the buildings has a centrally placed entrance porch in its northern elevation which originally had a wooden door covered with metal sheet and held by pintel hinges on to a wooden frame (Figure 9A), the slot for which is clearly visible. When open the magazine doors may have been secured with a hook located on the eastern porch elevation at a low level, which was possibly linked by a cord or chain to the small iron loop visible on the outer metal panel of the door that survives (Figure 9B). Each porch had a pitched roof with a concrete gable. A slot which carried the porches' wooden roof ridge is visible at the apex of the porch gable. No evidence of an inner door, described in the Explosives Inspector's report as having been visible on the brick magazine (Desborough 1905, 3), was noted.

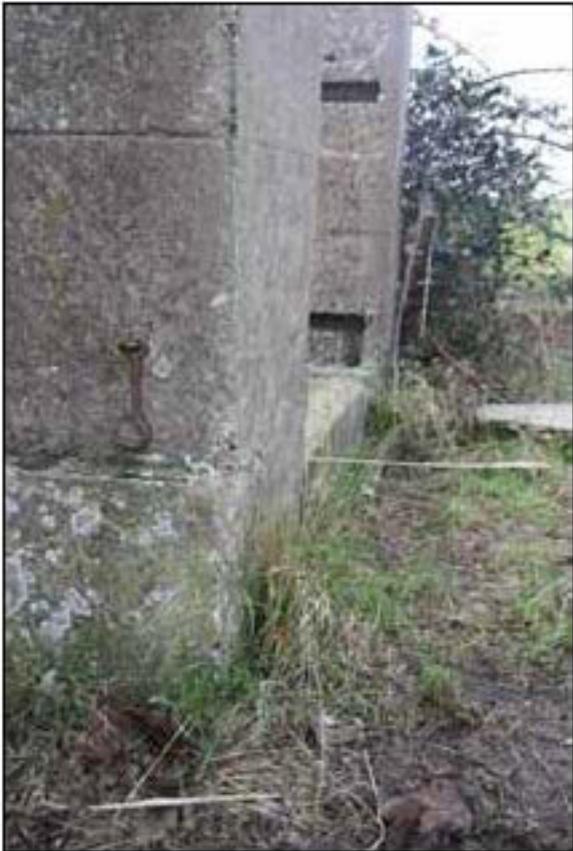
Figure 9B: Hook on east elevation of porch for securing door when open.

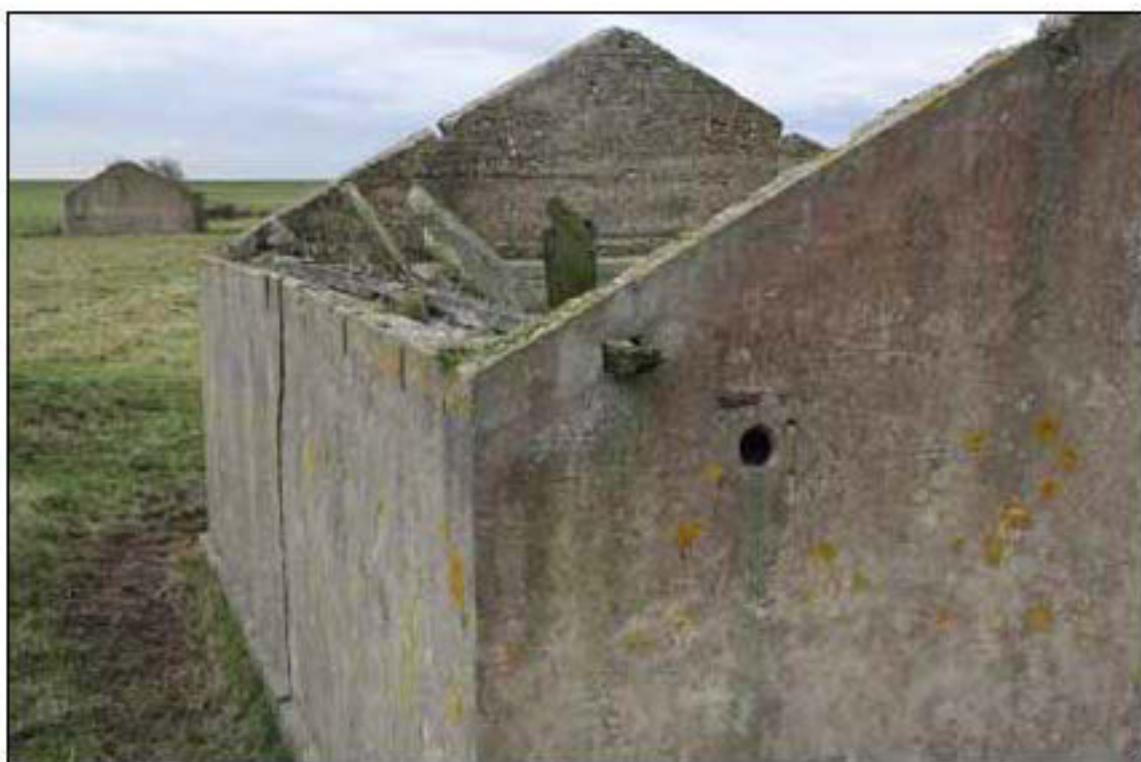
Figure 10: Surviving roof timbers in the magazine to the extreme south-east of the site indicate the position of the pole plate which protruded through both gables and carried the rafters. Evidence for some form of cover over the ventilation pipe in the east elevation is also visible

Gable ends to the main east and west elevations indicate that the buildings had pitched roofs with wooden frames. Square holes on either side of both gables indicate the position of two wooden pole plates, to support the rafters, which ran the length of the north and south elevations just above eaves height and protruded beyond the gable end (Figure 10). Three slots on each gable, one at the apex and two mid-pitch, indicate the position of the ridge plate and purlins which carried the roof. Similar slots are visible at eaves level in the north and south elevations where the wooden roof rafters protruded to form the eaves. Remains of the collapsed timber roof within a number of the structures show that the roof rafters had an element of detailing on the end that would have been visible. Small holes which run internally across the base of the gables may indicate the position of a ceiling (Figure 11). Evidence for a slate roof covering survives on the ground in and around the magazines, though drips of bitumen on the exterior of the magazine to the extreme south-east of the site suggest that patch repairs may have been made to its roof at some point.

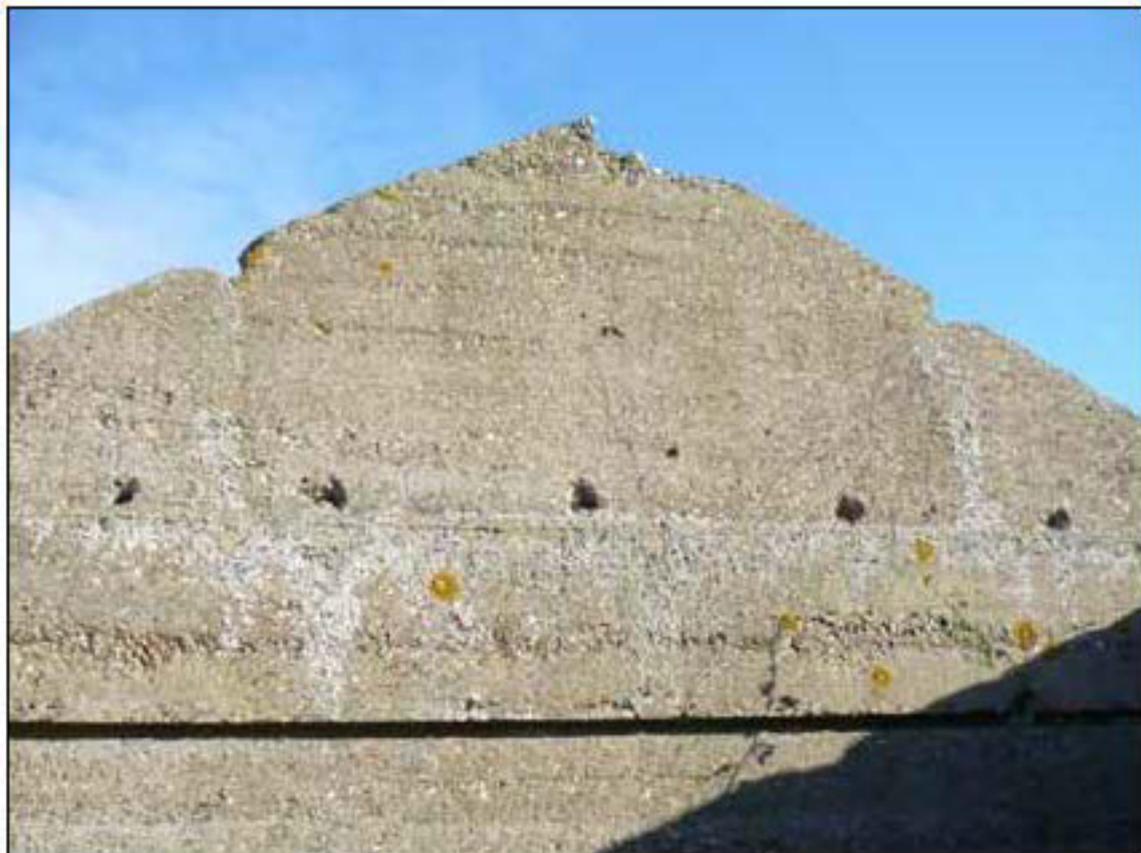
Figure 11: Small holes on the interior surface at the base of the gables that may indicate the position of a ceiling.

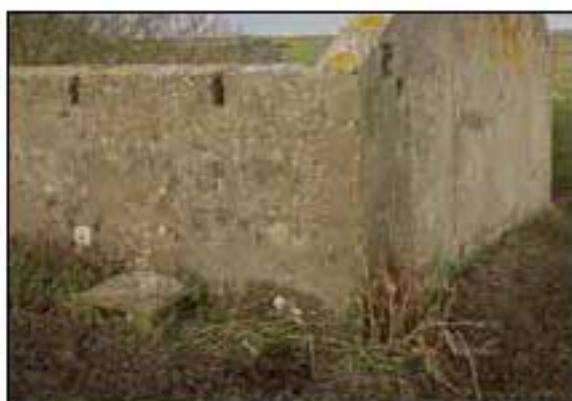
Figure 12A: An example of the concrete ventilation shafts visible buried in the bunds on the south elevation of the most northerly row of magazines.

Good ventilation was vital in the storage of explosives. Pairs of air bricks (or holes where they were located) are visible at ground level to the east and west of the door on the northern elevation of the magazines. At least two types of air brick were used: red unglazed bricks and brown glazed bricks (Figure 13). Curving ceramic pipes are visible on each building, at eaves level in the eastern gable at its southern end and in the western half of the southern elevation at a low level (Figure 14). The lower portion of each pipe is blackened internally. The pipes are probably related to the magazines' ventilation systems. Witness marks appear to indicate that the pipes in the eastern elevation had some sort of square external fitting, possibly a grill (Figure 10). Evidence for a different form of ventilation is also visible on the most northerly row of magazines. These magazines all have evidence for two (only one is visible on the most westerly magazine) rectangular-section concrete pipes buried vertically into the protective bund against the eastern and western ends of the southern elevation (Figures 12A and 12B). These vents originally had a concrete cap and metal grill in their southern face. This type of vent is not visible on the magazines further to the south and may relate to variations in the configuration of the bunds (see below). These vents could relate to the ventilation of the wooden floor.

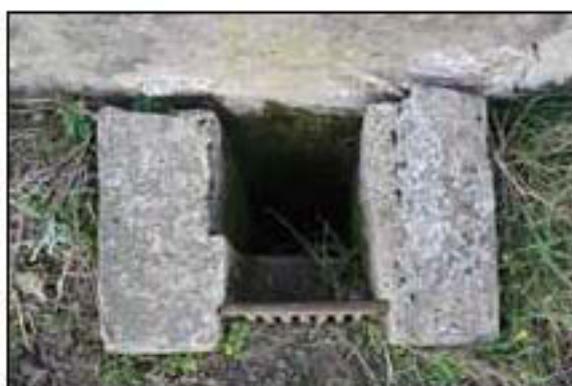
Figure 12B: A concrete ventilation shaft with the cap removed.

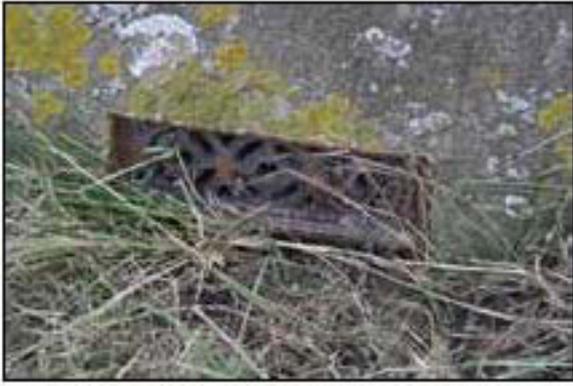
Figure 13: An example of the air bricks visible in the northern elevations of the magazines to the west and east of the porch.

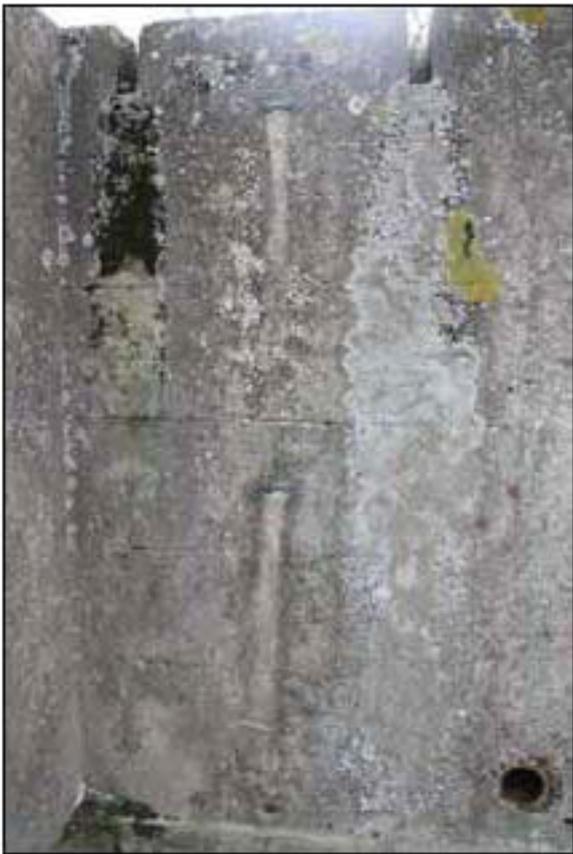
Figure 14: An example of the copper alloy fixings for the lightning conductors which were attached to each magazine. The ceramic vent pipe to the east of the entrance porch can also be seen.

Apart from the various types of ventilation there is little other external detail on the magazines. Evidence for lightning conductors in the form of a column of three copper alloy fittings is visible to the west of each magazine entrance porch (Figure 14) and other witness marks of unclear function are visible to the east.

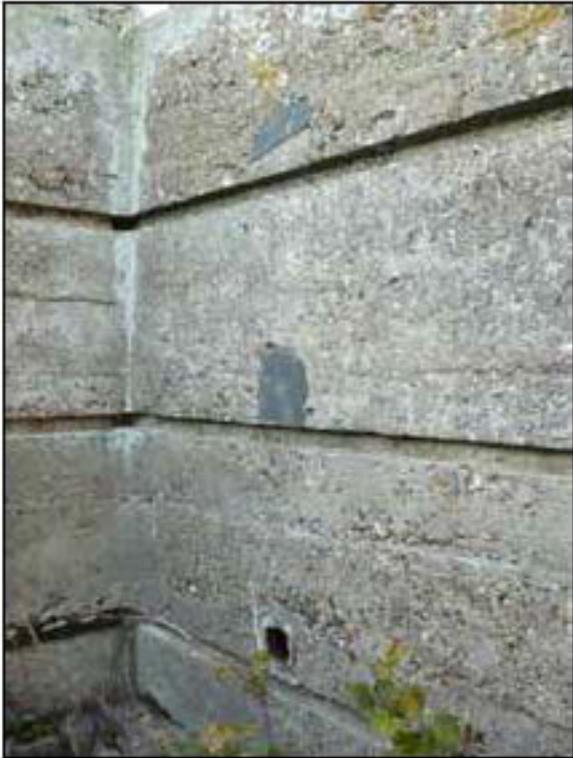
Figure 15: The internal slots which carried batons on to which wooden anti-spark 'match-lining' would have been fixed. Pieces of slate can be seen embedded in the interior face of the southern wall above a ceramic pipe. This may be related to the external concrete ventilation shaft seen on the southern elevation of some of the magazines.

Internally, three slots 5.5 cm wide run horizontally around the entire internal wall surface of the magazines (Figure 15), one 0.27m above floor level and two equally spaced 0.65m (2 feet) apart above that. The slots carried the batons for some sort of 'anti-spark' wooden cladding (match-lining). Some of the batons can be seen surviving in situ. A dwarf concrete wall running east-west across the centre of the buildings carried a floor, probably supported on the slightly protruding plinth at the base of the building (Figure 16A). Similar supporting concrete walls can be seen within the porch area of the building (Figure 16B). Slots in the plinth in each of the internal corners may have carried floor joists, as seen surviving in the magazine to the far south-east of the site. There are occasional pieces of slate attached to the walls which appear to be vertically aligned with a pipe in the southern wall of the magazines (Figure 15).

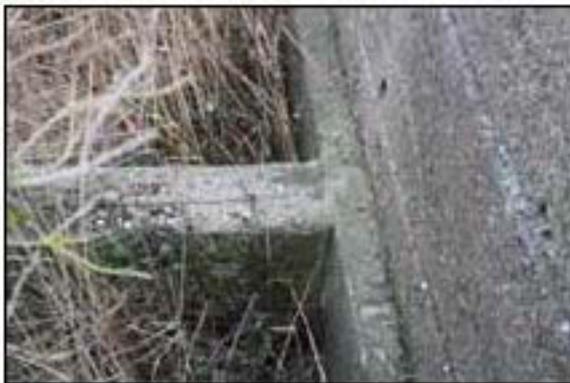
Figure 16A: East-west concrete dwarf wall which supported a floor.

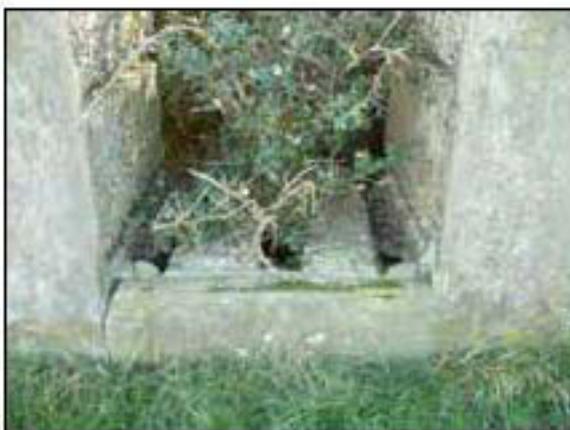
Figure 16B: Concrete floor supports within the entrance porch.

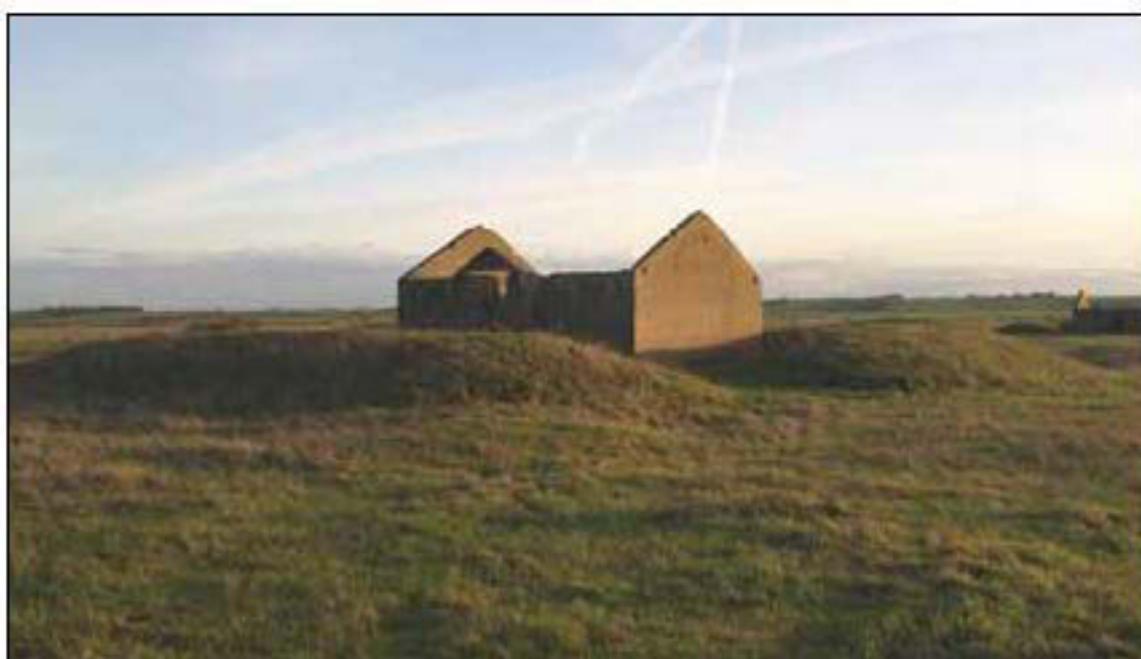
Figure 17: A surviving example of the earthwork bund which originally protected all the magazines (eastern of central two magazines).

On the 3rd edition 1908 Ordnance Survey map (Figure 5) all of the seven magazines are shown with a protective U-shaped earthwork bund around their western, eastern and southern sides with a separate linear bund to the north allowing access to the magazine entrance from the east and west. These earthworks were intended to minimise the impact of accidental explosions. Today the earthworks of the three most northerly magazines survive; to the south the westernmost of the next two magazines has lost its northern bund and possibly had the northern ends of its southern bund truncated; and to the south again, the bund of the westernmost magazine has been levelled on all sides and the northern bund of the eastern magazine has been removed whilst the southern bund has been truncated at its northern ends on both sides (Figure 17). The bund arrangements do not reflect the complex layouts proposed on the 1892 plan that accompanied the lease (MALSC DRcEgz 151/2; Figure 3).

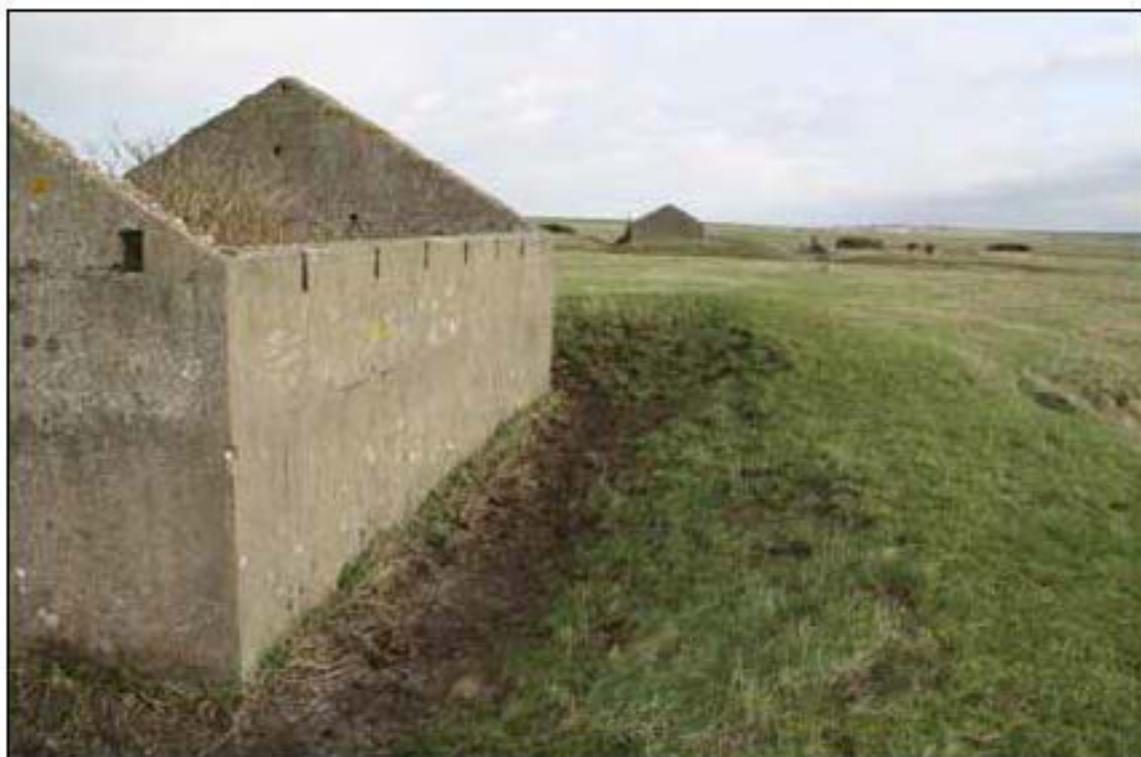
Figure 18: The western magazine of the central row has a clear gap between its southern elevation and the protective bund, in contrast to the row of magazines to the north.

bunds. As no vents are visible on the rear (southern) elevation of these magazines (or on the westernmost of the two southern magazines where the bund has been levelled) the gap may have been intended to allow for a less elaborate form of ventilation (Figure 18).

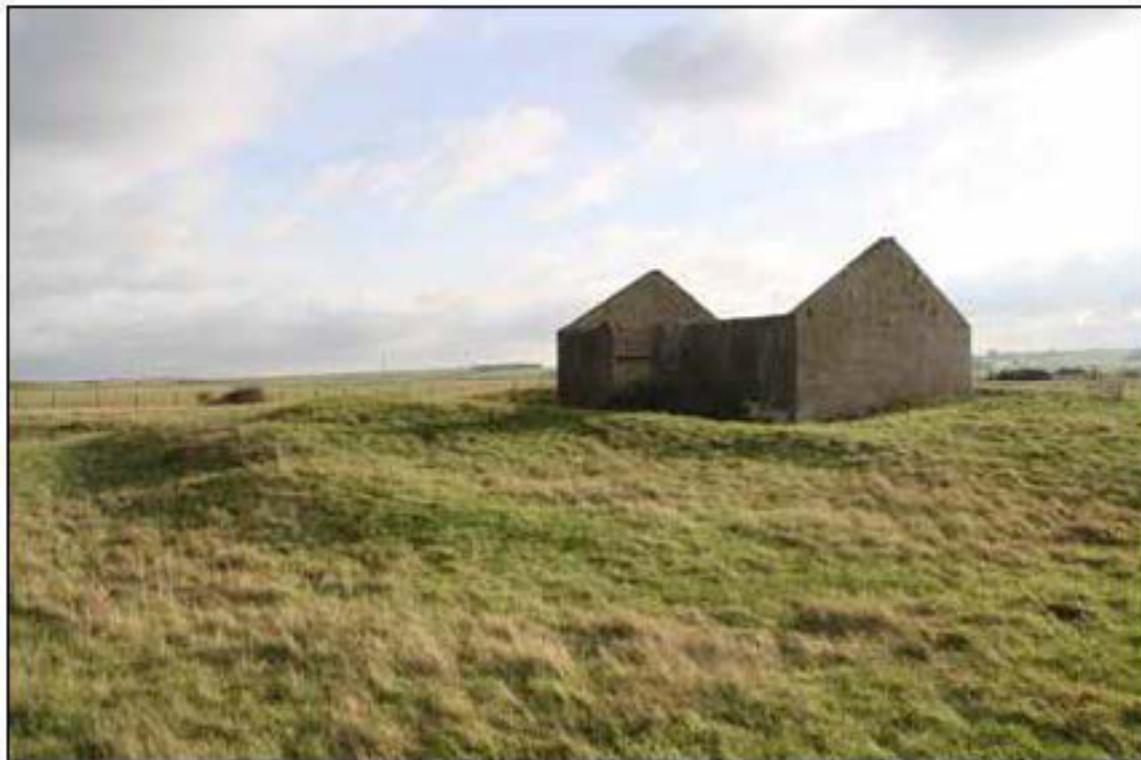
Figure 19: Location of possible building which post-dates the closure of the magazine complex, immediately to the north of the most easterly of the three northern magazines.

Evidence of another small structure survives to the north of the most easterly magazine of the northern row. At the western end of the northern earthwork bund which protects the door is a neat square scoop, 4m north-south by 3.6m east-west (Figure 19). Any structure which was located in this position must post-date the use of the magazine for explosives storage as a building would not have been permitted in such close proximity. Another possible platform was noted to the north of the eastern of the two magazines in the central row.

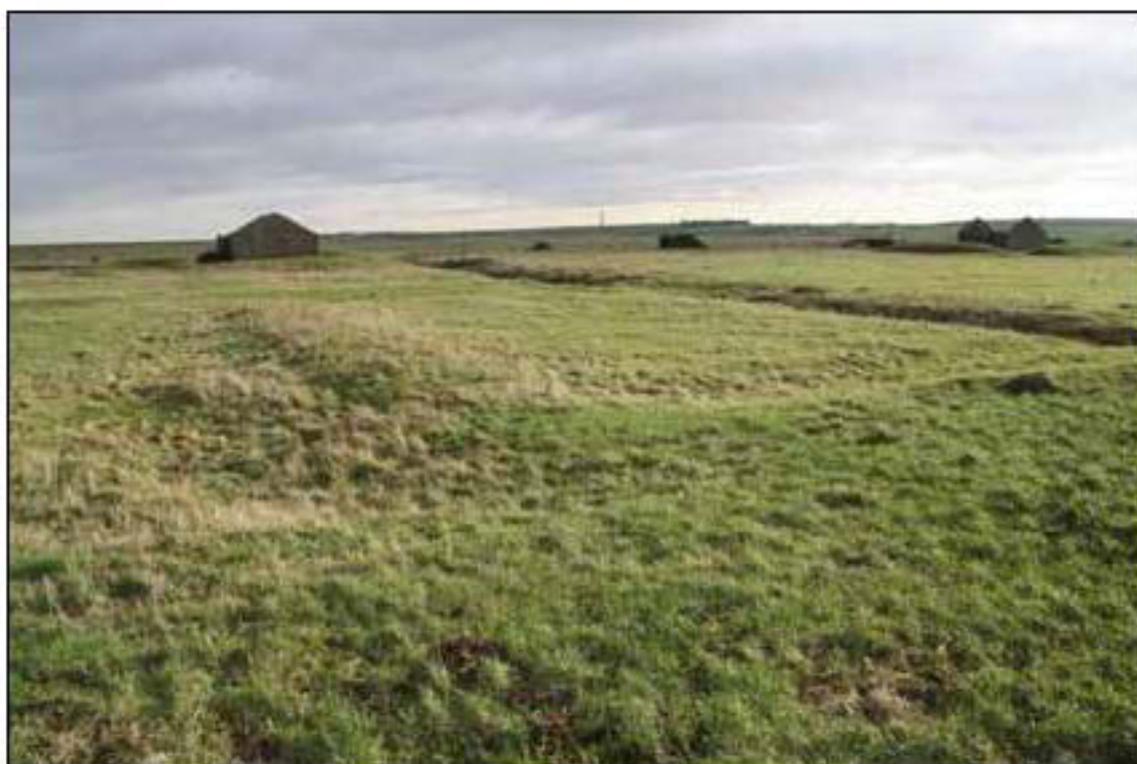
Figure 20: Embanked trackway which runs east-west between the northernmost row of magazines. It is truncated by the main north-south access track before it reaches the easternmost magazine.

An embanked trackway runs through the gaps in the bunds of the three most northerly magazines to link them together (Figure 20). Between the most north-westerly magazine and the one to the east, this track is roughly 3.5m wide at the base and 1.8m at the top. It does not directly align with the gap in the north-west bund, perhaps suggesting that it was constructed before the bund. As the track heads east towards the most easterly magazine it widens to 4.2m at its base and 2m at the top before being cut by the main north-south track into the site. There is no evidence of embanked tracks linking the other rows of magazines or the suggested site of the packing shed.

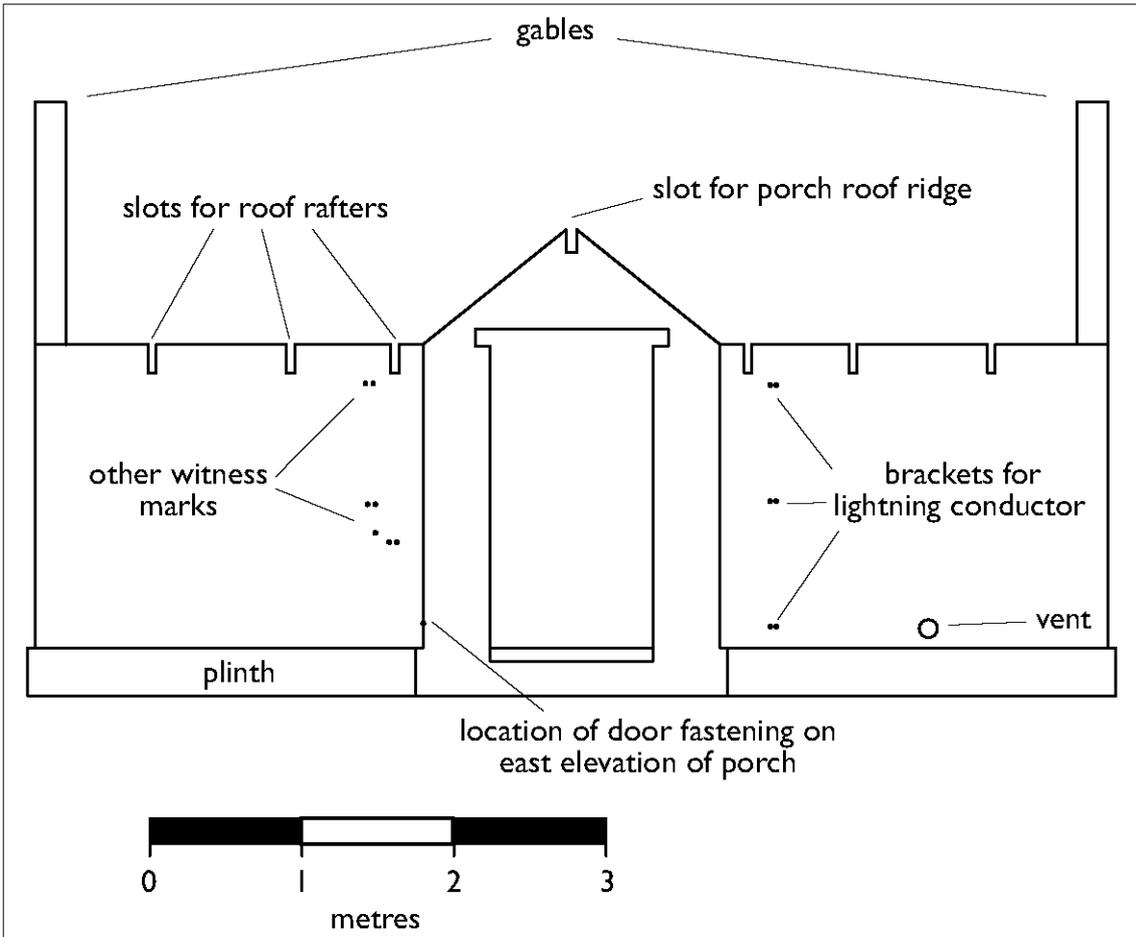
Figure 21: North elevation of explosives magazine (eastern magazine of central row measured).
