RESEARCH REPORT SERIES no. 52-2013

ST MARY'S MARSHES, HOO ST MARY, MEDWAY, KENT

AN ASSESSMENT OF THE LATE 19TH CENTURY EXPLOSIVES MAGAZINES

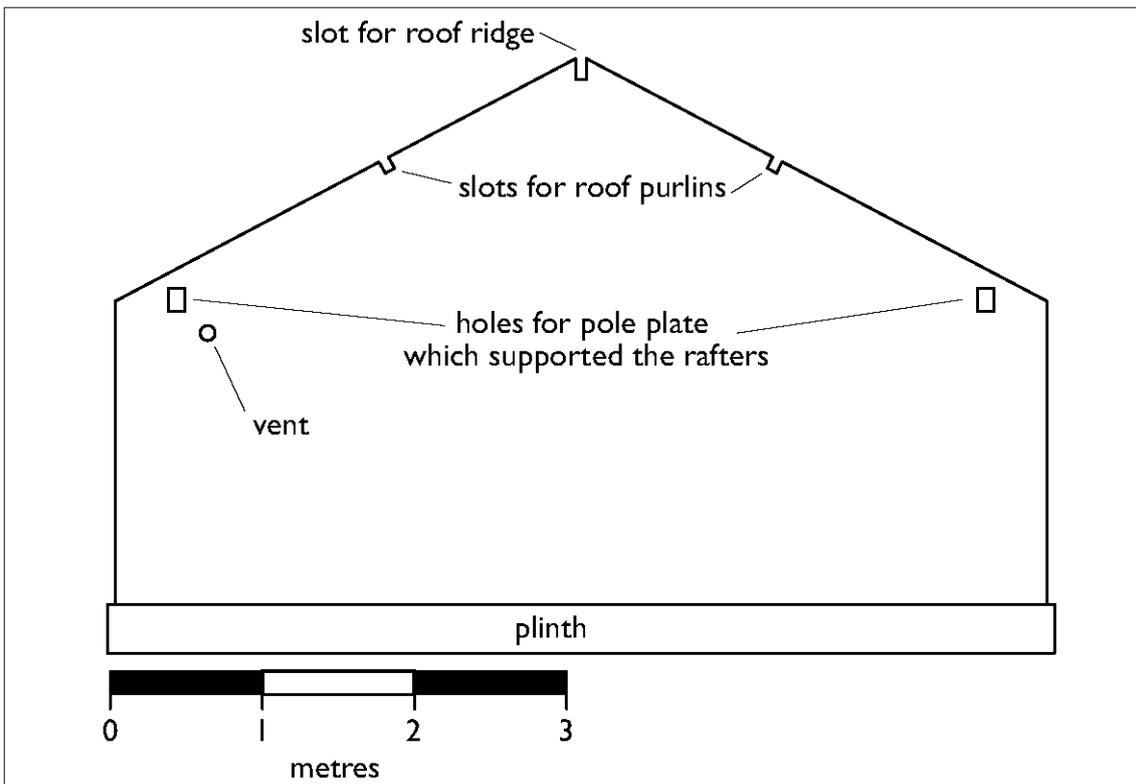
Figure 22: East elevation of explosives magazine (eastern magazine of central row measured).

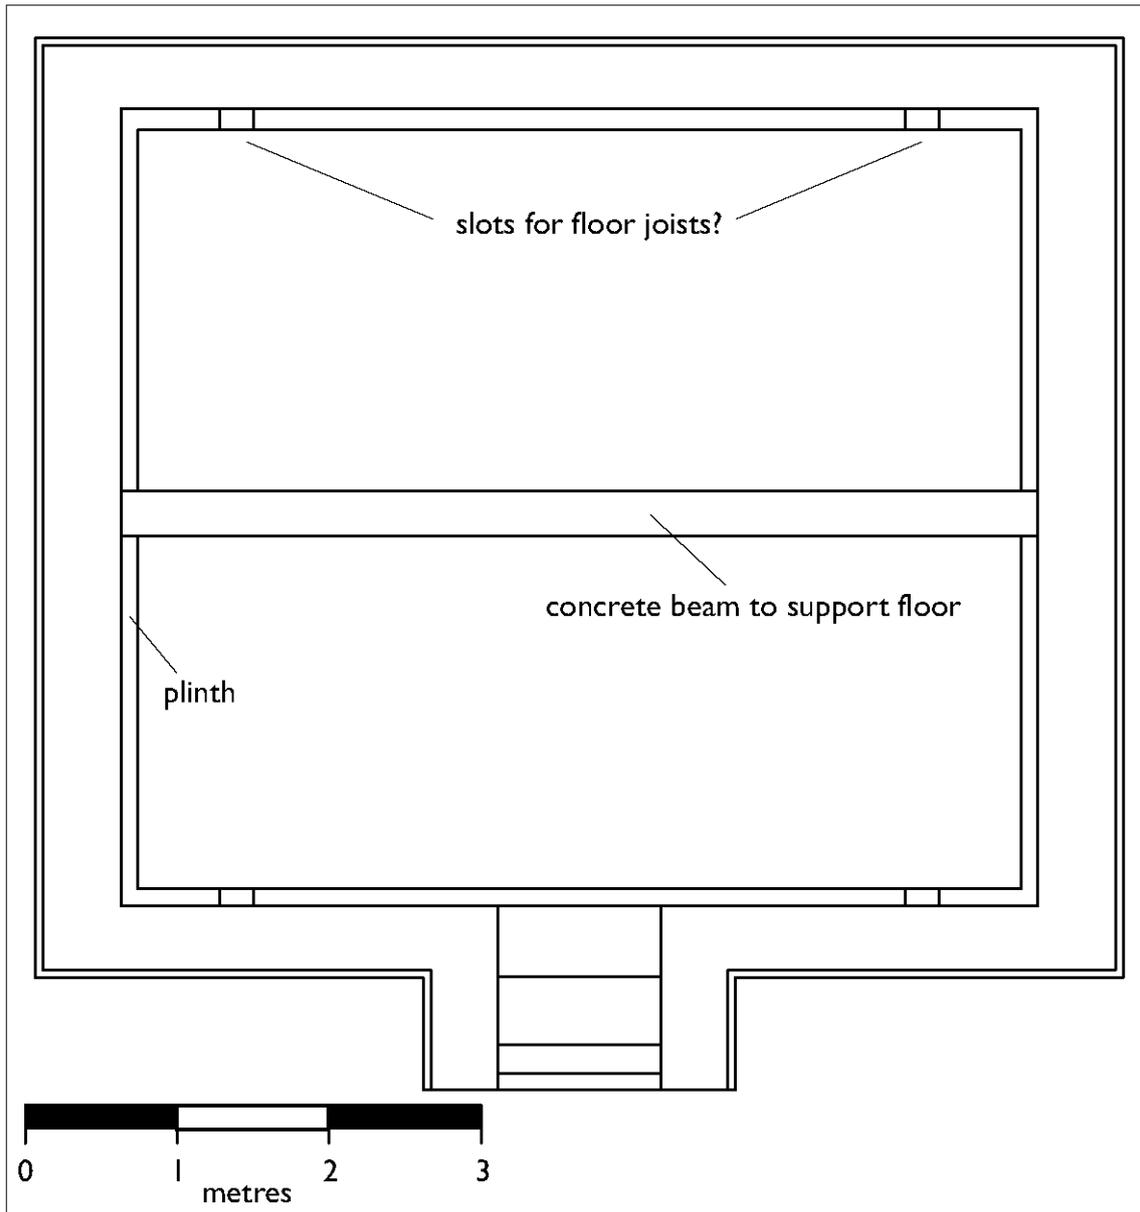
Figure 23: Floor plan of explosives magazine (eastern magazine of central row measured)
