# WOOD BARN, FAIRFIELD HOUSE, STOGURSEY, SOMERSET

## TREE-RING ANALYSIS OF TIMBERS

SCIENTIFIC DATING REPORT

#### Research Report Series 14-2014

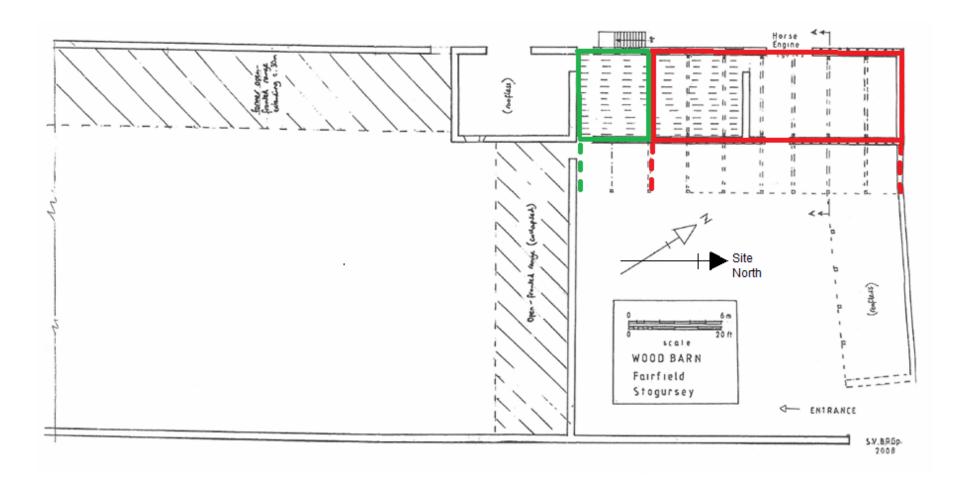
Figure 3: Plan of Wood Barn; main barn and pentice in red and extension and pentice in green (Chesher et al 2008)

Wood Barn on the Fairfield estate is located some distance from other estate buildings and is accessed from a track which was formerly a drive leading to the house (Figs 1 and 2). A survey of Wood Barn was undertaken by the Somerset Vernacular Building Research Group (Chesher et al 2008). The original barn is aligned north-east/south-west (north-south for the purpose of this report) and consists of seven bays with off-centre opposing doors; the southern three bays have a floor and are divided off from the rest of the barn by a stone wall. This wall does not continue at first-floor level. An open fronted pentice extends the full length of the south-east wall. To the east of the original barn is a large, fully enclosed yard which also had an open-fronted animal shelter along its north wall. To the south of the barn is a two-storey, single-room extension with external stone steps. There is a further substantial addition to the south, which may also have been floored at its south end. To the east of this, extending southwards, is another large yard formerly with an open-fronted range to its north and west (Fig 3).

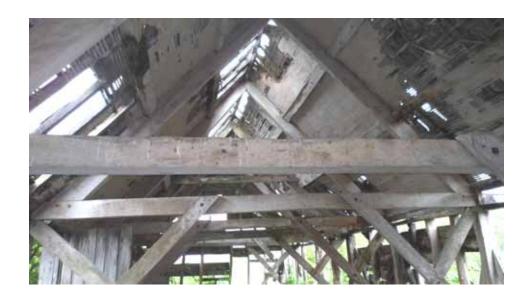
Figure 4: Main barn roof, looking north-east (Alison Arnold)

The original barn is timber-framed on a blue lias stone plinth. The framing consists of principal posts extending down from the roof trusses, with intermediate posts and two straight, diagonal braces running from the sole plate to the wall-plate in each bay. The roof structure consists of principal rafters with tiebeams and trenched purlins (Fig 4). Additional posts with cross-bracing have been inserted at a later date (Fig 5).

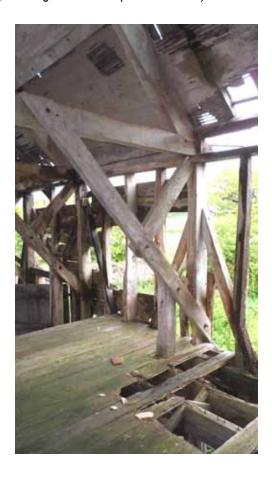
Figure 5: Main barn, later posts and bracing, from the west (Alison Arnold)

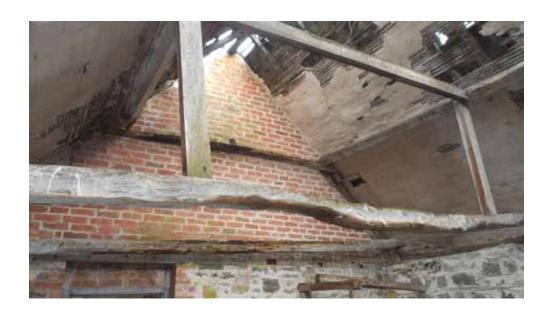
Figure 6: South extension, truss 10, from the south-west (Alison Arnold)

The roof of the southern extension is a much coarser construction with three tiebeams resting on wall plates, collars, and queen posts to the middle truss (Fig 6).

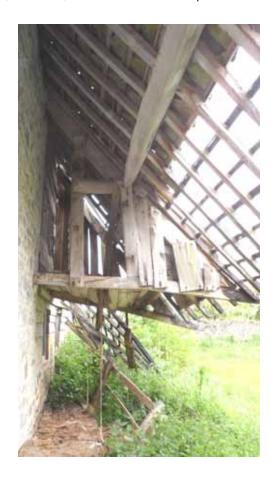
Figure 7: Main barn pentice, looking north-east (Alison Arnold)

The pentice, which once extended along the east wall of the original barn and southern extension, was open-fronted and supported on oak posts set on blue lias straddles (Fig 7).

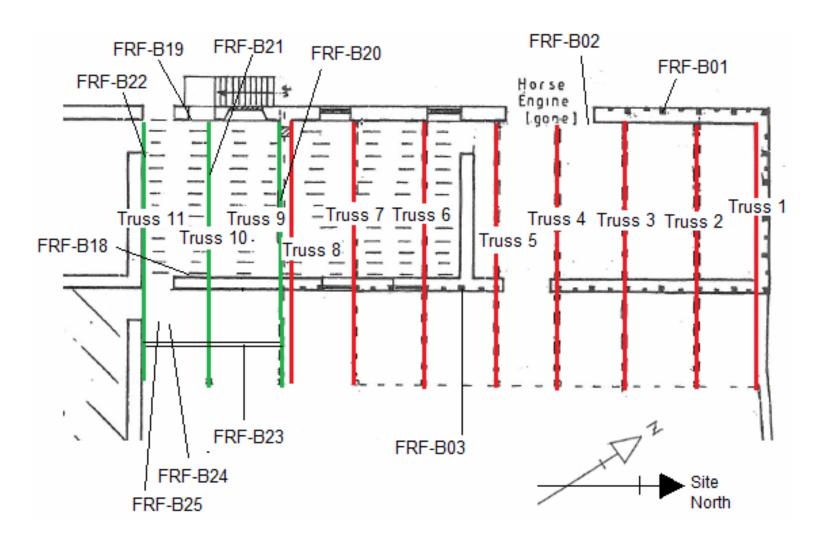
Figure 8: Plan of the barn and extension, showing the location of samples FRF-B01–03, and FRF-B18–25 (Chesher et al 2008)

A total of 25 timbers from the main barn, the single-bay southern extension, and their associated pentices was sampled by coring. Each sample was given the code FRF-B and numbered 1–25. The location of all samples was noted at the time of sampling and has been marked on Figures 8–15. Further details relating to the samples can be found in Table 1.

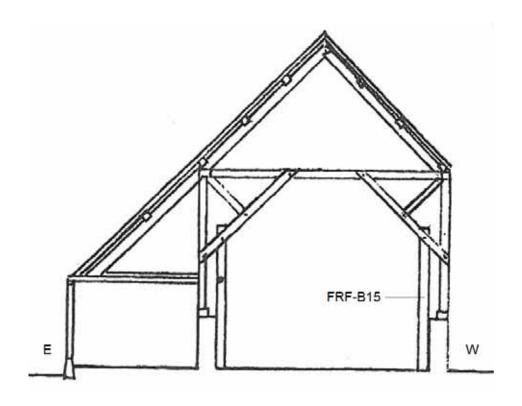
Figure 9: Truss 2, showing the location of sample FRF-B15 (Chesher et al 2008)

The later posts and framing of the main barn were fast-grown and unsuitable for tree-ring dating and so sampling of these timbers was abandoned after coring of two of them (FRF-B15 and FRF-B16).

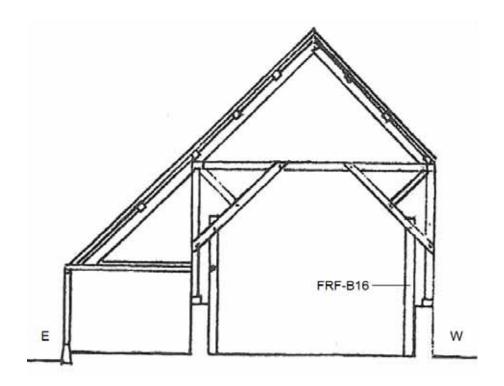
Figure 10: Truss 3, showing the location of sample FRF-B16 (Chesher et al 2008)

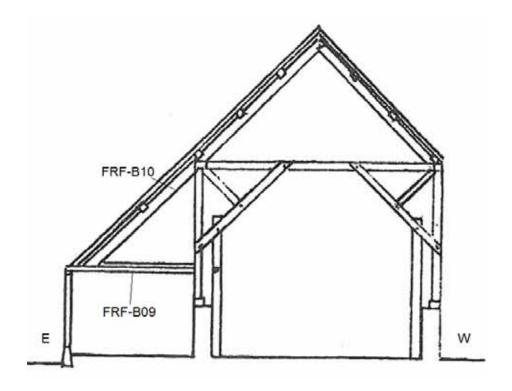
Figure 11: Truss 4, showing the location of samples FRF-B09 and FRF-B10 (Chesher et al 2008)

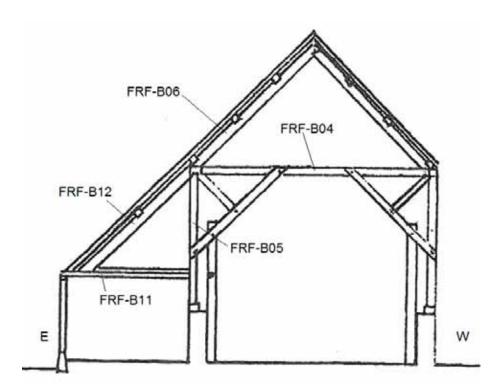
Figure 12: Truss 6, showing the location of samples FRF-B04—06 and FRF-B11—12 (Chesher et al 2008)

Twelve of the samples taken from the primary phase of the main barn and associated pentice have been successfully dated (Fig 17). Two of the dated samples, FRF-B04 and FRF-B06, have complete sapwood and the last-measured ring date of AD 1726, the felling date of the timbers represented. Seven further samples have the heartwood/sapwood boundary ring, the dates of which are broadly contemporary and suggestive of a single felling. The average heartwood/sapwood boundary ring date is AD 1707, allowing an estimated felling date to be calculated for the seven timbers represented to within the range AD 1722–47, consistent with these timbers also having been felled in AD 1726. The remaining three dated samples do not have the heartwood/sapwood boundary but with last-measured heartwood ring dates of AD 1643 (FRF-B11), 1646 (FRF-B14), and AD 1665 (FRF-B10) they have terminus post guem felling dates of AD 1658, AD 1661, and AD1680, respectively. Samples FRF-B11 and FRF-B14 match each other at t=10.7, a value high enough to suggest that the two beams represented were potentially cut from the same tree. Generally, the overall level of cross-matching of these three samples with the rest of the timber from the main barn and associated pentice is such to suggest a coherent group of timbers, and that these three timbers were also likely to have been felled in AD 1726.

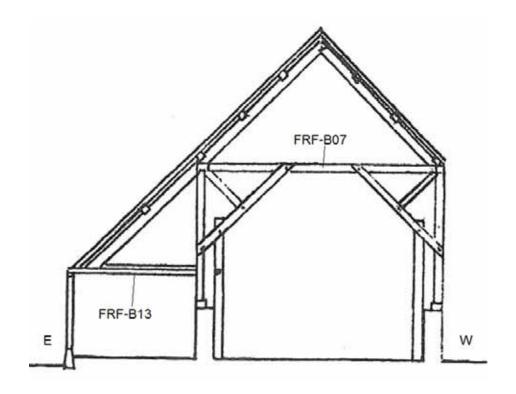
Figure 13: Truss 7, showing the location of samples FRF-B07 and FRF-B13 (Chesher et al 2008)

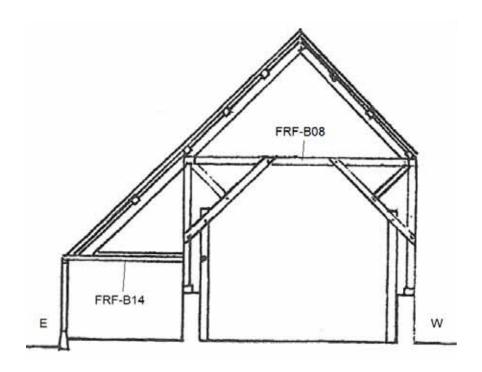
Figure 14: Truss 8, showing the location of samples FRF-B08 and FRF-B14 (Chesher et al 2008)

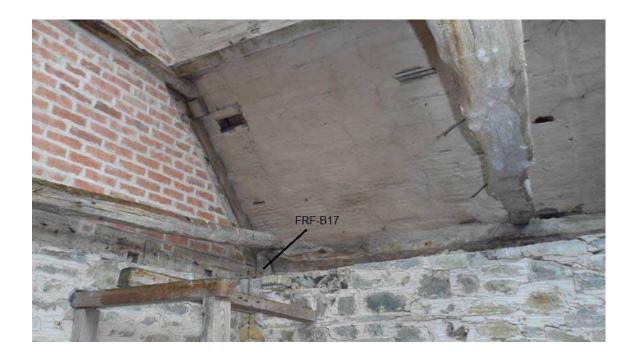
Figure 15: Photograph to show the location of sample FRF-B17, from the west (Alison Arnold)

Six samples taken from the southern extension and its associated pentice have been dated (Fig 17). Two of these (FRF-B21 and FRF-B17) have complete sapwood. Sample FRF-B21, taken from a post of truss 9 has the last-measured ring date of AD 1768, whilst FRF-B17, from the tiebeam of truss 9, has the last-measured ring date of AD 1771, the

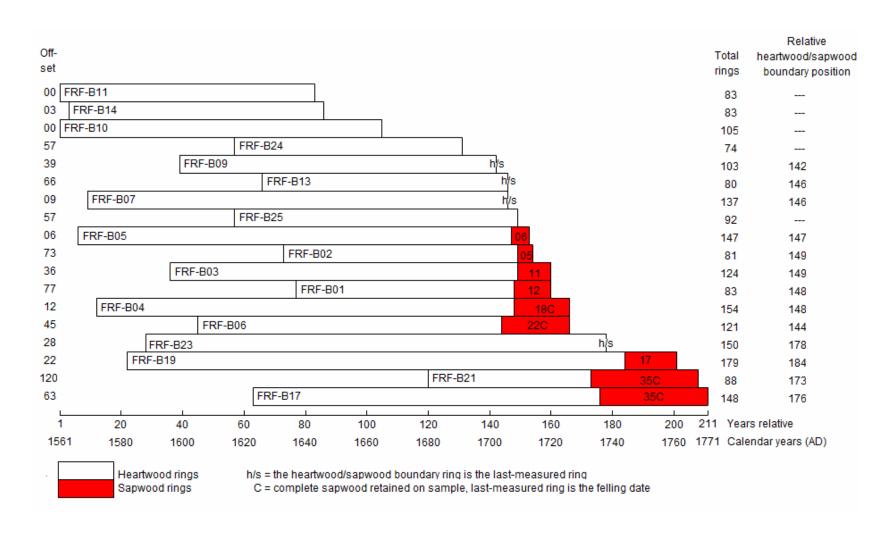
Figure 16: Bar diagram of samples in site sequence FRFBSQ01

Eighteen samples matched each other and were combined at the relevant offset positions to form FRFBSQ01, a site sequence of 211 rings (Fig 16). This site sequence was compared against a series of relevant reference chronologies for oak where it was found to span the period AD 1561–1771. The evidence for this dating is given in Table 2.

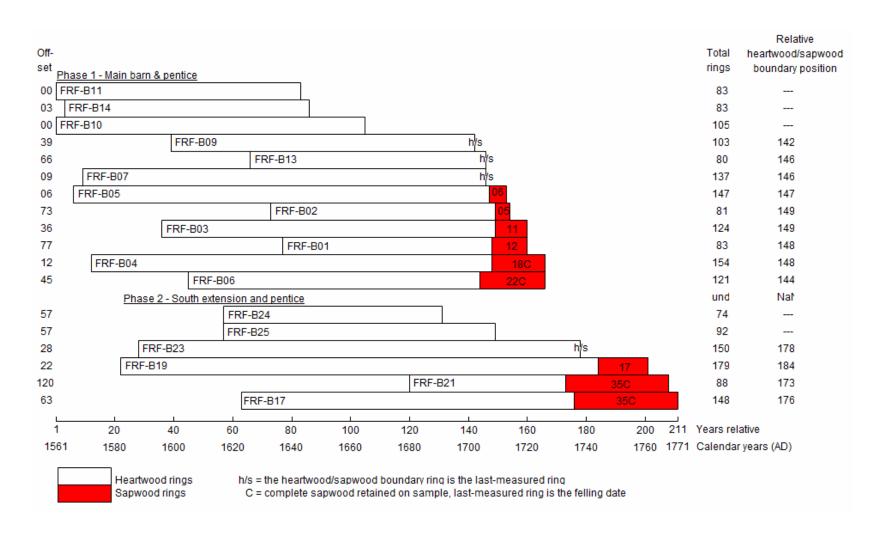
Figure 17: Bar diagram of dated samples, sorted by area

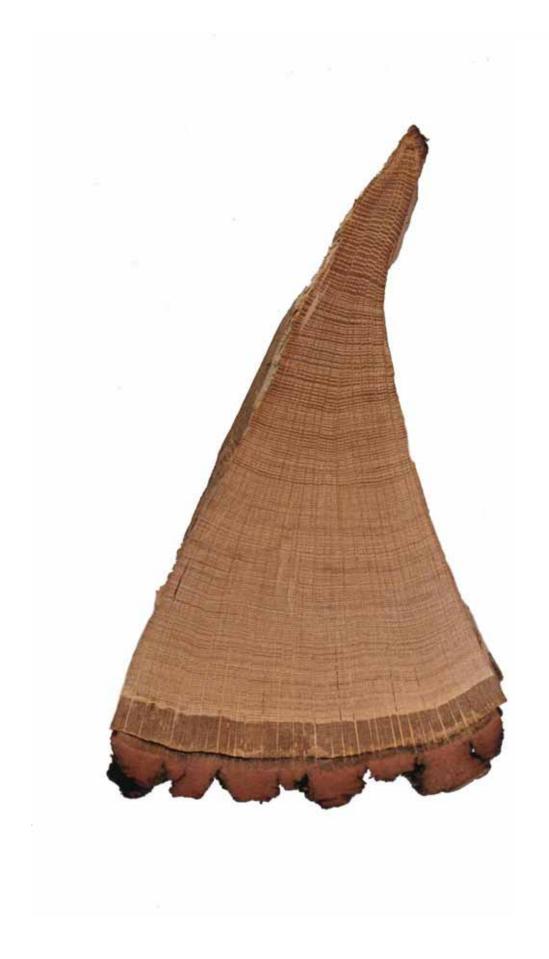
Figure A1: A wedge of oak from a tree felled in 1976. It shows the annual growth rings, one for each year from the innermost ring to the last ring on the outside just inside the bark. The year of each ring can be determined by counting back from the outside ring, which grew in 1976

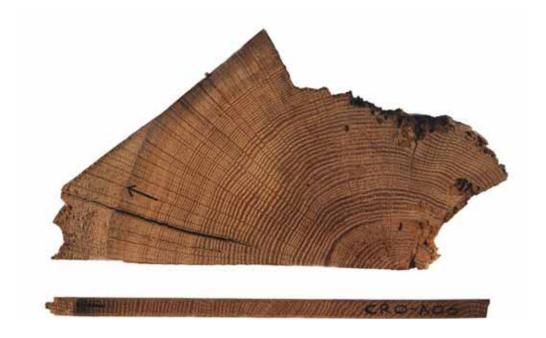
Figure A2: Cross-section of a rafter, showing sapwood rings in the left-hand corner, the arrow points to the heartwood/sapwood boundary (H/S); and a core with sapwood; again the arrow is pointing to the H/S. The core is about the size of a pencil

Quite often some, though not all, of the original outer rings are missing on a timber. The outer rings on an oak, called sapwood rings, are usually lighter than the inner rings, the heartwood, and so are relatively easy to identify. For example, sapwood can be seen in the corner of the rafter and at the outer end of the core in Figure A2, both indicated by arrows. More importantly for dendrochronology, the sapwood is relatively soft and so liable to insect attack and wear and tear. The builder, therefore, may remove some of the sapwood for precisely these reasons. Nevertheless, if at least some of the sapwood rings are left on a sample, we will know that not too many rings have been lost since felling so that the date of the last ring on the sample is only a few years before the date of the original last ring on the tree, and so to the date of felling.

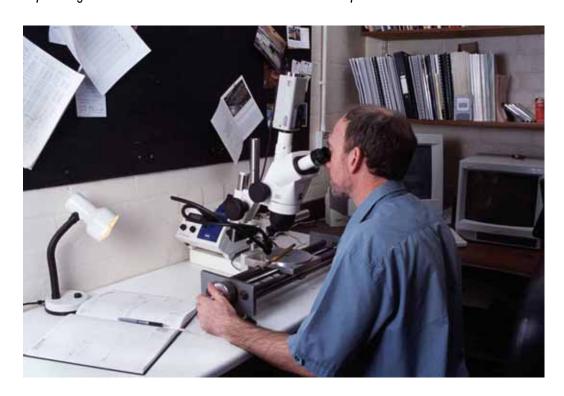
Figure A3: Measuring ring widths under a microscope. The microscope is fixed while the sample is on a moving platform. The total sequence of widths is measured twice to ensure that an error has not been made. This type of apparatus is needed to process a large number of samples on a regular basis

- 2. Measuring Ring Widths. Each core is sanded down with a belt sander using medium-grit paper and then finished by hand with flourgrade-grit paper. The rings are then clearly visible and differentiated from each other with a result very much like that shown in Figure A2. The core is then mounted on a movable table below a microscope and the ring-widths measured individually from the innermost ring to the outermost. The widths are automatically recorded in a computer file as they are measured (see Fig A3).

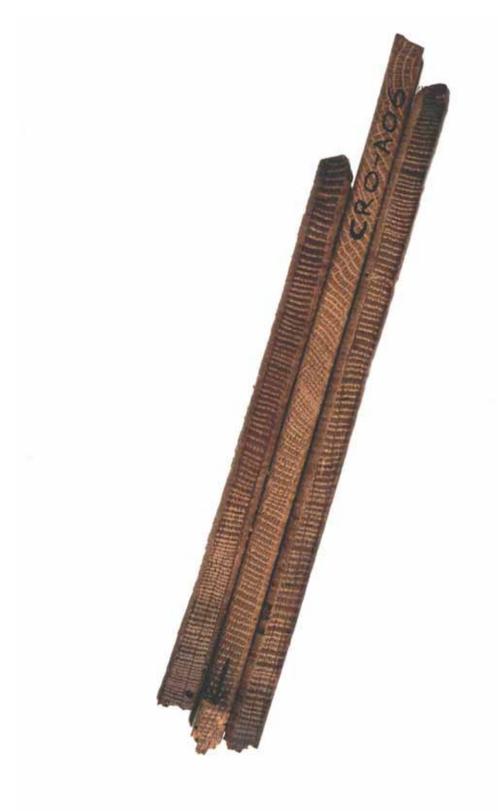
Figure A4: Three cores from timbers in a building. They come from trees growing at the same time. Notice that, although the sequences of widths look similar, they are not identical. This is typical

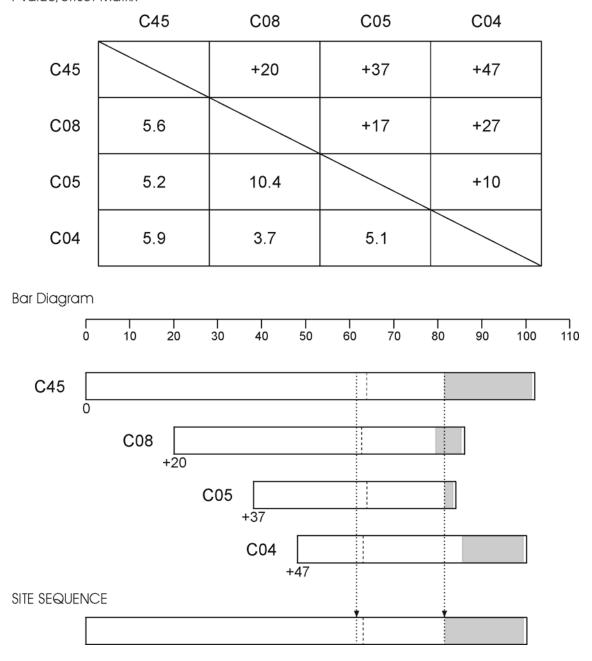
Figure A5: Cross-matching of four sequences from a Lincoln Cathedral roof and the formation of a site sequence from them

The bar diagram represents these sequences without the rings themselves. The length of the bar is proportional to the number of rings in the sequence. Here the four sequences are set at relative positions (offsets) to each other at which they have maximum correlation as measured by the t-values. The t-value/offset matrix contains the maximum t-values below the diagonal and the offsets above it. Thus, the maximum t-value between C08 and C45 occurs at the offset of t-20 rings and the t-value is then 5.6. The site sequence is composed of the average of the corresponding widths, as illustrated with one width.

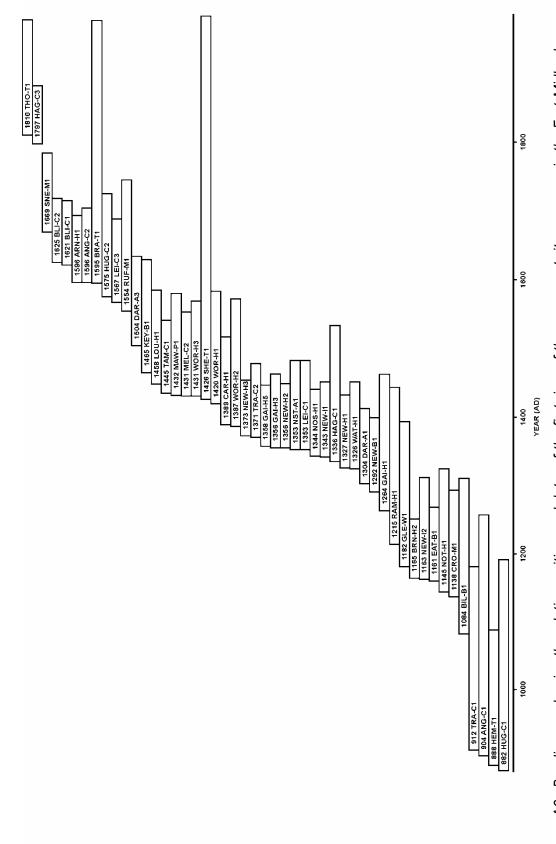
Figure A6: Bar diagram showing the relative positions and dates of the first rings of the component site sequences in the East Midlands Master Dendrochronological Sequence, EM08/87

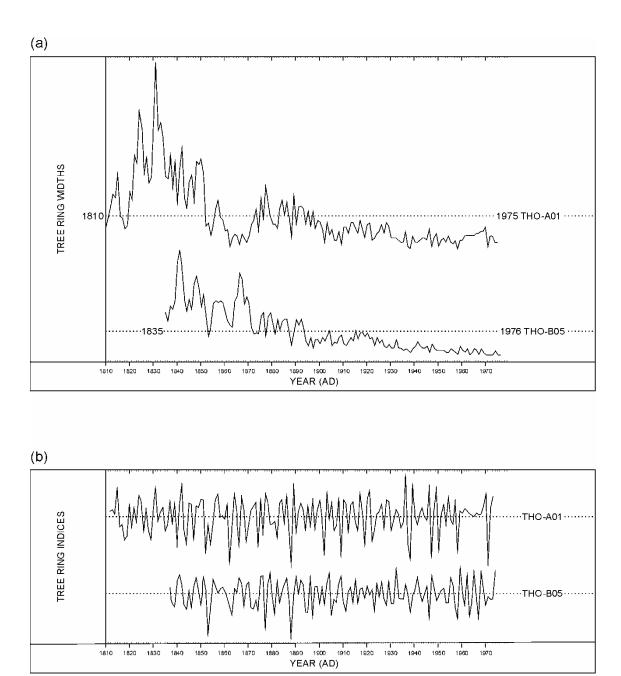
Figure A7 (a): The raw ring-widths of two samples, THO-A01 and THO-B05, whose felling dates are known

Here the ring widths are plotted vertically, one for each year, so that peaks represent wide rings and troughs narrow ones. Notice the growth-trends in each; on average the earlier rings of the young tree are wider than the later ones of the older tree in both sequences
