LANGLEY ABBEY, LANGLEY WITH HARDLEY, NORFOLK TREE-RING ANALYSIS OF TIMBERS

SCIENTIFIC DATING REPORT

Research Report Series 25-2014

NGR: TG 36243 02852 and TG 36220 02837

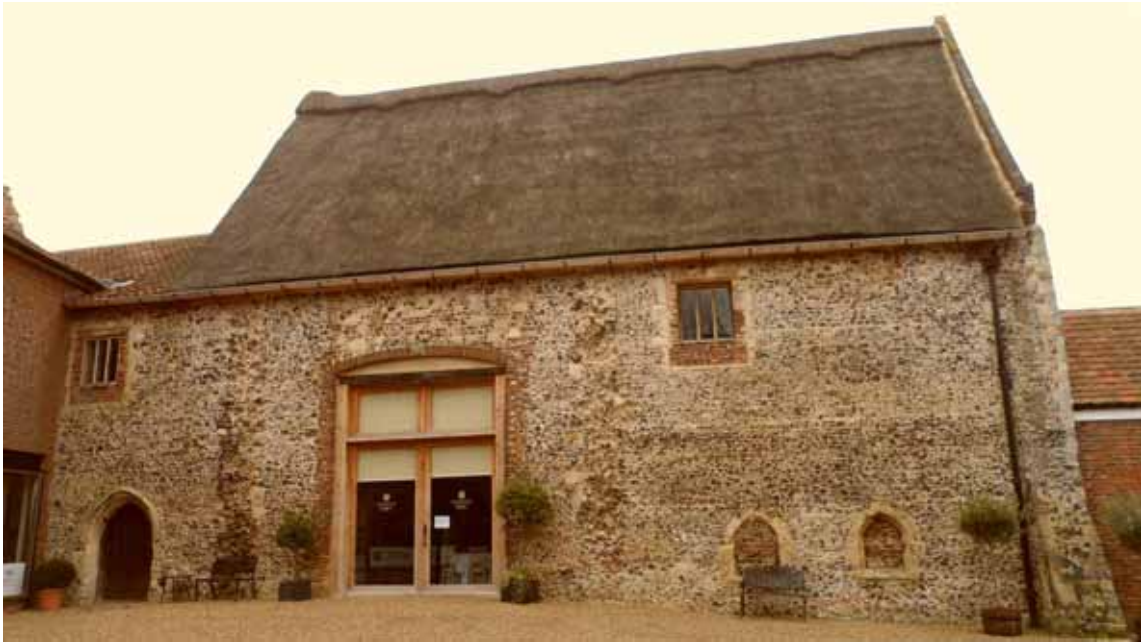
Figure 5: Former west range of the cloister, from the east (Alison Arnold)

This Grade 1 building is thought to date from the thirteenth century but has experienced substantial remodelling since this time. Its structure comprises limestone, brick, and flint with red brick, and limestone dressings (Fig 5). The main block was originally of two-and-a-half storeys with vaulting above the ground floor. It has a steeply-pitched, thatched roof over the south end, with a later, shallower-pitched, pantiled roof to the north; the north gable retains the line of the earlier roof. The roof comprises two tiers of butt purlins, tiebeams, and collars to principal rafters and appears to be a mixture of modern and historic timbers. Additionally, trusses 5, 6, and 8 retain wall-posts (either both or just to one side) and there are arch-braces to the west side of trusses 5 and 6 (Fig 6). This building is part of the Scheduled Ancient Monument.

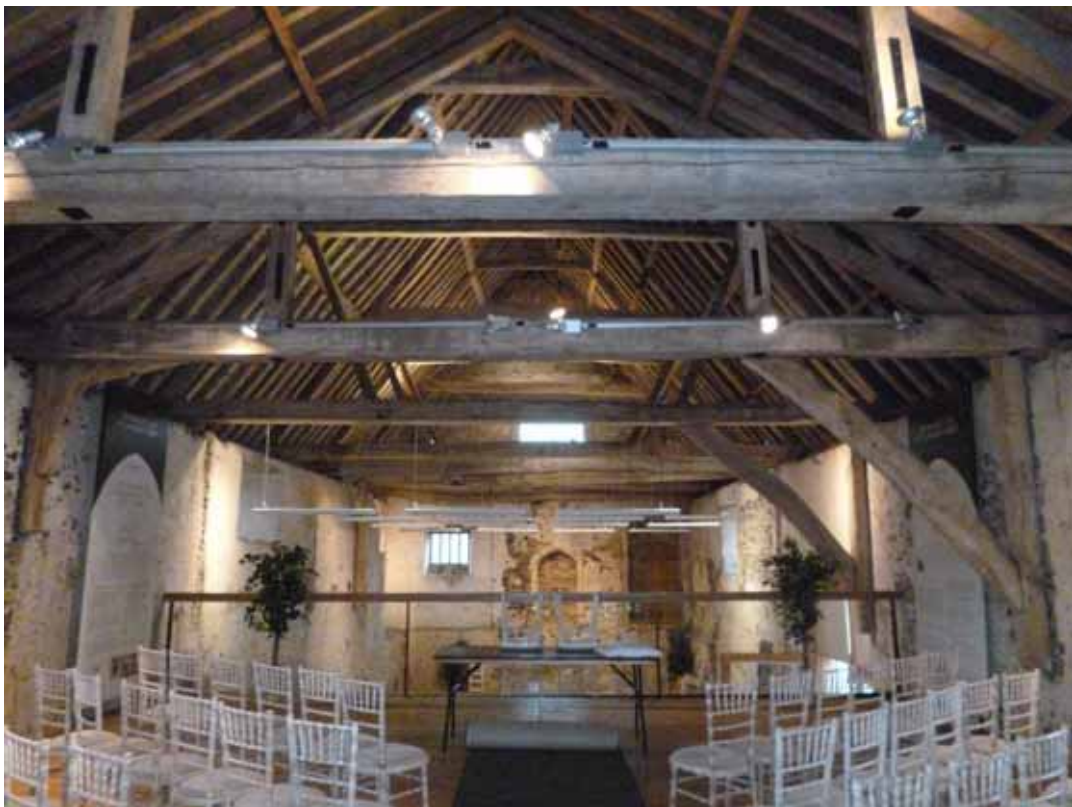
Figure 6: Former west range of the cloister, photograph taken from the south (Alison Arnold)

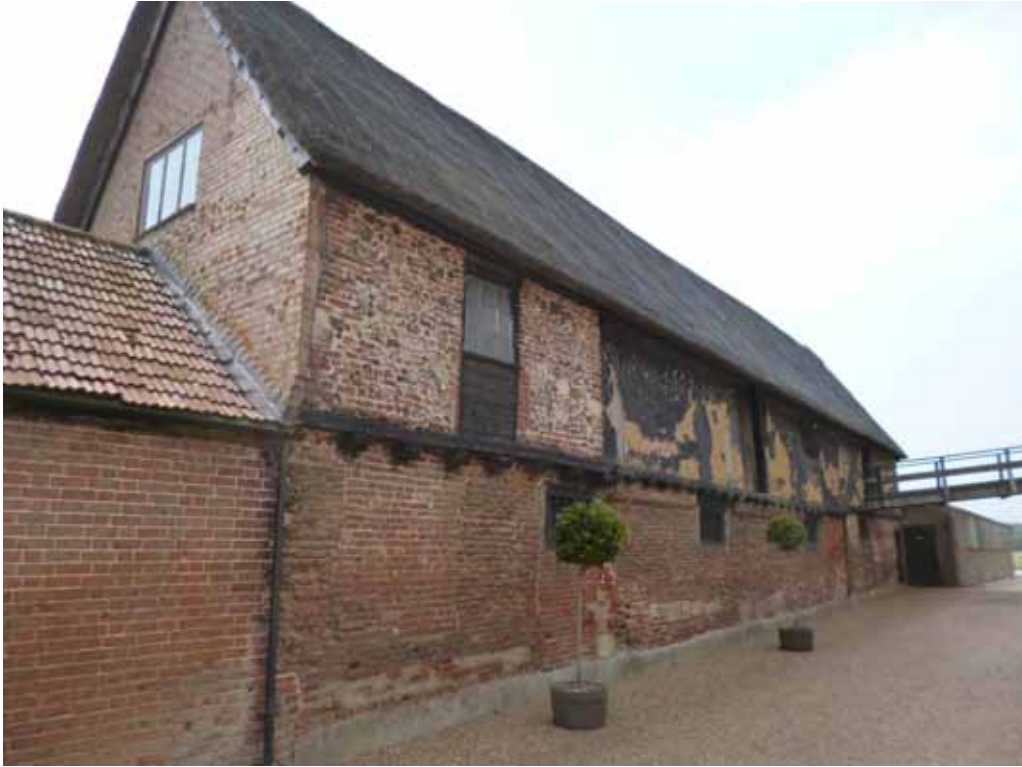
Figure 7: Former stable block, photograph taken from the north-west (Alison Arnold)

This Grade II* listed building on the Heritage at Risk register, has a red-brick ground floor with jettied timber-framed upper storey, beneath a steeply pitched, thatched roof (Fig 7). The roof is of a clasped purlin type, with curved wind bracing and surviving arch-braces to the two central tiebeams (Fig 8). Trusses 6 and 7 are immediately adjacent to each other suggesting they may have originally belonged to two separate buildings (Fig 9). The exposed first-floor frame consists of closely-set joists and bridging beams supported by timber posts (Fig 10). The building is currently thought to be sixteenth century with a rebuilt south gable in brick dating to the twentieth century.

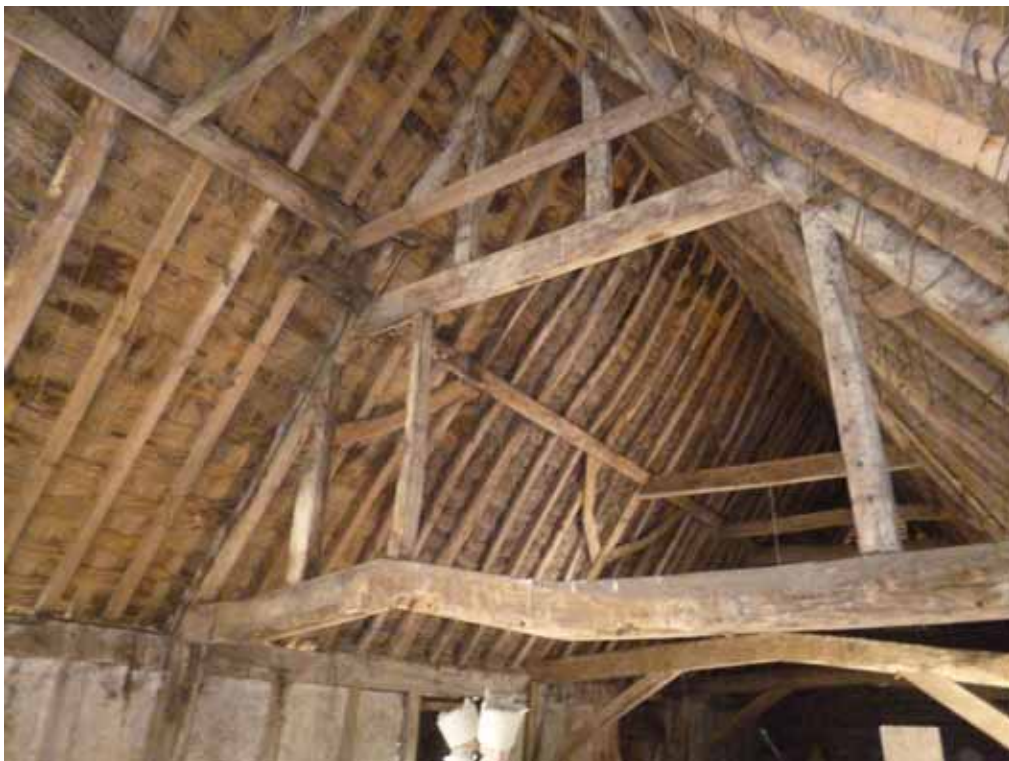
Figure 8: Former stable block, truss 3, photograph taken from the north-west (Alison Arnold)

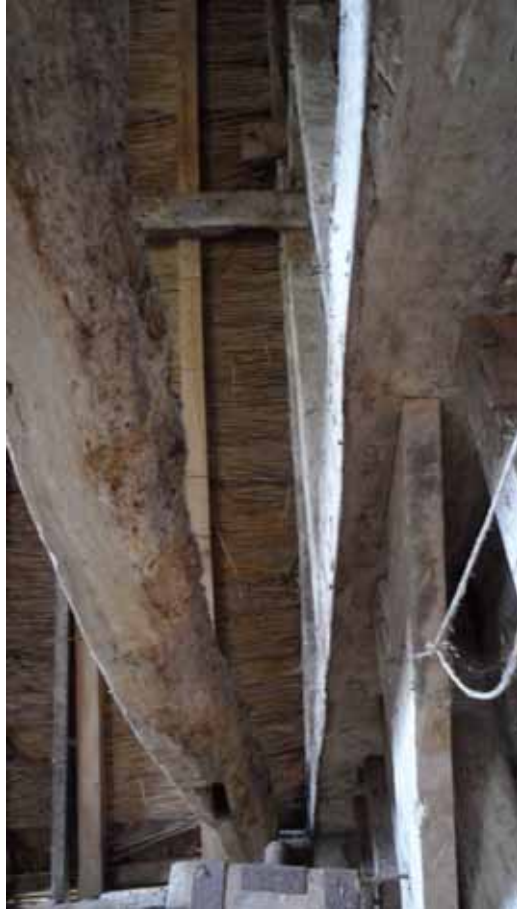
Figure 9: Former stable block, trusses 6 (right) and 7 (left) (Alison Arnold)

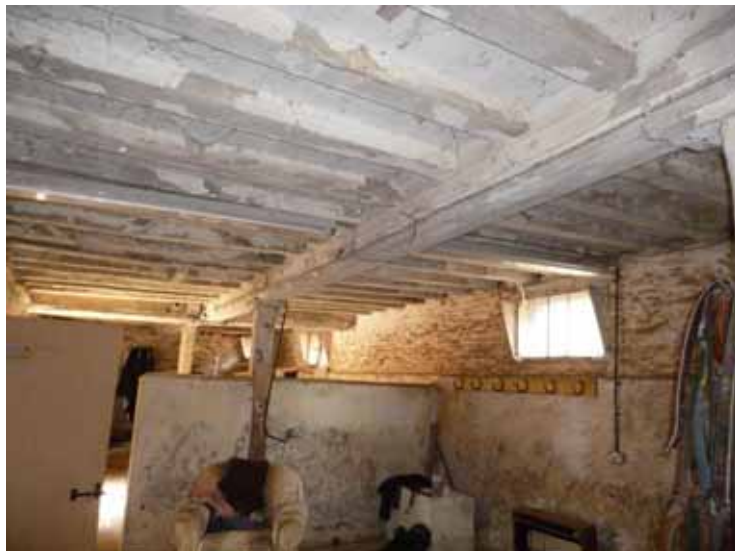
Figure 10: Former stable block, ground-floor ceiling (first-floor frame), photograph taken from the north (Alison Arnold)

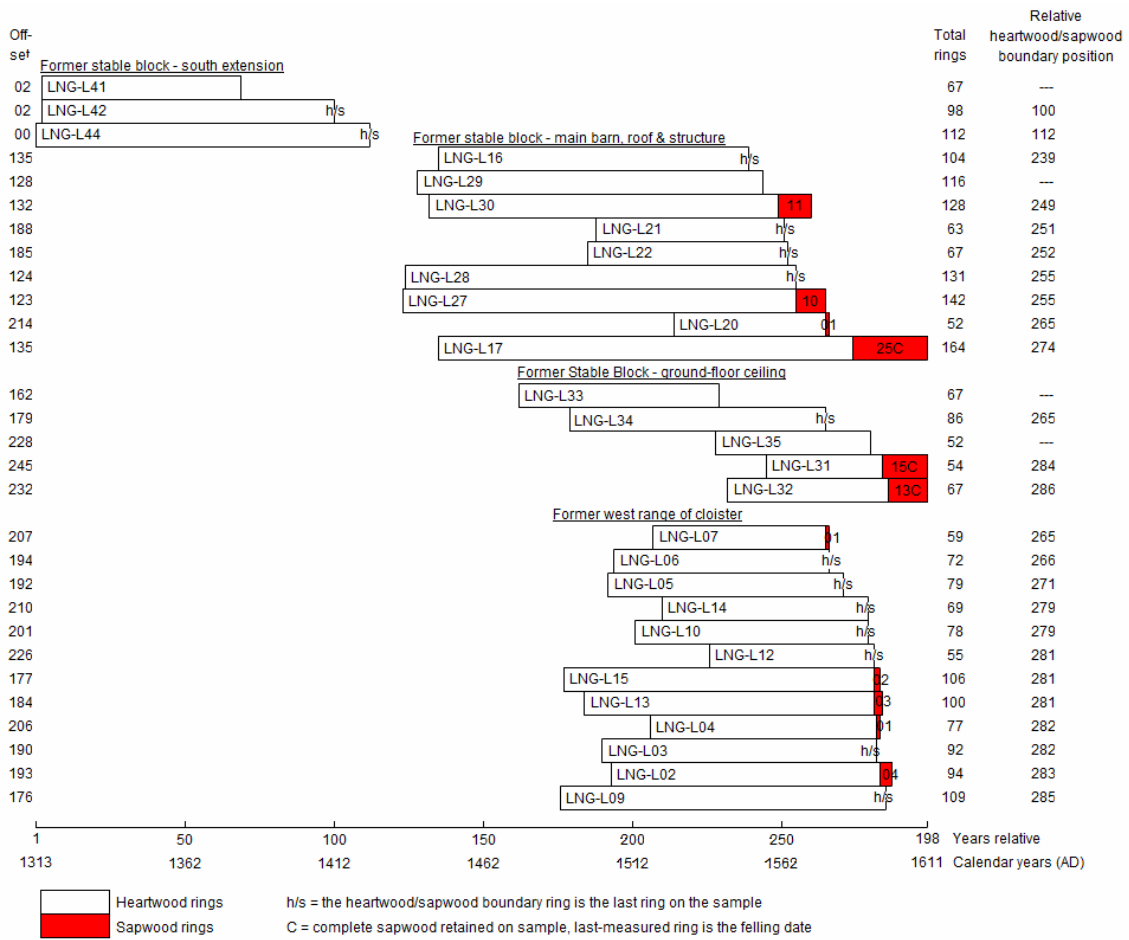
Figure 24: Bar diagram of all dated samples, sorted by area and heartwood/sapwood boundary ring position

Seventeen samples taken from the roof and floor frame of this building have been successfully dated (Fig 24), three within site sequence LNGLSQ01 and the remainder within LNGLSQ02.

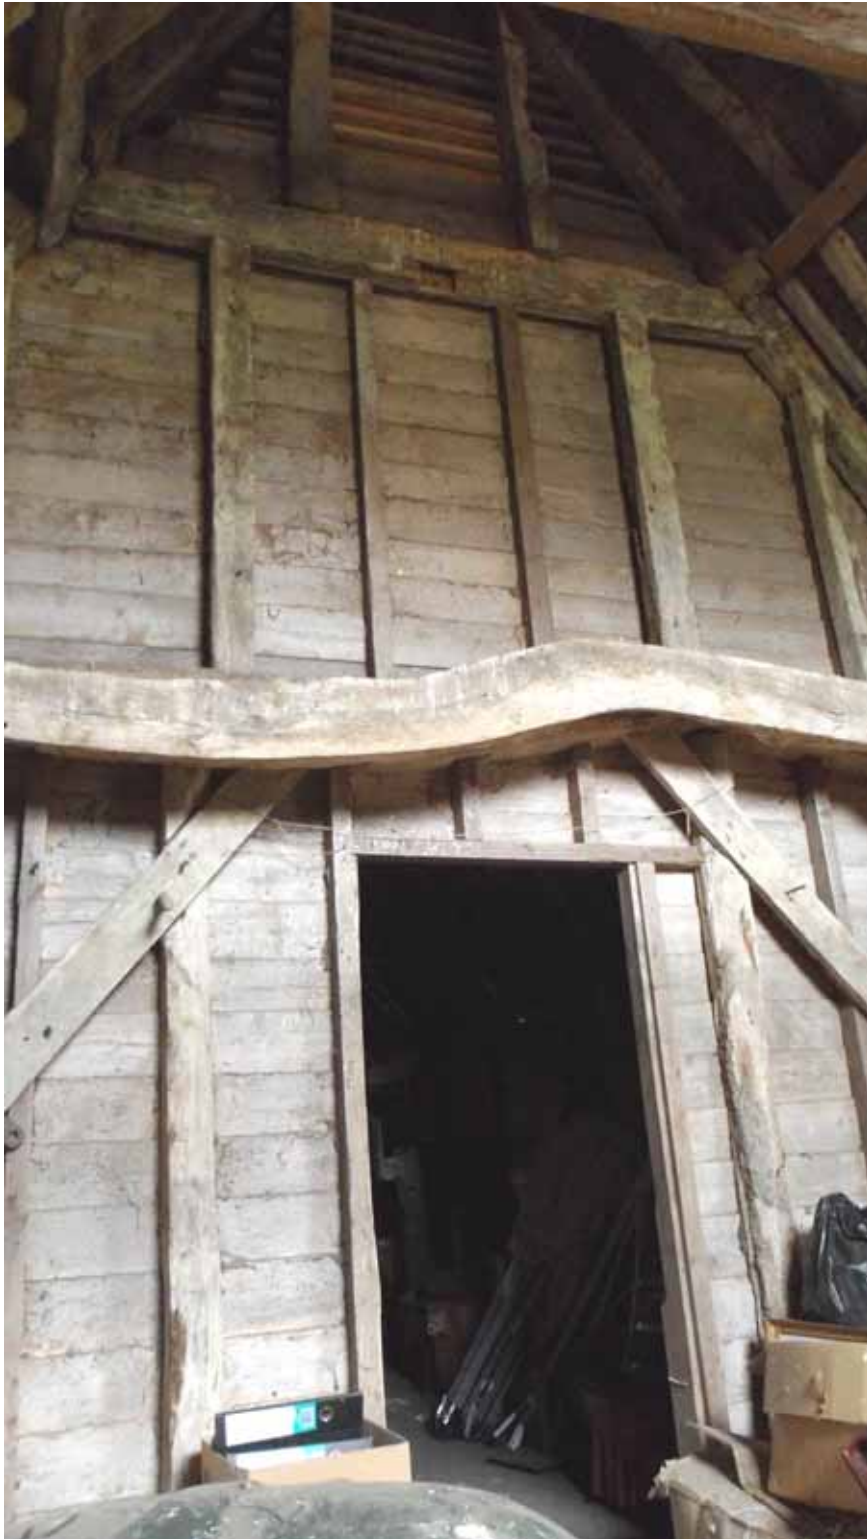
Figure 25: Truss 7 of the former stable block, with distinctive 'bend', taken from the south (Alison Arnold)

The dendrochronology appears to show the incorporation of a truss belonging to a mid fifteenth-century building into a later structure. Interestingly, it can be seen that the tiebeam of truss 7 is very similar in appearance to that of truss 3 with a distinctive 'bend' in it (Figs 8 and 25). The tiebeam of truss 3 was deemed unsuitable and not sampled whilst that of truss 7 has 47 rings only and is undated. Although conjecture, it may be that these two tiebeams are cut from the same tree suggesting the inclusion of at least one salvaged fifteenth-century timber in the main body of the barn (date by association with the other timber elements in this truss). Furthermore, this tiebeam appears to have an empty mortice for a brace with no matching mortice on the wall-post suggesting that either it is reused or the wall-post is a replacement.

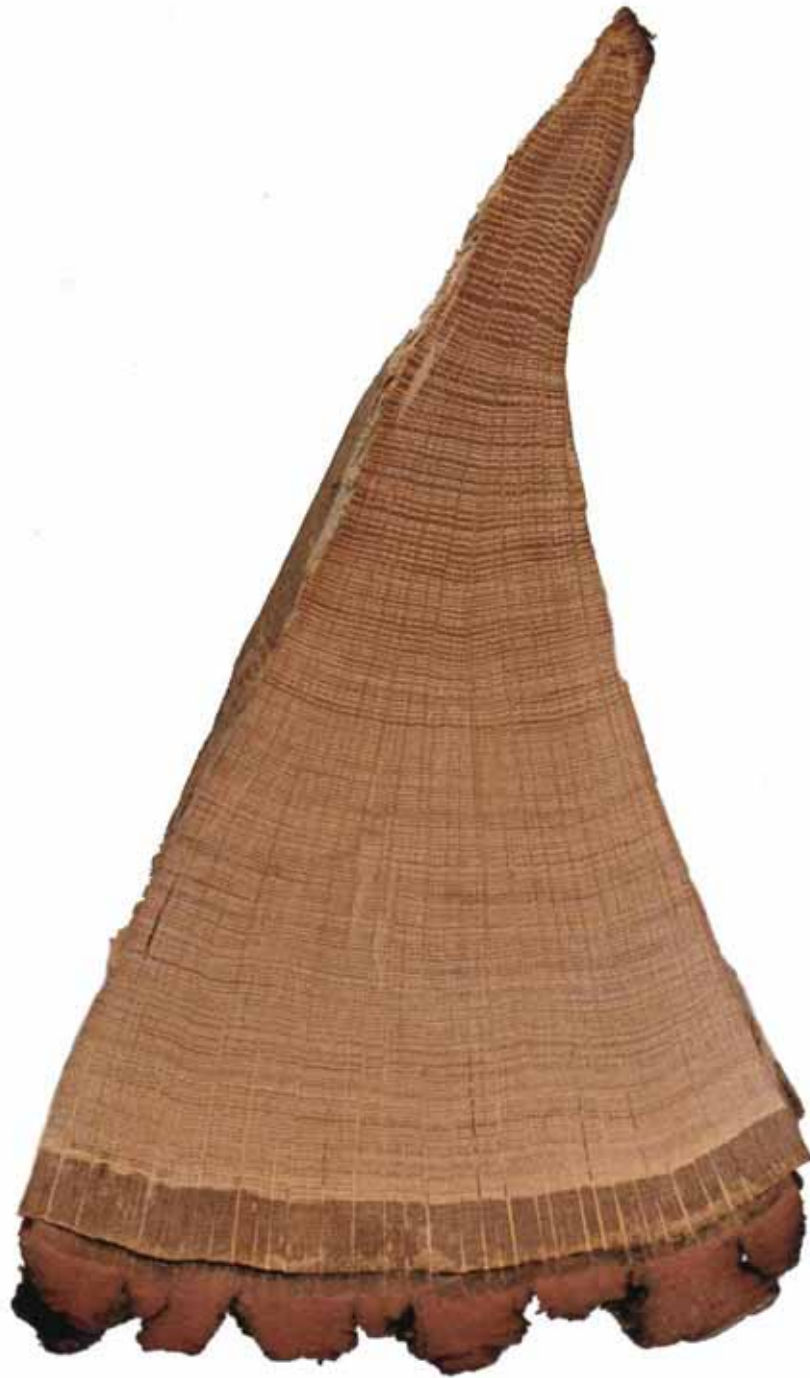
Figure A1: A wedge of oak from a tree felled in 1976. It shows the annual growth rings, one for each year from the innermost ring to the last ring on the outside just inside the bark. The year of each ring can be determined by counting back from the outside ring, which grew in 1976

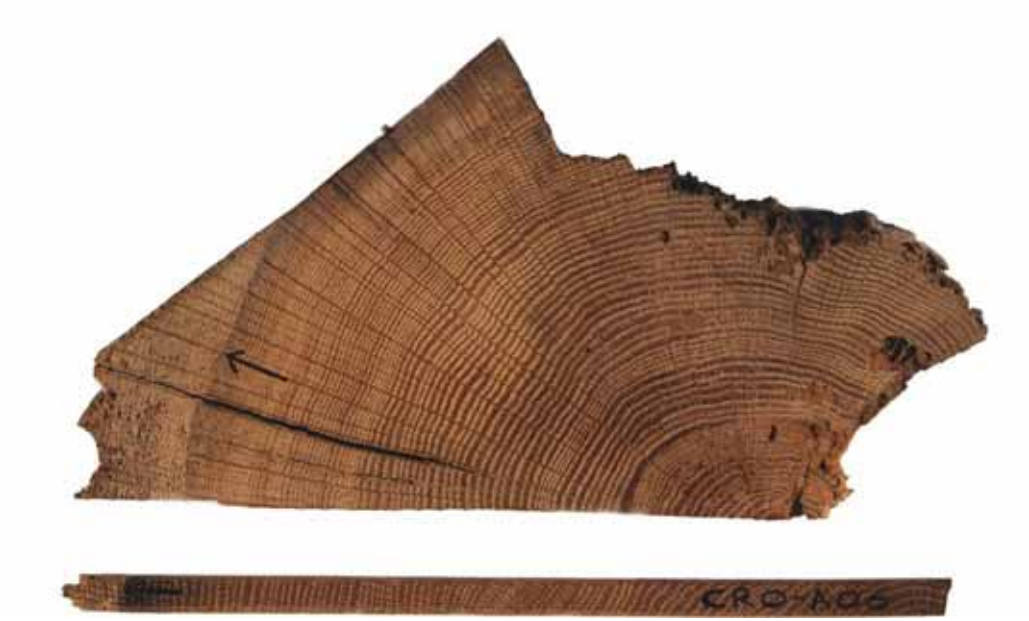
Figure A2: Cross-section of a rafter, showing sapwood rings in the left-hand corner, the arrow points to the heartwood/sapwood boundary (H/S); and a core with sapwood; again the arrow is pointing to the H/S. The core is about the size of a pencil

Quite often some, though not all, of the original outer rings are missing on a timber. The outer rings on an oak, called sapwood rings, are usually lighter than the inner rings, the heartwood, and so are relatively easy to identify. For example, sapwood can be seen in the corner of the rafter and at the outer end of the core in Figure A2, both indicated by arrows. More importantly for dendrochronology, the sapwood is relatively soft and so liable to insect attack and wear and tear. The builder, therefore, may remove some of the sapwood for precisely these reasons. Nevertheless, if at least some of the sapwood rings are left on a sample, we will know that not too many rings have been lost since felling so that the date of the last ring on the sample is only a few years before the date of the original last ring on the tree, and so to the date of felling.

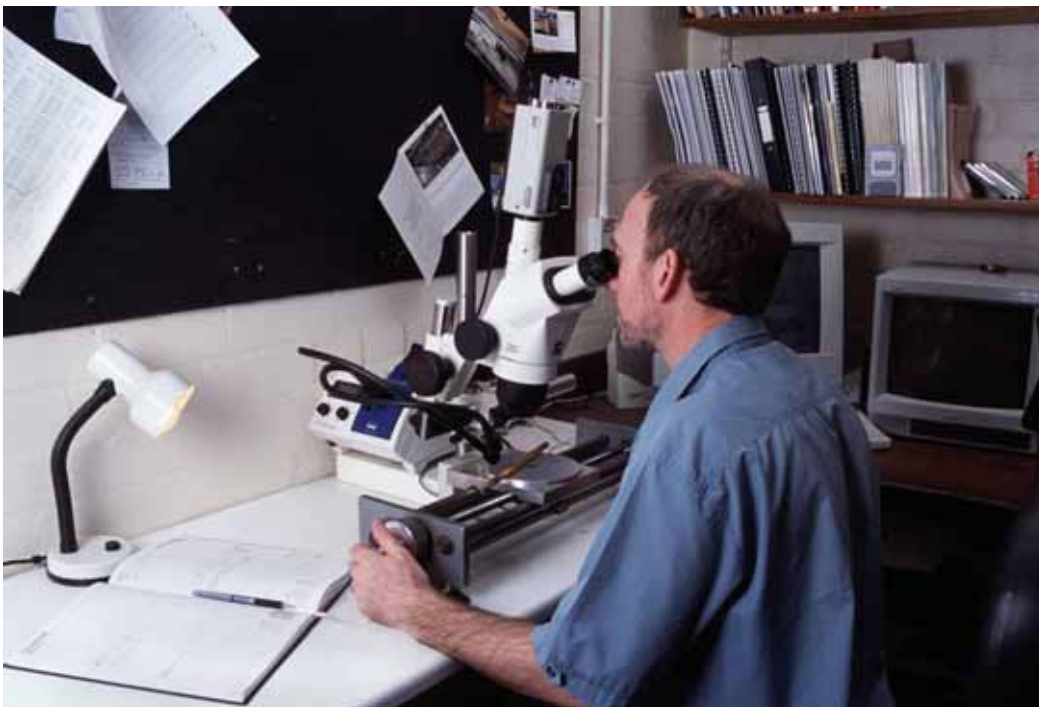
Figure A3: Measuring ring widths under a microscope. The microscope is fixed while the sample is on a moving platform. The total sequence of widths is measured twice to ensure that an error has not been made. This type of apparatus is needed to process a large number of samples on a regular basis

2. **Measuring Ring Widths.** Each core is sanded down with a belt sander using medium-grit paper and then finished by hand with flourgrade-grit paper. The rings are then clearly visible and differentiated from each other with a result very much like that shown in Figure A2. The core is then mounted on a movable table below a microscope and the ring-widths measured individually from the innermost ring to the outermost. The widths are automatically recorded in a computer file as they are measured (see Fig A3).
