RESEARCH REPORT SERIES no. 19-2014

PURCOMBE FARMHOUSE, BATTS LANE, MARSHWOOD, DORSET TREE-RING ANALYSIS OF TIMBERS

SCIENTIFIC DATING REPORT

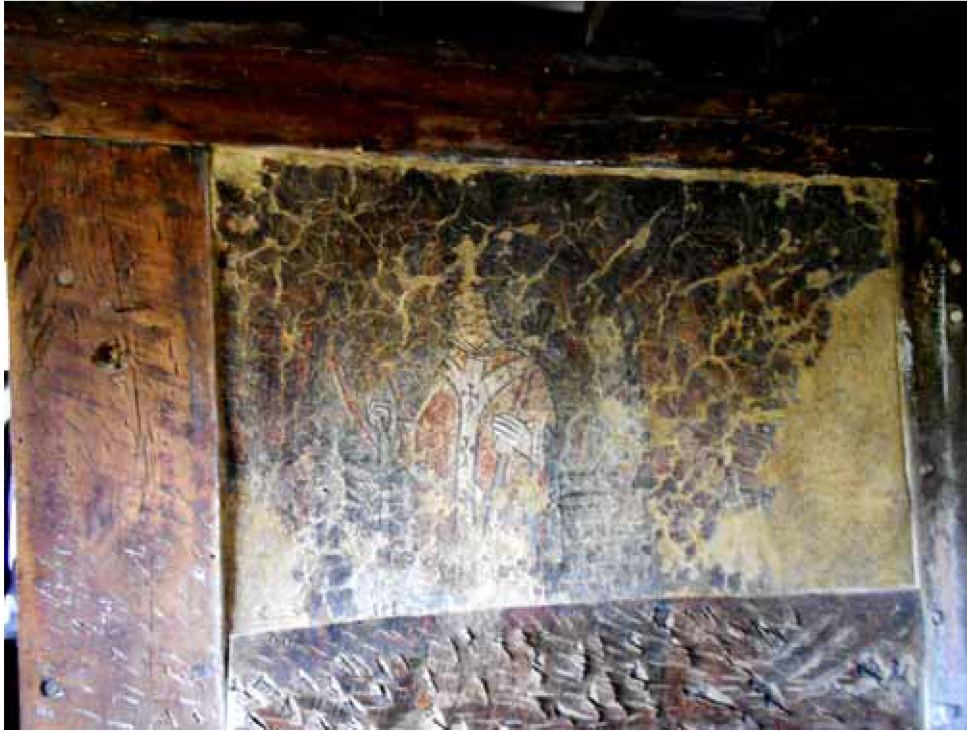
Figure 3: Painting of a saint extending onto the timber framework (Martin Bridge)

Another interesting outcome of the dating is being able to narrow down the date of the wall painting. This painting was probably done at the time of construction, although it could of course have been added later, but all the expert opinion suggests that it must be pre-Reformation. This narrows its date range to AD 1505–38.
